SD1998-18-F

The Determination of the Permeability, Density, and Bond Strength of Non-Metallic Fiber Reinforced Concrete in Bridge Deck Overlay Applications

Study SD1998-18 Final Report

Prepared by
Dr. V. Ramakrishnan, Distinguished Professor
Kumar R. Santhosh, Research Associate
Department of Civil and Environmental Engineering, SDSM&T,
501 East St. Joseph Street
Rapid City, SD 57701-3995

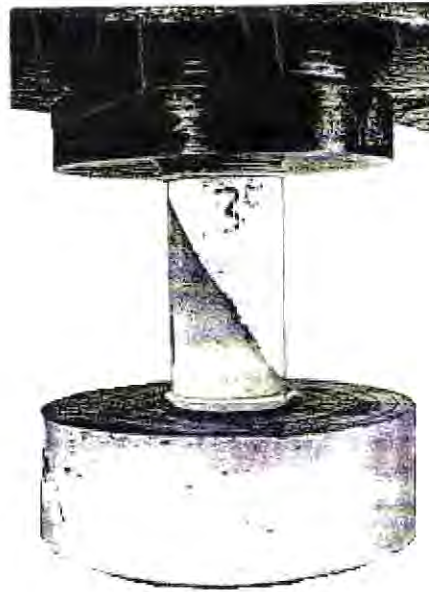
Figure 1.7: Slant Shear Specimen Being Compressed. One half of the Specimen was Base Portland Cement Concrete and the other half was the Repair Material.
(Reference 26)

The modification of ASTM C 882 (21) slant shear bond test consisted of replacing one-half of the slant shear specimens with repair material. That is, one-half of the specimen was repair material bonded to the other half, which was base concrete. The angle of the shear plane was approximately 30° with respect to the longitudinal axis of the cylinder. Figure 1.7 shows a slant shear specimen being compressed.

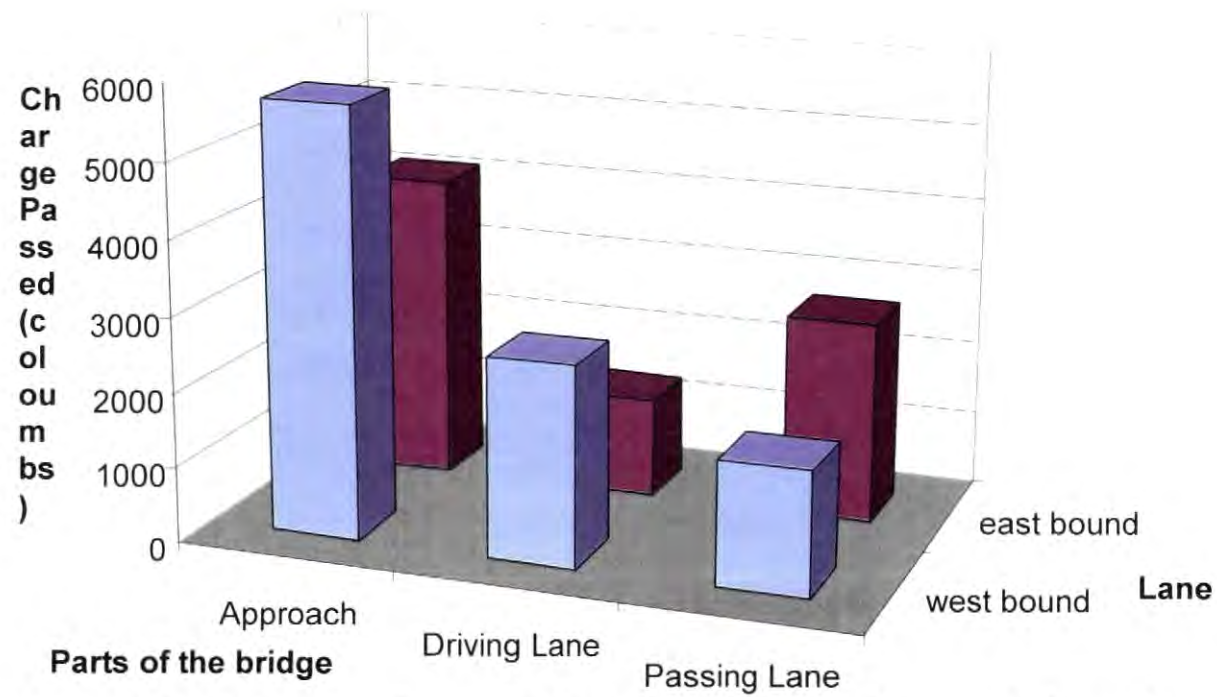
Figure 3.1: Comparison of the Total Charge Passes Through Cores from West and East Bound Lanes at Exit 32, I 90 (Sturgis)

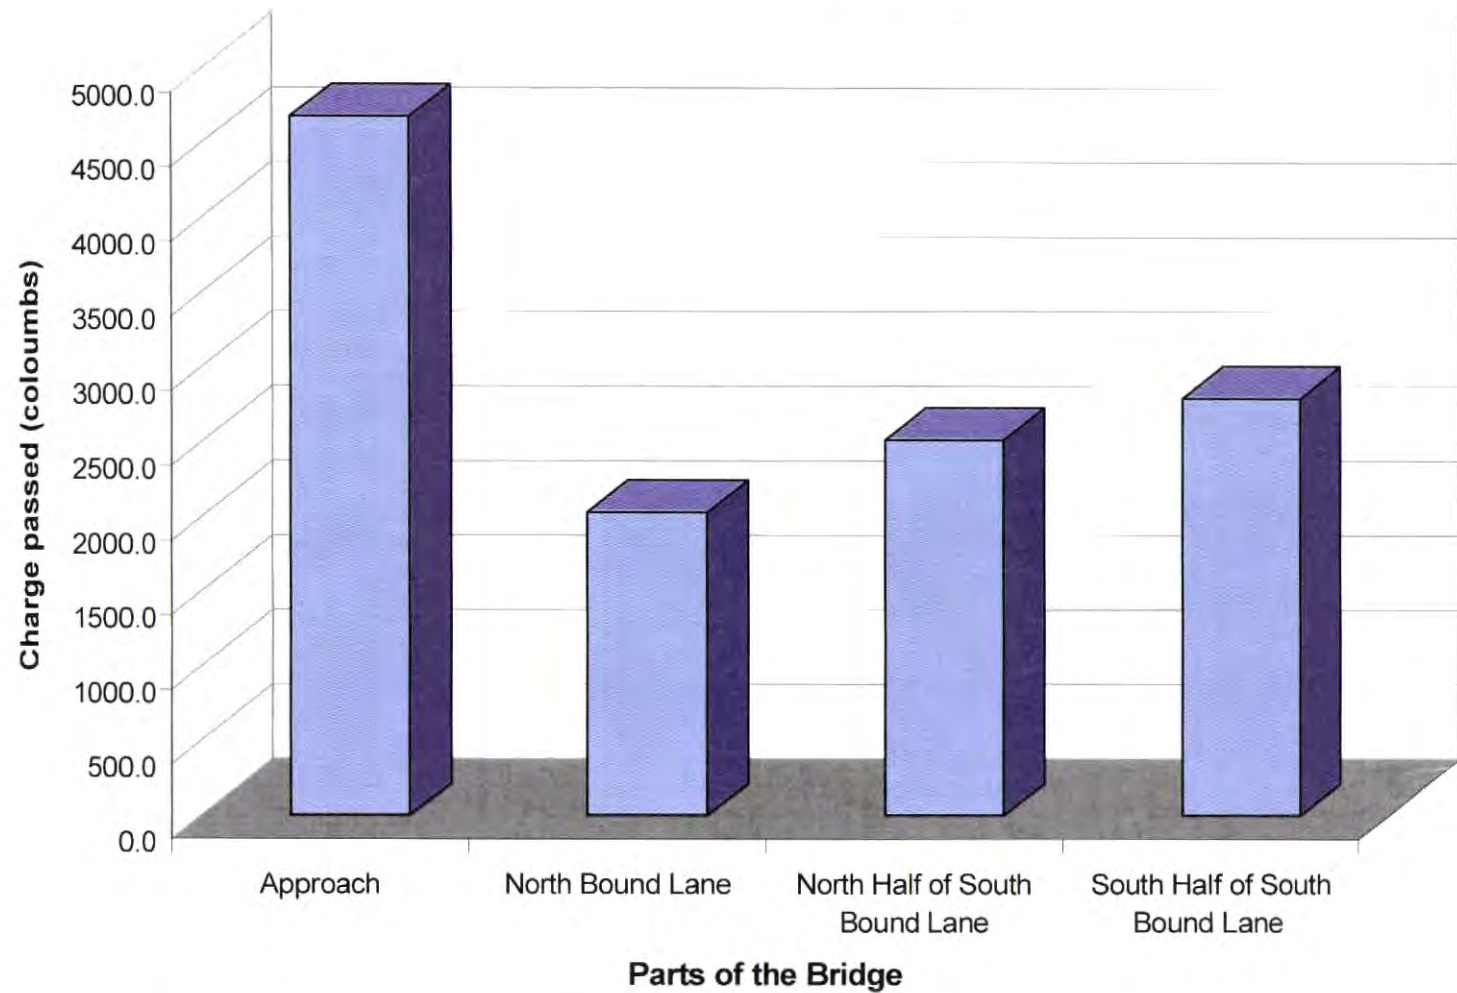
Fig 3.2: Comparison of the Total Charge Passed Through Cores from Various Locations on the Bridge at Exit 212, I 90 (Vivian)

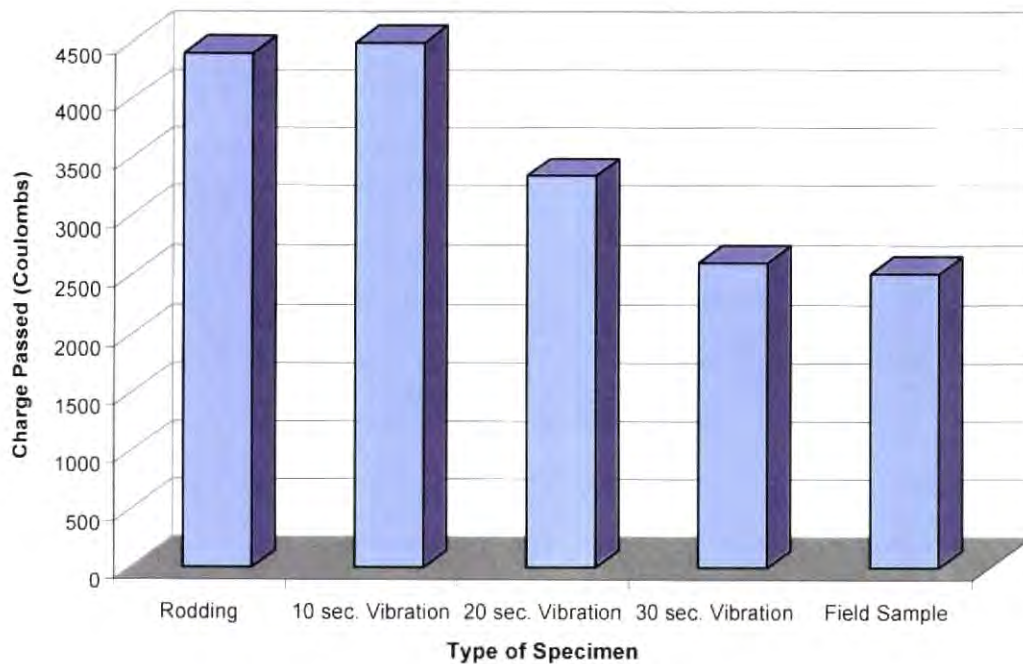
Figure 7.2: Comparison of Permeabilities of Cores from Field on the North Half of the South Bound Lane of the Bridge at Exit 212, I 90 (Vivian) and Cylinders cast in Lab

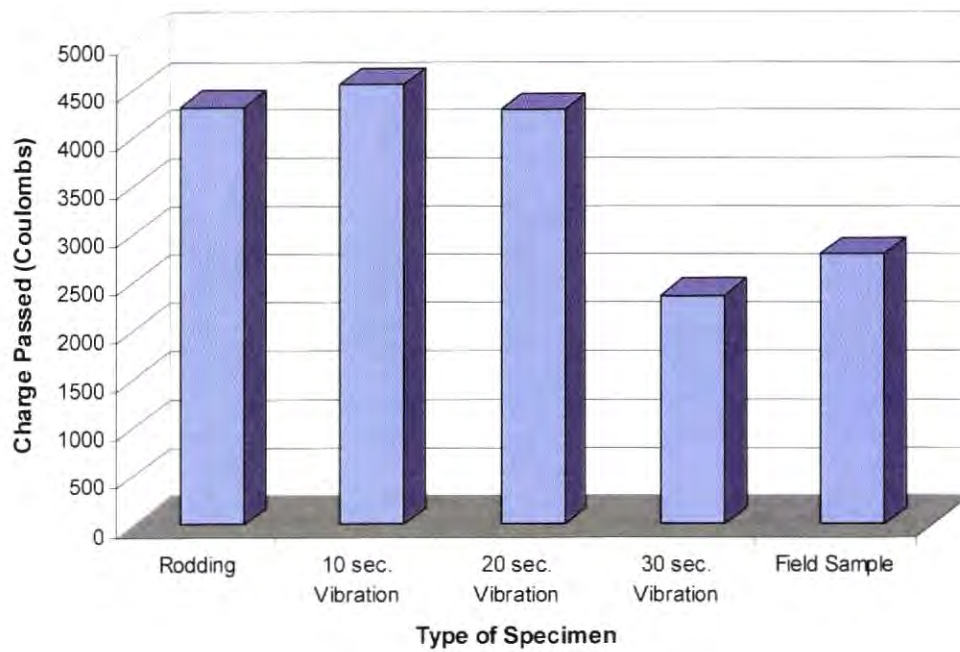
Figure 7.3: Comparison of Permeabilities of Cores from Field on the South Half of the South Bound Lane of the Bridge at Exit 212, I 90 (Vivian) and Cylinders cast in Lab

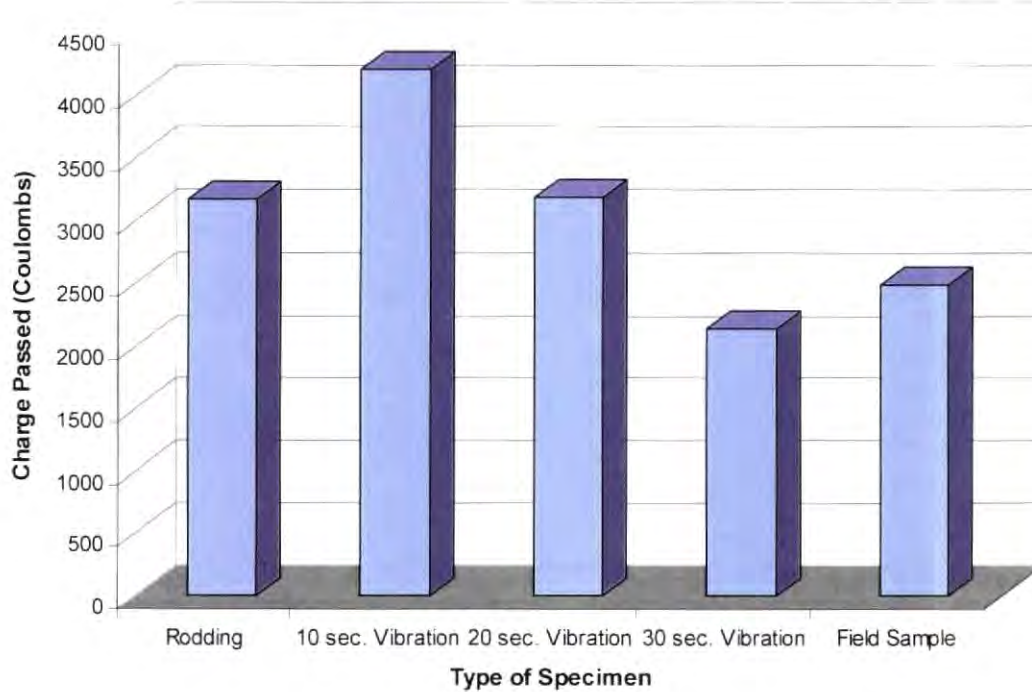
Figure 7.5: Comparison of Permeabilities of Cores from Field on the Bridge at Exit 32, I 90 (Sturgis) and Cylinders cast in Lab

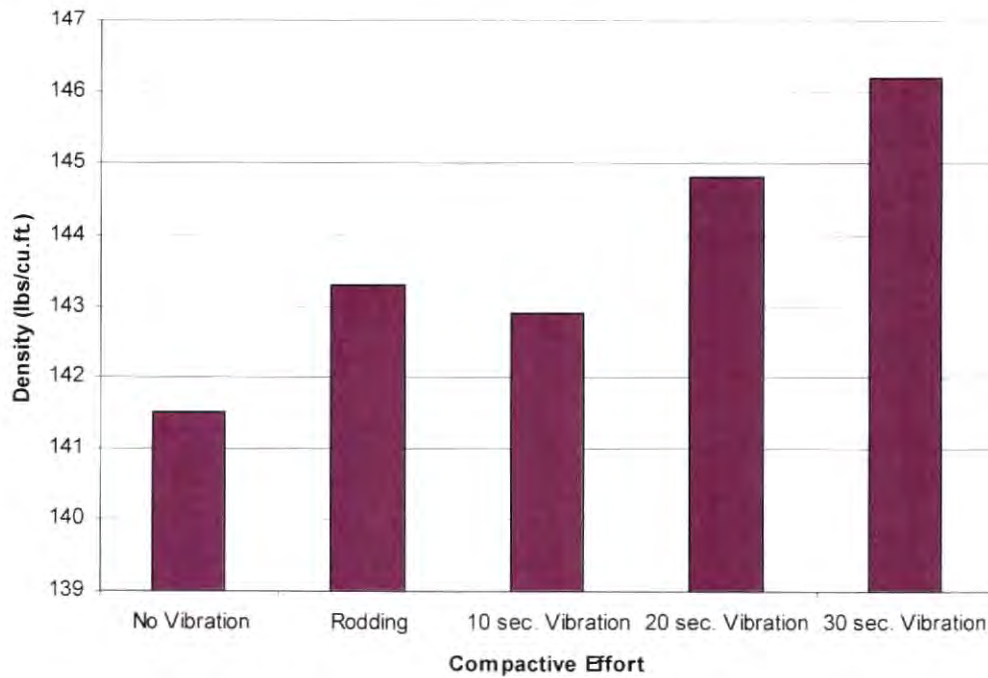
Figure 7.6: Comparison of Densities of Cylinders cast in Lab (North Bound lane of the Bridge at Exit 212, I 90 (Vivian))

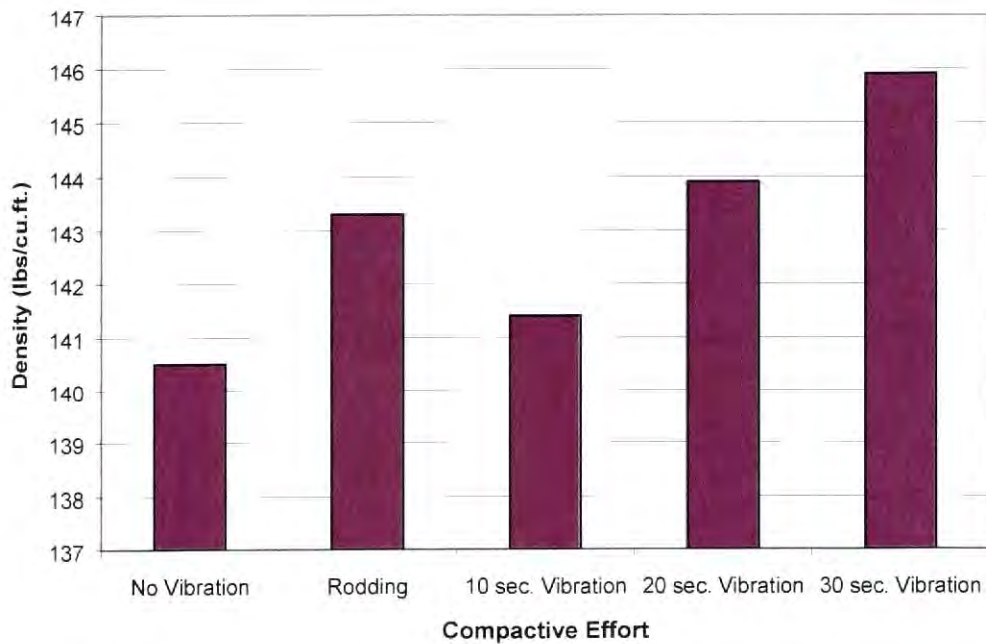
Figure 7.8: Comparison of Densities of Cylinders cast in Lab (South Half of South Bound lane of the Bridge at Exit 212, I 90 (Vivian))

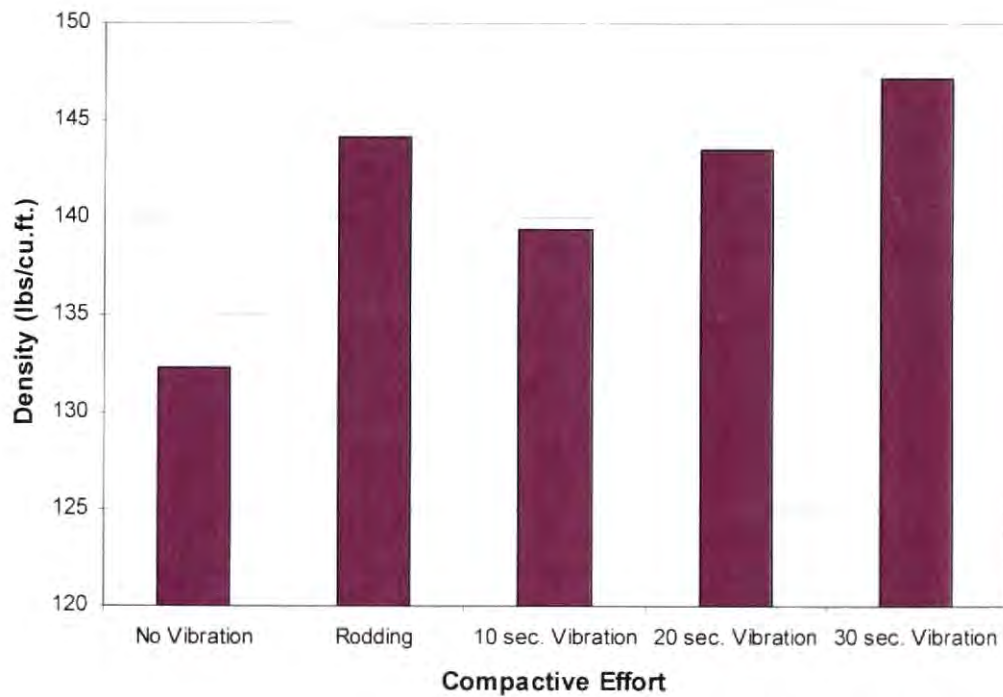
Figure 7.9: Comparison of Densities of Cylinders cast in Lab (Approach to the Bridge at Exit 212, I 90 (Vivian))

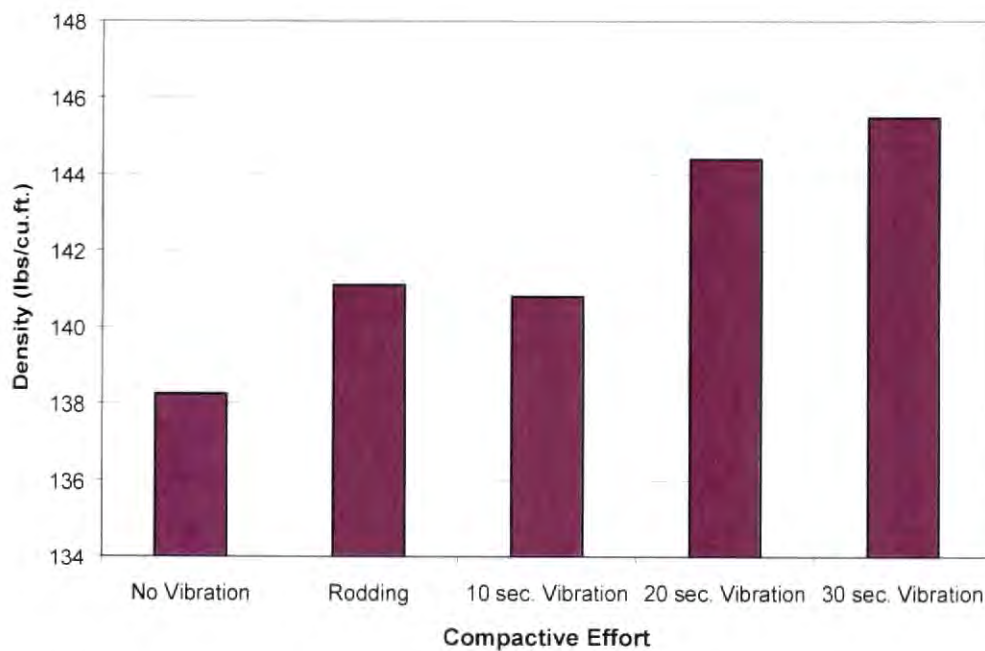
Figure 7.10: Comparison of Densities of Cylinders cast in Lab (Bridge at Exit 32, I 90 (Sturgis))

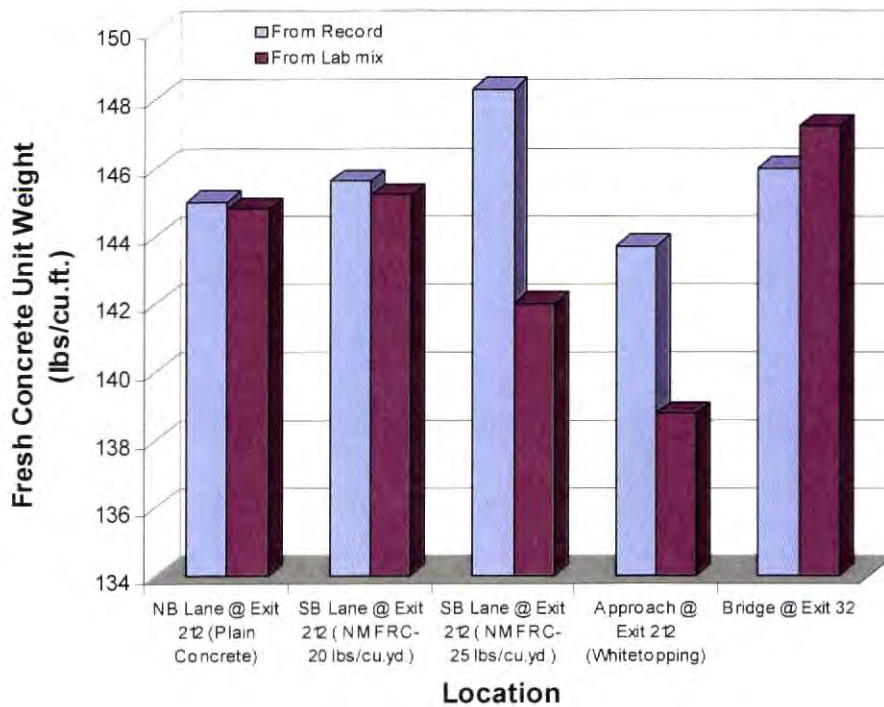
Figure 7.12: Comparison of the Fresh Concrete Unit Weight from Record and Lab Mixes

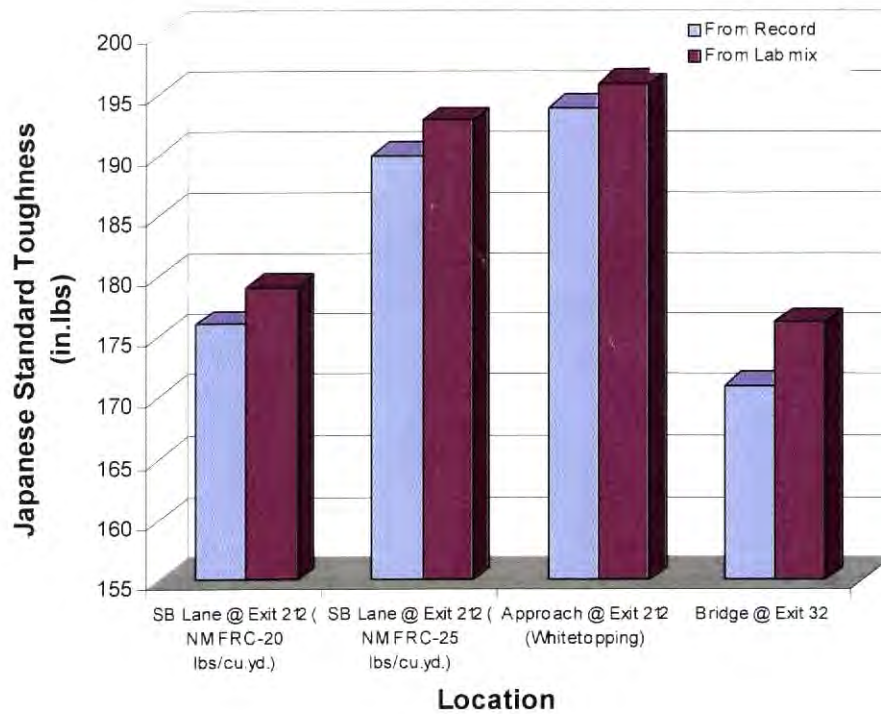
Figure 7.19: Comparison of Japanese Standard Toughness from Record and Lab Mixes

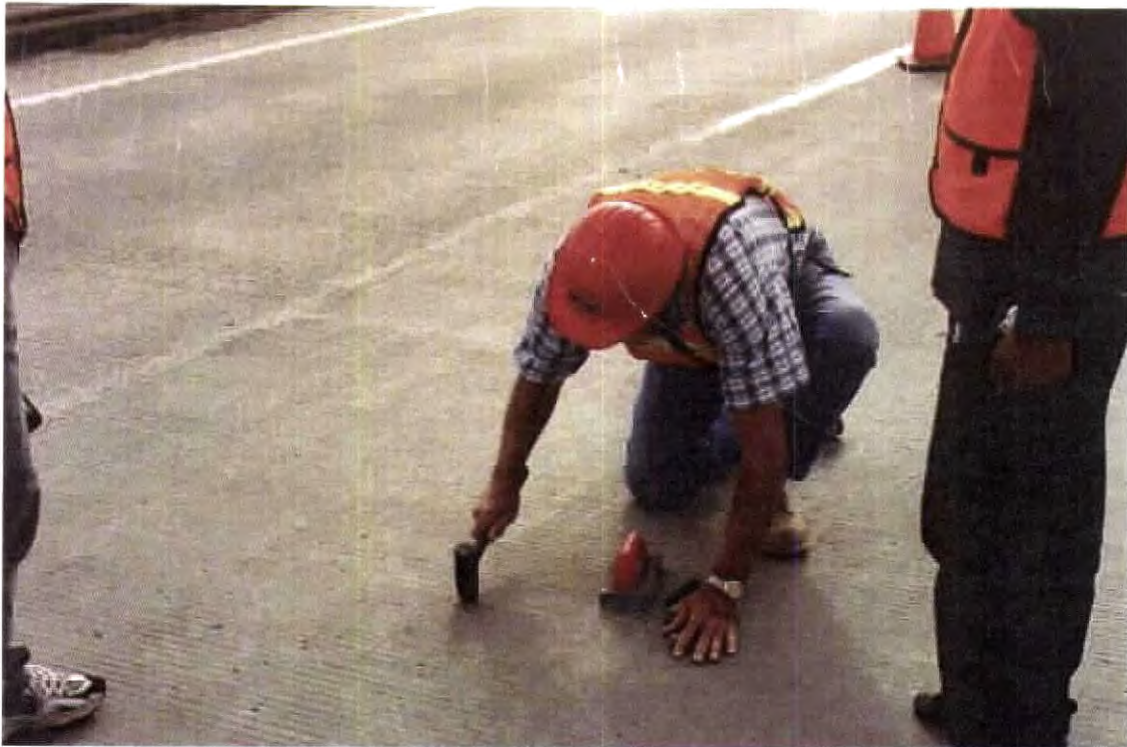
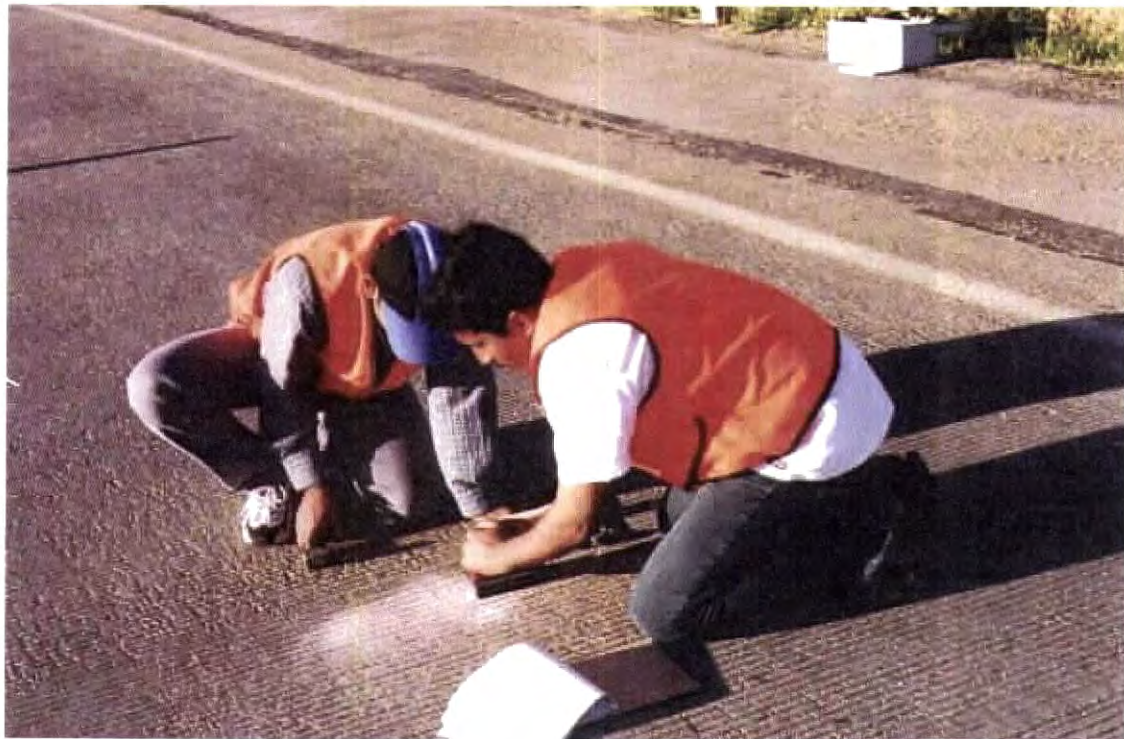
The surface of the pavement was scarified, (chipped with a hammer, smoothed with a concrete carbide abrasive and cleaned with a wire brush) prior to the coring. This was done to ensure that all the surface defects like swelling, carbonation and any presence of grease, oil, etc. were removed which in turn aids in the good bonding of the surface with epoxy.

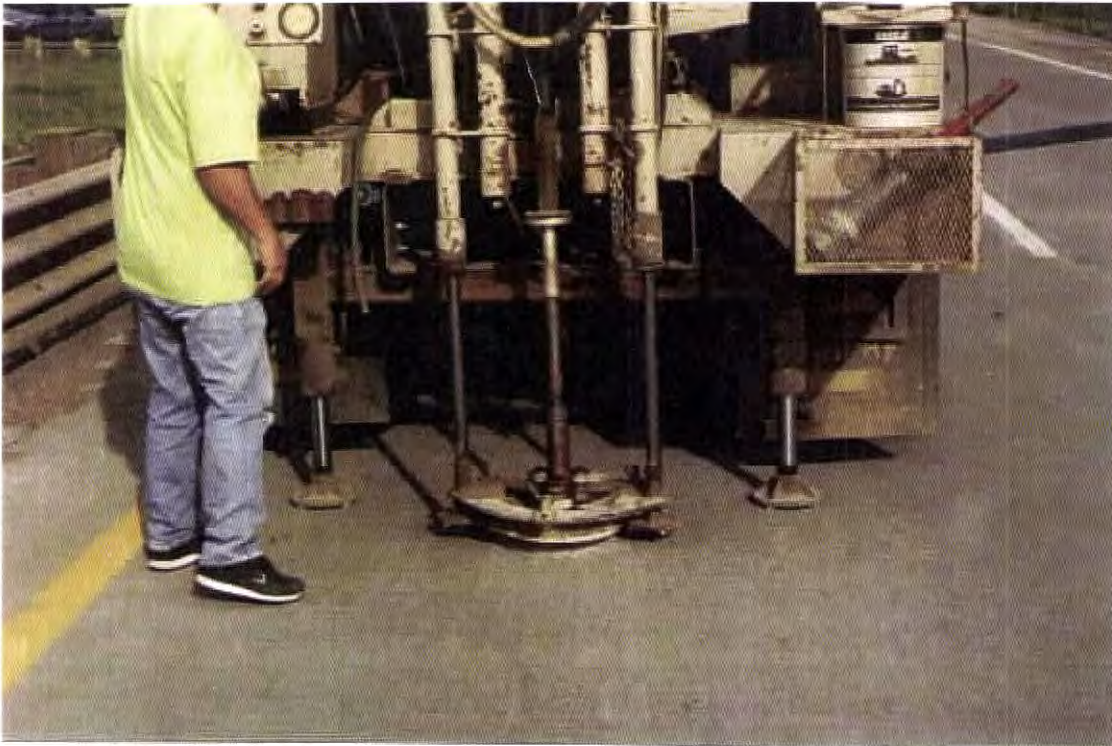
Alignment of the two legs to maintain the verticality of the core bit.

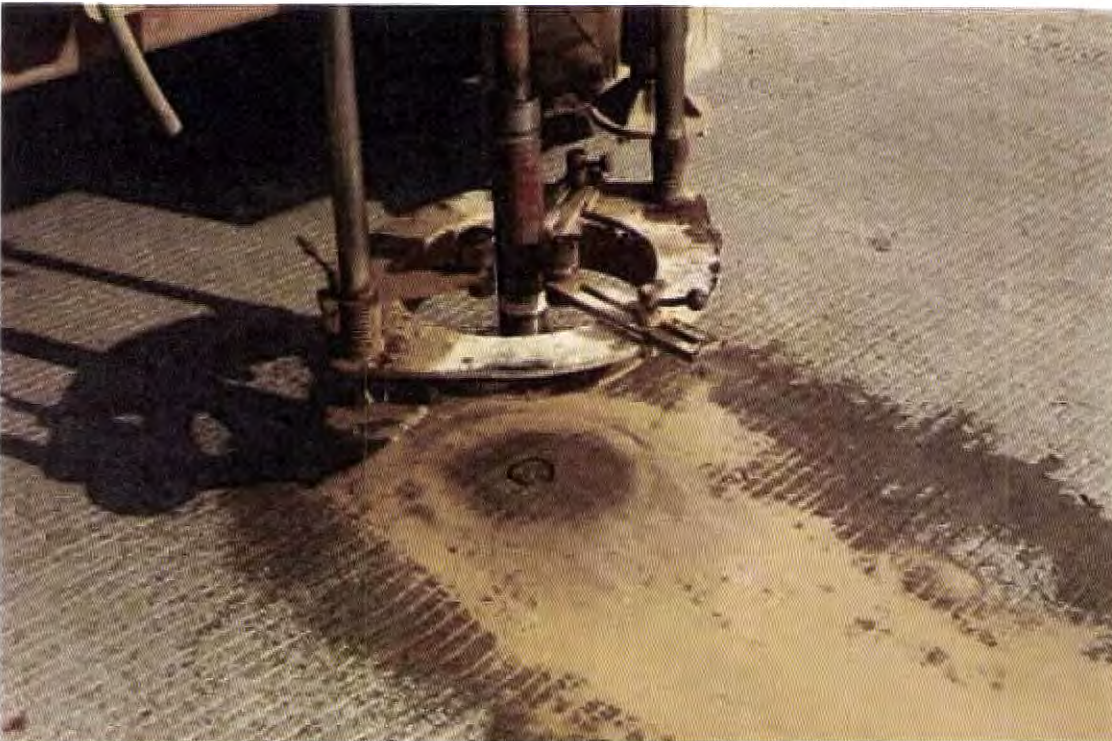
After the coring operation was completed the core bit was removed very carefully so that no lateral pressure was applied on the cores which might result in its breakage.

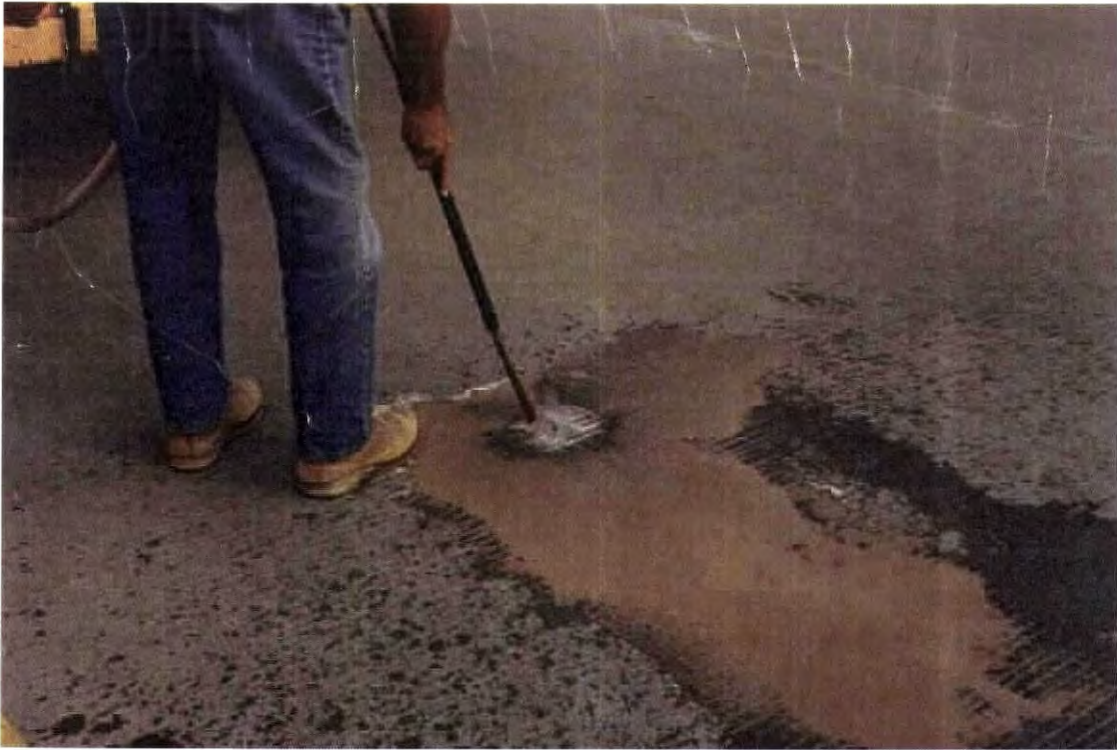
After the coring operation, the core location was thoroughly cleaned with compressed air. All the concrete dust, pieces of rock and moisture were removed from the core rim.

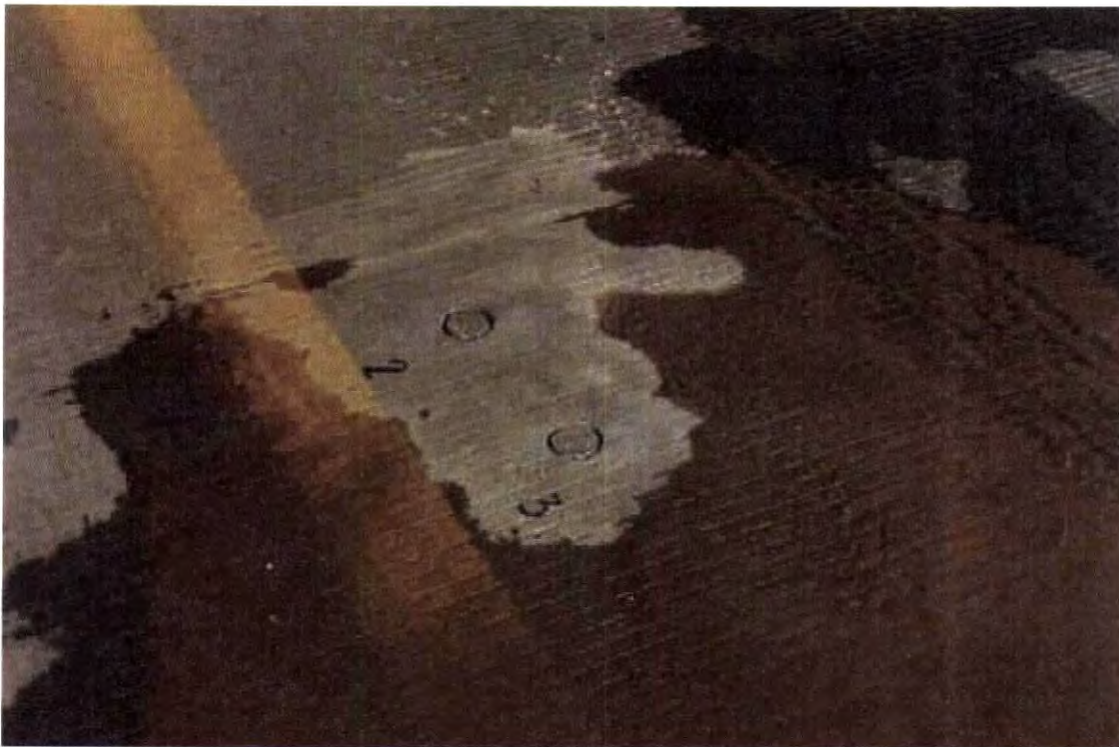
The core location was marked on the pavement and its position with respect to a permanent benchmark was measured and noted down.

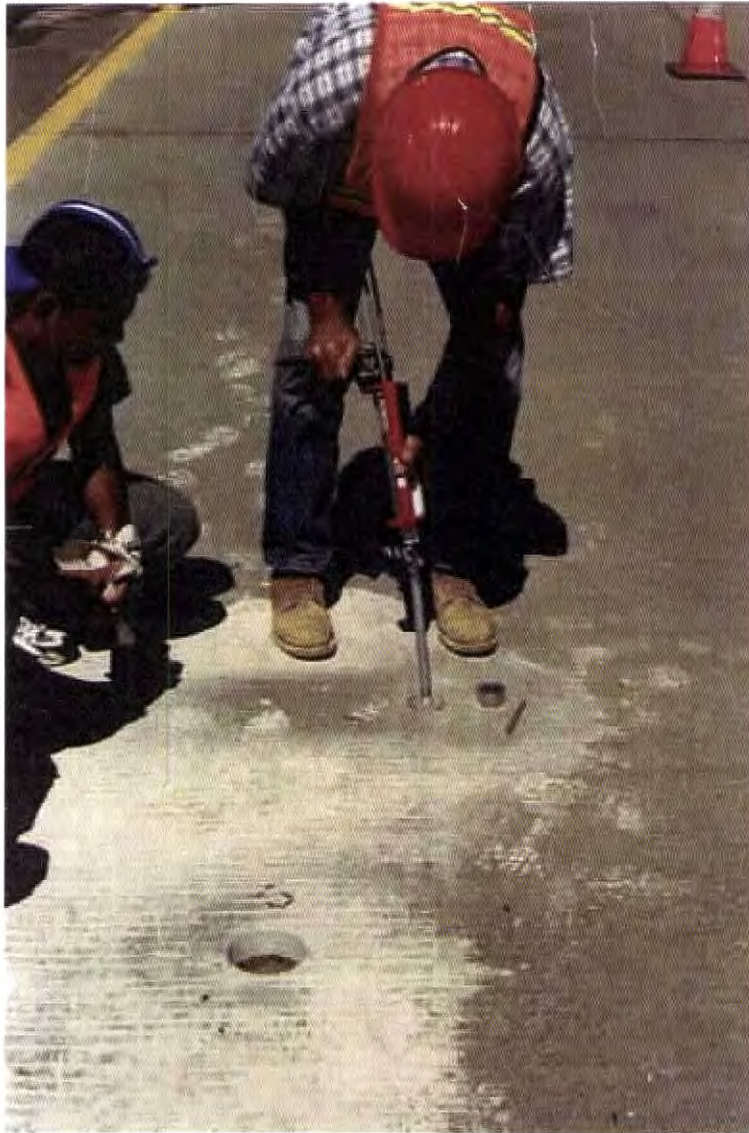
Sufficient quantity of epoxy was placed on the core such that it would adequately cover the core's top.

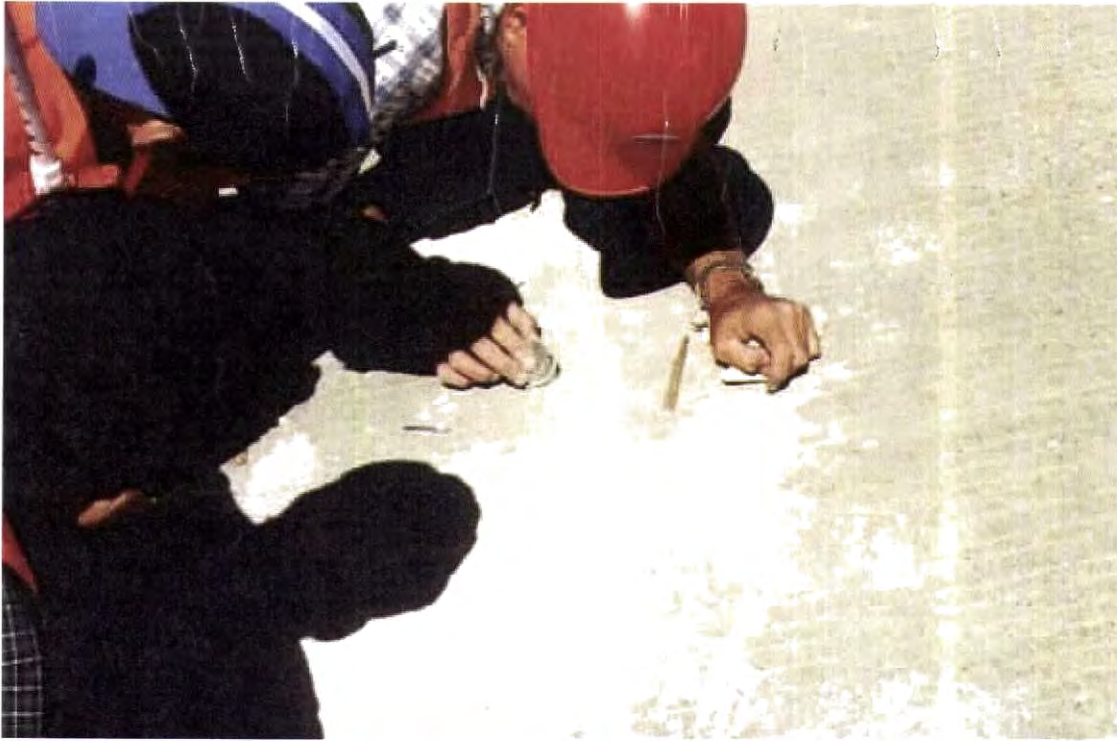
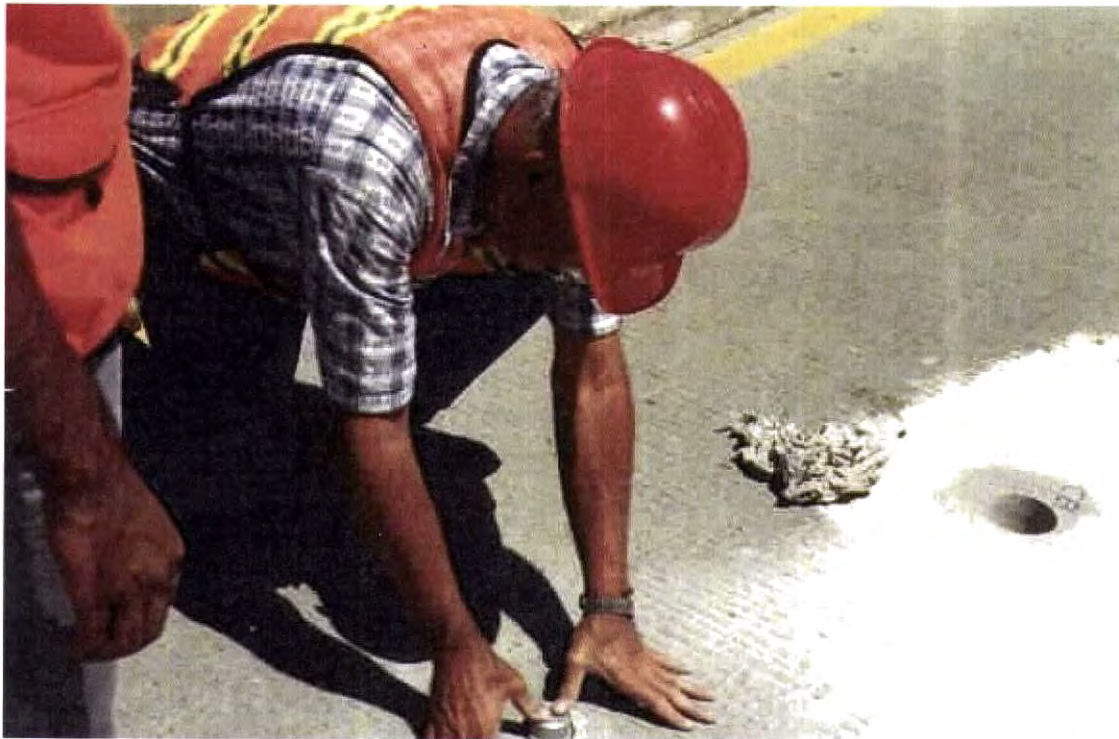
The bond disk was placed on the core such that the hole for the pull-pin face up and was gently pressed onto the core until it was finally seated and centered.

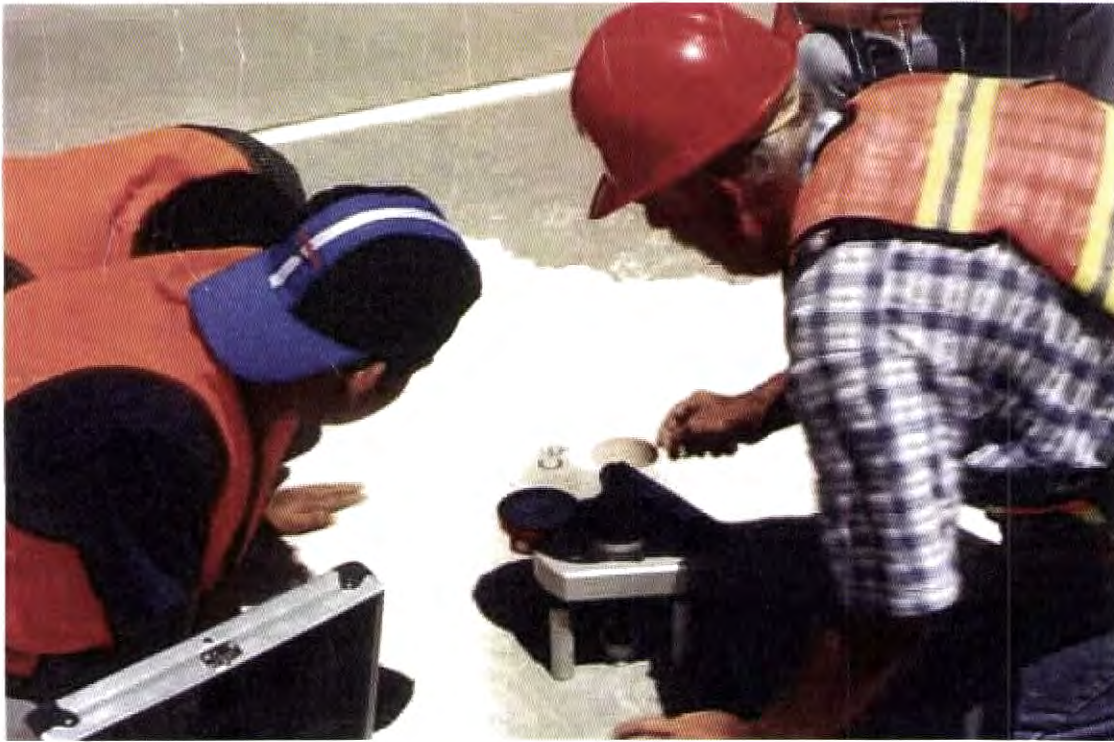
The bond test equipment was positioned on the disk.

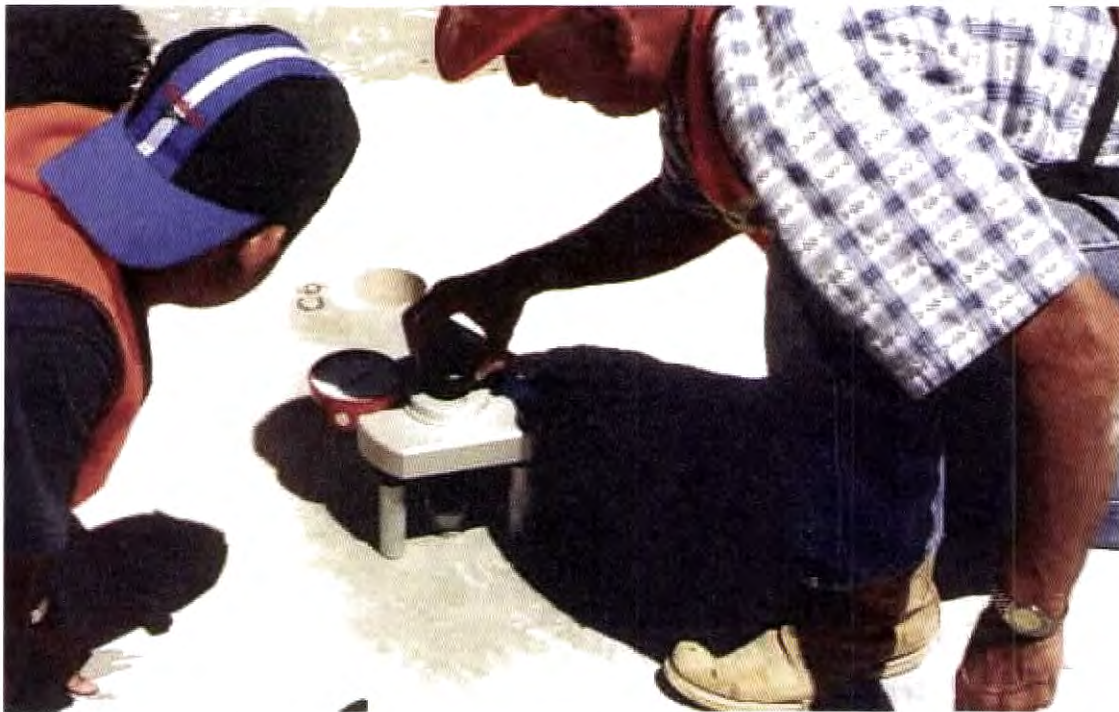
By adjusting the notched wheel on the top, the head of the pull-pin was fixed into the socket at the base of the central axis of the equipment. The equipment was leveled by adjusting the three legs.

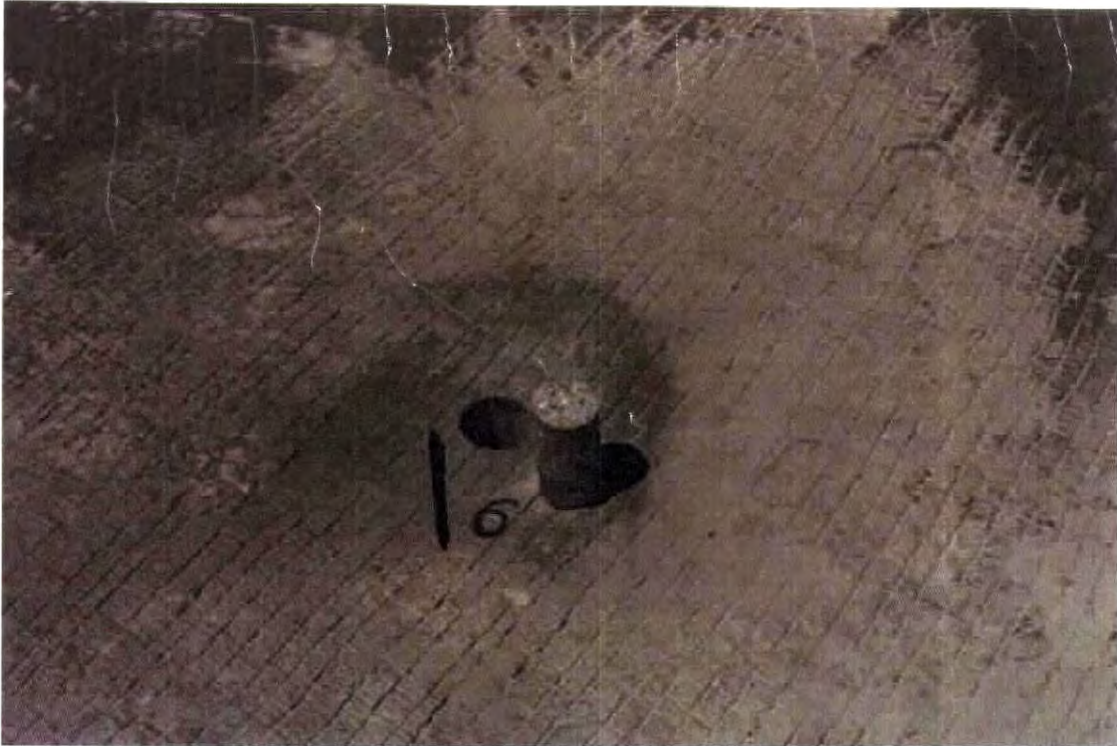
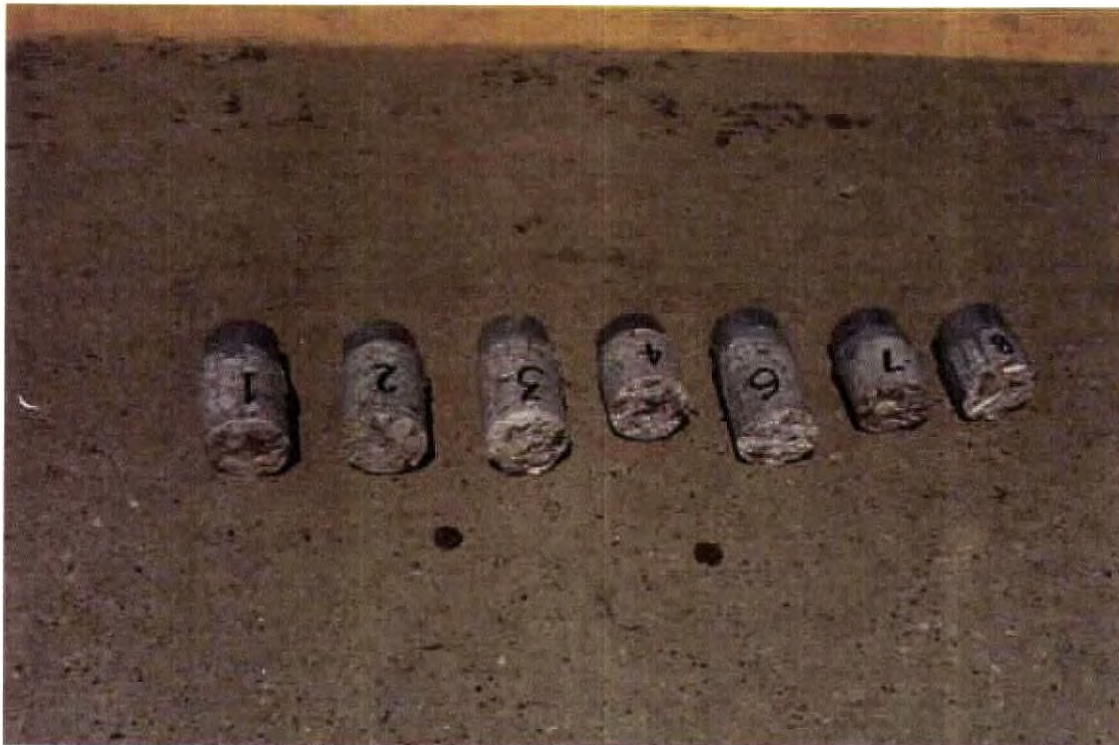
The pictures show fractured bond test specimens. The penny and pen are shown for size comparison.

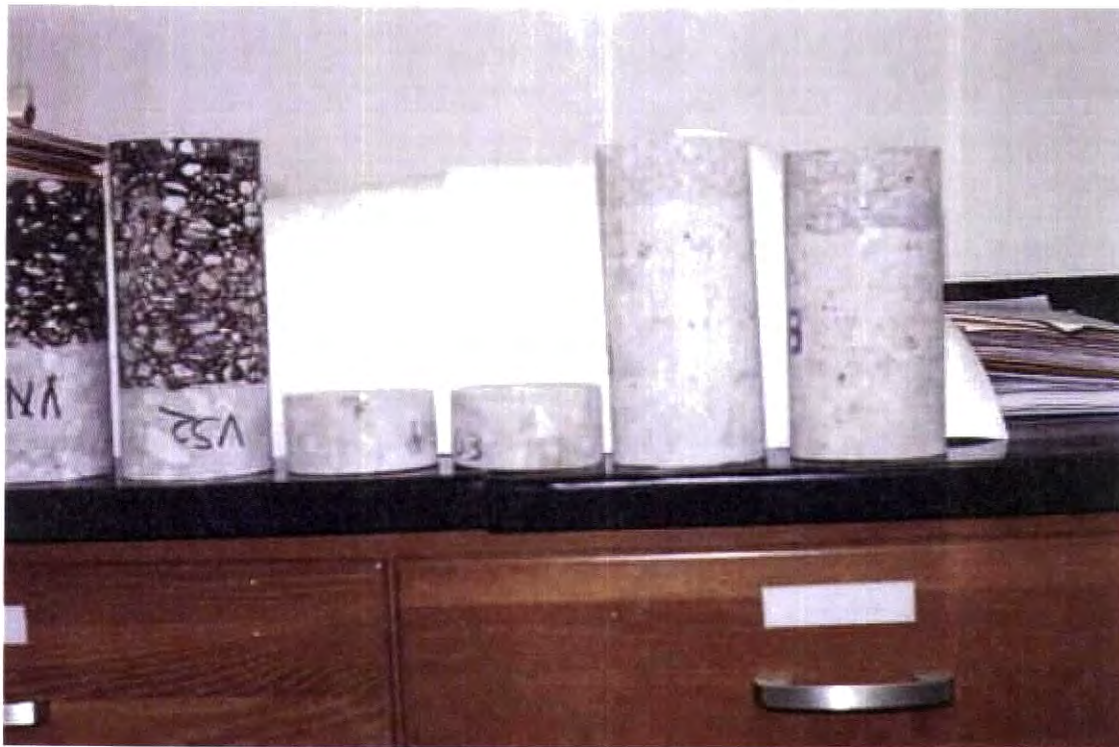
Specimens ready for lab bond test.

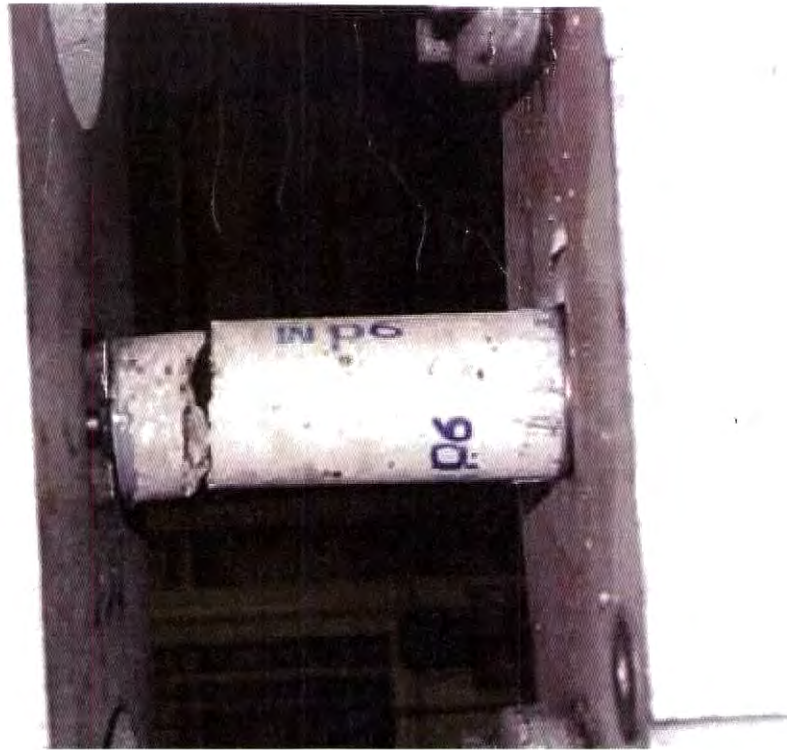
Fractured specimen immediately after lab bond test.

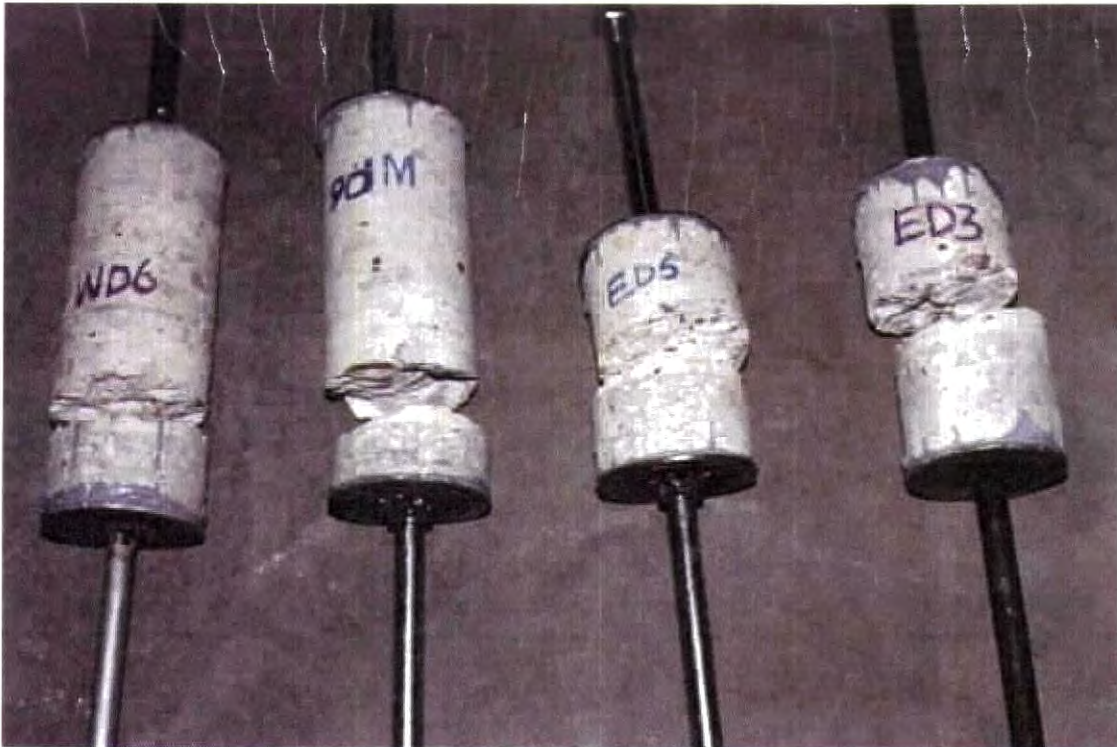
Fractured core specimens after lab bond test. The failure surface and the depth of overlay are very clearly visible. Specimens from the bridge at exit 32, I-90 (Sturgis).
