SD1998-18-F

The Determination of the Permeability, Density, and Bond Strength of Non-Metallic Fiber Reinforced Concrete in Bridge Deck Overlay Applications

Study SD1998-18 Final Report

Prepared by
Dr. V. Ramakrishnan, Distinguished Professor
Kumar R. Santhosh, Research Associate
Department of Civil and Environmental Engineering, SDSM&T,
501 East St. Joseph Street
Rapid City, SD 57701-3995

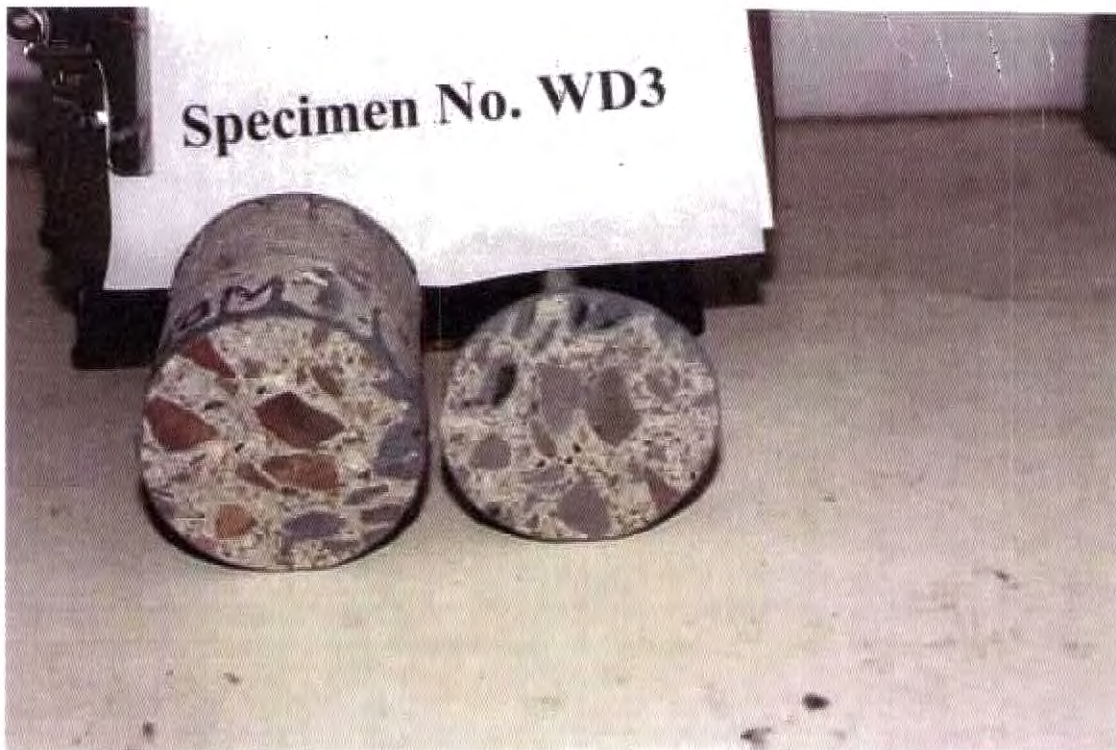
Fracture due to the failure of coarse aggregates.

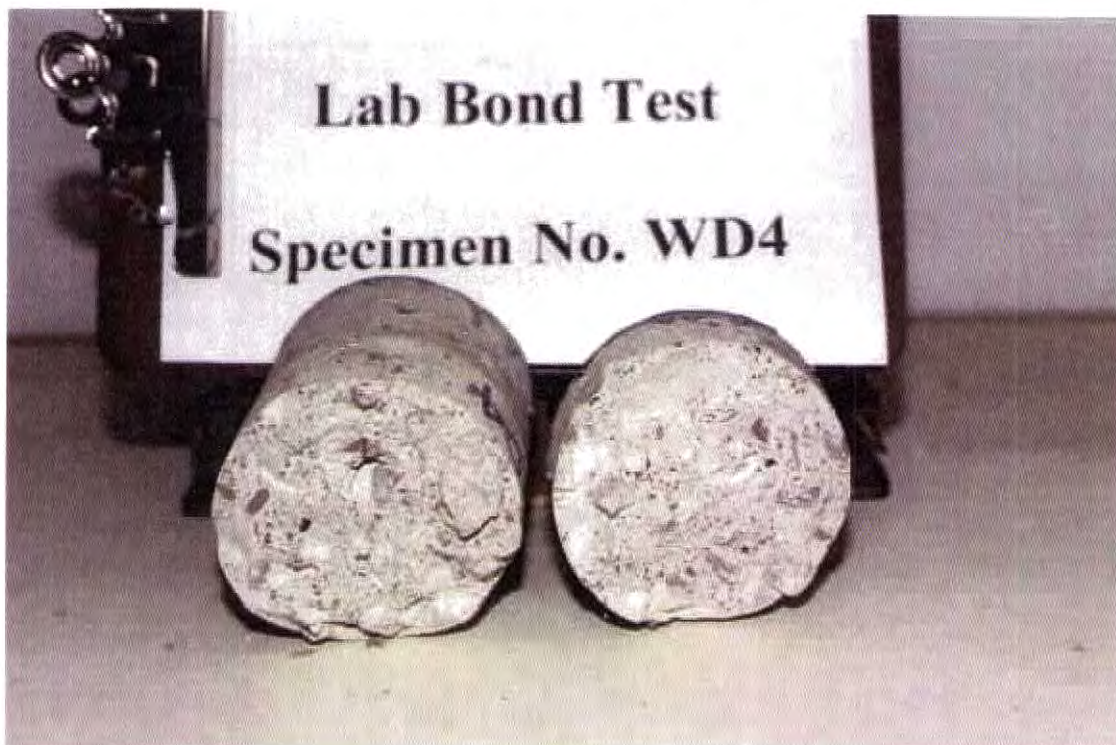
Fracture due to the lack of bond between coarse aggregates and cement mortar.

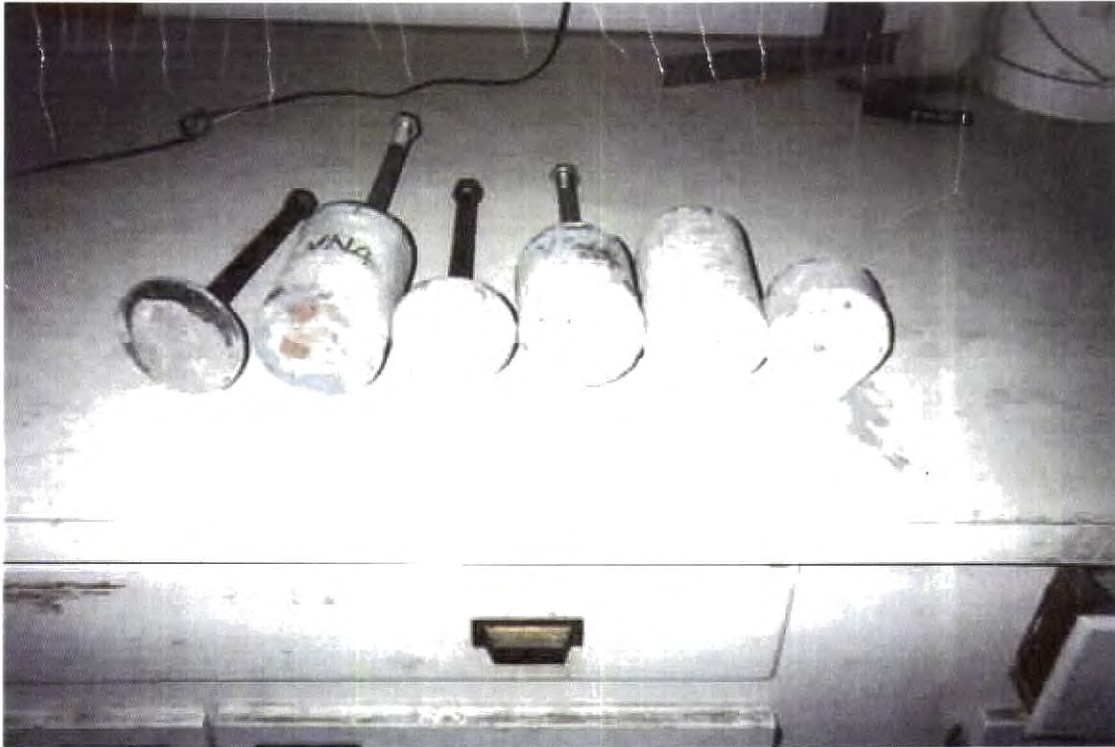
Fractured specimens of lab bond test from the bridge at Exit 212, I-90 (Vivian).
