# Testing, Analysis, and Load Rating of Precast Prestressed Concrete Deck Beams with Transverse Cracks

**ICT Project R27-226**

**May 2025**

ICT Series Report No. 25-002

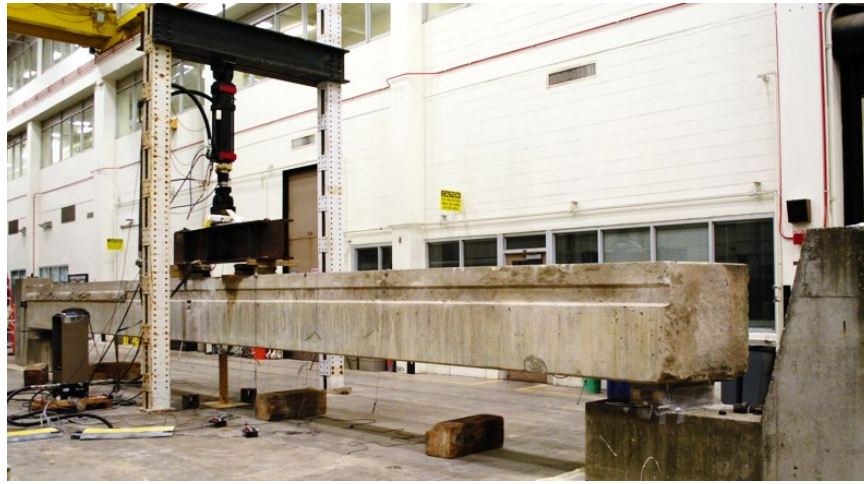
**Figure 6. Illustration and photo. Four-point bending test setup of G1 beam.**

Figures 6-A and 6-B present the schematic plan view and a side elevation photo of the four-point loading setup used to evaluate the damaged PPC beam. Two L-shaped concrete blocks were used on either end to support the beam. The roller and pinned supports were placed at either end of the beam with a clear spacing of 13.4 m (43.78 ft). The four-point load was applied using two plates with a skew angle of 10° and placed 1.37 m (4.5 ft) apart to simulate a tandem load. A spreader beam was used to distribute the load from the actuator to the plates. At midspan, two spring potentiometers and a linear variable differential transformer (LVDT) were placed to measure the deflection of the beam. A displacement-controlled load was applied at a rate of 1 mm/min (0.0394 in./min), and the rate was later doubled once the response of the beam plateaued.

Figure 6-C illustrates the 20 strain gauges attached to the exterior side (denoted by the small dark rectangles) near each crack's top and bottom ends and between a few individual cracks near the bottom. Figure 3-E shows strain gauge S21, the only gauge mounted on the bottom surface across crack C6. The strain gauges mounted across the cracks were used to enable the monitoring of the changes in the crack widths during the test, while the strain gauges placed between the cracks, near the bottom, allowed for monitoring stress redistribution as the cracks propagated.

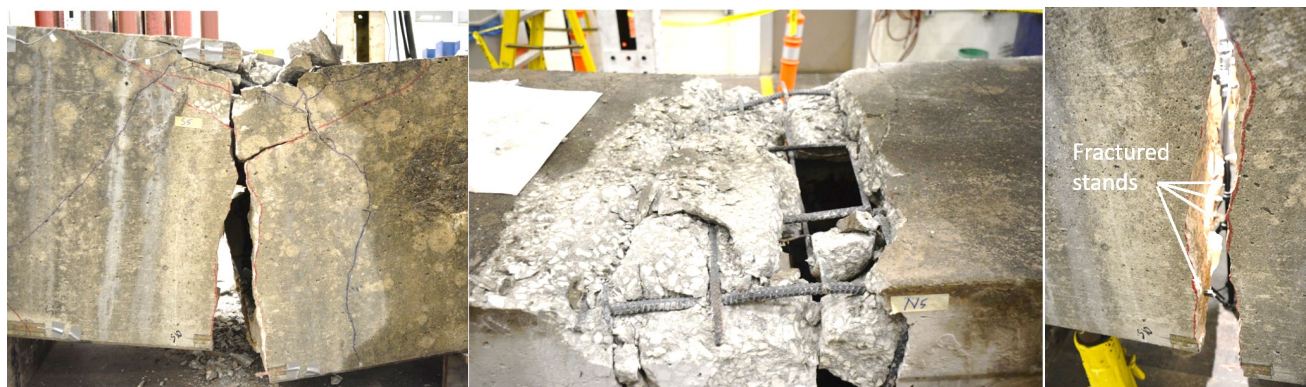
**Figure 8. Photo. Failed G1 beam specimen.**

The close-up photos of the tested PPC beam in Figure 8 indicate that its behavior was predominantly flexural. This resulted in a failure due to the crushing of the midspan top concrete fibers and the simultaneous fracture of the prestressing strands at crack C6. At the failure point, the concrete at the top was crushed, and the compression steel exhibited signs of yielding. Notably, the beam did not fail at the midspan location because of the presence of the middle diaphragm.

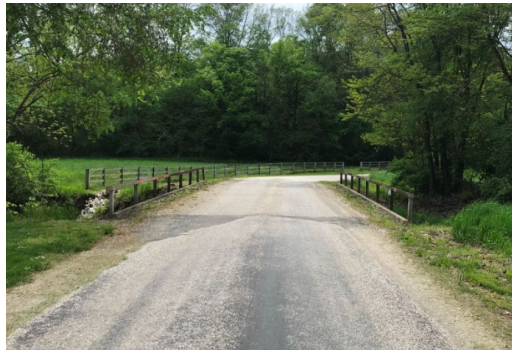
The second PPC deck beam specimen tested in this study was 21 × 36, hereby named the G2 beam. It was extracted from a single-span bridge (bridge no. 042-3020) in Jersey County, Illinois. Figure 11-A presents a view of the single-span bridge, which was constructed in 1962 and demolished after nearly 60 years of service. The bridge had a total span of 15.24 m (50 ft) and a total width of 6.1 m (20 ft). The bridge cross-section had seven 21 × 36 PPC deck beams (Figure 11-B) connected via a dry-packed shear key and 25.4 mm (1.0 in.) transverse tie rods at one- and two-thirds of the span length. A bituminous material layer was present on the deck surface. As shown in Figure 11-C, the bridge exhibited signs of distress, including corrosion and water leakage caused by longitudinal cracks under the deck. One interior beam (G2) was extracted and tested at the University of Illinois' Newmark Structural Engineering Lab to assess the performance of cracked and repaired PPC deck beams.

A. View of the single-span bridge

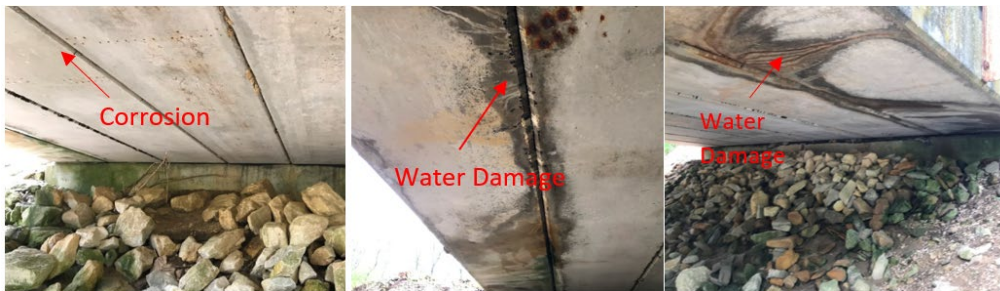
**Figure 11. Photo. Bridge no. 042-3020 in Jersey County.**

C. Corrosion and water damage under the deck

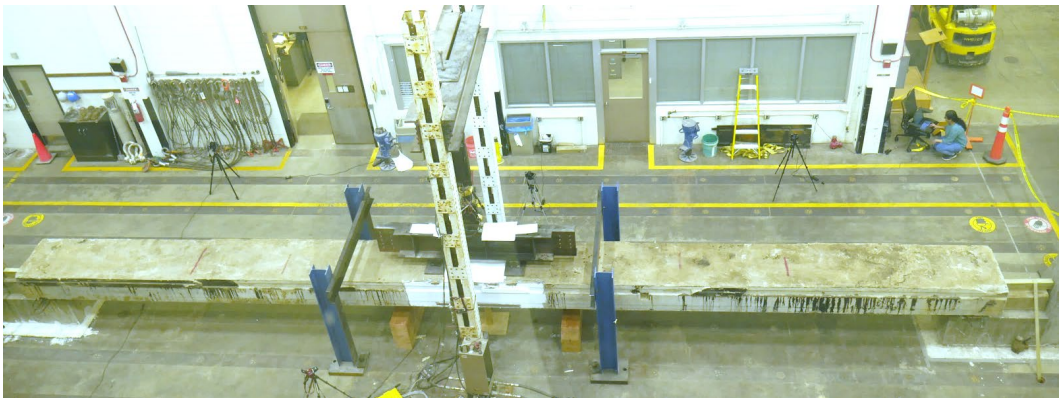
bottom to measure tensile strains. The gauges were placed within two loading plates to capture strains due to purely flexural cracks. One LVDT and two spring potentiometers were placed at midspan to measure the deflections of the beams under the applied load.

A. Side elevation view

B. Plan view

C. Strain gauge locations

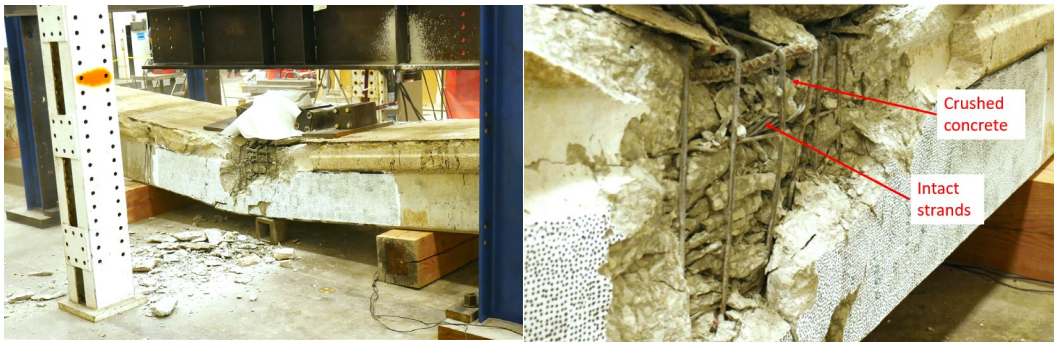
The beam was loaded to failure in Load Step 4 (LS4) at a rate of 24 mm/min (0.945 in./min). The G2 specimen failed at a fracture load of 348.29 kN (78.3 kips) with a final displacement of 481.84 mm (18.97 in.). Figure 16-B presents photos of the failed specimen. The beam failed explosively in compression while the prestressing strands and the longitudinal rebar remained intact. This showed that the beam was over-reinforced, as it failed by compression rather than in tension due to strand fracture. The fracture load was 45.6% higher than the nominal live load capacity for the G2 beam.

A. Load-deflection response in LS4

B. Failed specimen
