# **Highway Sign Support Systems: Condition Assessment Deterioration Models and Asset Management**

## **Final Report**

CT-2323-F-23-4

SPR-2323

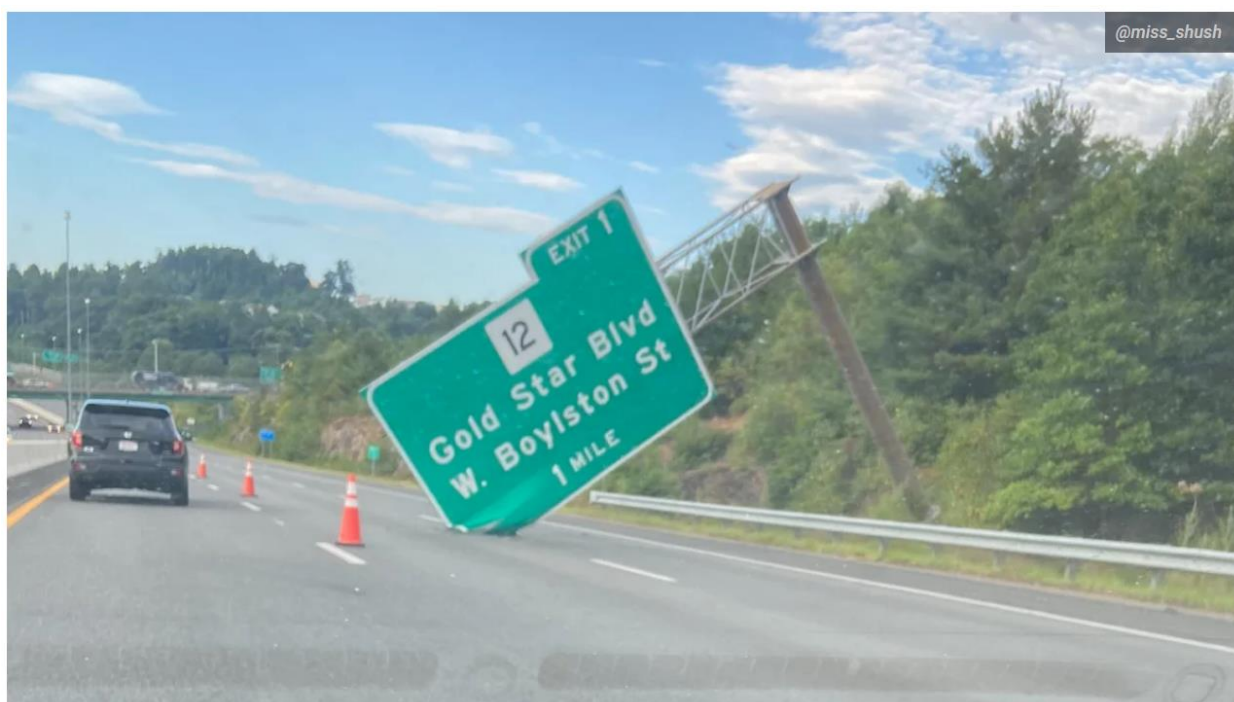
Figure 1.1. Collapsed Sign Support [1]

An event occurred on I-190 SB in Worcester, Massachusetts that underscores the importance of this project. On August 9<sup>th</sup>, 2022, a cantilevered sign support collapsed on the roadway obstructing traffic in both the low-speed and middle lanes (Figure 1.1). Thankfully no motorists were injured and MassDOT had the road clear by 8:43 am [1], but such an incident illustrates the potential risk associated with these structures and what can happen if they are not regularly maintained and replaced.

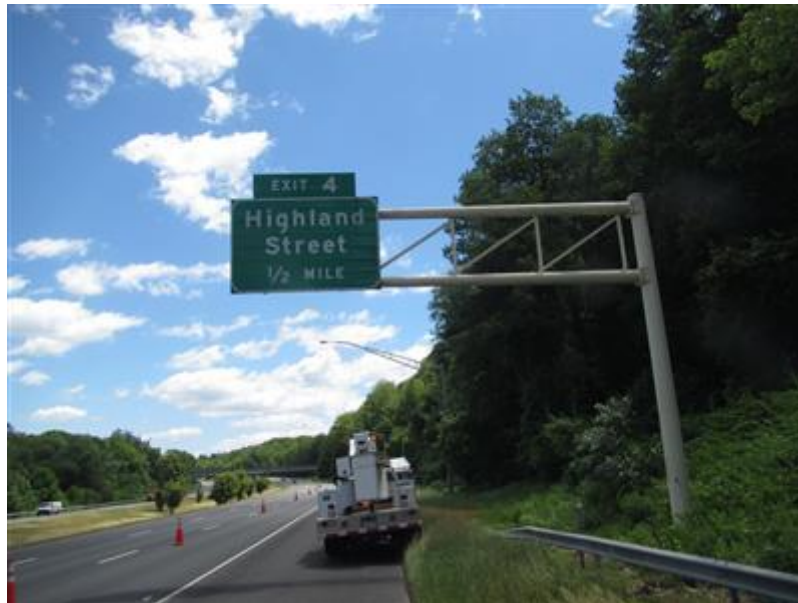
Figure 1.2. CTDOT Asset No. 21740

The research work then concentrated on the experimental and analytical phases of the project. In September 2022, CTDOT sign support asset no. 21740 located over I-384 in Manchester, CT was chosen for the experimental work (Figure 1.2). Prior to sensor installation, an overview of the Non-Destructive Testing equipment was conducted. A mounting procedure encompassing the obtained equipment was developed and executed once it was understood how the equipment operates,

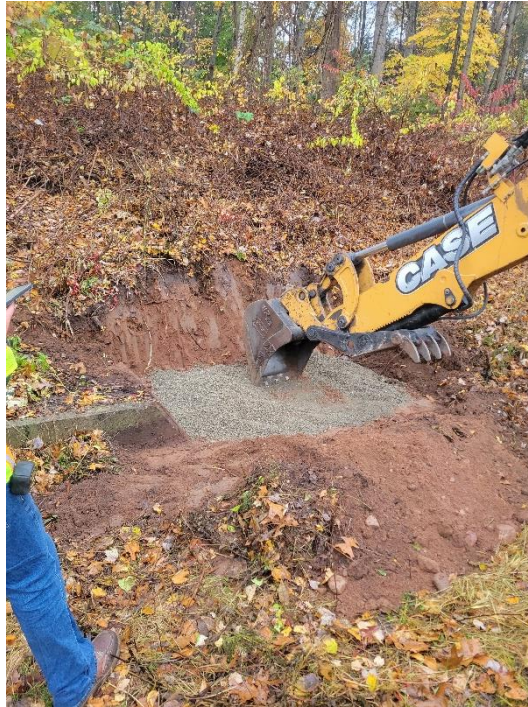
Figure 2.6. Excavation Backfilled with Stone

To secure the cabinet, a 3' 4" x 6' 8" concrete slab-on-grade was placed adjacent to the foundation of the sign support. The construction effort was organized by CTDOT who provided all the labor, materials, and equipment. After the traffic control crew established a safe work zone in the low-speed lane on I-384 EB, excavation for the slab and pole foundation commenced (Figure 2.6). The footing for the existing sign support is pictured to the left of the excavation. Approximately 6" of stone was placed in the hole and spread to match bottom of footing elevation. Figure 2.6 shows the first bucket of material being removed for the precast pole foundation. The foundation was set so that top of footing and top of precast were at the same elevation (Figure 2.7).

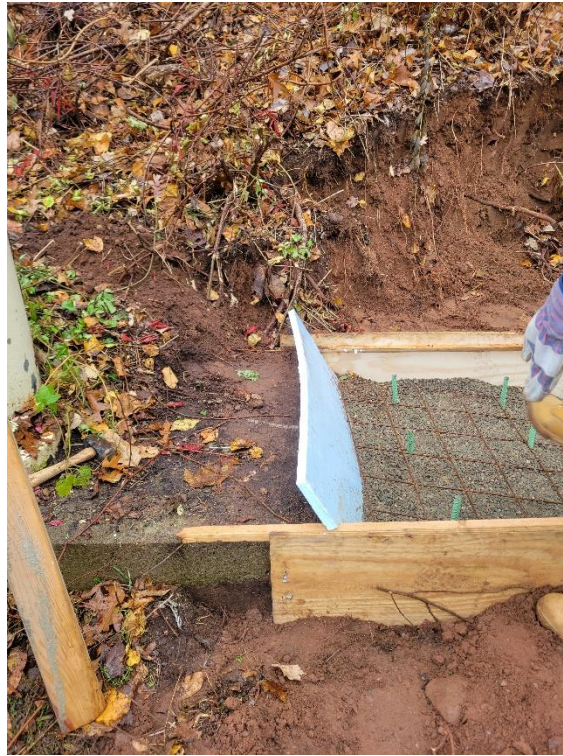
Figure 2.8. Expansion Joint and Reinforcing Steel

Additionally, a 1" piece of foam was used as an expansion joint between the slab and the existing footing (Figure 2.8) to prevent cracking in the slab during the curing process. The mix design used by CTDOT included two bags of Rapid Set DOT Cement, four 5-gallon buckets full of sand, four 5-gallon buckets full of 3/8" stone, and approximately 5 quarts of water. A portable cement mixer was used to mix the materials and the concrete was placed and finished using a wheelbarrow, mag floats, and brushes (Figure 2.9). Once the concrete went through a 24-hour curing process, the form was stripped and the utility pole was bolted down to the precast foundation.

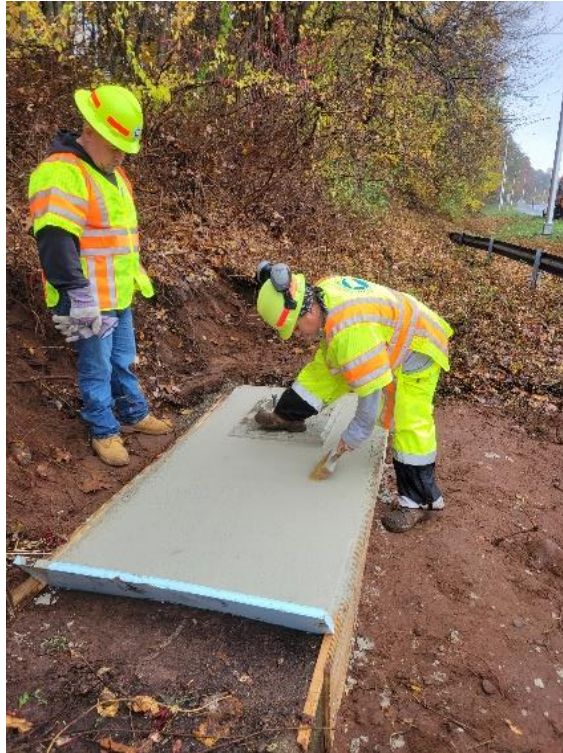
Figure 2.9. Concrete Slab Brush Finish

After the precast foundation was set to grade, the formwork and bulkhead for the concrete slab was installed. 3/4" plywood and 2" x 4" lumber was used to construct the form and bulkhead. The form and excavation created space for a 10" thick slab to properly anchor the utility pole and instrumentation cabinet. Some reinforcing steel was used to counteract any tensile forces within the slab. Ten 1' lengths of #4 rebar were driven into the stone vertically and one piece of wire mesh was laid horizontally inside the form prior to concrete placement.

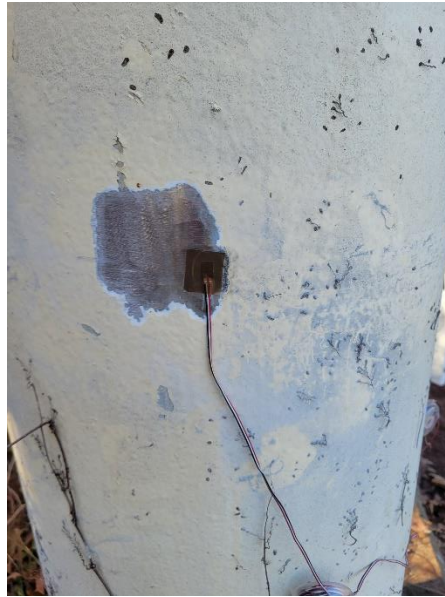
Figure 2.10. Typical Strain Gauge Installation

Each strain gauge was adhered along the major axis of the column using M-Bond 200 two-part epoxy (Figure 2.10). After the sensors were epoxied to the structure, they were insulated from the weather using absorbent pads and UV/water resistant foil. To enhance the data collected from the four strain gauges mounted around the circumference of the column, two bridges were installed. A bridge links two strain gauges on opposite sides of the column together to function as a unit. The two bridges make it possible for the strain gauges to detect forces acting on axes supplemental to the major axis, like torsion. A similar four strain gauge system was installed on the top chord of the cantilever arm.

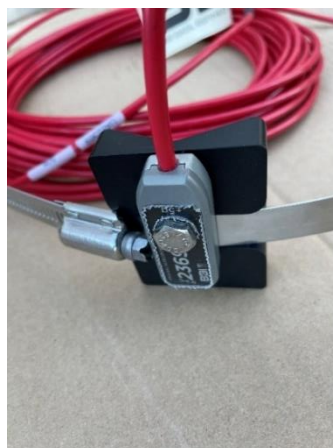
Figure 2.11. Accelerometer Attached to Band Clamp

Following strain gauge installation was accelerometer unboxing and preparation (Figure 2.11). The accelerometer's primary function is to "wake up" the instrumentation system and record data one second before and after activation. The accelerometer is activated once vibrations in the structure exceed a certain threshold. Mounted using a band clamp around the top chord of the cantilever arm, the accelerometer is located at the midpoint of the cantilever arm.

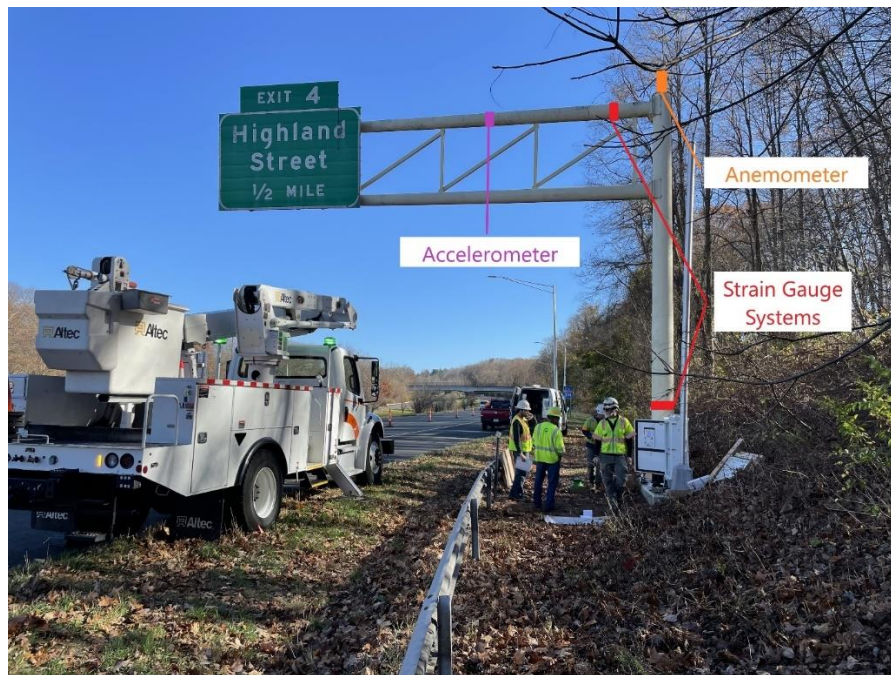
Figure 2.12. Sensor Types and Locations

The last piece of equipment fastened to the sign support was the anemometer which detects wind speed and direction. The anemometer was designed to receive a piece of 1" IPS pipe and was mounted to the top of the sign support column with two band clamps running around both the column and the 1" IPS pipe. Figure 2.12 portrays an approximate location of the sensory equipment fastened to the sign support.

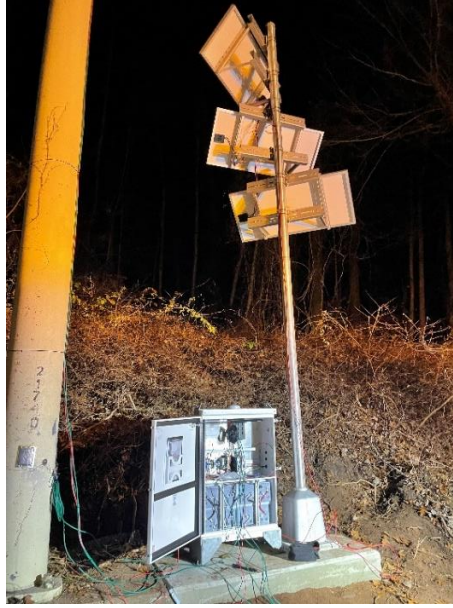
Figure 2.13. Solar Array

The final piece of field work to be completed was to setup the solar array. The array consists of three panels mounted to the top of the 12' utility pole. Each panel was rotated about the pole incrementally to create a fan-like shape maximizing UV exposure (Figure 2.13). The mounting brackets feature a lightweight CNC aluminum design providing a lightweight yet sturdy fastening solution.

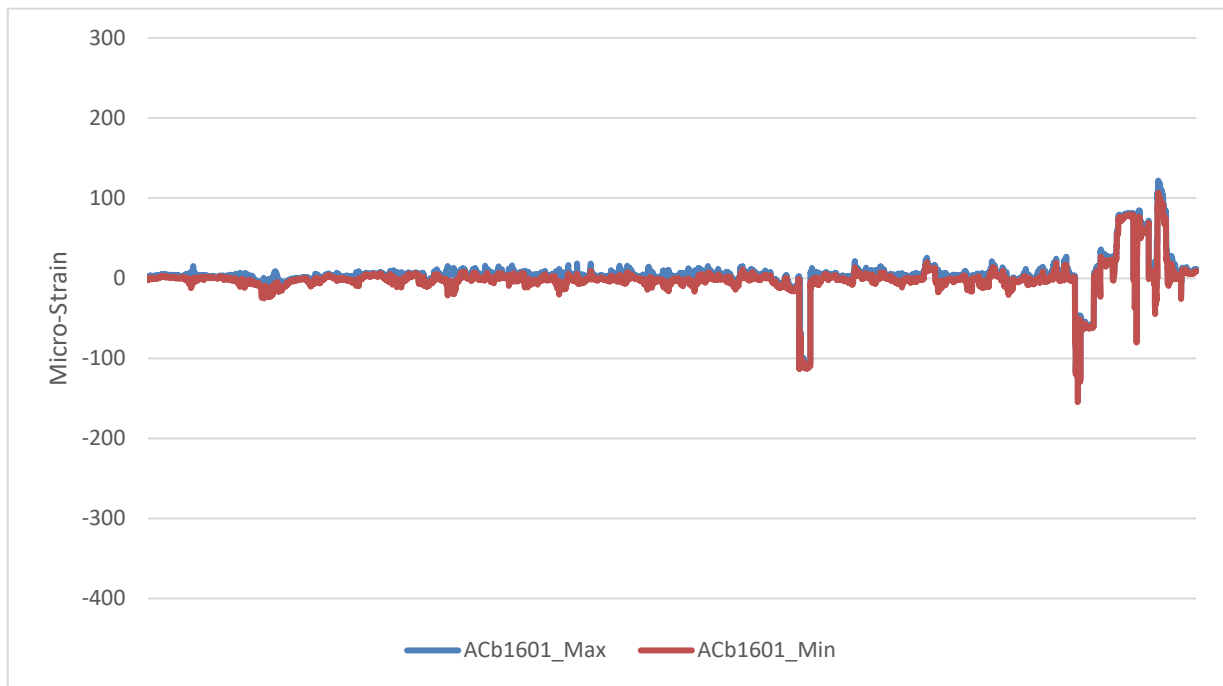
The x-axis for the four graphs represents time. An Accelerometer, that was placed at midpoint of the top arm (having the title UAb 2369 of Channel 5), had the ability to activate the system to capture the information from the sensors due to high vibration caused by wind gust loads. The system was programed to capture the highest strain levels experienced by the structure every one-hour period. There was also a wind speed sensor attached at the top of the vertical pole to provide wind loading data to assist with the experimental and finite element analysis (Figure 3.5).

From the experimental results, it is observed that the top horizontal pole experienced higher strains as compared to the bottom of the vertical pole. Further, the maximum strain was experienced only once and reached a value of 380 micro-strain. Otherwise, the strains range between 50 micro-strain and 130 micro-strain.

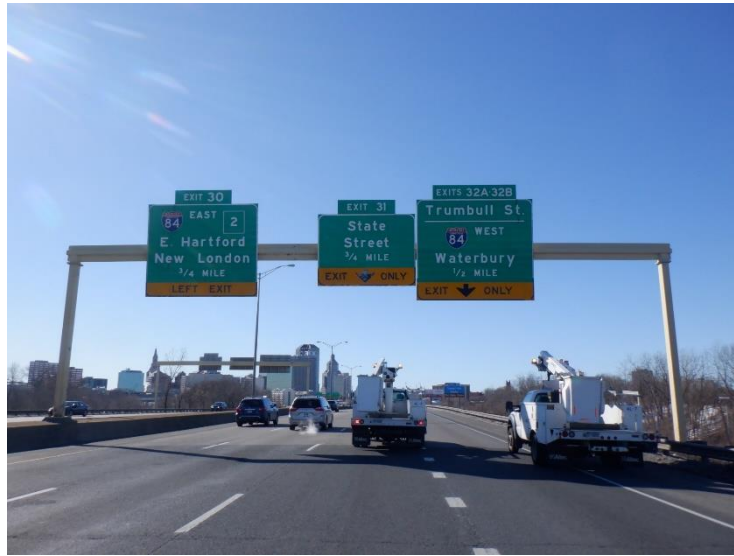
Figure 3.12. Support 21311 leading into Hartford, CT

span support located near Exit 32-A in Hartford (Figure 3.12) has a  $p(f) = 0.673$ , which is only in the middle range of  $p(f)$  values. Despite this, it is important to give this support more attention due to the high traffic and population density in the Hartford area.  $iCMT$  can be viewed as a "priority of inspection and replacement/repair" metric for each asset. It represents the risk, as it is determined by the combination of the probability of failure and the number of commuters. Consequently, sign supports with higher  $iCMT$  values should be prioritized for repair and maintenance to minimize the impact on commuters.
