UNIVERSITYTRANSPORTATIONCENTER
FOR UNDERGROUND TRANSPORTATION INFRASTRUCTURE

**THE CHARACTERIZATION OF DELAMINATION PROCESSES WITH
RESPECT TO WATERJET SHOTCRETE REMOVAL DURING TUNNEL
LINER REPAIR AND MAINTENANCE**

FINAL PROJECT REPORT

October 22, 2020

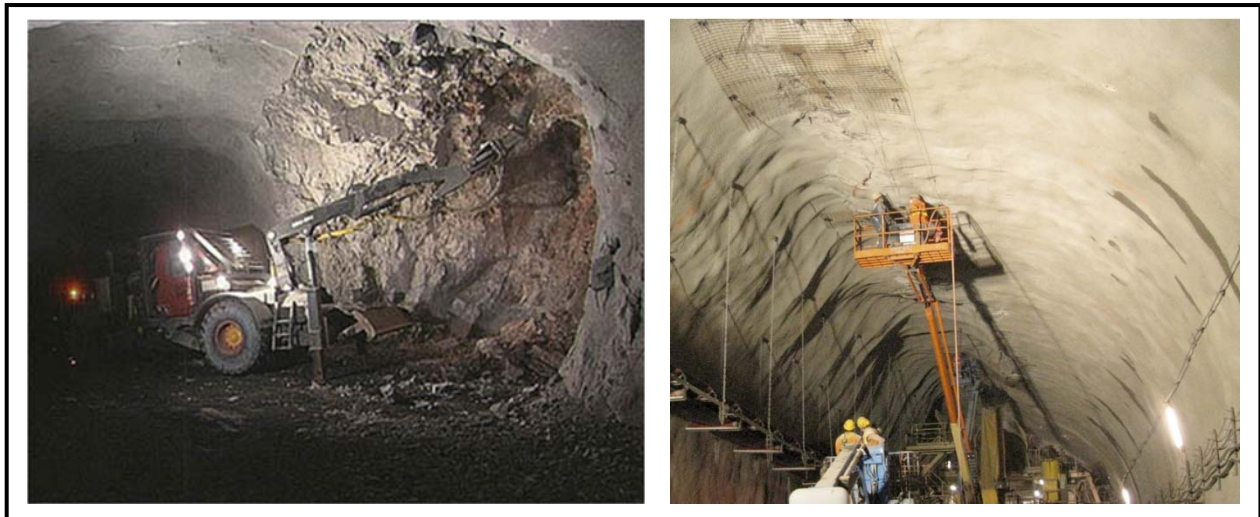
Figure 1-1: Conventional mechanized scaler for operating heights below 20 meters (left) and a manlift with operators and manually held impact hammer for operating heights above 20 meters (right) [6].

The repair of concrete and shotcrete liners that have been structurally compromised or damaged is a common maintenance and rehabilitation activity in tunnels and other types of underground workings. Age, in-situ stresses, geology, chemical and physical decomposition, accidental impacts, and water flow/seepage are but just a few of the many factors that necessitate the repair of these structural systems over time. In many cases, it is prudent to limit the repair to the isolated removal of the structural liner around the damaged area rather than the complete excavation of large sections of the support system. In specific types of geology and in high stress environments, the large-scale removal of the liner represents an inherent hazard associated with rock falls and failure. In these applications, traditional methods of liner removal include the use of hydraulic or pneumatic hammers that break and excavate the liner material through repetitive percussive impacts using spade or chisel bits. In operating environments where working heights are less than 20 m, these hammers are usually mounted to articulated booms attached to mobile rubber-tired or track equipment, such as a mechanical scaler. In applications that extend beyond the reach of conventional scalers, the height of the operating envelope usually necessitates the use of man-lifts, where workers manually remove the damaged areas from these elevated platforms using hand-held equipment. Each of these rehabilitation scenarios are shown in Figure 1-1.

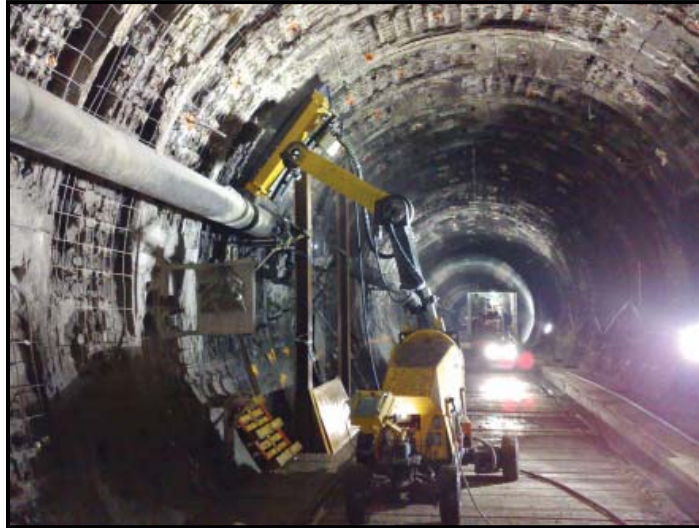
Figure 1-2: Hydroexcavation robot removing damaged concrete in Channel Tunnel liner [7].

A literature search was conducted to identify research papers that correlate with hydroexcavation of structural liners in underground workings. At the conclusion of the search, only one research paper was discovered for this particular field of work. In 2009, SME Mining Engineering published a journal article discussing how a conventional twin orifice rotating waterjet system selectively removed concrete damaged by a major fire that occurred in the Channel Tunnel linking Britain and France [7]. The tunnel fire burned for approximately 16 hours, with extreme temperatures rising up to 1,000 degrees Celsius, causing extensive damage to the concrete lining. Four conventional twin orifice rotating waterjet nozzle assemblies were utilized to remove the damaged concrete by cutting at a depth of 30 mm (1 inch) into 9,500 square meters (102,257 square feet) of the tunnel. Figure 1-2 shows the rehabilitation scenario.

Comprising the excavation system, jet motion was controlled using robots that were equipped with modified arching feedbeams, which carry the jet nozzle, to match the curvature of the tunnel wall. This specific equipment configuration was also equipped with a vacuum attachment to collect all of the water and excavated material during operation. The repair contract was deemed a success and a new concrete lining was sprayed for reinforcement before reopening the tunnel for shuttle train service.

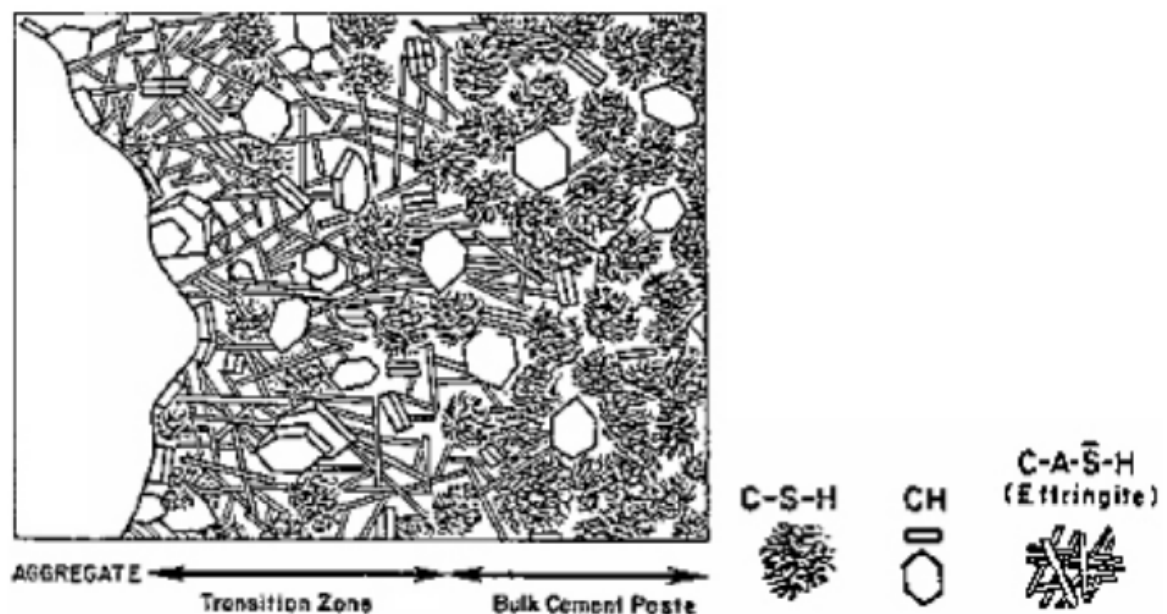
Figure 2-3: Illustration showing three phases of concrete structure including aggregate, transition zone, and bulk cement paste [11].

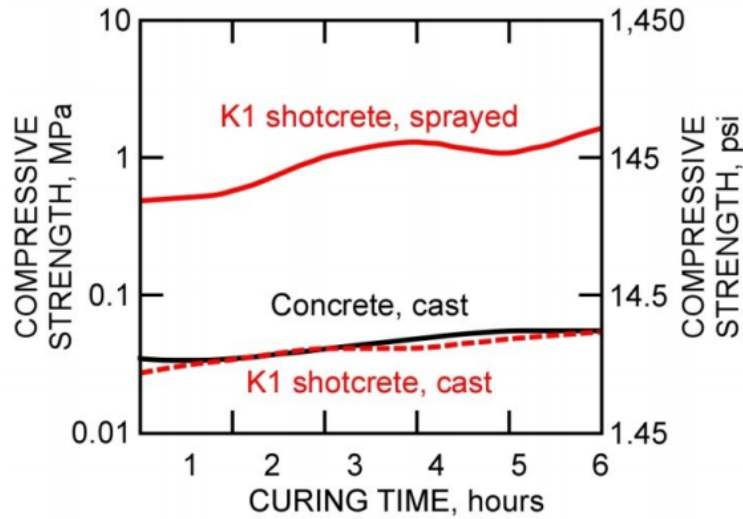
Figure 2-2: Early strength partial beam test results for dry mix shotcrete and concrete conducted by NIOSH, n=54 samples [15].

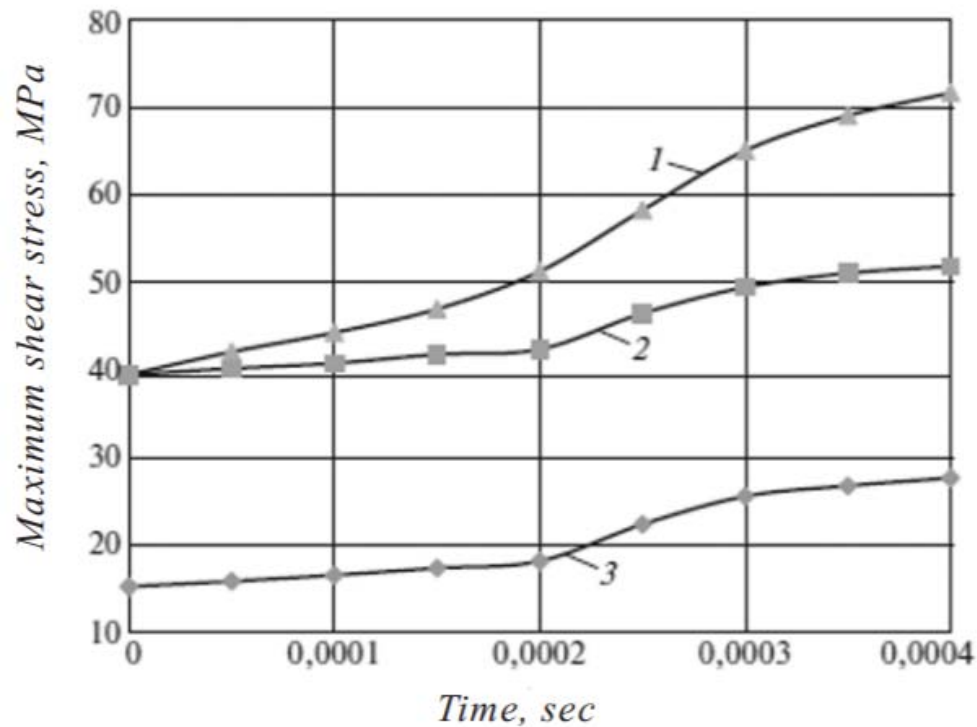
Figure 2-5: Maximum shear stress data under varying drilling conditions including (1) axial percussion plus torsional percussion plus rotary action, (2) axial percussion plus rotary action, and (3) axial percussion [20].

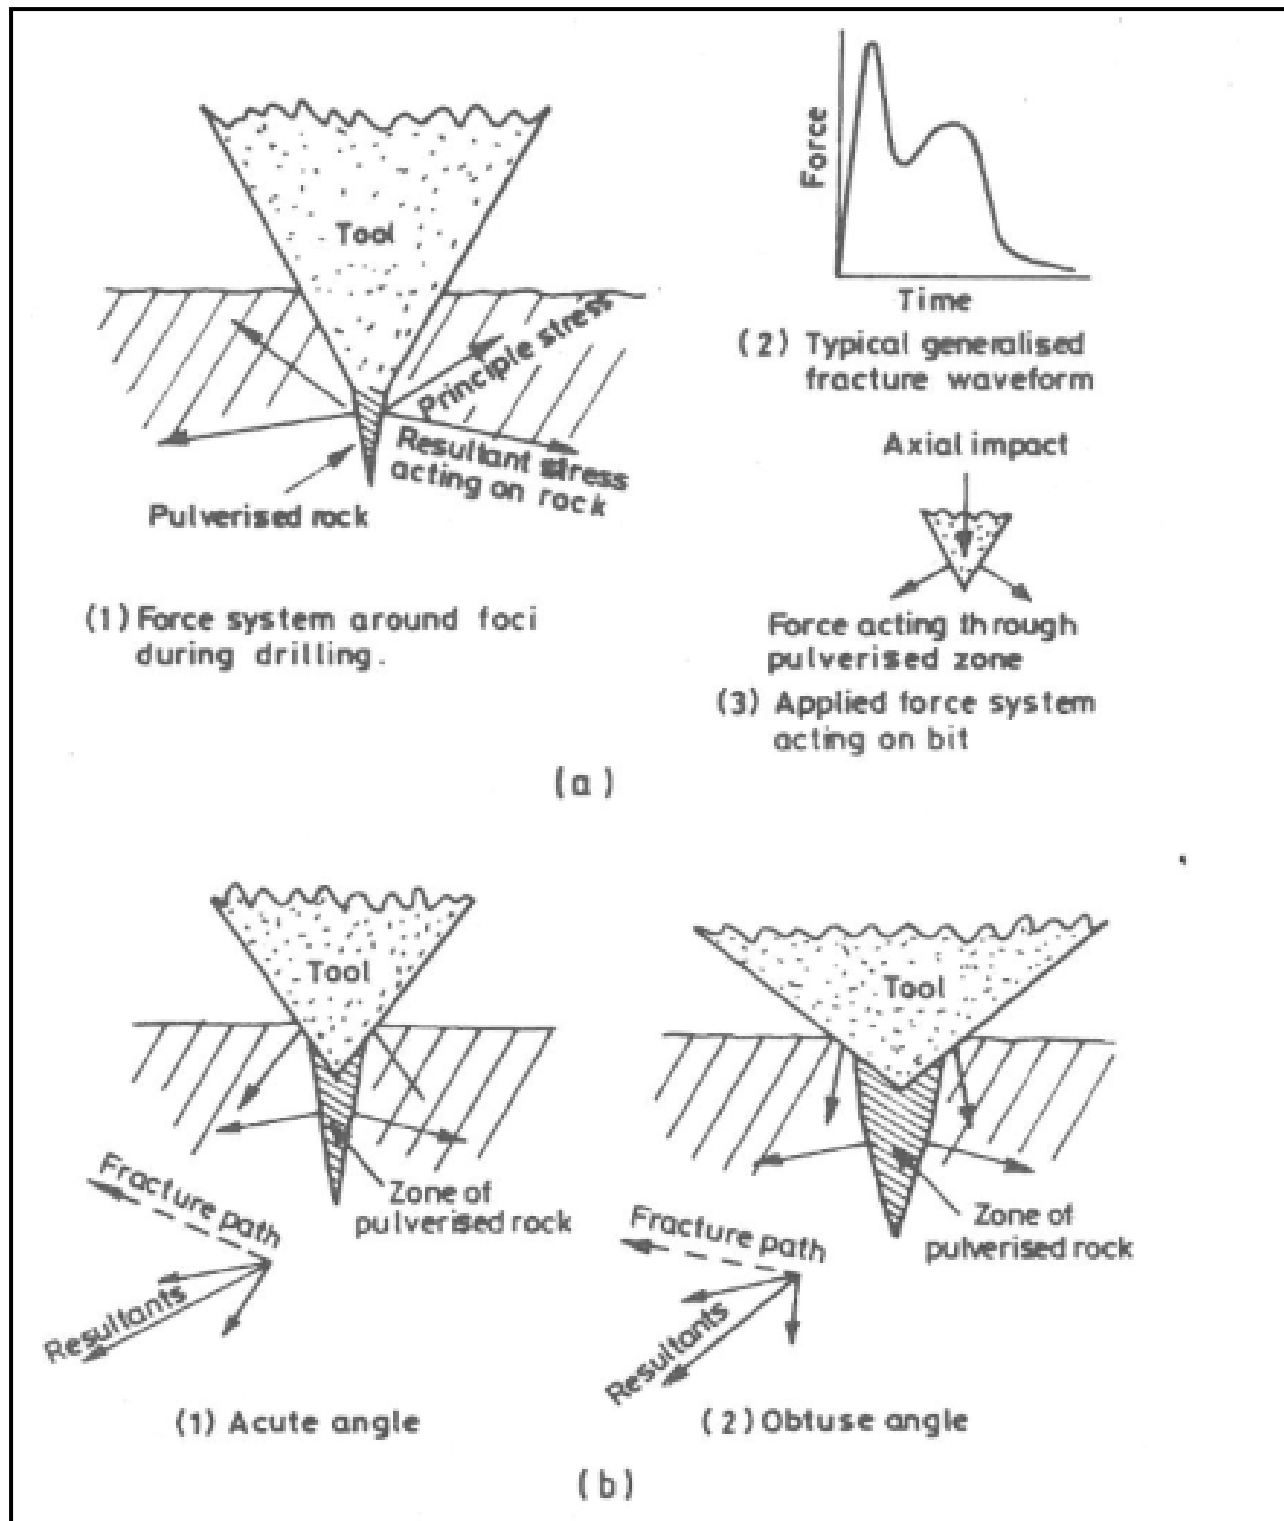
Figure 2-6: According to Karanam and Misra (a) forces acting on system during percussive drilling (b) how wedge angle effects geometry of forces during percussive drilling [19].

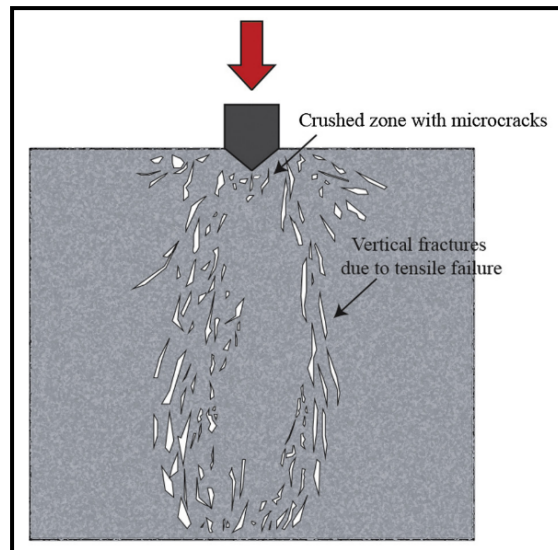
Figure 2-8: Morphology of fractures induced by a single indenter [26].

induced collateral damage in concrete substrates [26]. In this experiment, a pneumatic breaker was used to remove a concrete substrate layer. After testing was completed, an X-ray computed tomography method was used to investigate the porosity, crack width, and connectivity in the concrete substrates. After analysis of the results, Izumi et al were able to develop a figure showing morphology of fractures induced by the pneumatic hammer as shown in Figure 2-8.

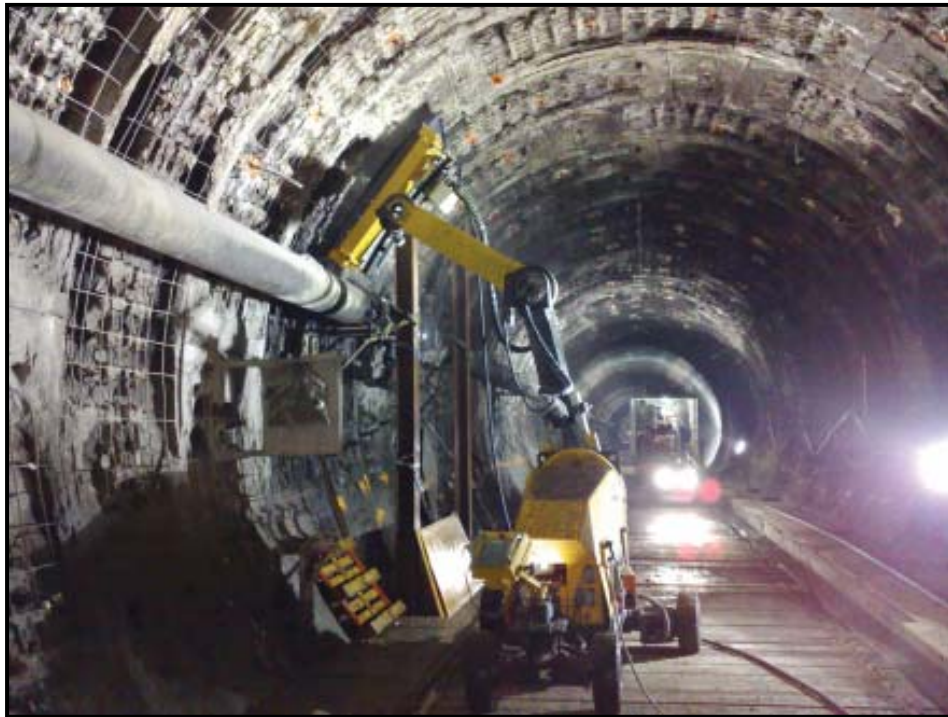
Figure 2-9: Hydroexcavation robot removing damaged concrete in tunnel liner [7].

The robots were equipped with modified arching feedbeams, which carried the jet nozzle, to match the curvature of the tunnel wall and maintain a consistent standoff distance between the nozzle and the rock surface. This specific system was also equipped with a vacuum attachment to collect the water and excavated debris during operation. The repair contract was deemed a success and a new concrete lining was sprayed for reinforcement before reopening the tunnel for shuttle train service.

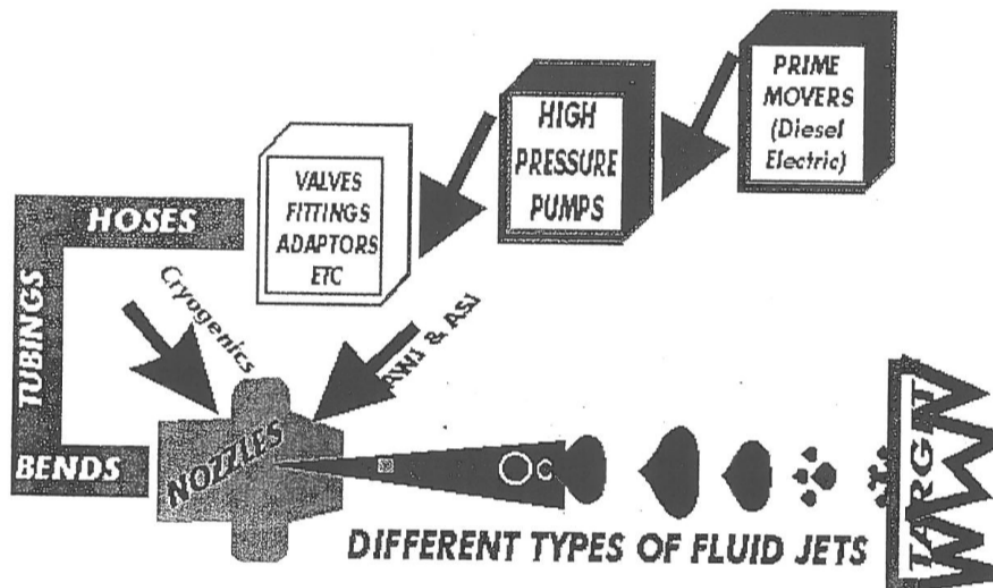
Figure 2-10: Components typically found in waterjet systems [32].

These systems can vary from ultrahigh-pressure systems greater than 690 MPa (100,000 PSI) and flow rates less than 3.8 lpm (1 gpm) to low-pressure systems of 7 MPa (1,000 PSI) at extremely large volumes of more than 7,010 lpm (1,850 gpm). Researchers, such as Vijay, found that precision cutting of most materials can only be obtained with a continuous waterjet at high-pressures or with entrained abrasives in the stream [32]. AWJ is not used within the scope of this research due to system complexity, cost, and material response. The focus of the literature search is directed primarily on conventional continuous waterjet systems. Figure 2-10 shows a schematic of a waterjet system's general components according to Vijay.

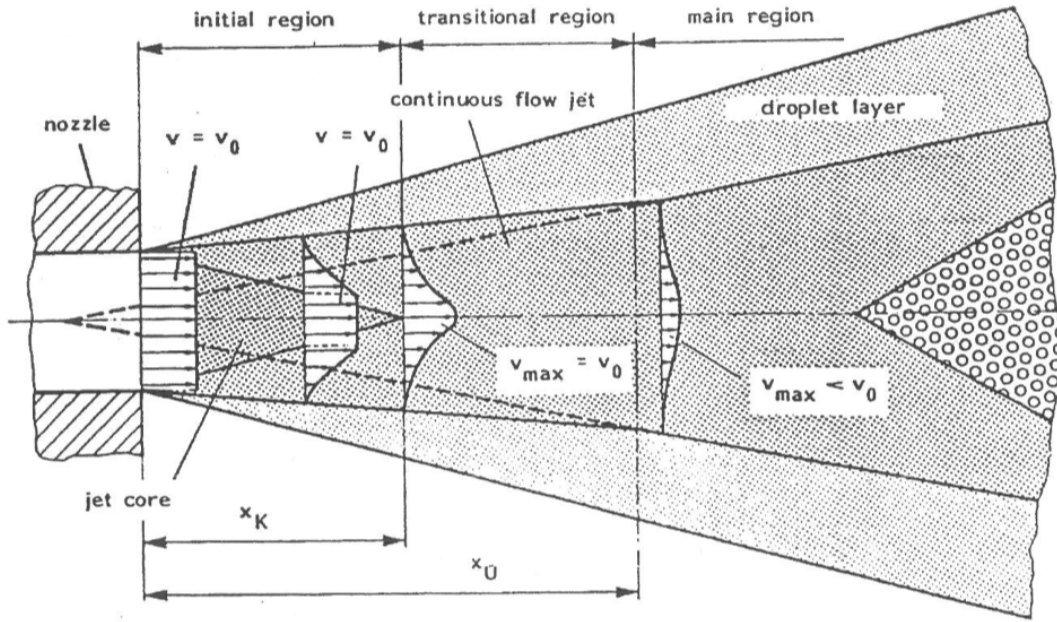
Figure 2-13: High speed waterjet showing sections of continuous flow jet, droplet layer, and final zone consisting of droplets and air [32].

Vijay outlines the structure of a high speed waterjet as it exits the nozzle, showing various sections of a continuous jet, droplet layer around the core, and final droplet and air zone as shown in Figure 2-13 [32]. As the jet travels in free-stream through the initial, transitional, and main regions, its structure changes from a coherent core to air-entrained and droplet zones. Following Bernoulli's equation, pressure within the waterjet system transitions into velocity as it exits the nozzle orifice, leaving the confined space and entering open air, exemplifying a change from potential to kinetic energy.

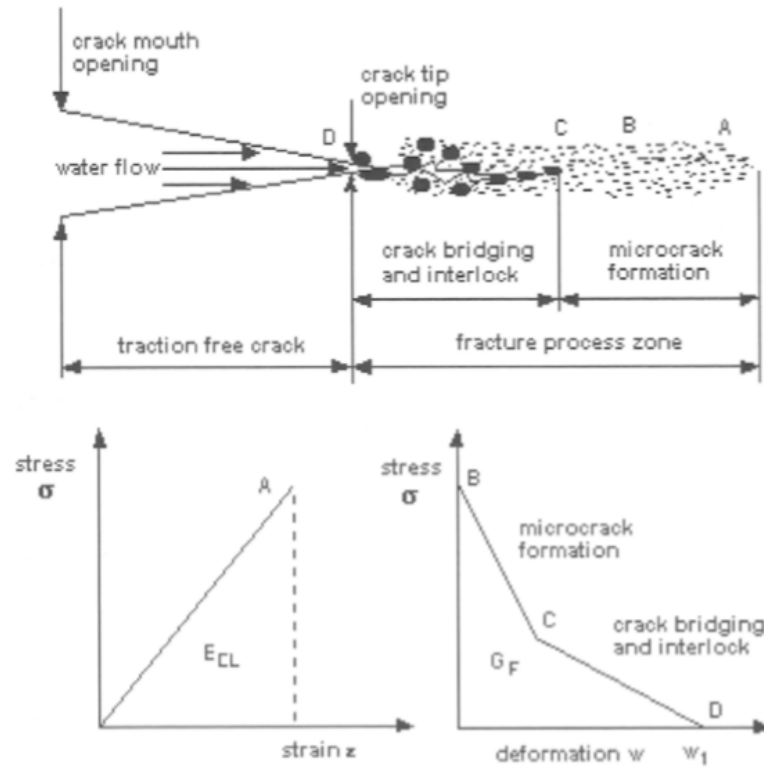
Figure 2-14: Fracture zone produced in tension-softening material [10].

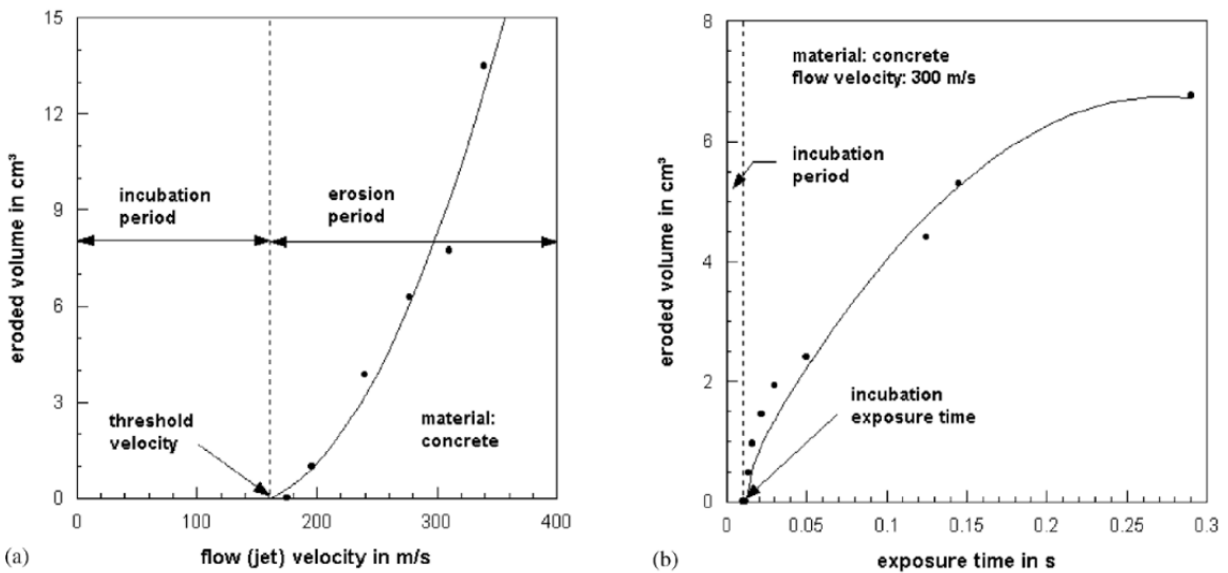
Figure 2-15: Incubation period and erosion period of concrete according to (a) flow velocity and (b) exposure time [37].

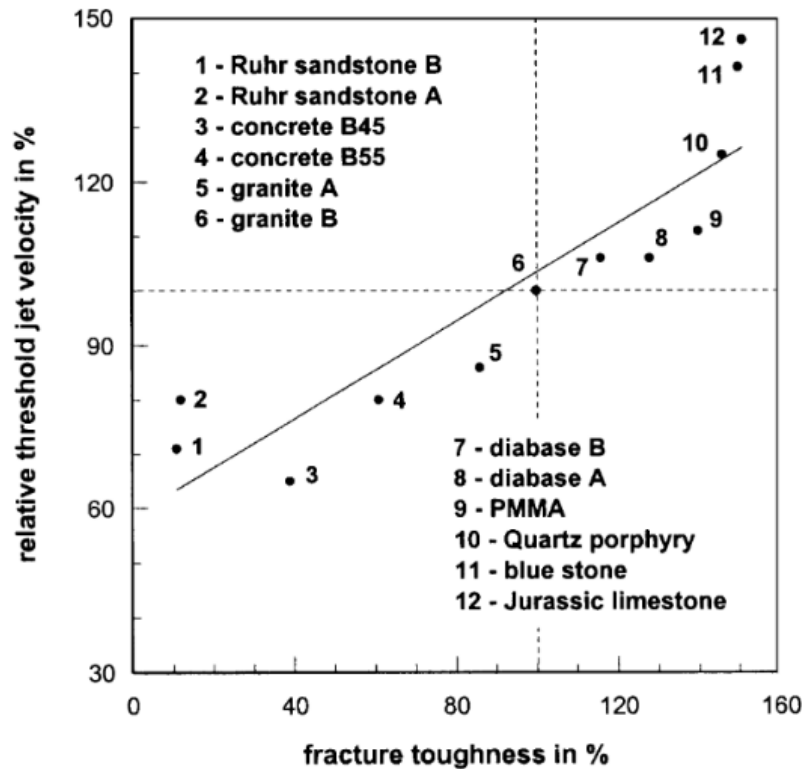
Figure 2-16: Relationship between threshold jet velocity and fracture toughness in varying rock types and concrete [37].

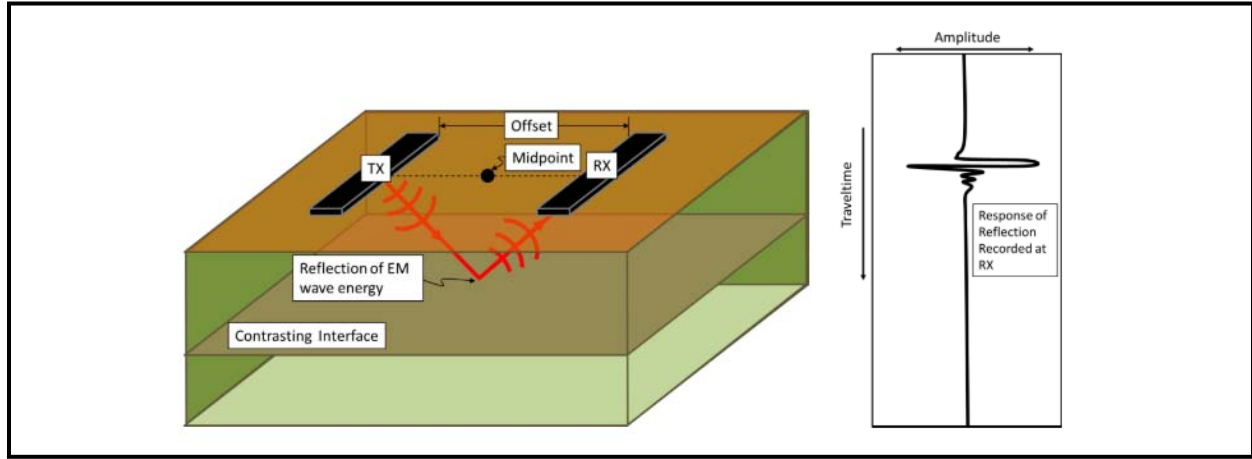
Figure 2-18: Schematic illustrating GPR data collection process [43].

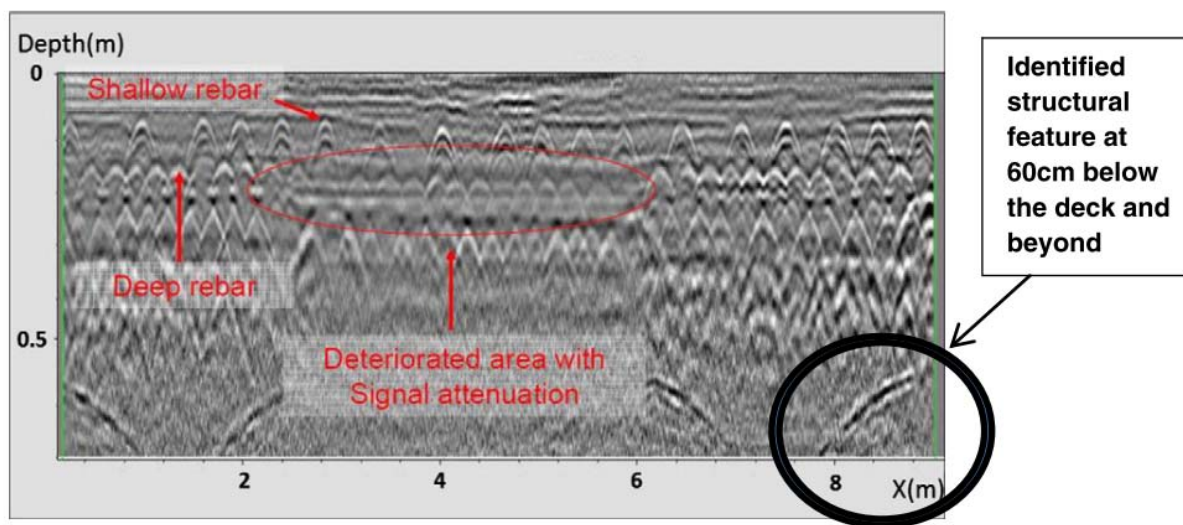
Figure 2-19: Alani et al GPR scan with rebar locations and deteriorated area of bridge deck [45].

central Scotland [45]. The survey was conducted using the RIS HI-Bright Bridge High Resolution Tomography and was performed in an 80 cm (31.5 inch) grid with 10 cm (4 inch) spacing between scans. Alani et al were attempting to gather information regarding thickness of structural layers within the bridge deck, location of shallow utilities and drainage, location and spacing of rebar, and possible moisture penetration and delamination. Surveys were conducted in three different areas on Forth Road Bridge. Alani et al discussed in detail results of processed GPR data in Area 1 as shown in Figure 2-19. The peak curves in the scan show two sets of rebar locations at specific depths as well as an area indicating deterioration due to attenuated amplitude feedback from EM waves. After excavation of the bridge deck, it was confirmed that the deteriorated area had a presence of moisture that penetrated below the upper rebar layer. This deteriorated area is further shown in plan-view sections acquired by the GPR survey in Figure 2-20.

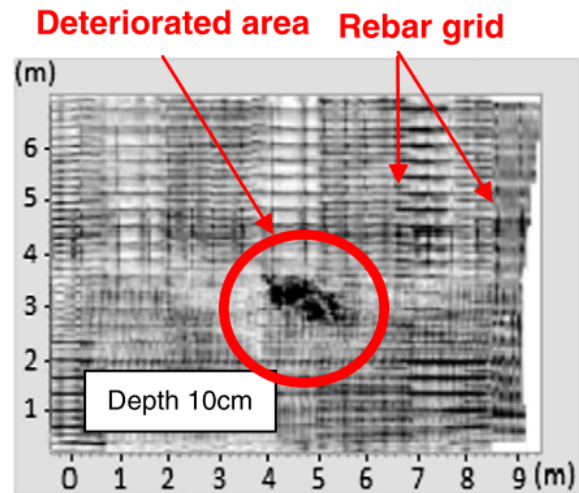
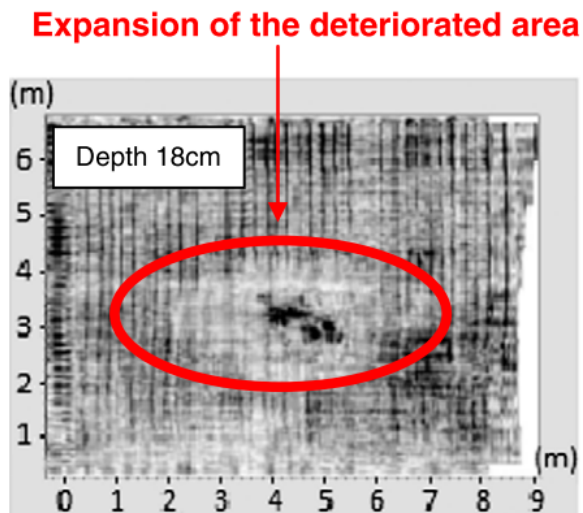
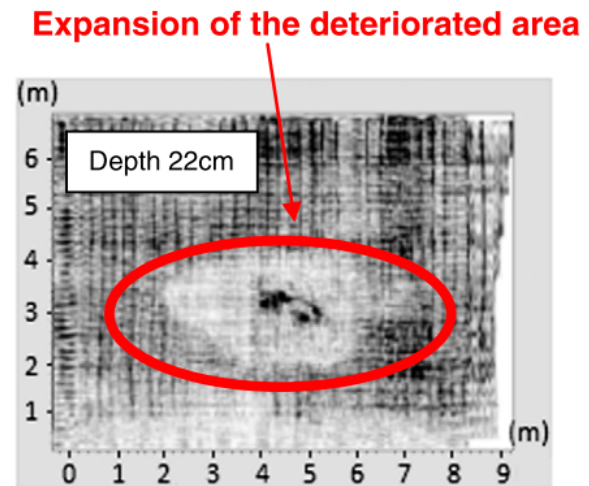
Figure 2-20: Plan-view GPR sections at increasing depths below surface [45].

The plan-view scans shown in Figure 2-20 indicate that GPR surveys have the ability to identify areas of deterioration, whether it be from moisture content or damage within the substrate. Research conducted by Varnavina et al [46] shows an additional example of bridge deck deterioration below the surface identified by a GPR scan (Figure 2-21). The authors note that the concrete deterioration is identified in the blurred areas of the scan due to an increase in two-way travel time. They also noted that the presence of saline moisture in a concrete bridge deck increases the dielectric constant and conductivity of the concrete. Most importantly, they argued that variations in travel time and signal attenuation are often associated with deterioration or in conditions favorable for the eventual occurrence of deterioration, making it a key characteristic during inspection of GPR processed data.

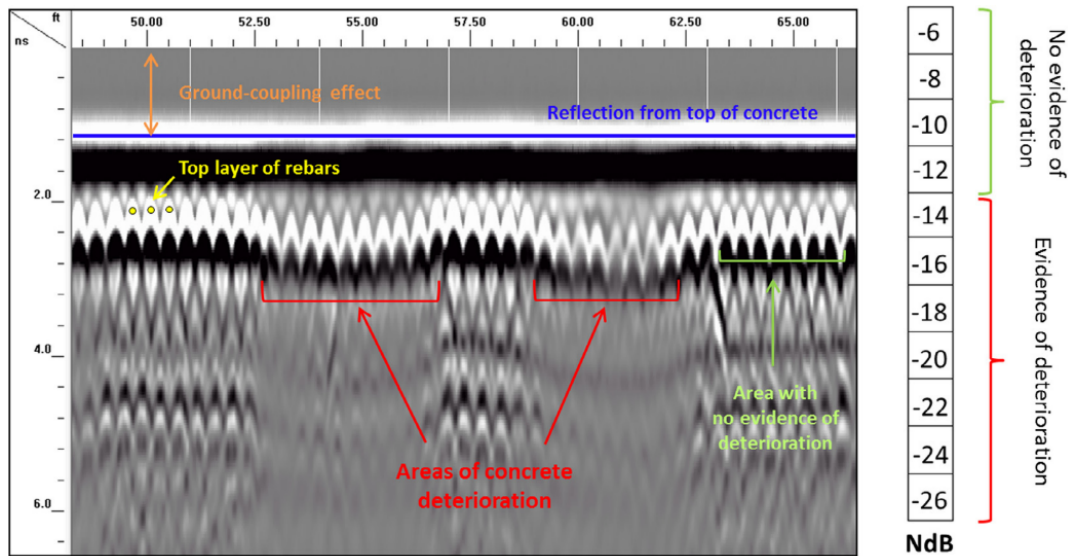
Figure 2-21: GPR scan showing concrete deterioration on bridge deck [46].

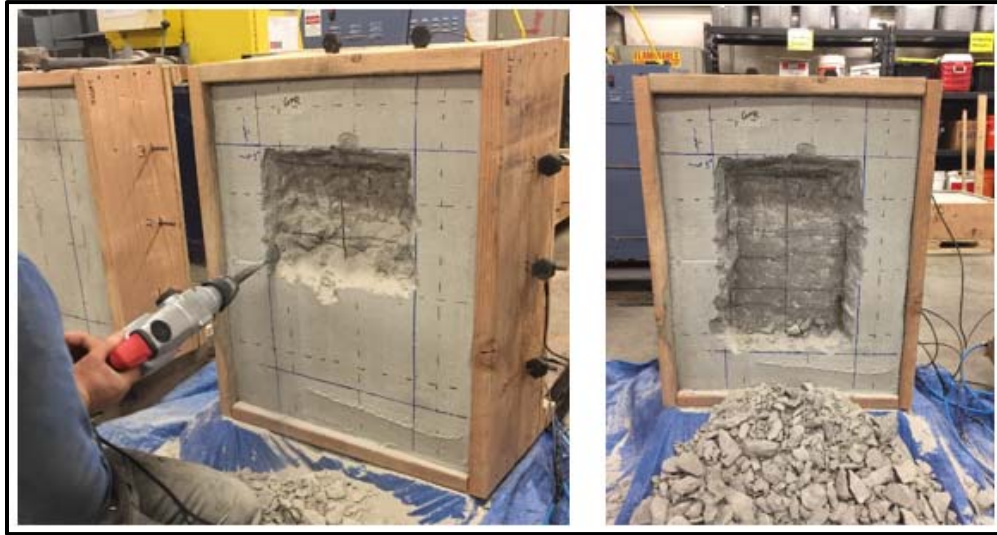
Figure 3-2: Process of mechanical excavation using Bauer impact hammer.

Excavation was conducted using a 1-inch (2.54 cm) concrete spade chisel. Bit rotation was disabled to allow for better operator control of the chisel location and orientation and to simulate common repair practice. A rectangular cavity was cut in the center of each panel and excavated to the top of the concrete layer. The process was slow, physically taxing, and extremely labor intensive. When possible, the wire mesh was left intact, although it was often inadvertently damaged by the concrete chisel. The mechanical excavation process is shown in Figure 3-2.

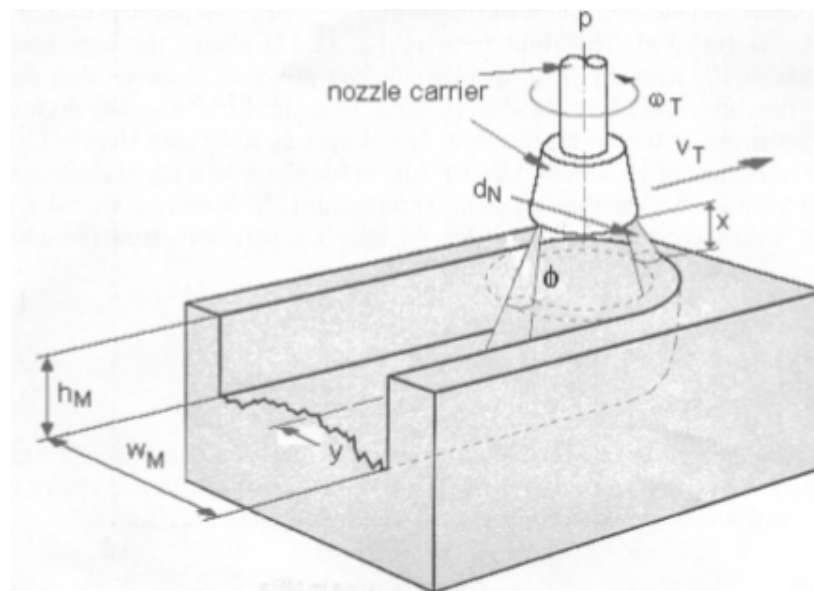
Figure 3-4: Target parameters associated with a twin orifice nozzle rotary head jet system [10].

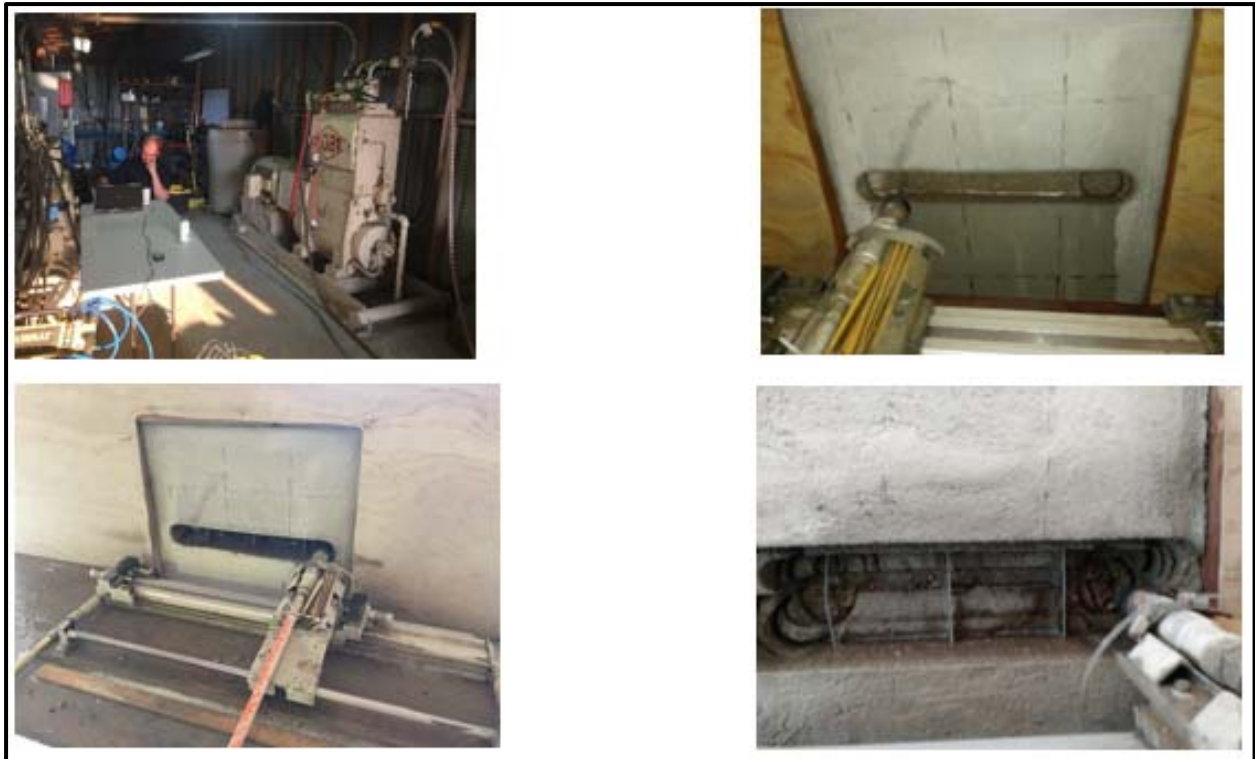
Figure 3-5: Waterjet excavation – SAI/RAMAX Laboratory set-up (upper left) start of slot in panel (upper right) kerf in panel (bottom left) close-up of kerf in panel (bottom right).

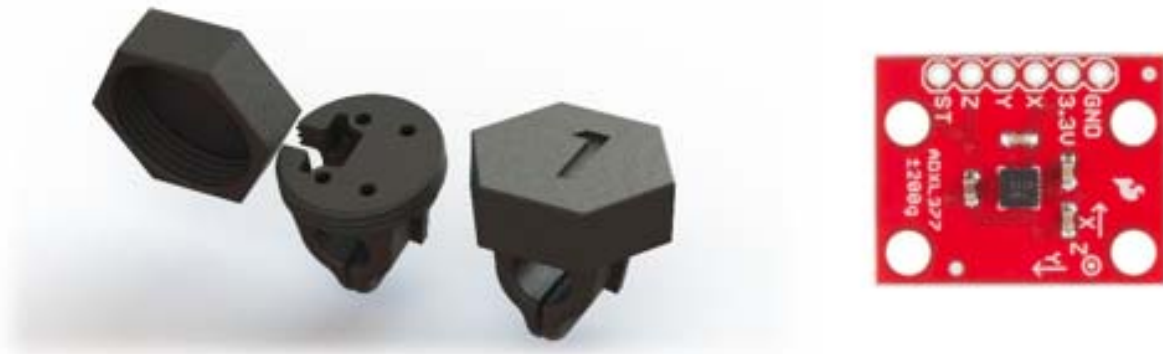
Figure 3-6: Accelerometer mount (left) and ADXL337 (right).

The accelerometers were mounted in enclosed 3D printed ABS sensor mounts (Figure 3-6). The ADXL337 was attached to the accelerometer mount by four screws. A cutaway was left in the base of the sensor mount for the wiring harness. The sensor mounts were pressed onto the rebar. To ensure a tight fit, the rebar was wrapped with electrical tape. The hexagonal tops of the sensor mounts were parallel to the surface of the panel. Seven sensor mounts were used during testing. These were arranged in a counter clockwise pattern around the sample starting with accelerometer 1 on the bottom right rebar end. There were three accelerometers on the right side of the sample, two on the top of the sample, and two on the left side of the sample. The sensor arrangement is shown in Figure 3-7.

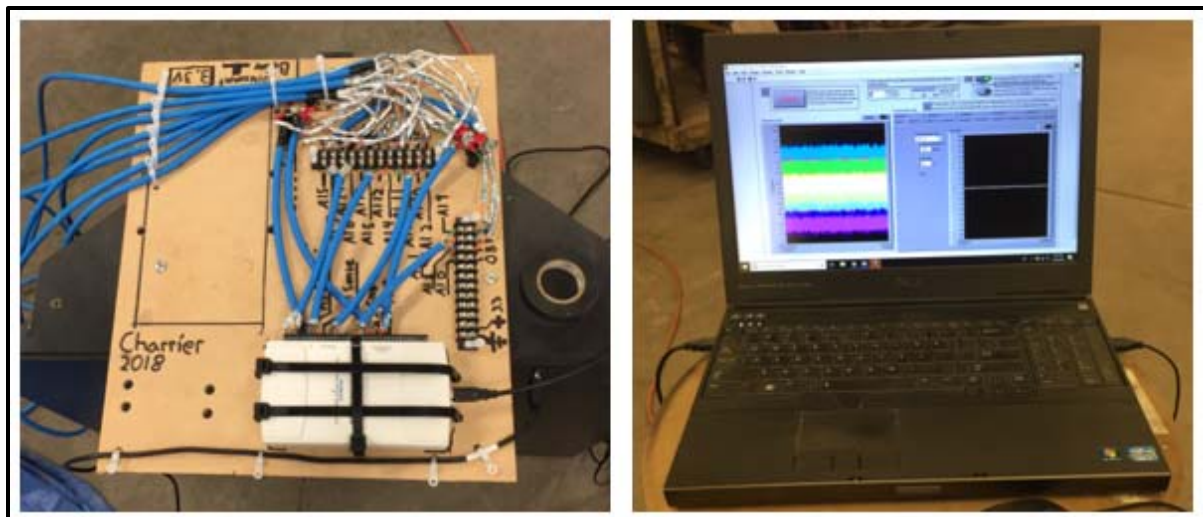
Figure 3-8: Data acquisition setup.

The accelerometers were calibrated to near zero for every test period. The VI wrote its collected data to disk every 30 seconds to prevent loss in the event of a system crash. The data from each cut was saved as an Excel file. The data files were post processed in Excel and MATLAB. The average acceleration of each channel was found and used as 0 since field calibration was only accurate to ± 0.5 G.

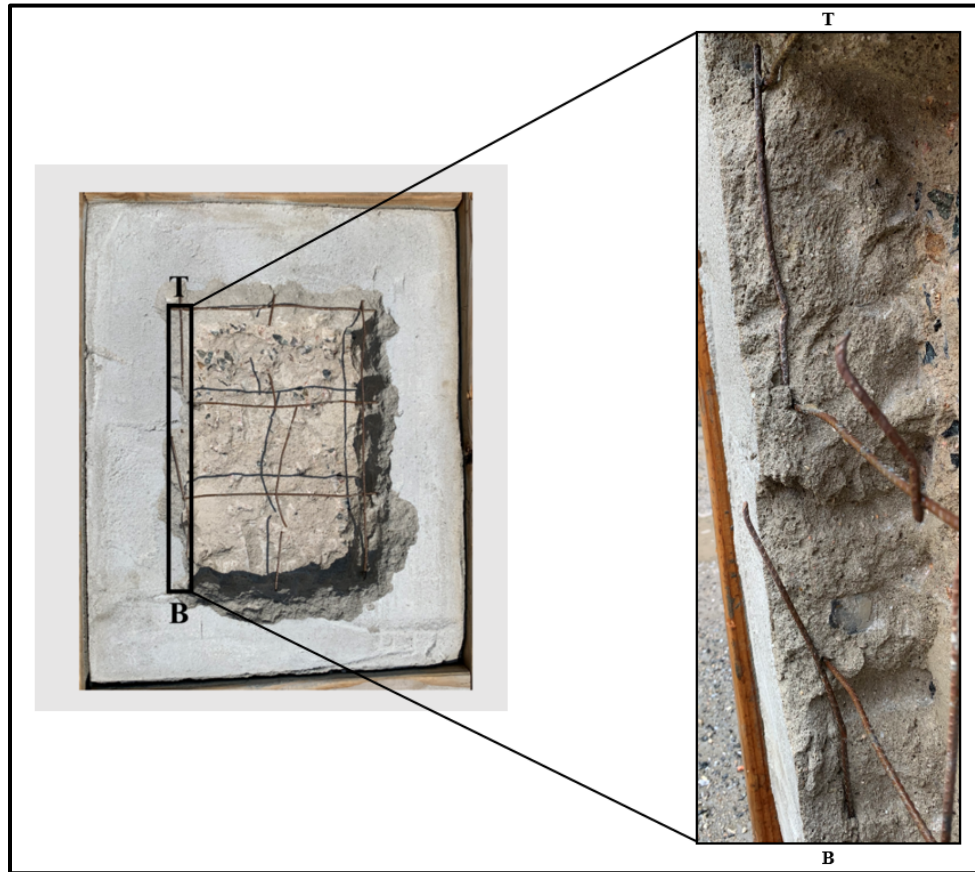
Figure 3-9: Example of visual inspection scenario for left face of panel 2.

to provide a clean, wet surface which aided in fracture/failure visibility to the naked eye. When each section was examined, areas of fracture/failure were noted. These areas either had a single fracture or a network of failure which were manually measured in millimeters using measuring tape. All of these areas were identified, measured, and summarized for each excavation section. Figure 3-9 gives an example of a specific section analyzed in Panel 2, which was tested upon using the impact hammer.

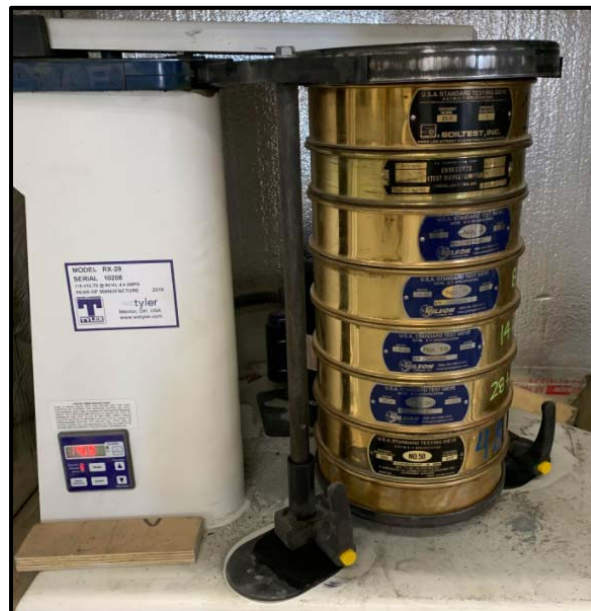
Figure 3-10: Model RX-29 Tyler sieve shaker used for sieve analysis of impact hammer cuttings.

Shotcrete simulant cuttings were collected during testing on all panels for examination. Impact hammer cuttings were analyzed at the EMI through three 500-gram (1.1 pound) samples which were poured through a sieve set of 48, 28, 14, 8, and 4 Tyler mesh with additional 12.7 mm (½ inch) and 25.4 mm (1 inch) mesh sieves for larger chip sizes. For each impact hammer sample, the sieve set was placed into a Model RX-29 Tyler sieve shaker, as shown in Figure 3-10, for dry screening, running for 15 minutes, after which each sieve was weighed and recorded. These recorded weights were used to generate a plot for cumulative percentage retained according to each sieve size. Waterjet cuttings were analyzed at the SAI/RAMAX laboratory through measurement of grains collected during testing. Due to the nature of waterjet testing, not all of the generated cuttings could be contained, resulting in a smaller sample size compared to that of impact hammer testing.

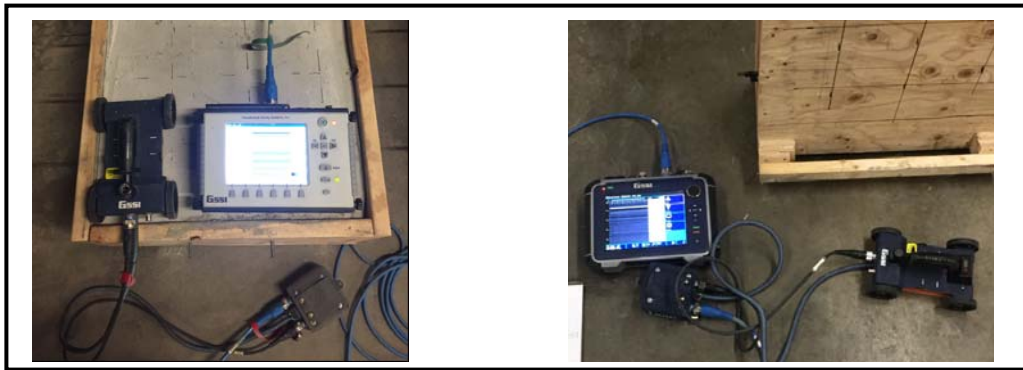
Figure 3-11: 2600 MHz radar antenna connected to SIR 3000 radar system control unit (left) 1600 MHz radar antenna coupled with SIR 4000 radar system control unit.

system gathered real-time non-destructive testing data in the form of DZT files. The data was collected using two GPR systems, a 2600 MHz radar antenna coupled with a SIR 3000 radar system control unit and a 1600 MHz radar antenna coupled with a SIR 4000 radar system control unit (Figure 3-11). Both sets of equipment were rented from Exploration Instruments, LLC, a geophysical instrumentation company located in Austin, TX. Parameters of the concrete samples, specifically through approximate ten-inch thickness and concrete/shotcrete material composition, led to selection of the 2600 and 1600 MHz radar antennas.

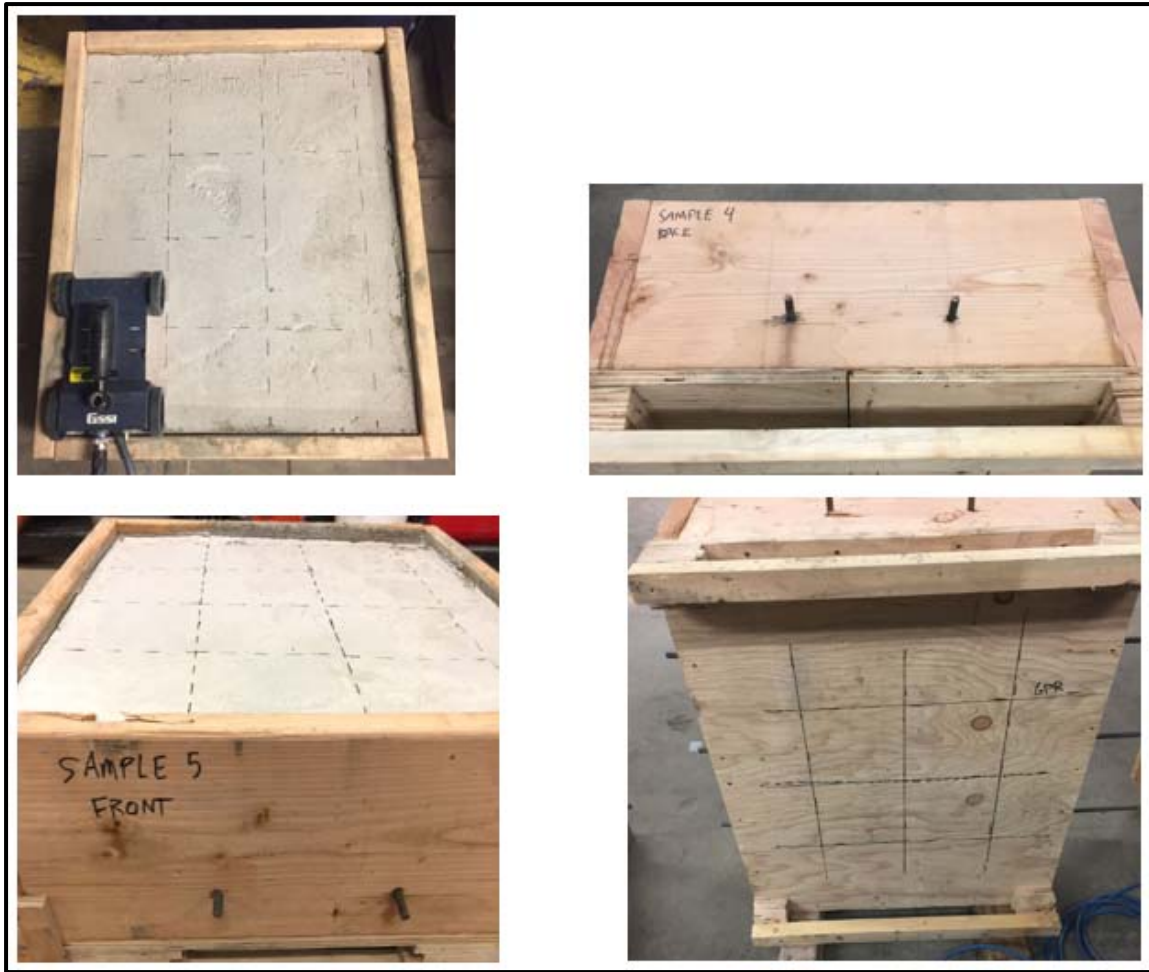
Figure 3-12: Top shotcrete face with GPR gridlines (top left) back timber form face to receive one GPR scan (top right) front timber form face to receive one GPR scan (bottom left) bottom plywood/concrete face with GPR gridlines (bottom right).

for the grid spacing chosen. The samples were scanned on the top shotcrete face, the front timber form face, the right timber form face, the left timber form face, the back-timber form face, and the bottom plywood/concrete face. Examples of these faces with drawn grid lines for the top shotcrete face and bottom plywood/concrete face is shown in Figure 3-12.

Each sample followed the same scanning procedure. For the top shotcrete face, the radar antenna started on the bottom left corner, as shown in Figure 3-12, and took scans from bottom to top. Once a scan was completed, the radar antenna would move to the next grid space to the right and take the next scan. The top shotcrete face had room for three full width grid spaces, followed by a remaining space that did not reach full width. When the radar antenna would reach this 4th smaller grid space, the right wheels would be moved to the shotcrete edge, meeting the timber form, and a bottom to top scan would be taken from there. The radar antenna would then be moved to the bottom right corner of the top face and face left, taking scans from right to left for four full grid widths. This scan sequencing is shown in Figure 3-13. The direction of the single scan taken at each sample's front, right, left and back face is shown.

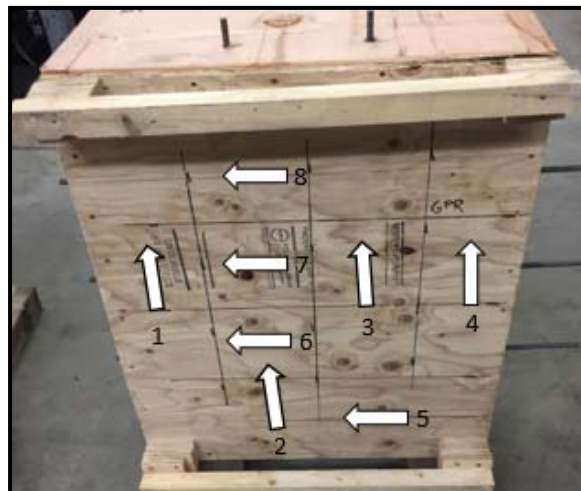
Figure 3-14: GPR scan sequencing for bottom plywood/concrete plan face.

For the front, right, left and back timber form face, a single scan was taken by lining up the wheels with the top edge of the wood form and moving in the direction indicated above. For the bottom plywood/concrete face, the scan sequencing is similar to that of the top shotcrete face. However, the sizing of the wooden form allowed for four even scans both bottom to top and right to left, as shown in Figure 3-14. The scanning procedures described were intended to gather data for each sample before mechanical and waterjet testing took place. This would establish a baseline for wire mesh and rebar location within each sample, as well as any pre-existing voids that were a result of the mix composition and casting process. After mechanical and waterjet testing took place, the scanning procedures for front face, right face, left face, back face and bottom plywood/concrete plan face were performed again to gather data representing each sample after mechanical/waterjet impact.

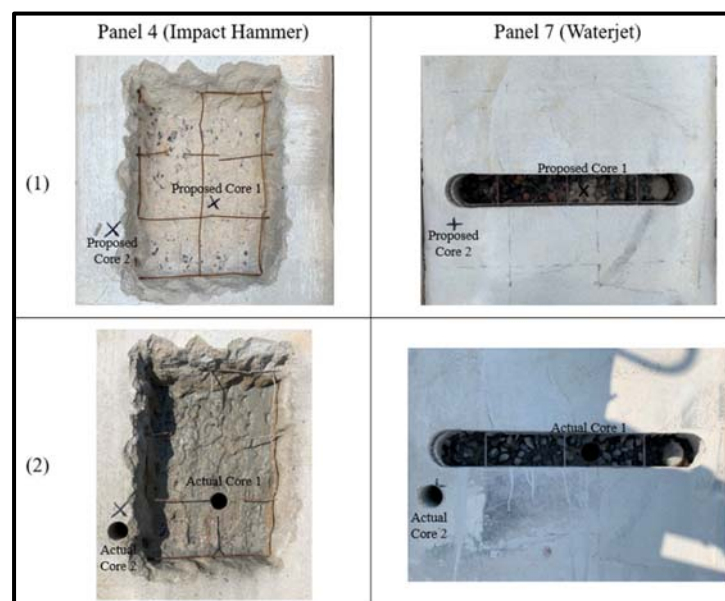
Figure 3-15: Coring process showing (1) proposed locations of cores and (2) actual locations of cores.
