UNIVERSITYTRANSPORTATIONCENTER
FOR UNDERGROUND TRANSPORTATION INFRASTRUCTURE

**THE CHARACTERIZATION OF DELAMINATION PROCESSES WITH
RESPECT TO WATERJET SHOTCRETE REMOVAL DURING TUNNEL
LINER REPAIR AND MAINTENANCE**

FINAL PROJECT REPORT

October 22, 2020

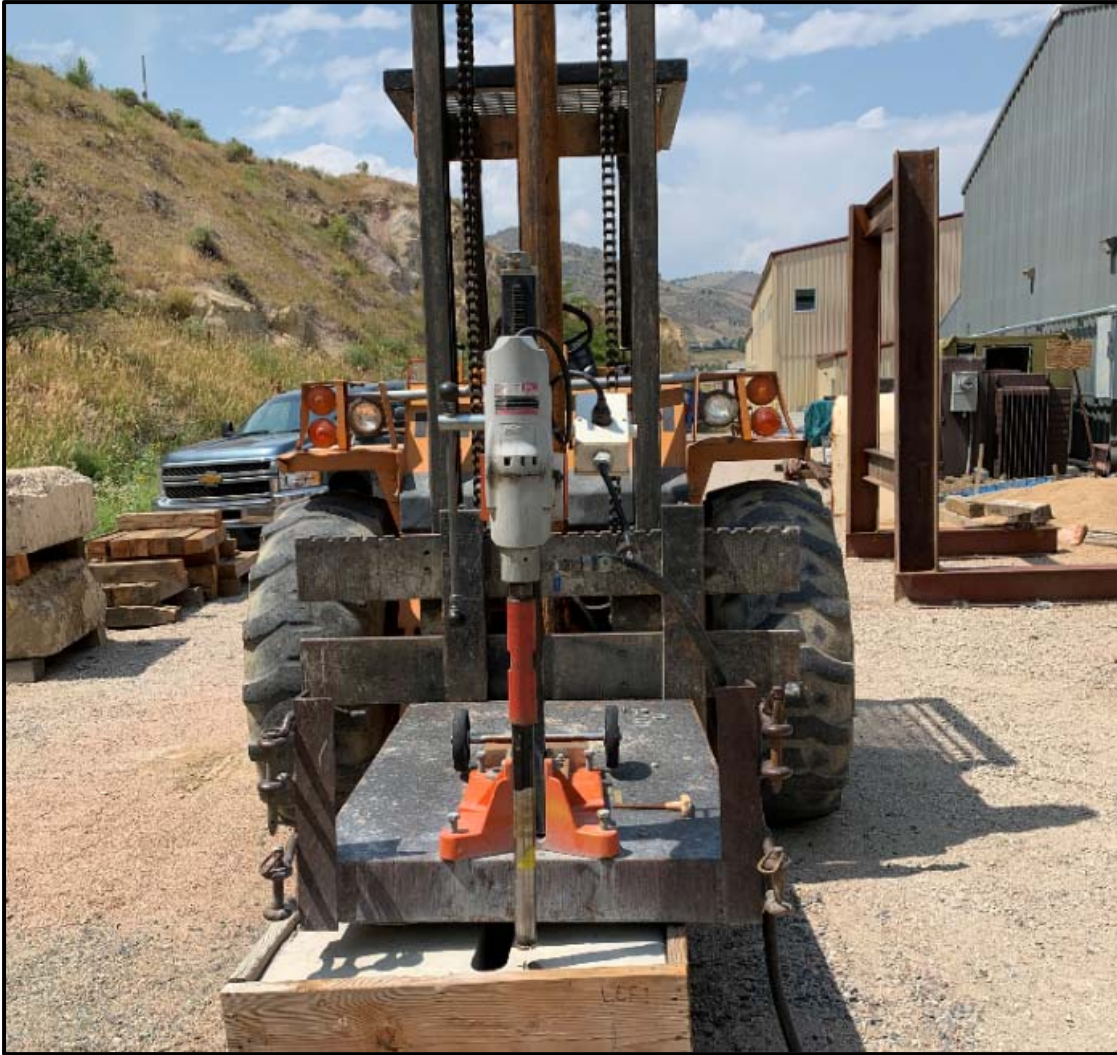
Figure 3-16: Core drill and bit set-up with forklift at EMI.

A Milwaukee 4094 dymodrill was used with a 41.3 mm (1-5/8-inch) diamond core bit as shown in Figure 3-16. This provided 35 mm (1-3/8-inch) core samples for microCT analysis. Each core was taken until the bit reached the plywood bottom of the panel, at which point, the bit retreated and the samples were removed. All four cores, as well as their associated lengths, are shown in Figure 3-17. In order to fit into the microCT scanner, each core had to be cut into 76 mm (3 inch) long segments using a continuous rim circular diamond saw blade.

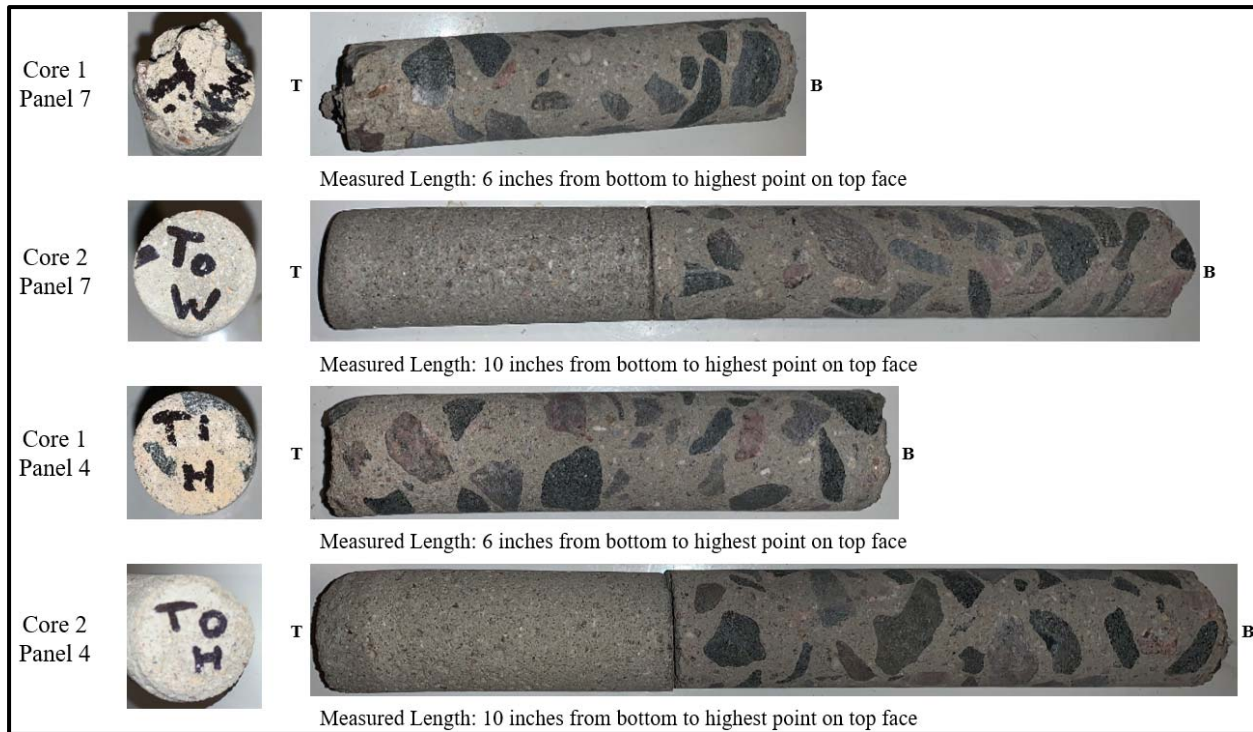
Figure 3-17: Cores and their respective lengths. Lettering “T” indicates the top of the core while “B” indicates the bottom of the core.

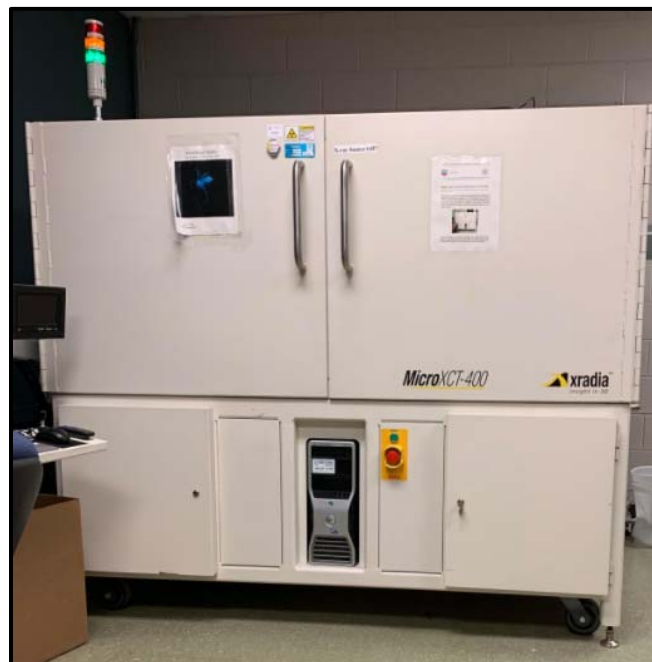
Figure 3-18: MicroXCT-400 equipment used for microCT analysis of core segments.

The scanner used for microCT analysis was a MicroXCT-400, as shown in Figure 3-18, operated by the Department of Geophysics at CSM. Each 76 mm (3 inch) long core sample required approximately 45 minutes of preparation through alignment onto the platform within the MicroXCT-400, as well as three hours to complete a full scan. The process of acquiring a microCT scan is shown in Figure 3-19. Through consultation with Kurt Livo, a graduate student at CSM who operates the scanning equipment within the Department of Geophysics, a resolution of approximately 25 microns was utilized for analysis of the 35 mm (1-3/8-inch) diameter cores with a step size of 0.1 degrees. This resolution was deemed appropriate due to the intention of the scans, which was to identify fractures due to testing. Due to availability of the scanning equipment within the Department of Geophysics, only Core 1 from Panel 7 and Panel 4 were examined while Core 2 from both panels were held in reserve for future research.

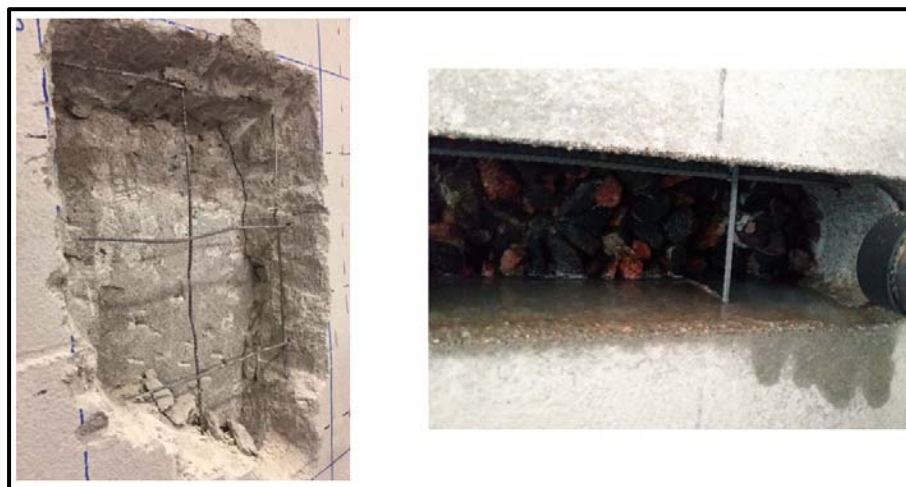
Figure 4-1: Photos taken at panel face showing cutting geometry and bond surface left after impact hammer testing (left) and waterjet testing (right).

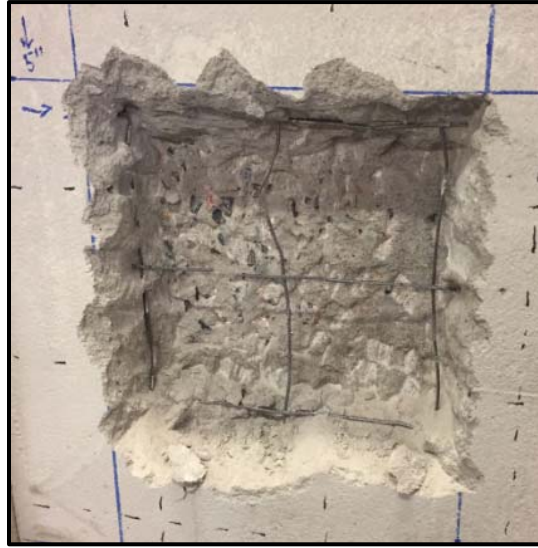
Figure 4-2: Example of inconsistent kerf and damage to steel infrastructure during impact hammer testing.

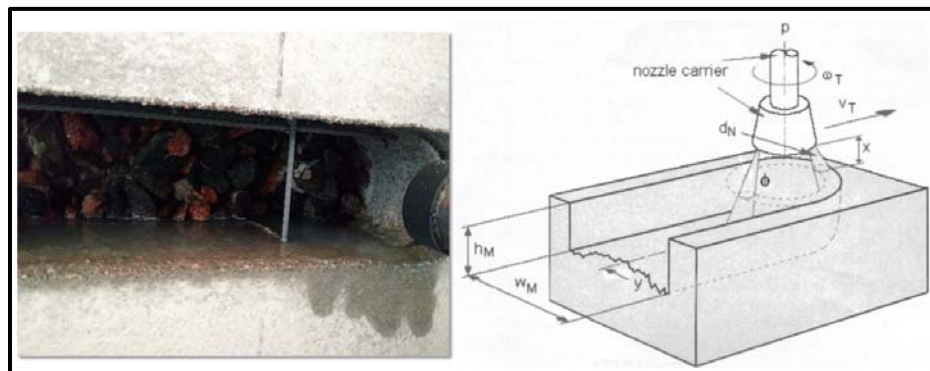
Figure 4-3 Comparison of shotcrete cutting with twin orifice rotating waterjet to Momber's diagram [10]

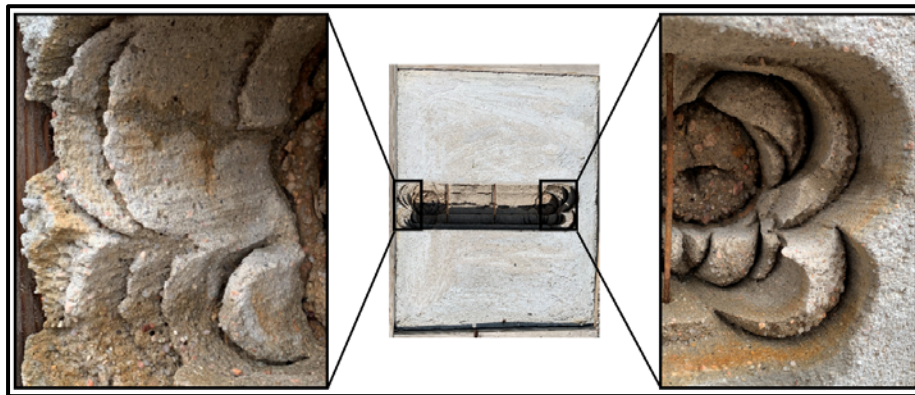
Figure 4-4: Ribs of shotcrete left on edges of panel TEST due to traverse limitations in reversing direction.

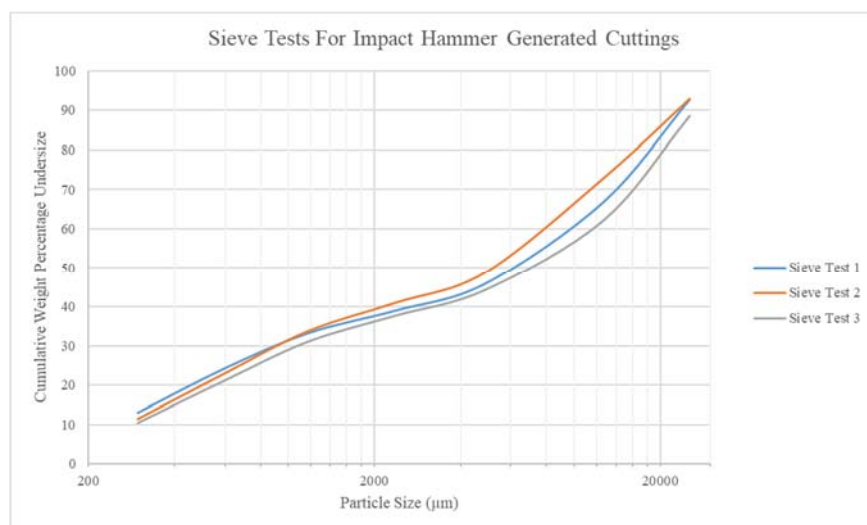
Figure 4-5: Semi-logarithmic plot of impact hammer sieve analysis tests.

For the cuttings generated by the impact hammer, three 500-gram (1.1 pound) samples underwent sieve analysis. The results of all three sieve tests is shown in Table 4-4. Figure 4-5 graphically shows the results of the sieve tests presented in Table 4-4 in semi-logarithmic form.

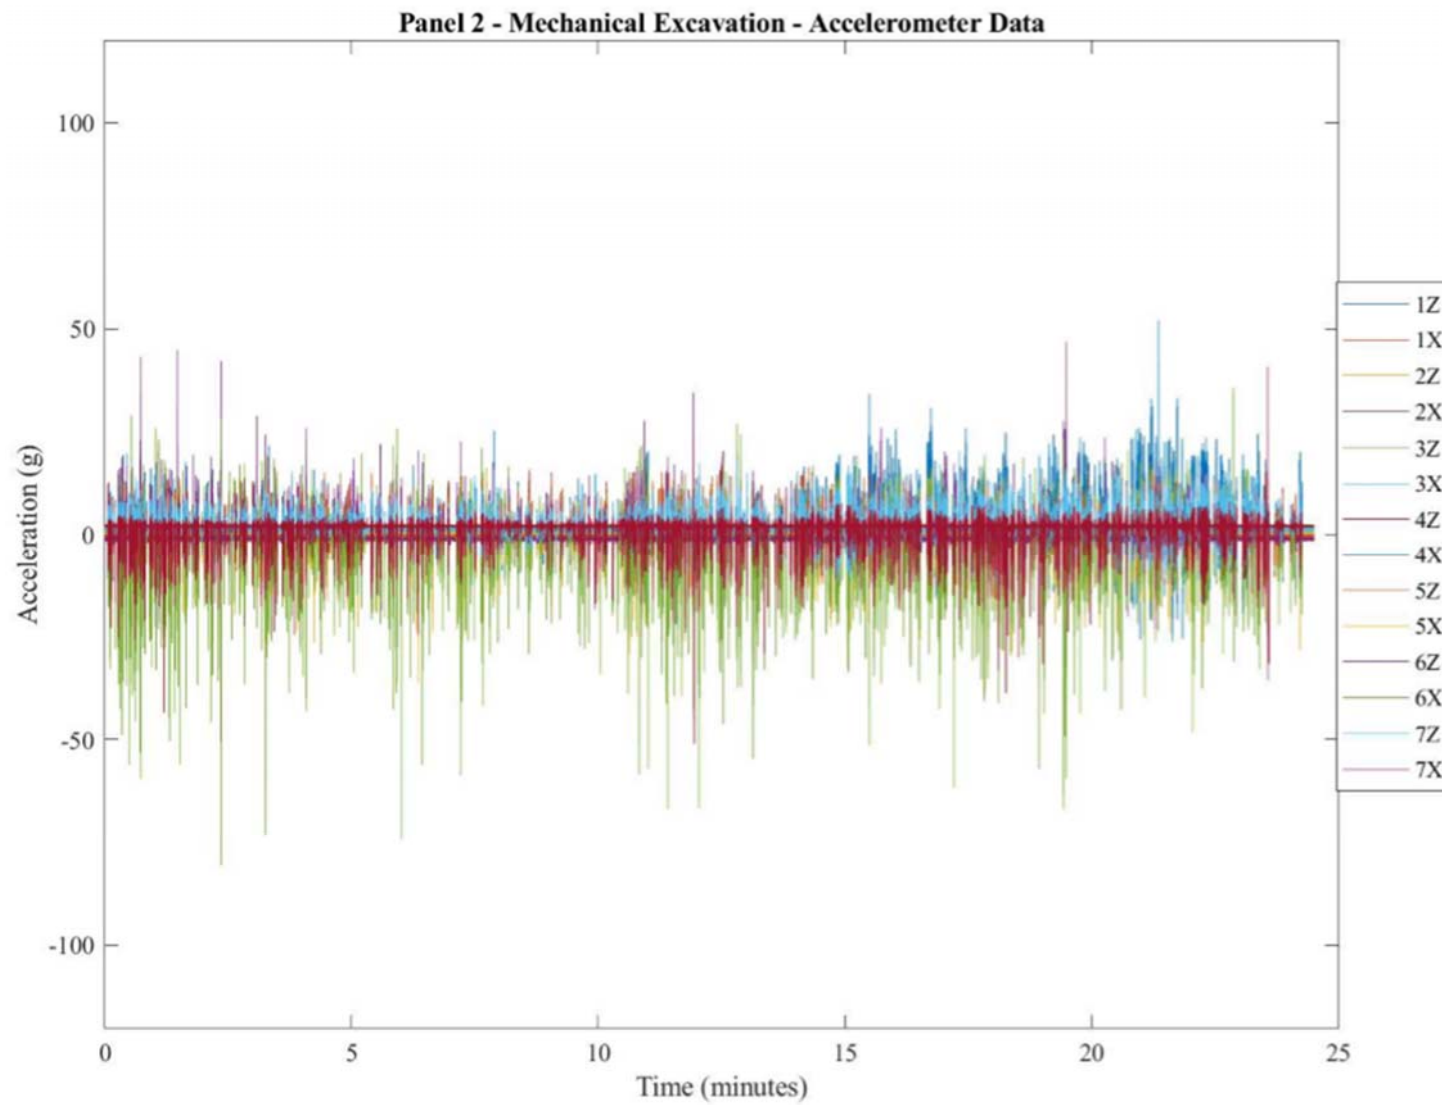
Figure 4-10: Vibration data acquired from accelerometers during impact hammer testing on panel 2.

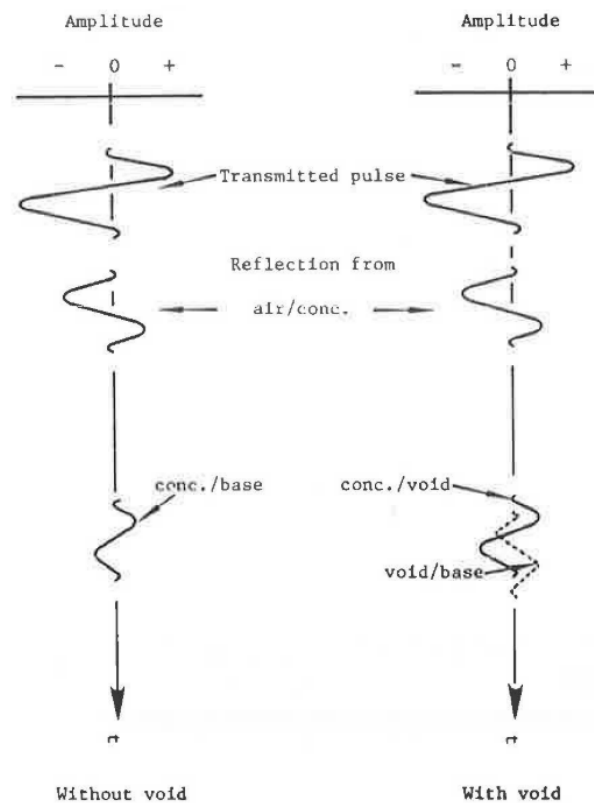
Figure 4-19: Microwave reflection profile for concrete pavement without a void and with a void [53].

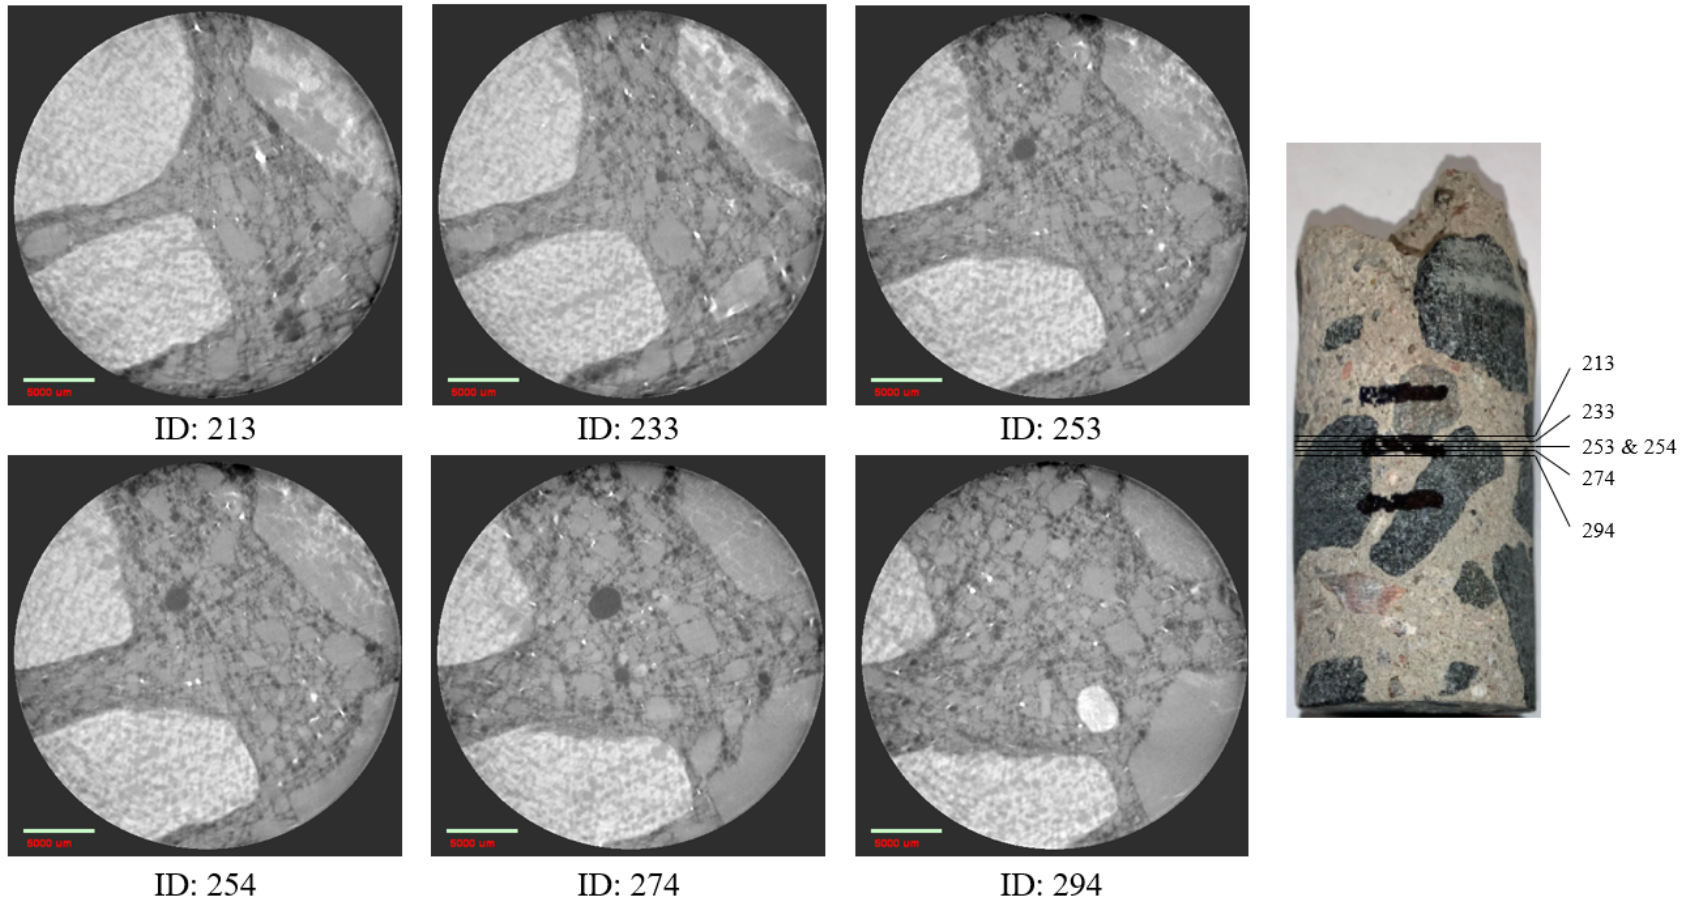
Figure 4-31: Core 1, panel 7 top half microCT scan sections with reference on core sample.

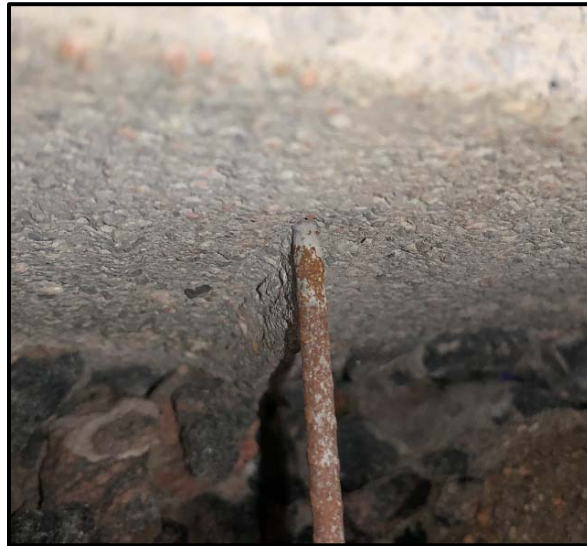
Figure 5-1: Example of edge effect caused by wire mesh, blocking erosion by waterjet, leaving shadow of shotcrete behind steel reinforcement.

intact (not split as observed with the mechanical impact tool) providing a rough, undamaged surface to adhere to.

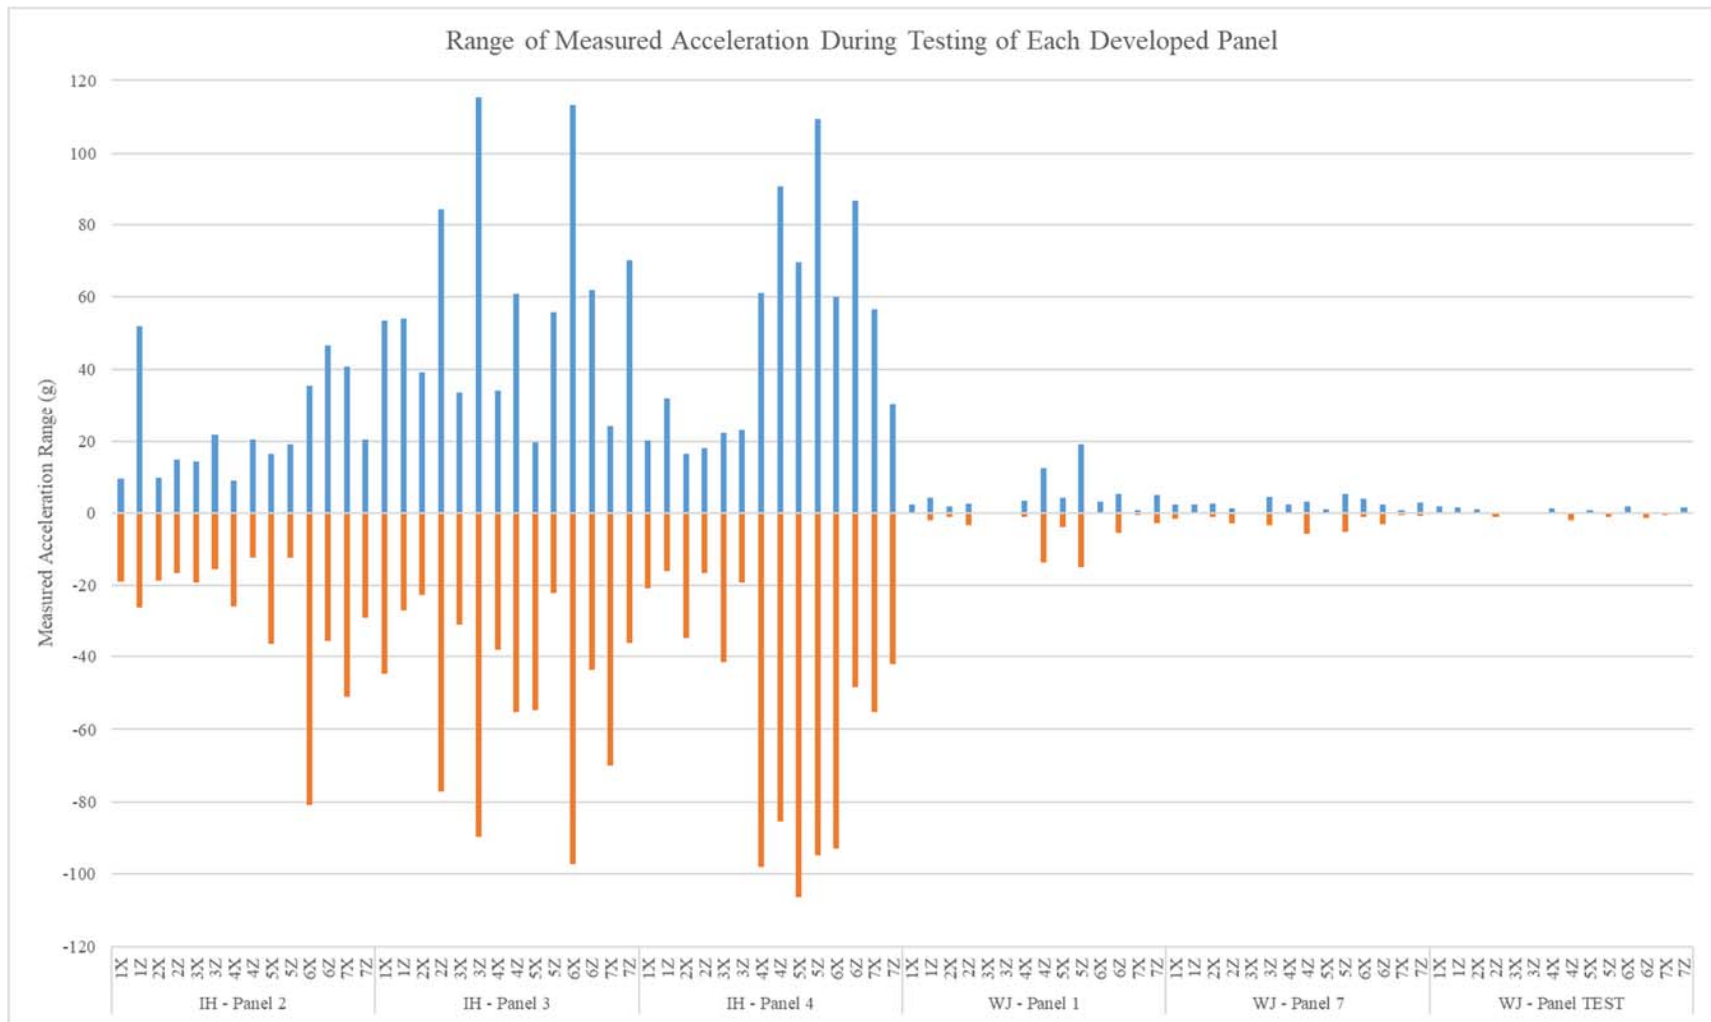
Figure 5-2: Range of measured acceleration during testing of each developed panel.

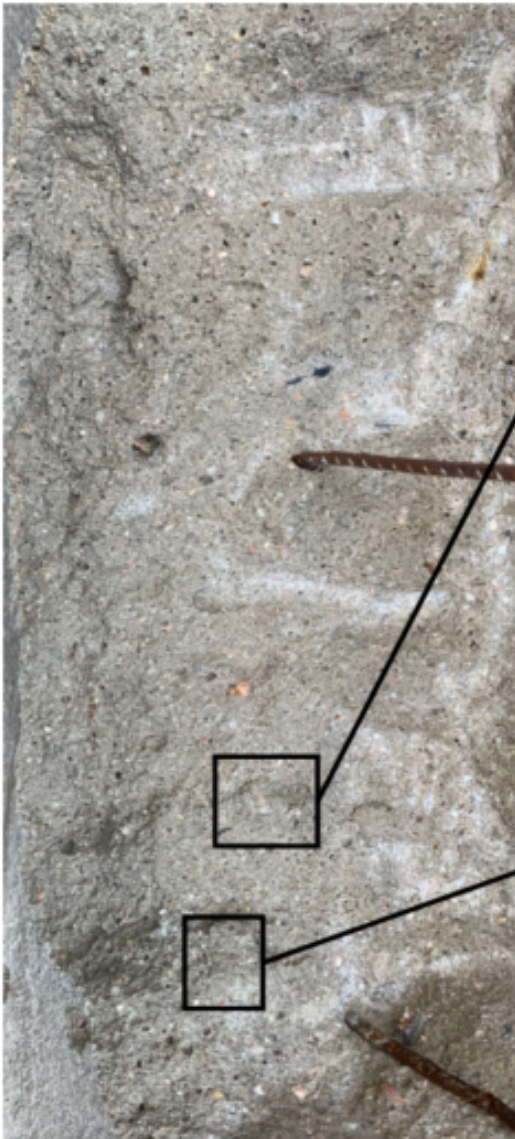
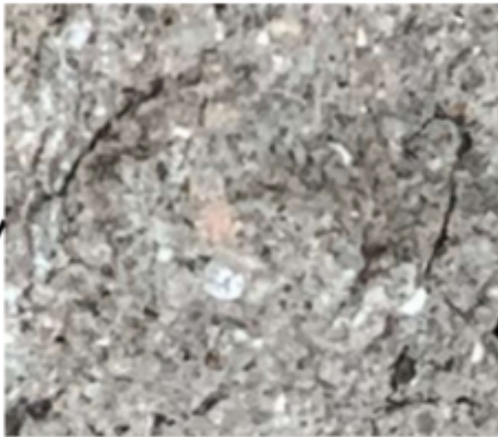
Panel Number: 2 Analyzed Surface: Lower Wall of Excavation	
<div>Notes</div> <div>No visible signs of delamination at the shotcrete/concrete interface. There also appears to be 2 areas of fracture/failure as highlighted below. The excavation tool left a wavy, irregular shape to the bottom wall.</div>

<div>Fracture/Failure Count: 2</div> <div>Total Fracture Length: 4.5 mm</div> <div>Damaged Wire Mesh? Yes</div>	
<div>T</div> <div>

<div>Measured Fracture/Failure Network: 1mm</div></div> <div>

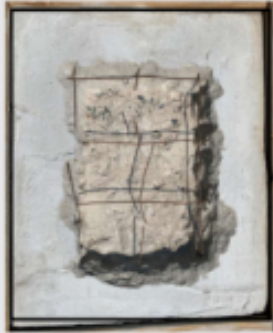
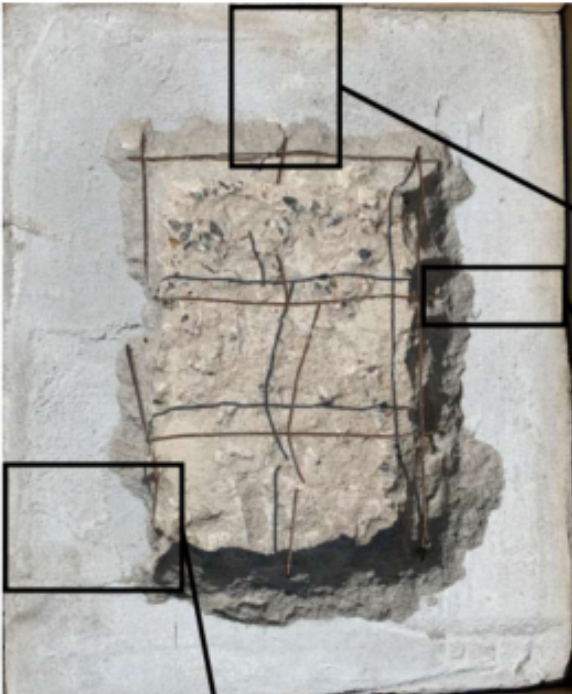
Panel Number: 2 Analyzed Surface: Area Outside Excavated Profile	
Notes 3 areas of failure were discovered along the shotcrete face surrounding the excavation profile. The fracture in the upper section identified above measures 13 mm, the fracture in the mid right section measures 11 mm, and the fracture identified in the lower left corner measures 8 mm.

Fracture/Failure Count: 3 Total Fracture Length: 32 mm

<div data-bbox="954 636 1347 1203" data-label="Image"> </div> <div data-bbox="971 1209 1331 1234" data-label="Caption"> <p>Measured Fracture/Failure Network: 13mm</p> </div> <div data-bbox="716 1360 1338 1614" data-label="Image"> </div> <div data-bbox="847 1621 1208 1646" data-label="Caption"> <p>Measured Fracture/Failure Network: 11mm</p> </div> <div data-bbox="254 1455 701 1770" data-label="Image"> </div> <div data-bbox="305 1776 656 1801" data-label="Caption"> <p>Measured Fracture/Failure Network: 8mm</p> </div>

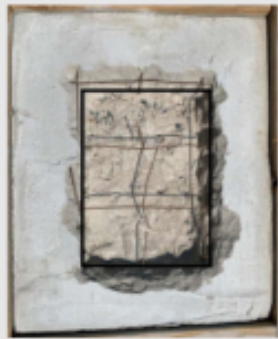
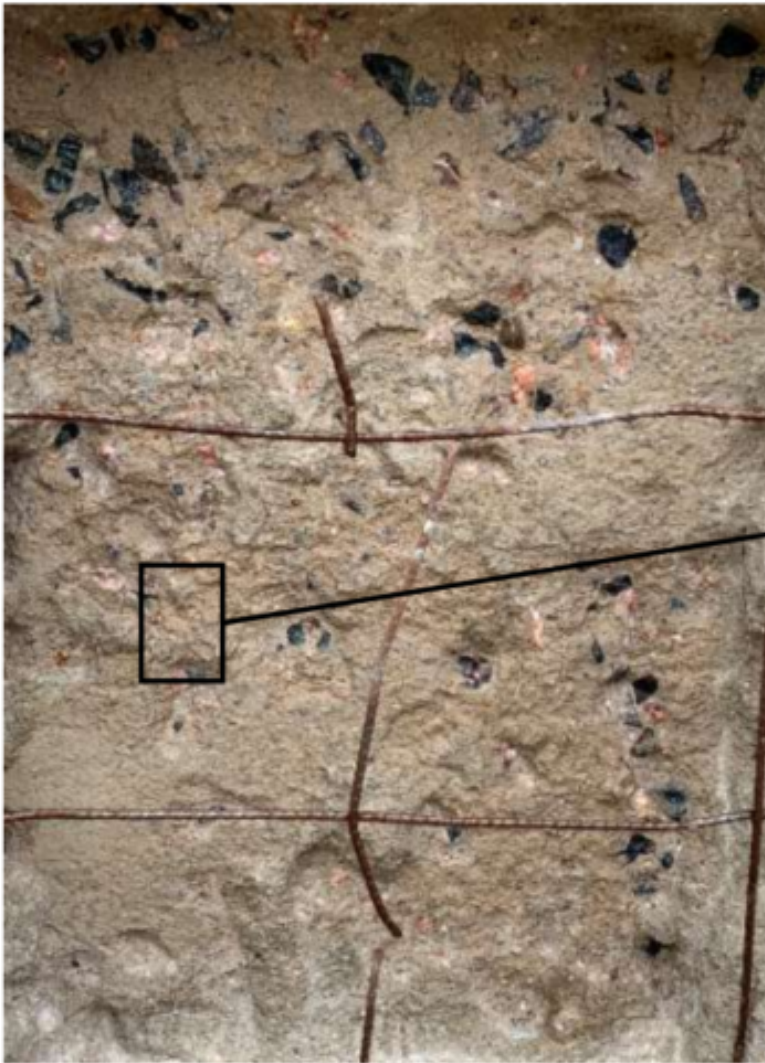
A large percentage of the exposed aggregate was fractured by the impact hammer. There is 1 area of the excavation face that shows failure around the perimeter of a piece of aggregate.	
Exposed Aggregate Count: 51 Percentage Aggregate Split: 32 split = 62.7% Fracture/Failure Count: 1 Total Fracture Length: 8 mm

Measured Fracture/Failure Network: 8mm

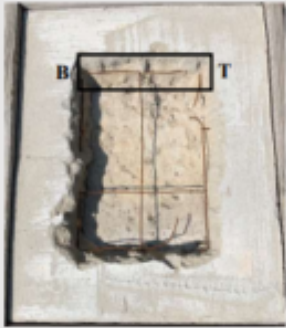
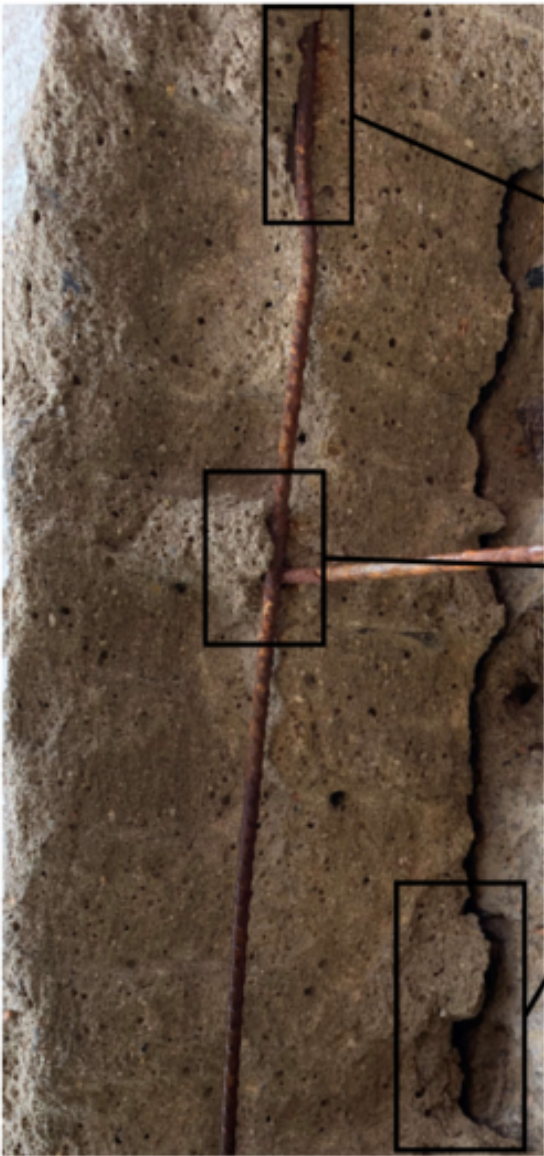
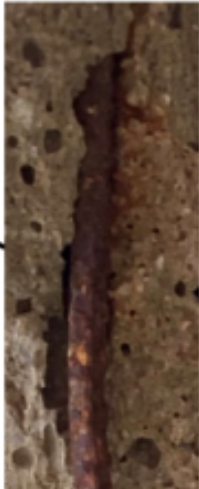
Panel Number: 3 Analyzed Surface: Upper Wall of Excavation	
Notes Significant delamination at the shotcrete/concrete interface along the entirety of the upper wall measuring 23.5 mm long with a 0.1 mm maximum gap. There are 2 signs of cracking/failure where the wire mesh enters into the shotcrete layer, possibly due to vibrations induced by the impact hammer. There is also 1 other area of failure/fracture as identified below. The excavation tool left a wavy, irregular shape to the upper wall.

Measured Delamination: 23.5 mm Fracture/Failure Count: 3 Total Fracture Length: 32.5 mm (including delamination) Damaged Wire Mesh? No	
<div style="display: flex; align-items: center;"> <div style="flex: 1;">

<p>Measured Fracture/Failure Network: 4mm</p> </div> <div style="flex: 1;">

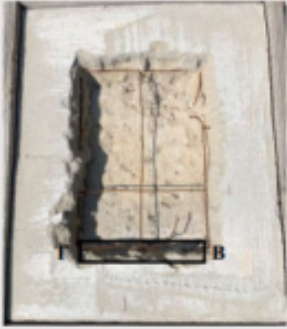
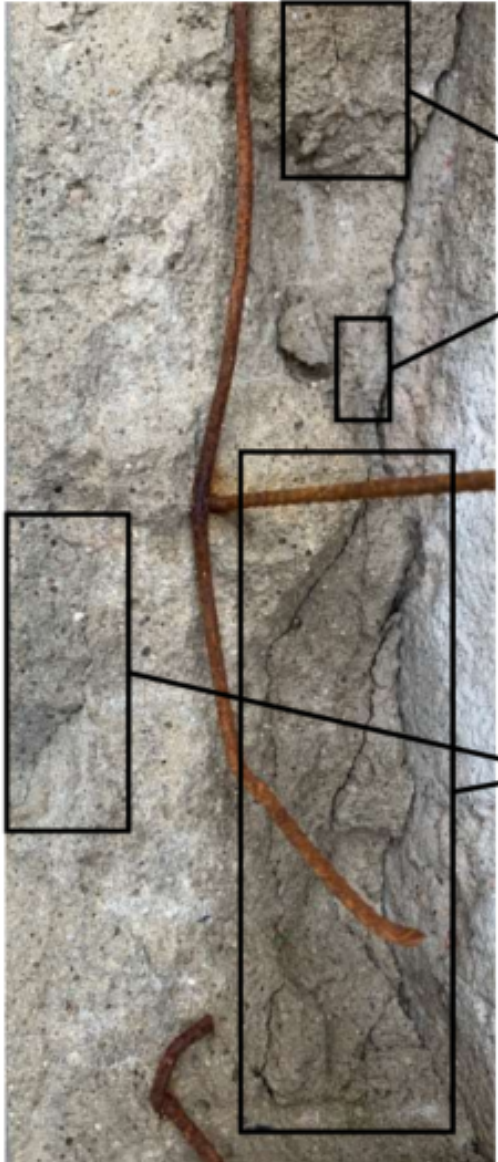
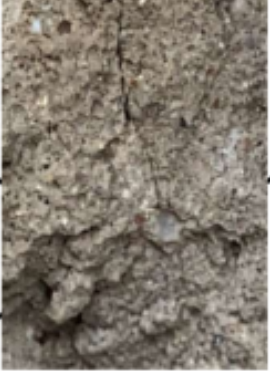
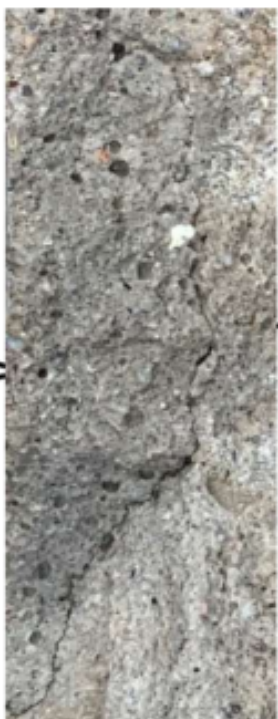
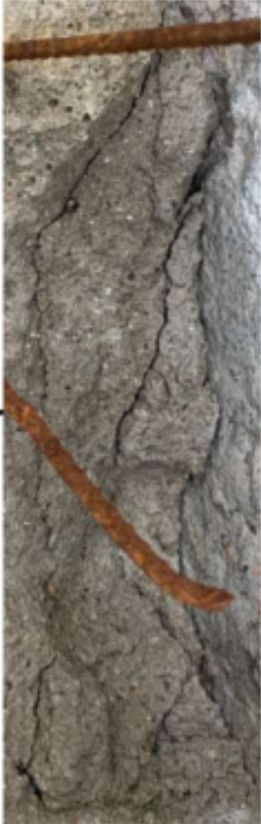
Panel Number: 3 Analyzed Surface: Lower Wall of Excavation	
Notes Significant delamination at the shotcrete/concrete interface along the entirety of the lower wall measuring 30 mm long with a 0.1 mm maximum gap. There are 4 areas of failure/fracture as identified below. The excavation tool left a wavy, irregular shape to the left wall.

Measured Delamination: 30 mm Fracture/Failure Count: 4 Total Fracture Length: 66 mm (including delamination) Damaged Wire Mesh? Yes

Measured Fracture/Failure Network: 2mm

Measured Fracture/Failure Network: 3mm

Measured Fracture/Failure Network: 9mm

Measured Fracture/Failure Network: 22mm

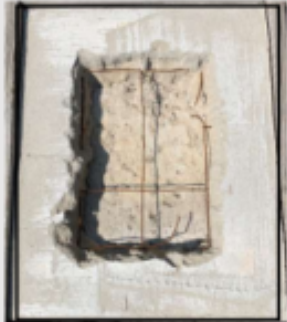
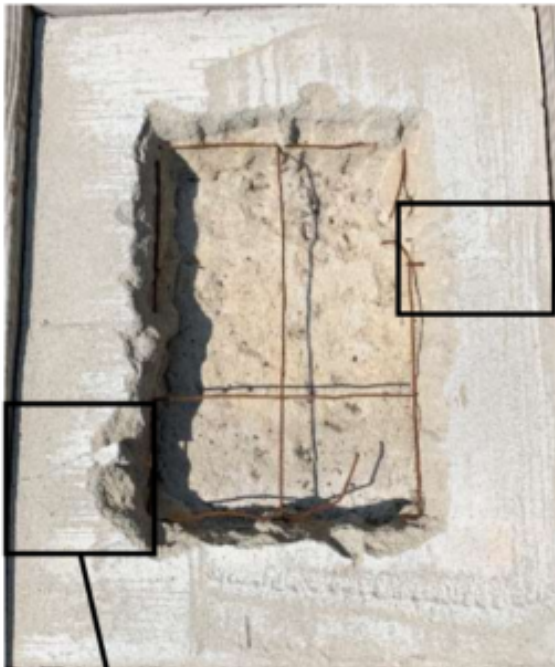
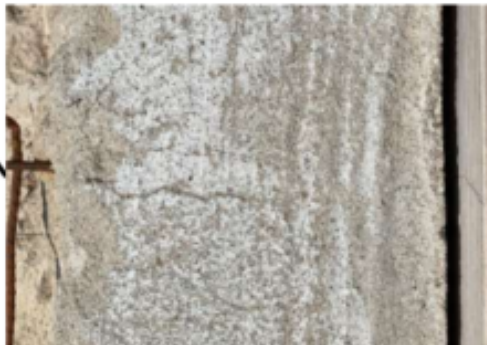
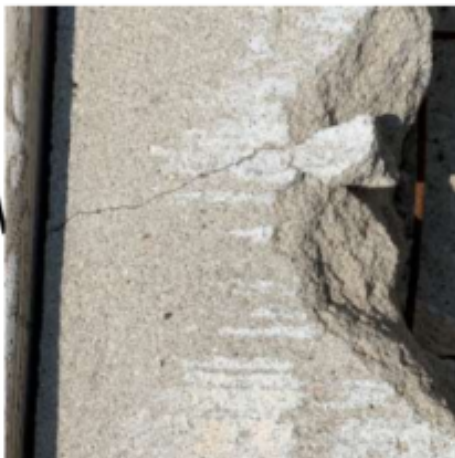
Panel Number: 3 Analyzed Surface: Area Outside Excavated Profile	
<p>Notes</p> <p>2 areas of failure were discovered along the shotcrete face surrounding the excavation profile. The fracture in the the middle right area measures 7 mm while the fracture in the lower left corner measures 11 mm.</p>

<p>Fracture/Failure Count: 2 Total Fracture Length: 18 mm</p>

Measured Fracture/Failure Network: 7mm

Measured Fracture/Failure Network: 11mm

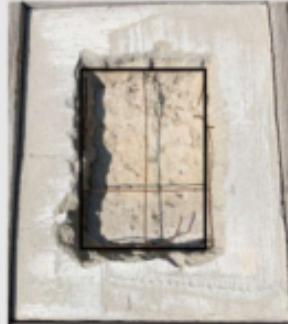
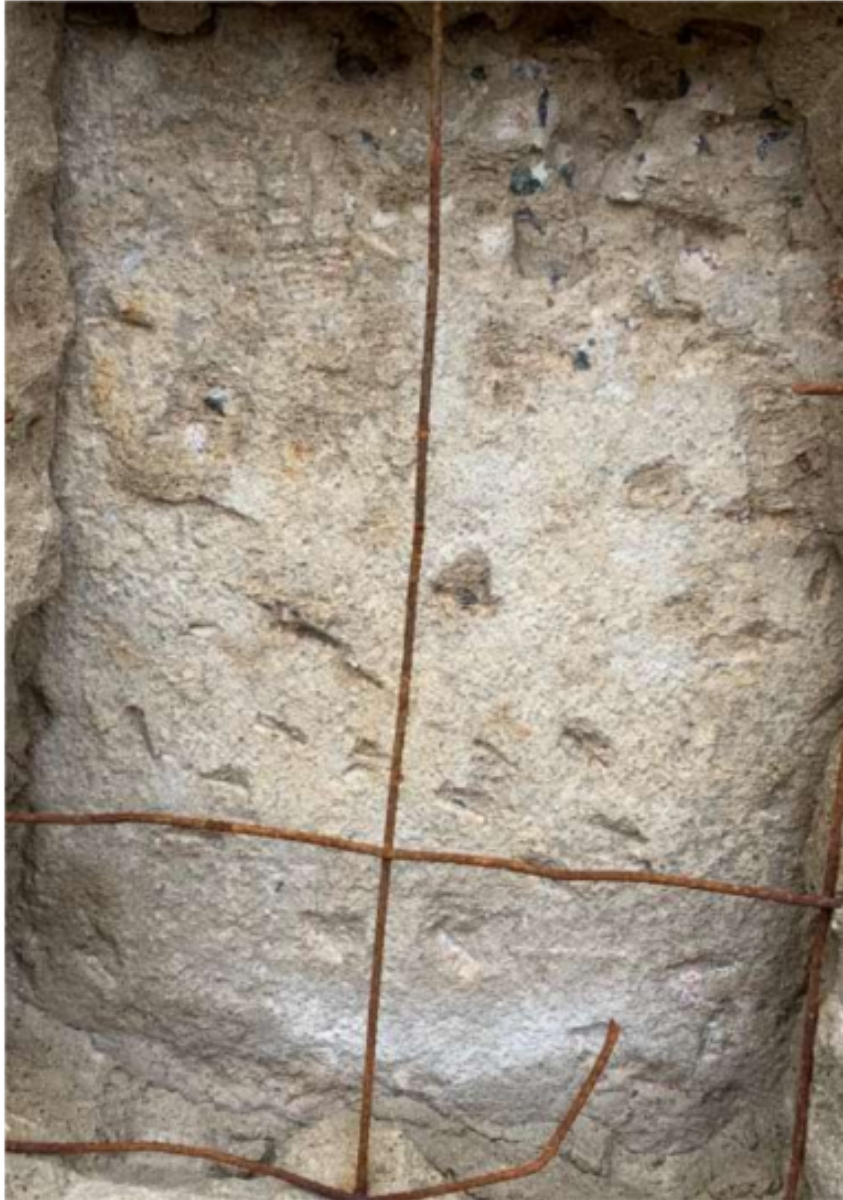
Panel Number: 3 Analyzed Surface: Excavation Face	
<u>Notes</u> While there was not a lot of exposed aggregate after excavation of this particular sample, a large percentage was still fractured by the impact hammer.

Exposed Aggregate Count: 16 Percentage Aggregate Split: 10 split = 62.5% Fracture/Failure Count: 0 Total Fracture Length: 0 mm

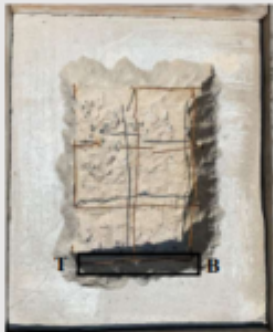
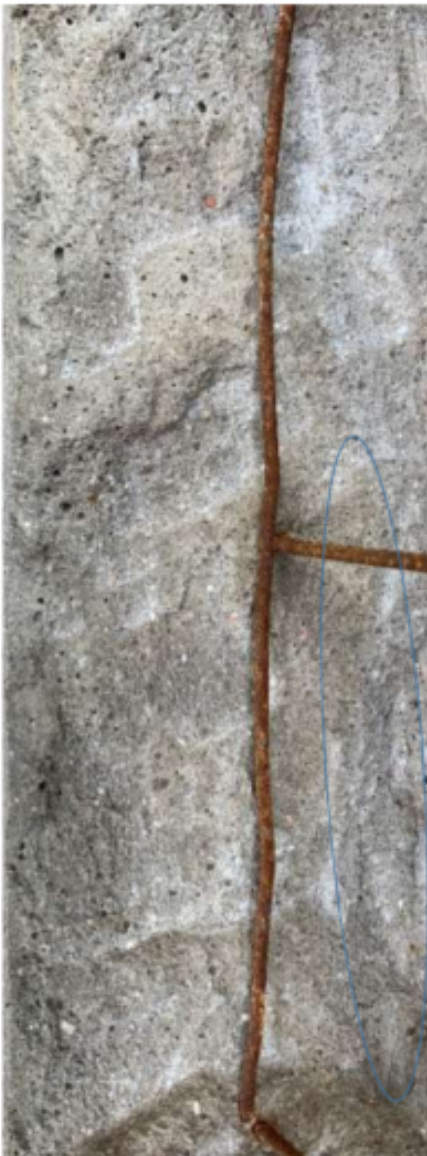
Panel Number: 4 Analyzed Surface: Lower Wall of Excavation	
Notes There are visible signs of delamination at the shotcrete/concrete interface identified within the blue oval in the figure below. The excavation tool left a wavy, irregular shape to the lower wall.

Measured Delamination: 22 mm Fracture/Failure Count: 0 Total Fracture Length: 22 mm (including delamination) Damaged Wire Mesh? No	
<div style="text-align: center;">T</div>

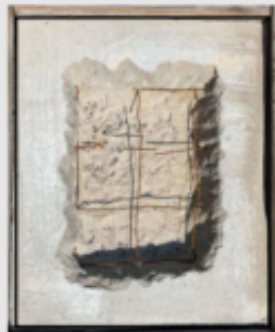
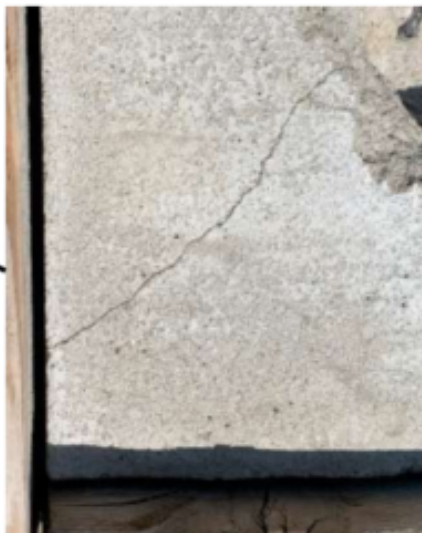
Panel Number: 4 Analyzed Surface: Area Outside Excavated Profile	
<p>Notes</p> <p>2 areas of failure was discovered along the shotcrete face surrounding the excavation profile. The fracture in the the lower left corner measures 16 mm and the fracture on the upper right corner measures 11 mm.</p>

<p>Fracture/Failure Count: 2</p> <p>Total Fracture Length: 27 mm</p>

Measured Fracture/Failure Network: 16mm

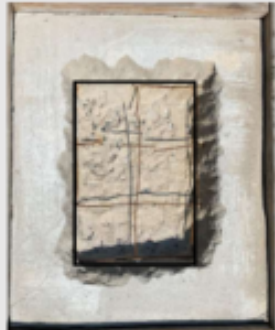
Panel Number: 4 Analyzed Surface: Excavation Face	
Notes A large percentage of the exposed aggregate was fractured by the impact hammer.

Exposed Aggregate Count: 57 Percentage Aggregate Split: 46 split = 80.7% Fracture/Failure Count: 0 Total Fracture Length: 0 mm

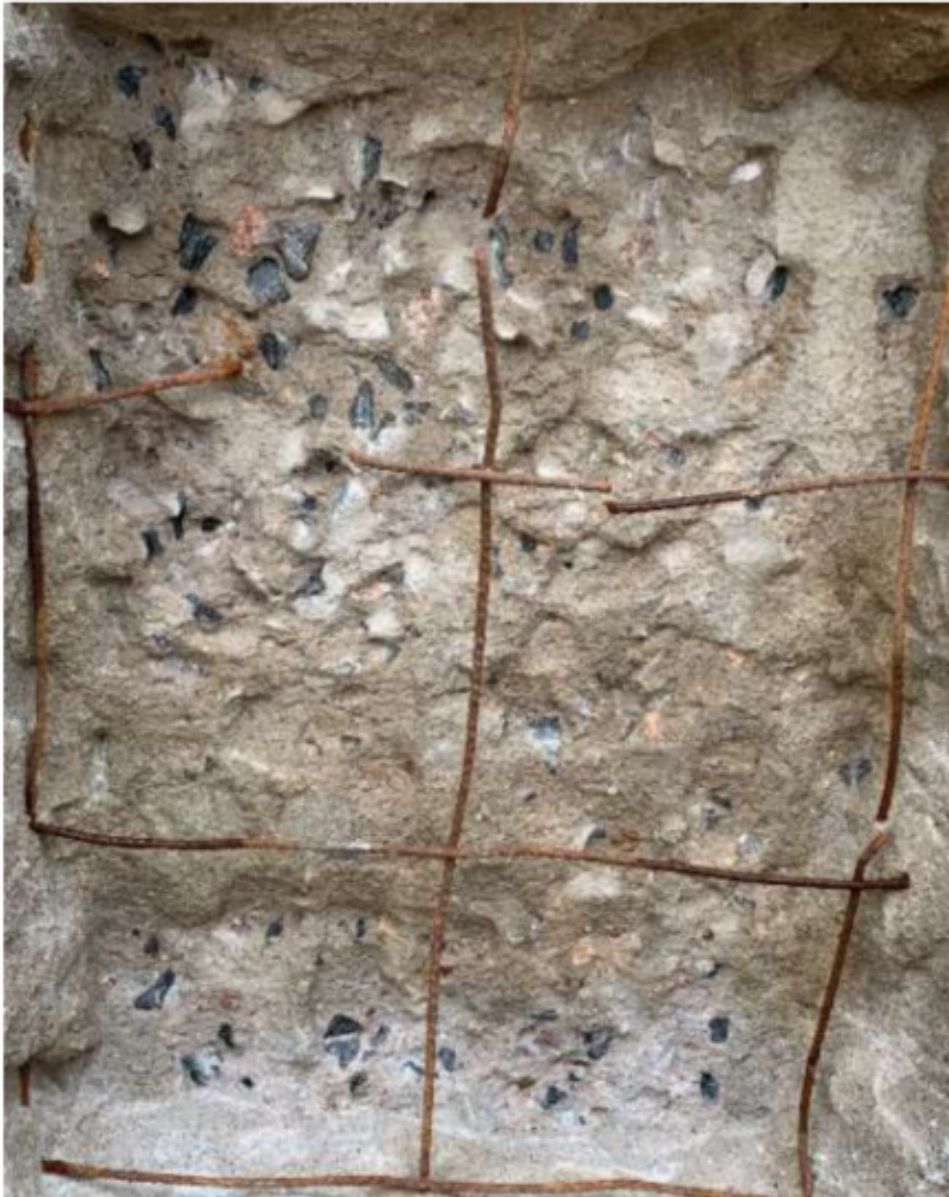
Panel Number: 7 Analyzed Surface: Left Wall of Excavation	
Notes No visible signs of delamination at the shotcrete/concrete interface. There is 1 area of failure/fracture as identified below. At this edge of the cut, 1 rib of material were left between jet passes, resulting in 1 inconsistency.

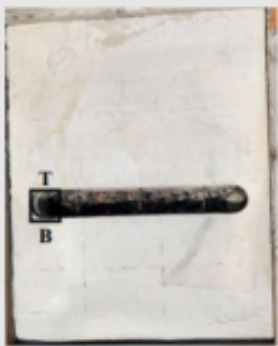
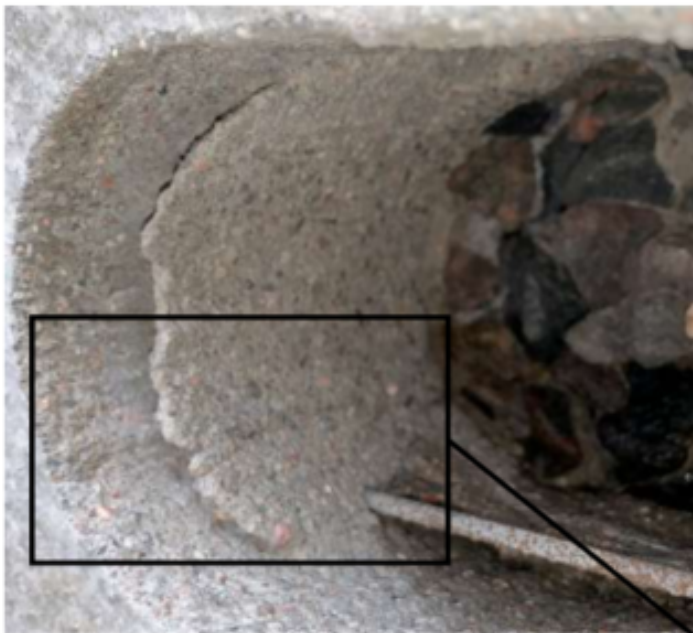
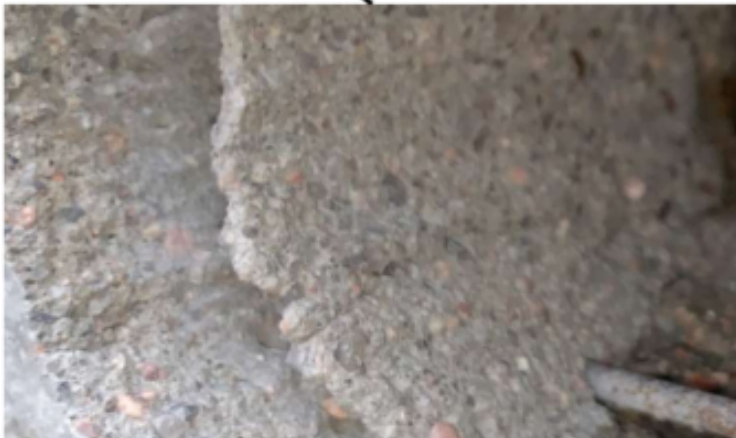
Fracture/Failure Count: 1 Total Fracture Length: 10 mm Damaged Wire Mesh? No	
<div style="text-align: center;">T

Measured Fracture/Failure Network: 10mm</div>

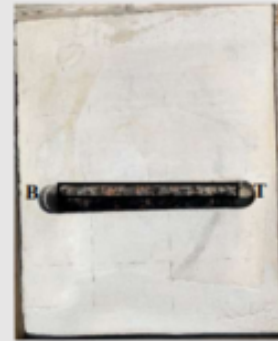
There are no visible signs of delamination. Sections that look like delamination are areas where jet cut slightly into the wall and a shadow is cast over it. Waterjet left a very clean cut across the upper wall, no deviations or wavy nature.

Fracture/Failure Count: 0
Total Fracture Length: 0 mm
Damaged Wire Mesh? No

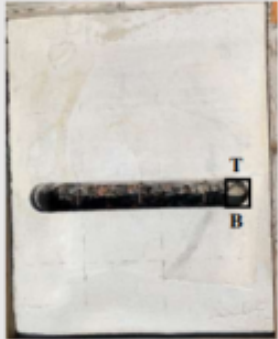
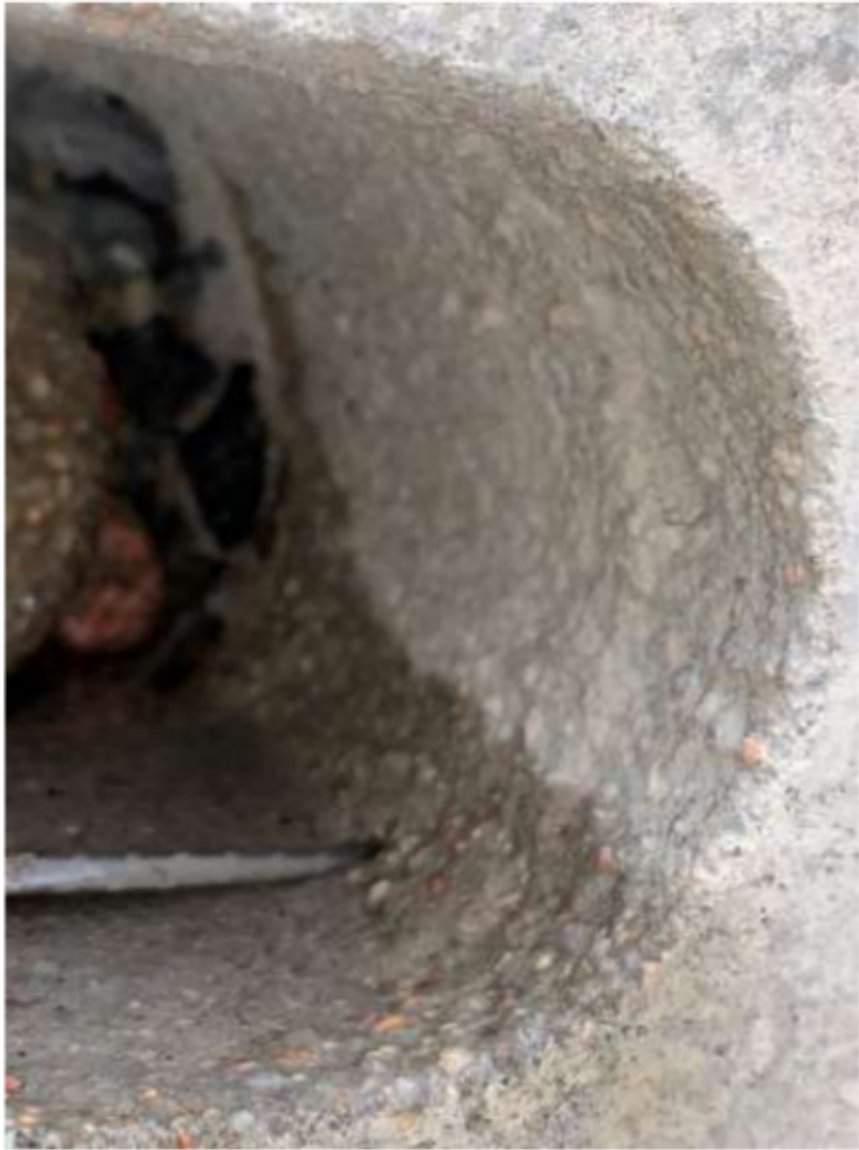
Panel Number: 7 Analyzed Surface: Right Wall of Excavation	
<u>Notes</u> No visible signs of delamination at the shotcrete/concrete interface. Waterjet left a very clean cut across the right wall, one slight rib deviation with no wavy nature.

Fracture/Failure Count: 0 Total Fracture Length: 0 mm Damaged Wire Mesh? No	
<div style="text-align: center;">T</div>
