UNIVERSITYTRANSPORTATIONCENTER
FOR UNDERGROUND TRANSPORTATION INFRASTRUCTURE

**THE CHARACTERIZATION OF DELAMINATION PROCESSES WITH
RESPECT TO WATERJET SHOTCRETE REMOVAL DURING TUNNEL
LINER REPAIR AND MAINTENANCE**

FINAL PROJECT REPORT

October 22, 2020

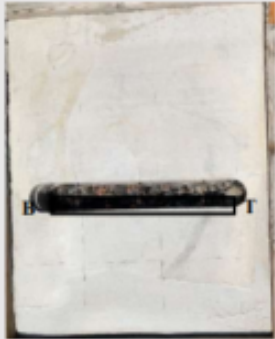
Panel Number: 7 Analyzed Surface: Lower Wall of Excavation	
<u>Notes</u> There are no visible signs of delamination. Waterjet left a very clean cut across the upper wall, no deviations or wavy nature.

Fracture/Failure Count: 0 Total Fracture Length: 0 mm Damaged Wire Mesh? No	
<p style="text-align: center;">T</p>

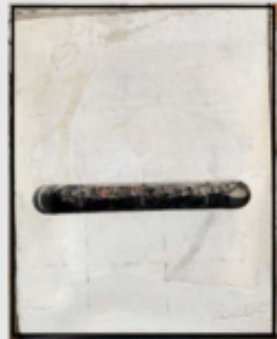
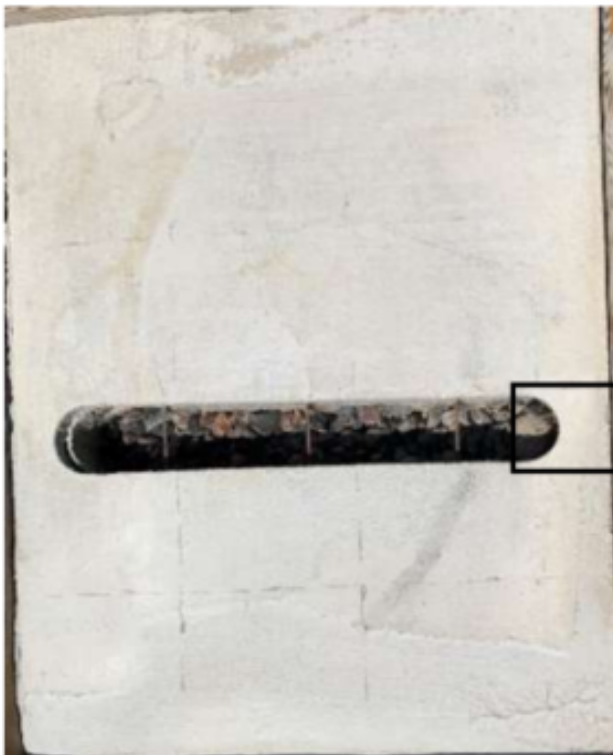
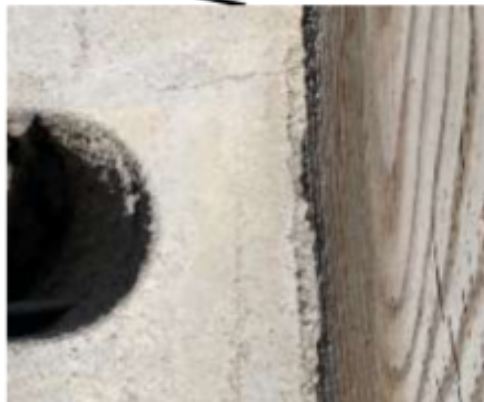
Panel Number: 7 Analyzed Surface: Area Outside Excavated Profile	
<p><u>Notes</u></p> <p>1 area of failure was discovered along the shotcrete face surrounding the excavation profile. The fracture measures 9 mm.</p>

<p>Fracture/Failure Count: 1</p> <p>Total Fracture Length: 9 mm</p>	
<div>

<p>Measured Fracture/Failure Network: 9mm</p></div>

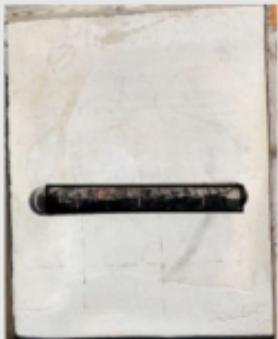
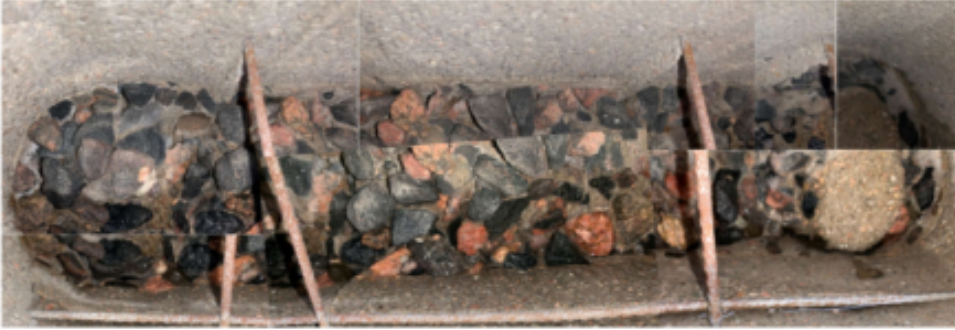
Panel Number: 7 Analyzed Surface: Excavation Face	
<u>Notes</u> For this panel, the waterjet cut through the shotcrete/concrete interface to expose aggregate. Out of all the exposed aggregate, the jet did not cut or split any and, instead, eroded the cement binder between it. The figure below is a combination of multiple pictures taken at the face. This was done to provide a clearer, close up visual of the exposed aggregate. This also explains why the wire mesh isn't exactly alligned.

Exposed Aggregate Count: 122 Percentage Aggregate Split: 0 split = 0% Fracture/Failure Count: 0 Total Fracture Length: 0 mm

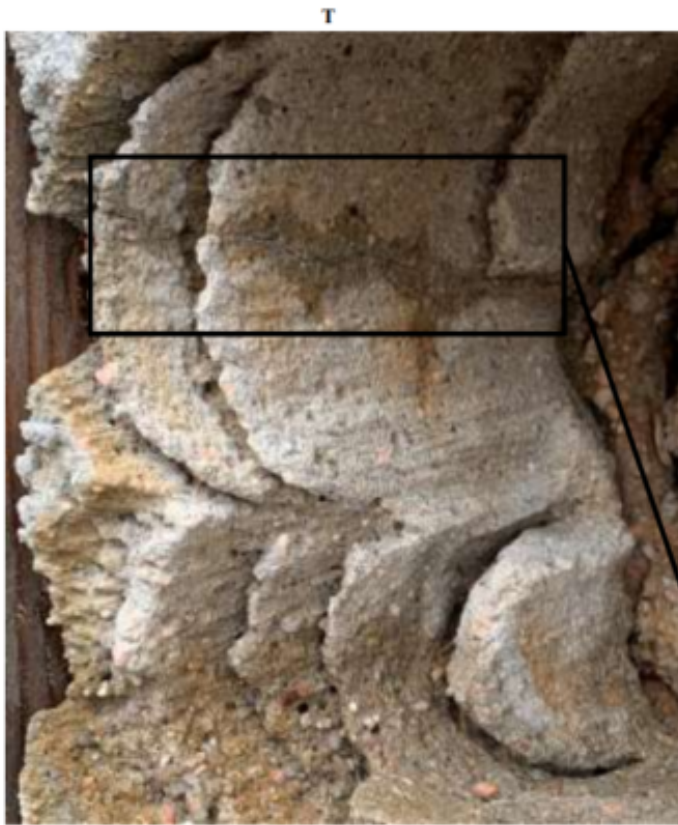
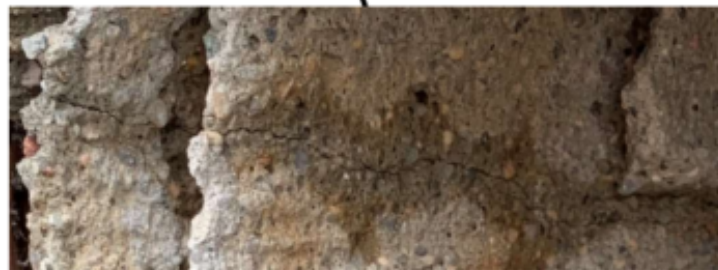
While this sample did not cut through the entirety of the shotcrete layer, there are no visible signs of delamination. There is 1 area of failure/fracture as identified below. At this edge of the cut, ribs of shotcrete were left between jet passes due to the system stalling while air bled out of the traverse in order to reverse direction.

Fracture/Failure Count: 1
Total Fracture Length: 13 mm
Damaged Wire Mesh? No

Measured Fracture/Failure Network: 13mm

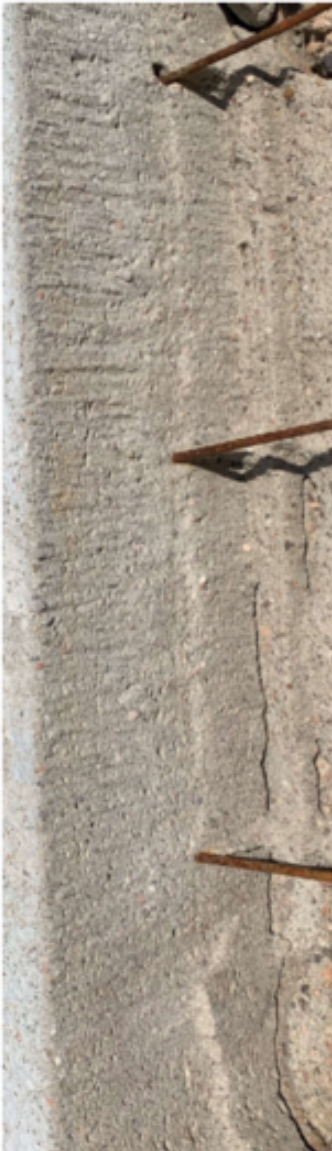
Panel Number: TEST Analyzed Surface: Upper Wall of Excavation	
<u>Notes</u> While this sample did not cut through the entirety of the shotcrete layer, there are no visible signs of delamination. The section that looks like delamination is an area where the jet cut slightly into the wall and a shadow is cast over it. Waterjet left a very clean cut across the upper wall, no deviations or wavy nature.

Fracture/Failure Count: 1 Total Fracture Length: 0 mm Damaged Wire Mesh? No	
<div style="text-align: center;">T</div>

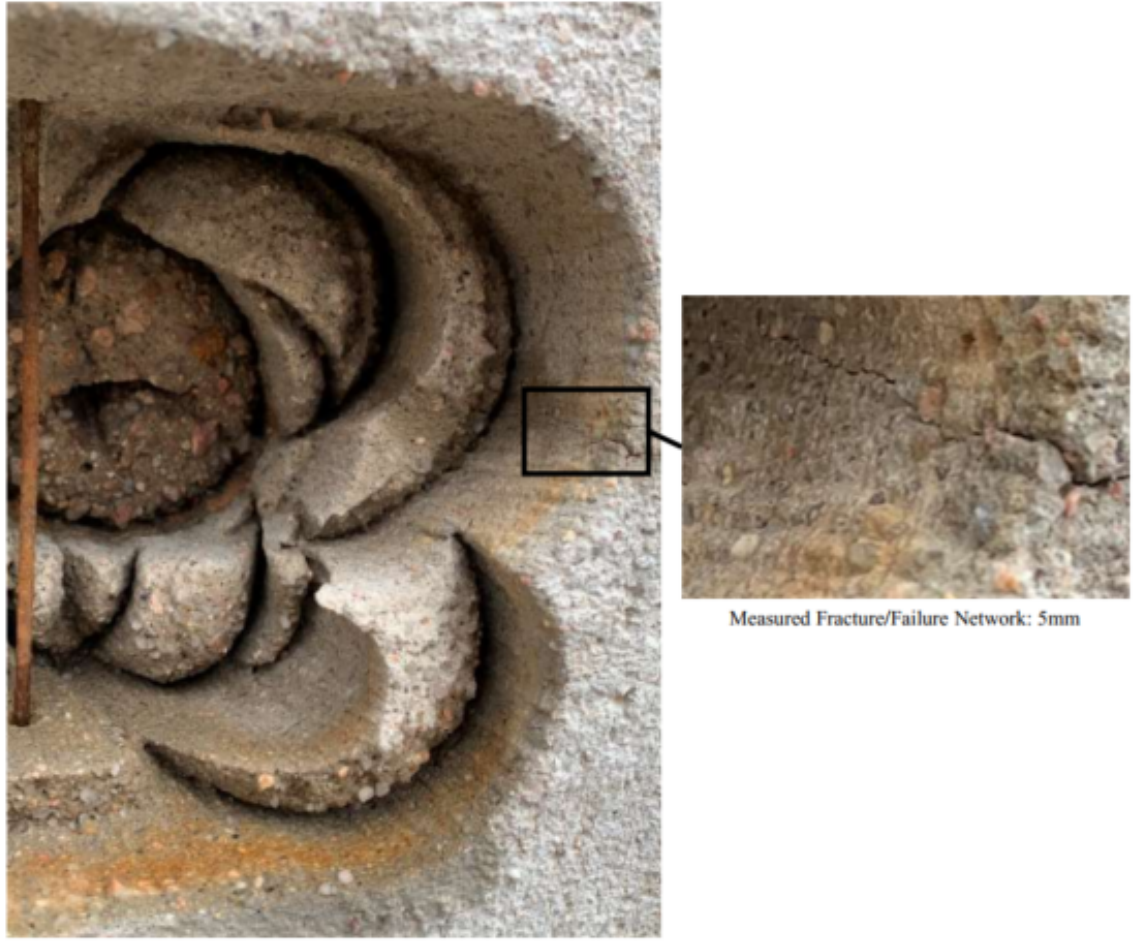
Panel Number: TEST Analyzed Surface: Right Wall of Excavation	
Notes While this sample did not cut through the entirety of the shotcrete layer, there are no visible signs of delamination. There is 1 area of failure/fracture as identified below. At this edge of the cut, ribs of shotcrete were left between jet passes due to the system stalling while air bled out of the traverse in order to reverse direction.

Fracture/Failure Count: 1 Total Fracture Length: 5 mm Damaged Wire Mesh? No	
<div style="text-align: center;"> T

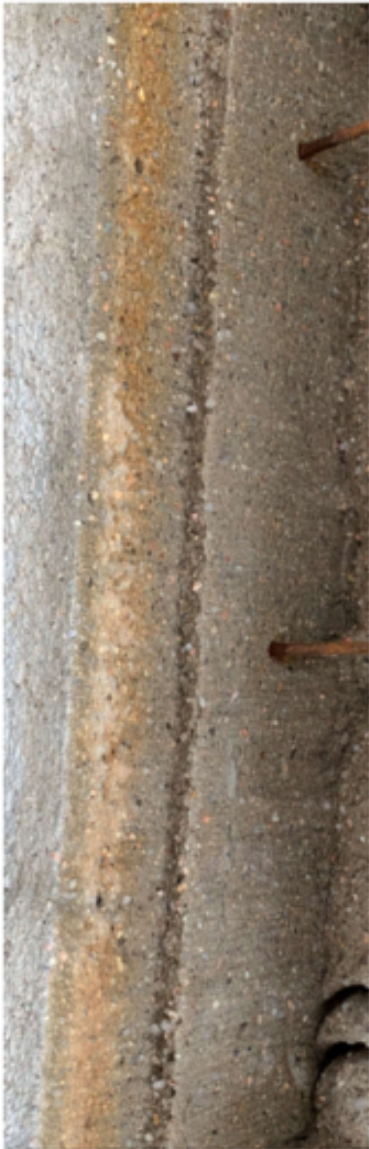
Panel Number: TEST Analyzed Surface: Lower Wall of Excavation	
<p><u>Notes</u></p> <p>While this sample did not cut through the entirety of the shotcrete layer, there are no visible signs of delamination. Waterjet left a clean cut across the lower wall, with one slight deviation but no wavy nature.</p>

<p>Fracture/Failure Count: 0</p> <p>Total Fracture Length: 0 mm</p> <p>Damaged Wire Mesh? No</p>	
<div style="text-align: center;">T</div>

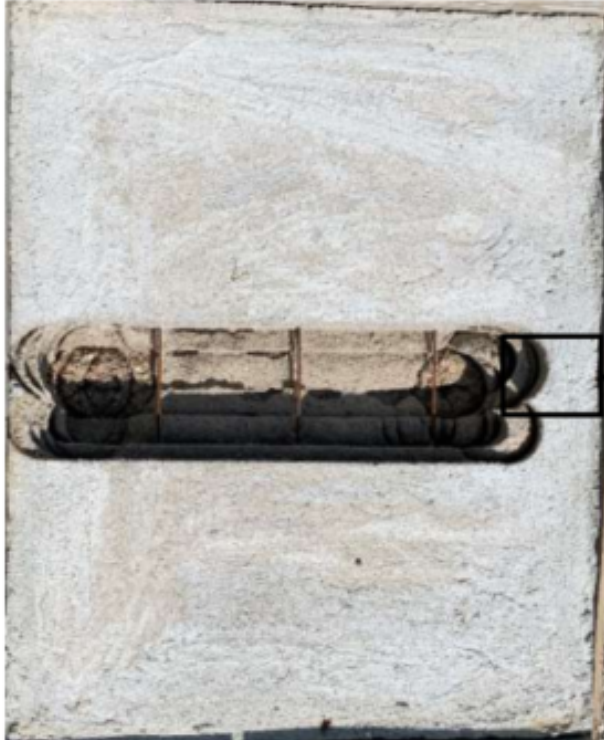
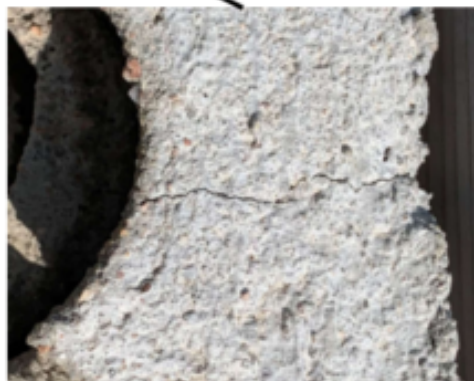
Panel Number: TEST Analyzed Surface: Area Outside Excavated Profile	
<u>Notes</u> 1 area of failure was discovered along the shotcrete face surrounding the excavation profile. The fracture measures 5.5 mm.

Fracture/Failure Count: 1 Total Fracture Length: 5.5 mm

Measured Fracture/Failure Network: 5.5mm

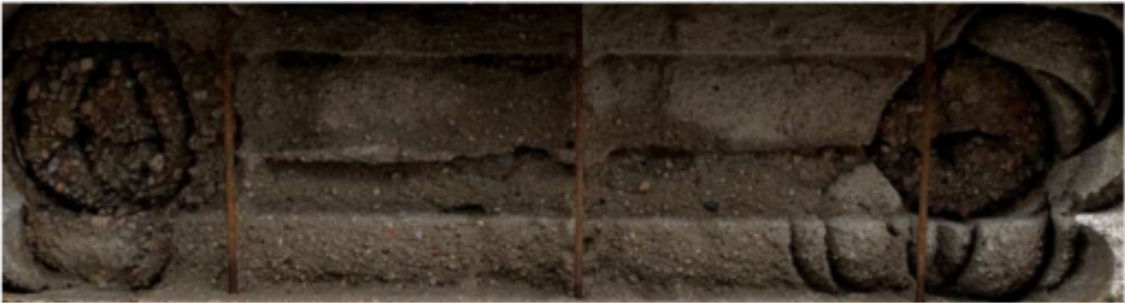
Panel Number: TEST Analyzed Surface: Excavation Face	
<u>Notes</u> For this panel, the waterjet did not cut through the entirety of the shotcrete layer so there was no exposed aggregate.

Exposed Aggregate Count: 0 Percentage Aggregate Split: - Fracture/Failure Count: 0 Total Fracture Length: 0 mm

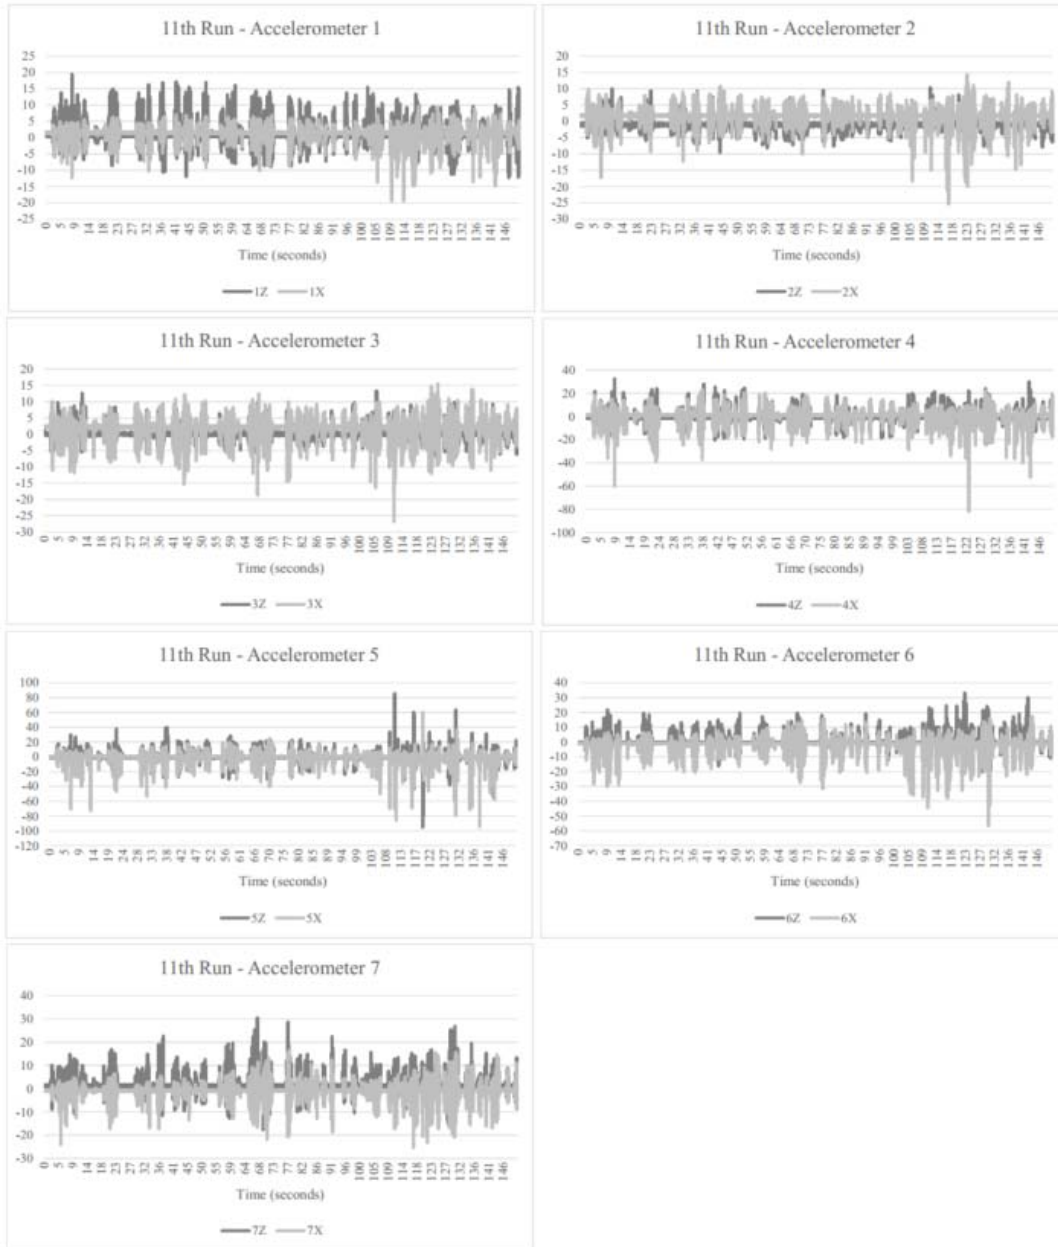
A National Instruments USB-6211 DAQ was used to read the analog signals from the accelerometers. This DAQ supported 16 analog channels. 14 of the channels were used for accelerometer data, one was used to monitor the accelerometer power supply voltage, and the remaining analog channel was not used. The Z axis and the X axis were used on each accelerometer due to the limited number of analog channels available. The Z axis was normal to the sample surface with +Z pointing towards the excavation equipment. The X axis ran parallel to the edge of the sample.
