# **Adaption of 3D Scanning Technology for High Precision Bridge Inspection**

CT-2310-F-23-2

**Research Project: SPR2310**

University of Connecticut  
School of Engineering  
Department of Civil and Environmental Engineering

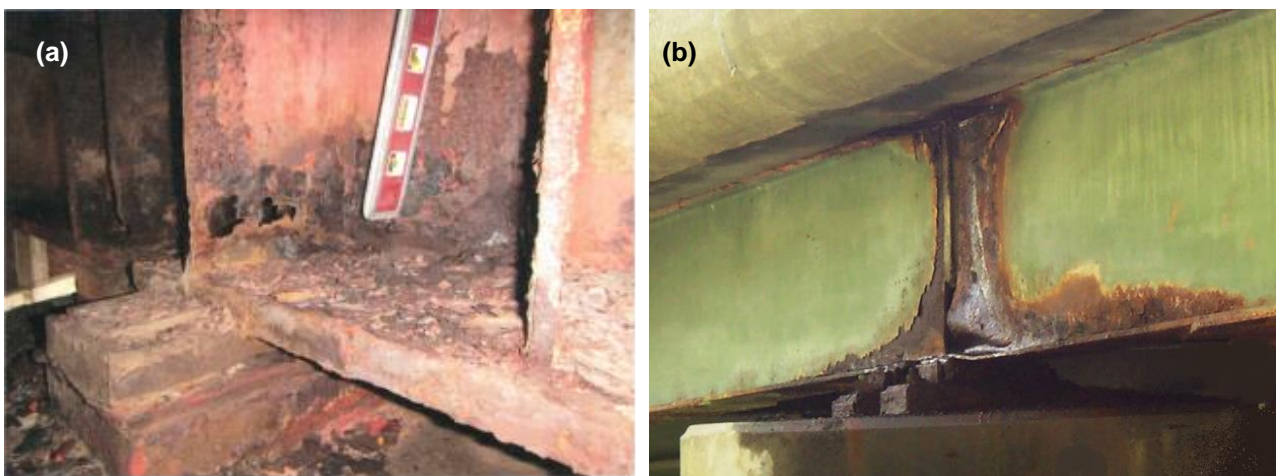
Figure 1. Corrosion at beam end resulting in (a) a hole in the bearing stiffener (Photo Courtesy of Luis Vila) and, (b) web crippling (Photo Courtesy of Michael Culmo).

Corrosion is one of the most widespread causes of damage in steel bridges. Corrosion of bridge beams is commonly found directly beneath deck expansion joints, due to leakage of water, deicing chemicals, and contaminants (Figure 1) (1). In some cases, bridges are unnecessarily restricted to traffic, closed, or replaced due to an inaccurate assessment of load-carrying capacity (2). Bearing capacity is reduced by corrosion of the web and bearing stiffeners. The extent of capacity reduction is dependent on the severity of section loss (1, 3). When localized bearing forces are combined with areas of extensive section loss, failures such as web crippling can occur (Figure 1b). The bearing capacity and load rating of a steel beam is directly dependent on the degree of section loss. Therefore, it is critical that the geometry and the extent of section loss are accurately assessed by inspectors.

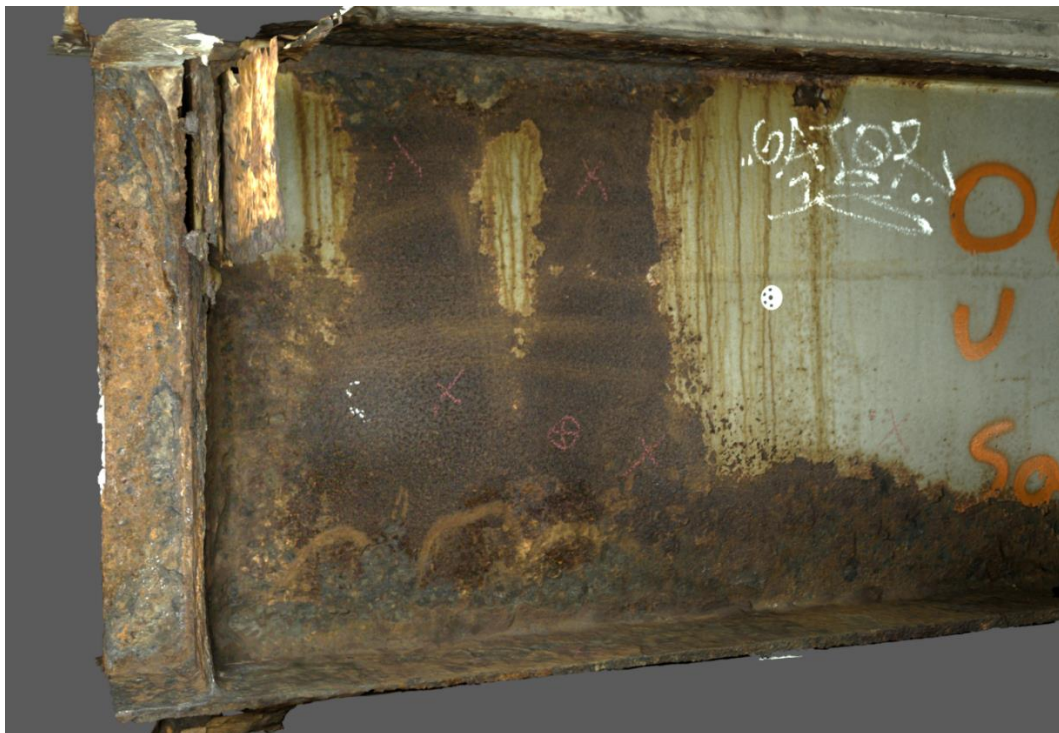
Figure 2. Sample of 3D model of corroded bridge beam generated with 3D scanning.

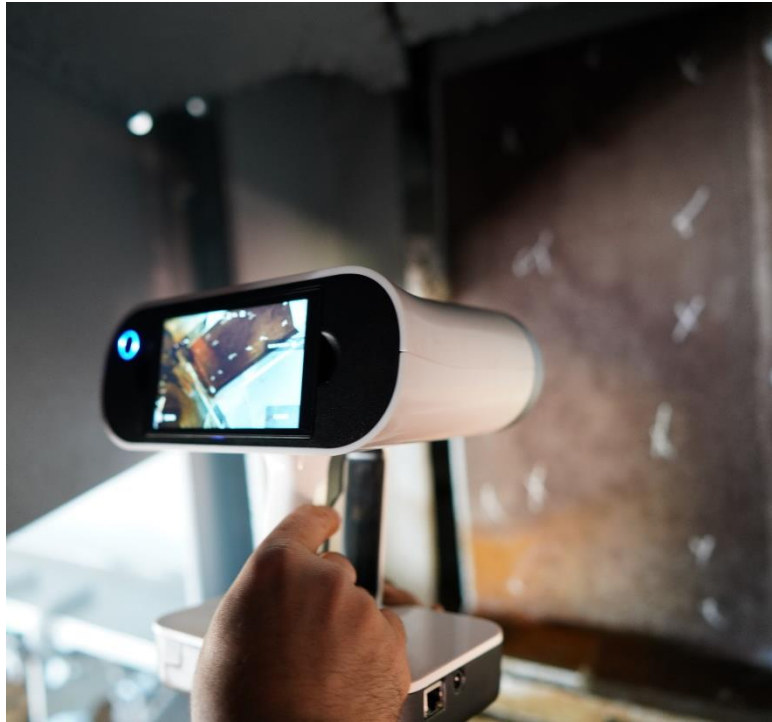
Figure 5. Updated 3D scanning equipment the Artec Leo shown a) in carrying case and b) in field.

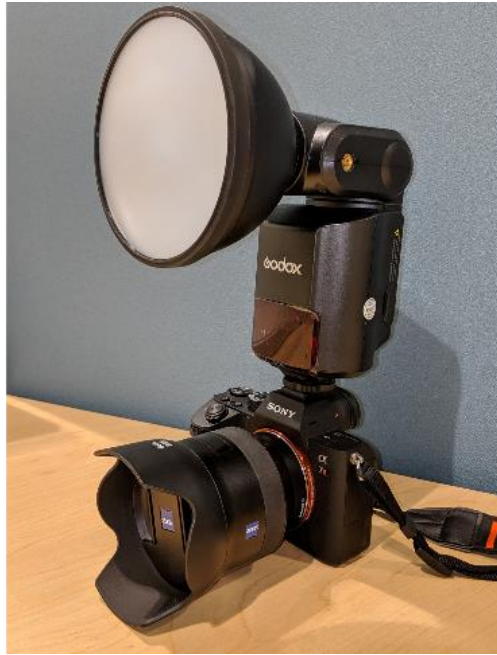
Figure 6. Equipment used for photogrammetry including the camera, lens and flash.

In this study, a desktop computer was used to run the software that processed the images and generated the 3D model (AMD Ryzen Threadripper 2990WX CPU at 3.0 GHz, 128 GB RAM, and ZOTAC GeForce GTX 1080 Ti 22GB GDDR5X GPU). This computer was chosen to increase the processing speed. The software, RealityCapture, was used to generate the 3D model and will be discussed in the data processing section of the report.

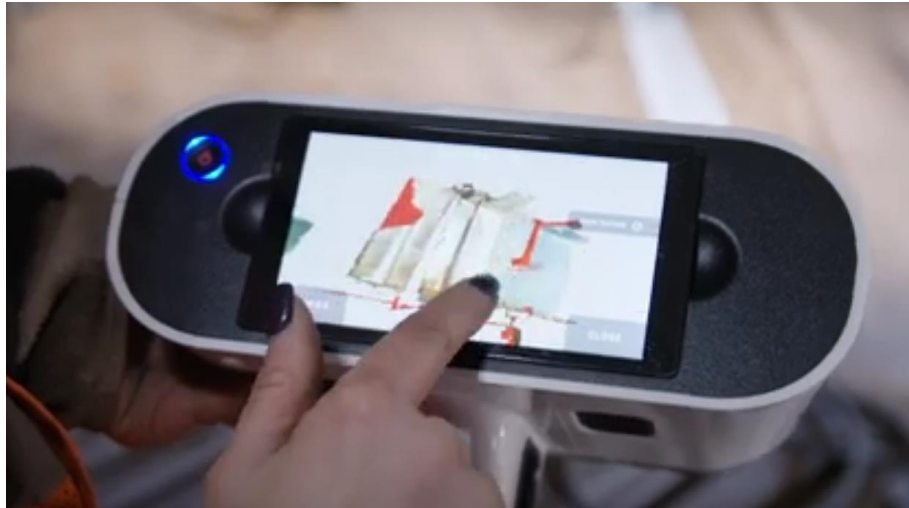
Figure 7. Representative view showing beam section scanned with Artec Leo in the field. Areas shown in red detail where information is missing.

During the scanning process, the laptop (for the Eva) or the scanner itself (Leo) provides a real-time image of the data being collected as shown in Figure 7. This allows the user to ensure that the bridge geometry of interest has been scanned. When scanning a homogenous surface, targets should be placed on the object to provide tracking points as the scanner is moved. To collect data, the user passes the scanner in a side-to-side motion from the top to the bottom of the object keeping the scanner relatively perpendicular to the surface of interest. The scanner may be rotated to capture all areas of interest, but rotating the scanner at extreme angles may cause issues with tracking. If there are issues with tracking, the scan will be terminated and a new scan file will be generated. At the conclusion of scanning, the geometry and texture of the object is pre-processed and saved. This is the most time-consuming step and is greatly influenced by the processing speed of the computer used.

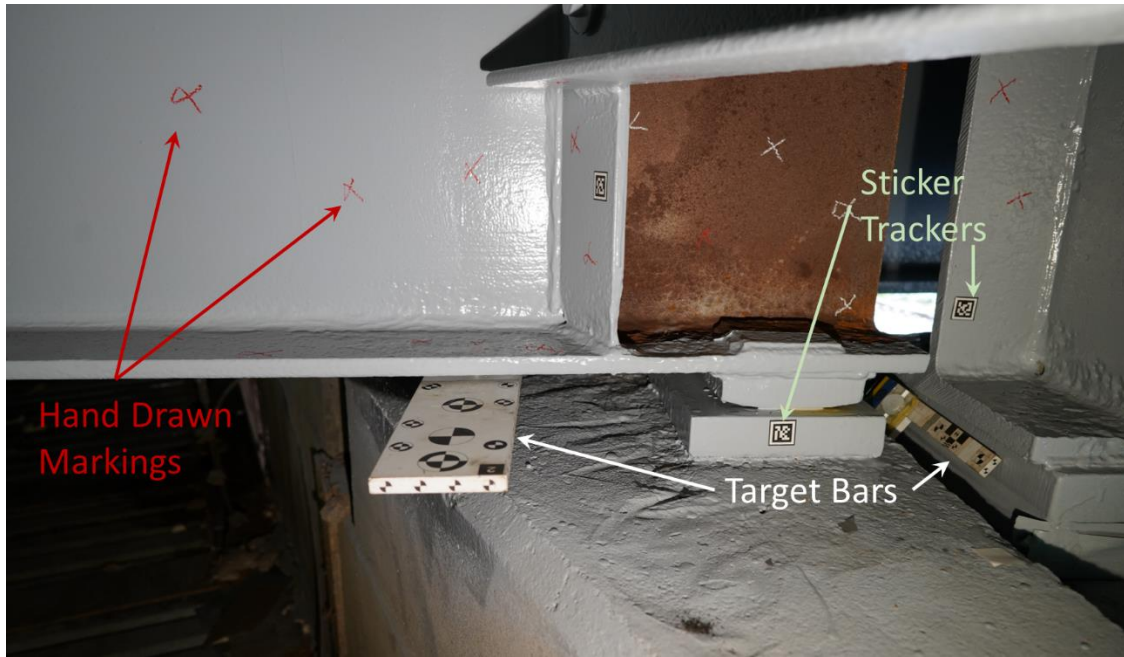
Figure 8. Representative views showing different tracking markers used for handheld scanning.

Alignment bars provide a known reference geometry that the scanner can use to align and stitch together multiple scans. By incorporating these bars into the scanning process, the scanner can more accurately determine the position and orientation of the scanned object in 3D space. This helps to reduce the accumulation of errors that may occur during the alignment process, ultimately resulting in a more precise 3D model. Furthermore, alignment bars can be particularly useful in situations where complex geometries or tight spaces make it difficult to capture the entirety of an object in a single scan. Utilizing alignment bars in such scenarios can greatly improve the overall quality and accuracy of the final 3D model, ensuring reliable data for subsequent analysis and structural assessments. Different alignment bars and tracking tools are shown below in Figure 8.

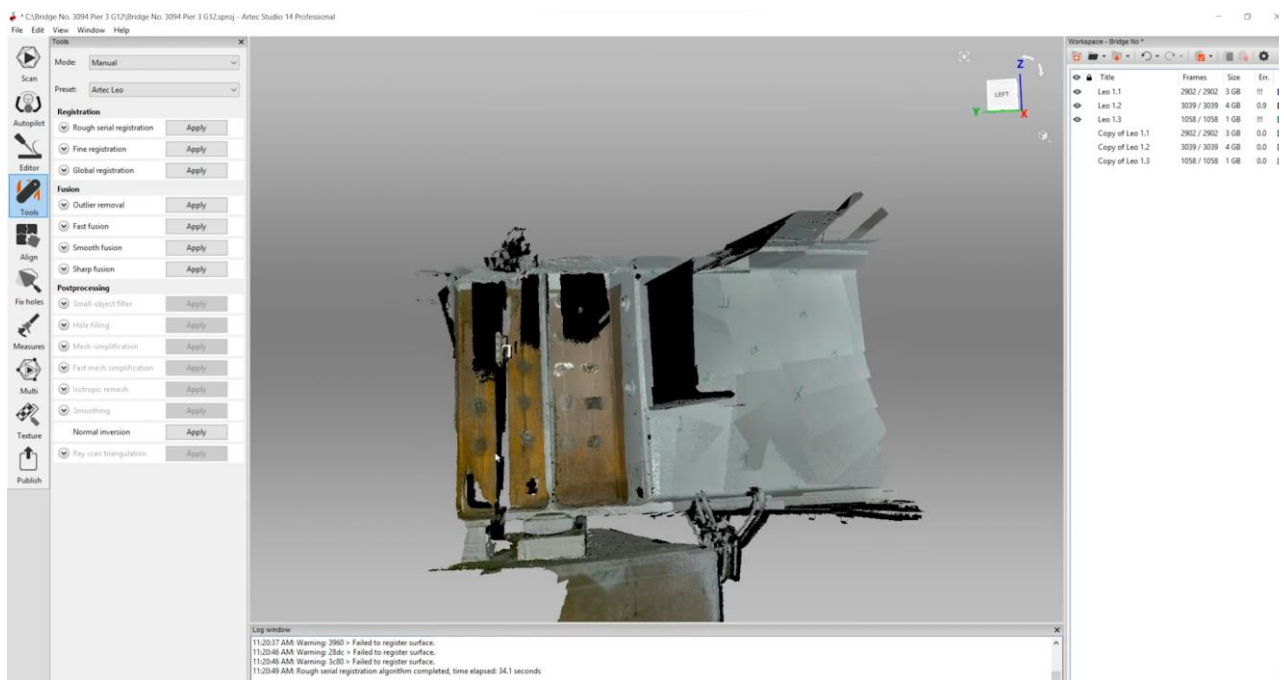
Figure 12. Sample view of data-processing interface in Artec Studio.

processing in Artec Studio is shown below in Figure 12.

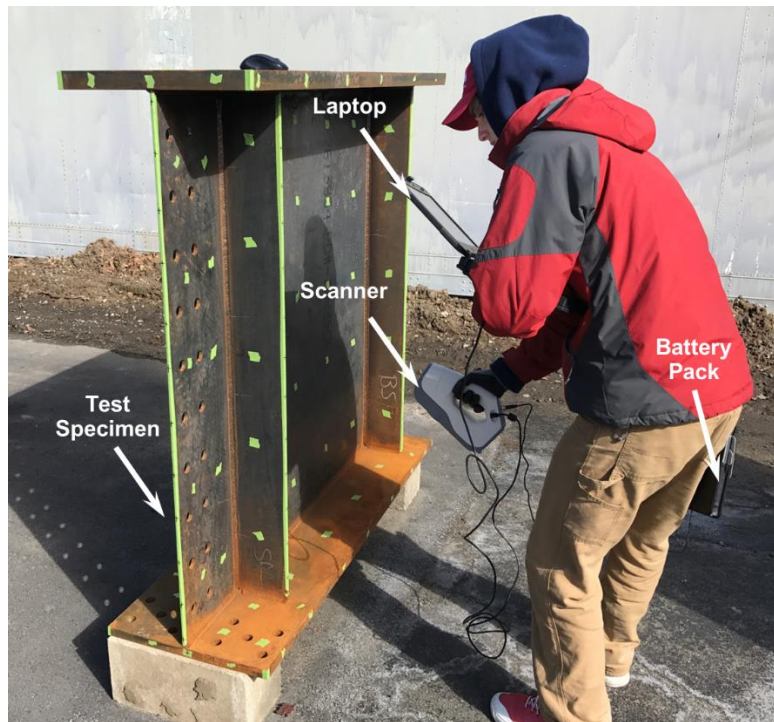
Figure 17. Scanning of beam end with simulated corrosion damage.

An outdoor trial was necessary after completing the indoor scanning to account for different temperatures and lighting conditions that replicate field conditions. Scanning in controlled indoor environments typically does not provide accurate representations of objects in the field. Outdoor conditions may include different weather conditions, lighting, and varying distances between objects, which can impact the accuracy of the scans. Conducting outdoor scans ensures that the technology and techniques used in the study are reliable and effective in real-world scenarios. This trial provides valuable insights into the potential limitations and challenges of using handheld 3D scanning technology and photogrammetry in field conditions and helps to establish best practices for future fieldwork. During scanning, the laptop shows a real-time image of the data being collected. This allows the operator to ensure that the geometry of interest is being collected. Individual scans are generated during the scanning process when the individual file sizes get large, tracking of the scanner is lost, or the user generates a new scan. In this study, data collection consisted of 3 overlapping scans that were generated over a period of approximately 30 minutes. A view of scanning the girder specimen prior to testing is shown in Figure 17. At the conclusion of scanning, the geometry and texture of the object are pre-processed and saved.

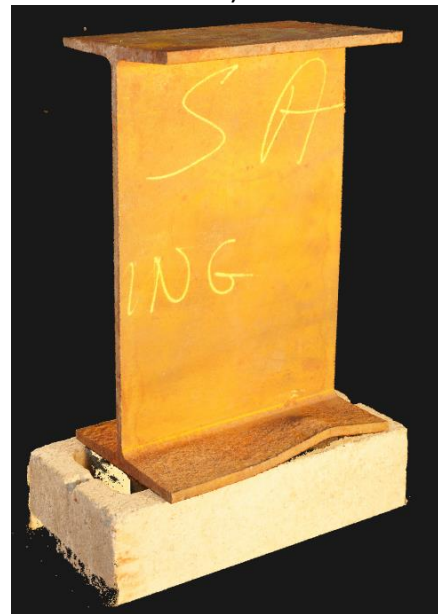
The models generated using the Sony a7RIII are displayed below in Figure 20. Upon visually examining the quality of the generated models, it was evident that the Sony models followed the suspected trend - a higher number of images resulted in a better-quality model. The higher number of photos allowed for a more accurate reconstruction of the object by providing additional reference points and better coverage of the object's surface. This increased accuracy led to a high-quality 3D model that closely resembled the actual object and provided more reliable measurements for further analysis.

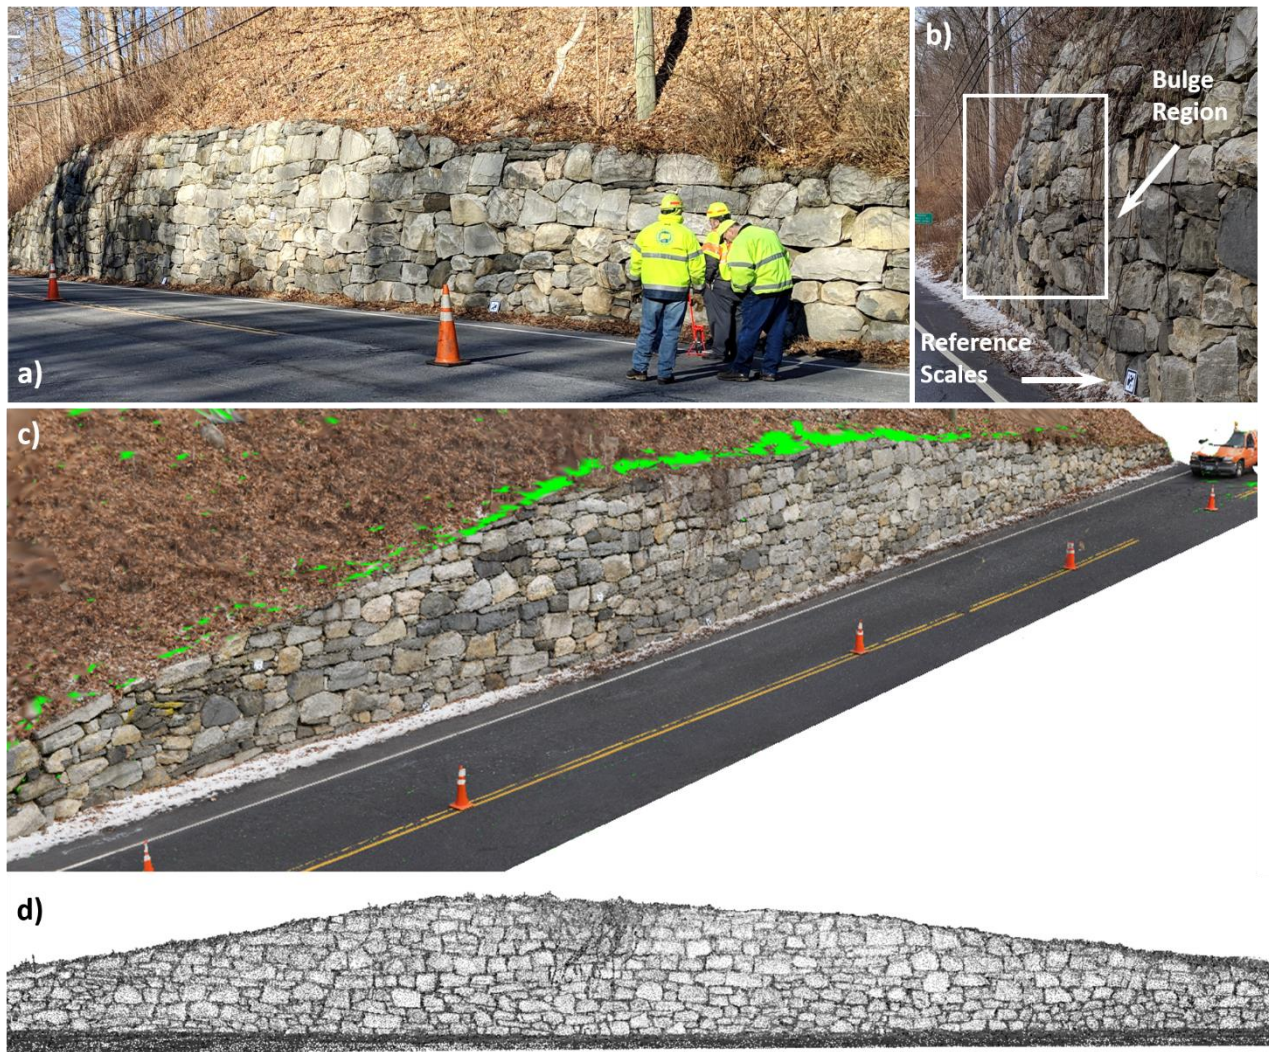
Figure 2. Retaining wall from Field Trial 1 in Connecticut showing a) overall view of wall, b) closeup of bulge region, c) image of 3D model of wall, and d) point cloud.

The initial processed models had average point densities of approximately 3,100,000 points/m<sup>2</sup> (288,000 points/ft<sup>2</sup>); but they were simplified for additional processing to an average of 31,000 points/m<sup>2</sup> (2,880 points/ft<sup>2</sup>). The final models of the field scans represented an area of approximately 150 m<sup>2</sup> (1,615 ft<sup>2</sup>) and consisted of more than 4 million vertices (**Error! Reference source not found.c** and **Error! Reference source not found.d**). The final 3D meshes were each approximately 1 GB in size with texture resolutions of 16384x16384 pixel.

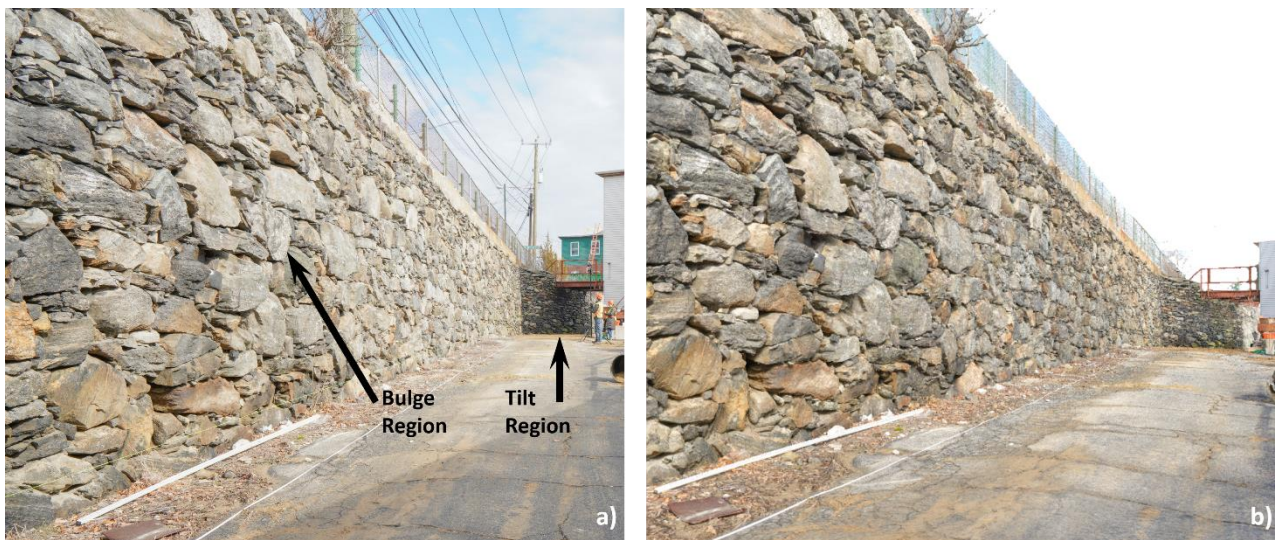
Figure 3. Retaining wall from Field Trial 2 in Connecticut showing a) picture from site and b) snip of 3D model.

The data was processed to generate a 3D model. The purpose of this trial was to determine if the access constraints and size of the wall would affect the quality of the 3D model, as well to provide valuable information to the department on the current state of the wall. The initial processed model had an average point density of 1,940,000 points/m<sup>2</sup> (180,200 points/ft<sup>2</sup>); but it was simplified for additional processing to an average of 54,000 points/m<sup>2</sup> (5,040 points/ft<sup>2</sup>). The final model of the field scan represented an area of approximately 600 m<sup>2</sup> (6,500 ft<sup>2</sup>) and consisted of nearly 30 million vertices (**Error! Reference source not found.b**). The relative accuracy of the model was obtained by comparing measurements in the model to known measurements such as those from the tape measure or surveying rod. Fifteen linear measurements were compared ranging from 0.305 m (1ft) to 3.96 m (13 ft). Measurements were only compared for distances that were not defined using tie points. The RMS error was 0.15% with the largest magnitude of error being -0.26% and the smallest magnitude being 0.066%. The final 3D mesh was approximately 5 GB in size with a texture resolution of 16384x16384 pixel.
