UNIVERSITYTRANSPORTATIONCENTER
FOR UNDERGROUND TRANSPORTATION INFRASTRUCTURE

**SPALL PROTECTION FOR STRUCTURAL TUNNEL LINERS
SUBJECTED TO BLAST OR FIRE**

FINAL PROJECT REPORT

by
Aerik Carlton¹
Ziyan Ouyang¹
Spencer E. Quiel¹
Clay J. Naito¹
¹ Lehigh University

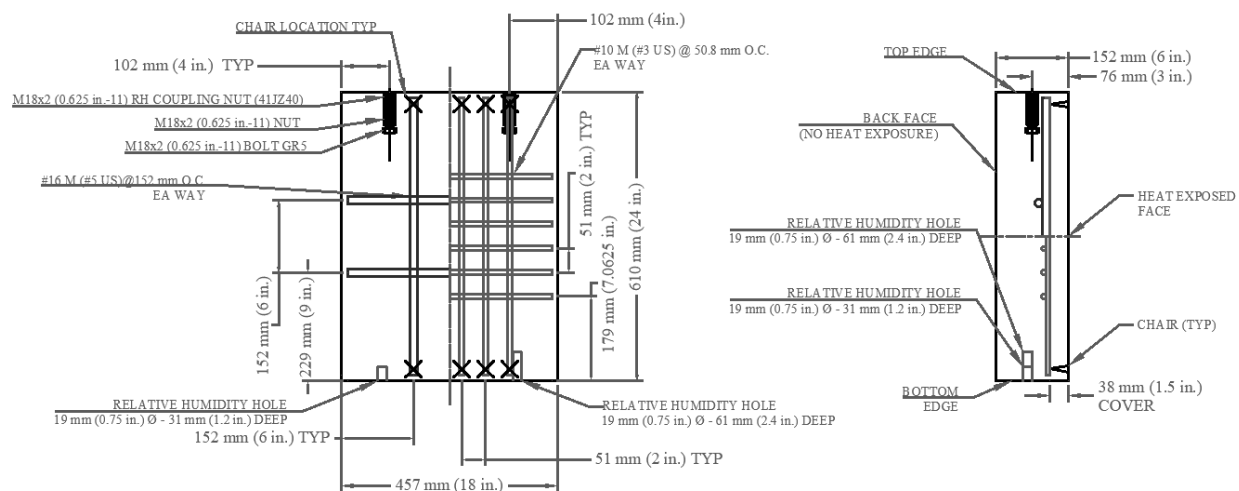
The typical concrete specimen was constructed as shown in Figure 2: 152 mm (6 in.) in thickness, 457 mm (18 in.) in width, and 610 mm (24 in.) in height; with two lifting lugs placed in the top edge to facilitate movement of the sample into and out of the loading frame; and two post-cure drilled relative humidity holes in the bottom edge of each specimen. Figure 2 shows two different reinforcing details in a split specimen format. The first reinforcing configuration includes #16M (#5 US) 420 MPa (Grade 60) steel reinforcing bars arranged with two longitudinal and two transverse, while the second reinforcing configuration includes #10M (#3 US) 420 MPa (Grade 60) steel reinforcing bars arranged with six longitudinal and six transverse. Both reinforcing configurations are located with the same 38 mm (1.5 in.) clear cover between the heat-exposed face and closest steel reinforcing.

Important to note, the heat exposed specimen face is covered at the top and bottom by 83 mm (3.25 in) of the loading frame flanges, which reduces the directly heat exposed area to 2032 mm² (315 in²), minimizing any thermal effects caused by the locations of lifting lug and reinforcing bar location chairs.

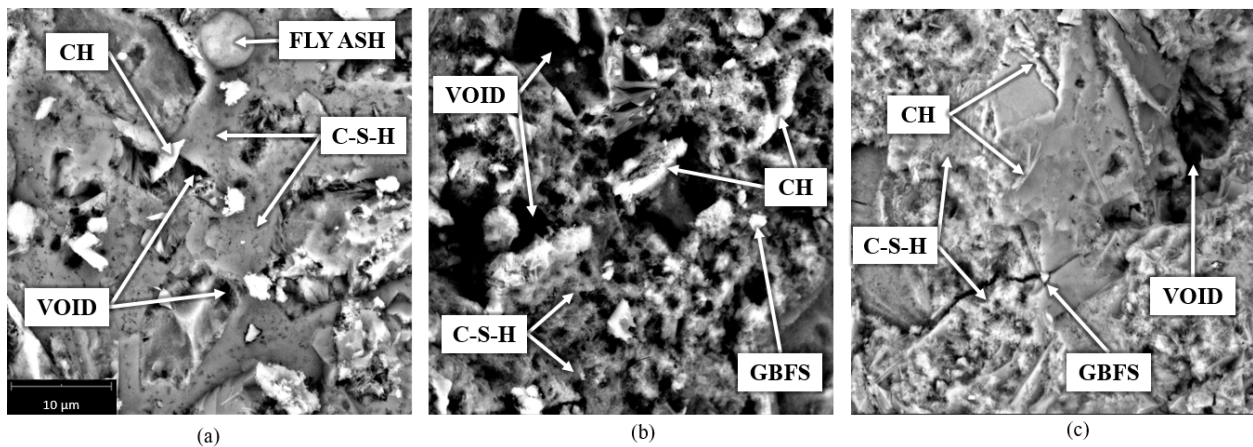
Figure 4: SEM 6500x magnification concrete mix comparison

In addition to the standards testing in Table 3, SEM was included as a visual confirmation of the mix design differences, and the comparisons are shown in Figure 3 and Figure 4 with C1 shown in (a), C2 in (b), and C3 in (c). The age of the concrete specimens shown in SEM is C1 at 742 days, C2 at 605 days, and C3 at 129 days. C1 was noticeably denser with larger voids widely spaced, while C2 exhibited smaller, more closely spaced voids. The apparent density difference visible in the SEM confirms expectations that higher compressive strength mixes with high thermal conductivity, lower void percentage, and lower permeability would show a denser microstructure; while lower compressive strength mixes with lower thermal conductivity, higher void percentage, and higher permeability would show more frequent, smaller, and more closely spaced voids [17]. The SEM of C1 shows well defined ettringite formation and smooth spherical fly ash particles, while C2 and C3 show a higher proportion of CH crystalline structures and jagged granulated blast

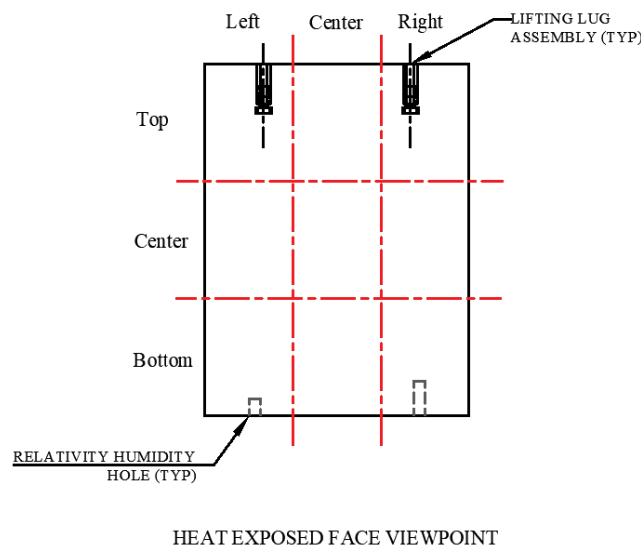
Specimen MC was periodically monitored for all specimens to allow for test execution at specific moisture conditions. The MC was taken from nine location on the to-be heat exposed face as shown in Figure 5 and averaged. The MC meter estimates the MC for the first 19 mm (0.75 in) of depth which is comparable to the observed spall depths. MC, RH, and material temperature measurements were taken prior to heat exposure testing.

Figure 5: Moisture content measurement locations

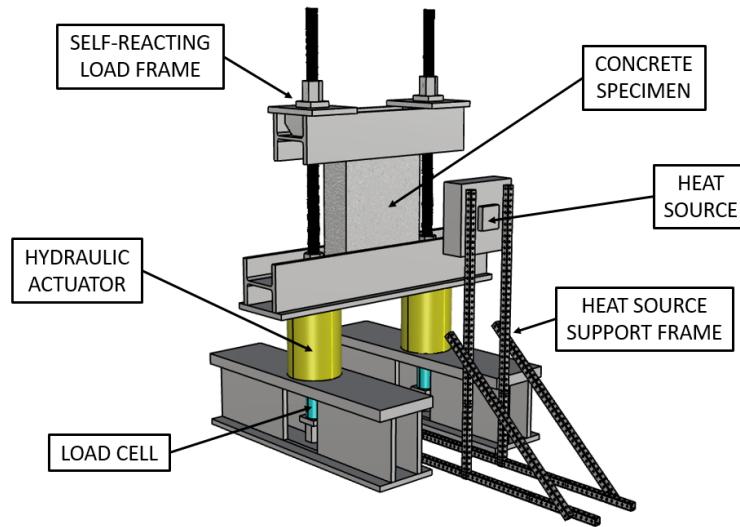
The testing apparatus is based upon the experimental setup described in Maluk et al. (2016), consisting of a self-reacting loading frame and heating source mounted on a movable track to control heat flux delivery as shown in Figure 6. A self-reacting load frame with two through-hole hydraulic actuators delivered axial load to the concrete specimen with the heating source mounted on a separate track. The testing apparatus was designed to allow for variation in applied axial load in one-direction while providing variation in applied thermal loading via standoff distance between the heat source and specimen.

Figure 6: Concrete heat and loading frame concept (based on H-TRIS [13])

The self-reacting frame consists of two double webbed, built-up I-sections acting as spreader beams to distribute the loading frame and specimen weight over a larger floor area. Between the spreader beams dual webs, an opening was cut to facilitate access to, and placement of, the capping nut and washers for the threaded rod and load cells. The threaded rod's bottom nut and washer sandwiches the hollow pipe-style load cell between the washer and the bottom of the spreader beam's top flange. The threaded rod passes through a hollow section hydraulic actuator ram and through a welded plate and w-section that acts as the base support for the concrete specimen. The threaded rods pass the sides of the concrete specimen and through the top built-up plate and wide flange section that acts as the top support for the concrete specimen, and are capped at the top with a nut and washer. The configuration allows for the hydraulic rams to push the bottom specimen support beam upward compressing the concrete sample against the top support beam.

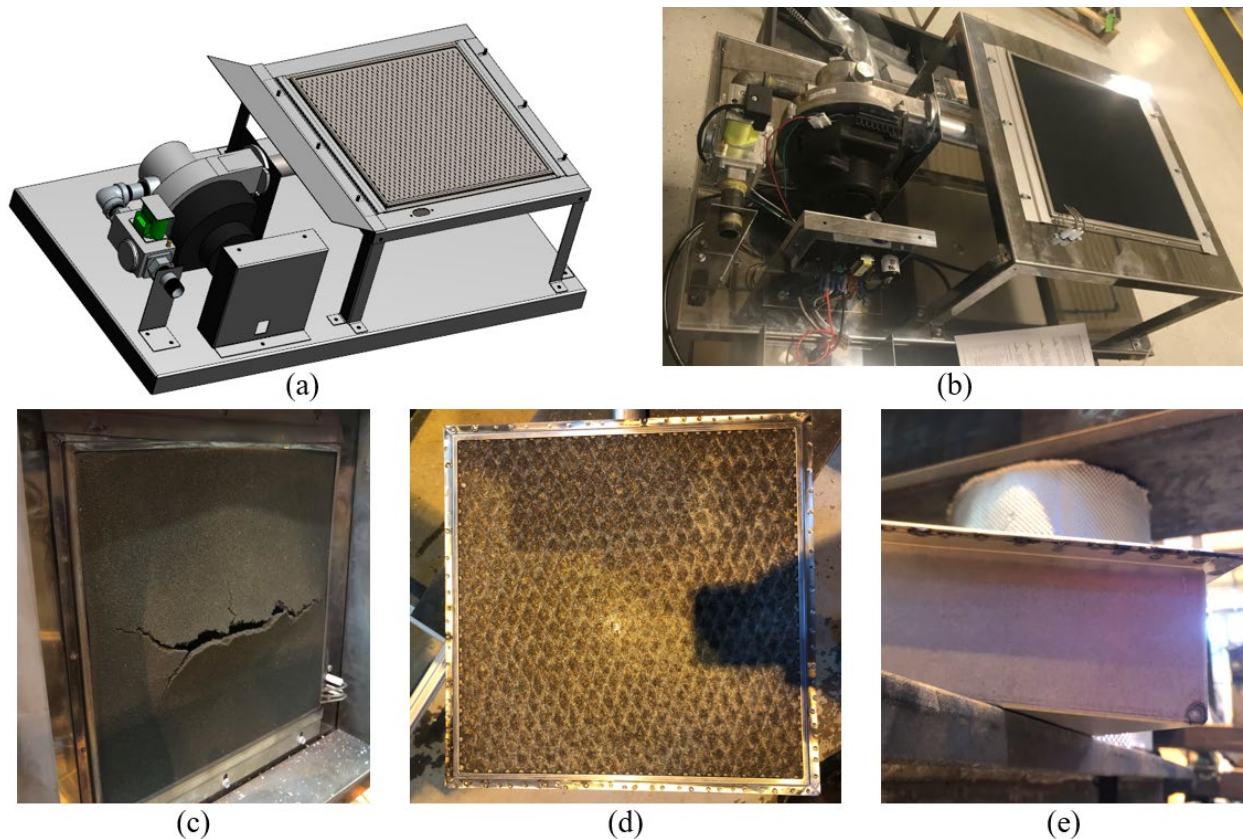
The heat source consisted of an adapted commercial cooker heating element mounted to an adjustable heater position, track mounted sled support frame. Figure 8 shows the commercial company's 3D rendered model of the heat source in (a), and the actual delivered heater in (b). The heating element is a natural gas fueled radiant panel heater which includes: a blower to optimize the fuel to air ratio, an electrical controller for fuel mixing and ignition, and an elevated rectangular fuel-feeder box topped with the radiant panel grill. Figure 8 (c) and (d) show the two different radiant panel grill materials used for testing, with (c) being a permeable metal foam material (used for the F1 heat flux curve) in a post heat cycling fatigue failure condition and (d) a compressed metal fiber material (the F2 and F3 heat flux curve grill material). Figure 8 (e) show the location of the feeder box pinch weld failure from the F2 heat flux curve set up, the radiant grill support frame to fuel mixing box seam experienced a heat cycling fatigue failure at testing pressure after 4 specimen tests. The pinch welded seam failure was rectified with an increase in the number of pinch welds, resulting in the F3 heat flux curve.

Figure 8: Heat source configurations (a) concept model (b) actual (c) F1 grill material failure (d) F2 and F3 grill material (e) F2 failure location

The heat source is mounted on a support frame to allow for three-dimensional adjustment. An extruded aluminum T-slot cross-section frame element was used to assemble the heat source support frame. A sled and track system to allow rapid movement of the heat source in the direction normal to the exposed specimen surface was integrated into the heat source support frame. Rapid standoff closing was needed to reduce the effect of heat source ignition on the sample before the

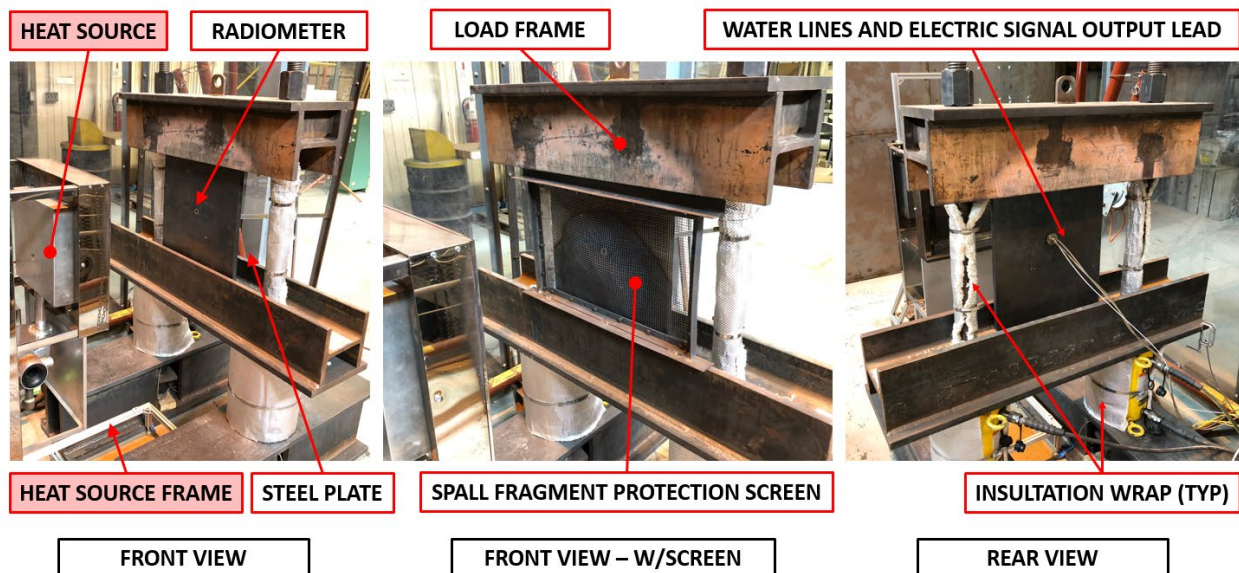
Calibration was performed using the setup shown in Figure 9. The heat flux delivered to the sample surface was recorded using a water-cooled Hukseflux SBG01 heat flux meter, which was flush face mounted through a 19 mm thick x 457 mm wide x 610 mm high (0.75 in thick x 18 in wide x 24 in high) steel plate. The plate width and height were matched to the dimensions of the concrete specimen's heat exposed surface to maintain a similar area to control for convective effects around the heater, loading frame, and specimen, and to duplicate the radiation feedback loop between the heating source, protection screen, and test specimen. The radiometer mounted plate was located in the loading frame, and the same measurements and adjustments listed in the experimental procedure, including placement of the protective screen, were repeated for calibration.

Figure 9: Testing apparatus heat flux calibration setup

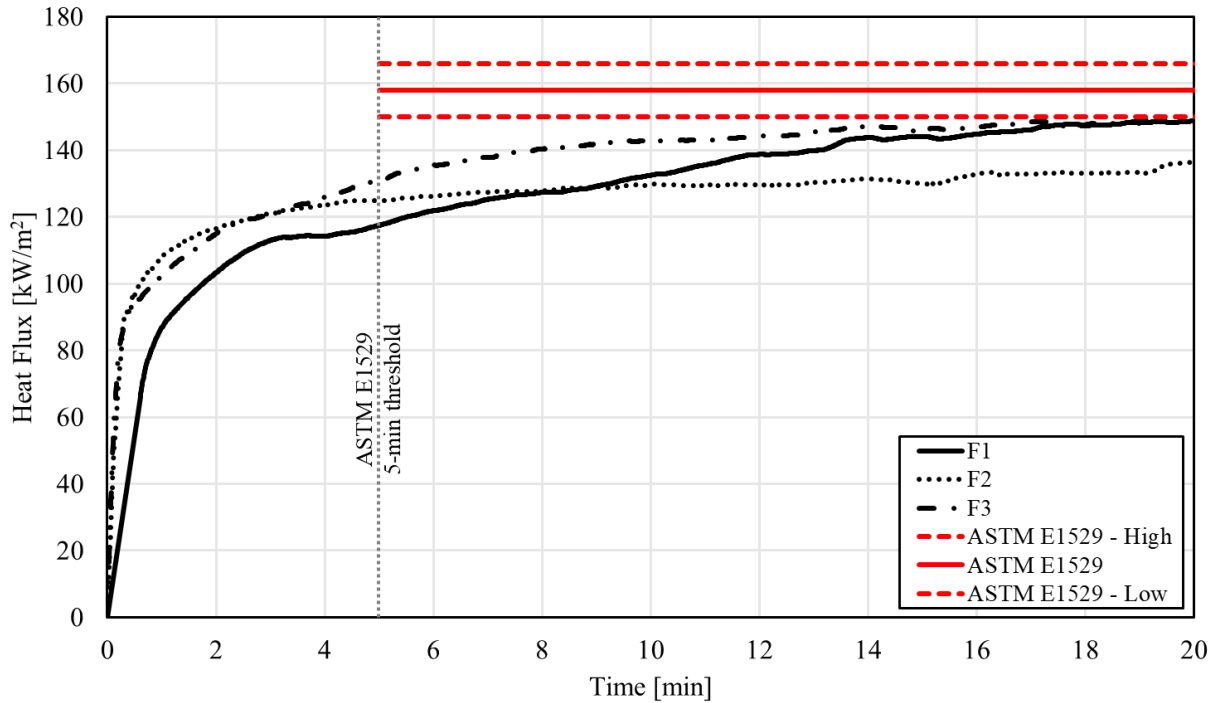
Figure 10 shows the three unique heat flux time history curves for the three different heating source configurations used during testing. Three configurations of the heating source were used, due to initial variations in the radiator grill material and fuel feeder enclosure. The calibration curves are plotted with the ASTM E1529 hydrocarbon fire curve which is defined as a heat flux of 158 kW/m^2 ($\pm 8 \text{ kW/m}^2$) reached within the first 5 minutes and maintained throughout the test duration [38]. The ASTM E1529 standard is used as a representation of the rapid heat development and energy output of a standardized hydrocarbon pool fire; consistent with gasoline and diesel fuel spill fires that would be seen in fires resulting from roadway vehicle collision. The heating curves used in our experimentation do not meet the ASTM E1529 standard at the equipment-safe testing standoff, however the delivered thermal load was sufficient to exhibit explosive concrete spalling.

Figure 10: Calibrated heat flux time history curves including reference to ASTM E1529

at 3 minutes and between 1010°C and 1180°C at and after 5 minutes [38]. Figure 10 notes the testing performance of this experimental program as less than ASTM E1529 standard under heat flux, and this is reinforced when examining the surface temperatures in Figure 15.

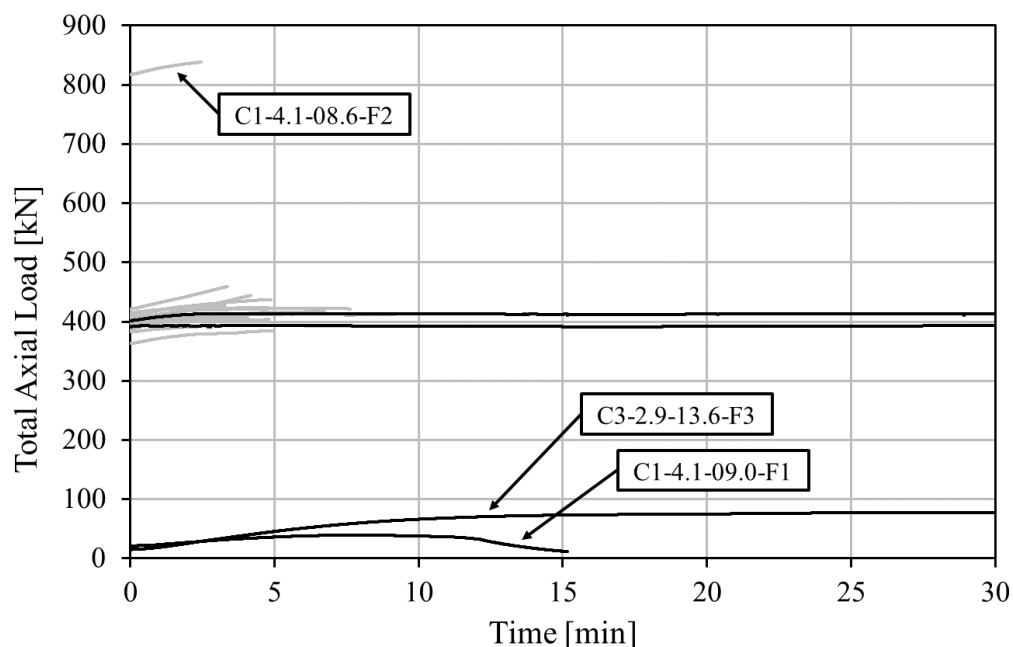
Figure 11 shows the total axial load time histories for all specimens. Grey lines indicate spalled panel specimens, while black lines indicate no-spall panel specimens. The time histories were halted at the time of spall occurrence, if applicable. All panel specimen axial load histories exhibit a positive slope at the start of heat exposure, showing an immediate thermal expansion effect on the pressure controlled hydraulic pump load delivery assembly and resultant load cell record. Only one of the doubled axial load specimens was available (C1-4.1-08.6-F2), the second high axial

load case had corrupted data. As can be seen in the two low axial load variation cases explosive spalling did not occur, but the variation in the load during testing was much greater than the standard load cases. This low axial load deviation from the initially set value was a functional limitation of the hydraulic pump used to load the specimens. Typical load variation due to thermal effects was at approximately 4%, when excluding the low axial load tests.

In Figure 11, C1-4.1-09.0-F1 was the panel specimen that exhibited small area delamination sluffing spall within two minutes of heat exposure. The C1-4.1-09.0-F1 spalling behavior was not explosive in nature, and the typical crackling behavior that indicated impending explosive spalling was not observed. C1-4.1-09.0-F1 heating was extended to 15 minutes, beyond the typical spall occurrence within 10 minutes of heat duration, before termination of the test. Within the standard load specimens, under the load time histories in Figure 11, we see that the non-spalled cases are bounded by spalled cases with slightly higher and slightly lower axial loads, indicating that loading stress alone was not a predictor. In the axial load variation case we see that the low axial load cases did not exhibit explosive spalling behavior while the double loaded cases did. We can conclude that mechanical loading stresses do play a part in explosive thermal concrete spall.

Figure 11: Total axial load time histories for all specimens

Ultimately, the performance of the testing apparatus illustrated in Figure 11 and Figure 13 through Figure 16 show some variation between the heating curves and test-to-test setup, however there is a strong correlation between imparted energy and spall time and between temperature records. As such, the comparison between concrete panel specimens across mix design, heating curve application, and moisture condition presented in this study was determined to be reasonable in exploring thermally-induced explosive concrete spalling behavior. Temperature time-history, in effect thermal stress, alone did not present an indicator of spall occurrence.

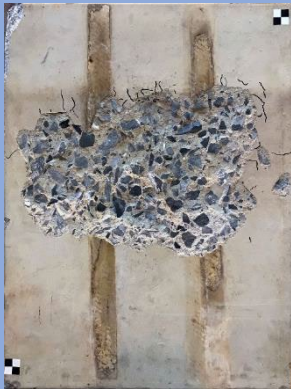
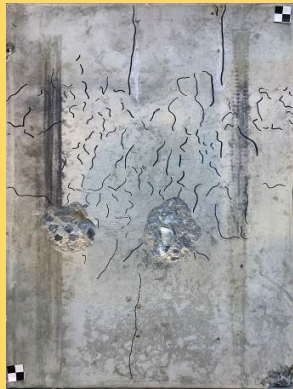
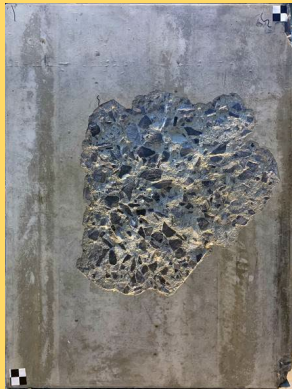
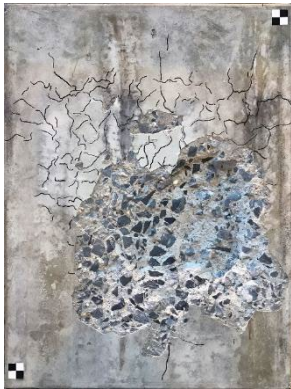
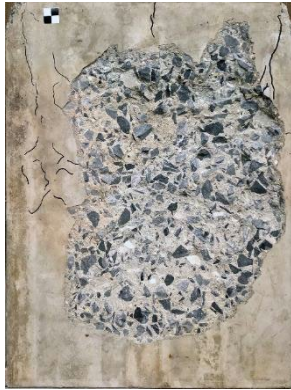
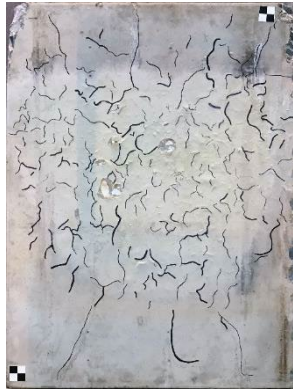
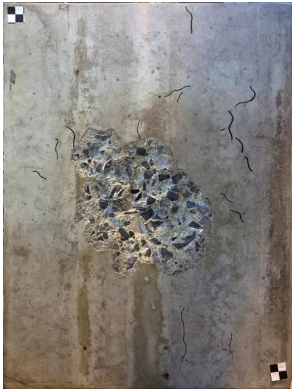
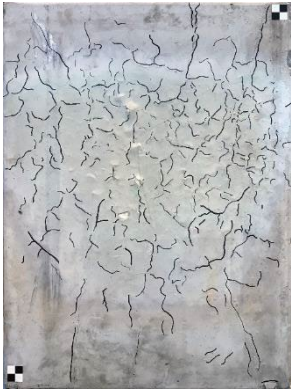
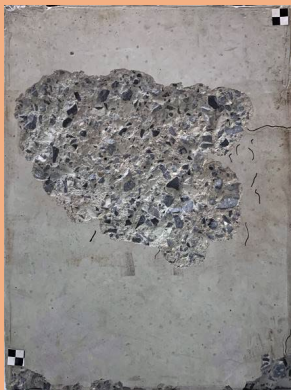
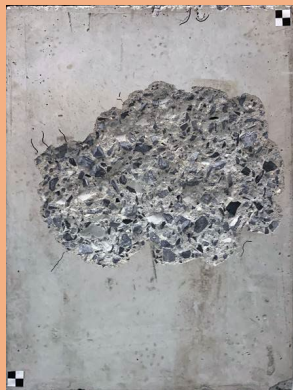
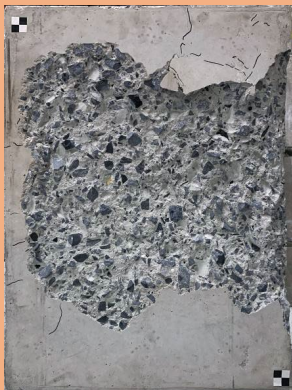
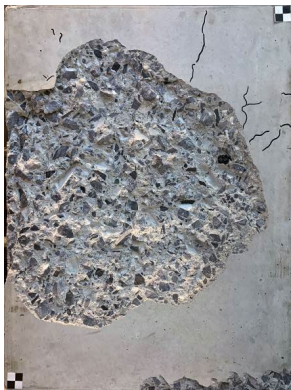
A post-test, perspective-corrected photo of the heated face of each specimen is provided in Table 6. A black felt-tipped marker was used to highlight the visible cracking on the heated face for these photos. Color coding in Table 6 is used to denote differences among specimen properties (curing method and reinforcement detail), as well as, the level of applied axial load.

C1-4.1-15.6-F1	C1-4.1-09.0-F1 (Low)	C1-4.1-08.6-F2 (High)	C1-3.8-13.2-F1

C1-3.8-12.4-F1	C1-3.3-16.7-F1	C1-3.3-03.4-F3	C1-3.0-13.7-F1
Concrete Mix: C2

C2-4.6-18.5-F1	C2-4.2-14.9-F1	C2-3.9-15.4-F1	C2-3.9-10.8-F1

Explosive spalling generally presented audibly as a loud “bang” with a large amount of chip and chunk debris suddenly being blasted into the protection screen. The onset of spalling in the C2 specimens was noticeably louder and more violent than for C1 or C3, and the C2 specimens gave little visible or audible warning before exploding. As shown in the photos in Table 6, the more

explosive C2 spalling reaction generally resulted in a greater amount of the spalled concrete on heated face. C1 samples typically had some small “pops” of dust and sand sized particulate debris accompanied by “fizzling” noise in advance of explosive spalling, in effect warning of an imminent explosive spall event. Spalling in the C3 specimens was sudden like the C2 specimens, but less violent, as demonstrated by the smaller area of lost concrete on the spalled C3 panel faces in Table 6.

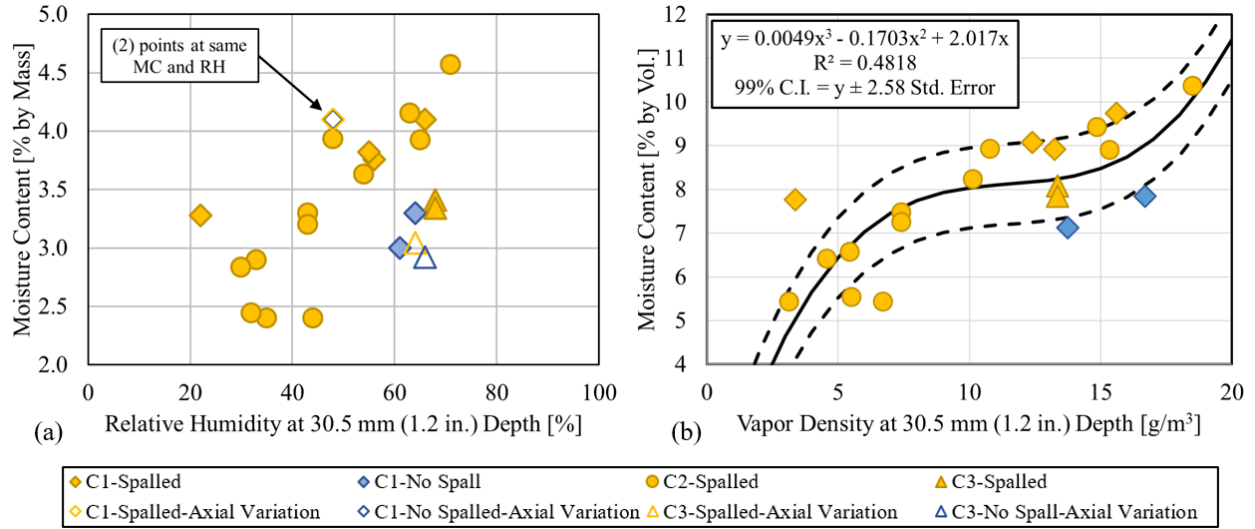
These differences between the overlapping specimens in RH but not in VD plotting, the larger spread between points, and the suggested demarcation between spall and non-spall occurrence in the VD plotting represent the authors’ arguments for reporting VD instead of RH. The RH, through saturated vapor density normalization, removes the direct quantity of water vapor and the material temperature from reporting, while VD does not. RH may prove to be important in comparison between spalling and non-spalling concrete cases, however the ambient temperature of the material shortly before heat testing should be included for detailed initial moisture state description.

Figure 12: RH and VD compared to MC results summary

Concerning Figure 12 (a), Hertz defines the MC threshold being between 3.0% and 4.0% depending on the concrete mix design, while Eurocode 2 and 4 define two different thresholds, the most conservative at 2.5% [18,39,40]. These thresholds appear to hold true for C1, however C2 spalling was observed at MC percentages below both definition limits, consistently. The RH/VD of the spalled C2 specimens were significantly lower than the non-spalled C1 specimens, which may indicate that the occurrence of spall may be dependent on the form in which water is present in the concrete (e.g. liquid or vapor). Looking more closely at the non-spalled cases in Figure 12, two C1 specimens did not spall with initial moisture states of: 64% RH, 16.7 g/m³ VD, and 3.3% MC by mass; and 61% RH, 13.7 g/m³ VD, and 3.0% MC by mass, respectively. The MC of these non-spalled specimens fall within the Hertz defined MC by mass threshold zone of no-spalling behavior, which was our initial interpretation of the behavior. However, Mindeguia et al. (2011) have shown high moisture condition concrete specimens to exhibit reduced pore pressures under heating when compared with lower moisture state concrete specimens of the same mix design; justifying the findings as being resultant of early cracking due to water expansion during early stage heating [41]. These cracks would create ventilation routes for vapor, impeding large pore pressure buildup, in effect increasing the concrete gas permeability. Overall, the results shown in Figure 12 are suggestive that MC alone is insufficient for the prediction of thermally induced explosive concrete spalling behavior under a representative hydrocarbon fuel fire scenario.

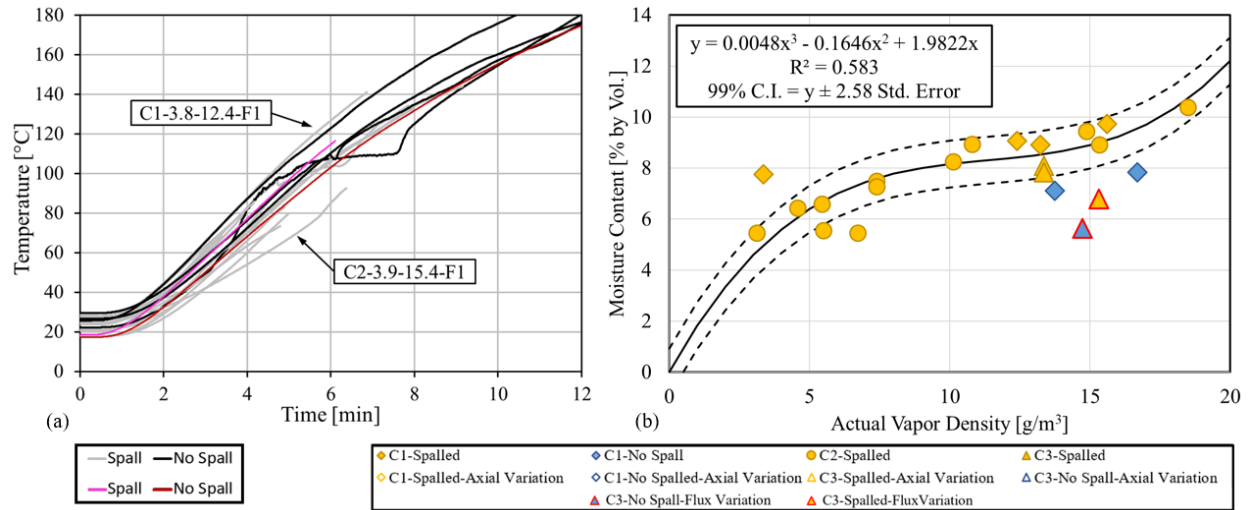
focused on heat flux variation is required to address the change in spalling behavior to evaluate the existence of a threshold surface, as well as to evaluate the risk of spalling for normal weight concrete with regard to the thermal load. The initial apparatus setup thermal testing calibrations, completed before the initiation of the dataset presented in this paper, suggested a minimum required heat flux to generate the spalling condition.

Figure 19: Heat Flux Variation (a) 25.4 mm depth temperature time history (b) MC to VD
