U.S. Department
of Transportation
**Federal Railroad
Administration**

Single Passenger Rail Car Impact Test Volume I: Overview and Selected Results

Rail Passenger Equipment Collision Tests

Final Report
March 2000

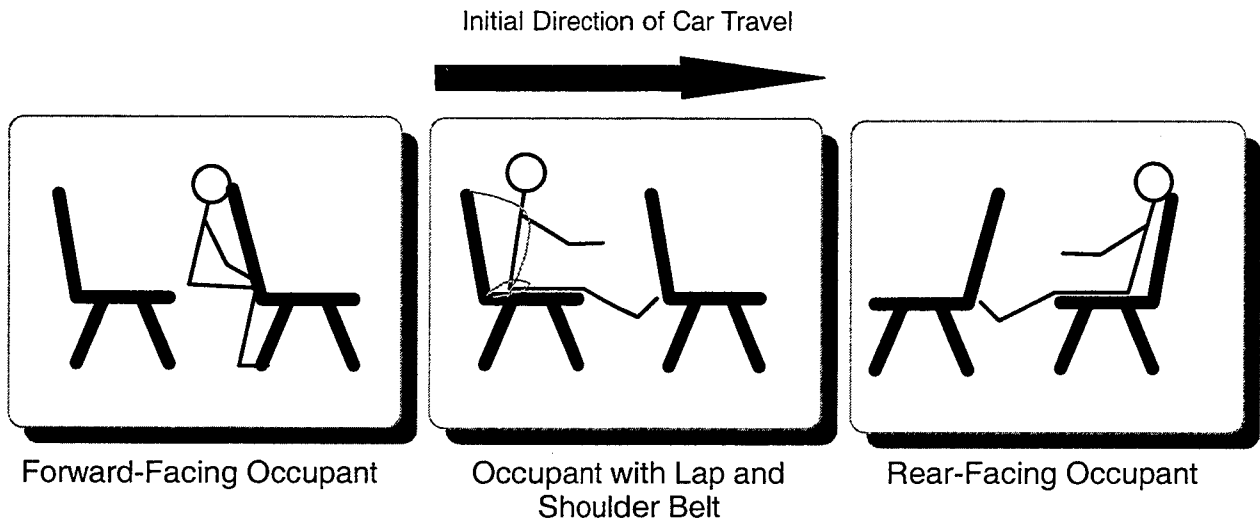
Figure 4. Occupant Protection Configurations Tested During Single-Car and Two-Car Tests

These occupant protection configurations are illustrated in Figure 4.

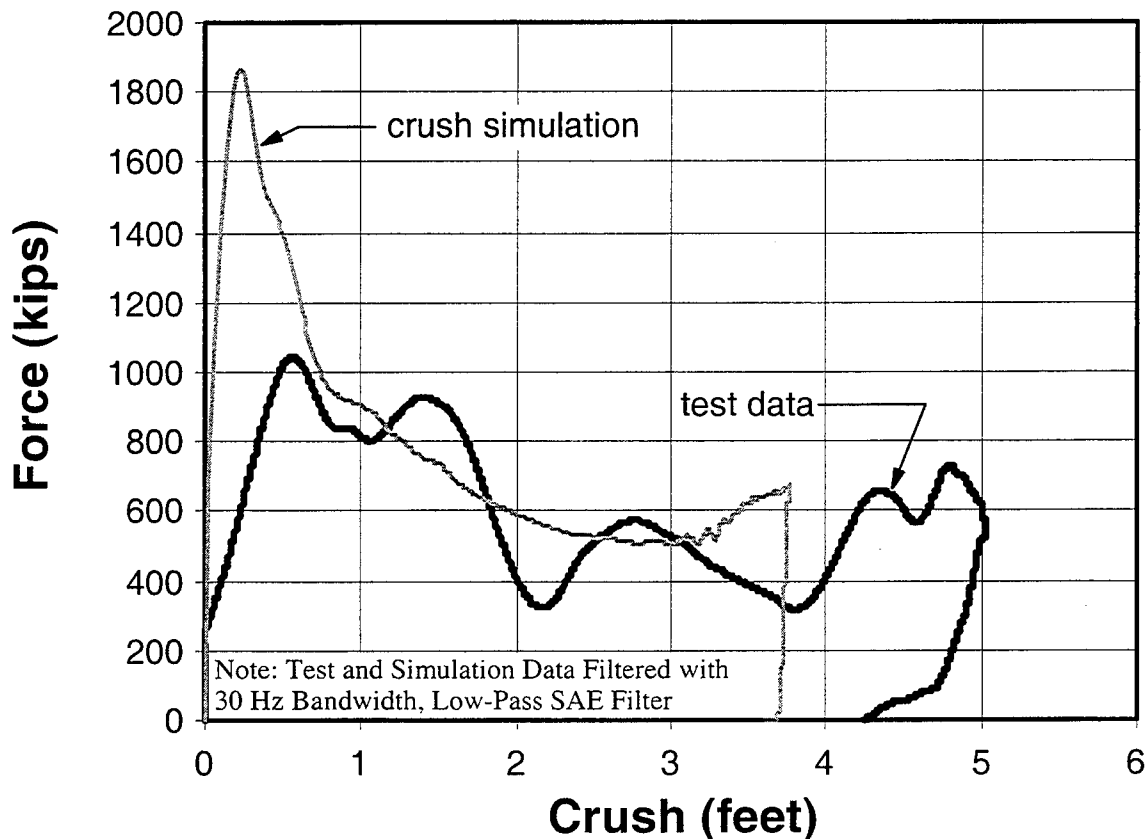
Figure 11. Car Force/Crush Characteristic, Reduced from Test Data and from Simulation Results

Figure 11 shows the force/crush characteristic, derived from the accelerometer measurements and calculated with the car crush model. Although overall agreement is reasonable, there are a number of differences between the force derived from the test data and the pre-test analysis. The peak force estimated prior to the test was about 1.8 million pounds, while the peak force derived from the test data was just over 1 million pounds. The average force derived from the test data is 600 kips, while the average force from the simulation is 700 kips. The total crush calculated prior to the test was about 3.8 feet, and the total crush measured during the test was about 5 feet.

It has been shown that the variation in the peak force derived from test measurements can be as much as 140 percent for ostensibly identical structures crushed under similar test conditions; it also has been shown that the variations in average force computed from test data can be approximately 20 percent [14]. The variation in the peak force predicted prior to the test and derived from the single-car test data is 75 percent, and the variation in the average force is 17 percent. These variations are close to the variations that would be expected if the test were to be repeated with another ostensibly identical car; i.e., the analysis predictions are within the likely range of repeatability of the test. The specimens tested in Reference 14 and the structure of the car tested in the single-car test did not include any cutouts, dimples, or any other perturbations intended to limit the peak force. It is expected that there would be substantially less variation in the peak forces derived from test data and determined from analysis for structures with perturbations than for structures without perturbations.

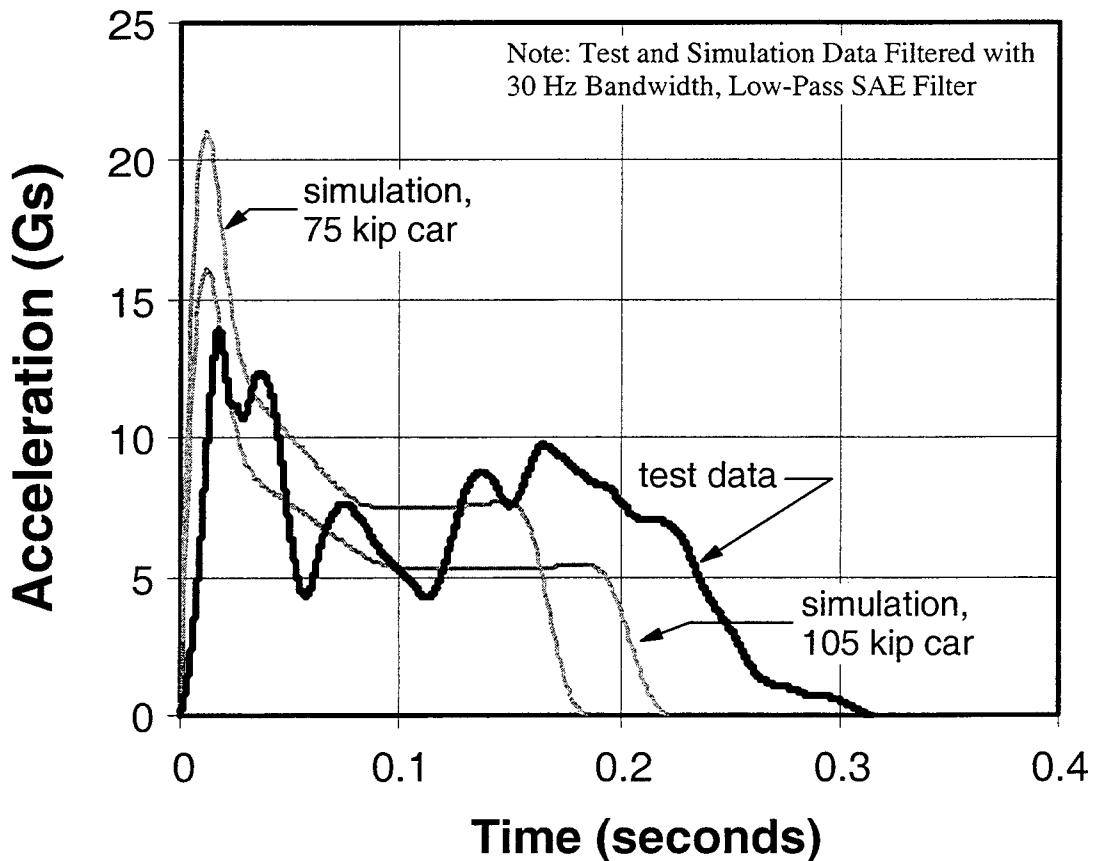
Figure 13. Occupant Volume Deceleration Time History, Measured and Pre-Test Simulation Results

Figure 13 shows the time history of the longitudinal deceleration of the occupant volume (crash pulse), as measured during the test and as simulated prior to the test. Two lines are shown for the pre-test simulations: one for a car with a total weight of 105 kips and the other for a car with a total weight of 75 kips. The measured and calculated crash pulses are in reasonable agreement. The peak deceleration measured is somewhat lower than estimated; however, this number is extremely sensitive to filtering, and by itself has no direct influence on the occupant response.

The average deceleration, which is more closely related to occupant response, is approximately 8 Gs for the measured data, about 7 Gs for the 105 kip car simulation, and 9 Gs for the 75 kip car simulation. The duration of the measured crash pulse is somewhat longer than those from the simulations. This is due in part to the average force being somewhat lower than estimated and to the car's rebound velocity off the wall being higher than predicted before the test.

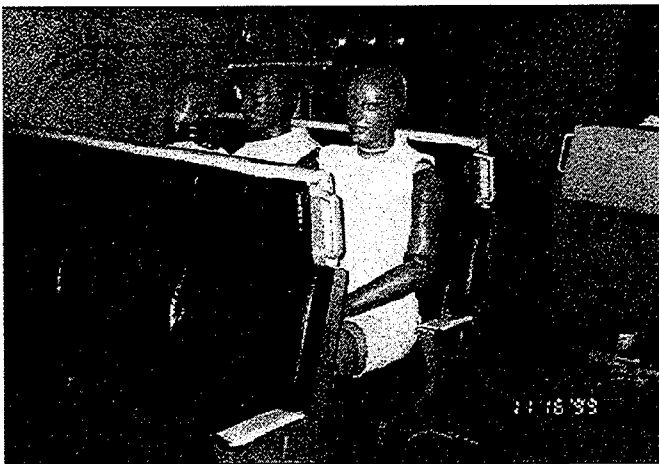
Figure 14. Photographs of Interior Occupant Protection Configurations Tested During Single-Car Test

Figure 14 shows photographs of the three interior configurations tested during the single-car test:

1. Forward-facing unrestrained occupants seated in rows, compartmentalized by the forward seat in order to limit the motions of the occupants.
2. Forward-facing restrained occupants with lap and shoulder belts.
3. Rear-facing unrestrained occupants.

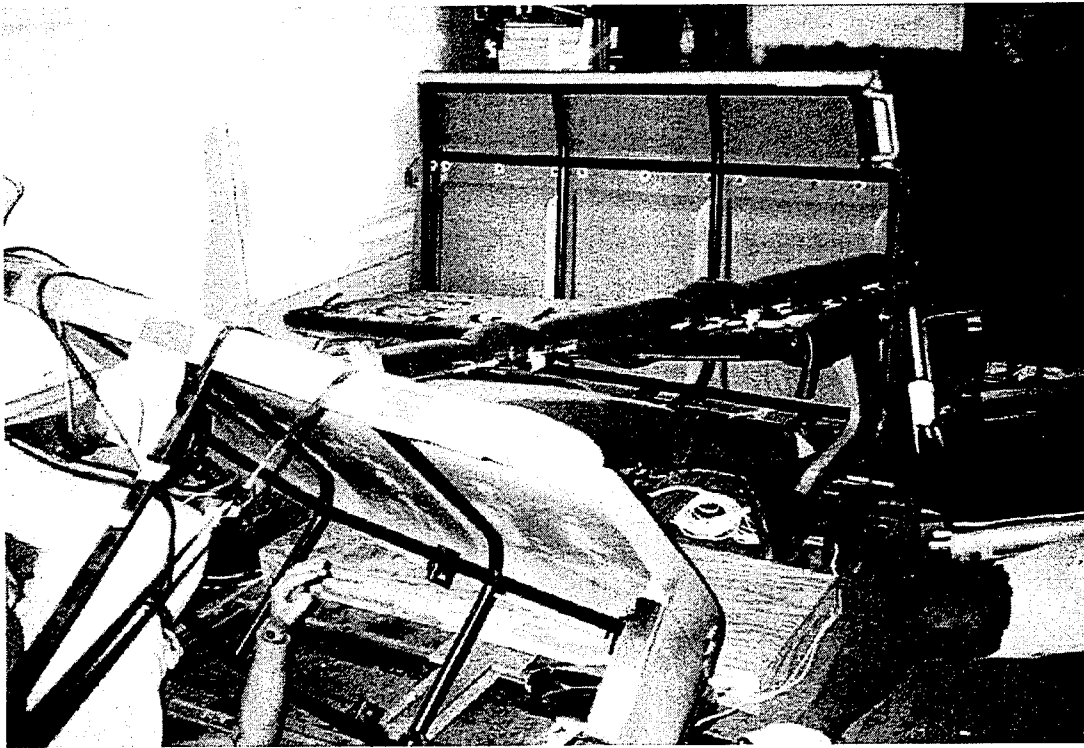
Figure 6. Experiment No. 1 – Loss of Passenger Compartmentalization

Gross failure of the seat pedestal in Experiment No. 1 allowed the seat to be pushed out of the way, resulting in a complete loss of occupant compartmentalization (see Figure 6). Overall, the measured occupant injuries were low because the seat offered little or no restraint value and the ATDs were tethered. There were no further obstacles for the occupant to impact before landing on the floor. The Hybrid III 50th-percentile ATD in the rear window seat was instrumented, and recorded a lower neck extension moment that exceeded the injury criterion.
