**COLORADO**

**Department of Transportation**

CDOT Office of Applied Research

## **Part I: Nondestructive and Destructive Tests for Damage Quantification of Deteriorated Structural Timber**

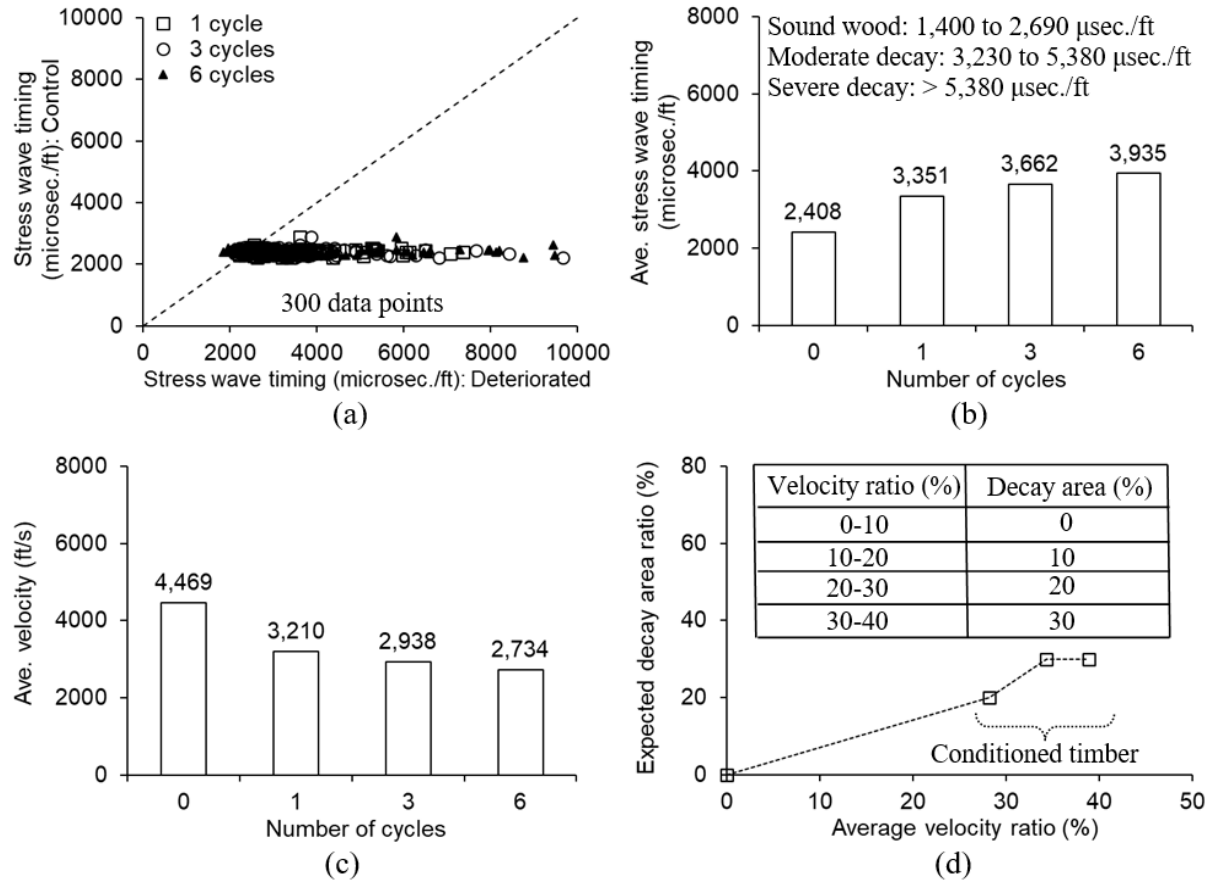
**Fig. I.4.** Stress wave timer: (a) measured wave timing; (b) average wave timing; (c) average velocity ratio; (d) expected decay area ratio

Figure I.4(a) plots the stress wave timing of the control and deteriorated specimens. The elapsed time of the conditioned ones parallel to the abscissa manifests the progression of internal damage. For clarity, the average stress wave timing of the individual categories was calculated and is provided in Fig. I.4(b). The transmission time of 2,408 microsec./ft belonging to the control category was within the range of the *Sound wood* category (1,400 to 2,690 microsec./ft, Brashaw et al. 2014), whereas the stress wave time gradually rose with the conditioning cycle and all values ranging from 3,351 to 3,935 microsec./ft were within the *Moderate decay* category (3,230 to 5,380 microsec./ft, Brashaw et al. 2014). Contrary to the coefficient of variation of the control specimens being  $\text{COV} = 0.039$ , those of the conditioned ones remarkably increased ( $\text{COV} = 0.345, 0.403$ , and  $0.487$  for the one-, three-, and six-cycled specimens, respectively) owing to the nondeterministic nature of deterioration. The travel velocity of the stress waves is

charted in Fig. I.4(c), where the adequacy of the test method is reaffirmed since the average velocity of 4,469 ft/s for the control specimens fell within the range of 3,940 ft/s to 4,920 ft/s seen in undamaged timber (Kasal et al. 2010). The retarded velocities of the conditioned specimens are ascribed to the irregularly crushed cellular structure of the timber (Carreon and Carrillo 2021), which diminishes physical contacts necessary for transmitting wave signals. Figure I.4(d) infers decay areas in the test specimens based on a velocity ratio ( $V_R$ )

where  $V_{cont}$  and  $V_{det}$  are the velocities of the control (0 cycles) and deteriorated specimens (1 to 6 cycles), respectively. According to the inset of Fig. I.4(d) showing a rough estimation of decay areas (Dackermann et al. 2014), the conditioned timber was expected to have a decay area ratio spanning from 20% to 30% (Fig. I.4(d)). In view of the fact that timber elements are rated as deteriorated if a decay level is greater than 10% per the AASHTO inspection manual (AASHTO 2019), the accelerated test protocol of ASTM D1037 (ASTM 2020) appears to be acceptable in terms of reproducing the deterioration of in-situ timber bridges.

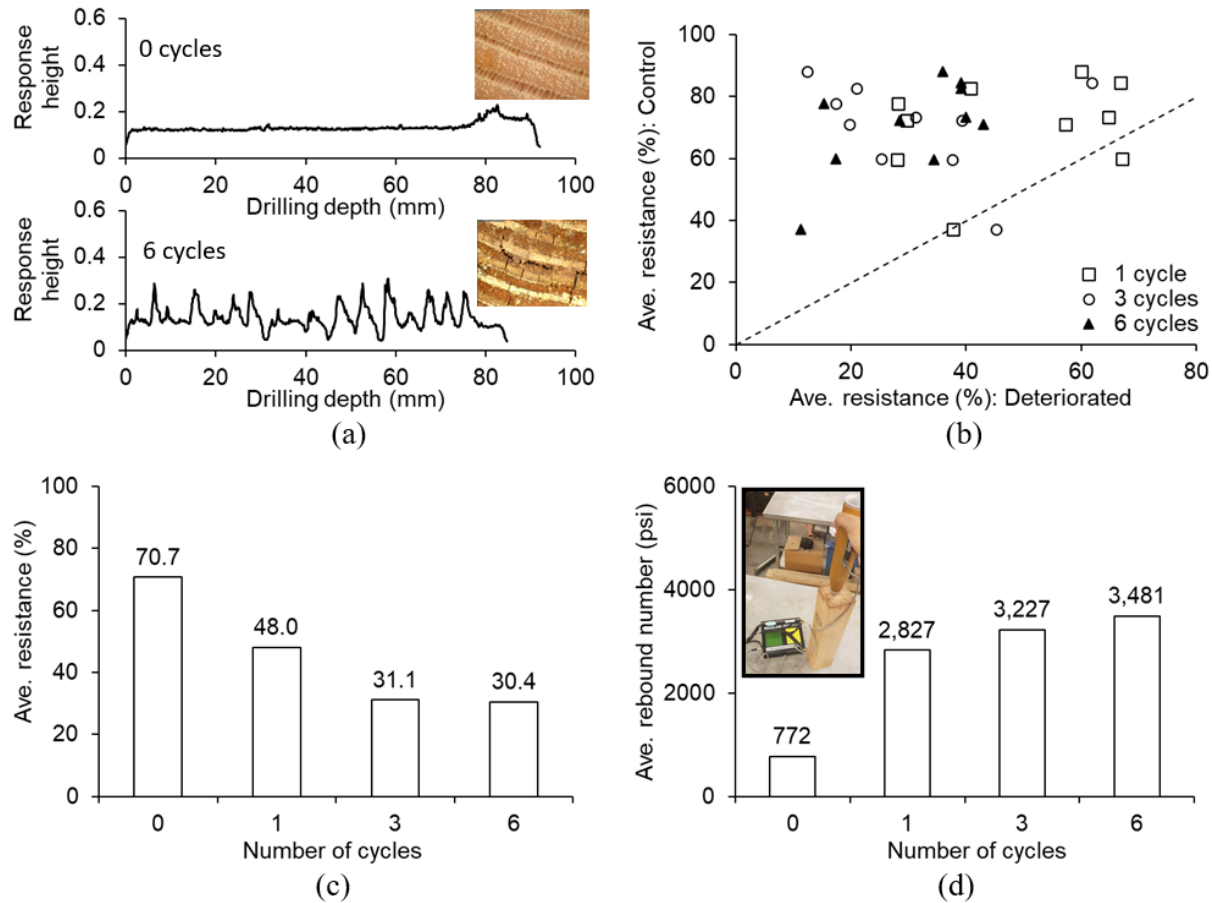
**Fig. I.5.** Microdrill: (a) individual data; (b) measured resistance; (c) average resistance; (d) rebound hammering

Microdrilling responses for the control and deteriorated specimens are given in Fig. I.5(a). If voids or discontinuities are inherent in the timber, drilling resistance would drop significantly. The consistent resistance of drilling at 0 cycles signifies that the control specimen had uniform quality across the cross section without physical decay pockets (Fig. I.5(a), up). By contrast, the fluctuating pattern of the deteriorated specimen at 6 cycles insinuates that the conditioning created nonhomogeneous configurations inside the timber (Fig. I.5(a), down); specifically, the periodic spikes of the resistance are related to the conformational arrangement of the grain constituents: hardened cell walls and collapsed lumens (Xu et al. 2013; Aloisio et al. 2023). The average resistance of the deteriorated specimens is contrasted with that of the control in Fig. I.5(b). The variability in the conditioned timber's responses resulted in disorganized data; nonetheless, the control category showed more resistance relative to the conditioned groups on

most occasions. This inclination is underscored in Fig. I.5(c), instantiating the average ratios between peak and valley resistances. After one cycle of accelerated aging, there was a 32.1% reduction in the average resistance; however, the resistance level was preserved in the 3- and 6-cycled specimens. Fibers and vessels in the arranged cellular structure contributed to the internal stability of the wood during the drilling process (Hoadley 2000). Figure I.5(d) depicts the near-surface hardness of the specimens, represented by the readings of the rebound hammer. Hardening was obvious with the increased conditioning cycles due to the enhanced stiffness of the cell walls from lignin and the mechano-sorptive creep deformations of the fibers (Tarvainen et al. 2006; Xin et al. 2022). Additionally, the irreversible swelling of the surface layers was another influencing factor (Rautkari 2012).

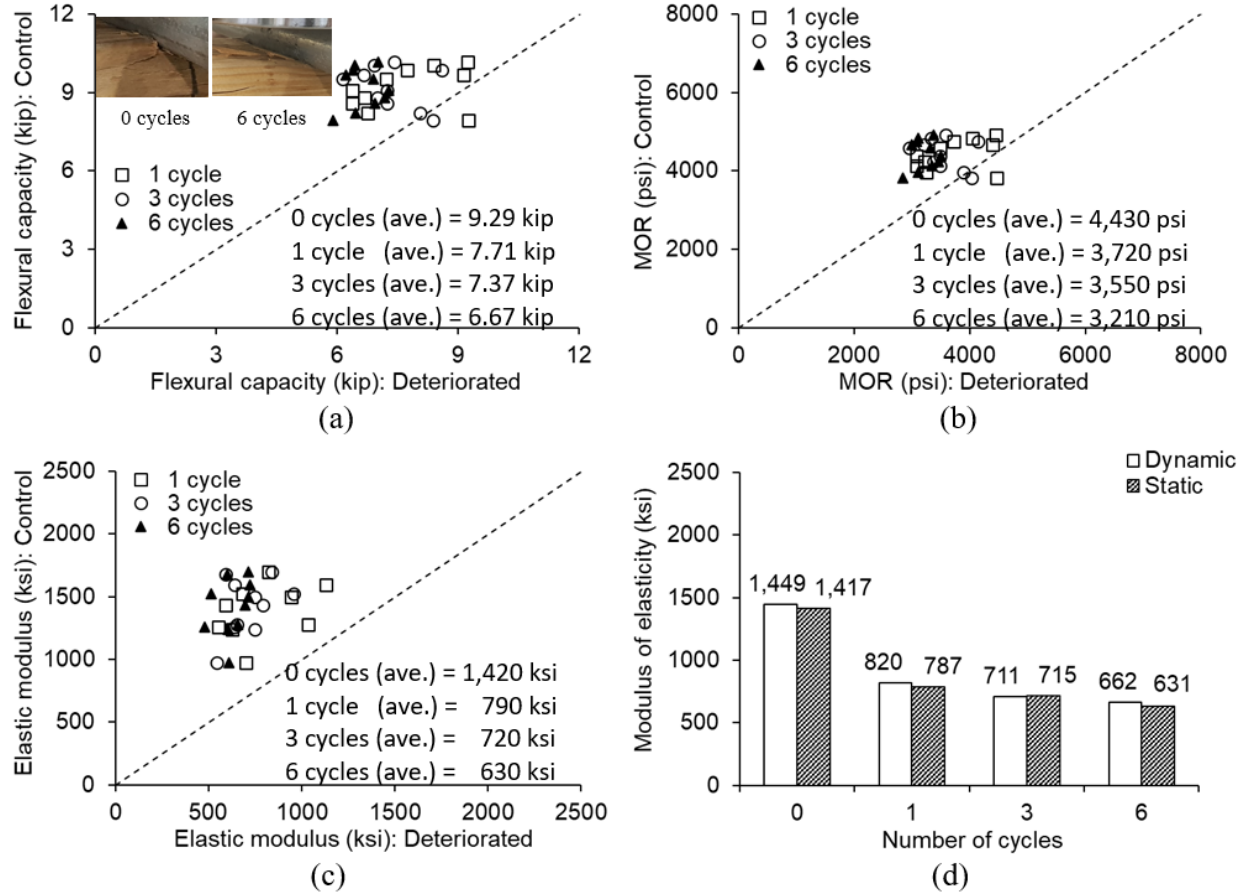
**Fig. I.7.** Three-point bending test: (a) flexural capacity; (b) modulus of rupture; (c) static elastic modulus; (d) comparison of average static and dynamic elastic moduli

where  $\rho$  is the density and  $V$  is the velocity of the stress wave (Ilharco et al. 2015). Irrespective of the conditioning cycles, the dynamic elastic modulus tended to be higher than their static counterparts because the local-level properties (dynamic) pertaining to the stress waves were influenced by the internal friction of the cell structures (Ross et al. 1999).

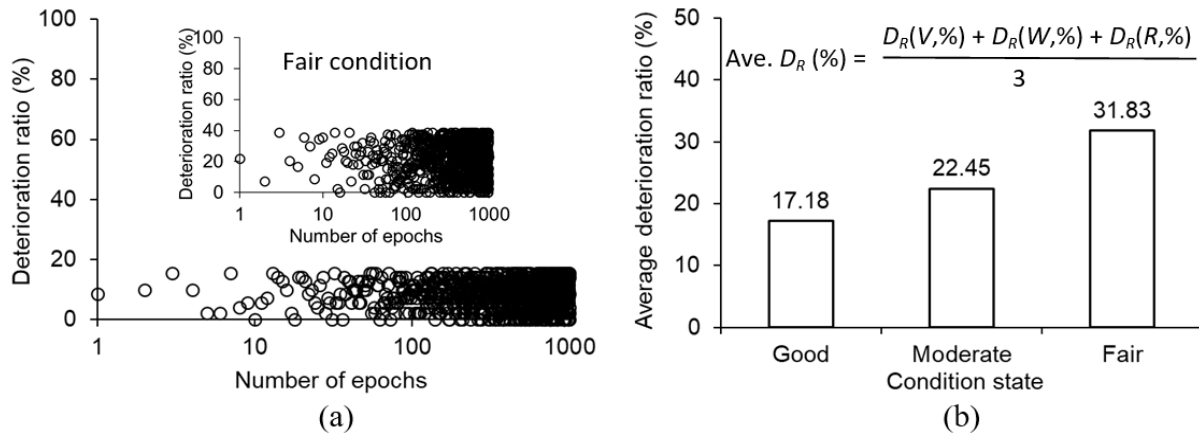
**Fig. I.12.** Practice recommendations: (a) random simulation using velocity ratios regression under Good condition; (b) average deterioration ratio

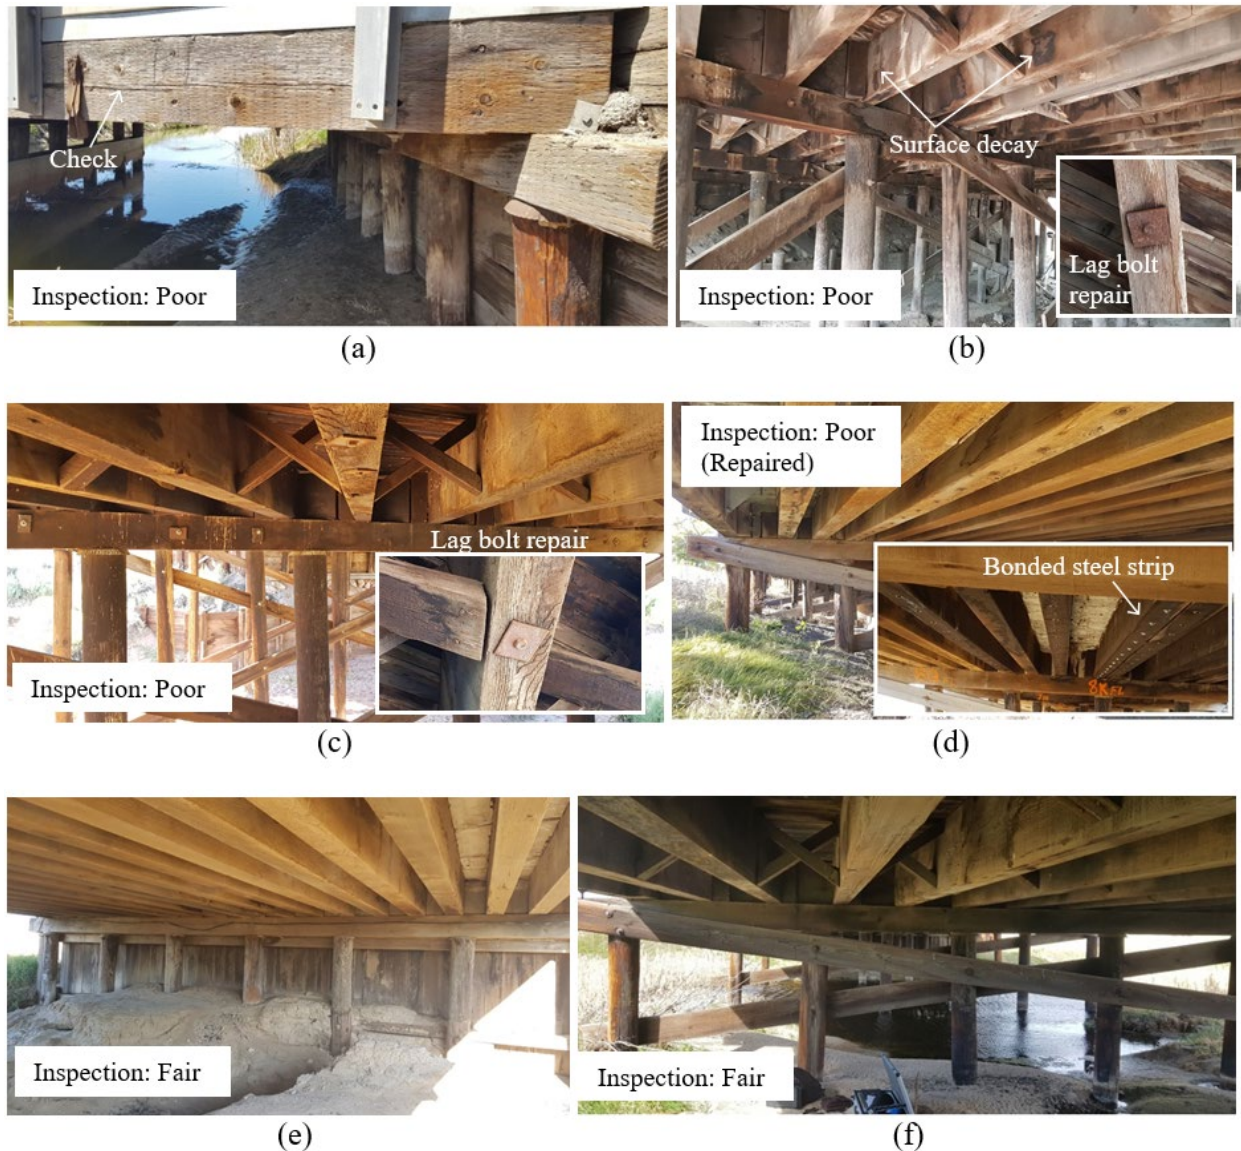
**Fig. II.2.** Visual inspection of timber bridges: (a) D-18-B; (b) K-18-AD; (c) M-16-Q; (d) F-20-C; (e) F-19-C; (f) H-19-K

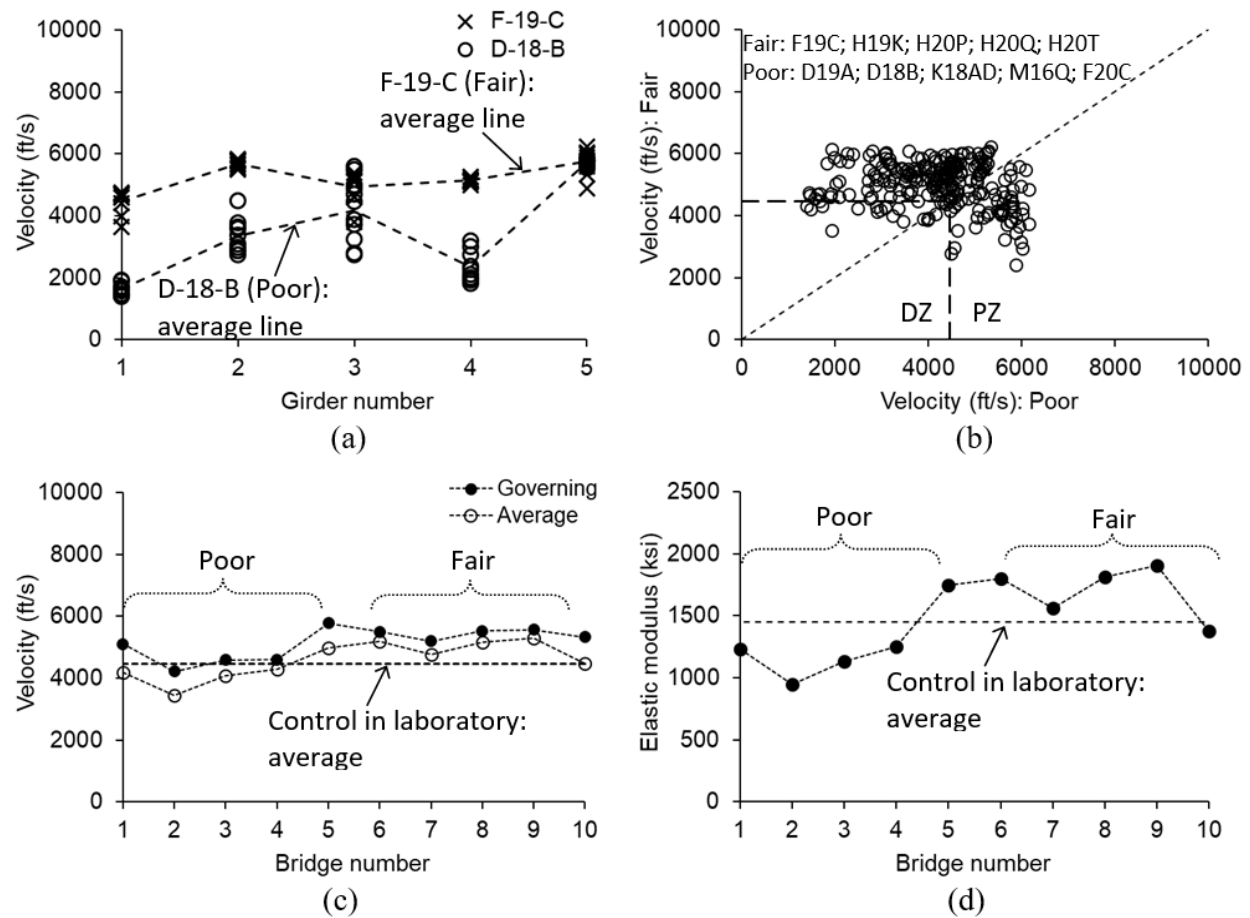
**Fig. II.4.** Velocity (PZ = pristine zone; DZ = deteriorated zone): (a) individual response; (b) comparison between Poor and Fair bridges; (c) individual bridge response; (d) elastic modulus

Shown in Fig. II.4(a) is the velocity of stress waves for D-18-B (Poor) and F-19-C (Fair). The measured responses of F-19-C generally surpassed those of D-18-B and, dissimilar to the former, the latter revealed remarkable fluctuations among the girders. The inconsistent data for D-18-B point out that internal damage was irregular; in other words, voids and delamination randomly distributed throughout the interior of the deteriorated bridge hindered the progression of the stress waves (Pahnabi et al. 2024). In the context of microstructural reactions, impaired cellulosic crystalline tracheids in the wood cells dissipated energy and disrupted the transmission of acoustic signals (Bucur 2006; Lazarus et al. 2020). Owing to the erratic response of the damaged bridge girders, apparent disparity was not noticed between the Poor and Fair bridges (Fig. II.4(b)) and a significant portion of the measured velocities were in the pristine zone (PZ), rather than in the deteriorated zone (DZ), which was partitioned by the baseline velocity of  $V_{cont} = 4,467$  ft/sec. Nonetheless, the average velocities of the Poor bridges were by and large slower (Fig. II.4(c)). The elastic moduli of the bridges converted from the average velocities using Eq. II.1 are given in Fig. II.4(d). The moduli oscillated around the modulus of undamaged timber tested in the laboratory (10 GPa) and the range of variation closely paralleled to the values for Douglas Fir, 1,160 ksi to 1,940 ksi, specified in the wood handbook of the United States Department of Agriculture (USDA 2010). In contrast to other bridges rated as Poor, the properties of Bridge No. 5 (F-20-C) were comparable to those of the bridges rated as Fair (Figs. II.4(c) and (d)).

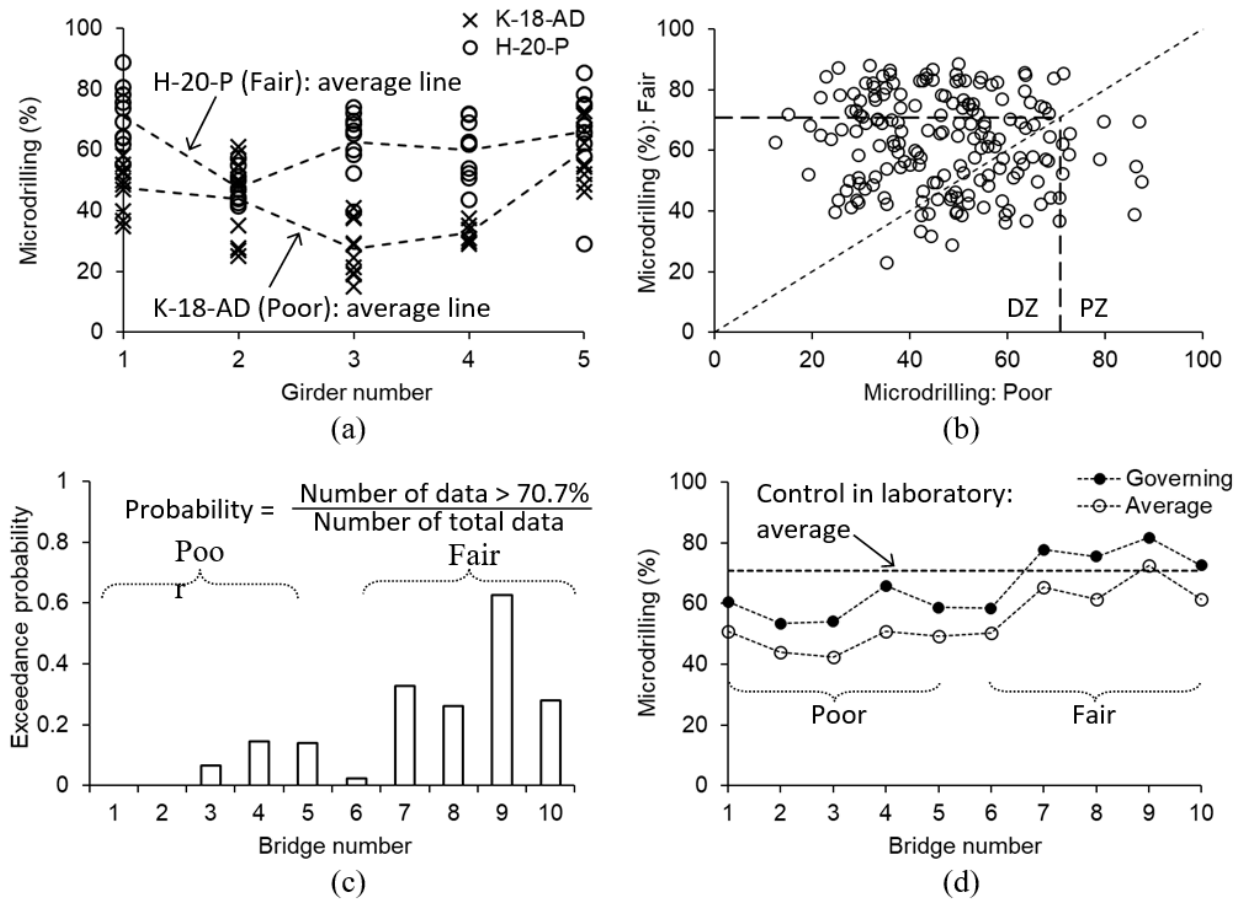
**Fig. II.6.** Microdrilling (PZ = pristine zone; DZ = deteriorated zone): (a) individual response; (b) comparison between Poor and Fair bridges; (c) exceedance probability; (d) individual bridge response

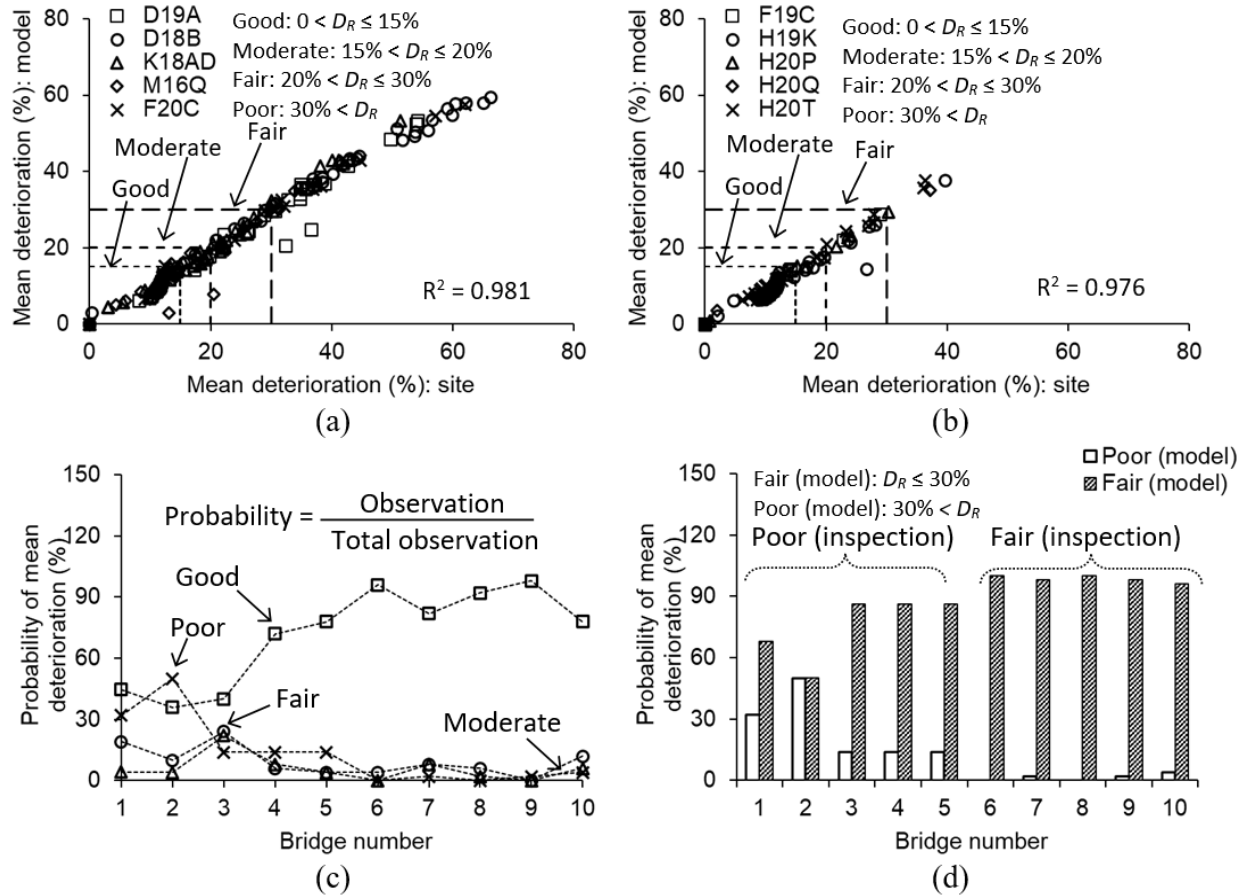
**Fig. II.10.** Assessment of mean deterioration ( $R^2$  = coefficient of determination): (a) comparison of model and site data for bridges rated as Poor; (b) comparison of model and site data for bridges rated as Fair; (c) probability of predicted mean deterioration; (d) overall prediction

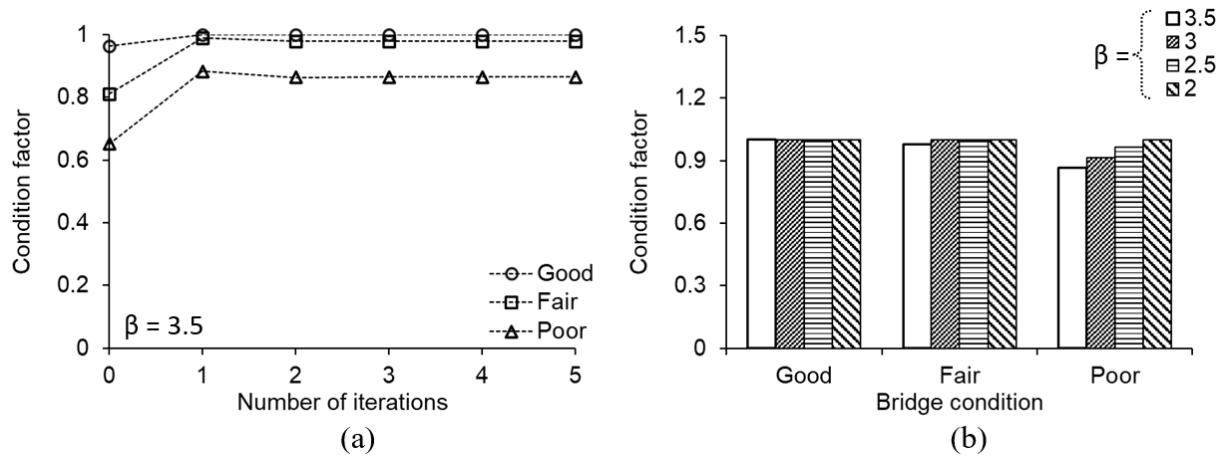
**Fig. II.12.** Calibration of condition factor for timber bridges: (a) convergence; (b) variable reliability index

To implement Eq. II.19, the COV values of the bridges were taken from literature (Nowak 1999; Barker and Puckett 1997; Kim and Ha 2024): COV = 0.156, 0.0264, and 0.18 for the nominal capacity, dead load, and live load, respectively. With successive iterations, the solutions for the condition factor converged (Fig. II.12(a)): three condition states (Good, Fair, and Poor) were designated to ensure conformity with the AASHTO bridge evaluation manual (AASHTO 2017). Since the level of safety is not constant but case-specific, varying safety indexes were considered from  $\beta = 2.0$  to 3.5. The condition factor was consistent at  $\phi_c = 1.0$  for the Good state; however, as the bridge condition deteriorated, variations were noted (Fig. II.12(b)). Table II.3 lists the proposed condition factors reflecting structural conditions and safety levels, which can be used for rating aged timber bridges.
