Autonomous Truck Mounted Attenuator Incident Response - CSU Data Report

Technical Report Documentation Page					
1. Report No.	Government Accession No.).	3. Recipient's C	atalog No.		
CDOT-2022-04						
4. Title and Subtitle			5. Report Date			
Autonomous Truck Mounted Attenuator (ATMA)Incident Response -			May 2022	May 2022		
CSU Data Report	6. Performing C	6. Performing Organization Code

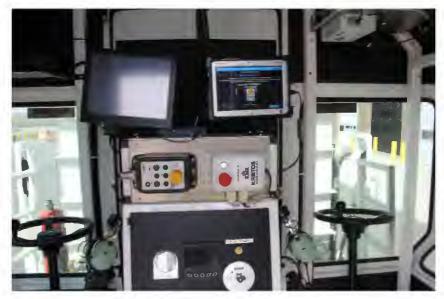
Figure 3: Kratos Leader Vehicle Setup showing the ATMA control panel

In addition to the vehicle data available via the J1939 interface, separate log files are recorded in the Kratos Technology ATMA system. The leader vehicle control station is pictured in Figure 2 and the Ethernet connection provides access to the data is pictured in Figure 3. It is important to note that the Kratos data logging system is separate from the vehicle CAN Bus network. It requires a direct Ethernet connection access the log files. Download of the Kratos ATMA log files requires a browser input of a specific IP address along with a username and password. Of note, a recommendation for security is to implement a non 'root' username and a lower permission level for the data extraction, see Figure 20. Kratos log files were captured during our series of tests of the ATMA system on 13 Jan 2022.

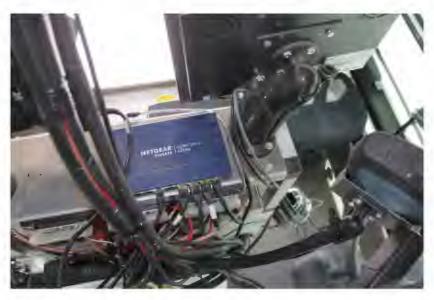
Figure 4 Kratos Ethernet Setup in the leader vehicle allowing physical access to the server

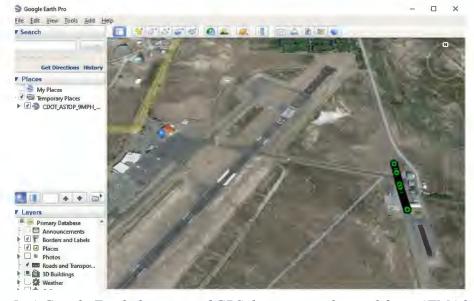
Figure 5: A Google Earth depiction of GPS data points obtained from ATMA log files.

GPS latitudinal and longitudinal data can be imported from the nav log file to Google Earth, as shown in Figure 5. Of note, the data fields do not include any data fields extracted from the CAN bus. As such correlation of the data directly to the on-board data extracted from the truck systems is more challenging. Further discussion on this and recommendations is included in Section 6.

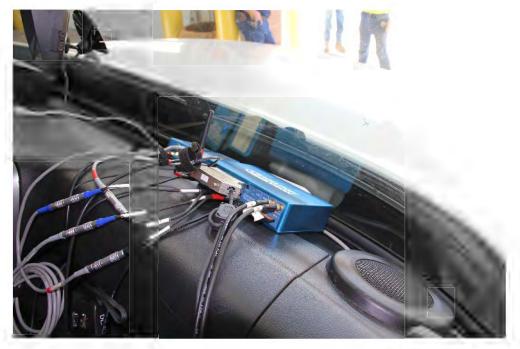
Figure 6: VBox Setup in the follower vehicle to collect TSPI.

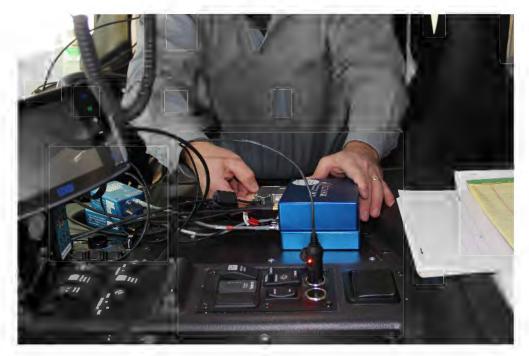
Figure 7: VBox Setup in the leader vehicle showing the connection between antennas.

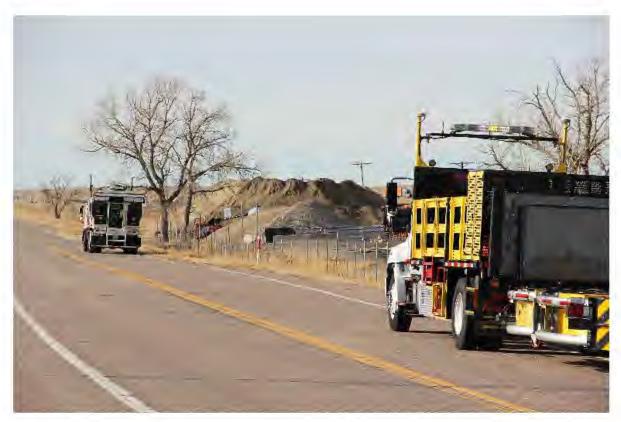
Figure 8: Nominal Test Setup for Test 1-3 – Sudden Deceleration Events

The execution of the test events occurred on 13 January 2022 in Limon Colorado on a dry 55-degree Fahrenheit day. The nominal setup for tests 1-3, consisting of runs 1-6, is pictured in Figure 8. The leader vehicle was at least 100 ft in front of the follower vehicle, and the two were generally aligned laterally for the tests. Tests 1-3 exercised the various sudden deceleration modes of operation expected to be encountered in normal operating conditions. The specific mode of deceleration is described for each test scenario. Test 4 was an unplanned stoppage of the follower due to object detection. After completion of the deceleration testing, the team then transitioned to a service area where object intrusion, using a barrel, was exercised in Test 5.

Of note, in these runs, it was discovered that the ESTOP command not only applies full braking power to the follower, it also kills the ignition power on the engine. This became problematic with the setup of the onboard data logs. Once ignition power was removed, the onboard ATMA logs ceased data recording. For these two runs, no data is recorded on the actual ESTOP event as the data logs terminate just before hard braking is applied upon termination of ignition power. The nominal test setup is shown in Figure 8.

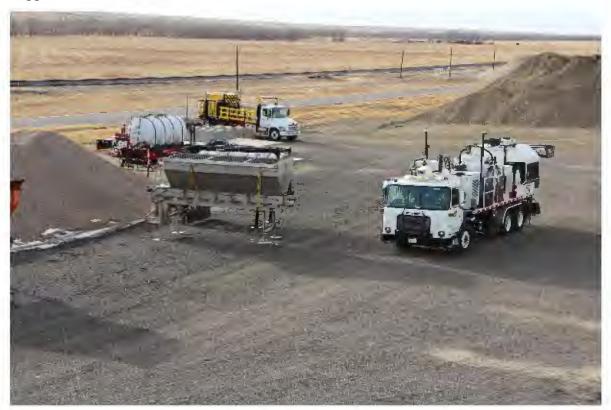
Figure 9: CDOT Limon Yard Entry Uncommanded Stop - Test Event 4

to enter the test setup area for Test 5, followed by another 90-degree turn to the right, shown in Figure 9. Upon completion of the first 90-degree turn the follower triggered an ASTOP. This was not expected as hard braking did not occur and no known intrusions to the path occurred. The team suspects an object in the yard to the edge of the drive path may have triggered an object sensor and triggered the ASTOP.

Test 4 (Run 7) was an unplanned test as the goal was to move towards Test 5 after the ESTOP tests. However, during the maneuver of turning left into the yard shown in Figure 9, the follower went into the ASTOP mode, so the team collected the data from the longer run ending in the left turn. The ATMA log files capture the operations of turn, which tool place at between 6 and 7 km/h, which is shown on the right side of the Run 7 graph.

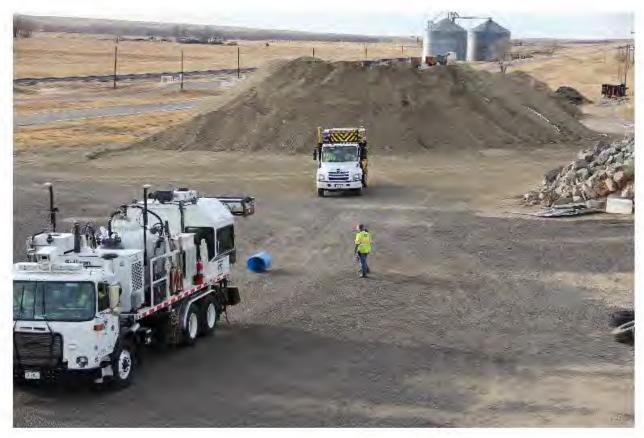
Figure 10: CDOT Limon Yard Setup for Test 5 Barrel Instrusion

Runs 8 and 9 consisted of a sudden deceleration event, but this time triggered by a team member rolling a barrel in between the leader and follower vehicles, as seen in Figure 10. This obstacle intrusion triggers an ASTOP in the follower vehicle.

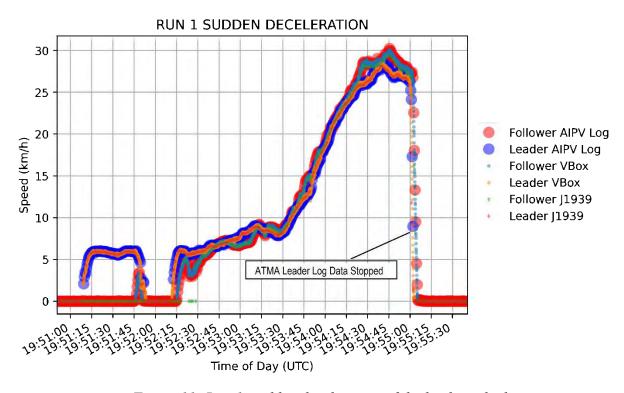
Figure 11: Run 1, sudden deceleration of the leader vehicle

The first two test events had the leader vehicle apply hard brakes and come to a quick stop. The results of the sudden deceleration events from runs 1 and 2 are shown in Figure 11 and Figure 12. The follower vehicle appeared to detect the rapid deceleration and initiate an ASTOP event coming to a similarly abrupt stop while maintaining close to the preset follow distance. Of note, this effort and report is focused on data collection methods and not performance testing, however some behavior was documented that may want to be reviewed further by ATMA performance and requirements experts. Run 1 went as expected and the data demonstrates close alignment between the sources of data. During Run 2 the follower vehicle entered a rapid deceleration as expected but then did not come to a complete stop with the same speed profile as the leader; instead, the follower

The end of the graphs (right side) shows a steep decent of speed with respect to time. These steep slopes are the highest accelerations. The graph in Figure 11 shows a consistent decrease in speed. However, in Figure 12, the speed change of the follower stops and the graph shows a slight increase in speed of the follower from about 5 to 6 km/h after the leader had stopped. There are three independent data sources for each vehicle shown in the graphs. Furthermore, the test team noticed the change in acceleration in the follower during run 2. This speed behavior would be consistent with the notion of trying to reduce the distance gap between the vehicles to the set amount, however, it is not the intent of this project or report to analyze the control algorithms and mode switching criteria for the AIPV system.

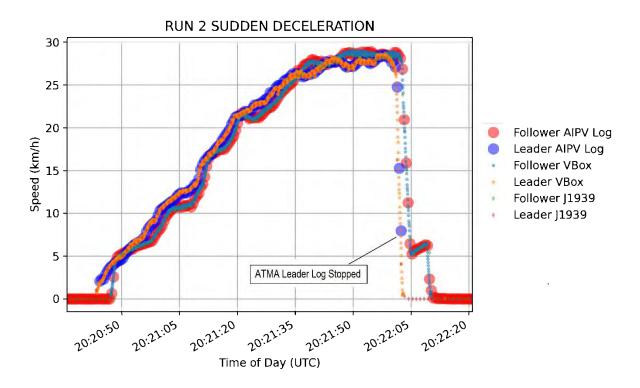
Figure 12: Run 2, sudden deceleration of the leader vehicle

vehicle slowed but then released brake pressure to roll forward before initiating full brake application, see Figure 12.

The AIPV log files for these events were uploaded to the pooled fund Google Drive share. The log files for Run1 and Run 2 show the follower vehicle was operating in different states between runs. On run 1, as soon as the leader began his sudden deceleration, the logs show the detection of the leader's braking and the follower vehicle enters an ASTOP mode triggering its own rapid deceleration and full brake application. During Run 2, while the rapid deceleration occurred, the follower mode remained in RUN rather than changing to ASTOP as it did in Run 1. The leader's driving and operation were consistent between the runs.

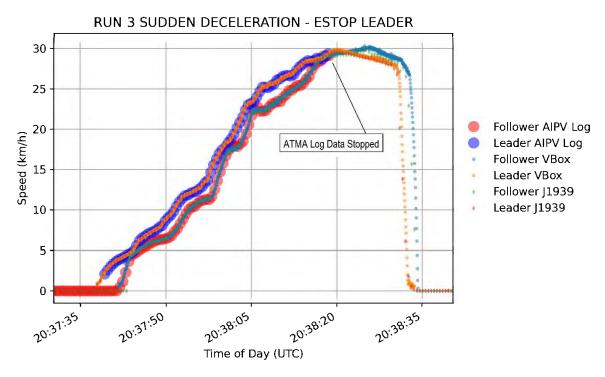
Figure 13: Run 3, Estop initiated in the leader vehicle during braking

Runs 3 and 4 test the ESTOP functionality as triggered from the leader vehicle. The test engineer sat with the crew in the "dog house" of the paint striping vehicle. The ESTOP button was pushed by the test engineer. Shortly after initiating the ESTOP, the driver of the

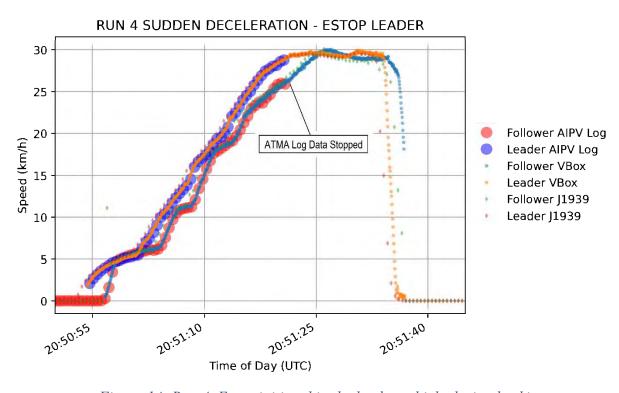
Figure 14: Run 4, Estop initiated in the leader vehicle during braking

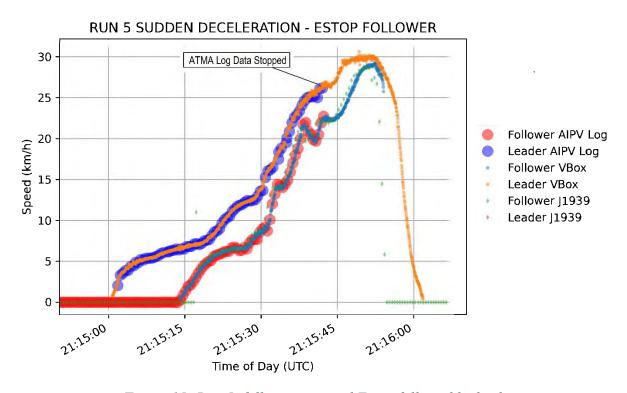
Figure 15: Run 5, follower initiated Estop followed by braking.

Runs 5 and 5 shows the log files generated before an ESTOP fail to capture the speeds and operation of the system at or slightly before the ESTOP was pressed. The ESTOP was pressed at the time slightly before the speed record begins to rapidly decrease. Notice the speed record of the follower vehicle comes to a stop before the leader. This is because the human driver of the leader vehicle was reacting to the initiation of the ESTOP from visual and audio (hand-held radio) stimuli. The braking on the leader was a reaction and the human driver chose to apply hard brakes, which mimicked the follower. However, the leader speed could have easily slowed more gradually if the brakes were not applied as hard. The order of the braking events, (follower first, leader second) is different than Runs 3 and 4. Due to the similarity of the shapes of the graphs between tests 2 and 3, it can be confusing on which vehicle initiated the ESTOP and which vehicle came to a stop first. The causal chain of events is important for an incident investigator to determine. It is not clear to the authors as to why it appears as the data is missing.

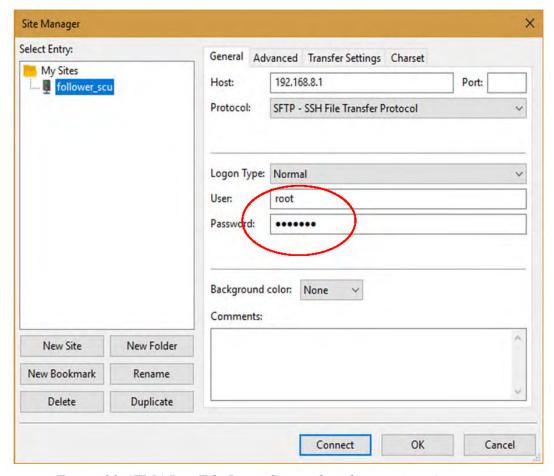
Figure 20 ATMA Log File Login Screenshot showing 'root' username

A security concern was uncovered during the data download procedures currently in place. The download instructions currently use the "root" permission, Figure 20, which is a security vulnerability [5].
