PERFORMANCE OF OPEN-GRADED FRICTION COURSES

Research Report 234-1F
Research Study 2-9-78-234

June 1979

Texas Transportation Institute

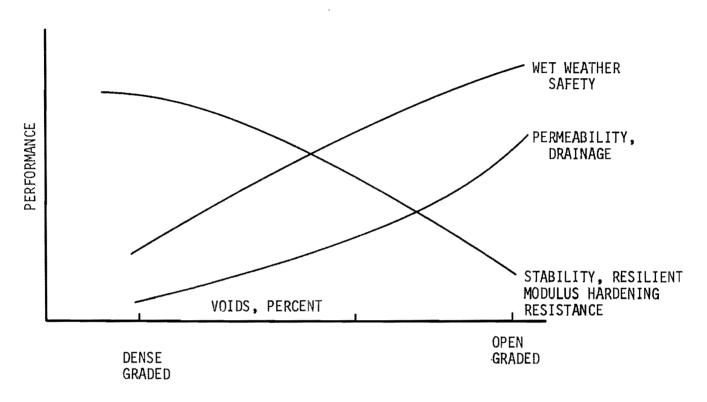
Figure 1. Performance of Compacted Bituminous Mixtures as Influenced by Their Porosity

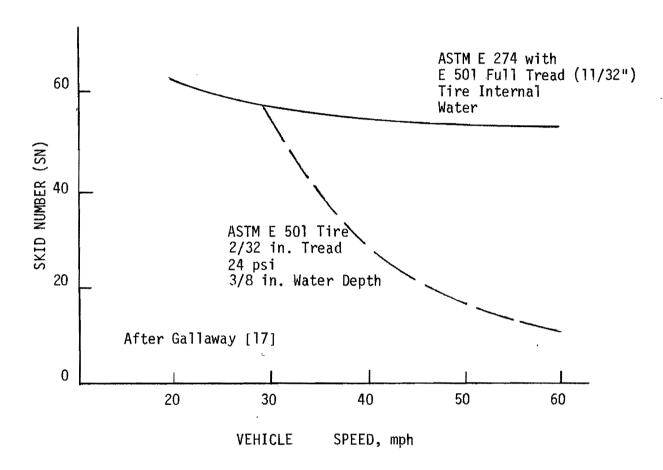
Figure 2. Water Film Thickness Influences Tire-Pavement Friction for an OGAFC

In a previous discussion of the significance of Figure 2, it was pointed out that when the surface is not flooded, the relative wet skid resistance of an OGAFC pavement will be indicated by ${\rm SN}_{40}$ (ASTM E274) values. These numbers, in turn, are controlled by the pavement surface microtexture which, for OGAFC pavements, depends mostly on the aggregate particle surface texture. The information obtained in this study clearly supports this view. For example, Table 31 summarizes the ${\rm SN}_{40}$ values found on the OGAFC evaluation pavements and compares these numbers with representative polish values (Texas Method, Tex-438-A) of the aggregates used in the construction of these friction courses. The resulting relation between OGAFC pavement skid resistance and aggregate polish value is shown in Figure 34. As expected, somewhat lower skid numbers are measured on traffic lanes than on adjacent passing lanes as a result of a slightly different balance between aggregate weathering and tire polishing in the two situations. The benefits of using aggregates with relatively high polish values, such as the lightweight aggregates often CRUSHING RATINGS: 1 = NEGLIGIBLE, 2 = SLIGHT, 3 = MODERATE, 4 = SEVERE

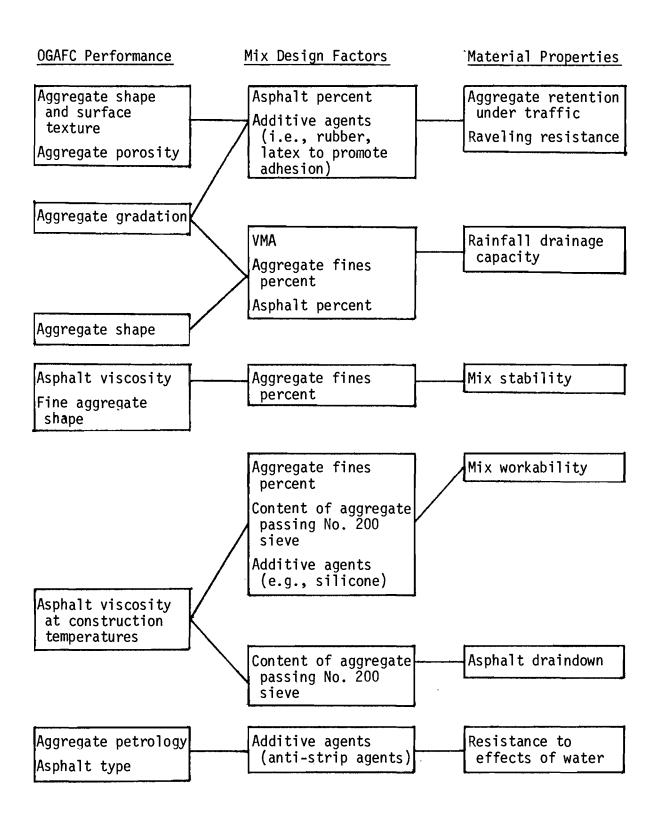
Figure 3. Influence of Material Properties and Mix Design on OGAFC Performance

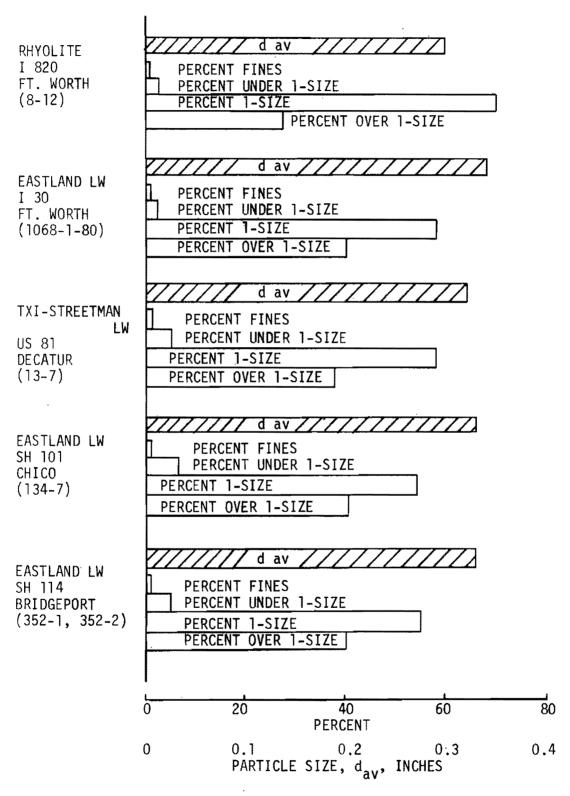
Figure 4. Gradation of Aggregates Used in Texas OGAFC Evaluation Pavements - District 2.

These gradation parameters for the aggregates used in Texas OGAFC evaluation pavements are presented graphically in Figures 4, 5, 6 and 7. Gradation parameters for aggregates used for the experimental OGAFC pavements are presented in Figure 8. In each of these figures the aggregate is identified by name, highway route number, nearest town, and highway control number.

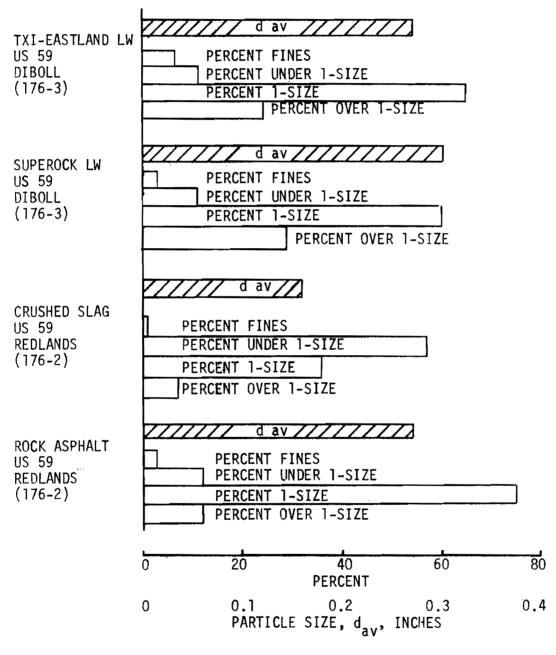
Figure 5. Gradation of Aggregates Used in Texas OGAFC Evaluation
Payements - District 11

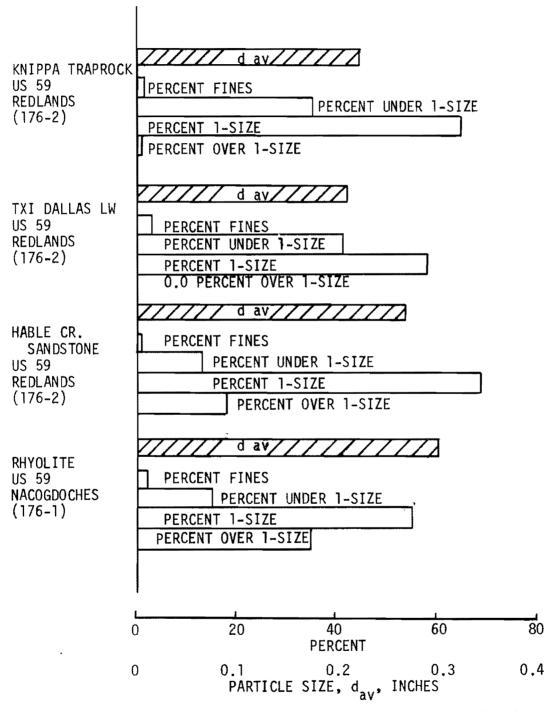
Figure 6. Gradation of Aggregates Used in Texas OGAFC Evaluation Pavements - District 11

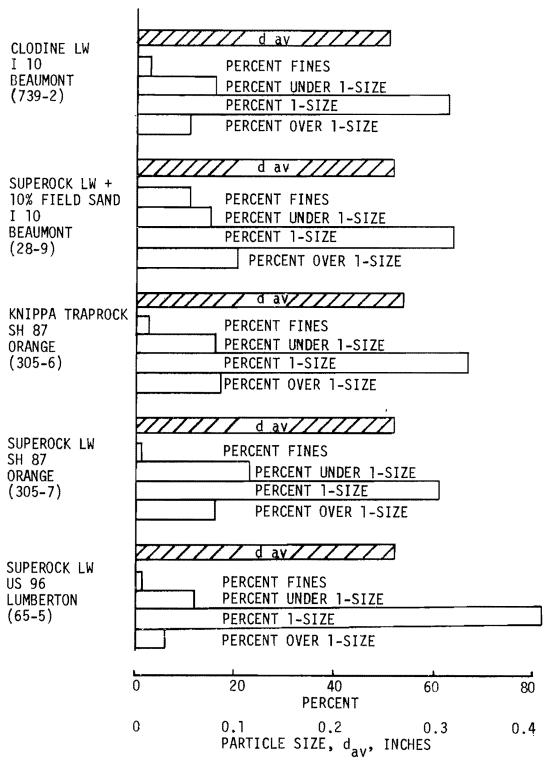
Figure 7. Gradation of Aggregates Used in Texas OGAFC Evaluation Pavements - District 20

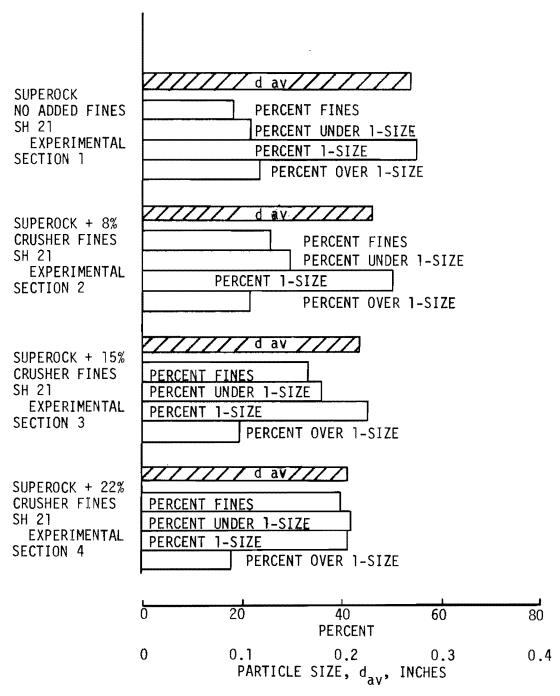
Figure 8. Gradation of Aggregates Used in Experimental OGAFC Sections - District 17

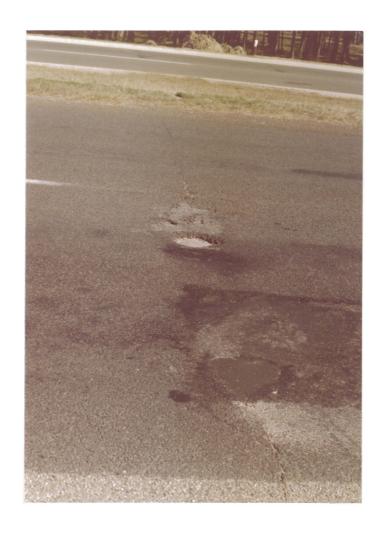
Figure 9. Example of OGAFC Layer Removal Along Reflection Crack. Location: Highway US 59, Control No. 1763, M.P. 22.4, District 11

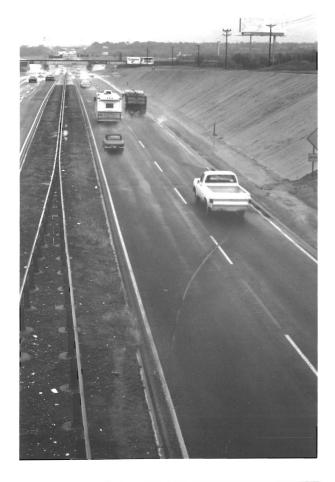
Figure 10. Splash and Spray Behind Automobiles in 0.02 in/h Rainfall; Location: 820/812/L,M,R,S 11/8/77

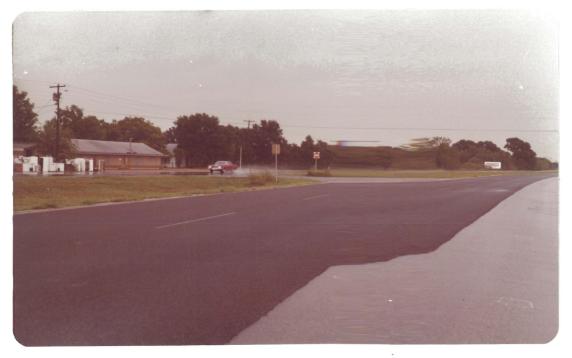
Figure 24. Pavement Surface in 0.02 in/h Rain a 1 Kest = 0.2, Experimental OGAFC Section 2, Cont No. 1164, District 17. Spray Shown Behind A mobile on Dense-Graded Median.

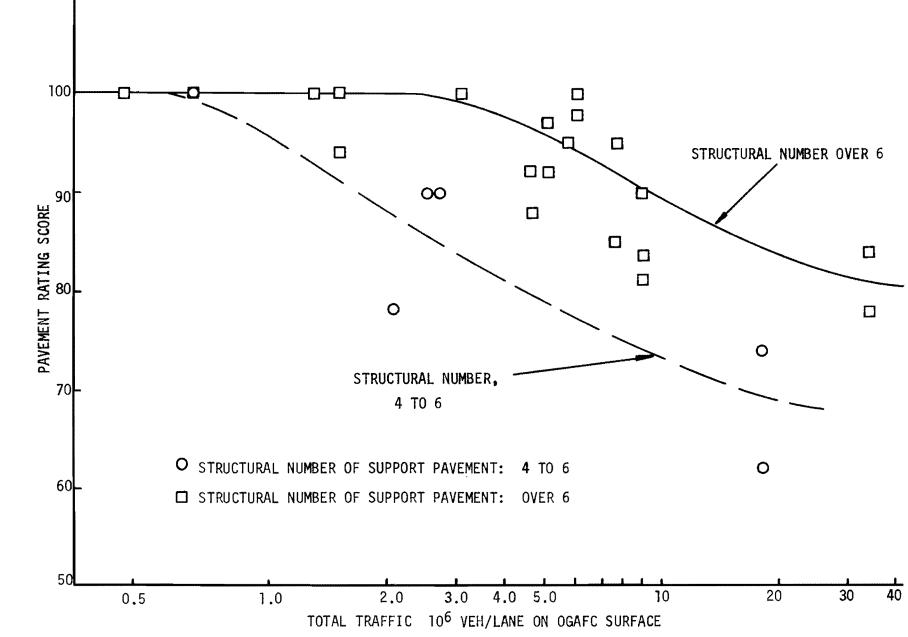
Figure 29. Influence of Support Pavement Structural Number on Deterioration of OGAFC Evaluation Pavement Condition Resulting from Traffic Application

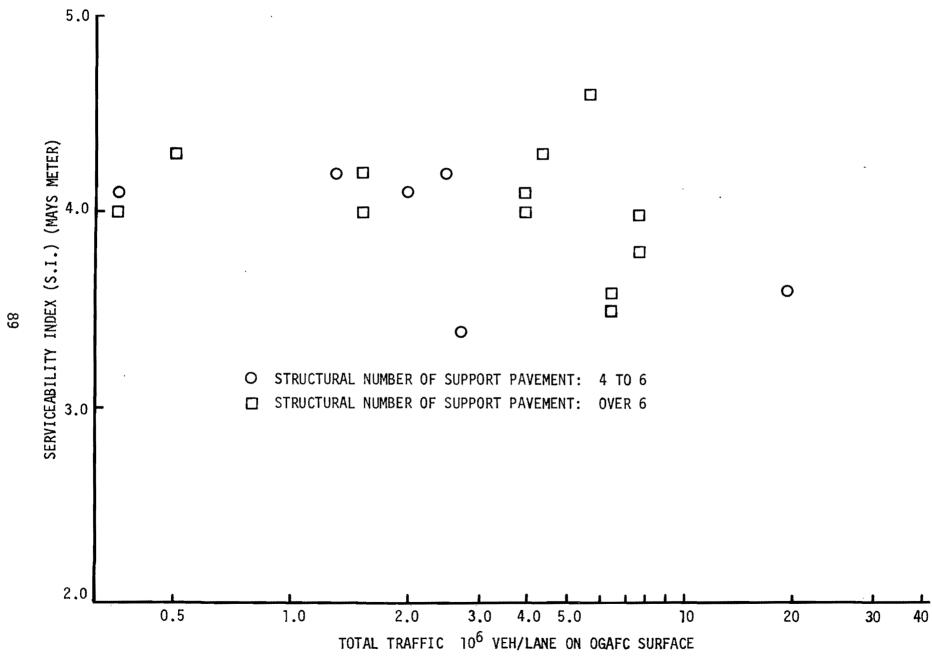
Figure 30. Riding Quality of OGAFC Pavements After Various Amounts of Traffic Application

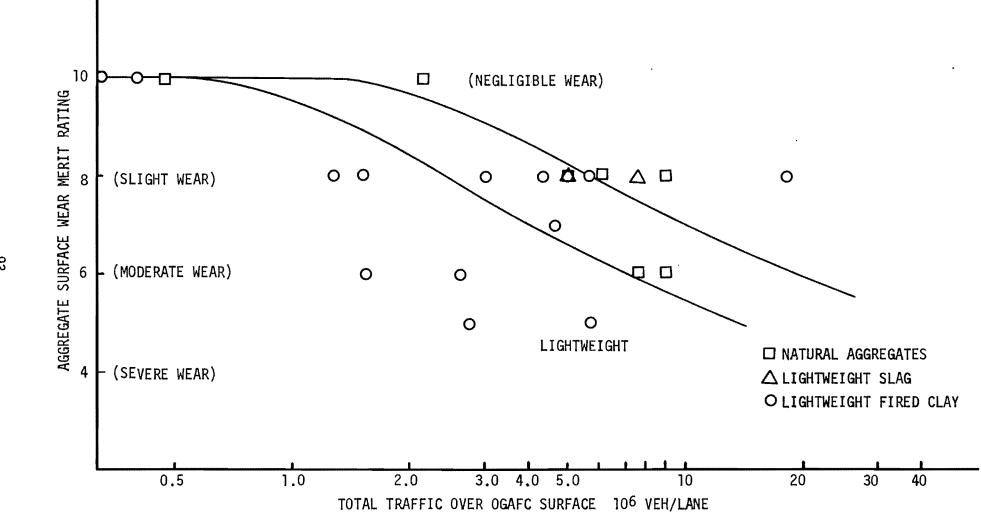
Figure 32. Trend of OGAFC Surface Wear With Applied Traffic With Various Kinds of Aggregate

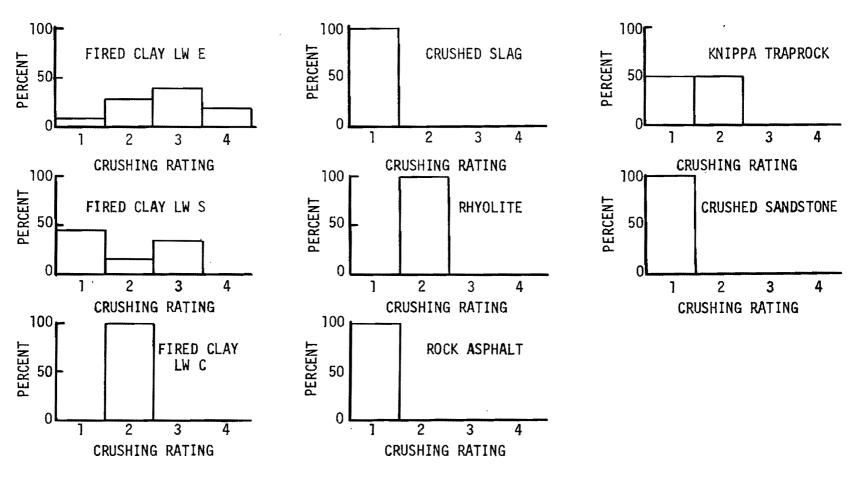
Figure 33. Distribution of Aggregate Crushing Observed in OGAFC Evaluation Pavement Cores

Descriptions of aggregate crushing, based on laboratory examination of OGAFC evaluation pavement scores reported in Tables 18, 19, and 20, were also converted into ratings based on the relative degree of aggregate particle crushing noted. The distributions of these ratings

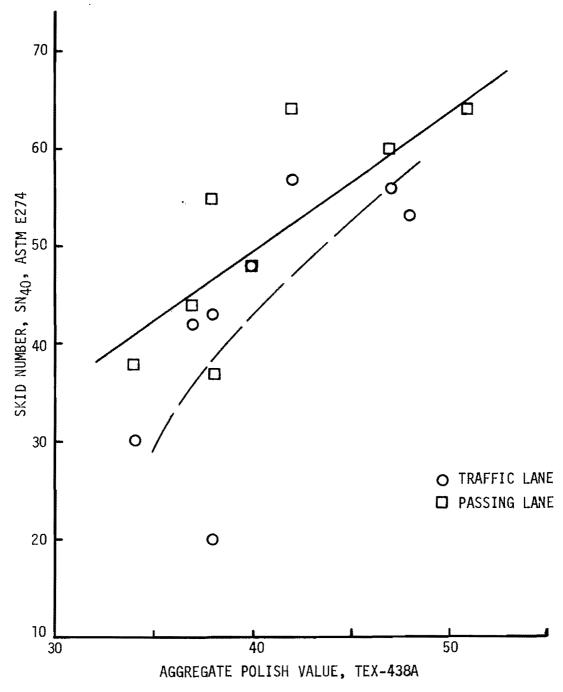
Figure 34. Relation Between OGAFC Pavement Skid Resistance and Aggregate Polish Value

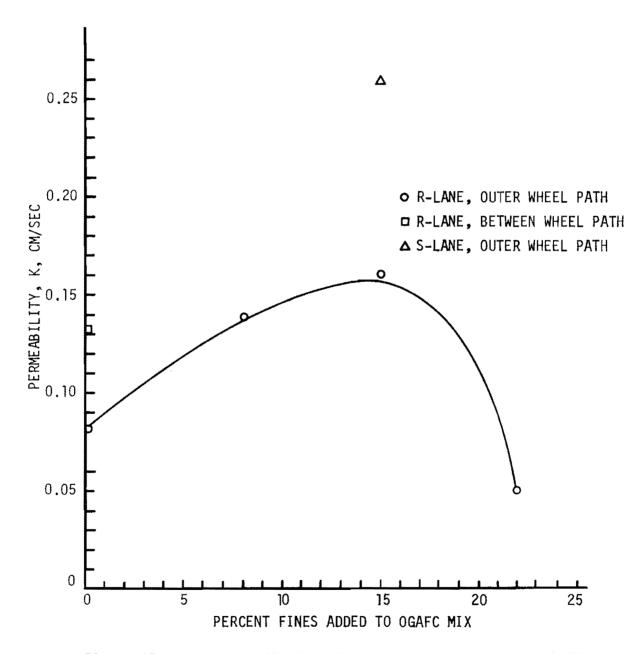
Figure 35. Effect of Mix Fine Aggregate Content on Permeability of Experimental OGAFC Pavements

It was possible to estimate the effect of aggregate gradation, as indicated by the percent of fine material (passing a No. 10 sieve) used in the mix, on the drainage capacity of experimental sections of OGAFC on SH 21. This effect is indicated by the plot of permeability vs. percent fines in Figure 35. Since added fines will tend to fill voids between the "one-size" aggregate particles, the initial increase in permeability shown in the plot, to a maximum value, was unexpected. However, the influence of the initial addition of fine material on mix workability and compactability may be stronger than the void-filling tendency, and this could result in the trend shown. This suggests that addition of fine material to an OGAFC mix, up to 10 or 12 percent, may be beneficial in many respects. However, the size distribution and shape of such material may strongly influence the balance implied by the Figure 35 plot, and effects of these parameters

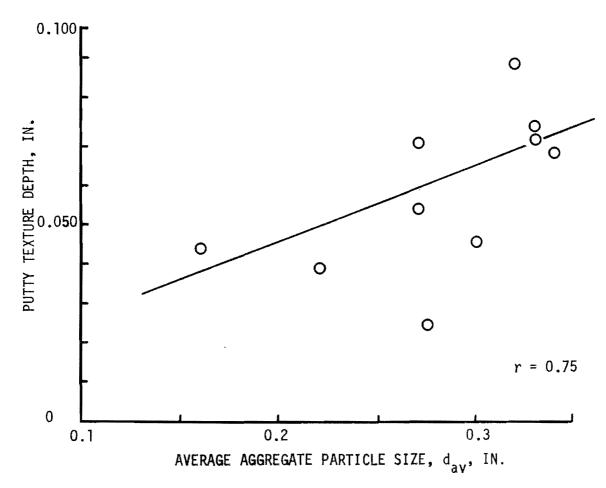
Figure 36. Influence of Aggregate Particle Size on Surface Macrotexture of OGAFC Pavements

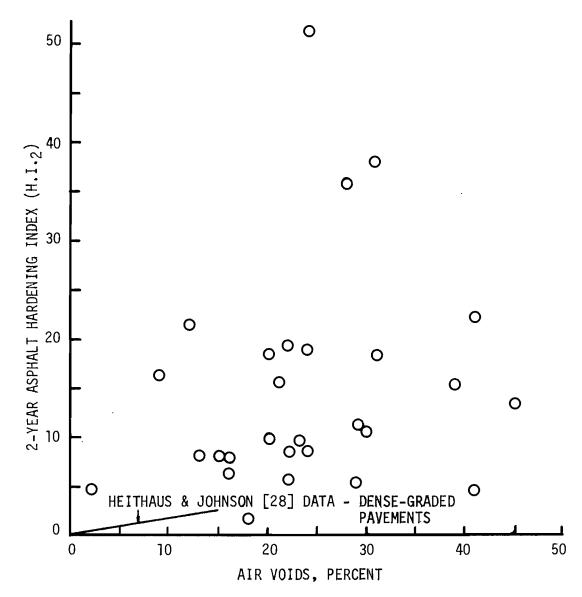
Figure 37. Plot of Asphalt Hardening Index Against OGAFC Air Void Content

In this study, the tendency of the asphalt binder to harden was indicated by estimating a 2-year Hardening Index (H.I.₂) from the viscosity of asphalts extracted from selected cores of OGAFC evaluation pavements (Tables 21, 22 and 23). Both the oxidation stability of the asphalt used and the air void content will affect these results. However, results of the thin film oven test (TFOT) (Table 14) indicate little variation in oxidation stability among the asphalts used and so the major consideration was air exposure as indicated by void content. A plot of H.I.₂ values against air-void content is given in Figure 37. Although there appears to be a general tendency for the hardening index to increase as the air void increases, as might be

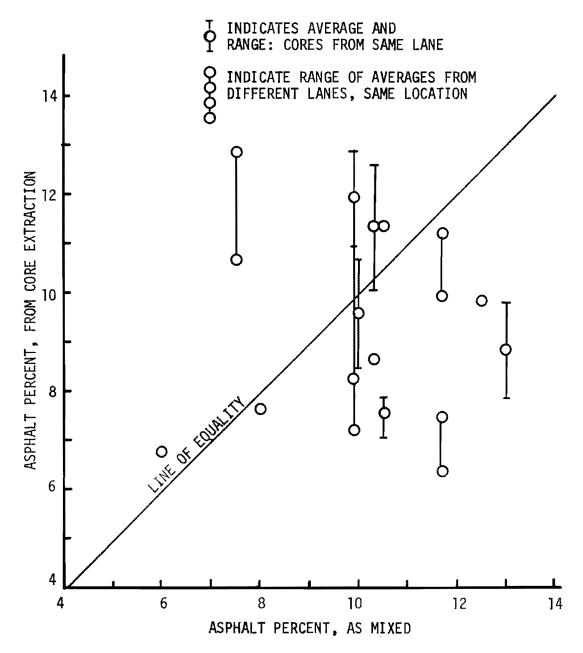
Figure 38. Comparison of OGAFC Mix Asphalt Content with Asphalt Percent Determined on Evaluation Pavement Cores

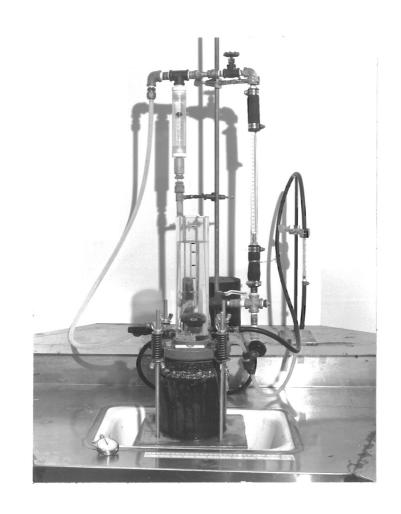
Figure B-1. Permeability Test Apparatus

For testing purposes, a support assembly was constructed to hold the specimen and support the permeameter assembly. A "silicone-sponge rubber" gasket, unlike the gasket used by the Waterways Experiment Station, was developed and used as a seal between the standpipe base and the pavement surface (see discussion in next section). Compression

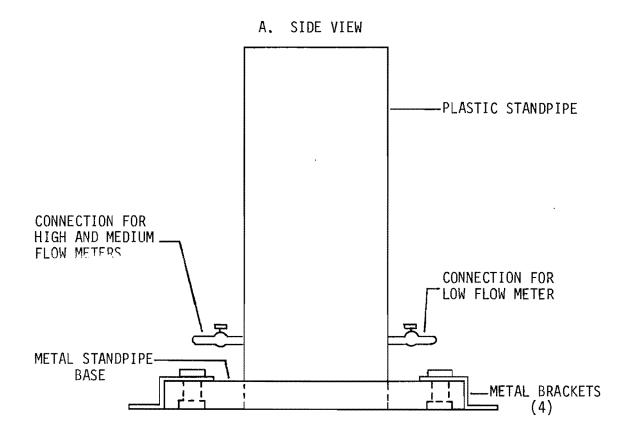
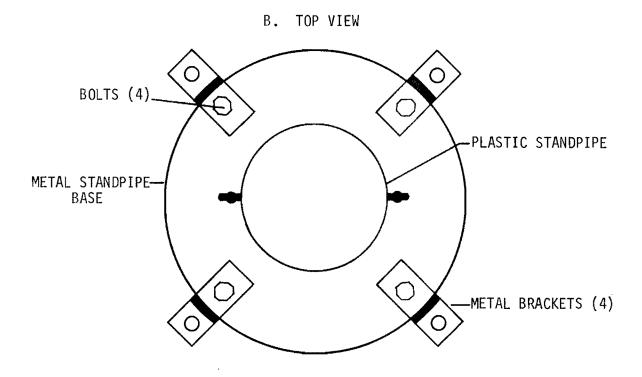
Figure B-2. Schematic of Permeameter Assembly

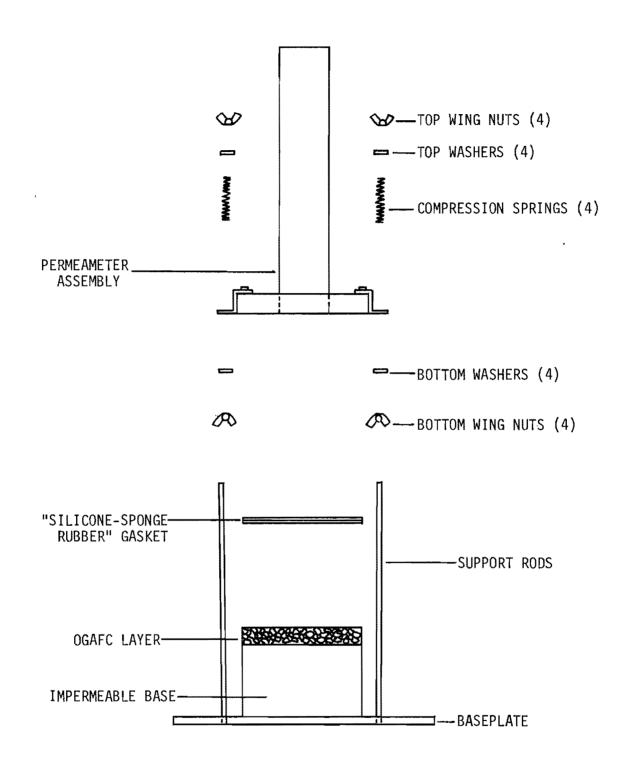
Figure B-3. Schematic of Permeability Test Set-Up Procedure

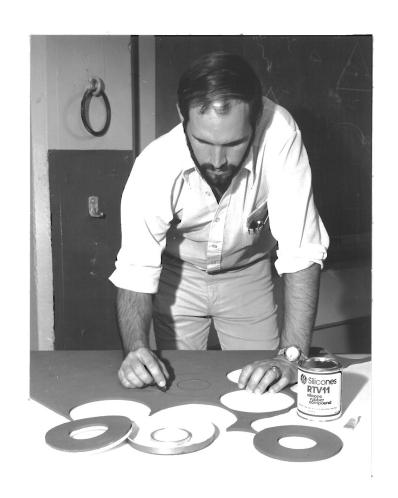
Figure B-4. Preparation of "Silicone-Sponge Rubber" Gasket

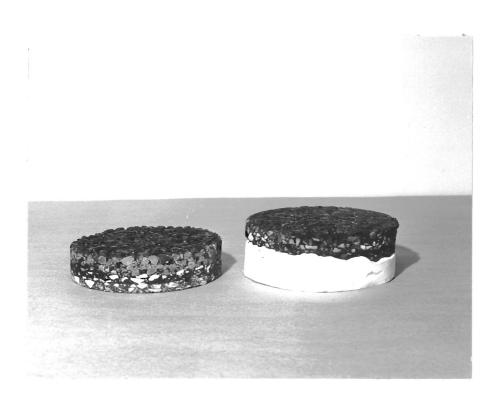
Figure B-5. Specimens Showing Impermeable Base

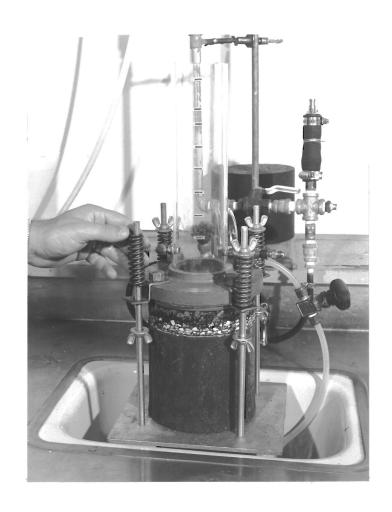
Figure B-8. Compression Springs Being Positioned on Support Rods

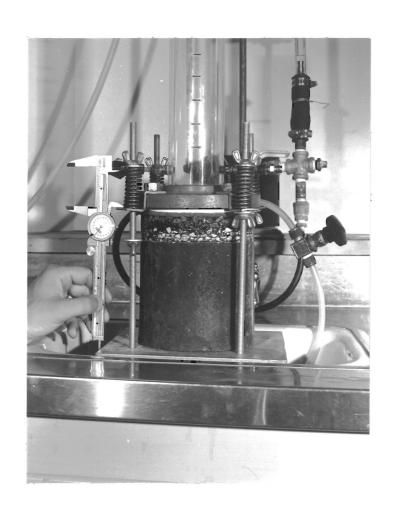
Figure B-9. Compression Springs in Place and Load Being Applied

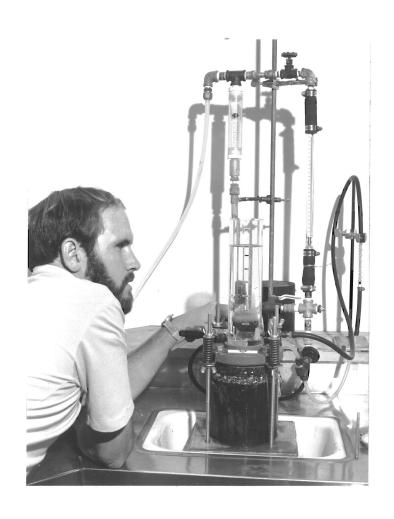
Figure B-11. Constant Head Permeability Test in Progress

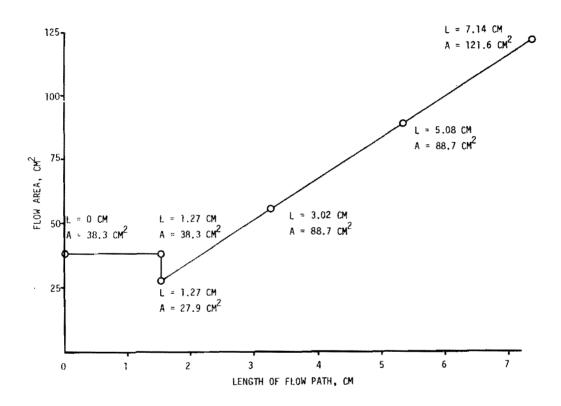
Figure B-14. Flow Area vs. Length of Flow Path for 15.24 cm (6 in.) Diameter, 2.54 cm (1 in.) Thick Specimen

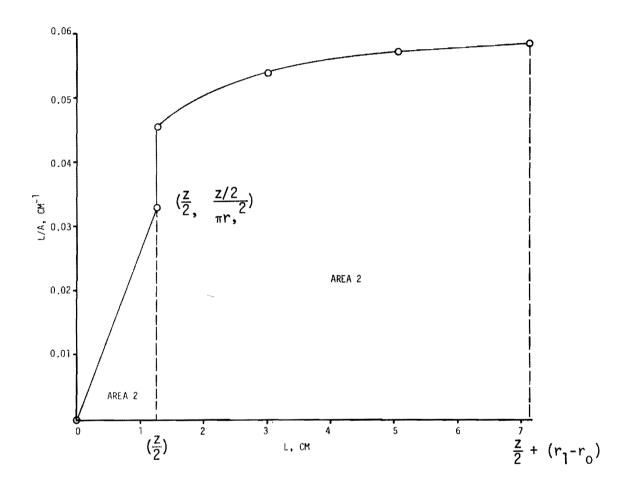
Figure B-15. L/A vs. L a 15.24 cm (6 in.), 2.54 cm (1 in.) Thick OGAFC Specimen

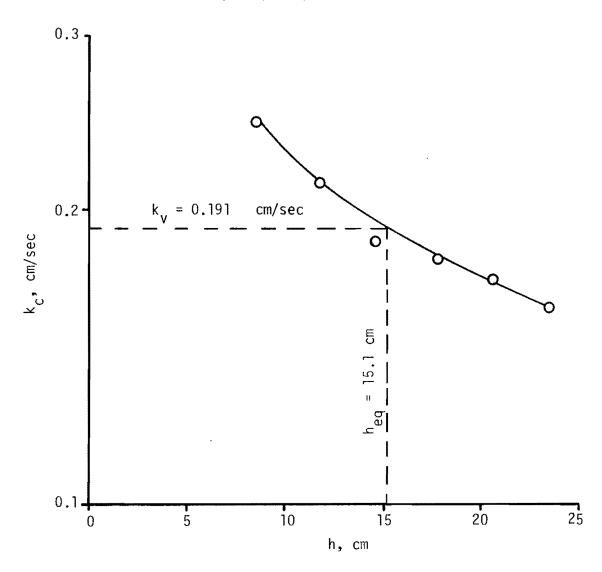
Figure B-16. Typical Semi-log Plot of k_c vs. h

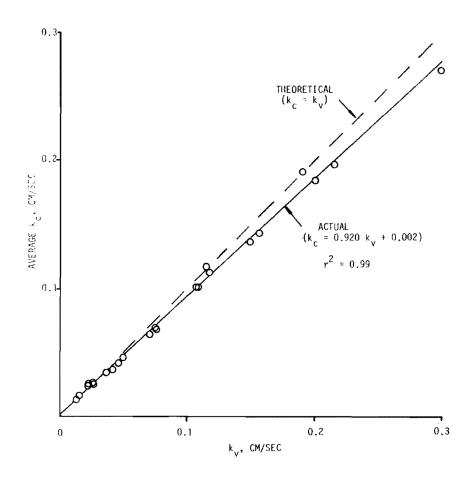
Figure B-17. Average k_c vs. k_v

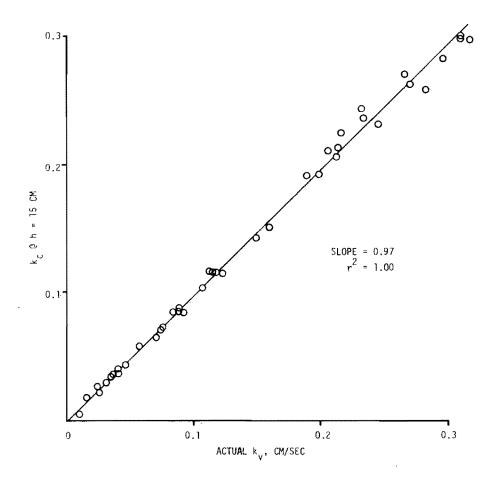
Figure B-18. K_c @ h = 15 cm vs. k_v

For the remaining specimens (excluding those which were impermeable) a variable head test was performed as usual and a constant head test was performed at a single h value of 15 cm (5.9 in.). A $k_{\rm C}$ value at h = 15 cm was also obtained from the semi-log plots of $k_{\rm C}$ vs.h. The results are plotted in Figure B-18

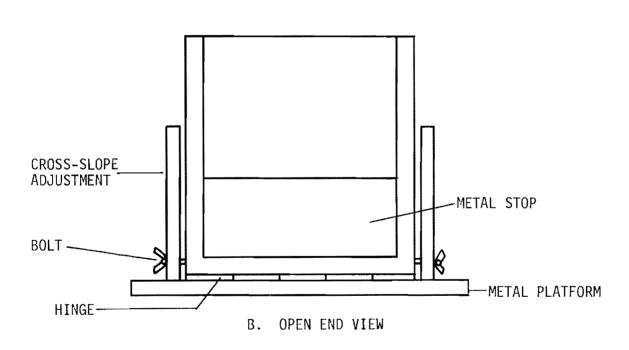
Figure C-2. Schematic of Drainage Test Apparatus

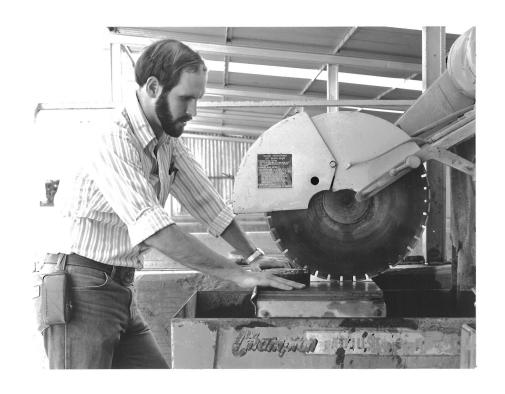
Figure C-3. Drainage Test Specimen Being Cut from Permeability Test Specimen

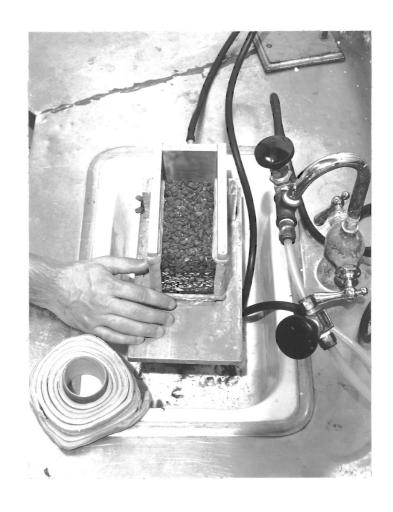
Figure C-7. Overlap Portion of Impermeable Membrane Being Folded Back Over Top of Permagum

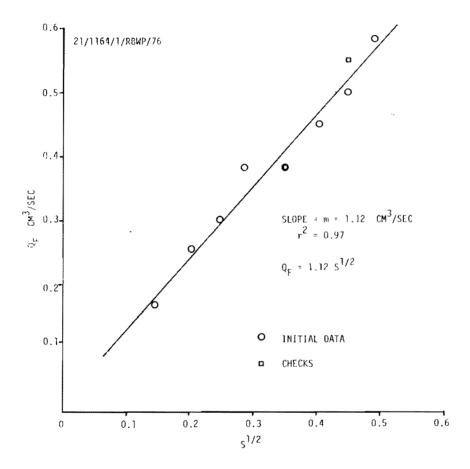
Figure C-9. Q_F vs. $S^{1/2}$ Representing Drainage Test Data from Figure C-5

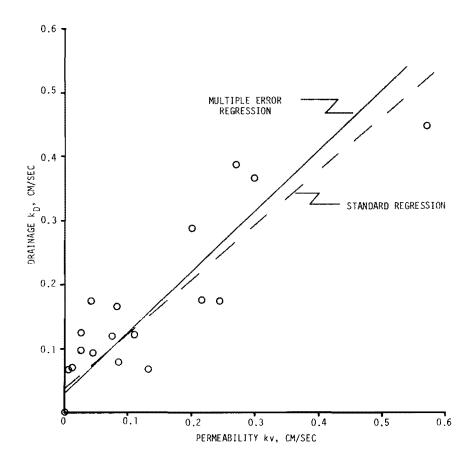
Figure C-10. Relation Between Drainage Coefficient and Permeability Coefficient

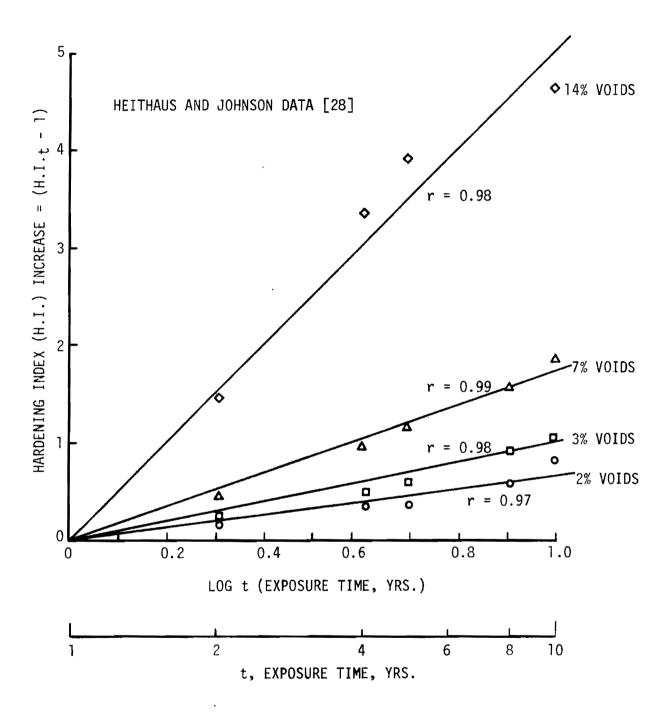
Figure D-1. Increase in Asphalt Hardening Index with Age in Midwestern Pavements

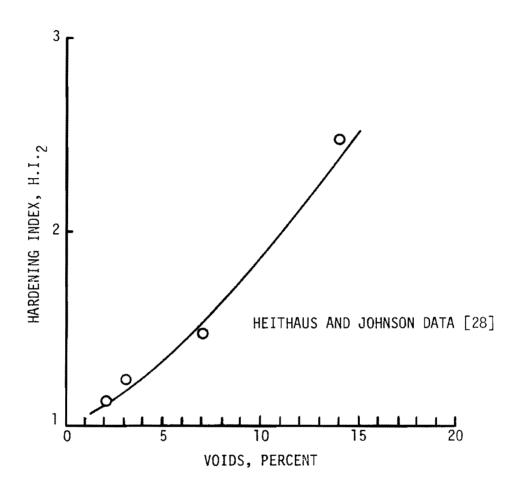
Figure D-2. Effect of Void Content on Asphalt Hardening in Dense-Graded Pavements

percent voids for the two types of compacted mixes. Such a plot for dense-graded mixes can be made using the Heithaus and Johnson data; this plot is presented as Figure D-2. This plot can be compared with a similar plot of data obtained from OGAFC pavement cores taken in this study.
