APPENDIX C. IMPLEMENTATION OF REAL-TIME SURFACE MONITORING FOR ACTIVE LANDSLIDES

Note that this appendix contains the Project 2020 STIC & SPR807 Supplement Memorandum Submitted by Andrew Senogles, Michael J. Olsen, and Ben A. Leshchinsky in August 2021 to ODOT and the FHWA. Minor updates have been made.

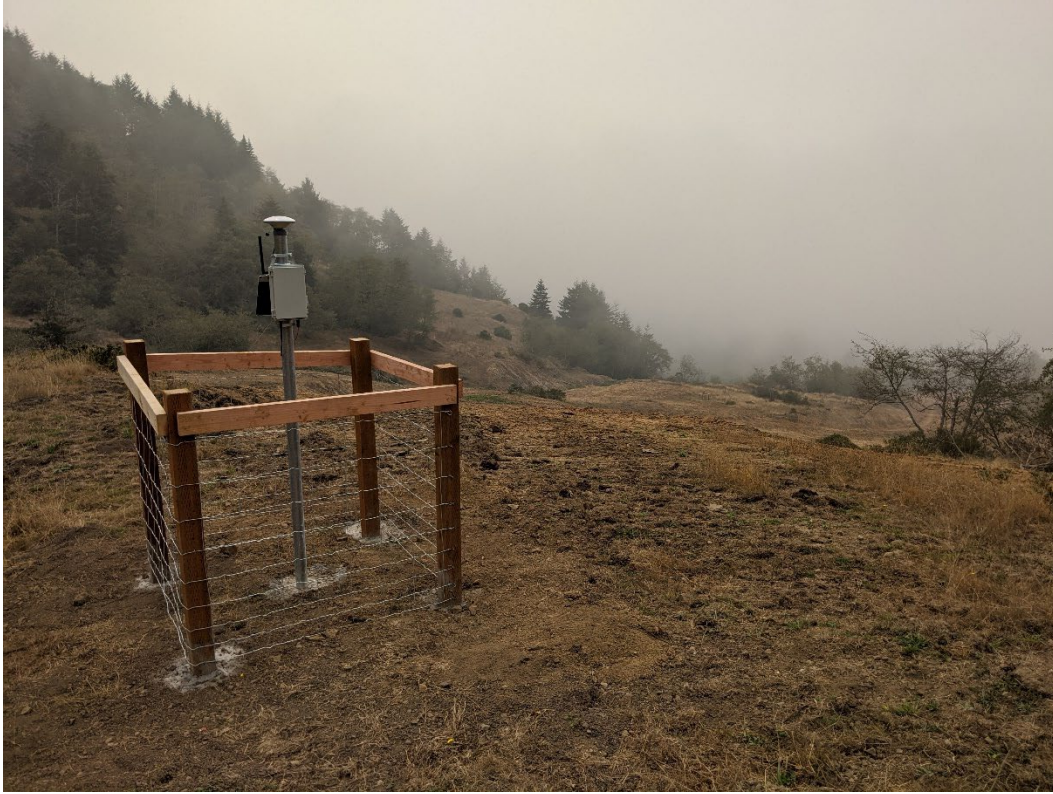
Figure C-1: Photograph of the fence constructed around Rover 3 at the Hooskanaden landslide in order to keep livestock from disturbing the station.

If possible, vegetation surrounding the RTK-GNSS sensor should be removed in order to reduce multipath and prevent any shadows being cast on the solar panel (if applicable). Users should consider the construction of fence to mitigate humans or wildlife from disturbing the RTK-GNSS monument, an example fence as setup at the Hooskanaden Landslide is shown in Figure C-1.

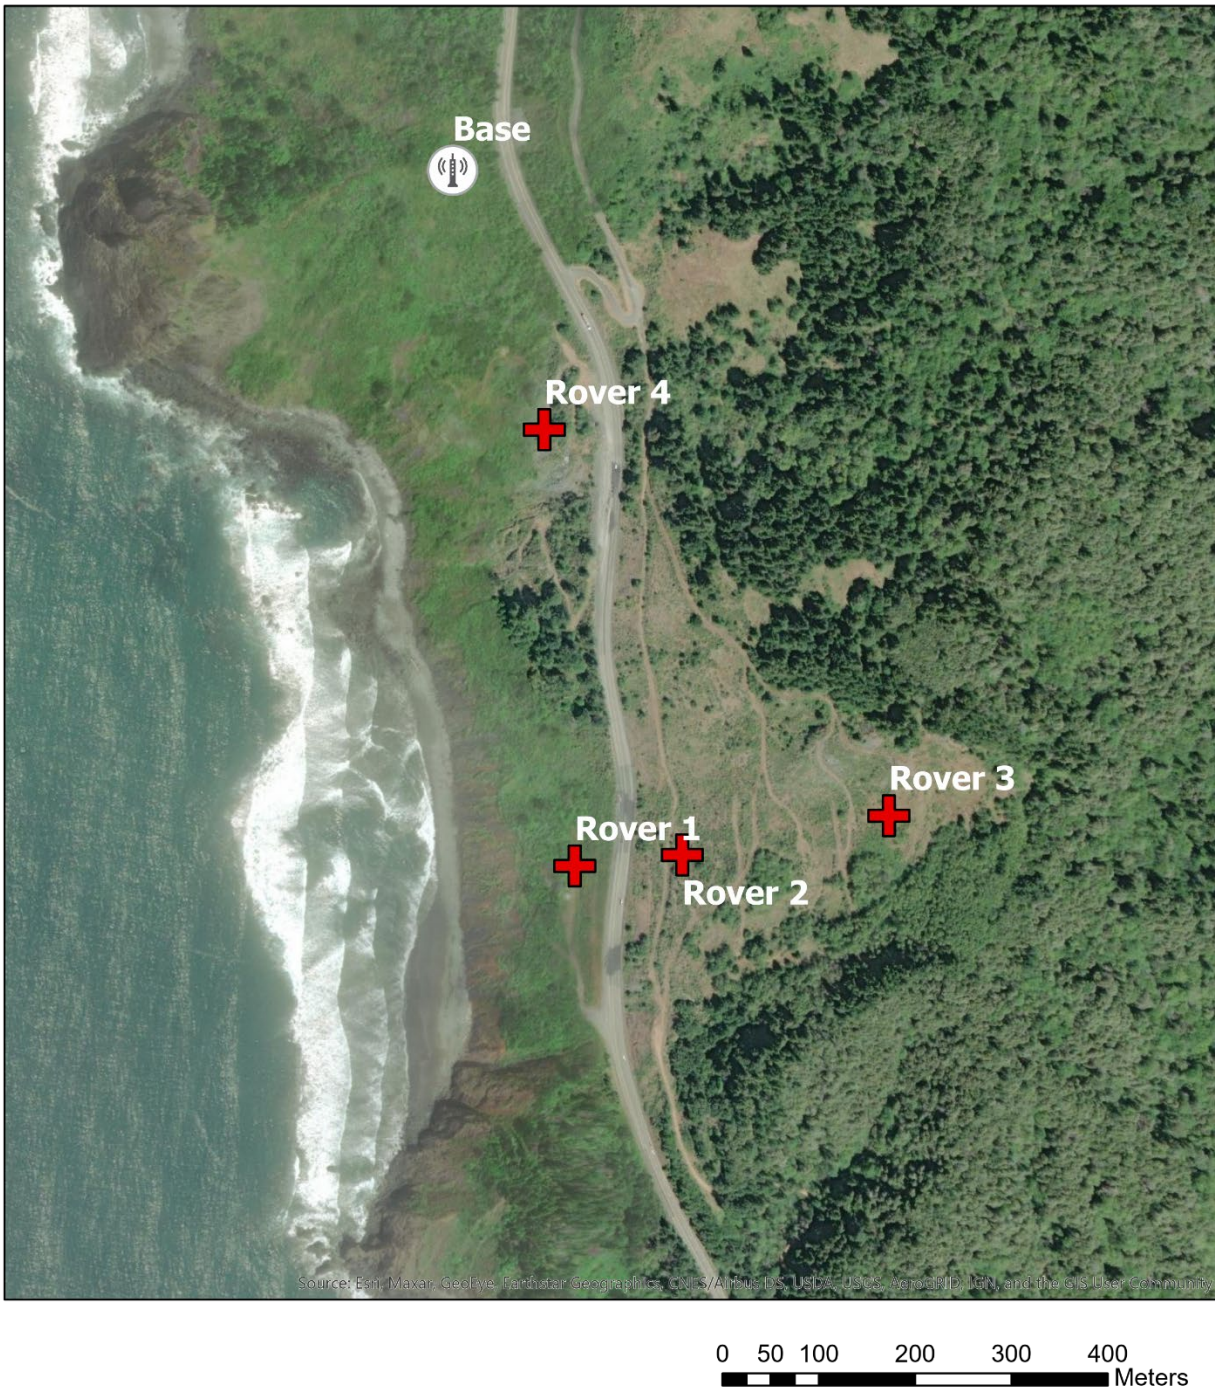
Arizona Inn GPS Sensors

Figure C-3: Map of the Arizona Inn Landslide showing the location of the RTK-GNSS base and rover stations.

A total of 1 base station and 4 rovers were installed at the Arizona Inn landslide (Figure C-3). The base station is located on the ridge leading up to lookout rock, approximately 50m west of Hwy 101. This location was selected as it is a stable area thought to be experiencing no ground deformation. This location also has clear sky visibility, allowing for uninterrupted GNSS satellite visibility maximizing the potential accuracy of the system. Lastly, this area is in a relatively high elevation overlooking the rest of the landslide body, which allows for uninterrupted broadcast of radio messages for communication with the rovers. A photograph of the Base station and overview of the landslide is shown in Figure C-4.

Below is a description of the four rovers installed at the site:

- **Rover 1** is situated approximately 30m north of the cistern previously installed during the 1990's to collect water from the horizontal drain arrays throughout the upper landslide body. This location was chosen as it is directly above a failing section of the sea cliff and centered within a lower block of the main landslide mass that appears to be the most active region of the landslide. A MEMS in-place inclinometer (consisting of Measurand Shape Accel Array (SAA) systems) and piezometer sensors were previously installed at this location from Feb 2017 to March 2019 and showed a total of 80mm of displacement during that time, approximately half of which occurred during 2019 just prior to the instrument shearing.

- **Rover 2** is situated approximately 110m east/upslope from Rover 1, directly uphill from Hwy 101. This position was chosen as it is approximately located at the head scarp of the previously described lower block. This also coincides with being centered between the two most active crack forming locations on Hwy 101 at this landslide. In combination with Rover 1, this Rover allows for constraining of the landslide movement on this section of Hwy 101 without placing a sensor directly on Hwy 101, which would be infeasible.

- **Rover 3** is situated approximately 220m east/upslope of Rover 2, toward the upper end of the main landslide. This location was chosen in order to monitor any displacement in the upslope portion of the landslide.

- **Rover 4** is situated approximately 450m north of Rover 1, and 70m west of Hwy 101 in the northern portion of the landslide. This location was chosen in order to monitor any erosion driven displacement in the northern portion of the landslide complex.

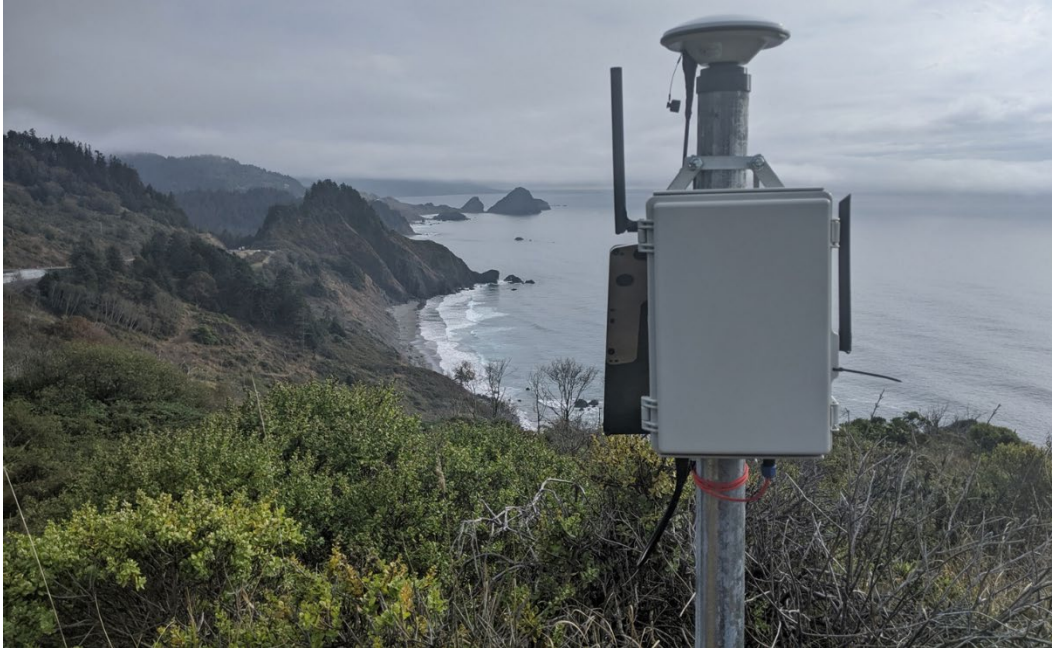
Figure C-4: Photograph of the base RTK-GNSS station at Arizona Inn overlooking the rest of the landside to the south.

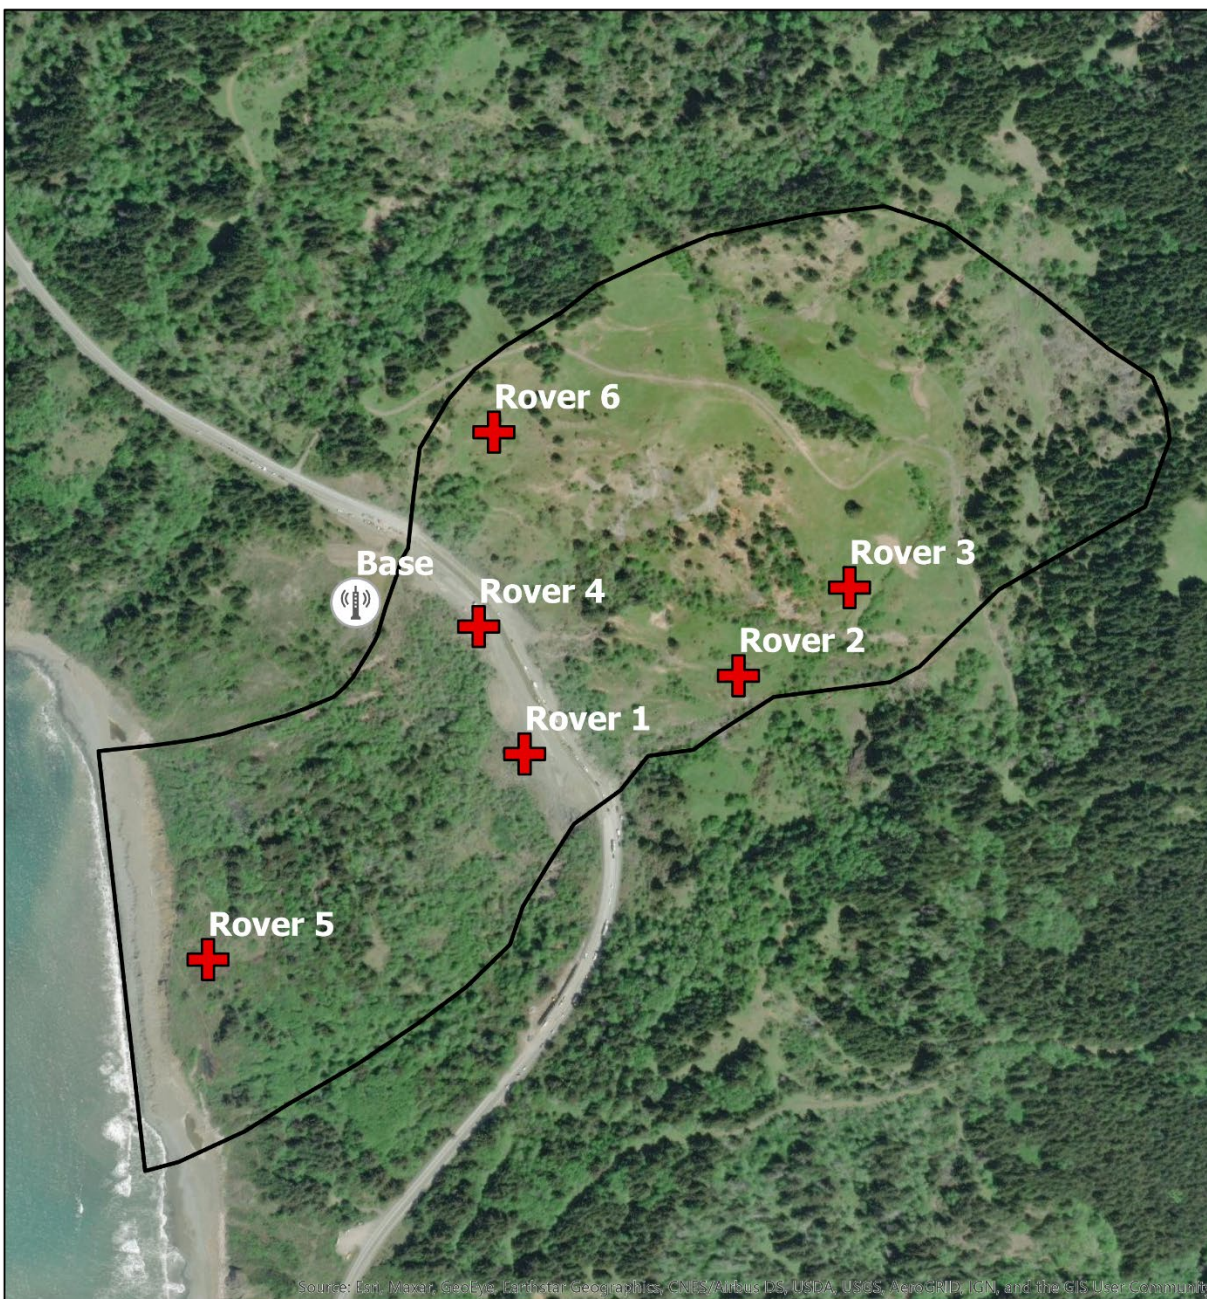
Hooskanaden GPS Sensors

Figure C-5: Map of the Hooskanaden Landslide showing the location of the RTK-GNSS base and rover stations and approximate extent of the most active portion of the landslide.

Below is a description of each rover:

- **Rover 6** is located approximately 195m NEN of Rover 4, and 125m NE of Hwy 101, on the northern portion of the landslide. This location was chosen to monitor displacement of the landslide upslope of the highway in the northern portion of the landslide.

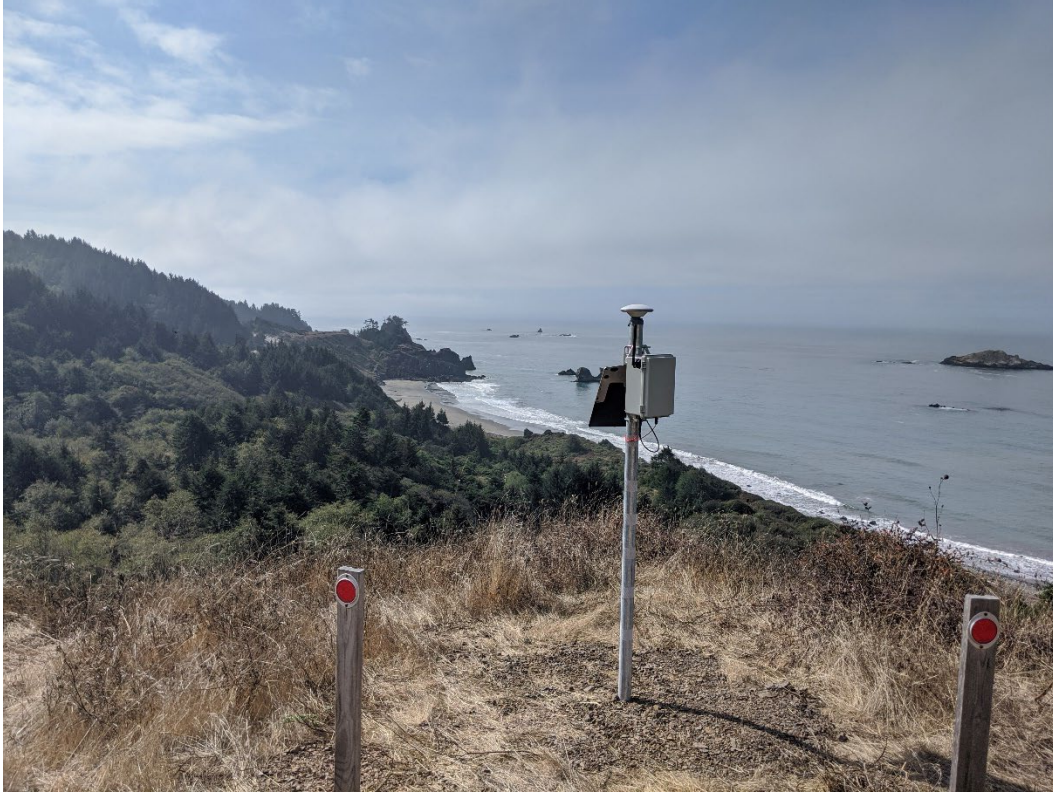
Figure C-6: Photograph of the base RTK-GNSS station at Hooskanaden looking south overlooking the bottom portion of the landside.

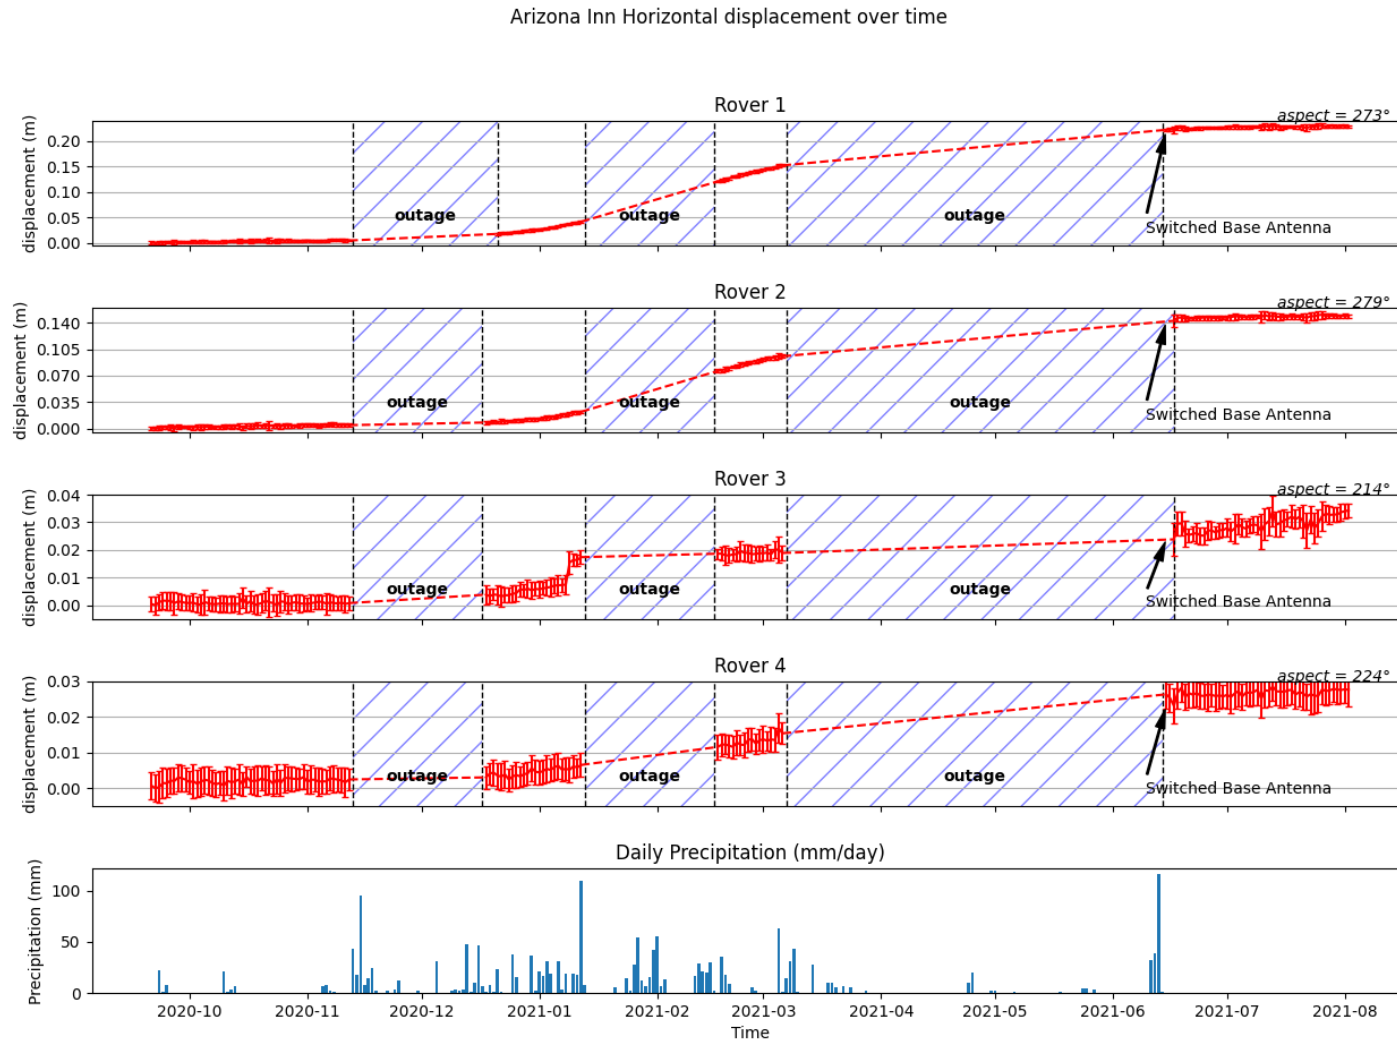
Figure C-7: Graph of daily Horizontal Displacement over time for each rover at the Arizona Inn landslide from September 2020 to the beginning of August 2021. Error bars represent the standard deviation of daily measurements. The bottom graph shows histogram of the daily precipitation in mm during the same time period. Data outages are represented by the hatched area and dashed line.

experienced 15cm horizontal and -15cm vertical displacement, which is the largest vertical displacement observed at the site. Rovers 3 & 4 experienced negligible amounts of displacement. Several data outages were experienced at this site. These outages, including causes and repairs are discussed in Section 1.5.3.

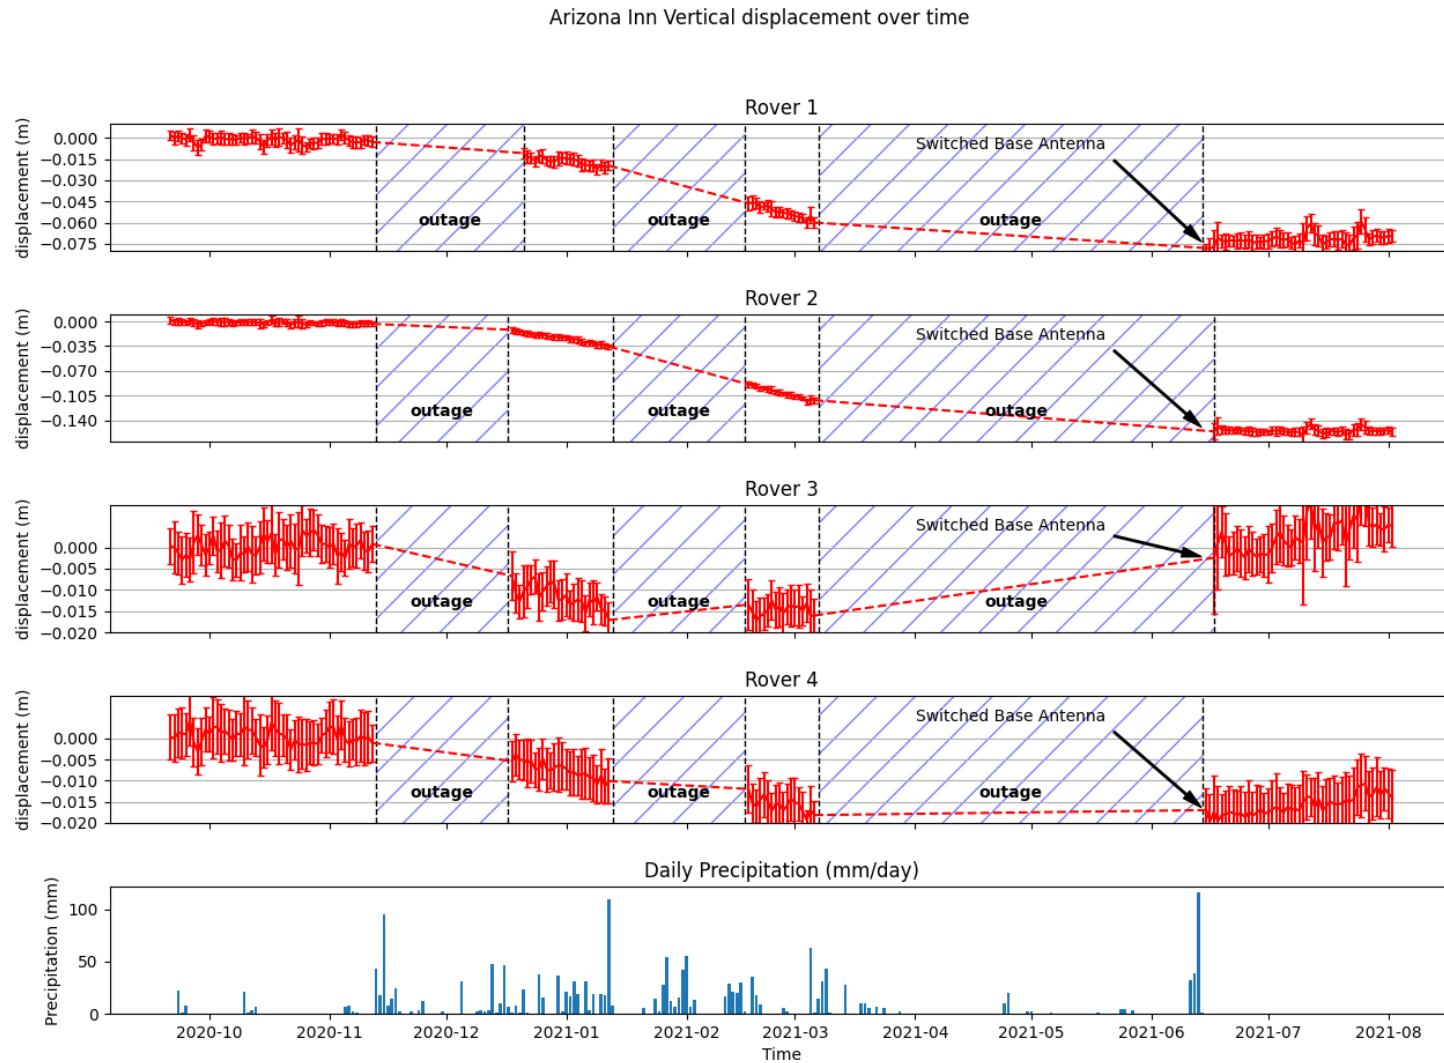
Figure C-8: Graph of daily vertical displacement over time for each rover at the Arizona Inn landslide from September 2020 to the beginning of August 2021. Error bars represent the standard deviation of daily measurements. The bottom graph shows histogram of the daily precipitation in mm during the same time period. Data outages are represented by the hatched area and dashed line.

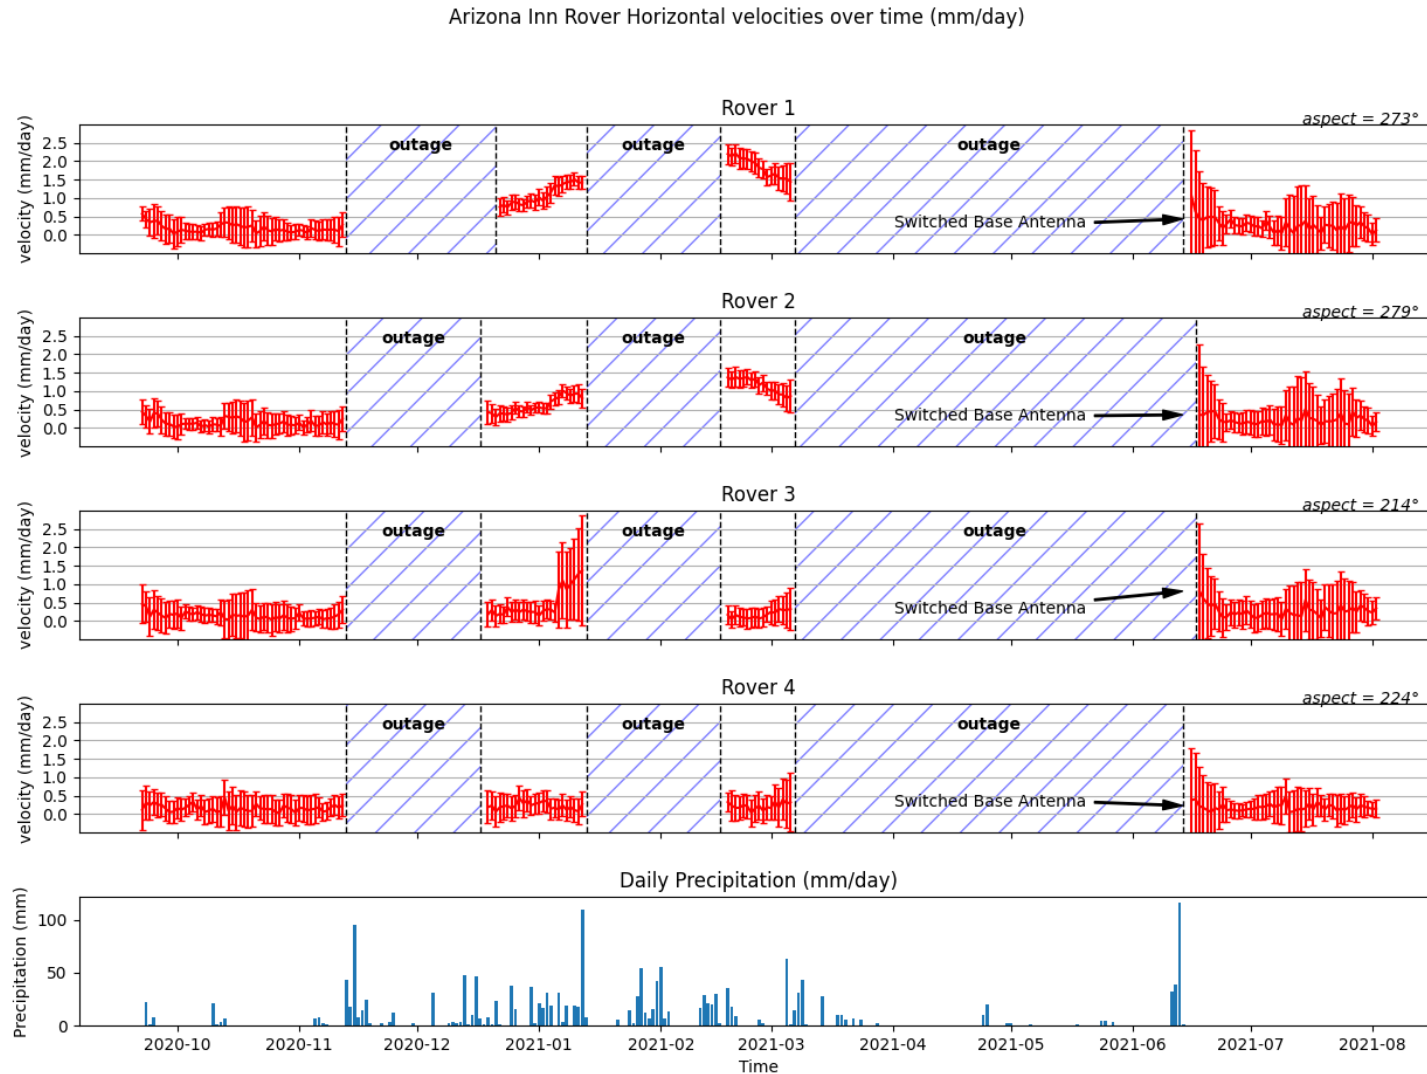
Figure C-9: Graph of Rover Horizontal velocities over time for each rover at the Arizona Inn landslide from September 2020 to the beginning of August 2021. Error bars represent the standard deviation of velocity calculations. Bottom graph shows histogram of the daily precipitation in mm during the same time period. Data outages are represented by hatched area.

In addition to plotting the displacement of each rover over time, the velocity of each rover can also be observed in order to visualize landslide activity at each of the rovers across time (Figure C-9).

Figure C-9 shows the peak horizontal velocity for Rover 1 was approximately 2.25mm/day during mid-February compared with approximately 1.5mm/day for Rover 2 during the same time. The peak in velocity at Rover 2 appears to have occurred about a week after the peak in velocity at Rover 1, which would indicate retrogressive failure; however, the data outage that occurred before this time period makes this difficult to confirm. Rovers 3 & 4 moved too slowly to confidently register a positive velocity reading. Overall, the propagated measurement standard deviations can be used as uncertainty estimates and show that for this RTK-GNSS system/site a velocity uncertainty of approximately 1mm/day is achievable.
