DOT HS 813 229 July 2025 (Revised)

Evaluation of LATCH Usability Tools Update

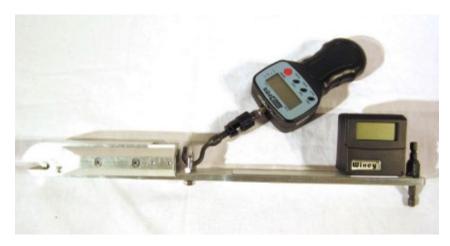
Figure 5. IIHS Clearance Angle Tool

The IIHS clearance angle tool was very similar to NHTSA's except it included a digital read-out force gauge. The IIHS clearance angle tool is shown in Figure 5.

Unlike the NPRM CAT, the IIHS CAT (Figure 5) did not include recordable instrumentation but used a digital read-out force gauge and inclinometer. Otherwise, the IIHS CAT was the same as the NPRM CAT; however, there were differences in the test methods. In the IIHS method, the user applies a 67-newton (15-lb) force perpendicular to the tool. If seat back interaction prevents the 67-newton force from being achieved, the user applies the force following the seat back contour, as shown in Figure 15, until the 67-newton force is met. The maximum angle is then recorded. While using the IIHS CAT, technicians found that it was difficult to apply and hold a vertical load of 67 newtons while trying to read the angle of the tool from the inclinometer. This

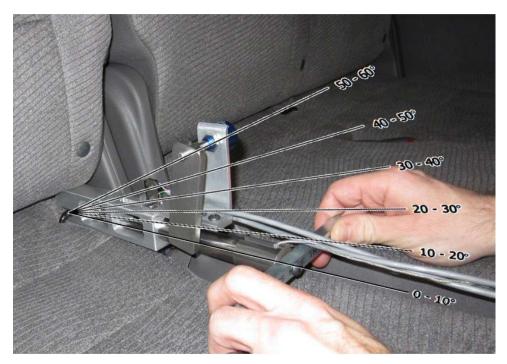
Figure 6. NPRM AFT With Force Being Applied at Initial Approach Angle

NHTSA received comments about the repeatability and reproducibility of the NPRM AFT due to operator variability and the tool being too small to apply the load in a repeatable manner. The proposed procedure had the operator push on the back of the tool while maintaining a minimal force at different approach angles (beginning at 5° from horizontal and increasing in 10° increments to a maximum of 55°) (Figure 6). The angles were measured with a tilt sensor, and the force of engagement was recorded.

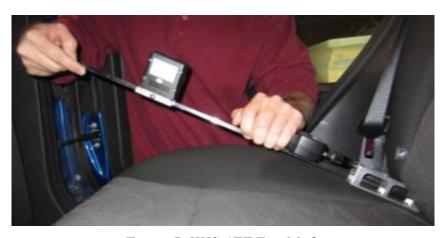
Figure 7. IIHS AFT Test Mode

The overall concept was very useable, and the guide rod and overall length of the tool seemed to improve the ease of use of the tool. However, it was difficult to read the angle on the digital inclinometer and the load on the digital read-out force gauge while loading the tool through the fabric onto the anchor.

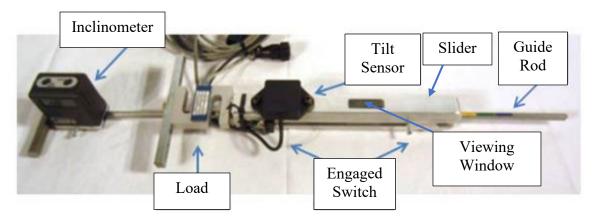
Figure 8. Modified AFT/ADT

Based on the evaluation of the IIHS force/depth tool and to address the NPRM comments, a modified AFT/ADT was developed which incorporated the guide rod and force gauge slider body into one tool, like the IIHS tool. The slide pin, slide tab, and spring assembly in the NPRM AFT were replaced with a 6.4-mm square cross-section guide rod with a concave notch that prepositions the tool to align it with the lower anchor before the force is applied. The instrumentation was also modified: an analog position sensor (Model G-NSDOG2-003²) and an Interface S-Type load cell (Model SSM-AJ-100³) were added. In addition, the tool was lengthened by 116 mm, and handles were added for hand placement, allowing additional stability and space for instrumentation. The modified AFT/ADT is shown in Figure 8, and it is a total new design for the AFT from the NPRM AFT. Also, the previously discussed test methods specified by IIHS for aligning the jaw of the tool on the fabric and determining the approach angle were adopted.

NHTSA decided that the modified AFT/ADT used with the IIHS test methods for measuring the force would result in more consistent results than the NPRM AFT test procedure, by resolving the issue of aligning the tool with hidden anchors and reducing the inconsistencies from off-axis loading.

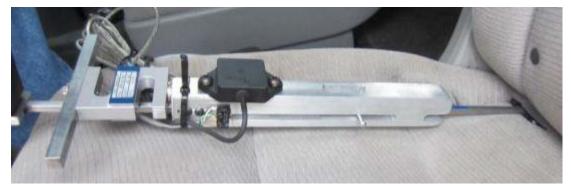
Figure 9. Aligning the Modified AFT/ADT for Depth Measurement

The procedure used to make depth measurements with the modified AFT/ADT followed the same approach as that specified for the IIHS force/depth tool. The procedure places the tool on the seat cushion and has the user place the notched end of the guide rod in the center of the lower anchor bar when the slider of the tool is retracted, as seen in Figure 9.

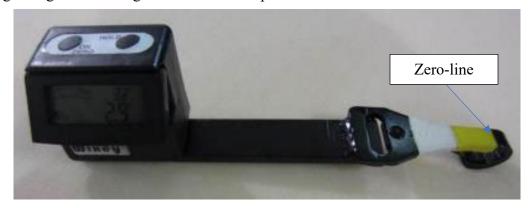
Figure 14. Meet/Not Meet ADT

The results of this preliminary analysis led to a new, simpler tool design that was similar to the NPRM ADT. The new tool was a metal bar with an attached CRS anchor hook and a scribed line that represents the zero-line marked on top of the hook. The zero-line represents the back side of the lower anchor as it was attached. To make it more visual, yellow tape was wrapped around the tool from 0 to 20 mm and white tape was wrapped around from 20 to 40 mm. The tool is then used as a simple meet/not meet indicator, by visual inspection (Figure 14). Also, instead of taking the reading at a viewing angle of 30° from vertical, as proposed in the NPRM, this angle was changed to a range of 20 to 40° from horizontal. Based on testing, it was determined that allowing a range of view angles from 20 to 40° provided consistent results between testers.

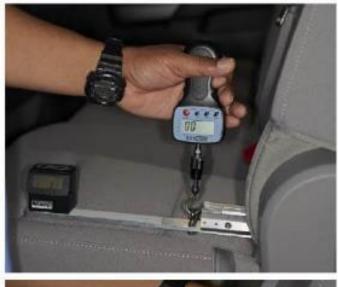
Figure 15. IIHS CAT Testing

method was slightly different than the NPRM-proposed method of applying the 67-newton force vertically, and it added variability while applying the load along the seat back.

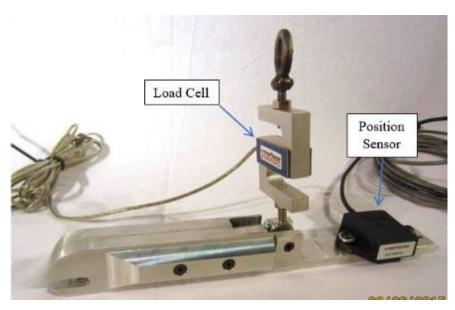
Figure 16. CAT V1 Instrumentation

NHTSA performed several modifications to the NPRM CAT to create the CAT Version 1 (CAT V1). The NPRM CAT had digital instrumentation that allowed time-history data to be recorded, but after reviewing the comments received on the NPRM, it was determined to add new instrumentation that is more repeatable and more easily acquired (Figure 16). The rotary potentiometer was replaced by an analog position sensor (Model G-NSDOG2-003), as the new sensor more reliably collects the angle data. Also, an Interface S-Type load cell (Model SSM-AJ-100) replaced the latch load cell.

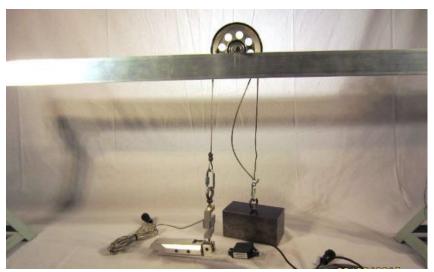
Figure 17. CAT V1

A CAT pulley bridge was designed and added to improve the ease of use and reduce operator variability (Figure 17). The pulley bridge was set-up to span the space between the front and rear seats. Once in place and directly above the CAT, the pulley bridge is leveled by adjusting the front seat height and/or using shims. Once leveled, the attachment cable and the 67-newton weight are attached to the CAT. The cable is checked and adjusted so that the force is applied vertically to the tool. The data acquisition system is not triggered until the CAT is loaded with the weight hanging motionless. The pulley bridge does add time to the test setup, but it helps in applying a more vertical load on the tool.

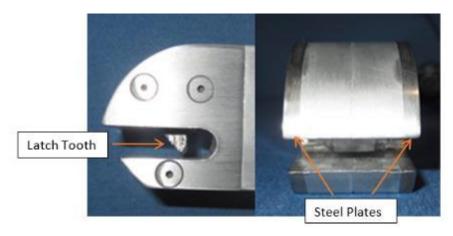
Figure 18. Steel Reinforcements of CAT V1

In addition, the tool face was modified to improve its durability. The head of the NPRM CAT was originally made from aluminum, but with use, the edges started to wear down which could allow for inconsistent results. For CAT V1, the jaw of the tool was reinforced with steel plates, and the latch tooth was refabricated to be made completely out of steel. These changes did not affect the tool's shape or functionality. The steel reinforcements are shown in Figure 18.

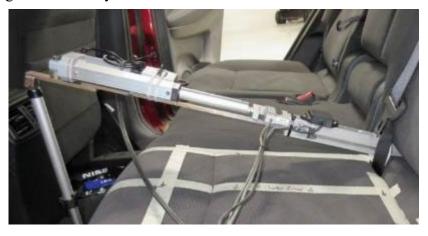
Figure 21. UMTRI Attachment Force Tool in Vehicle (AFT V2)

After discussions with NHTSA about the force tool (Section 2), UMTRI re-modified the modified AFT/ADT force tool to add stability to the tool and to resolve the variability of the approach angle. The first modification was to add a motorized actuator to allow for a steady rate of force application (two different actuators were used during the UMTRI study, which had similar specifications). In addition, a support leg was added to the rear of the tool to stabilize the tool and maintain the approach angle. An additional modification was made to the guide rod to remove the colored rod and replace it with a solid rod for simplicity, since this tool will not be used for depth measurements. This new tool will be referred to as AFT V2 for this report (Figure 21). The second identical tool from Section 2 was modified in the same way to evaluate tool variability during the GRR study.

During the pilot study, UMTRI determined the approach angle of the tool as $20 \pm 2^{\circ}$ relative to horizontal and developed a procedure for use with the updated tool (AFT V2). The procedure calls for the operator to place the guide rod, while the slider body is retracted, onto the center of the lower anchor and set the tool at 20° to horizontal. The operator then applies a reaction force to the rear of the AFT V2 by holding the rear of the tool and bracing their elbow on the B-pillar or front seatback. The operator then turns on the switch that drives the actuator forward until it engages with the lower anchor and triggers the data collection software. Data is collected for approximately ten seconds prior to the trigger event and one second post event. The maximum force prior to the event is recorded as the attachment force.

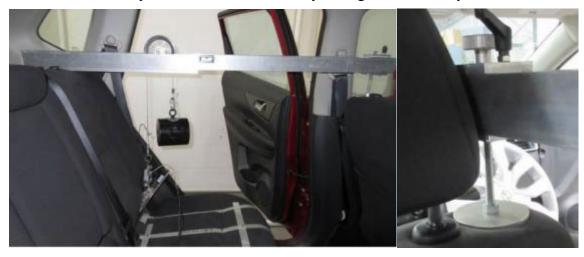
Figure 22. UMTRI Clearance Angle Tool in Vehicle (CAT V2)

UMTRI did not have any modifications to the CAT V1 itself but did some minor modifications to the pulley bridge. They modified it by adding an adjuster leg to the front of the tool as well as a bubble level indicator to aid in placing the bridge as horizontal as possible (Figure 22). This tool will be referred to as CAT V2 for this report. The second identical tool from Section 2 was modified in the same way to evaluate tool variability during the GRR study.

UMTRI made additional clarifications to the test procedure for this tool, including adding tolerances to the positioning of the pulley bar $(0 \pm 5^{\circ} \text{ relative to horizontal})$ and to the vertical cables $(90 \pm 5^{\circ} \text{ relative to horizontal})$.

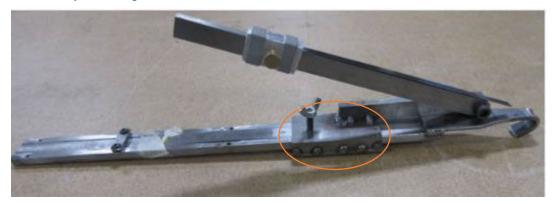
Figure 23. VRTC Lengthened Attachment Depth Tool (ADT V3)

Based on observations from the UMTRI study, a new depth tool was created by VRTC for an additional comparison (Figure 23). This tool was called ADT V3 in the VRTC usability study discussed in earlier section. The new tool added more stability to the slider by increasing the sheath size, or the amount of material that encases the base, circled in Figure 23. This reduced the amount of wobbling in the slider as it is manipulated during the test. The length of the tool was also increased to give the tool base a length of an additional 305 mm. This length change provided more stability with the tool when placed on the seat and allowed the user to have more area for holding the tool. Last, the front end of the tool was bent to the same radius as the hook from the UMTRI tool (ADT V2) and the aluminum hanger was removed. The zeroing line was etched on top of the tool to represent the edge of the LATCH anchor bar; this is the zero point on this tool and the yellow tape was not used with this tool.

Both ADT V2 and ADT V3 were tested following the UMTRI procedure of setting the view bar to 30° from the horizontal plane as the tool is zeroed based on the contact area. The tool was then placed on the seat pan and the view bar was moved forward until the strip or bar touched the seatback. At this point the depth was measured from the rear of the tool.

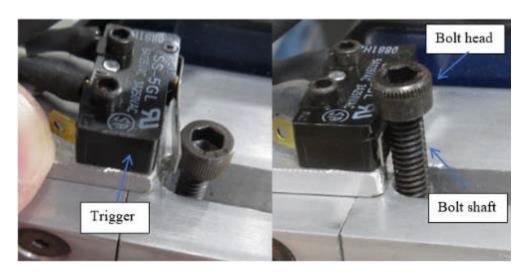
Figure 25. Bolt Head (left) Versus Shaft Contacting Switch (right)

Based on observations from the UMTRI study, small adjustments were made on both tools. It was observed that the guide rod was not flush inside the front of the tool, which could cause the trigger to be off when engaging with the lower anchor. The trigger and bolt were adjusted so that when the tool is triggered, the guide rod was flush with the face of the tool instead of sticking out slightly as shown in Figure 24. This was done by changing the length of the bolt so that the shaft

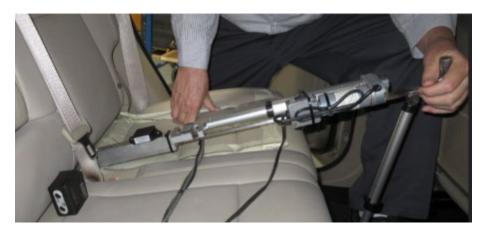
Figure 27. Attachment Force Tool (AFT V3)

One of the AFT V2 tools had two modifications made to create AFT V3. The first modification was adding a handle to the rear of the tool to assist the operator in applying the necessary reaction force when using the tool with the actuator. UMTRI had observed that when conducting the study with two different actuators, there was some difference in the length of the tool depending on which actuator was used. For consistency, it was suggested to either add a slot at the mounting location of the actuator or a through hole and nut to the S-Type loadcell to give some flexibility for installing different models of actuators. Therefore, the second modification made was a through hole and nut (Figure 26) to monitor how this change affected the overall results and if it improved the tool usability. The AFT V3 fully assembled is shown in Figure 27.

The VRTC usability study used the UMTRI test procedure for both AFT V2 and AFT V3. With the tool head fully retracted, the guide rod of the tool was placed on the center of the anchor. The tool and support leg were adjusted so the tool was held $20 \pm 2^{\circ}$ to horizontal. The operator then braced their elbow against the front seatback or B-pillar and pressed the switch to activate the actuator. The switch was held until the tool head was fully engaged with the anchor.

As discussed in earlier in the report, a through hole was added to the AFT V3 to accommodate different actuators. After assessing the tool in this usability study, it was found this modification caused some additional flexing at the bolt, which led to questionable data spikes at impact or soon thereafter. Figure 31 shows this phenomenon.

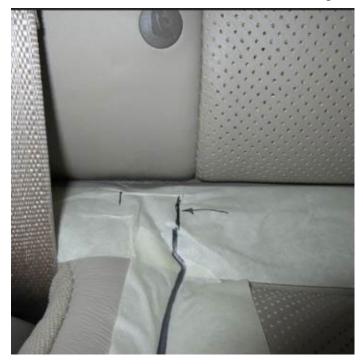
Figure 29. Jeep Grand Cherokee Hidden Anchors

The results show that there were no major differences between tool versions in the meet/not meet results. Two noted differences were with the depth tool in the Jeep Grand Cherokee and the clearance tool in the Nissan Rogue. In the Grand Cherokee with ADT V3, the responses showed a majority of results met the criterion, whereas with ADT V2, the majority did not meet the criterion. All the Jeep results that did not meet the criterion were near the threshold and had to be repeated. The Jeep Grand Cherokee had hidden anchors as shown in Figure 29.

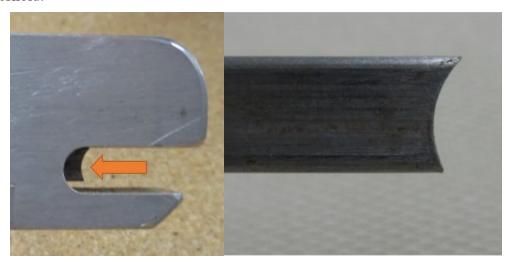
Figure 30. Curvature of Guide Rod

Also, the shape of the guide rod was offset to the anchor as shown in Figure 30. While this shape aligns with the tool profile, it allowed for the tool to slip off some of the lower anchors, causing disengagement of the tool. It was noted that for the lower anchors where the AFT criterion was not met, it was due to disengagement of the tool during the test rather than the tool exceeding the force threshold.

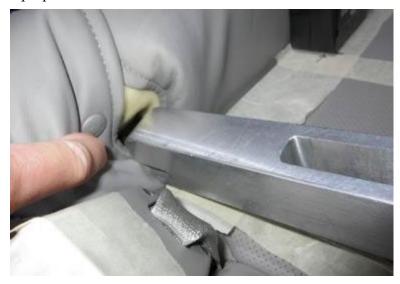
Figure 32. Interaction of AFT With ATS Tunnel Flaps

Generally, in the vehicles where the anchors did not meet the proposed criterion with the force tool, the lower anchor also did not meet the proposed criterion with another tool. An exception to this was the Cadillac ATS. This vehicle had tunnels, or flaps of material, in front of the lower anchors. The AFT was not able to fit into this opening because the tool was too wide (Figure 32). This anchor met the proposed criteria when tested with the ADT and CAT.

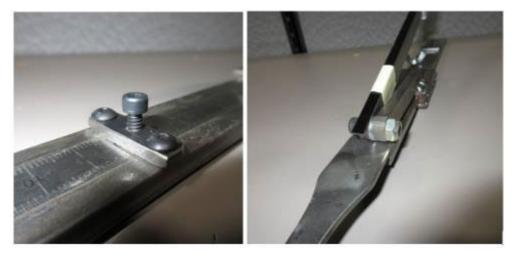
Figure 33. Additional Modifications to ADT (ADT V4)

Additional minor modifications to ADT V3 were made after this usability study was completed to make the tool more stable and easier to use, and they were not expected to affect the resulting measurements. This tool was named ADT V4. The tool was modified with a set screw that could be loosened or tightened by hand quickly to easily move the measurement ruler to the zero setting. Also, at the front of the tool a lock nut replaced the traditional nut to keep the view bar from loosening during the view angle adjustment. A piece of tape was added to the front of the view bar to hold the zeroing strip along the view bar and decrease its flexing. These modifications are shown in Figure 33 and are reflected in the final drawing package in Appendix C. In addition, the test procedure was revised to reflect changes to the zeroing method due to the tool modifications described above.

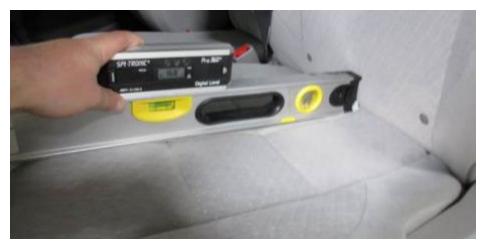
Figure 35. Measuring Seat Pan Angle Using 2-Foot Level and Inclinometer

To reduce potential variability of laying the tool on the seat, it was determined to modify the procedure so that the tool is held parallel to the seat pan, as was proposed in the NPRM. The additional steps to the procedure are as follows. First, measure the seat pan angle using a two-foot level that is placed on the longitudinal centerline of the seat pan such that it just contacts the seat back. Place an inclinometer on the level and record the angle (Figure 35). Place the tool at the desired base angle using shims or blocks to hold the tool stable, if needed (Figure 36).

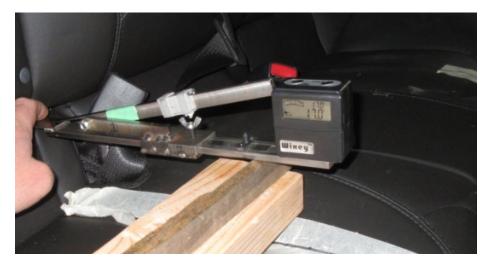
Figure 36. ADT Measurement Using Shims to Hold Base Angle

Although this was limited testing, the additional methods and tool modifications provide less subjectivity due to measuring the seat pan, and the longer length of ADT V4 allows the tool to be more stable in vehicles during the testing. Waterfall bolsters do provide more of a challenge with the depth tool, but if the lower anchors are 20 mm or less in the seat bite, it will be less of an issue for the testing. The test results using ADT V4 in the Cadillac CTS and Kia Forte can be found in Appendix F.

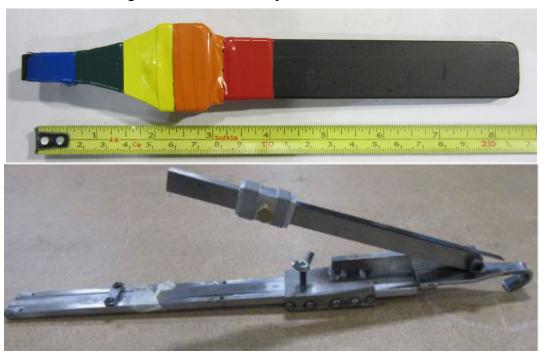
Figure 37. NPRM ADT (Top) Versus ADT V4 (Bottom)

The tool was redesigned. The longer tool provides stability, and the 30° viewing angle combined with the zero-strip and depth gage allow for actual depth measurements rather than just indicating whether the anchor met or did not meet the criterion. Figure 38 shows the proposed tool and the final tool design as detailed in this report.

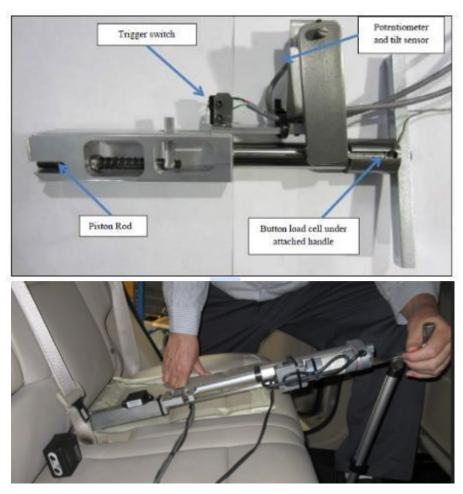
Figure 38. NPRM AFT (Top) Versus AFT V3 (Bottom)

The AFT overall shape did not change, but the instrumentation was updated, the anchor attachment was updated, and the overall length of the tool was increased. To help the operator apply the load consistently, an actuator was added along with a handle and support leg (Figure 39). Overall the improvements increased the usability and repeatability of the tool, but force measurement issues with the tool still exist, such as disengagement of the tool from the anchor and interaction with the seat cover or tunnel flaps.

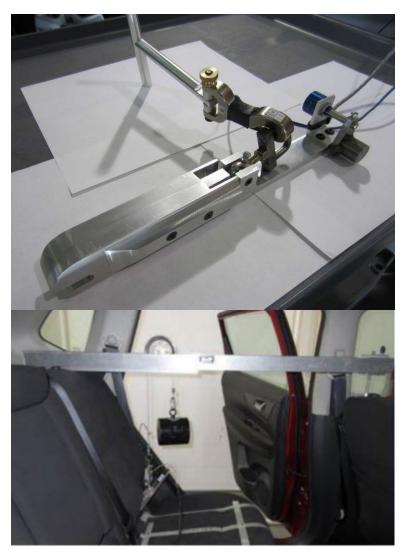
Figure 39. NPRM CAT (Top) Versus CAT V2 (Bottom)

The CAT overall shape did not change, but the instrumentation was updated, and a pulley bridge was added with a 67-newton weight to apply a consistent, vertical force to the tool (Figure 40). This tool was the most repeatable of the three usability tools.

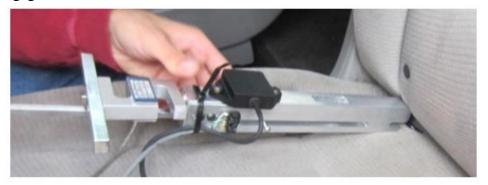
Figure A-5. Measuring Lower Anchor Attachment Force

4.2 While maintaining the angle recorded in step 2.3, move the force tool slider along the guide rod (Figure A-5) until the force tool slider bottoms out, which occurs when the engaged switch is activated.

Record the attachment force using the AFT. The attachment force recorded should be the peak value that occurs during the entire motion, from initial cushion contact (if applicable) until the force tool has bottomed out.

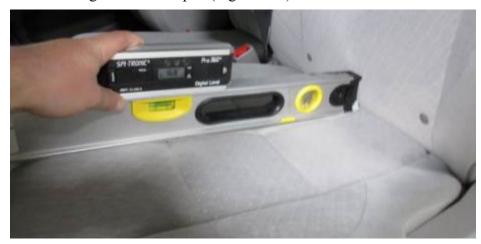
Figure D-2. Measure the Seat Pan Angle Using a 2-Foot Level and Inclinometer

1.1 Place a 2-foot level along the centerline of the seat. Place an inclinometer on the level and record the angle of the seat pan (Figure D-2).

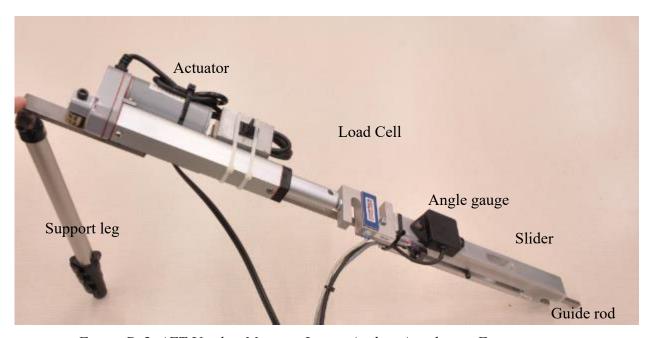
Figure D-5. AFT Used to Measure Lower Anchor Attachment Force

The lower anchor attachment force is measured using the attachment force tool (Figure D-5). The AFT consists of a square cross-section guide rod, force tool slider, load cell, actuator, digital angle gauge, and support leg.

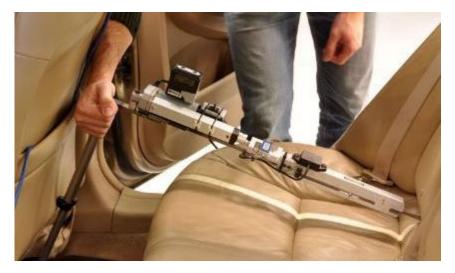
Figure D-6. Initial Position of Force Tool Slider with Approach Angle of 20°

- 2.1. With the force tool slider fully retracted (guide rod should be extended beyond the front surface of slider), place the notched end of the guide rod in the center of the lower anchor bar and apply gentle pressure to seat it.
- 2.2. As shown in Figure D-6, position the force tool so the approach angle is $20 \pm 2^{\circ}$ relative to horizontal. Adjust the force tool leg support so it rests on the rear floor of the vehicle and keeps the tool at the 20-degree approach angle. If the force cannot be measured at this angle, measure the force at the closest angle to this corridor and document this angle.

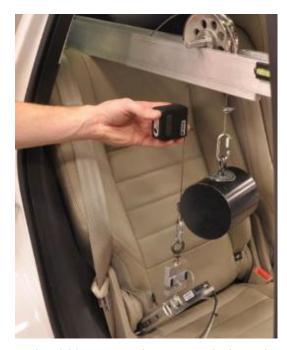
Figure D-8. Pulley Wire Should be Vertical From Both the Side and Front of Vehicle

- 3.1 Prepare the lower anchor test position by either removing the head restraints from the seat in front and behind the lower anchor or lift them to their highest position.
- 3.2 Place the pulley bridge so it rests on the tops of the rear and front seatbacks above the lower anchor. Use the leveling feet to position the bridge so it is horizontal within \pm 5° about its longitudinal axis. If necessary, change the front seatback angle to help level the pulley bridge.
- 3.3 Attach the CAT to the center of the lower anchor hardware and the pulley cable. Insert the pulley wheel onto the bridge and route the cable over it.
- 3.4 Gently attach a weight of 67 ± 0.4 N (15 ± 0.1 lb) to the attachment cable. The weight should be hanging freely without any swinging. The attachment cable should be vertical within $\pm 5^{\circ}$ from both the front and the side, as shown in Figure D-8.
