A FRAMEWORK FOR FIELD INSPECTION OF IN-SERVICE FRP REINFORCED/STRENGTHENED CONCRETE BRIDGE ELEMENTS: Technical Summary

1. Report No. 800014727-2		2. Government Accession No.		3. Recipient's Catalog No.	
4. Title and Subtitle A Framework for Field Inspection of In-service FRP Reinforced/Strengthened Concrete Bridge Elements: Technical Summary				5. Report Date July 2025

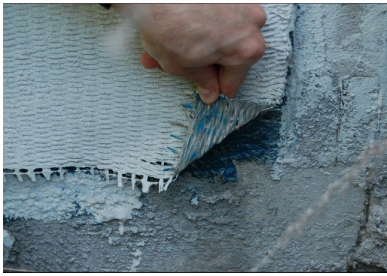
Location 1.

Debonding, 6-inch diameter, at the easternmost column of Pier 2.

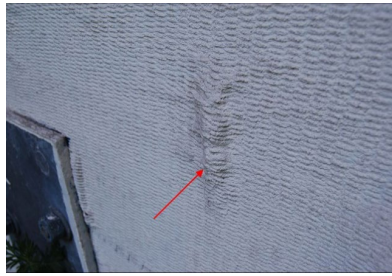
Location 2.

Wrinkling, 4 inches long, in GFRP sheet at crashwall of Pier 2.

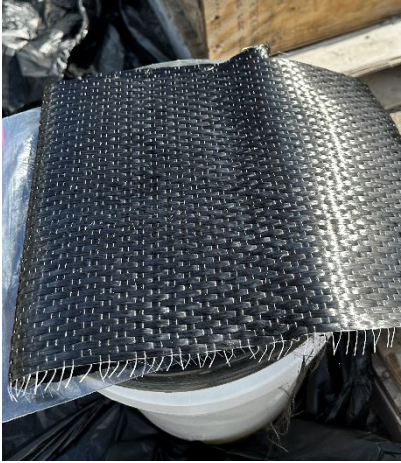
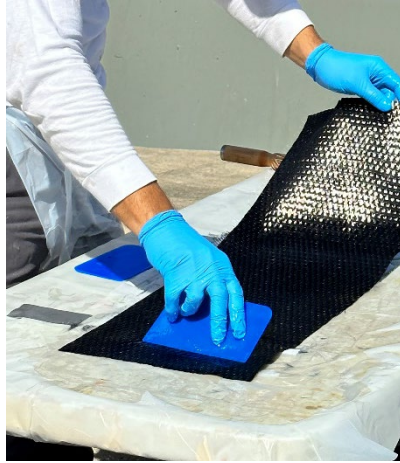
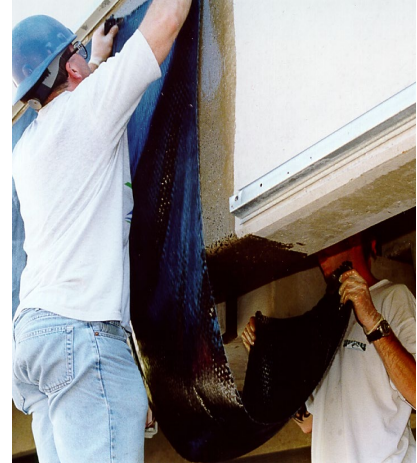
Quantity Calculation:	Sum of the number of piles visible for inspection.				
<u>FRP External Strengthening/Repair/Retrofit or Shell</u>						
601	FRP Sheets	Classification:	BME	Unit of Measure:	ft²	
	Description:	Layered FRP sheets or wraps, usually a woven cloth, normally saturated and installed at site, for strengthening/repair/rehabilitation regardless of the type of substrate material.

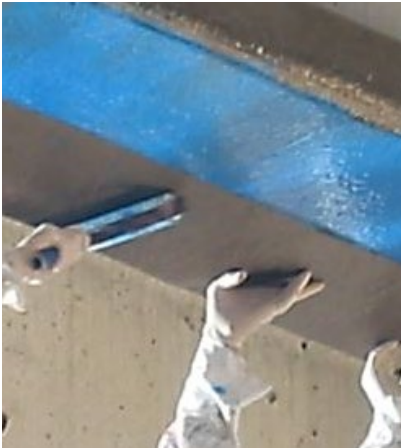
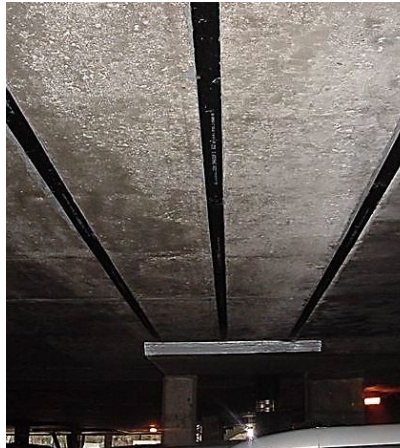
602 FRP Pultruded Laminate

<u>Quantity Calculation:</u>	<u>Area of FRP sheet application.</u>			
	<u>Notes:</u>	<u>This can also include factory-made layup to create a shell which serves as stay-in-place form.</u>			
602	<u>FRP Pultruded Laminate</u>	<u>Classification:</u>	<u>BME</u>	<u>Unit of Measure:</u>	<u>ft²</u>
	<u>Description:</u>	<u>FRP pultruded laminates, such as plates or shells, prefabricated at shop and attached to an element for strengthening/repair/rehabilitation regardless of the type of substrate material.</u>			
	<u>Quantity Calculation:</u>	<u>Area of FRP laminate application.</u>			
	<u>Notes:</u>	<u>This can also include prefabricated shells to serve as stay-in-place forms.</u>			
603	<u>FRP Near Surface Mounted (NSM) Reinforcing Bars</u>	<u>Classification:</u>	<u>BME</u>	<u>Unit of Measure:</u>	<u>ft</u>
	<u>Description:</u>	<u>FRP reinforcing bars placed in grooves cut in the substrate material and covered by grout or resin for strengthening/repair/rehabilitation regardless of the type of substrate material.</u>

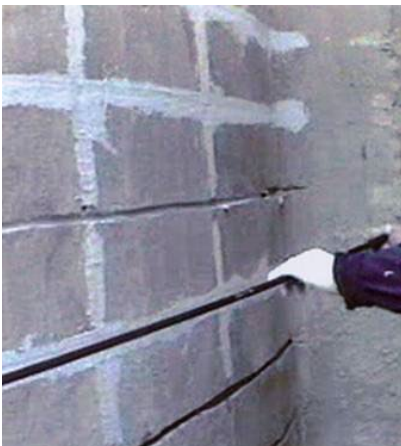
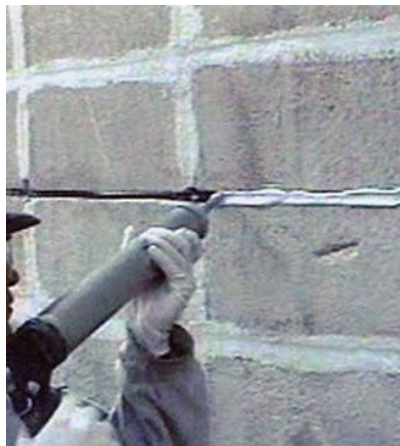
603 FRP Near Surface Mounted (NSM) Reinforcing Bars

<u>Quantity Calculation:</u>	<u>Sum of all the lengths of reinforcing bars</u>			
604	<u>FRP Post-Tensioning</u>	<u>Classification:</u>	<u>BME</u>	<u>Unit of Measure:</u>	<u>ft</u>
	<u>Description:</u>	<u>FRP post-tensioning bars, strands, or laminates for elements bonded to or separate from the substrate, regardless of the type of substrate material.</u>			
	<u>Quantity Calculation:</u>	<u>Sum of all the lengths of post-tensioning bars, strands, or laminates</u>			
	<u>Notes:</u>	<u>Anchorage devices are not covered in this item.</u>

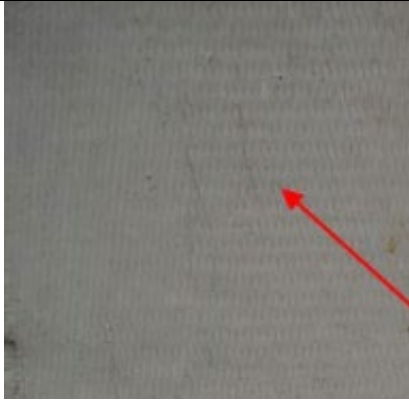
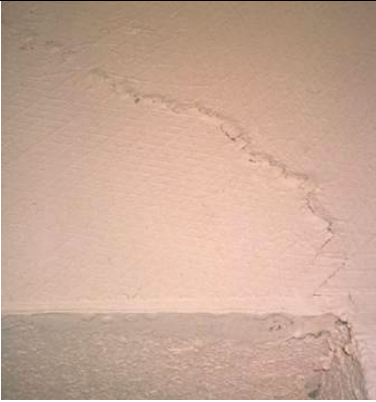
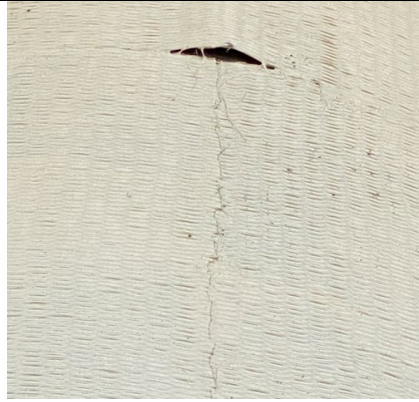
Defect 1230 Cracking (FRP)

Condition State 1	Condition State 2	Condition State 3
<u>Hairline surface cracks</u>	<u>Shallow cracks limited to the polymer, with no fibers visible and parallel to the major stress direction.</u>	<u>Wide or deep cracks, especially if perpendicular to major stress or fiber directions but no through rupture or puncture.</u>

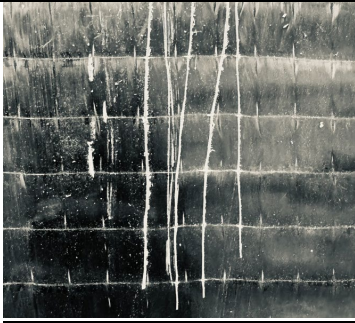
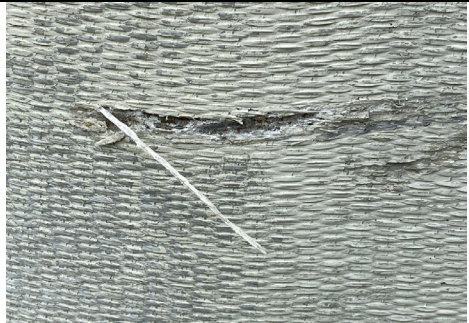
Defect 1240 Scratches (FRP)

Condition State 1	Condition State 2	Condition State 3
<u>None</u>	<u>Shallow scratches limited to the polymer, with no fibers visible and parallel to the major stress direction.</u>	<u>Wide or deep scratches, especially if perpendicular to major stress or fiber directions but no through rupture or puncture.</u>

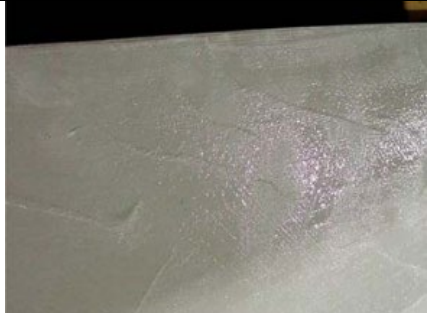
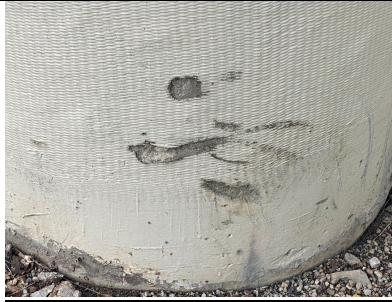
Defect 1290 Abrasion (FRP)

Condition State 1	Condition State 2	Condition State 3
None	Shallow abrasion, limited to the polymer, with no fibers visible and parallel to the major stress direction.	Wide or deep abrasion, especially if perpendicular to major stress or fiber directions but no through rupture or puncture.

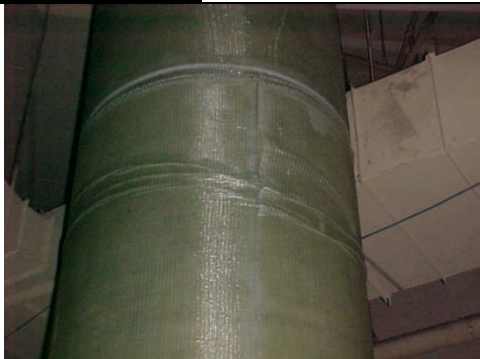
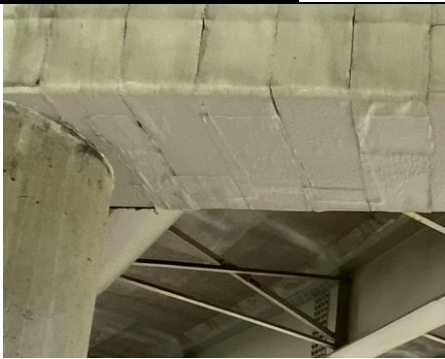
Defect 1210 Wrinkling (FRP)

Condition State 1	Condition State 2	Condition State 3
None	Less than 1 in. raised or less than 6 inches diameter or length.	More than 1 in. raised or more than 6 inches in diameter or length.

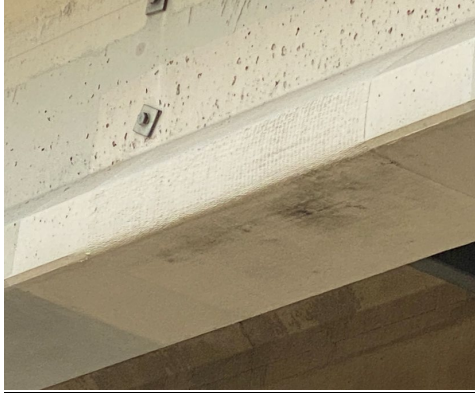
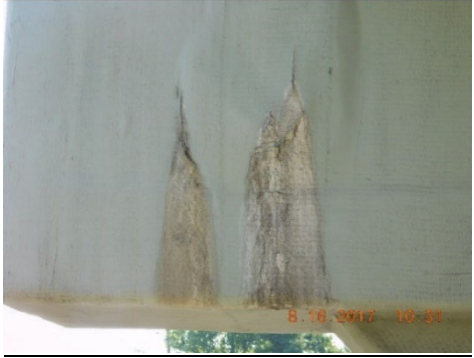
Defect 1250 Discoloration (FRP)

Condition State 1	Condition State 2	Condition State 3
None or none after cleaning superficial stain	Permanent shallow discoloration or UV exposure and protective coating degradation of 6 inches in diameter or less.	Permanent discoloration or UV exposure with cracking, brittleness, or distress, or more than 6 inches in diameter.

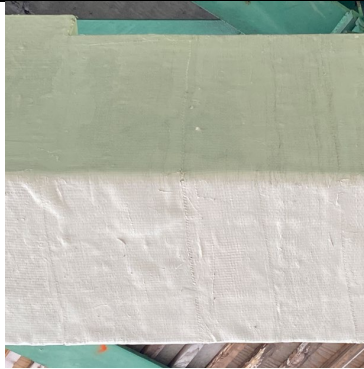
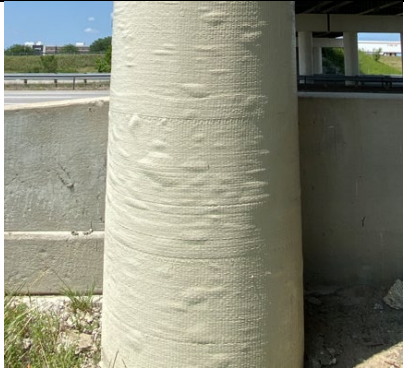
Defect 1260 Blister (FRP)

Condition State 1	Condition State 2	Condition State 3
None	Less than 1 inch raised or less than 6 inches in diameter or length.	More than 1 inch raised or more than 6 inches in diameter or length.

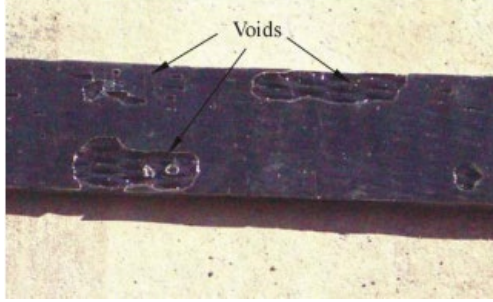
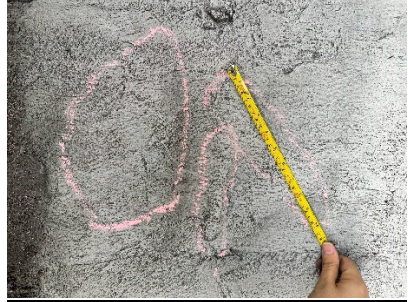
Defect 1270 Voids (FRP)

Condition State 1	Condition State 2	Condition State 3
None	Less than 1 inch raised or less than 6 inches in diameter or length.	More than 1 inch raised or more than 6 inches in diameter or length.

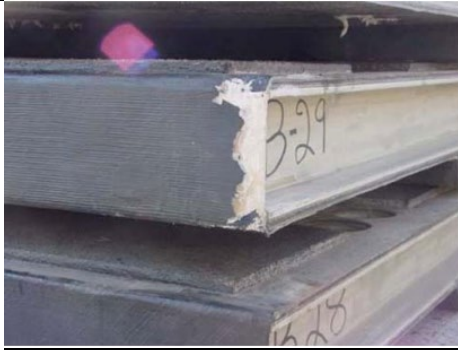
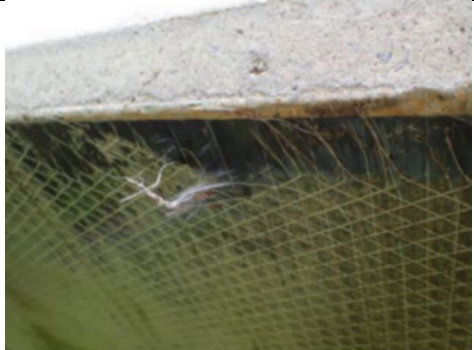
Defect 1280 Fiber Exposure (FRP)

Condition State 1	Condition State 2	Condition State 3
None	Exposed but not ruptured, buckled, or debonded at the surface damage location.	Fibers exposed and debonded (especially in cracks perpendicular to major stress or fiber directions), but not buckled or ruptured at the surface damage location.

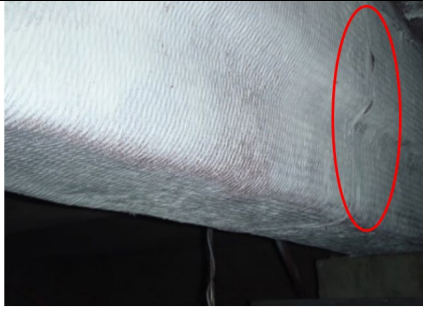
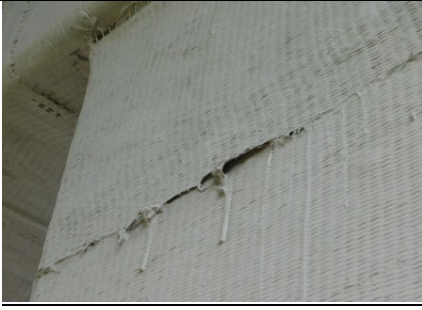
Defect 1205 Delamination/Debonding (FRP)

Condition State 1	Condition State 2	Condition State 3
None	Delamination smaller in every dimension than 6 inches but away from sensitive details (e.g., connections) to have structural effects.	Delamination smaller in every dimension than 6 inches but near sensitive details (e.g., connections) to have structural effects.

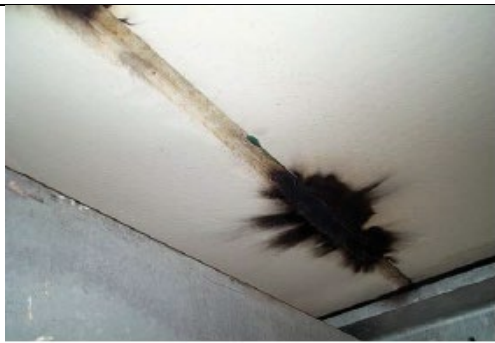
Defect 1215 Fire Damage (FRP)

Condition State 1	Condition State 2	Condition State 3
None or none after cleaning superficial stain or fire mark	Permanent shallow discoloration 6 inches in diameter or less.	Permanent discoloration and with cracking, brittleness, or distress or more than 6 inches in diameter.

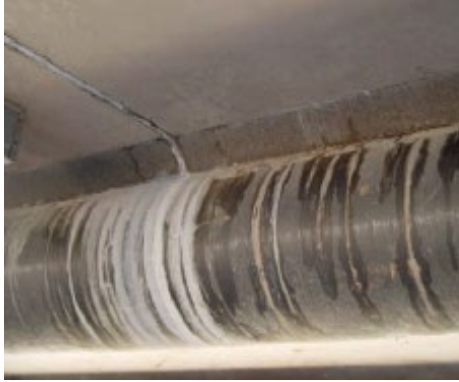
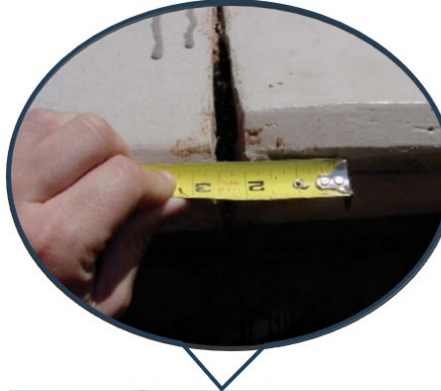
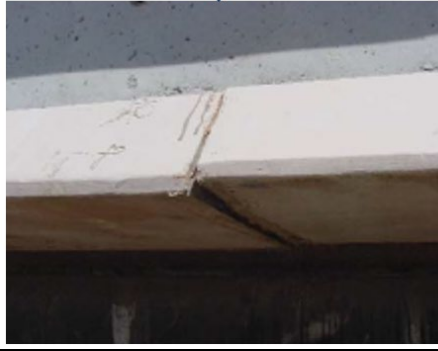
Defect 1225, 1235, 1245 Panel Joints (FRP)

Condition State 1	Condition State 2	Condition State 3
Minor deterioration with hairline cracks less than 1/32 in. No noticeable water leakage observed from underside.	Evidence of joint degradation visible due to cracking in overlay or topping above panel joint locations. Gaps and cracks of up to 1/16 inch; no loss of bolts, clips, or other devices. Signs of water leakage maybe minimal.	Gaps, misalignment, and cracks of up to 1/4 inch in overlay. Few clips or bolts loose or lost, minor elevation changes for adjacent panels evident. Leakage may be moderate, more than a drip and less than a free flow of water.

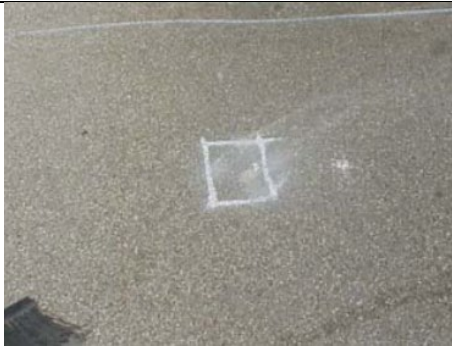
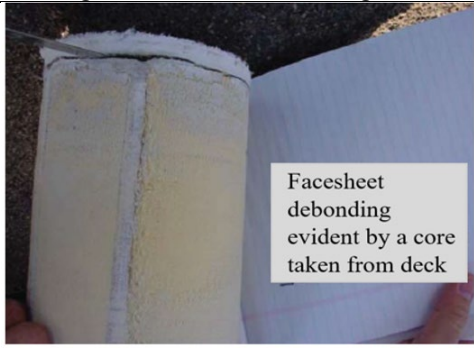
Defect 1255 Facesheet Debonding (FRP)

Condition State 1	Condition State 2	Condition State 3
None	Visible minor bulge or peeling on the top surface indicating initiation of debonding.	Noncritical damage to surrounding structural elements, such as reflective cracking at wearing surface or local damage to joints resulting in detection of debonding.

Facesheet debonding evident by a core taken from deck
