# Evaluation of Stripping Tests for Asphalt Mixtures to Replace AASHTO T283 Method in Missouri

May 2025  
Final Report

Project number TR202306  
MoDOT Research Report number cmr 25-006

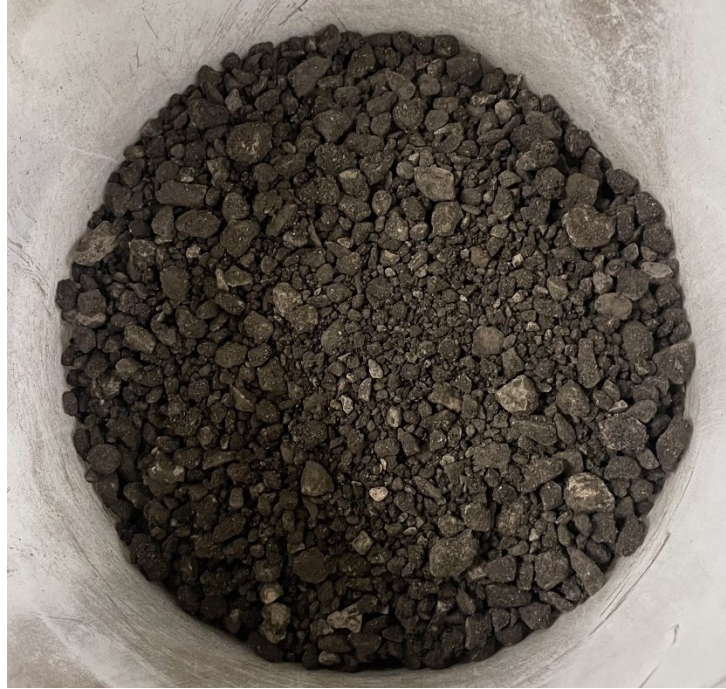
**Figure 2.1. RAP Stockpile**

For this study, all mixes were made using a RAP sourced from a contractor located in eastern Missouri, near the St. Louis area, in 2022 by MAPIL. Figure 2.1 shows an image of the RAP stockpile used in this study and Figure 2.2 shows its gradation. Obtaining the original RAP used in the mixtures was not feasible. The researchers are aware that this may have affected the performance of some mixes. The asphalt content (AC) of the RAP stockpile was reported to be 4.7%. Due to the use of different RAP, some of the mixtures had to be adjusted in terms of virgin asphalt content. Details of the final mixture designs are discussed in the next section.

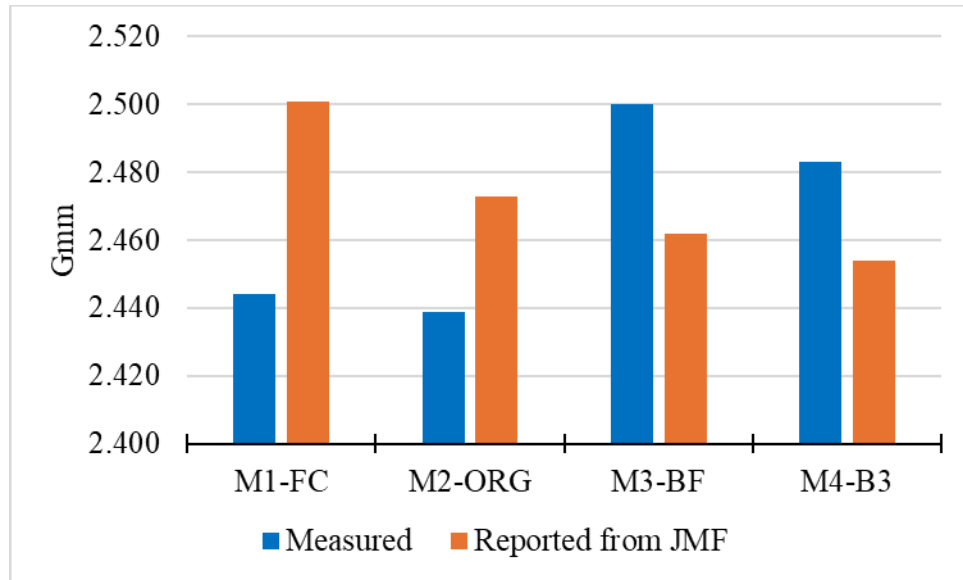
**Figure 2.4. Comparing different Gmm values for studied mixtures (Measured = Test performed in MAPIL; JMF = job mix formula)**

available to the researchers and thus, asphalt binders from MAPIL's material reference library were used for this study. The research team used the same grade of binder for each mix as specified in the original JMF, and wherever possible, from the same region of the state. For instance, in the case of M4-B3, a PG64-22V binder was obtained from a supplier in the St. Louis area for this study. Details of the final mixture designs, including the volumetrics data, are shown in Table 2-6. Additionally, Figure 2.4 shows the comparison of the theoretical maximum specific gravities (Gmm) of the lab-produced mixtures with their corresponding JMF-reported values. Changes in the RAP stockpile and base (virgin) binder are likely the primary reasons for the differences in the Gmm values.

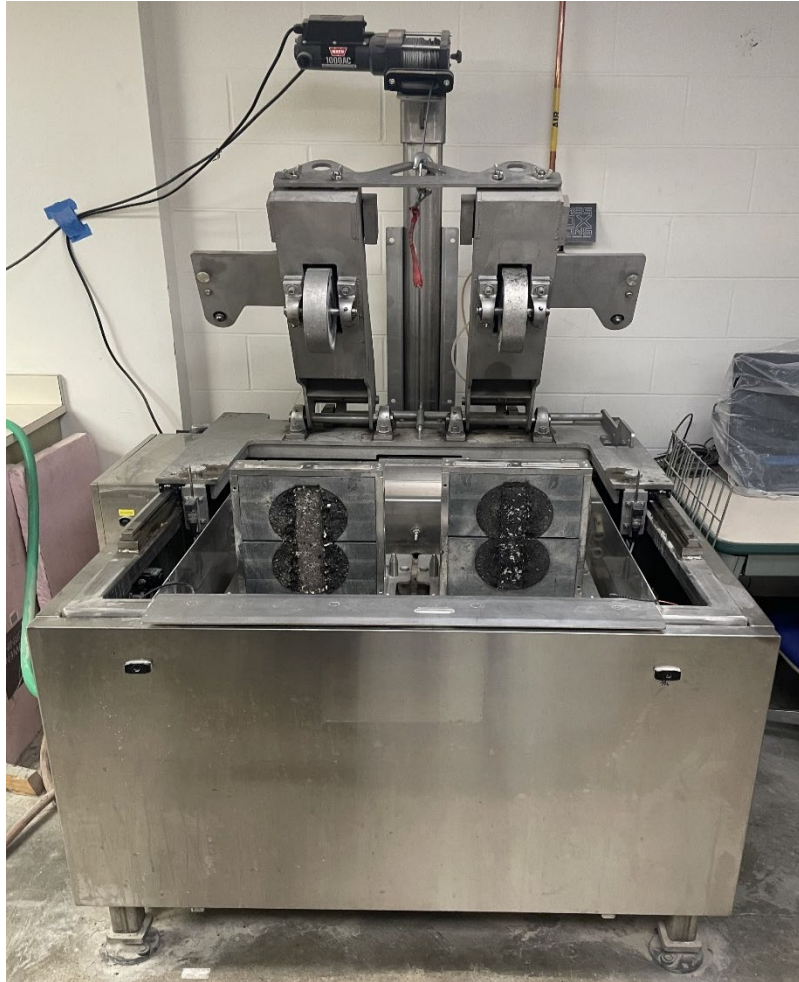
**Figure 3.1. Hamburg Wheel Track Test (HWTT) device**

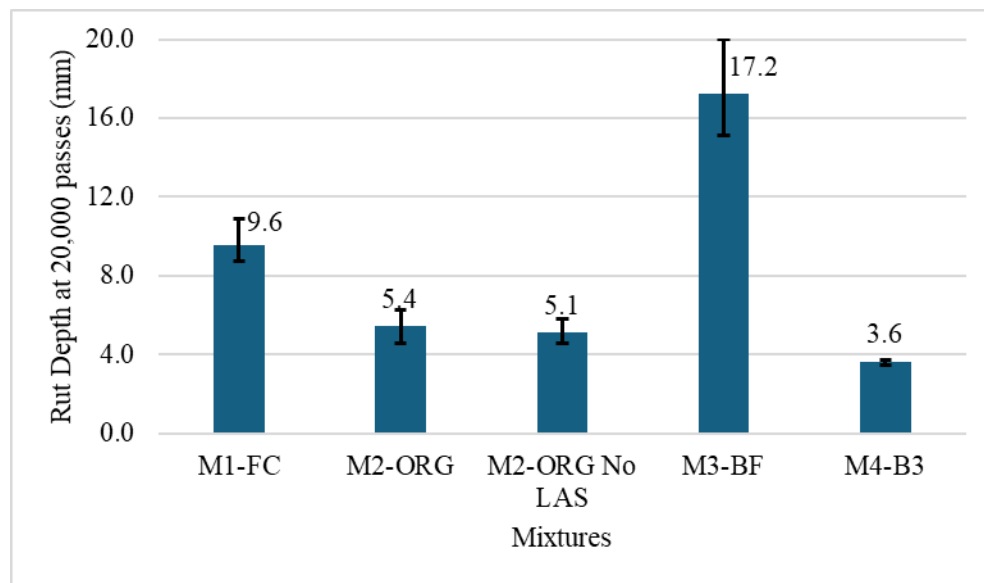
Figure 4.1. Rut depth reported at 20,000 passes for each mixture

Only M3-BF failed the rutting criteria based on the imposed threshold of 12.5 mm at 20,000 passes. High rut depths obtained in the HWTT conducted in a water bath could be an indication of moisture damage. Based on field performance information gathered from MoDOT, M1-FC and M3-BF were expected to exhibit stripping potential, which is accompanied by higher rut depths, as recorded in the results. Conversely, M4-B3 was expected to be resistant to stripping, which often results in lower rut depth.

However, M2-ORG mixture, which showed signs of stripping on-field (per discussion with MoDOT) recorded low rut depth and no stripping (discussed in later sections). The use of different aggregates and RAP compared to the original mixture could likely be the reason for this discrepancy. Another reason could be the use of a different LAS than the original JMF. Since the original LAS was not available for use in testing, the team proceeded to test the mixture without any LAS to investigate if its removal affects the rutting and stripping results. The resulting mixture, named as M2-ORG No LAS, recorded marginally lower rut depth.

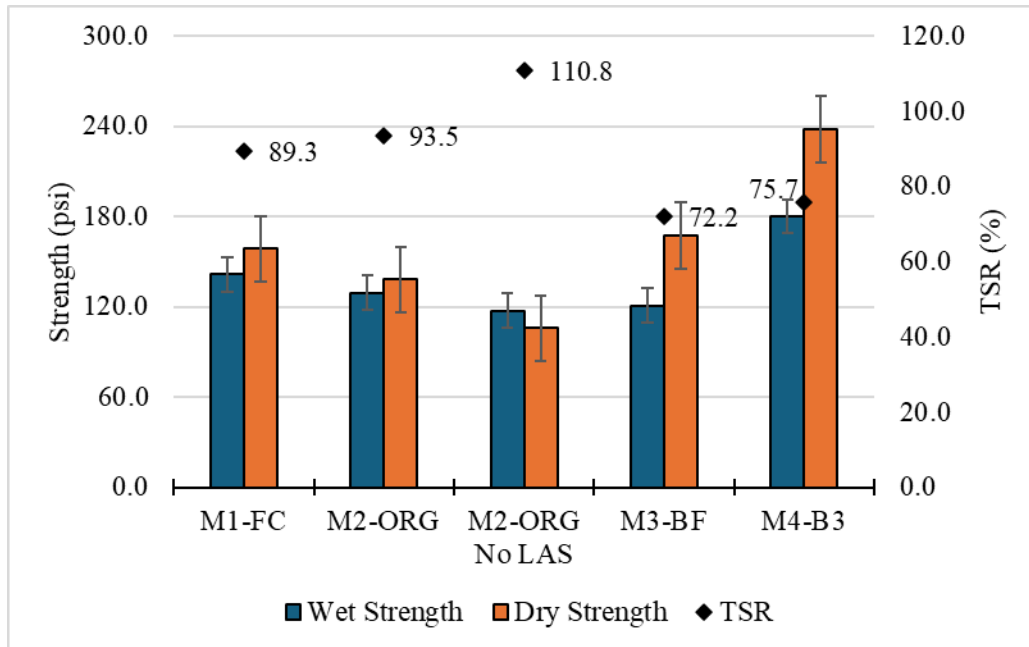
**Figure 4.3. Indirect tensile strength in wet and dry conditions, and TSR for all mixtures**

The TSR results are shown in Figure 4.3. Using MoDOT's criteria of a minimum of 80% TSR, only two of the original four mixtures, M1-FC and M2-ORG, pass. The other two mixtures, M3-BF and M4-B3 recorded lower than 80% TSR values. In addition, the M2-ORG No LAS mixtures recorded a significantly higher TSR compared to its original counterpart. Interestingly, the wet condition for the mixture exhibited higher strength compared to the dry conditioned specimens. It was also noteworthy that the recorded peak strengths for the mixture in wet and dry conditions were the lowest amongst all tested mixtures.

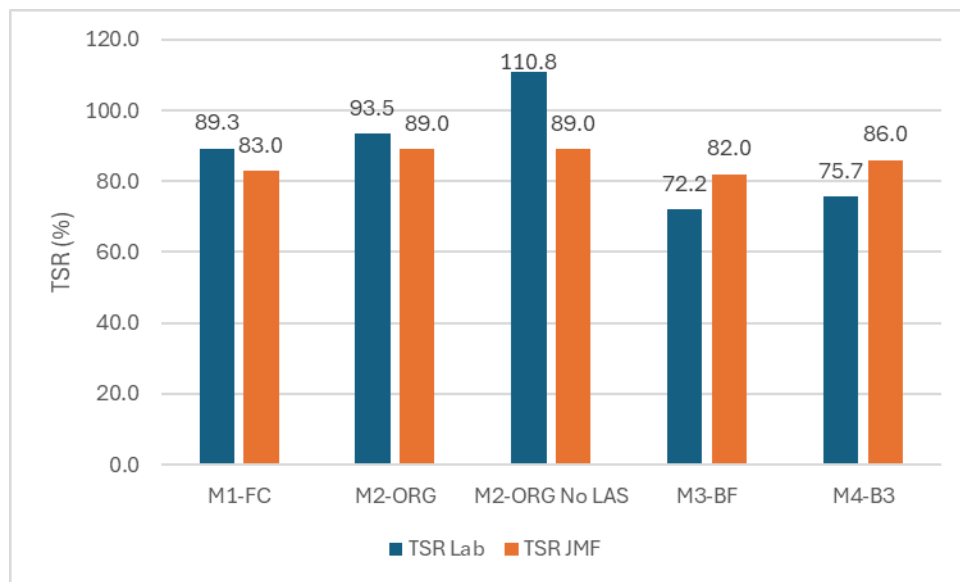
**Figure 4.4. Comparison of TSR values obtained in this study with the values reported in the JMFs**

Figure 4.4 shows the comparison of the lab measured TSR values to the ones reported on the original job mix formulas (JMFs). All the mixtures were reported to have a passing TSR score of above 80%. It is worth recalling that all the mixtures were produced using a different RAP source than their original JMFs, which could affect the results.
