Coarse Aggregate Deterioration in Granular Surfaces and Shoulders

**Final Report
April 2025**

1. Report No. IHRB Project TR-769	2. Government Accession No.	3. Recipient's Catalog No.	
4. Title and Subtitle Coarse Aggregate Deterioration in Granular Surfaces and Shoulders		5. Report Date April 2025

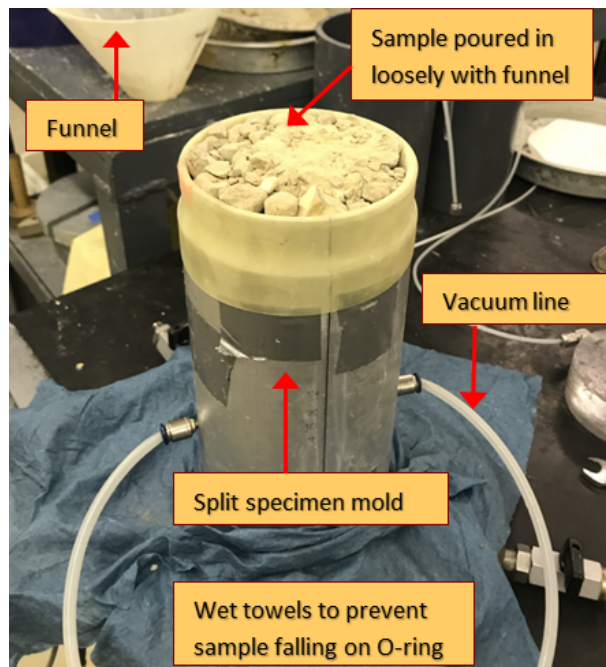
Figure 13. Split vacuum mold and filling of triaxial specimen

The membrane was expanded and held in place by vacuum pressure applied to a split mold, as shown in Figure 13. The aggregate specimen was then poured loosely using a funnel to achieve a uniform distribution. The funnel was held as close to the sample as possible to avoid densifying the specimen. Wet paper towels were used on the base to keep the O-ring and vacuum grease free of soil to ensure good sealing at the base of the cell and prevent air leakage during tests.

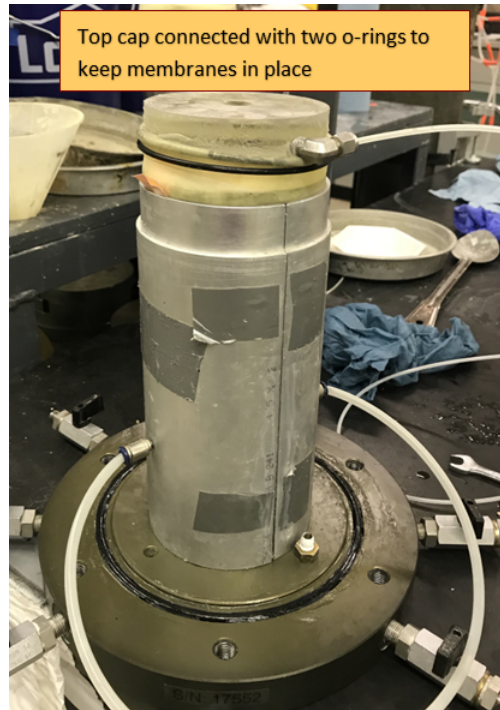
Figure 14. Placing of top cap and O-rings around membrane

The top cap was connected, and the membrane was secured with two O-rings as shown in Figure 14. A second membrane was carefully placed around the specimen as shown in Figure 15 to minimize puncturing of the membrane by the specimen during the shearing stage. The entire preparation procedure took approximately two to three hours per specimen.

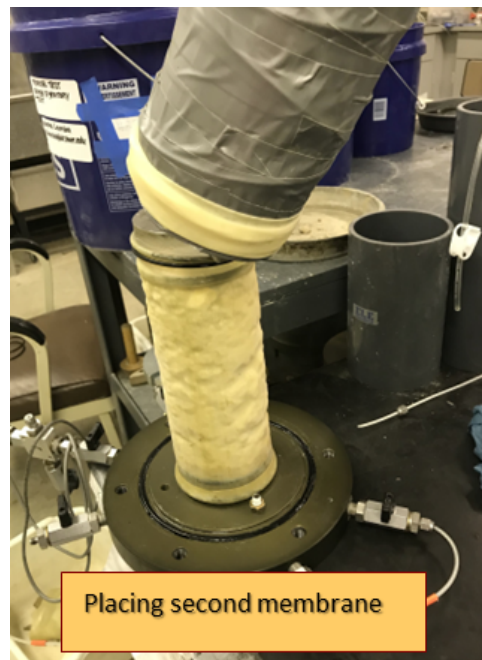
Figure 15. Placement of second membrane around the specimen

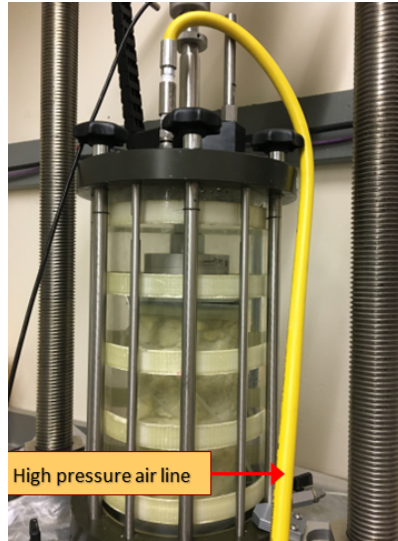
Figure 16. Triaxial testing – shearing in progress

Once consolidated, the samples were sheared at a constant displacement rate of 0.0079 in./min (0.2 mm/min), corresponding to a strain rate of 0.098%/min (Figure 16). As shown in Figure 17, the specimens were tested to failure by large axial strains of approximately 20% to 30%. The slow shearing process allowed for the drained response to be captured, and required six to seven hours per test (Figure 18). A summary of the triaxial testing parameters obtained from the tests is presented in Table 4.

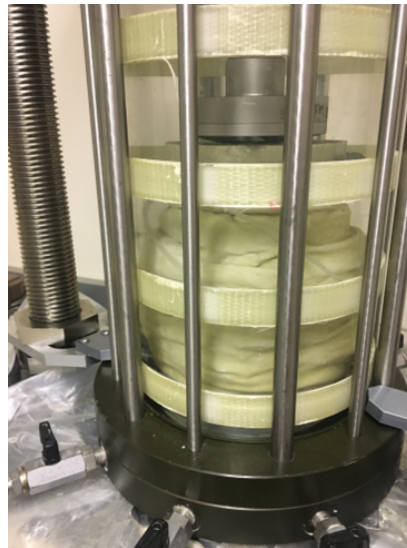
Figure 17. Triaxial testing – sample failed at 30% strain

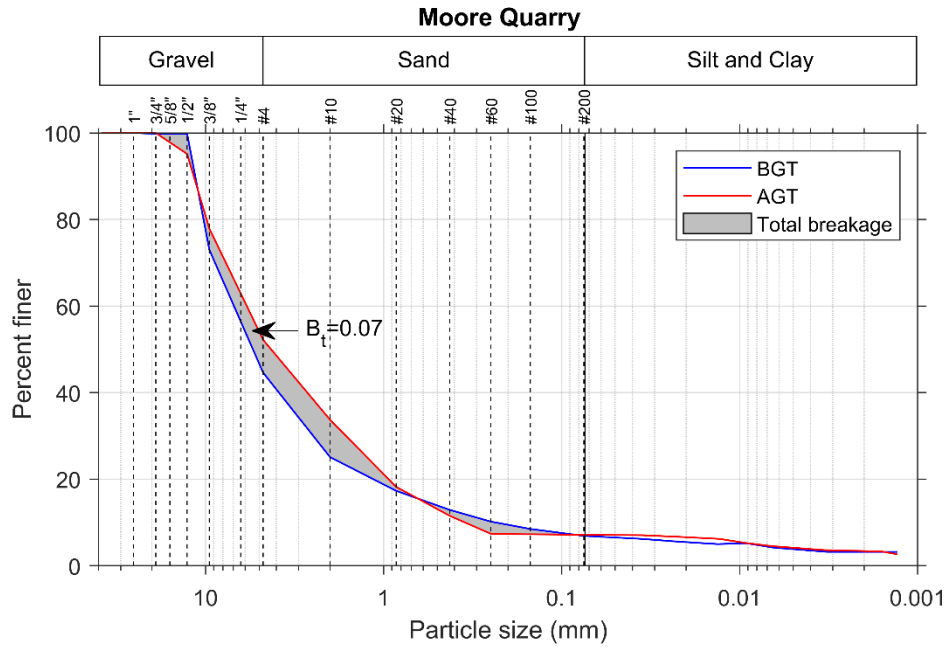
Figure 20. Particle size distributions from sieve and hydrometer analysis and evaluation of total breakage of coarse aggregate samples from Moore Quarry

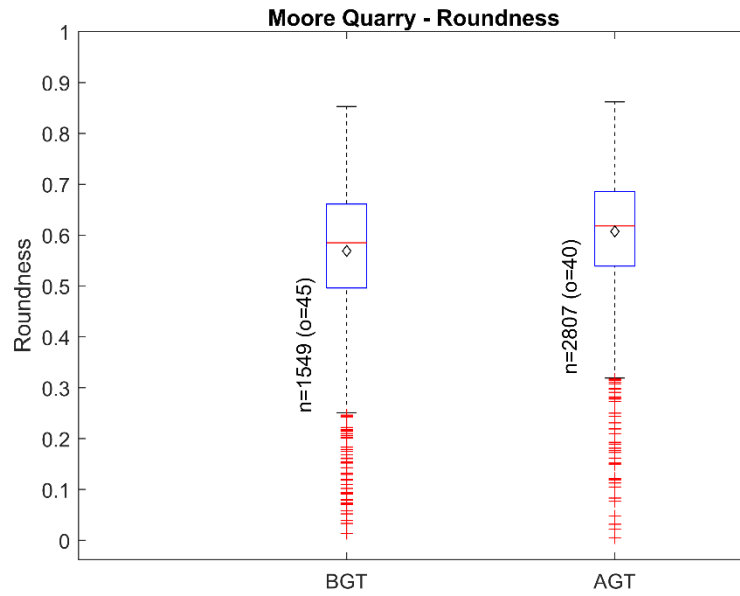
Figure 22. Comparison of roundness for BGT and AGT specimens from Moore Quarry

As can be seen in in Figure 22 through Figure 27, the total number of gravel-sized particles (n) for Moore Quarry increased from 1,549 to 2,807 during gyratory compaction due to particle breakage, and the number of outliers was typically between 0.04% and 8.1% of n . The increase in number of gravel sized particles during gyratory compaction is opposite the trend observed for Pedersen Quarry (discussed in a later section), meaning that more of the Moore Quarry aggregates remained within the gravel size range above the No. 4 sieve after breaking, whereas more of the Pedersen Quarry aggregates broke into particles smaller than the No. 4 sieve. As shown in Table 7, the median values of roundness, sphericity, and form factor for Moore Quarry increased by 5.6%, 5.3%, and 20.1% respectively, indicating that the particles became more rounded and spherical during gyratory compaction. Conversely, corresponding decreases of 16.8%, 7.0%, and 22.0% in shape factor, roundness index, and angularity, respectively, were observed for the same specimens.

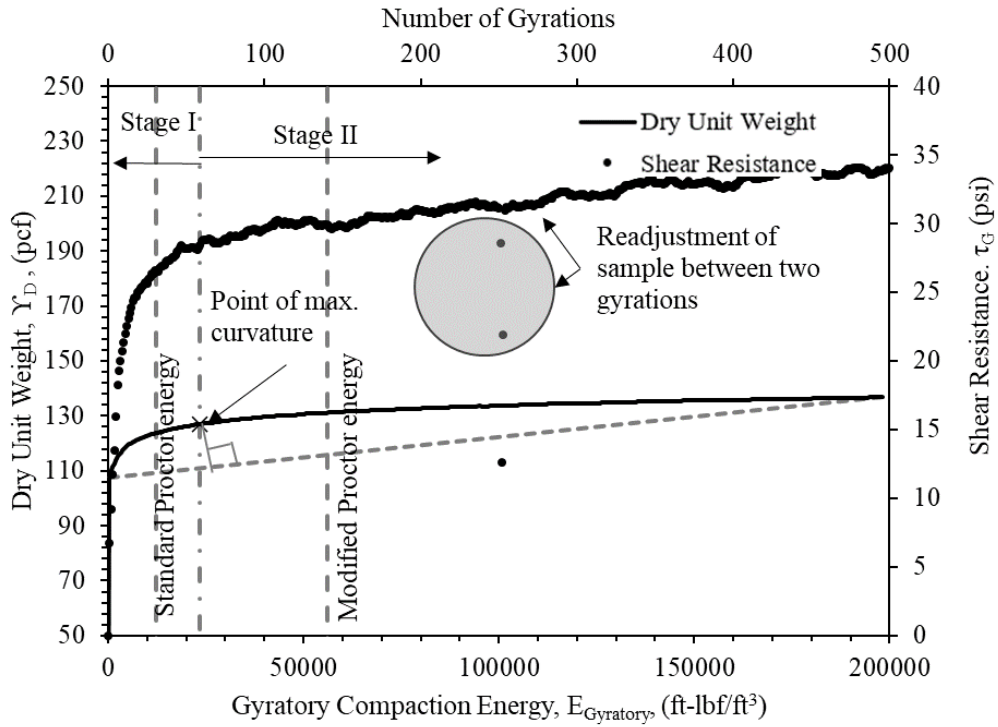
Figure 29. Relationships between dry unit weight, gyratory compaction energy, shear resistance, and number of gyrations for coarse aggregates from Moore Quarry

The shear resistance and gyratory compaction energy of the specimen were calculated from the force and eccentricity data recorded by the PDA during the test, and the shear resistance is also shown in Figure 29 and Figure 30. The point of maximum curvature for the resulting plot of dry unit weight versus gyratory compaction energy in Figure 29 occurs at a dry unit weight of 127.0 pcf, and the changes in compaction energy and dry unit weight before and after this point, defined herein as compaction Stages I and II, are tabulated in Table 8. Stage I is characterized by a rapid increase in dry unit weight and rapid decrease in void ratio, while State II is characterized by slower changes in these parameters. As illustrated by the figure and table, the point of maximum curvature in the dry unit weight curve used to define Stages I and II denotes the point after which continued compaction delivers diminishing returns, making it a good target for field compaction specifications. For the aggregates tested in this study, this point was typically found to occur above Standard compaction energy but below Modified Proctor compaction energy, as will be shown in subsequent sections.

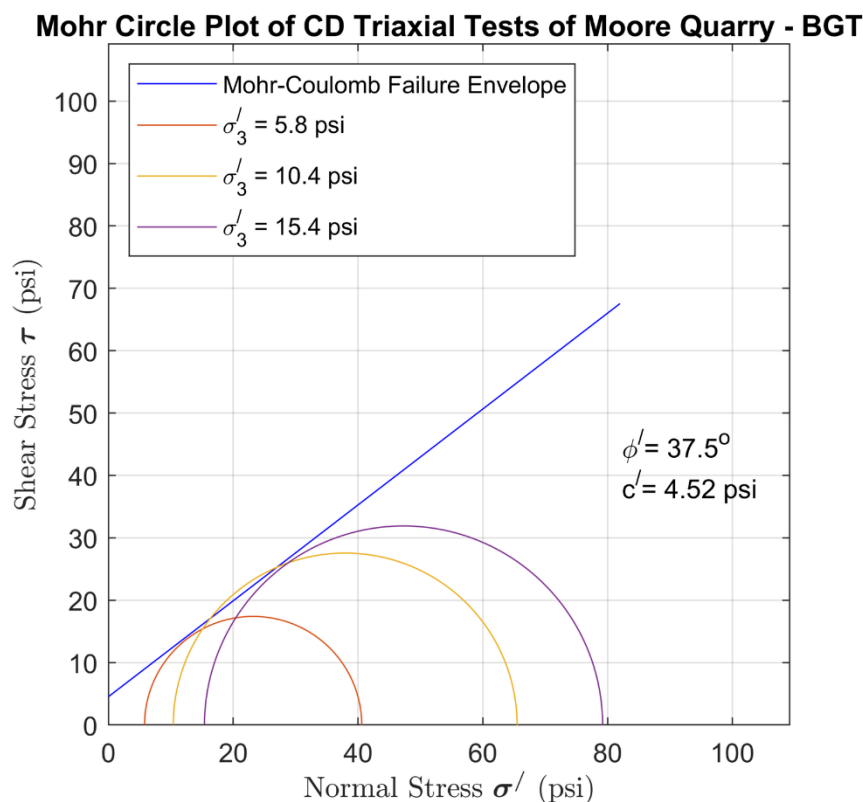
Figure 31. Triaxial test results for Moore Quarry specimens before gyratory testing

The chamber confining pressures applied in the triaxial tests on the Moore Quarry aggregates were 5.8, 10.4 and 15.4 psi for the BGT specimens, and 5.2 and 12.7 psi for the AGT specimens. The Mohr-Coulomb failure envelopes resulting from the tests are shown in Figure 31 and Figure 32. The resulting drained cohesion (c') and friction angle (ϕ') values were 4.52 psi and 37.5° for the BGT specimens, and 6.14 psi and 32.5° for the AGT specimens. Therefore, the particle degradation caused by the gyratory compaction tests resulted in an increase of 35.8% in the cohesion but a 13.3% decrease in friction angle for this material.

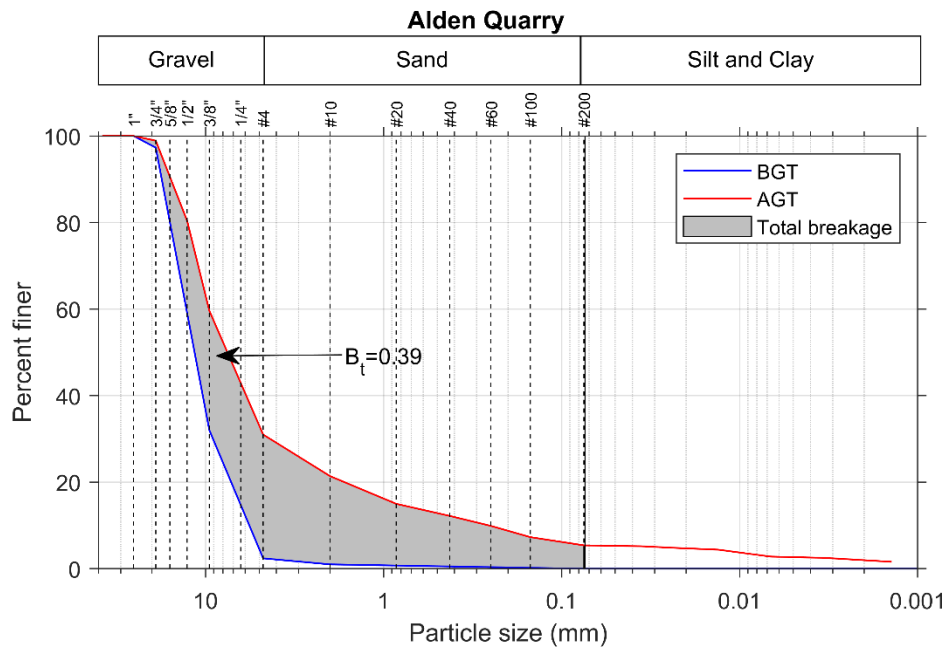
Figure 34. Particle size distributions from sieve and hydrometer analysis and evaluation of breakage of coarse fraction for samples from Alden Quarry

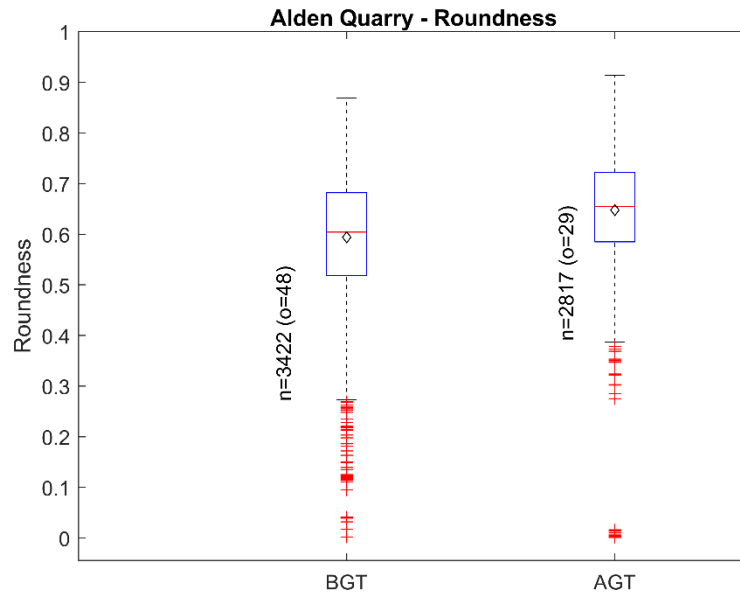
Figure 36. Comparison of roundness for BGT and AGT specimens from Alden Quarry

The morphological parameters evaluated by 2D image analysis for the BGT and AGT Alden Quarry specimens are presented in Figure 36 through Figure 41, and the corresponding statistical measures of these morphological parameters are presented in Table 12. The relative changes in the morphological parameters during gyratory testing are also computed and presented in Table 12, quantifying the mechanical degradation experienced by the specimens as well as the changes in geometry of the gravel-sized particles. As detailed in Table 12, the median values of roundness, sphericity, and form factor increased by 8.4%, 7.9%, and 0.3% respectively. Accordingly, the specimen exhibited decreases of 28.7%, 13.3%, and 24.0% in shape factor, roundness index, and angularity, respectively, during the gyratory test.

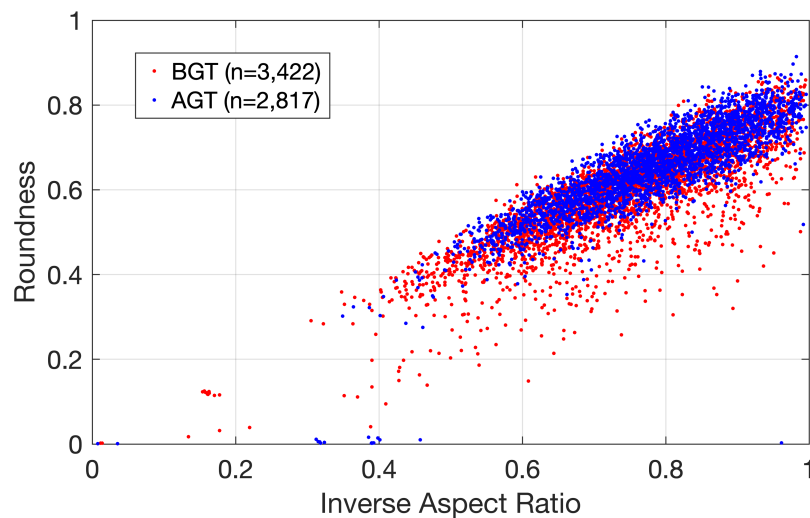
Figure 42. Roundness versus inverse of aspect ratio for BGT and AGT specimens from Alden Quarry

The roundness is plotted versus the inverse of aspect ratio in Figure 42, exhibiting similar trends to those previously noted for Moore Quarry. The increase in roundness after gyratory compaction testing is also noticeable in this plot.

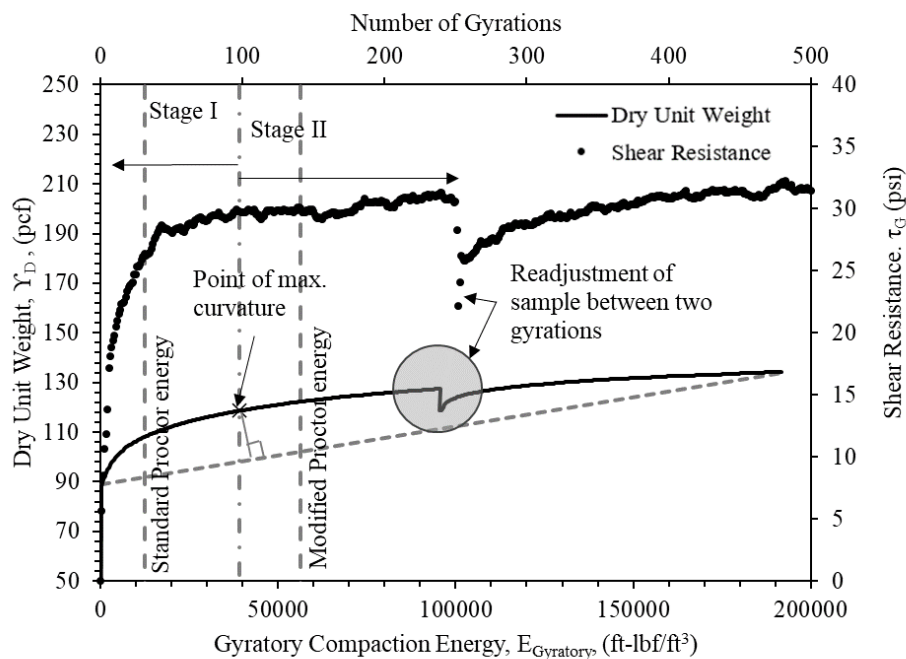
Figure 43. Relationships between dry unit weight, gyrotory compaction energy, shear resistance, and number of gyrations for coarse aggregates from Alden Quarry

The evolving void ratio and dry unit weight calculated from the specimen height during the gyrotory compaction test for the Alden Quarry material are plotted in Figure 43 and Figure 44 with respect to the number of gyrations and compaction energy. An overall decrease in void ratio of 70.5% and corresponding 52.2% increase in dry unit weight were observed through Stages I and II of the test. The shear resistance and gyrotory compaction energy of the materials were calculated using the data collected by the PDA during the test. The resulting point of maximum curvature for the plot of dry unit weight versus gyrotory compaction energy occurred at a dry unit weight of 118.66 pcf (Figure 43). The changes in compaction energy and dry unit weight for both stages of the test are shown in Table 13.

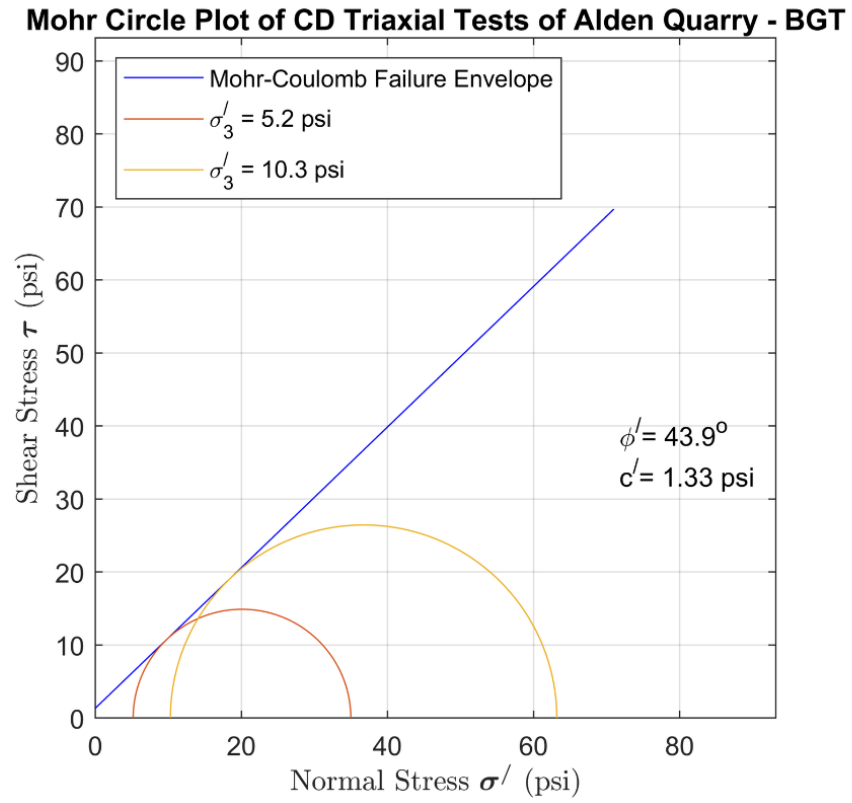
Figure 45. Mohr-Coulomb plot of samples from Alden Quarry – before gyratory testing

Confining pressures of 5.2 and 10.3 psi were applied on the BGT triaxial test specimens, and pressures of 5.3, 10.4 and 15.2 psi were applied to the AGT specimens. The Mohr-Coulomb plots of the results are shown in Figure 45 and Figure 46. The resulting cohesion and friction angle values were 1.33 psi and 43.9° for the BGT specimens, decreasing to 0.181 psi and 43.4° for the AGT specimens. Therefore, the gyratory compaction caused a decrease of 86.4% in the cohesion and a decrease of 1.1% in the friction angle for this material.

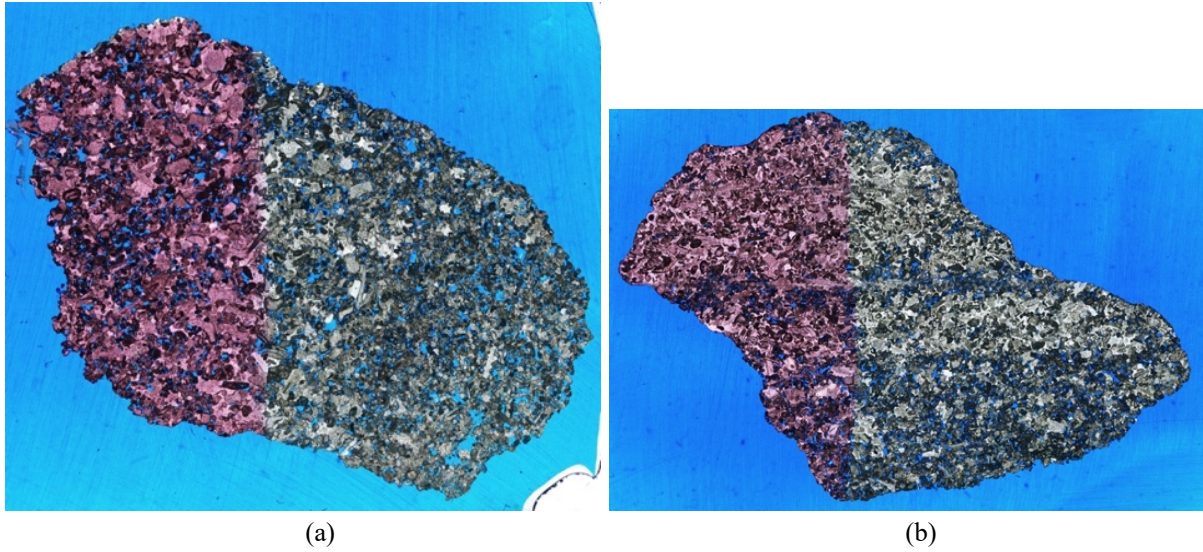
Figure 48. Magnified view of Rock Type 2 for Alden Quarry: (a) BGT sample with observed abundance of 30%, (b) AGT sample with observed abundance of 3%

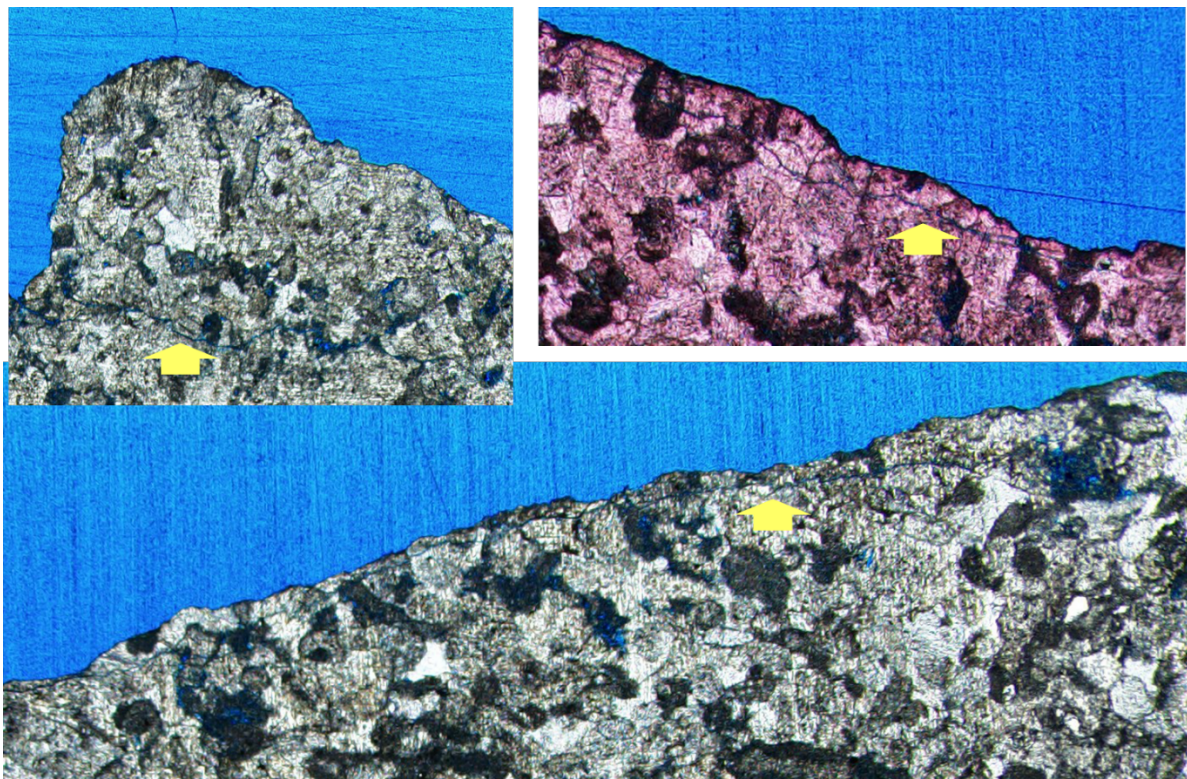
Figure 49. Magnified views of Rock Type 1 for Alden Quarry AGT sample

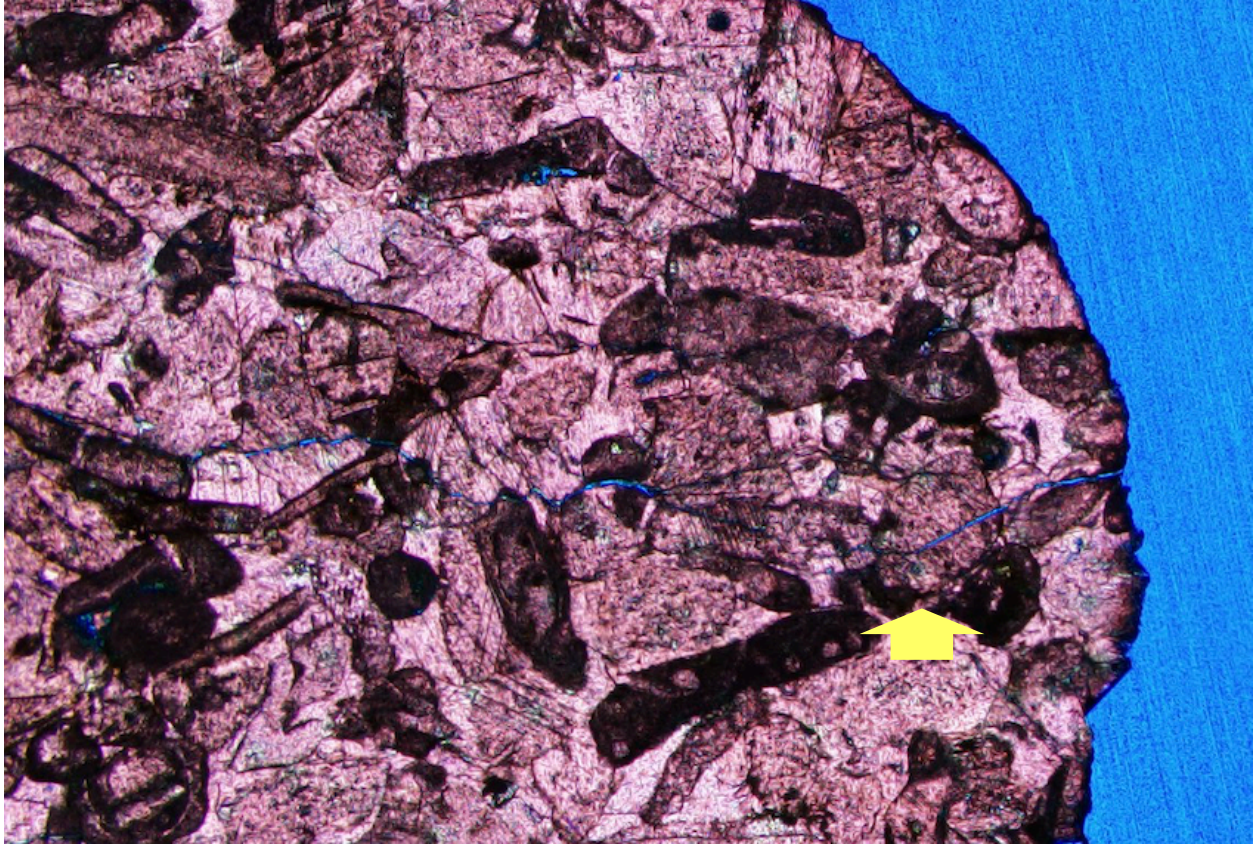
Figure 50. Magnified view of Rock Type 2 for Alden Quarry AGT sample

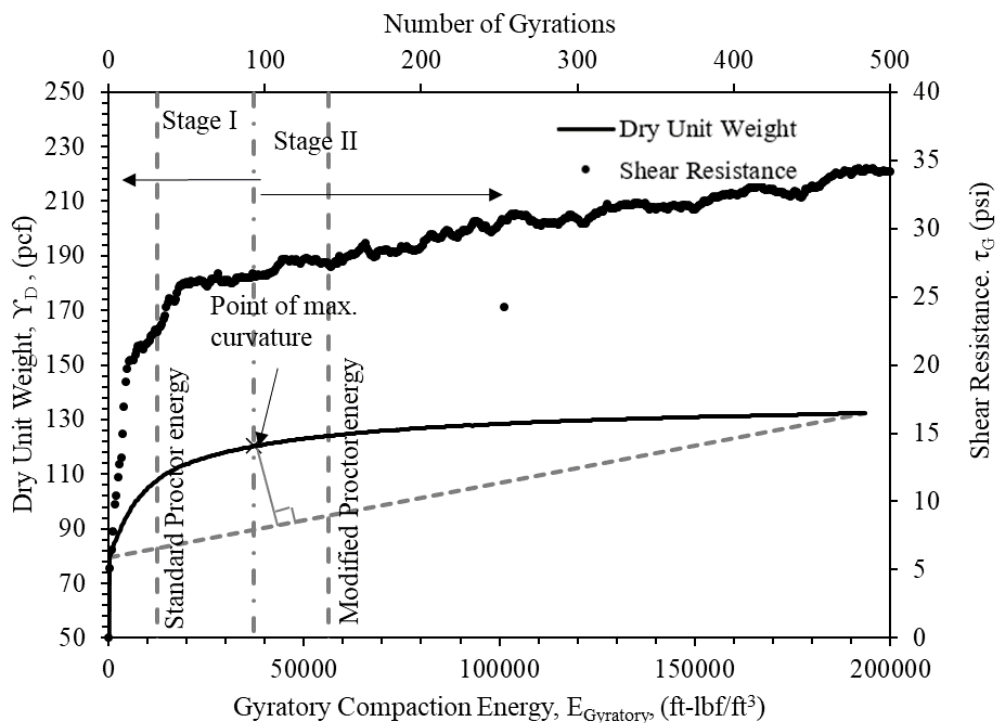
Figure 60. Relationships between dry unit weight, gyratory compaction energy, shear resistance, and number of gyrations for coarse aggregates from Gehrke Quarry

The dry unit weight, shear resistance, and void ratio during the gyratory compaction test are plotted in Figure 60 and Figure 61 with respect to the compaction energy and number of gyrations. The corresponding changes in compaction energy and dry unit weight for Stages I and II of the test are shown in Table 18. Through both test stages, a total decrease in void ratio of 74.4% and increase in dry unit weight of 66.5% were observed. The point of maximum curvature for dry unit weight in Figure 60 occurred at a dry unit weight of 120.32 pcf, in between the Standard and Modified Proctor compaction energy levels.

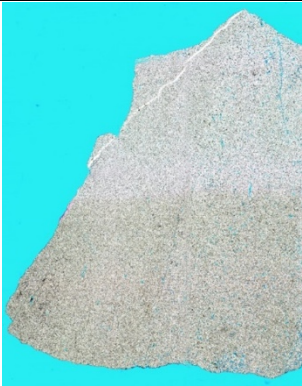
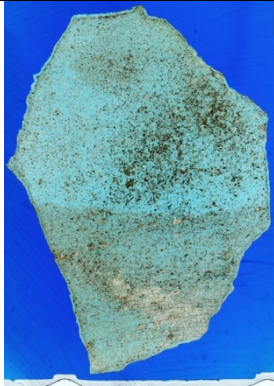
Geological Parameters	Rock Types		
	Rock Type 1	Rock Type 2	Rock Type 3
Grain Density (g/cm ³)	2.91	2.68	2.89
Abundance	63%	14%	9%
Porosity	Nonporous	Porous	Porous
Images of the Thin Sections

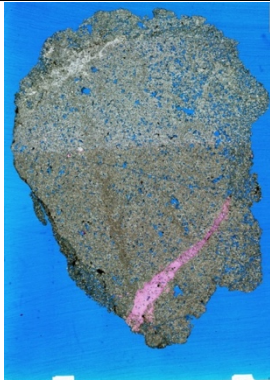
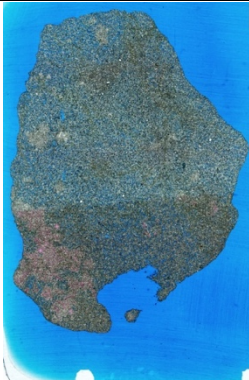
Rock Type 4	Rock Type 5	
	Grain Density (g/cm ³)	2.89	2.89
	Abundance	9%	6%
	Porosity	Minor-porosity	Porous
Images of the Thin Sections

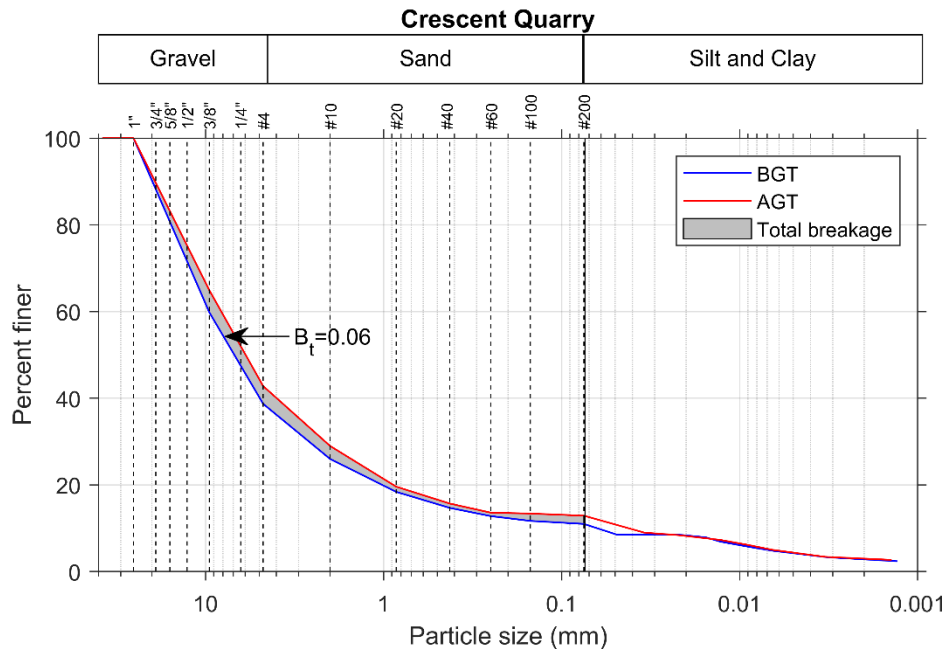
Figure 64. Particle size distributions from sieve and hydrometer analysis and evaluation of breakage of coarse fraction for samples from Crescent Quarry

Following the same procedures described in previous sections, particle size distribution analyses were carried out by laboratory sieve and hydrometer tests and 2D image analyses for the Crescent Quarry clean samples before and after a gyratory compaction test. The PSD curves from sieve and hydrometer analysis are presented in Figure 64, and the curves from 2D image analyses are presented in Figure 65. The mechanical degradation represented by Hardin's total breakage was determined to be 0.06 for the coarse fraction based on sieve and hydrometer data, and 0.05 for the gravel fraction based on the 2D image analyses. The corresponding breakage parameters, detailed in Table 20, show that the gravel fraction decreased by 4.1% during the gyratory test, while the sand and fines fractions increased by 3.8% and 0.3%, respectively.

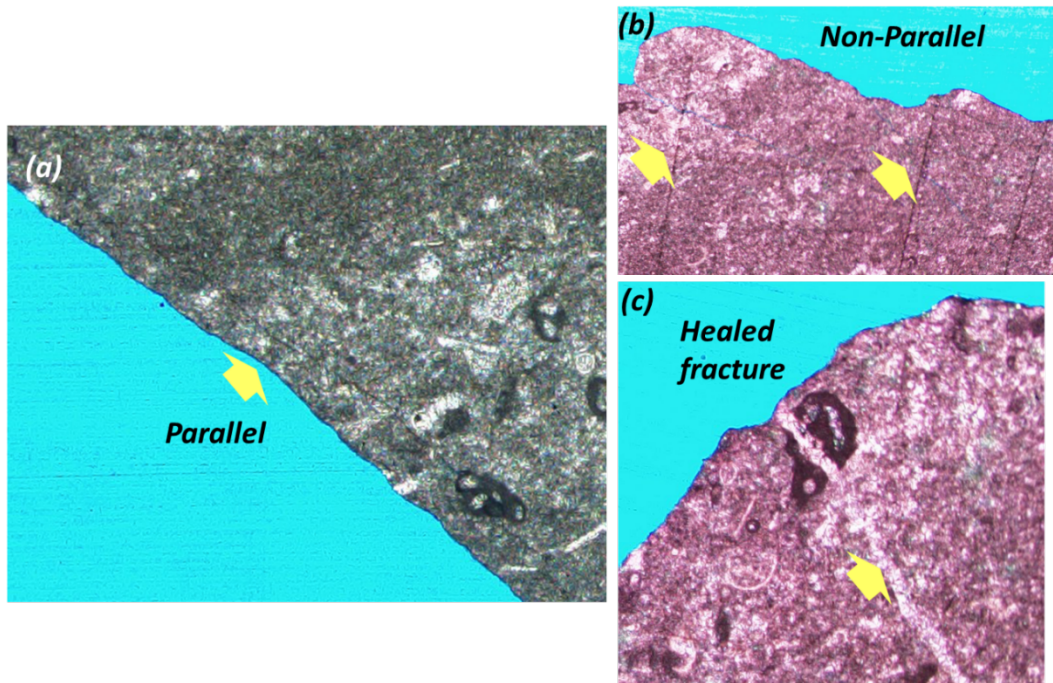
Figure 77. Magnified view of Rock Type 1 for Crescent Quarry AGT specimen: (a) cracks parallel to edge, (b) cracks nonparallel to edge, (c) healed fracture

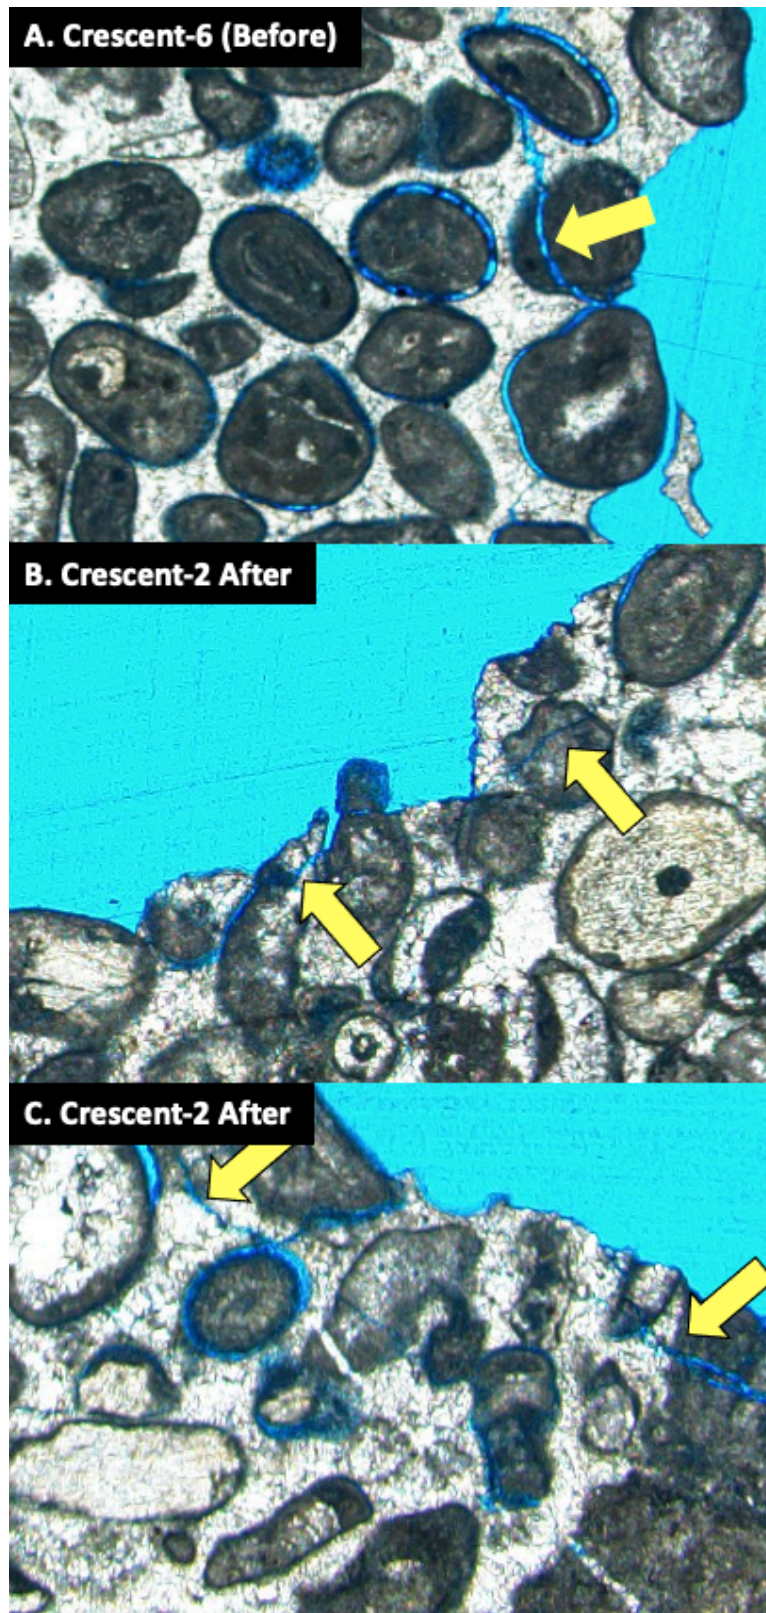
Figure 78. Grain-boundary hugging fractures visible in Crescent Rock Type 6 BGT and Rock Type 2 AGT

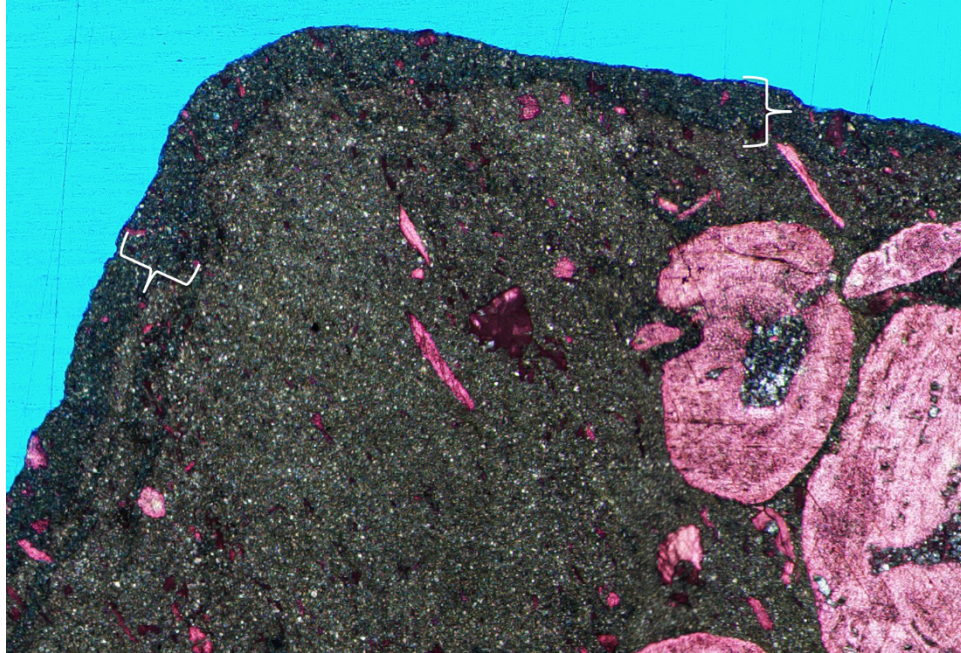
Figure 79. Magnified view of Rock Type 5 for Crescent Quarry AGT specimen showing porous rims

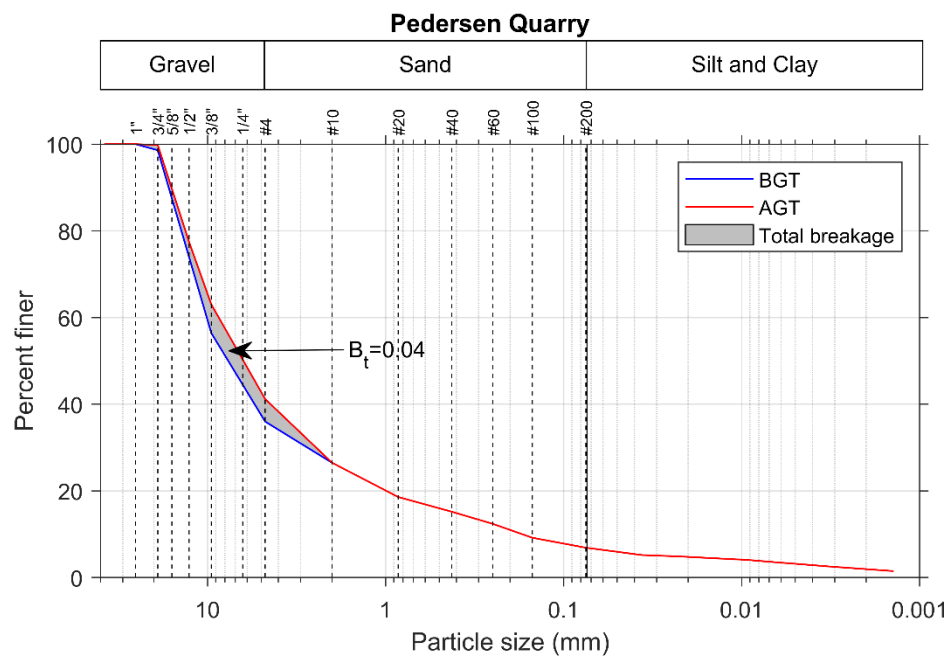
Figure 81. Particle size distributions from sieve and hydrometer analysis and evaluation of breakage of coarse fraction for samples from Pedersen Quarry

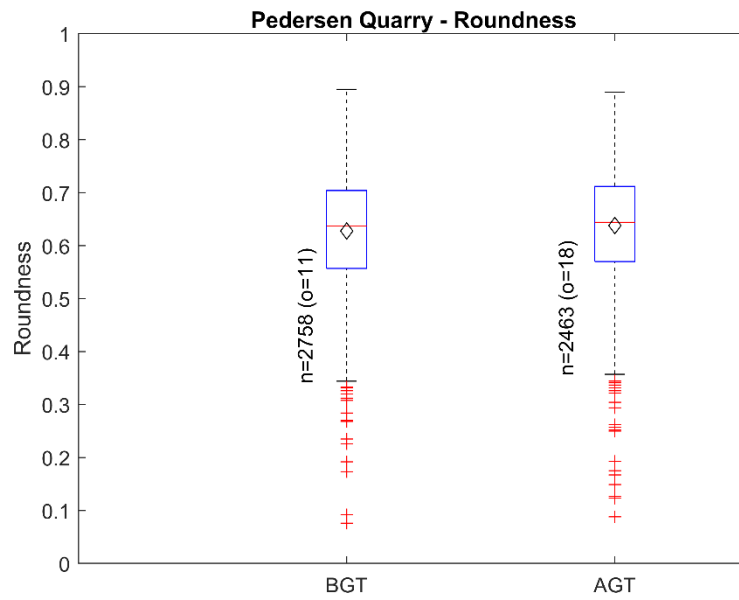
Figure 83. Comparison of roundness for BGT and AGT specimens from Pedersen Quarry

decreases of 0.4% in shape factor and roundness index along with a decrease of 5.7% in angularity were observed for the same specimens.

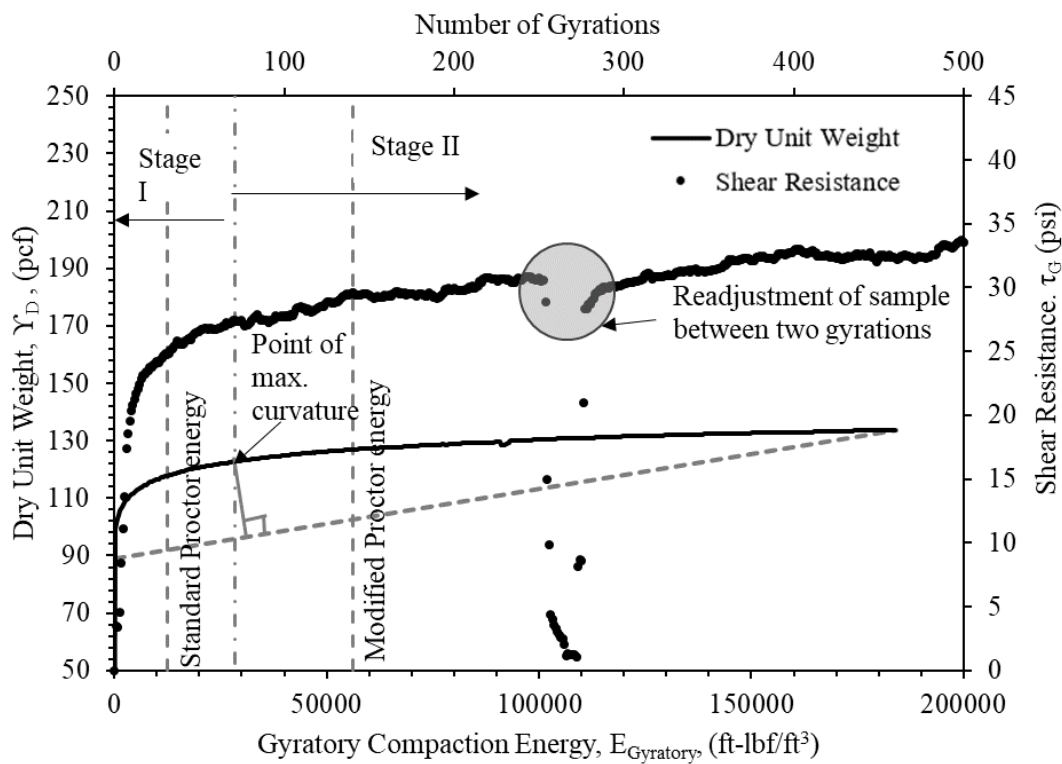
Figure 90. Relationships between dry unit weight, gyrotory compaction energy, shear resistance, and number of gyrations for coarse aggregates from Pedersen Quarry

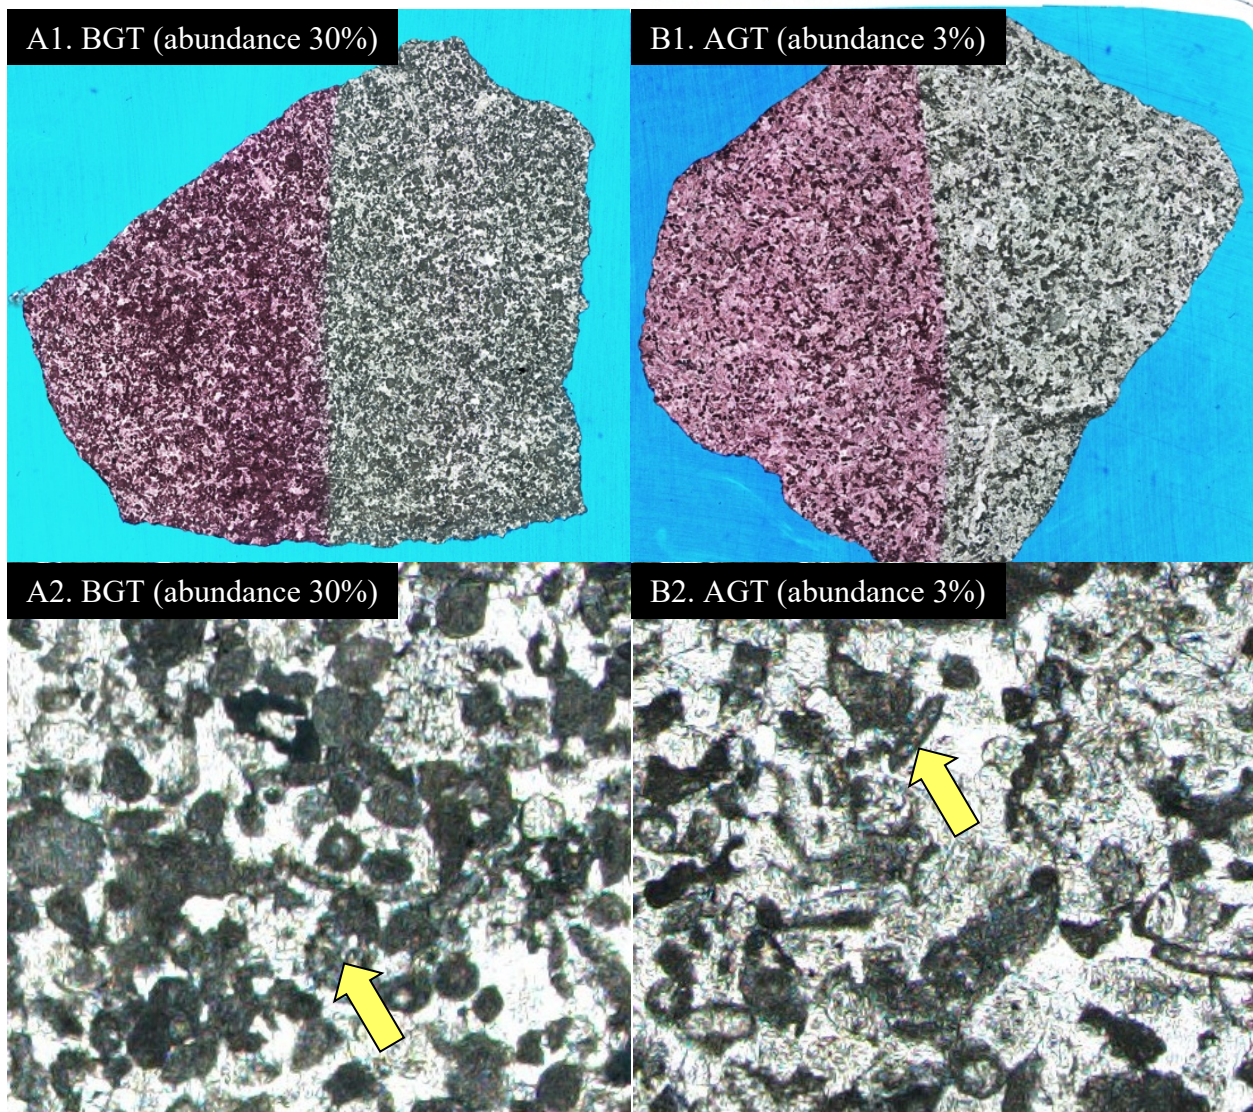
Figure 1. Macroscopic and microscopic views of thin sections of Pedersen Rock Type 2 BGT and AGT. Pore space is barely visible in macroscopic views (A1 and B1) but is more apparent at microscopic level (A2 and B2).

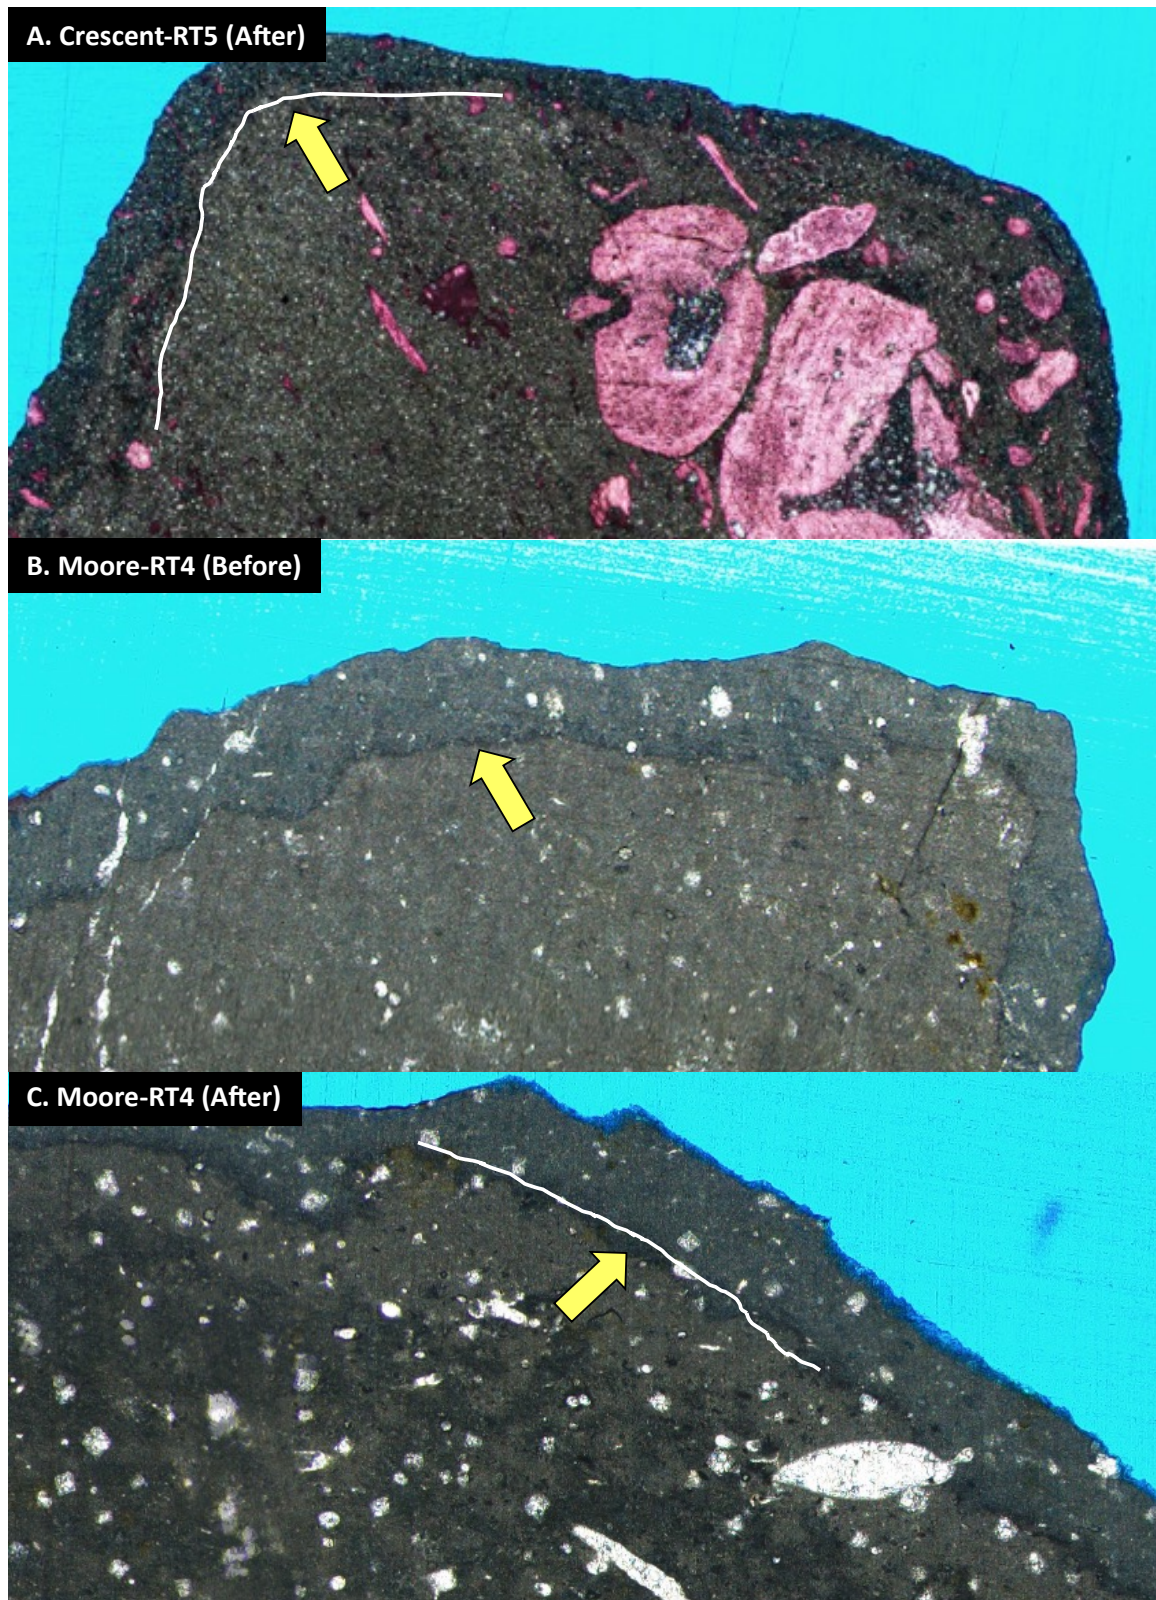
Figure 96. Porous rim visible in (A) Crescent Rock Type 5 AGT, (B) Moore Rock Type 4 BGT, and (C) Moore Rock Type 4 AGT
