Coarse Aggregate Deterioration in Granular Surfaces and Shoulders

**Final Report
April 2025**

1. Report No. IHRB Project TR-769	2. Government Accession No.	3. Recipient's Catalog No.	
4. Title and Subtitle Coarse Aggregate Deterioration in Granular Surfaces and Shoulders		5. Report Date April 2025

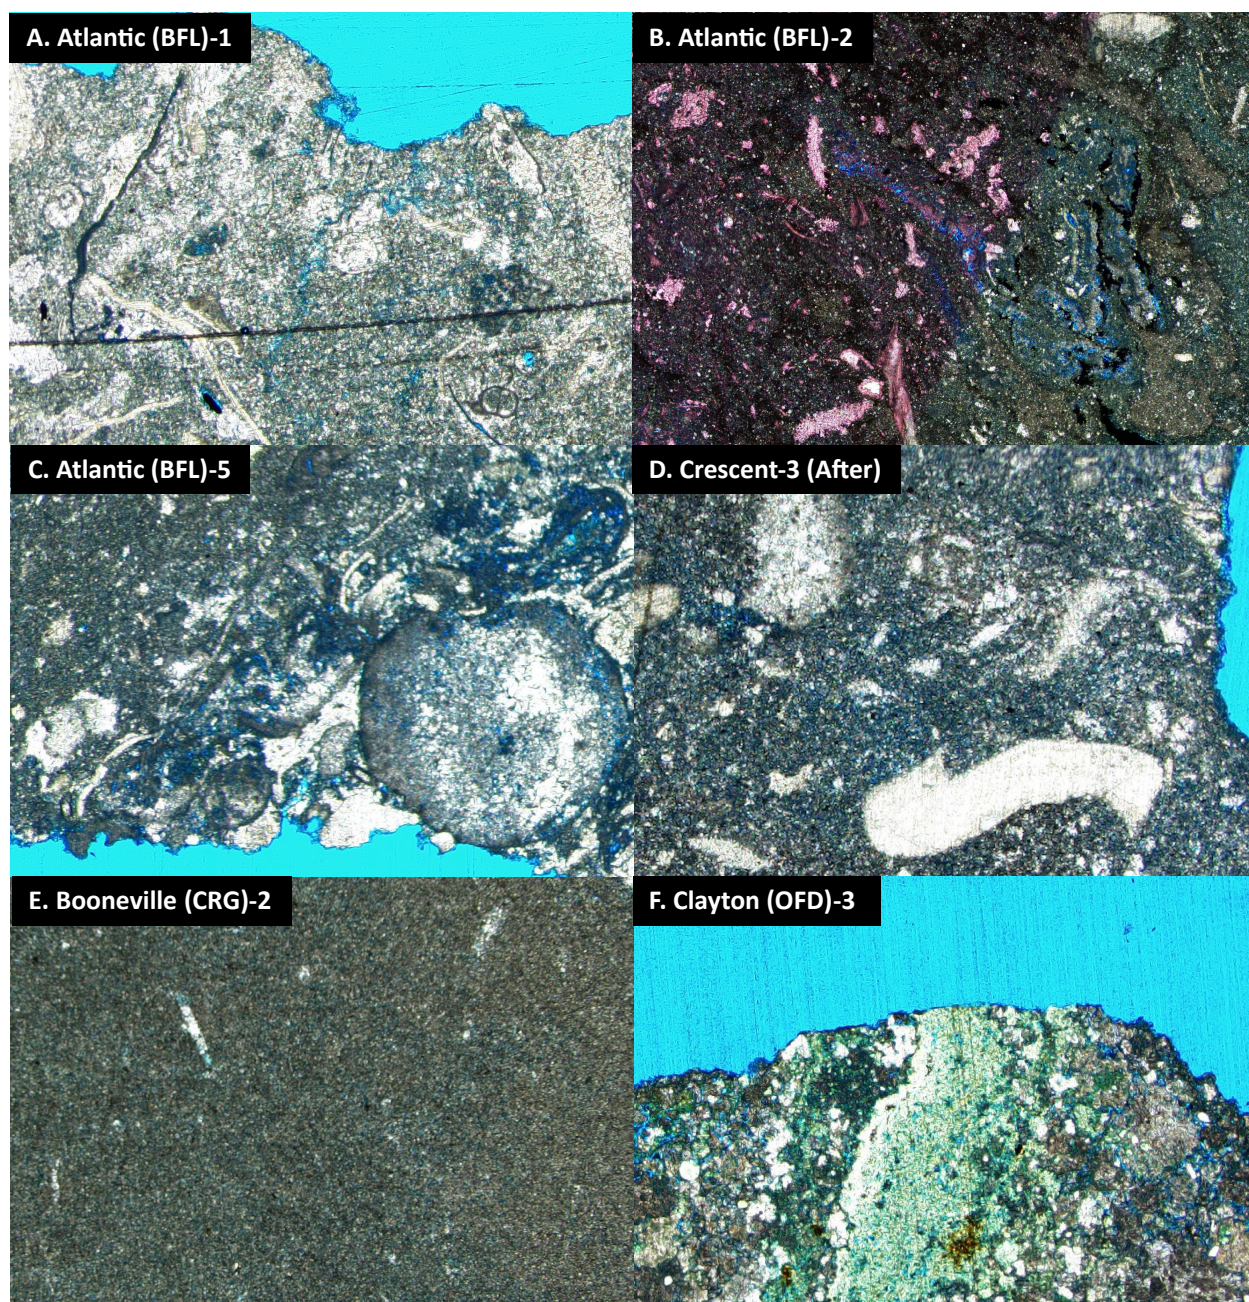
Figure 98. Examples of microporosity (highlighted by blue-dyed epoxy) manifesting as a hazy matrix between grains

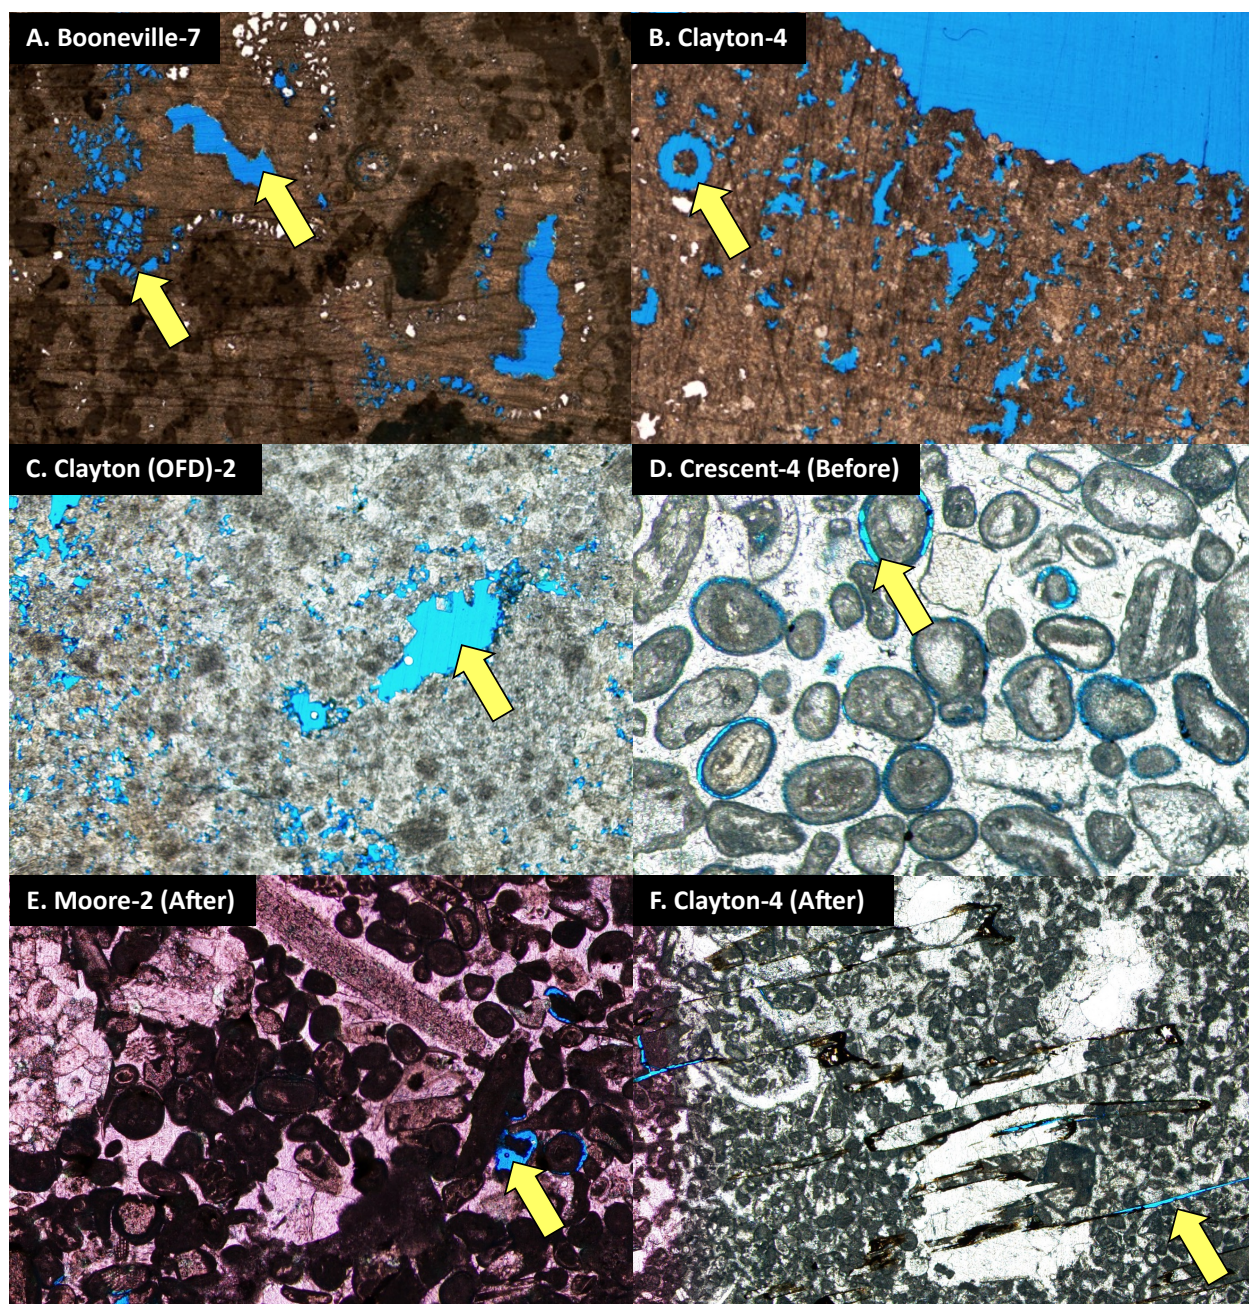
Figure 99. Examples of separate vuggy pore space (highlighted by blue-dyed epoxy) manifesting as pore spaces between sedimentary grains either completely disconnected from other pores or only connected through a microporous matrix

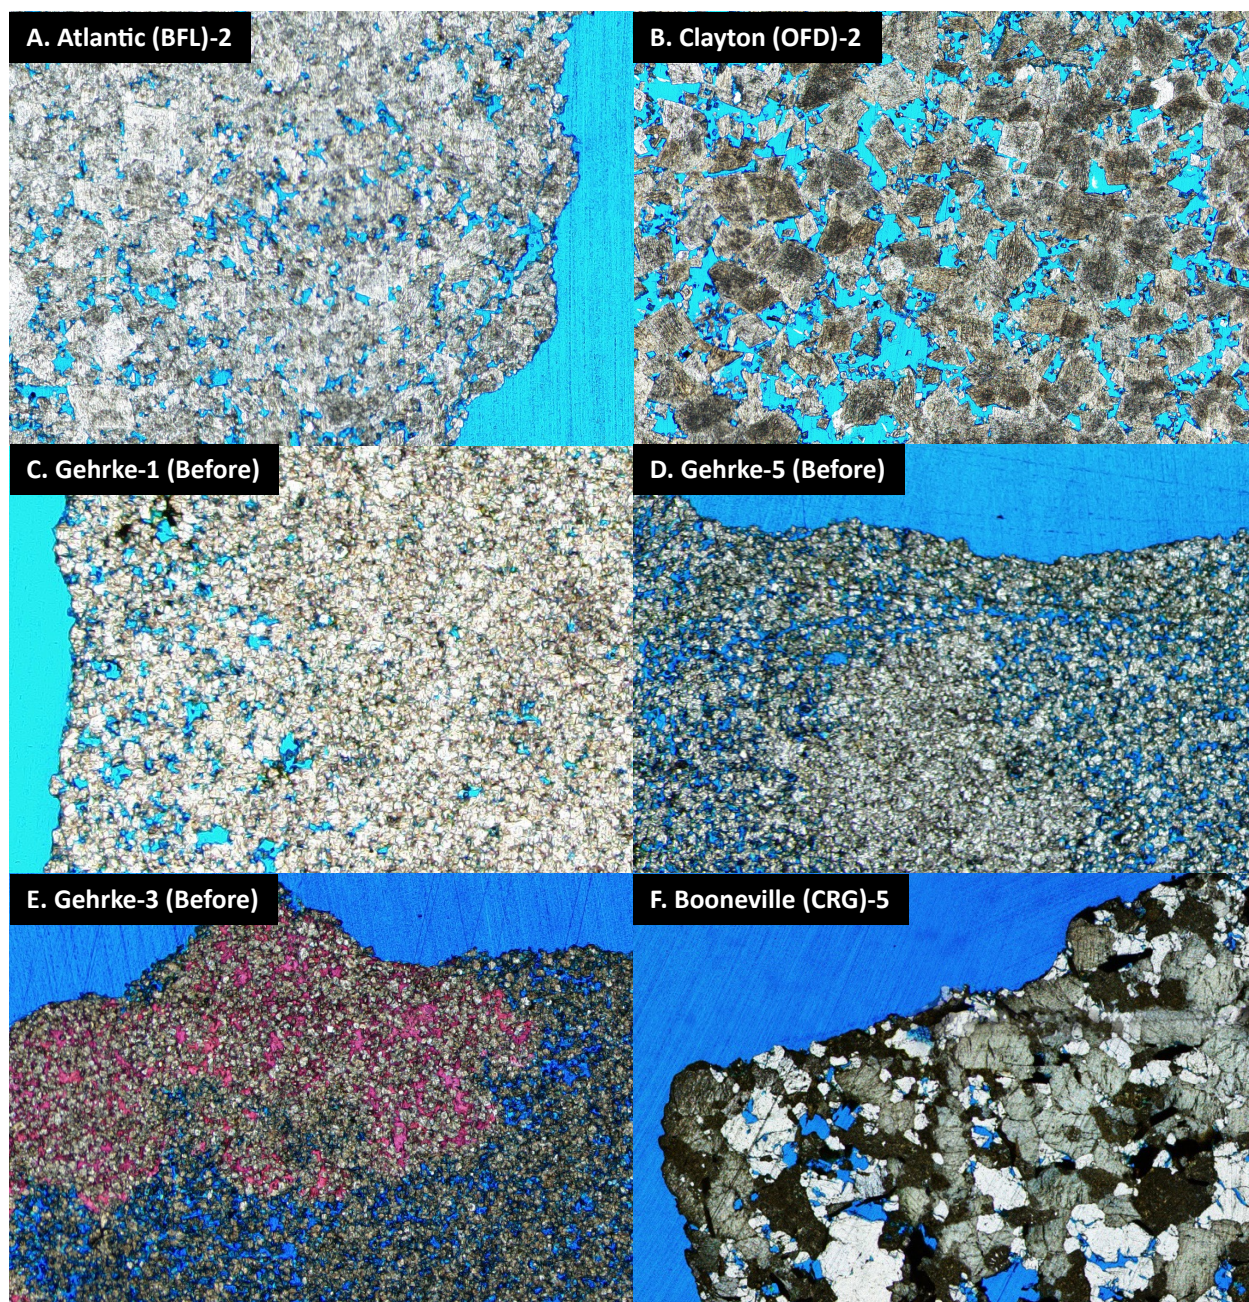
Figure 100. Examples of intercrystalline pore space

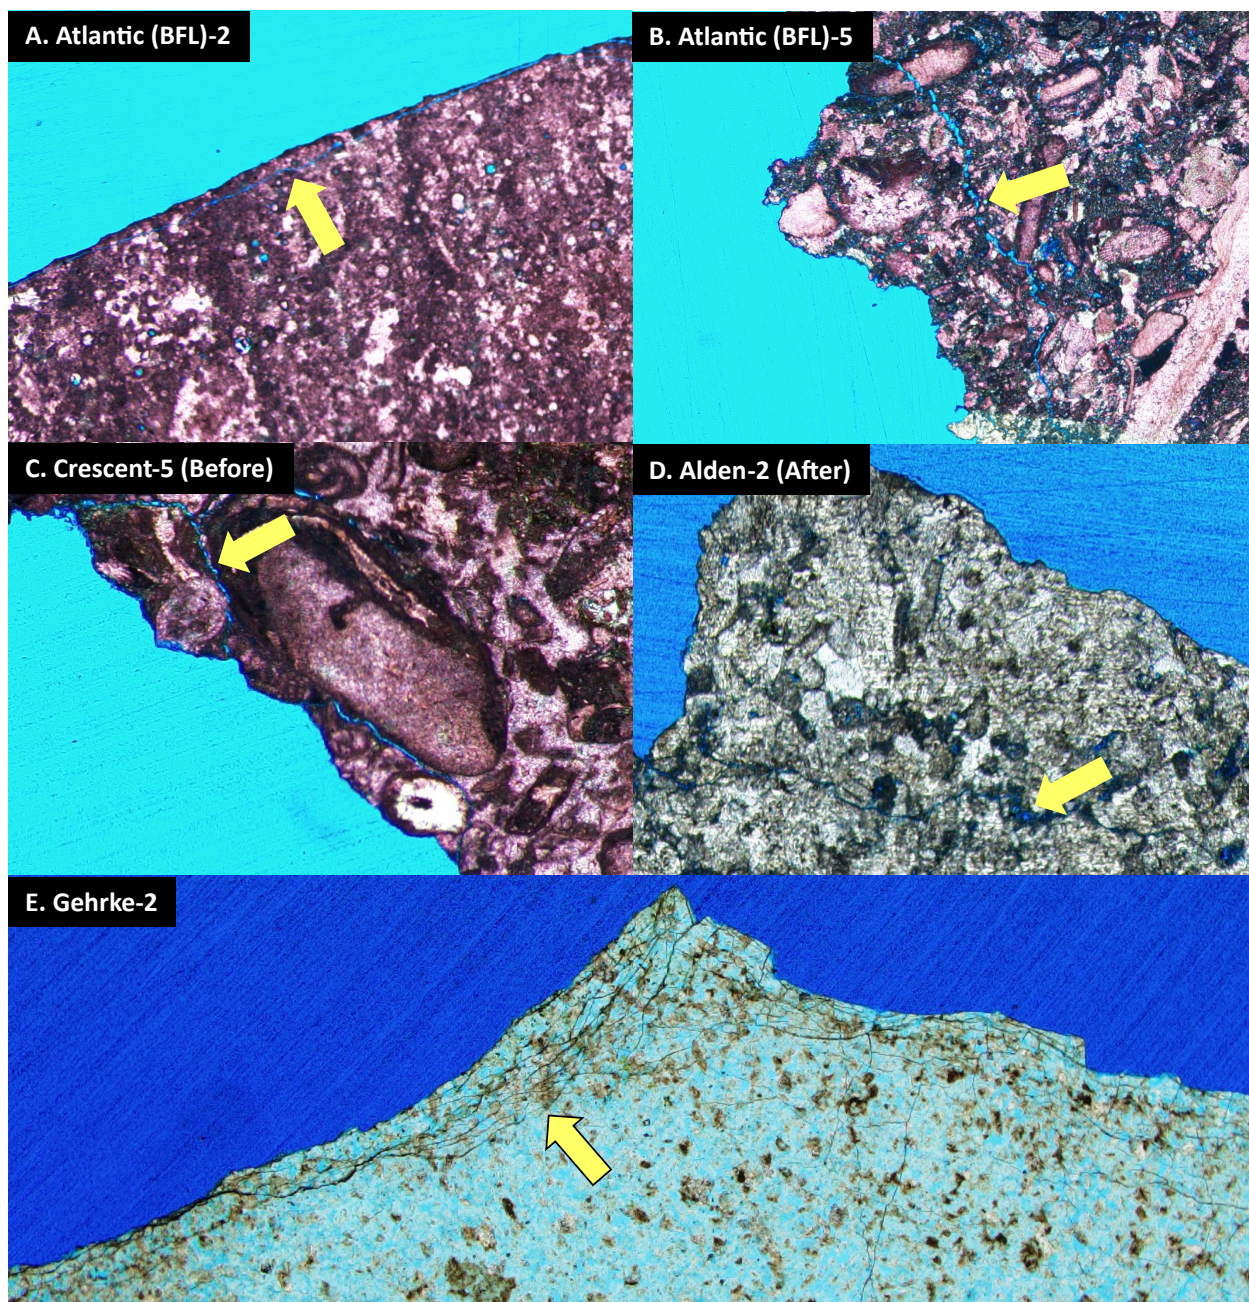
Figure 101. Hairline fractures parallel to particle edges visible in various rock types before and after compaction

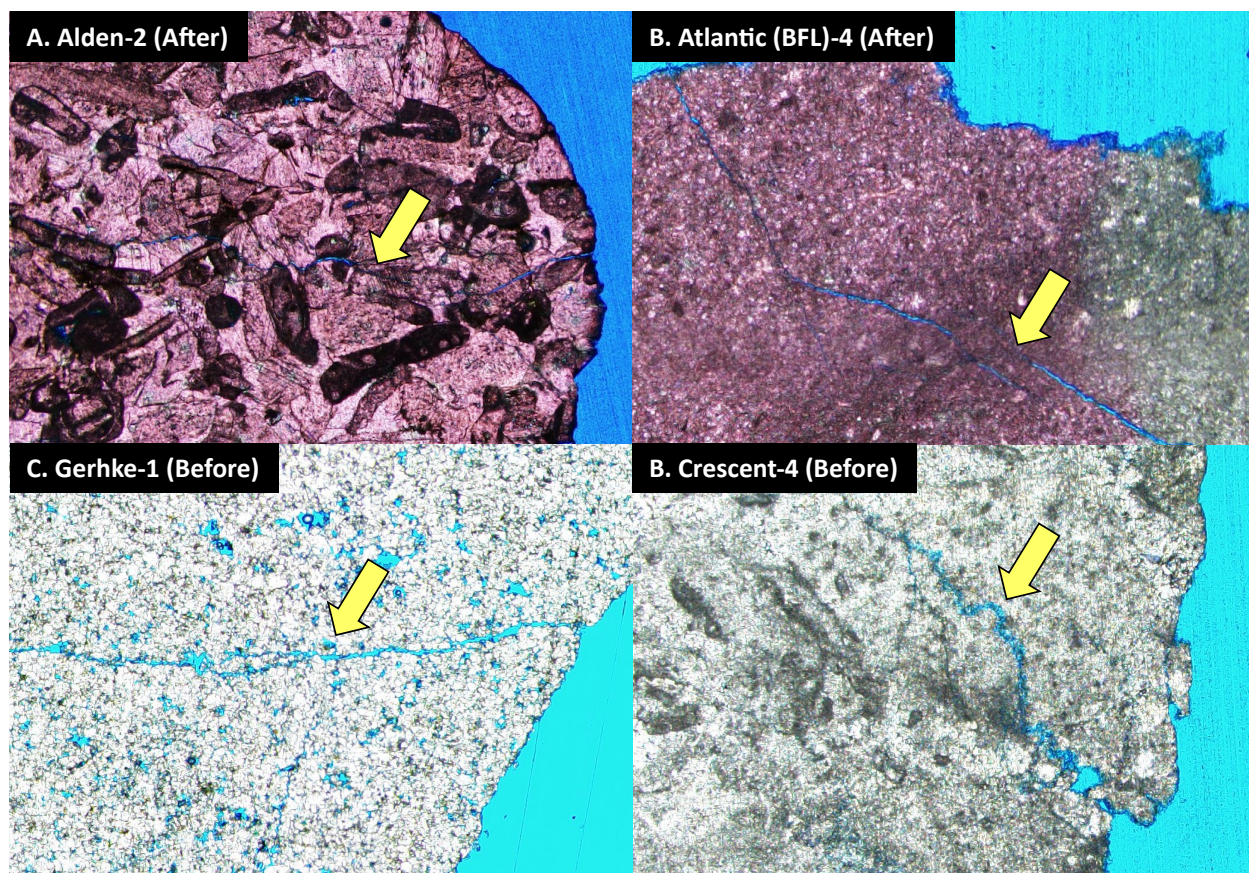
Figure 102. Hairline fractures perpendicular to particle edges visible in numerous rock types before and after gyratory compaction

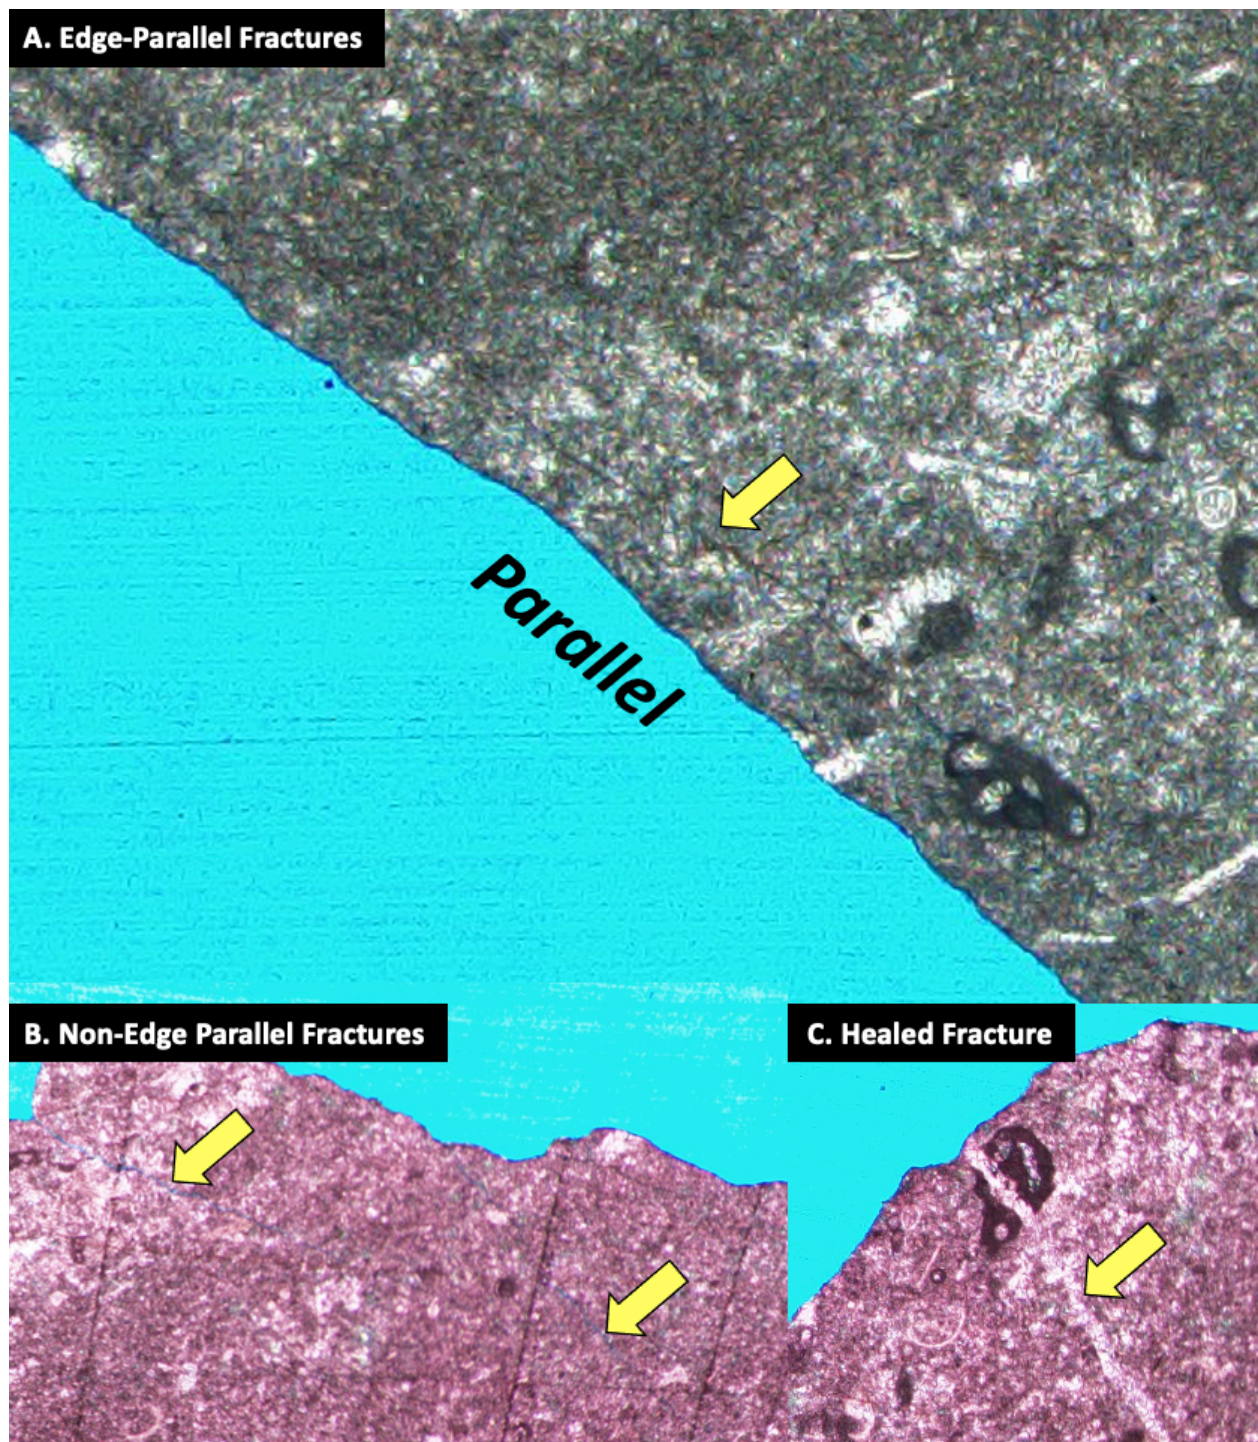
Figure 103. Hairline fractures parallel (A) and nonparallel (B) to particle edges in Crescent Rock Type 1 after gyratory compaction. Evidence of healed fractures from before quarrying (C) were also visible.

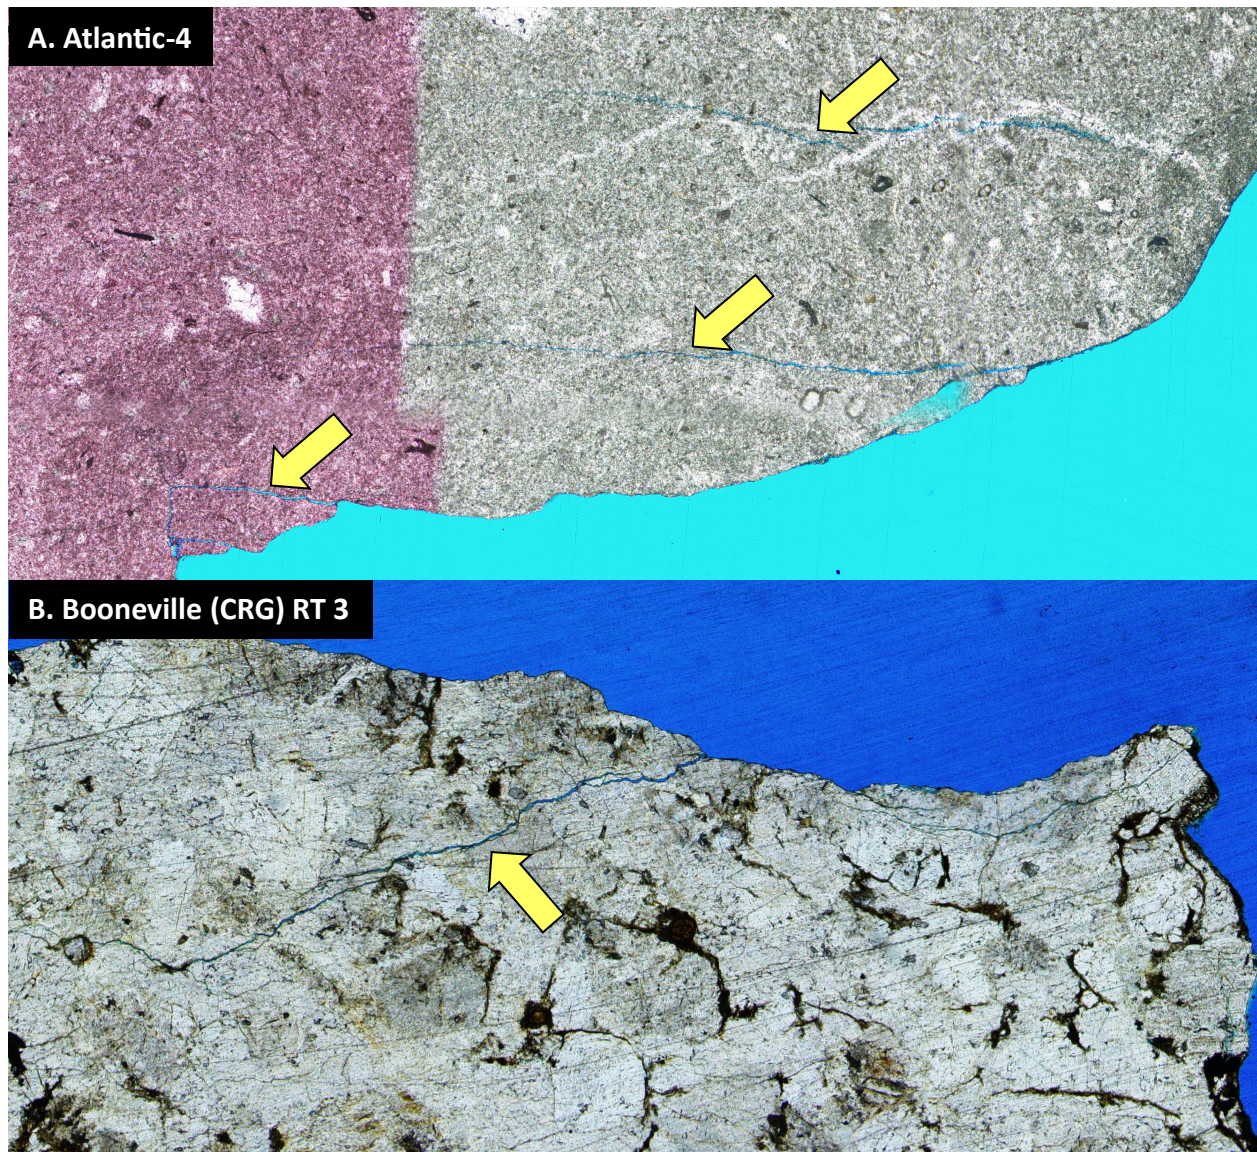
Figure 104. Multiple hairline fractures extending oblique from particle edge in Atlantic (BFL) RT4 and Booneville (CRG) RT3

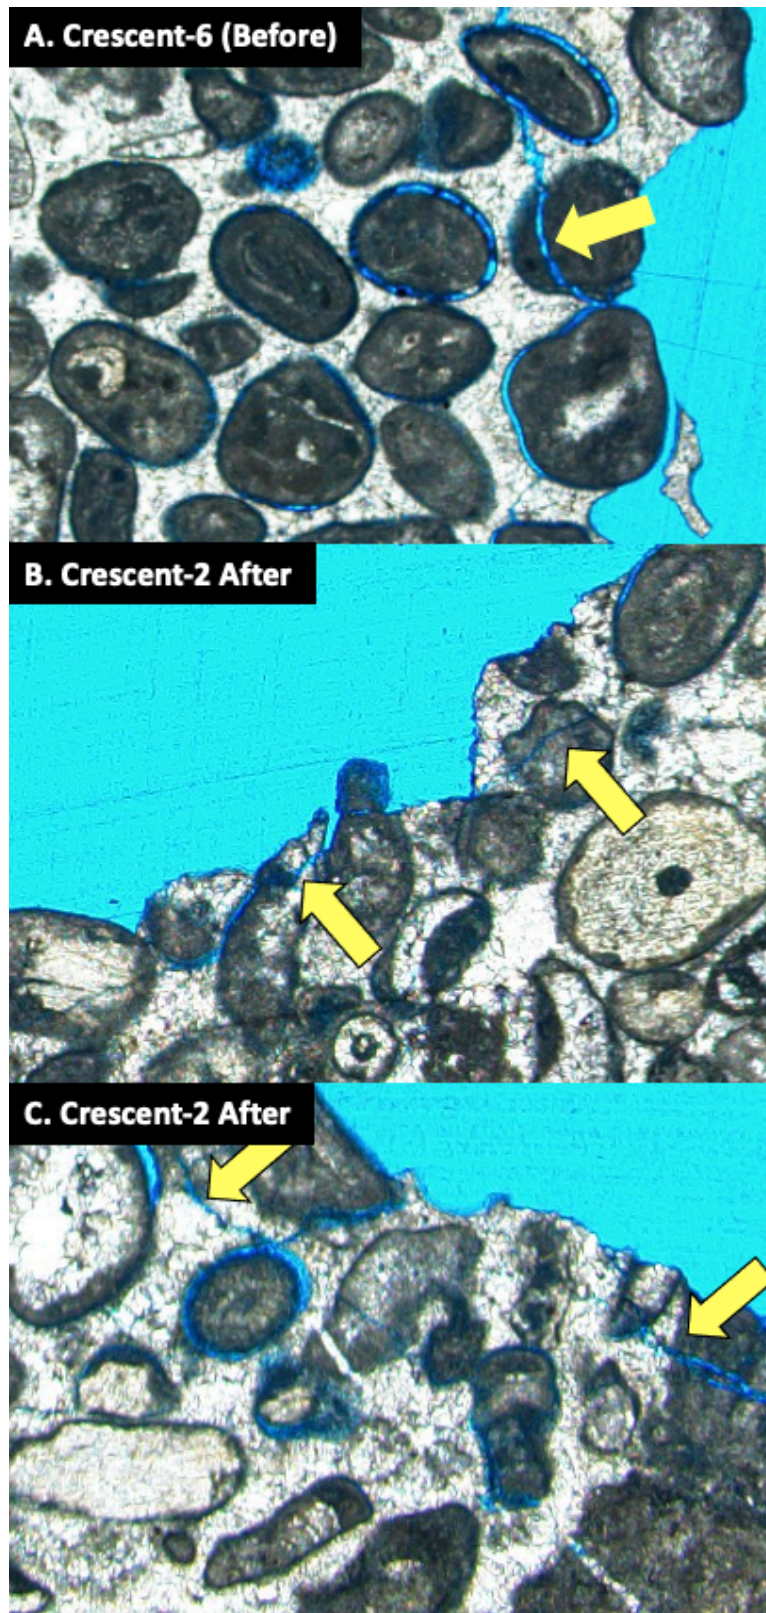
Figure 105. Grain-boundary hugging fractures visible in Crescent RT6 (BGT) and Crescent RT2 (AGT)

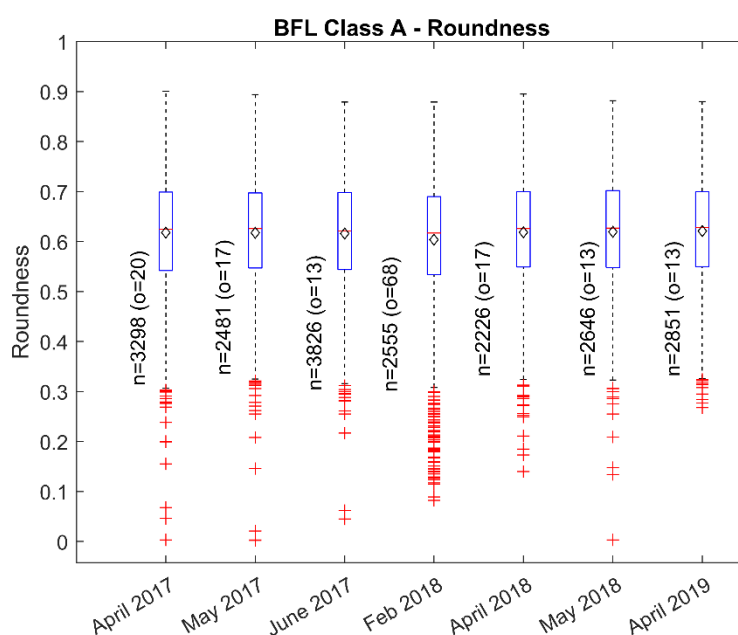
Figure 116. Comparison of roundness for BFL Class A samples collected over time

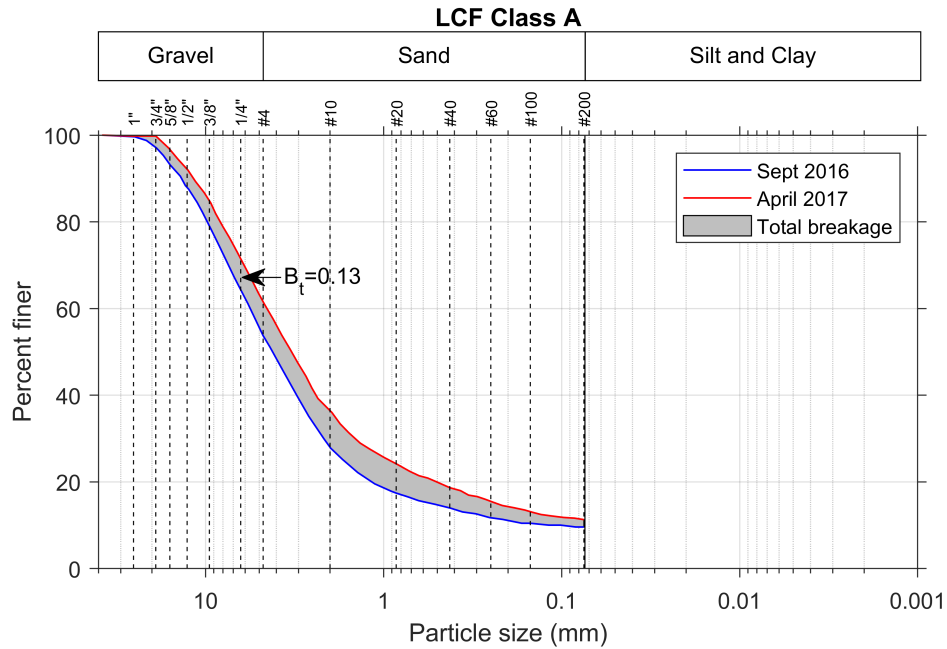
Figure 124. Particle size distributions of coarse fraction from sieve analysis and evaluation of total breakage between September 2016 and April 2017 for LCF Class A test section

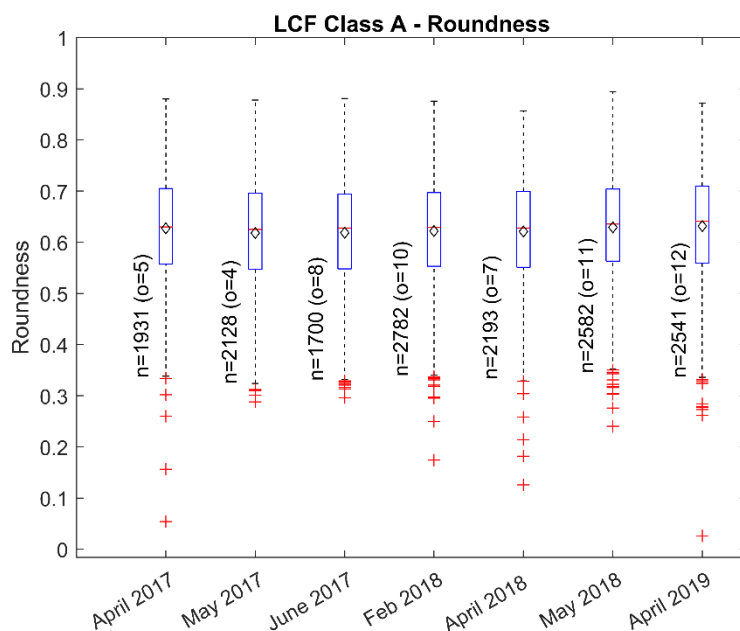
Figure 135. Comparison of roundness for LCF Class A samples collected over time

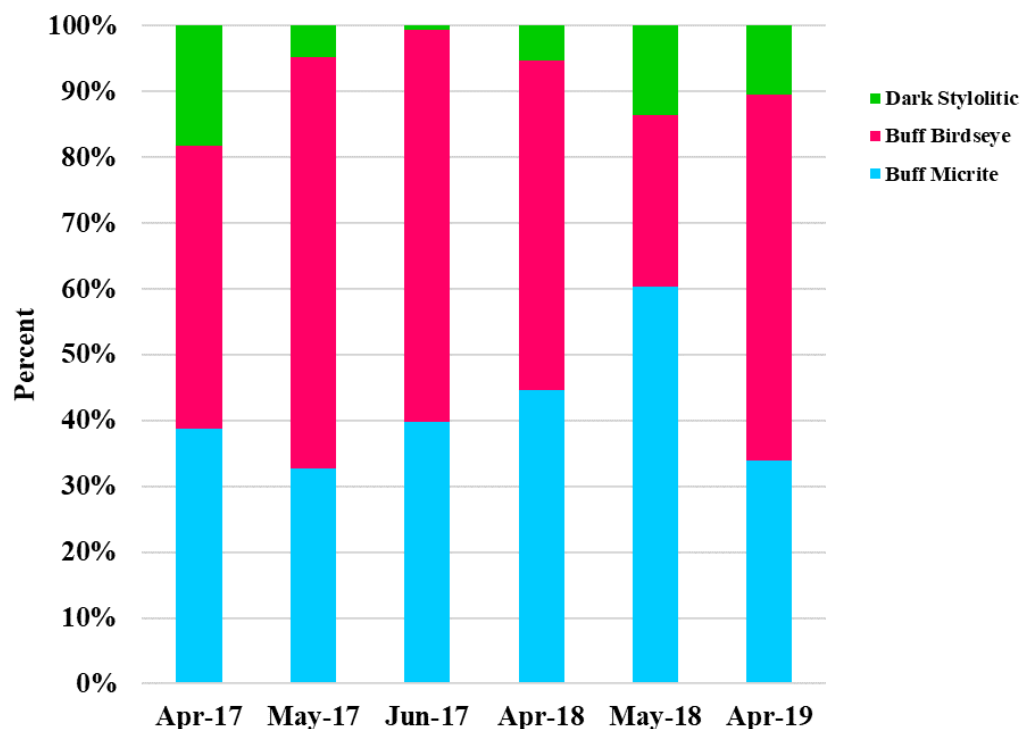
Figure 141. Percentages of rock types in LCF Class A samples collected over time

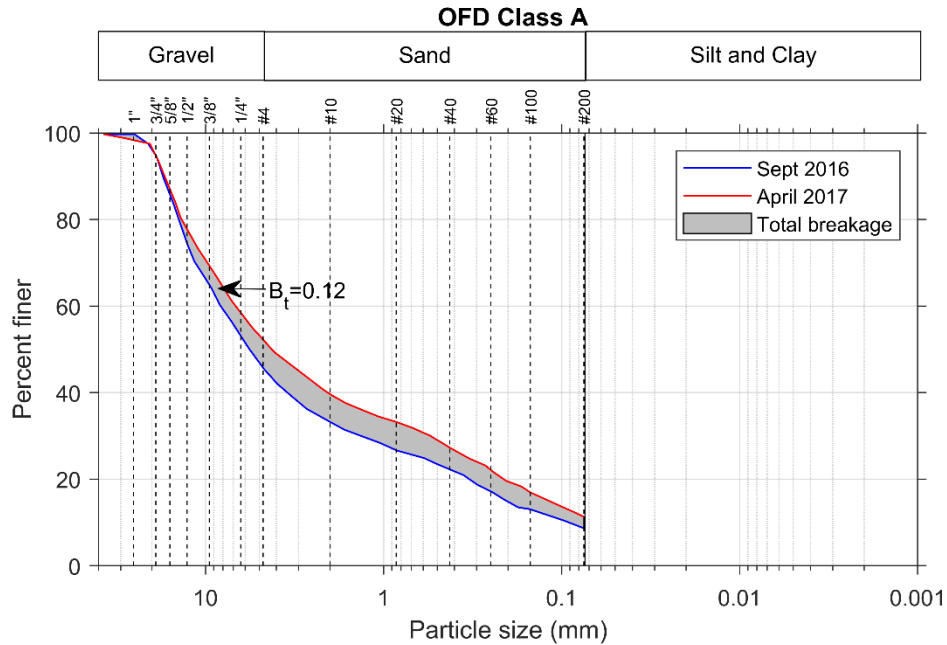
Figure 143. Particle size distributions of coarse fraction from sieve analysis and evaluation of total breakage between September 2016 and April 2017 for OFD Class A test section

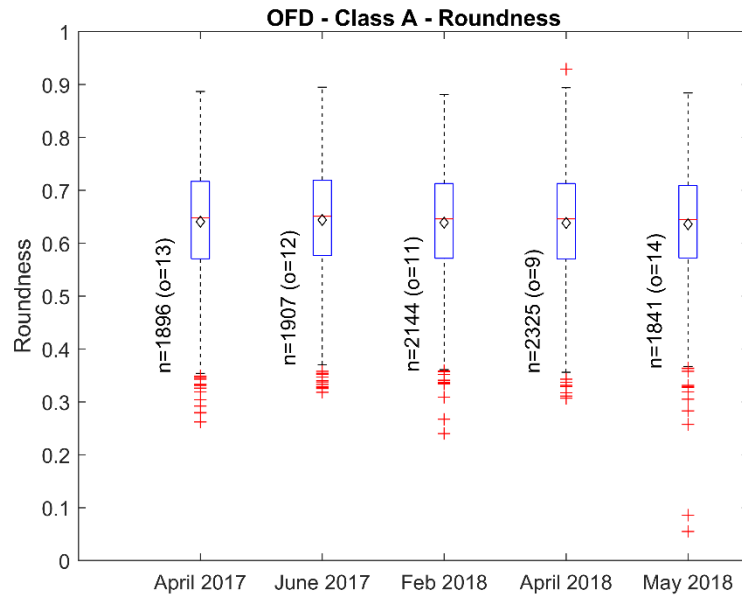
Figure 152. Comparison of roundness for OFD Class A samples collected over time

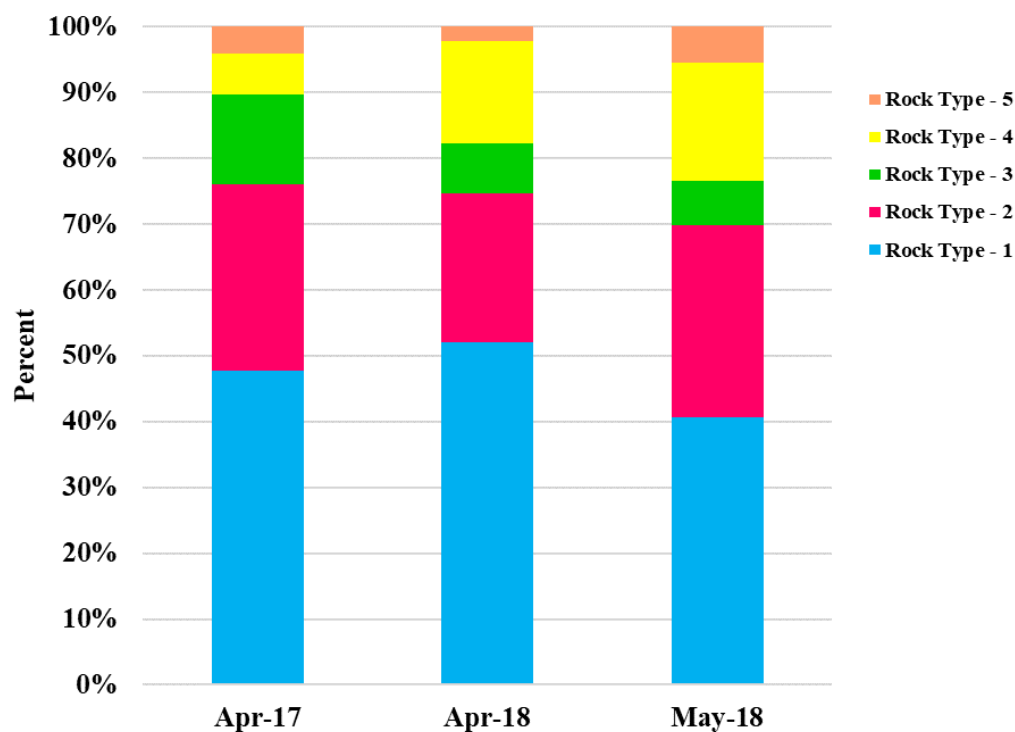
Figure 158. Percentages of rock types in OFD Class A samples collected over time

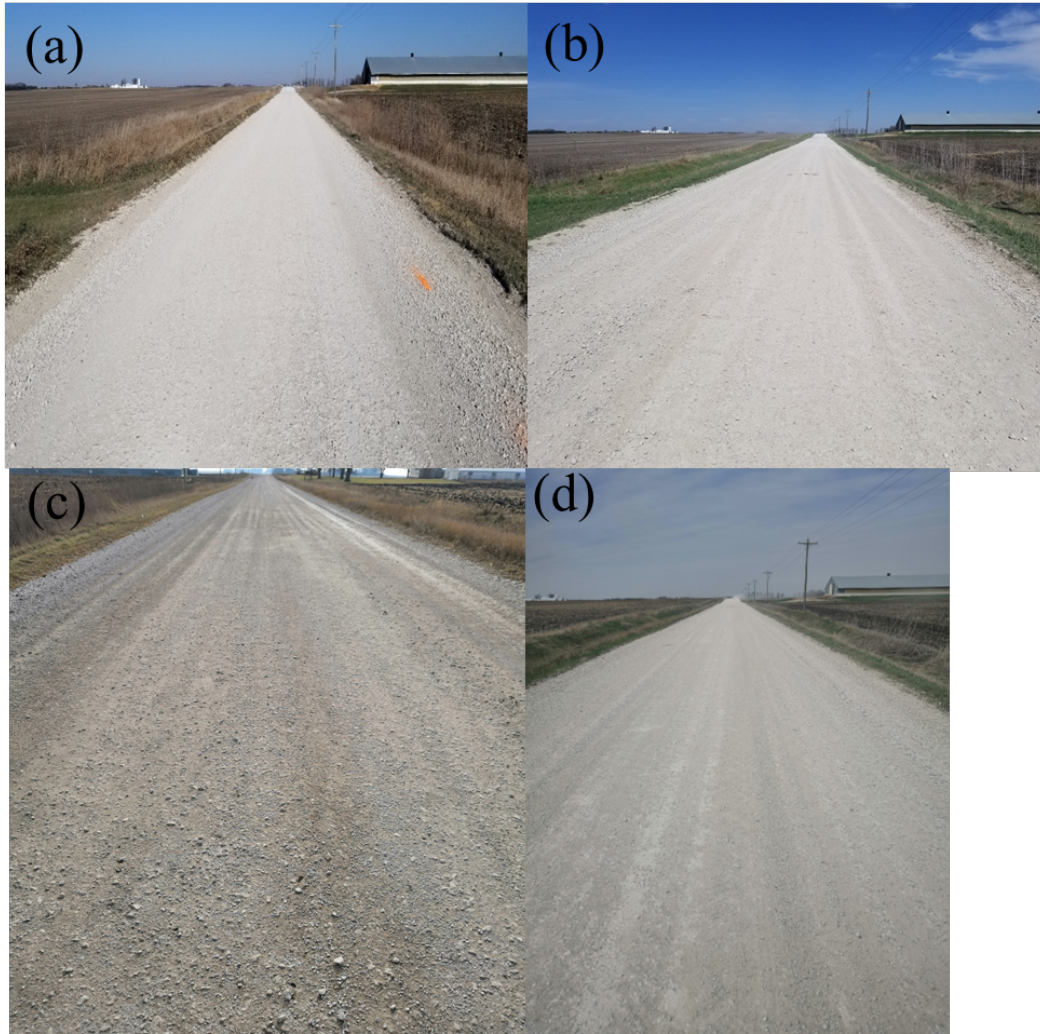
Figure 220. Visual surveys of Hamilton County OGCS section over time: (a) fall 2018, (b) spring 2019, (c) fall 2019, (d) spring 2020

Visual surveys of the Hamilton County OGCS section over the duration of the TR-721 project are shown in Figure 220. As seen in the photos, the increase in cohesion offered by the clay fines in the slurry resulted in improved binding of the aggregates, reducing their loss and slowing their degradation relative to the control section.

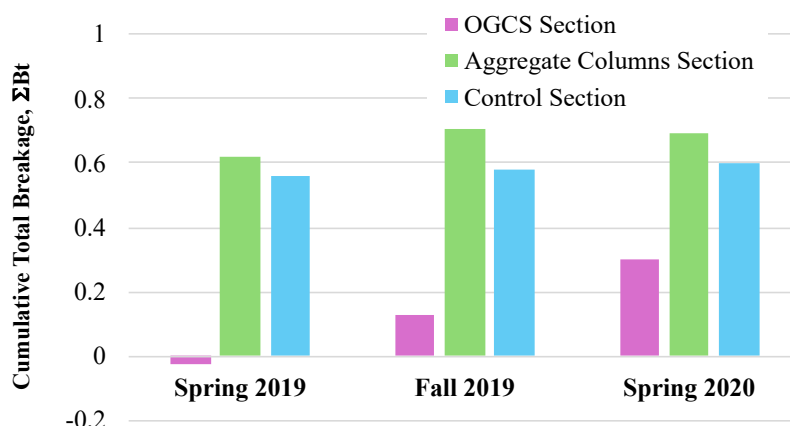
Figure 235. Comparison of cumulative total breakage of samples from Hamilton County OGCS section, Aggregate Columns section, and Control section collected over time

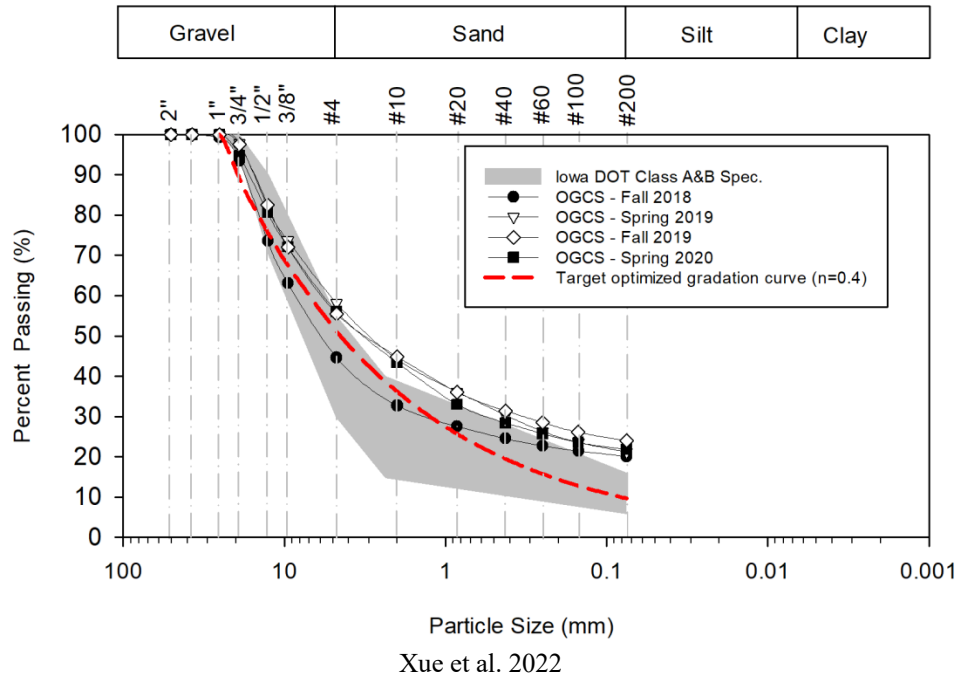
Figure 252. Particle size distribution curves of Washington County OGCS section for samples collected over time

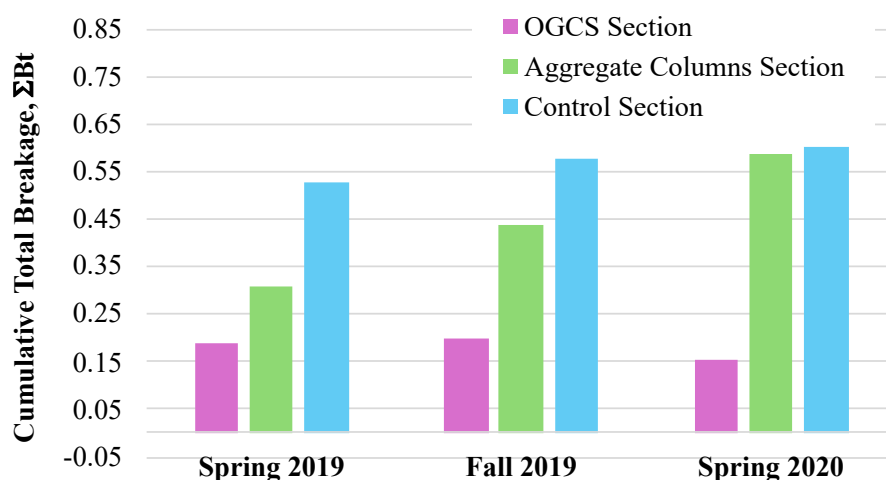
Figure 274. Comparison of Hardin’s total breakage of samples from Washington County OGCS section, Aggregate Columns section, and Control section collected over time

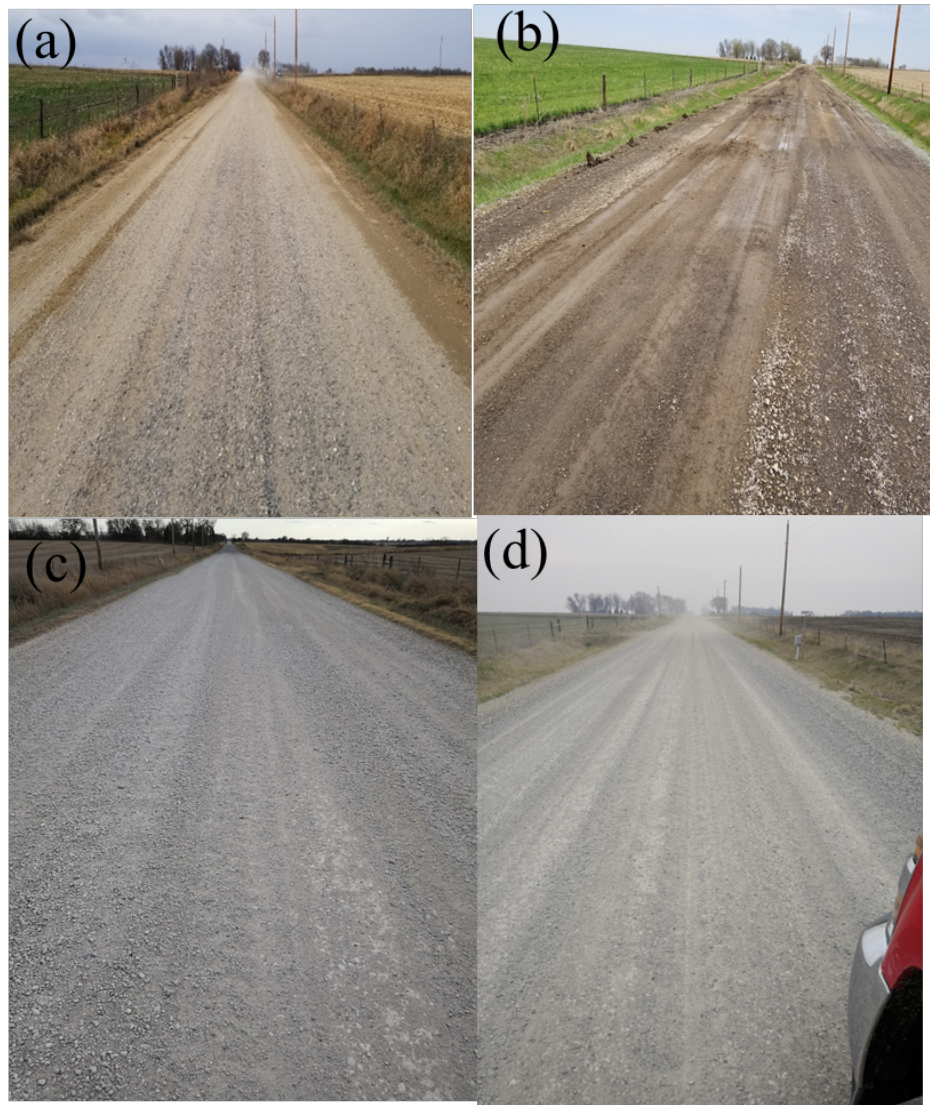
Figure 296. Visual surveys of Cherokee County Control section over time: (a) fall 2018, (b) spring 2019, (c) fall 2019, (d) spring 2020

Photos from visual surveys of the Cherokee County Control section taken over time are shown in Figure 296. The visual surveys confirmed that the gravel fraction of the surfacing materials decreased over time from fall 2018 to fall 2019 while the sand and fines fractions increased. The section also exhibited significant rutting and frost boils in spring 2019.

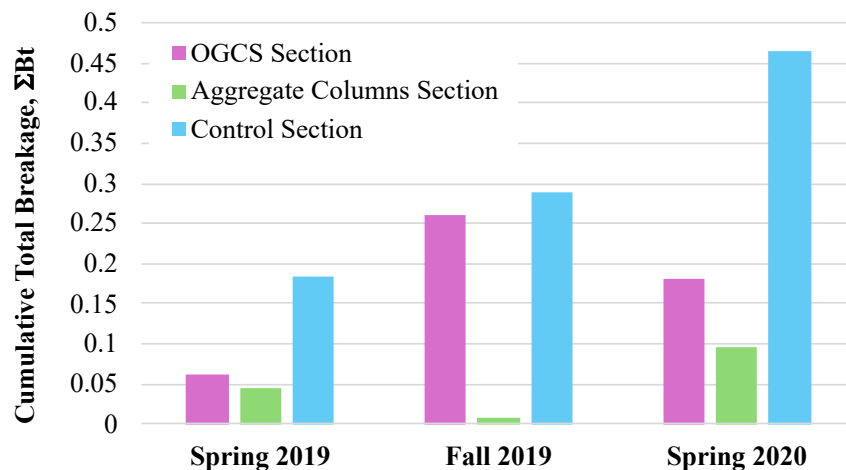
Figure 319. Comparison of cumulative total breakage of samples from Cherokee County OGCS section, Aggregate Columns section, and Control section collected over time

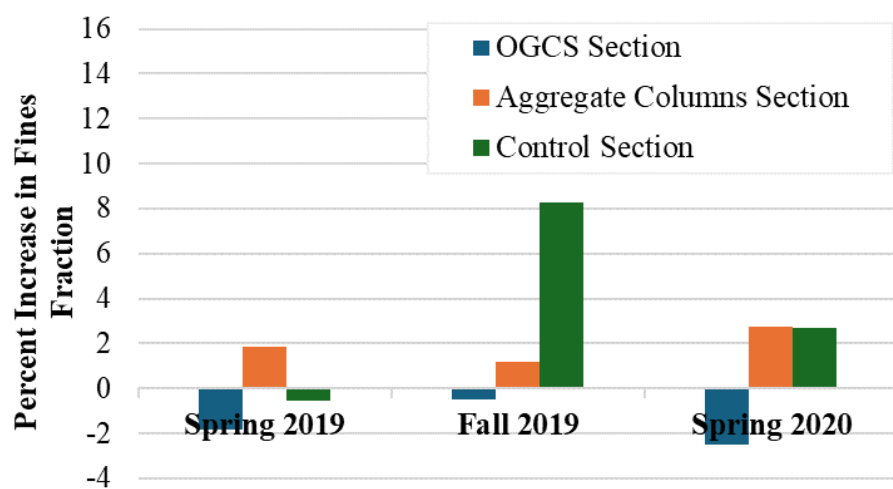
Figure 326. Comparison of percent increase in fines fraction relative to 2018 for samples from Cherokee County OGCS section, Aggregate Columns section, and Control section collected over time
