Federal Highway Administration University Course on Bicycle and Pedestrian Transportation

Lesson 22: Tort Liability and Risk Management

July 2006

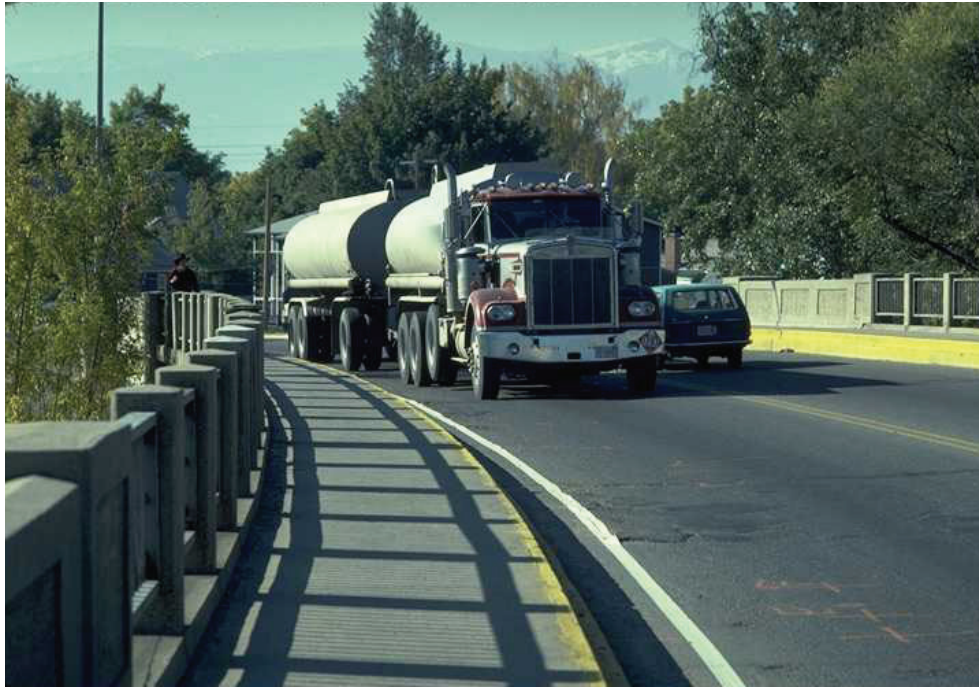
Figure 22-2. Photo. Bridges are a recurring theme in many tort liability claims.

Example Case 4. On a bridge that provides the main linkage to downtown, the surface is badly broken up, the pavement has deteriorated on the decking, and seams have been patched over, leaving dangerous ridges (see figure 22-2). This bridge is known to be heavily used by bicycles, and the city has written to the State three times asking that the bridge be repaired due to the potential hazard. Because of these and other hazards, bicyclists cannot ride too near the curb and crowd the motorists in narrow lanes. The State has not responded, despite repeated requests for action.

A semi-tractor-trailer left his air brake on. As he approached the bridge, he released his foot, activating the brake, which caused a loud noise. A 23-year-old woman bicycling across the bridge heard the noise behind her and moved closer to the curb. The trucker once again activated the brake, causing another loud noise as he approached the bicyclist. The bicyclist panicked, rode into the curb, fell, and was killed by the truck. The bicyclist's family and the truck driver's insurance company both sued the State.

Because of the letter written by the city and the length of time the condition had been present, the State settled out of court. In addition to the poor pavement conditions, it was found that the bridge sloped slightly to the right and the State had, over time, let the centerline of the roadway drift toward the right. The right-hand lane was 4.0 m (13 ft) wide, while the left-hand lane width was 5.2 m (17 ft). The bicyclist was forced to share a dangerously narrow lane with both hazardous pavement conditions and heavy truck traffic. The lesson here is to take action promptly in response to identification of hazards, even if it means only the interim measure of posting warning signs until the correction can be made.

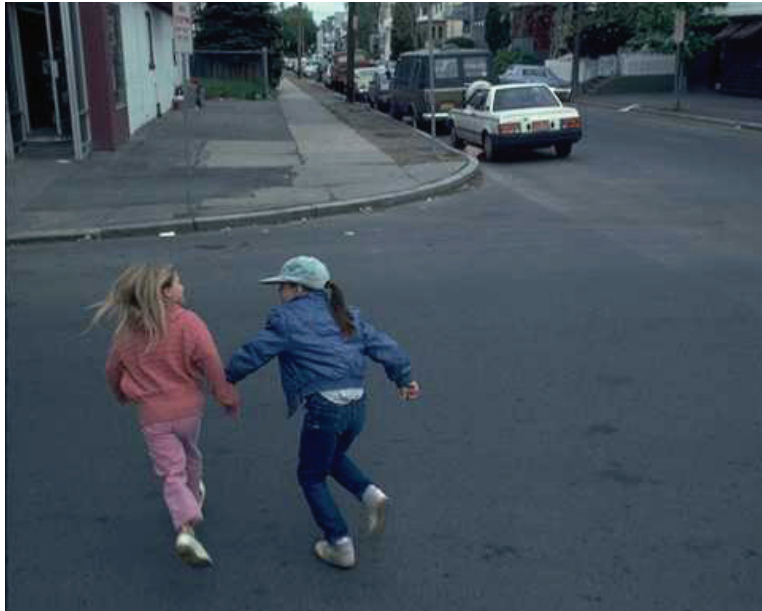
Figure 22-3. Photo. The needs of all users, young and old, should be considered in transportation planning and design.

The best approach is to develop a strong, proactive program to plan, design, build, maintain, and operate a fully balanced transportation system that responds to the needs of all potential users (see figure 22-3). The program must be based on a diligently applied set of defensible standards and a public process that allows involvement by all affected parties. It is very important that an agency be able to demonstrate it is aware of potential problems and is taking systematic steps to address them.

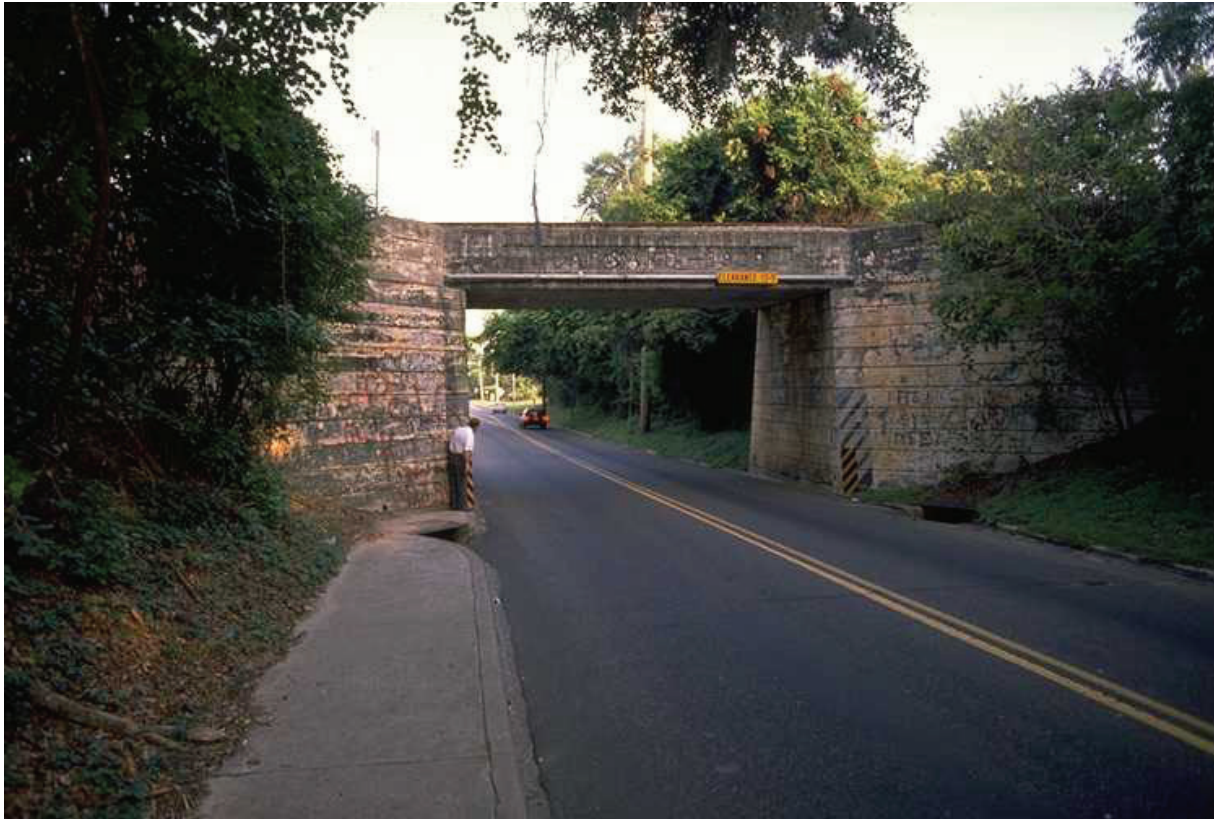
Figure 22-4. Photo. Example of a sidewalk ending at a bridge abutment with no warning or alternative path.

- **Paths that end suddenly at hazardous locations with no transition or escape route provided** (see figure 22-4 for an example). In court, you will hear that these paths “lead the customer into a trap.” All facilities should be ended logically, with a reasonable warning (e.g., “Path Ends”), a transition to an alternative route, and some design precautions taken so the inattentive path user is not launched off a cliff, slammed into a barricade around a blind corner, or otherwise penalized too harshly.

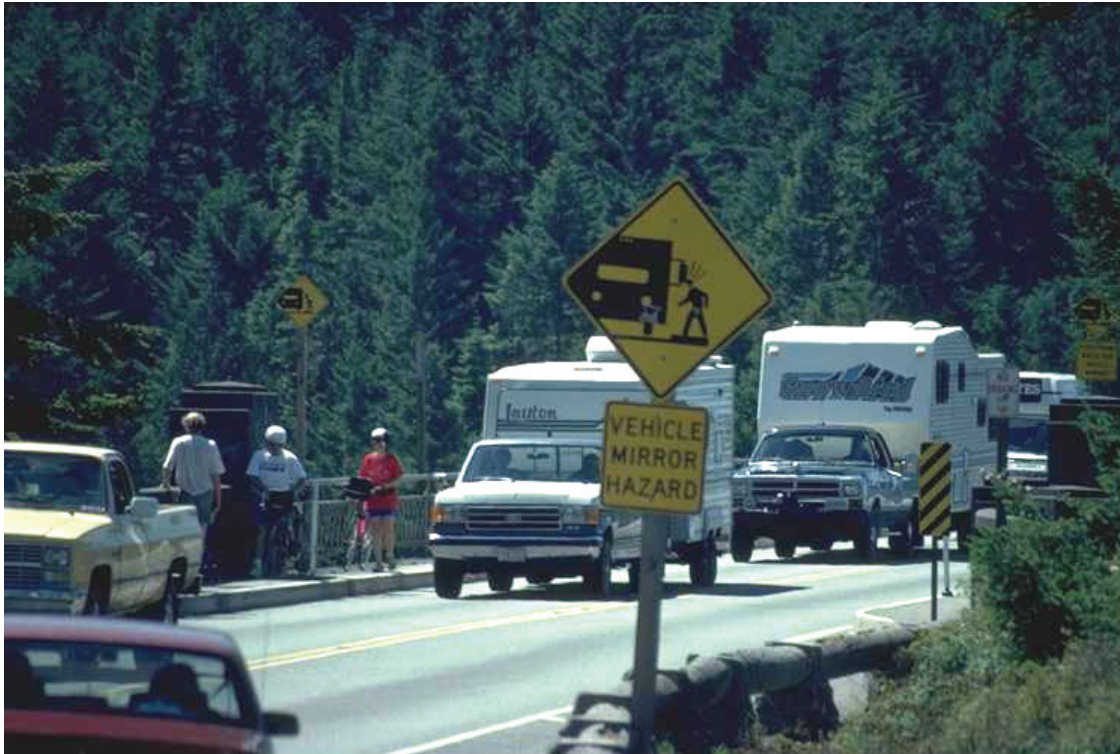
Figure 22-6. Photo. Use of signing to warn motorists and pedestrians of the potential hazard posed by vehicle mirrors on narrow bridge sidewalks.

Signing a hazardous condition has long been recognized as an important interim treatment for many conditions (see figure 22-6 for an example). Failing to sign a known condition is difficult to defend. Signing and warning offer two types of benefits: first, people are more cautious, so the number of crashes and injuries are reduced; and second, the attempt to alert the public about a potentially hazardous condition generates good will and makes it more difficult for a plaintiff's attorney to argue that the plaintiff was surprised by the condition. Signing should make use of international symbols and follow the standard signing and marking practices found in MUTCD.
