Ohio Department of Transportation Research Project Fact Sheet

Cost Effective Alternatives for Mitigating Debris and Environmental Impacts Around Bridge Piers

Researcher(s)	Jonathan Witter, Zane Raudenbush
Agency	Ohio State ATI, Davey Institute
Report Date	December 2024
Project Number	109461

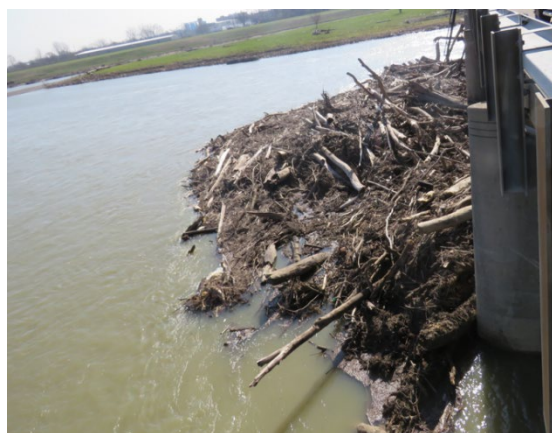
Figure 1. A large debris accumulation at State Route 122 over the Great Miami River in Butler County.

Floating debris in rivers, such as tree trunks and branches, can catch on bridge piers and accumulate leaves, trash, and sediments that impede flow. Some debris accumulations may become extensive and block a portion of the bridge opening thus leading to increased potential for overtopping the roadway and flooding of adjacent properties. Debris piles can redirect and misalign flow causing bank erosion in the vicinity of the bridge with potential impacts to roadway embankments. Debris accumulations can also cause scour around piers and abutments undermining the bridge foundation. Furthermore, flowing water exerts horizontal forces on the debris pile and piers that the bridge was not designed to withstand. Debris accumulations are a threat to the structural integrity of bridges and the safety of motorists. Addressing these problems requires costly and dangerous maintenance, highlighting the importance of effective debris management and preventive measures to ensure the safety and longevity of bridges.

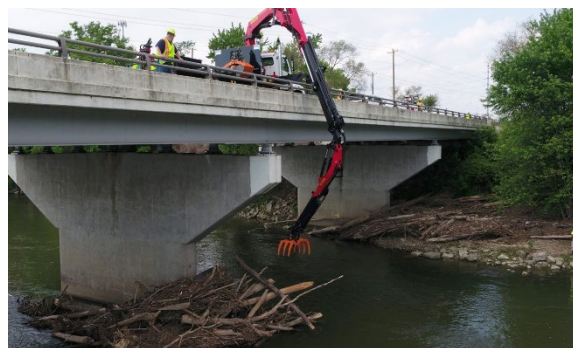
Figure 2. A counterweighted knuckleboom crane with grapple attachment capable of reaching beneath the bridge deck on hammerhead piers.

Debris Removal - A counterweighted, knuckleboom crane (Figure 2) with grapple and saw attachments was developed and tested for debris removal. In total, 60 debris removal projects and 18 other projects (e.g. rip rap placement, etc.) were completed. Labor needs for small projects completed internally were reduced by 43% on average. Larger projects typically completed by contractors over many months could now be completed in weeks by ODOT forces with ~80-90% reduction in cost. The equipment was able to reduce environmental permitting requirements and minimize road closures to a single lane and better maintain traffic. Worker safety and work quality were improved over previous methods.

The research suggests debris removal via the knuckleboom crane is highly effective. Results also indicate the approach is economical with return-on-investment <1-year. Where debris is problematic, the equipment should be utilized broadly. Debris mitigation measures were effective; however, implementation is likely best at small sites due to complexity and costs associated with working in large rivers. Scour detection and bathymetric surveys can be completed effectively with sonar. A single unit likely meets statewide needs.
