US DOT National
University Transportation Center for Safety

Landslides: 3D reconstruction with smartphone images

Final Report – August 2025

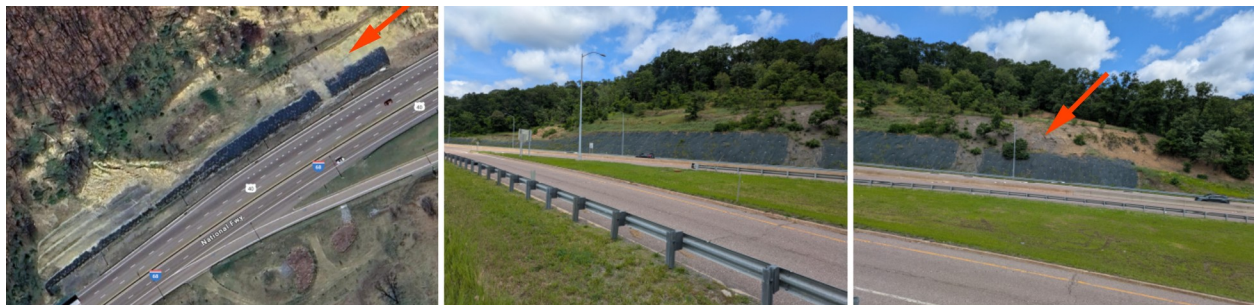
Figure 1: Landslide area next to I68 at Cumberland. On the left is a satellite view (Google Maps). The middle picture shows the area from across the interstate along the landslide. On the right is a direct view of the area we will analyze in detail (red arrow).

As a test site we choose a stretch of I68 in Cumberland, MD. It has the GPS location of (39.64339, -78.79495). Figure 1 shows a satellite view and the view from across the interstate.

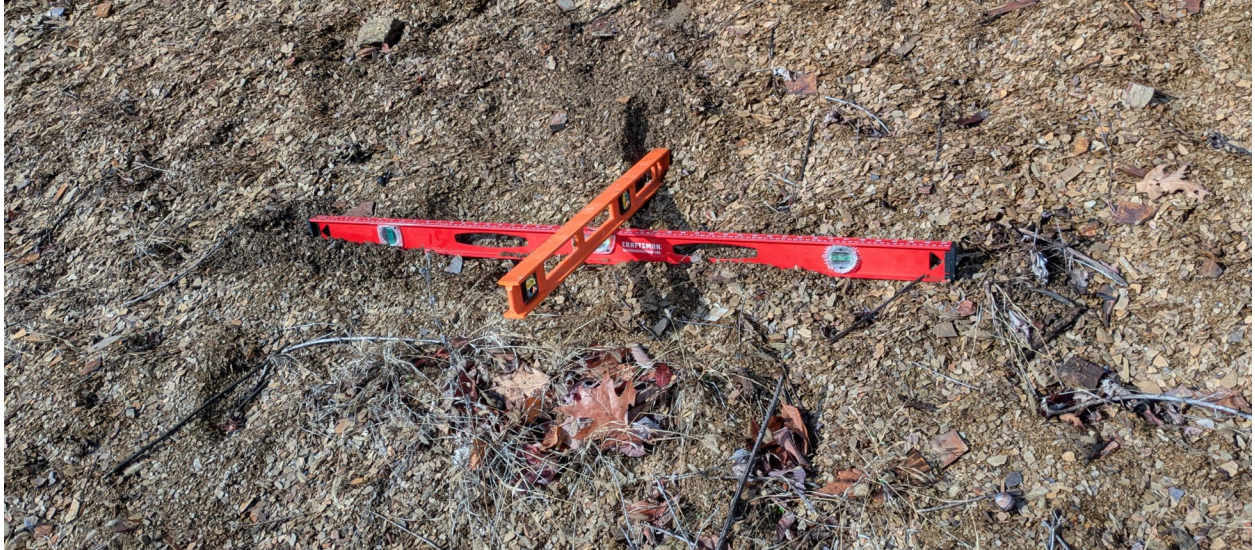
Figure 2: Two levels that will allow the 3D reconstruction to be scaled and leveled.

Before we took any pictures, we placed two levels on the ground (see Figure 2) which define the horizontal plane and an absolute scale.

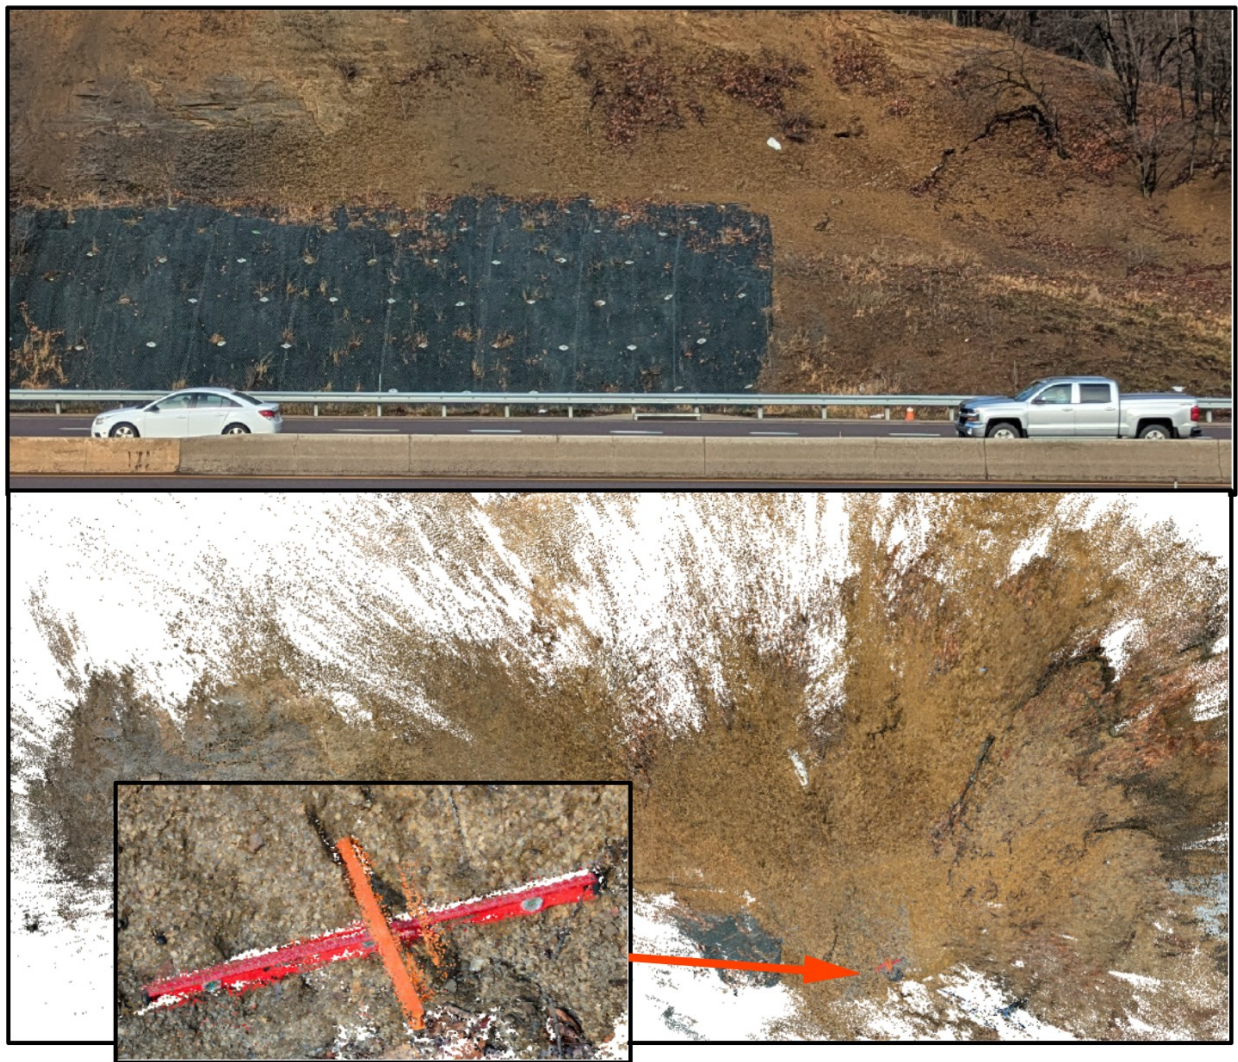
Figure 3: 3D reconstruction (bottom) of a hill side (top). The insert shows the 3D point cloud of the levels. Notice that the orange level has a faint double. This is a sign of misalignment.

At first we did a reconstruction of a large part of the hill side. The point cloud shown in Figure 3 was made from 324 images. Unfortunately, some of the images were misaligned. The evidence for the misalignment can be seen in the bottom insert of Figure 3. There is a faint double of the orange level.

Misaligned images and their corresponding points in the point cloud can be removed with the help of the COLMAP GUI. Clicking on a misaligned point will show the corresponding images. Clicking on one of those images brings up a menu where one can delete this image from the reconstruction.

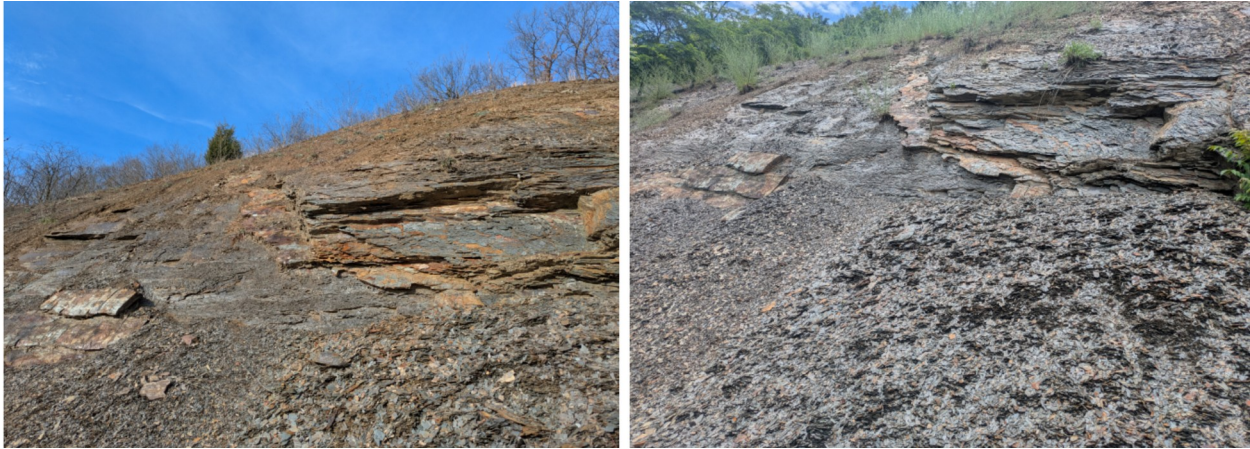
Figure 4: Left and right pictures were taken in late Fall and late Spring respectively

are covered with similar looking loose rocks. We therefore concentrated our effort on a smaller area with a mix of loose and solid rocks. Figure 4 shows two images of that area, one taken 12/17/2024 and the other taken 6/19/2025. In the next section we will make 3D point clouds of this area from the two dates and compare them.

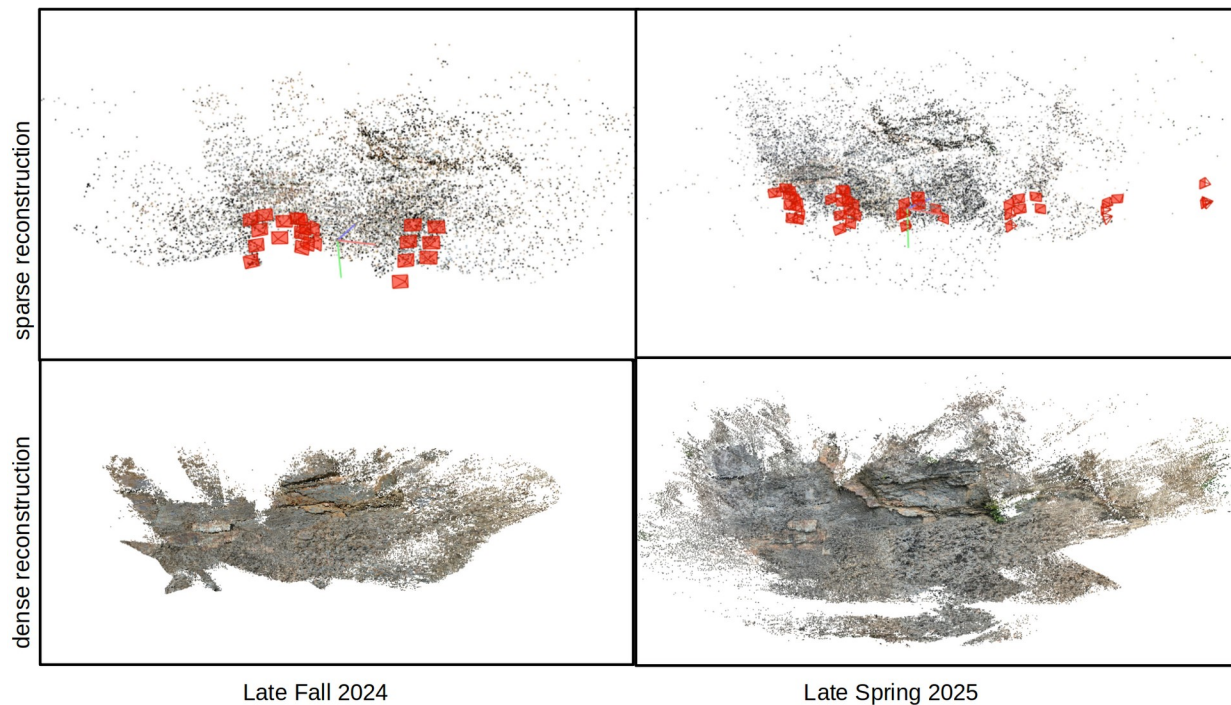
Figure 5: Sparse (top) and dense (bottom) point clouds from the images taken 12/17/2024 and 6/19/2025 respectively. The sparse point cloud and the camera positions (red pyramids) are displayed by the COLMAP GUI. The dense point clouds are displayed by the program CloudCompare. They are scaled and aligned to each other.

We took 22 images from the late Fall dataset and 44 images from the late Spring dataset and did a 3D reconstruction of each respectively. We did the usual steps of feature extraction, feature matching, sparse reconstruction and finally dense reconstruction. Figure 5 shows the resulting point clouds.

From the levels in the large point cloud (Figure 3) we know the absolute scale of the hillside. Next we need to align the two dense point clouds. At first we tried to use COLMAP to align the two sets of images. This can be done by combining the two sets into one dataset and letting COLMAP match all the images with each other. Unfortunately, this did not work with our images. Alternatively, can do this the alignment with the help of the program CloudCompare⁴. It is a two step process. First we do a coarse alignment by picking four corresponding point pairs “Align (point pair picking)”. The second

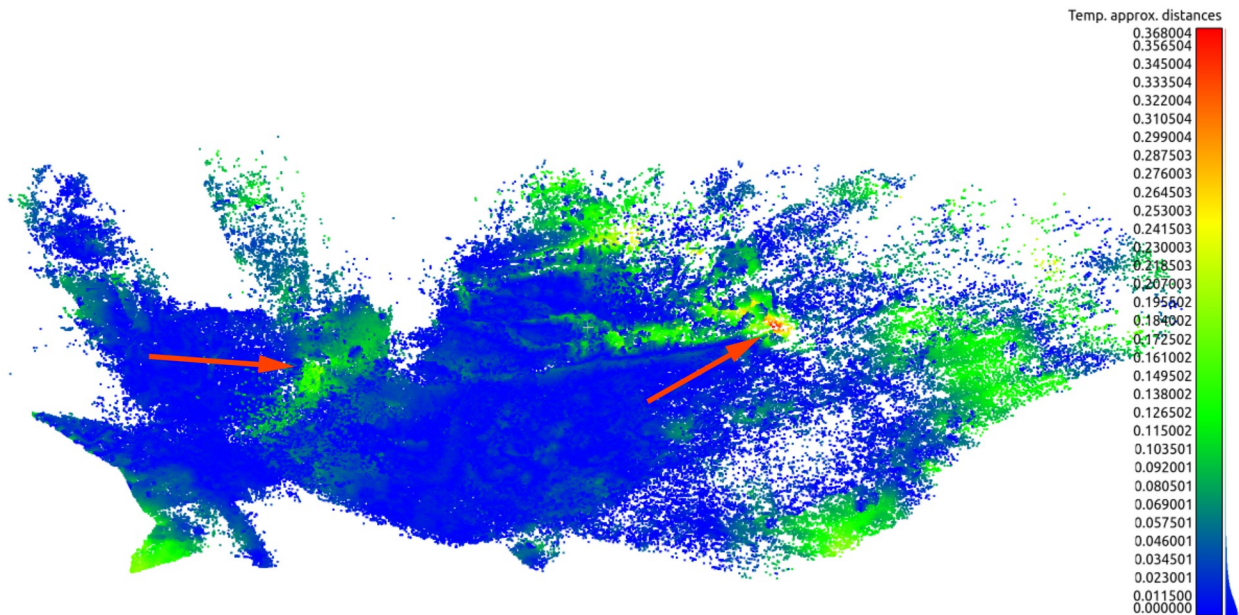
Figure 6: Point cloud difference. The color of each point indicates the distance of this point to the other point cloud. The distance values are in meter. The red arrows point to two significant locations.

Now that the two point clouds are aligned, we can measure the distance between them. For each point in one point cloud we measure the shortest distance to the other point cloud. This results in a distance plot as seen in Figure 6 where the color of a point indicates distance to the other point cloud. Most of the area is colored in blue, i.e. the distance between the two point clouds is small (~ 1 cm). Some areas are green, indicating differences of about 10 cm. The largest distance we found is about 37 cm. Two arrows point to two locations which we look at in more detail.
