# Traffic Control Device Analysis, Testing, and Evaluation Program: FY 2024 Activities

Technical Report 0-7198-R1

TEXAS A&M TRANSPORTATION INSTITUTE  
COLLEGE STATION, TEXAS

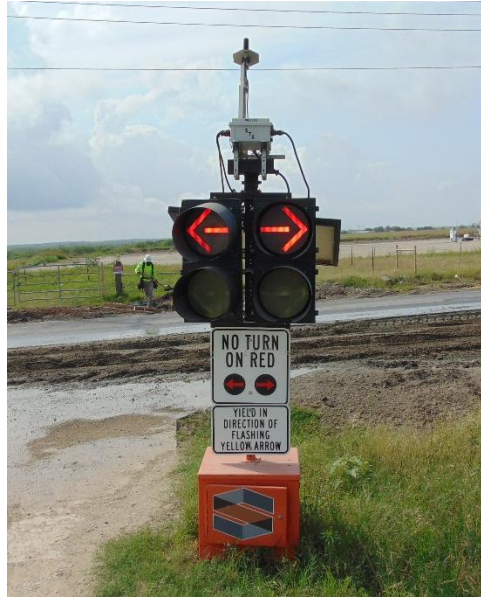
**Figure 1. Example of Four-Section Stacked DAD.**

steady red arrow indications, a modified R10-11 sign is typically used with a second supplemental sign (YIELD IN DIRECTION OF FLASHING YELLOW ARROW) (see Figure 1). However, based on previous study findings, TxDOT requested that TTI change out the two supplemental signs at the driveway where researchers collected data to a R10-11b sign (NO TURN ON RED) and a WAIT/TURN ONLY IN DIRECTION OF FLASHING YELLOW ARROW sign (see Figure 2).

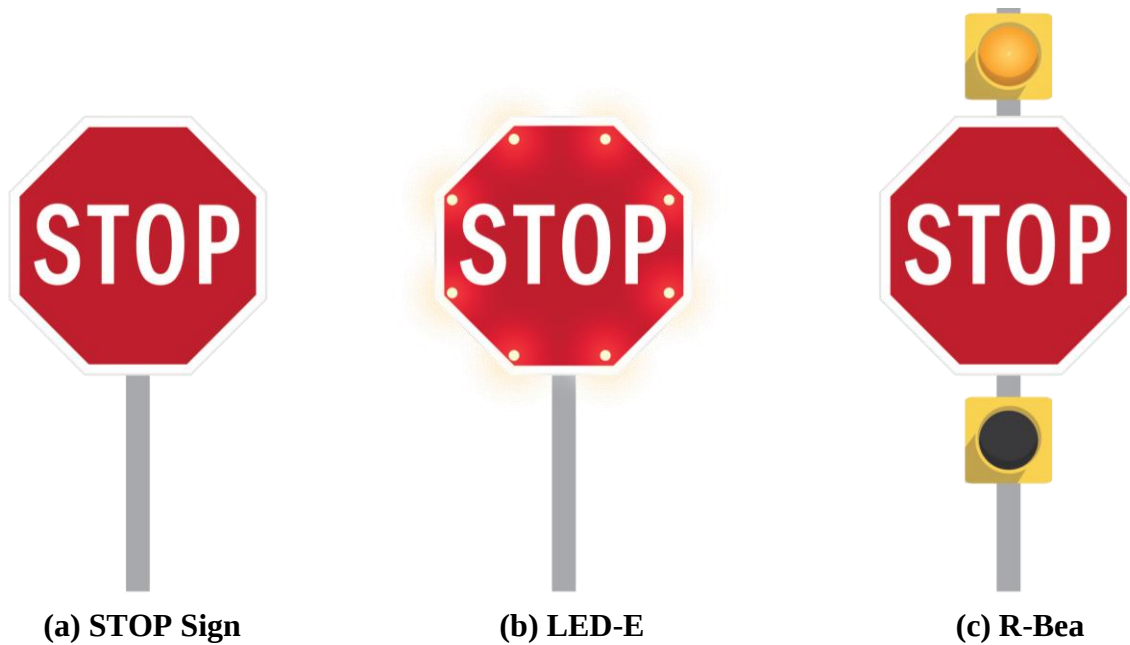
- **STOP Sign.** A typical STOP sign installed at the intersection.
- **LED-E.** LED-embedded STOP signs.
- **R-Bea.** Roadside intersection beacons where the beacons are mounted above and below the STOP sign located at the intersection.

**Figure 16. Examples of Beacon Treatments Being Considered in This Research.**

The three treatments selected for this research are illustrated in Figure 16 and include the following:

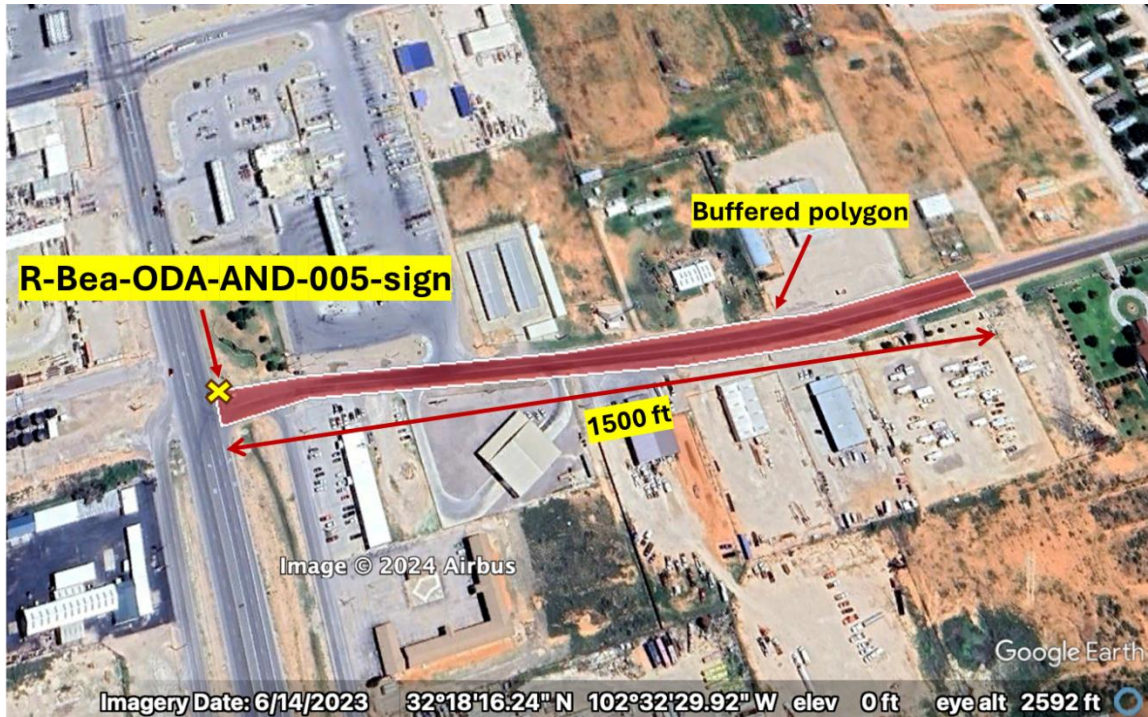
Figure 18. Buffered Polygon at Site R-Bea-ODA-AND-005.

The CV data storage and analysis are hosted in the cloud (Microsoft Azure services) to overcome local machines' processing power limitations and comply with privacy requirements. The defined speed measures in the previous section require having data points within 1200 ft upstream of the intersection. Thus, a boundary with the length of 1500 ft was drawn in QGIS/ArcGIS for each site to subset the Movements data in the upstream (see Figure 18) and create a buffered polygon. Figure 19 highlights the selected waypoints (triangle markers) during the subsetting process at site R-Bea-ODA-AND-005. Extending the 1200 ft requirement by an additional 300 ft provides a short history (speed and trace) of the drivers before they enter the study zone. This prior information of the vehicle entering the study zone helps to define and implement the filtering process explained in the following section.
