MPC 24-563 | C. Cameron, D. Todorut, W. Marshall, N. Coppola,
C. Ai, and B.Janson

PEDESTRIAN
INFRASTRUCTURE AND
ADA COMPLIANCE:
LEVERAGING ADVANCES IN
SPATIAL TECHNOLOGIES

1. Report No. MPC-678		2. Government Accession No.		3. Recipient's Catalog No.	
4. Title and Subtitle Pedestrian Infrastructure and ADA Compliance: Leveraging Advances in Spatial Technologies				5. Report Date September 2024

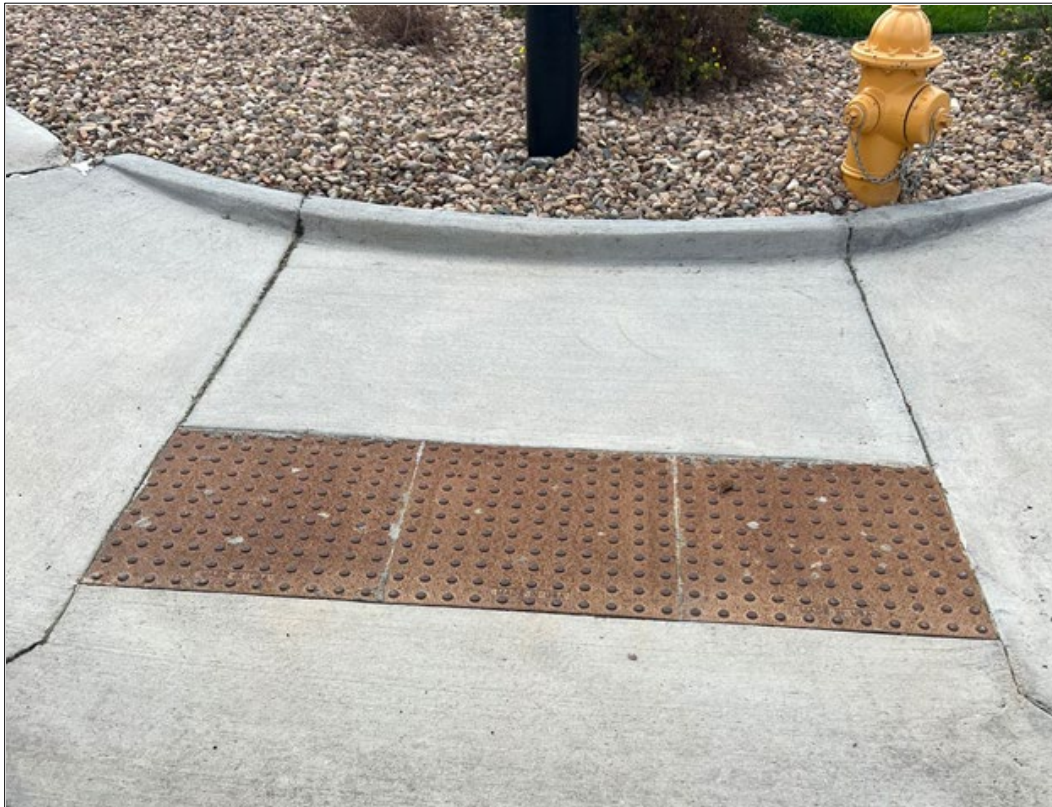
Figure 2.1 Curb Ramp Detectable Warning

An interesting finding in the 2010 ADA Standards is that detectable warnings, commonly referred to as truncated domes in the construction industry, are not required on all curb ramps. Detectable warnings serve as a visual and tactile cue for pedestrians with disabilities, indicating the presence of a curb ramp where they can cross the roadway. We had initially believed that detectable warnings were mandatory for all ADA-compliant curb ramps. However, according to the United States Access Board, detectable warnings are only required on curb ramps at transit facilities, such as rail stations and bus stops. Figure 2.1 shows a visual example of detectable warnings on a curb ramp.

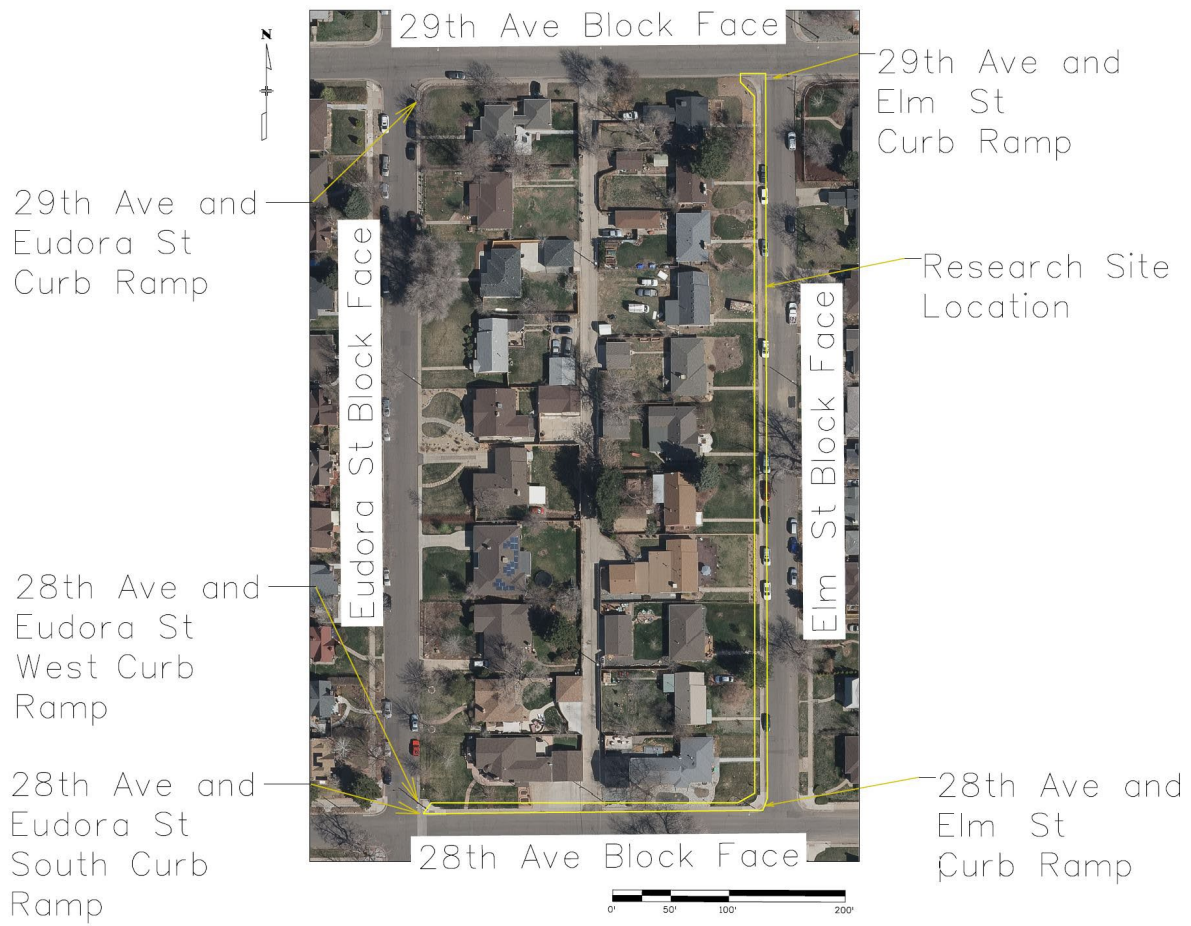
Figure 3.2 Plan View of Project Location

Figures 3.1 and 3.2 show aerial views of the project site location from Google Maps. Figure 3.2 shows an alleyway at the midpoint between Eudora Street and Elm Street that runs from 28th Avenue to 29th Avenue. Figures 3.3 through 3.11 depict the site conditions.

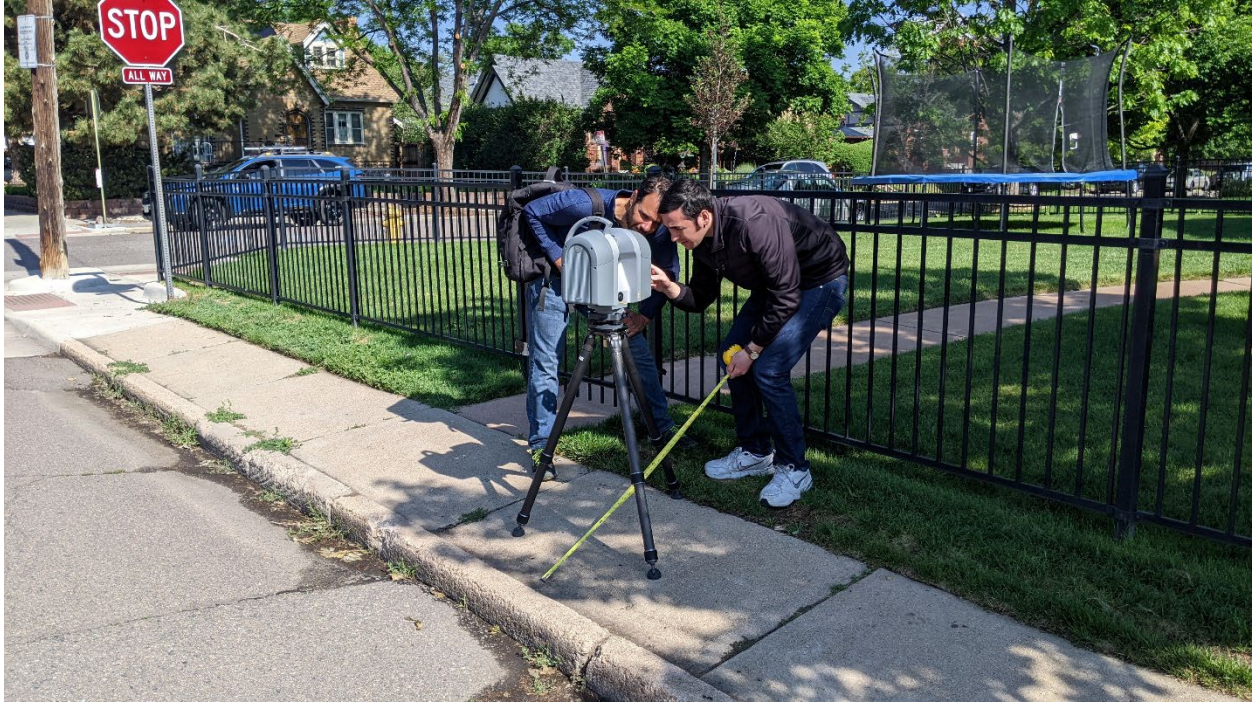
Figure 3.12 Trimble TX7 LiDAR Equipment

Figures 3.12 through 3.16 depict the equipment used to capture LiDAR data and conduct manual field measurements.

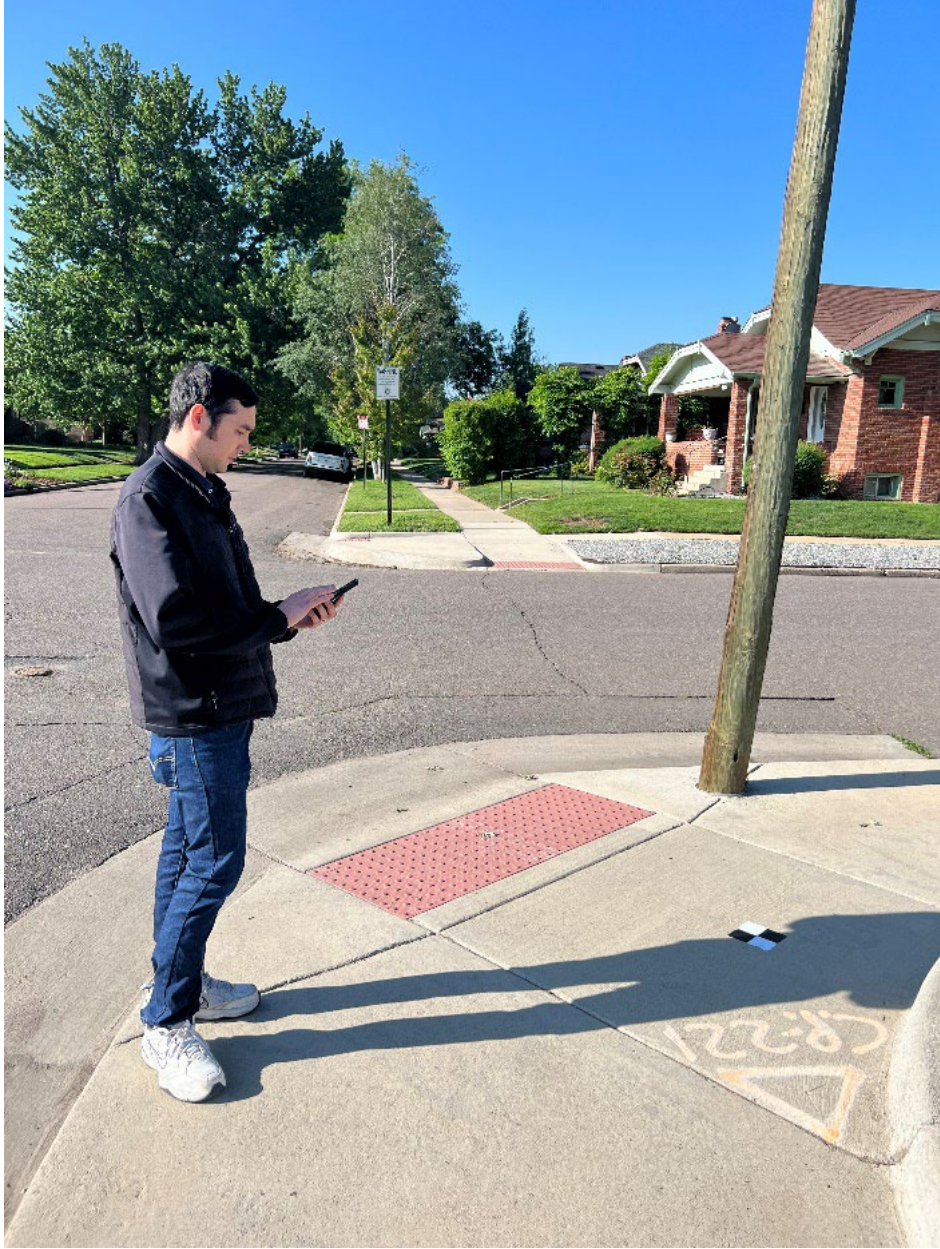
Figure 3.13 iPhone 13 Pro LiDAR Equipment

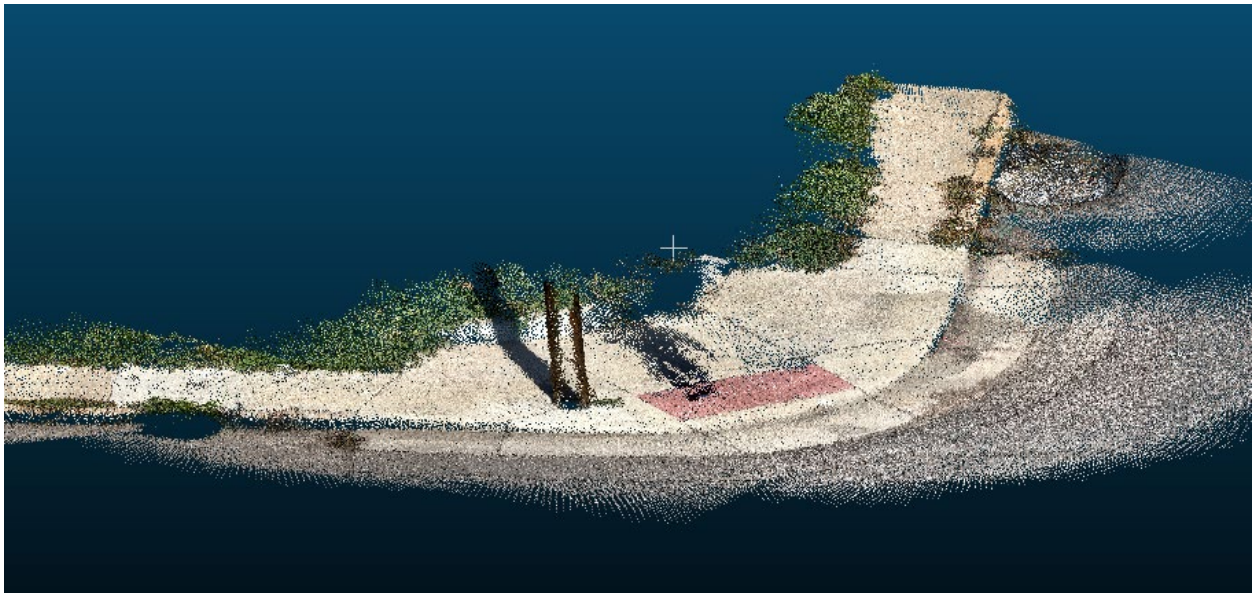
Figure 4.1 iPhone Point Cloud Dataset 28th Avenue and Elm Street Curb Ramp

The iPhone LiDAR data were gathered using the LiDAR CAD and 3D scanner applications on the iPhone 13 Pro. During the initial site visit on June 2, 2022, the LiDAR CAD application focused primarily on capturing the sidewalk infrastructure, which resulted in incomplete data for the curb ramps. A subsequent site visit on September 24, 2022, used the 3D scanner application to specifically capture the curb ramp infrastructure. Therefore, the point cloud data from the 3D scanner application were selected for comparison with field measurements and Trimble TX8 data, as it provided a more comprehensive capture of the curb ramp features. Additionally, the open-source software “Cloud Compare” was used to analyze the iPhone point cloud data for ADA compliance of the pedestrian infrastructure. Cloud Compare allowed for the measurement of running slopes, cross slopes, and widths of the pedestrian infrastructure using the point-picking tool. Figures 4.1 through 4.7 below provide screenshots of the data analysis performed in Cloud Compare.

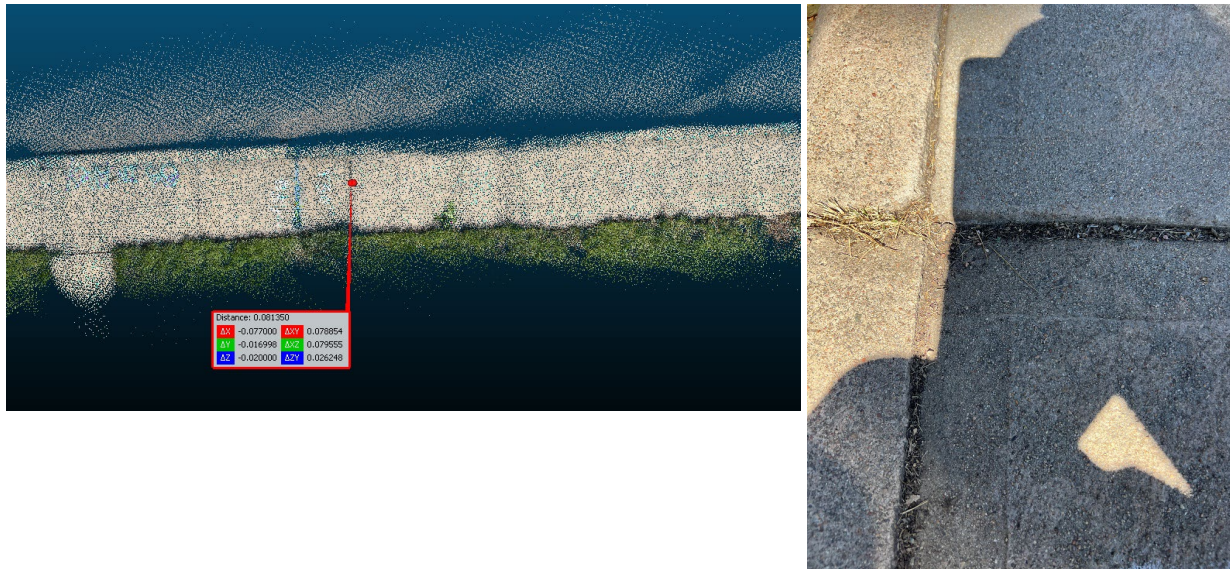
Figure 4.8 iPhone Point Cloud Dataset Lip 1 Eudora Street Sidewalk

All four lips were then identified in the iPhone point cloud data using Cloud Compare software. Figures 4.8 through 4.11 illustrate the lips identified on the project site through field measurements and iPhone point cloud data.

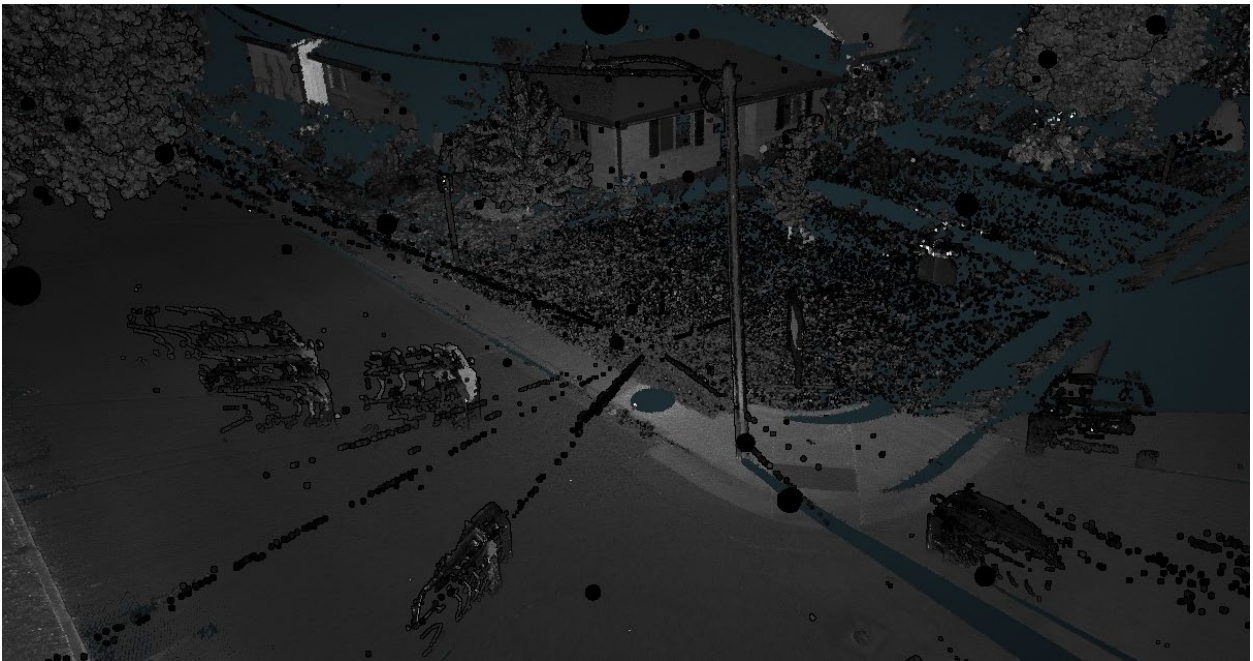
Figure 4.13 Trimble TX8 Point Cloud Dataset 28th Avenue and Elm Street Curb Ramp

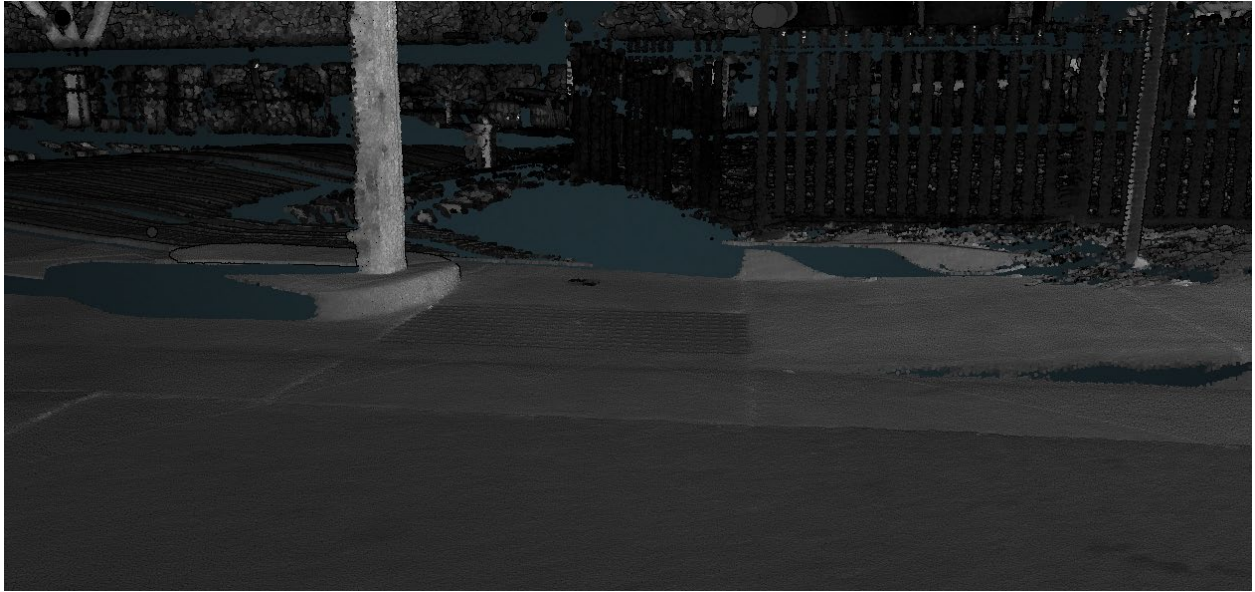
Figure 4.14 Trimble TX8 Point Cloud Dataset 28th Avenue and Eudora Street South Curb Ramp

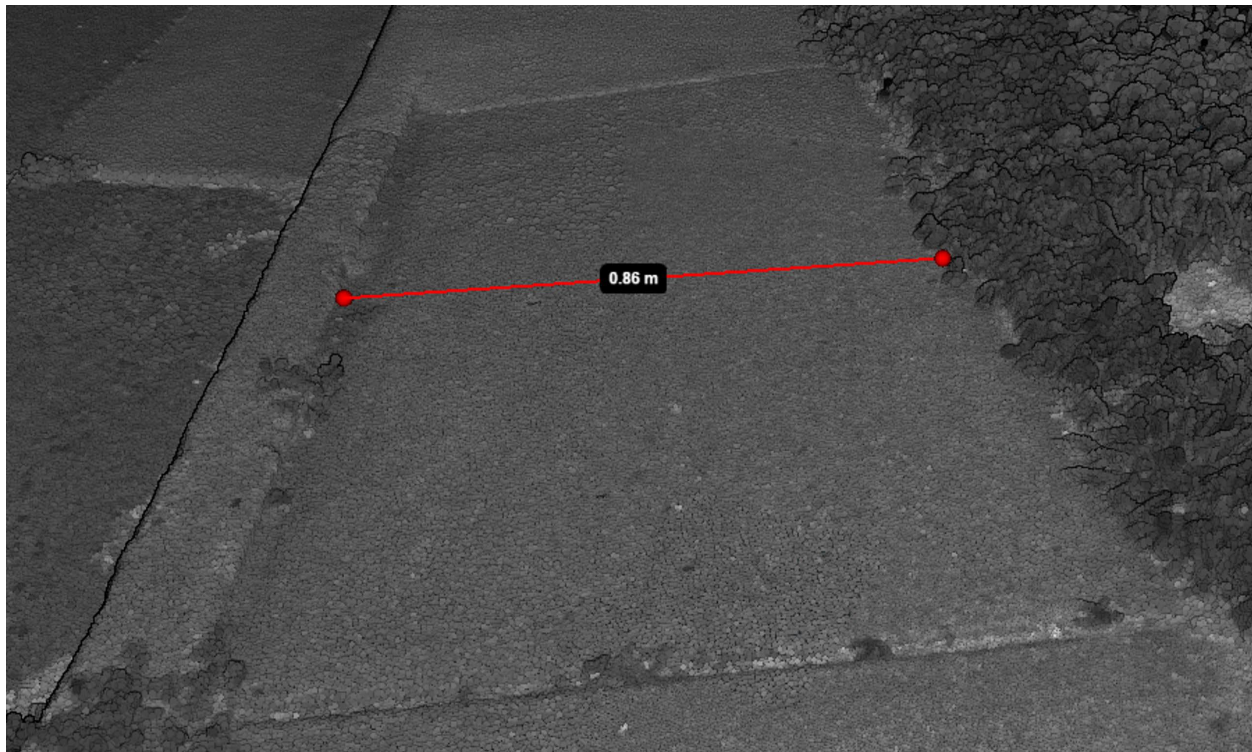
Figure 4.19 Trimble TX8 Point Cloud Dataset 28th Avenue Sidewalk Width

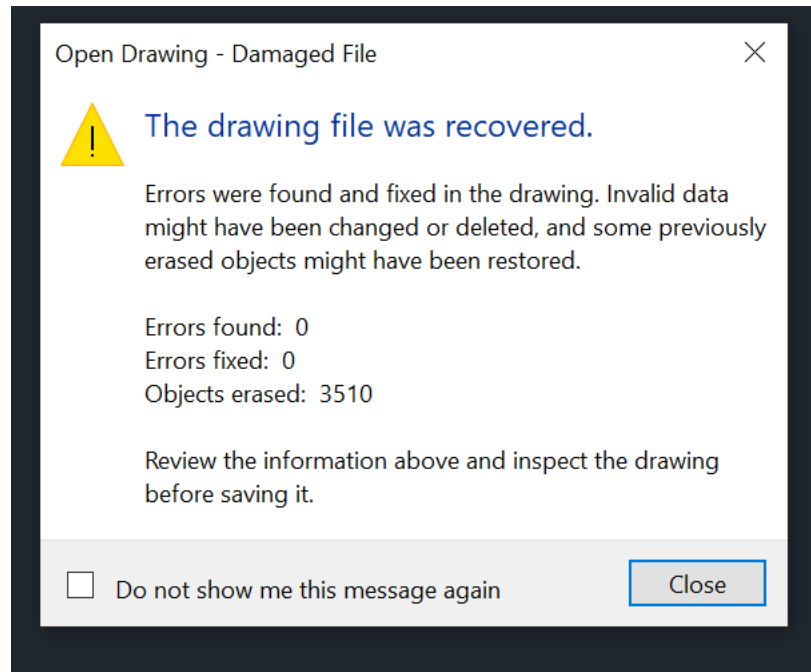
Figure 6.2 AutoCAD Civil 3D Objects Erased

Another issue encountered with the LiDAR CAD application was its compatibility with AutoCAD Civil 3D. The original DWG output files from the LiDAR CAD application contained point cloud data, mesh data, GPS coordinates, and imagery of sidewalks, curb ramps, and the surrounding terrain. Mesh data represent a polygonal surface that approximates the point cloud data. However, when these DWG files were imported into AutoCAD Civil 3D, multiple error messages appeared and many objects were deleted from the original files before they could be opened. As a result, only the mesh data and GPS coordinates were retained in the modified DWG files in AutoCAD Civil 3D, while the point cloud data and imagery of sidewalks, curb ramps, and the surrounding terrain were missing. This omission created challenges in distinguishing the boundaries of the sidewalks and curb ramps from surrounding features such as grass, private property, and the roadway's curb and gutters. Figure 6.2 below illustrates this issue.

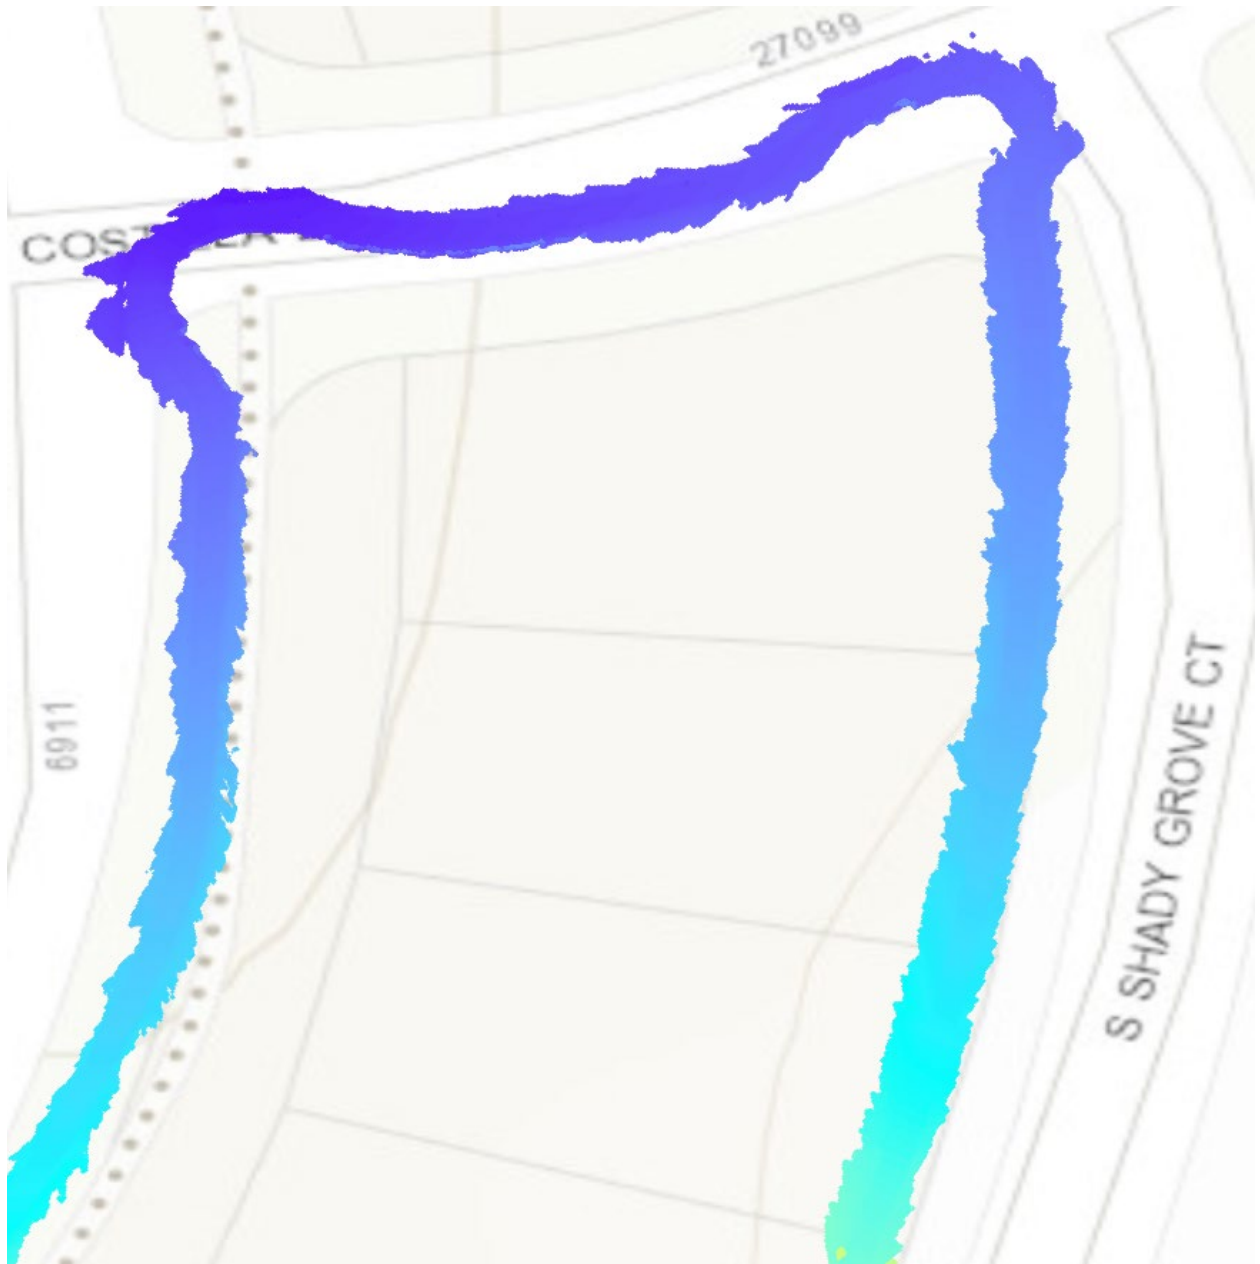
Figure 6.3 iPhone Point Cloud Dataset City Block in Aurora, Colorado, from ArcGIS Pro

Due to the issues encountered with the LiDAR CAD application, the project shifted focus to evaluating another iPhone-based LiDAR application that might be more effective for crowdsourcing LiDAR data. The 3D scanner application was selected for this evaluation. The 3D scanner app offers five scan modes: LiDAR, LiDAR Advanced, Point Cloud, Photos, and TrueDepth. Upon initial review, the LiDAR, LiDAR Advanced, and Point Cloud modes appeared to be the most effective for capturing point cloud data suitable for measuring sidewalks and curb ramps for ADA compliance. The LiDAR scan mode, in particular, was successful in capturing geo-referenced point cloud data. As an experiment, the LiDAR scan mode was used to capture point cloud data of a city block in the Southshore neighborhood of Aurora, Colorado. The sidewalk and curb ramp point cloud data were geo-referenced and accurately positioned when viewed on a street map of Aurora, Colorado, in ArcGIS Pro. Figures 6.3 and 6.4 below provide an illustration of this.

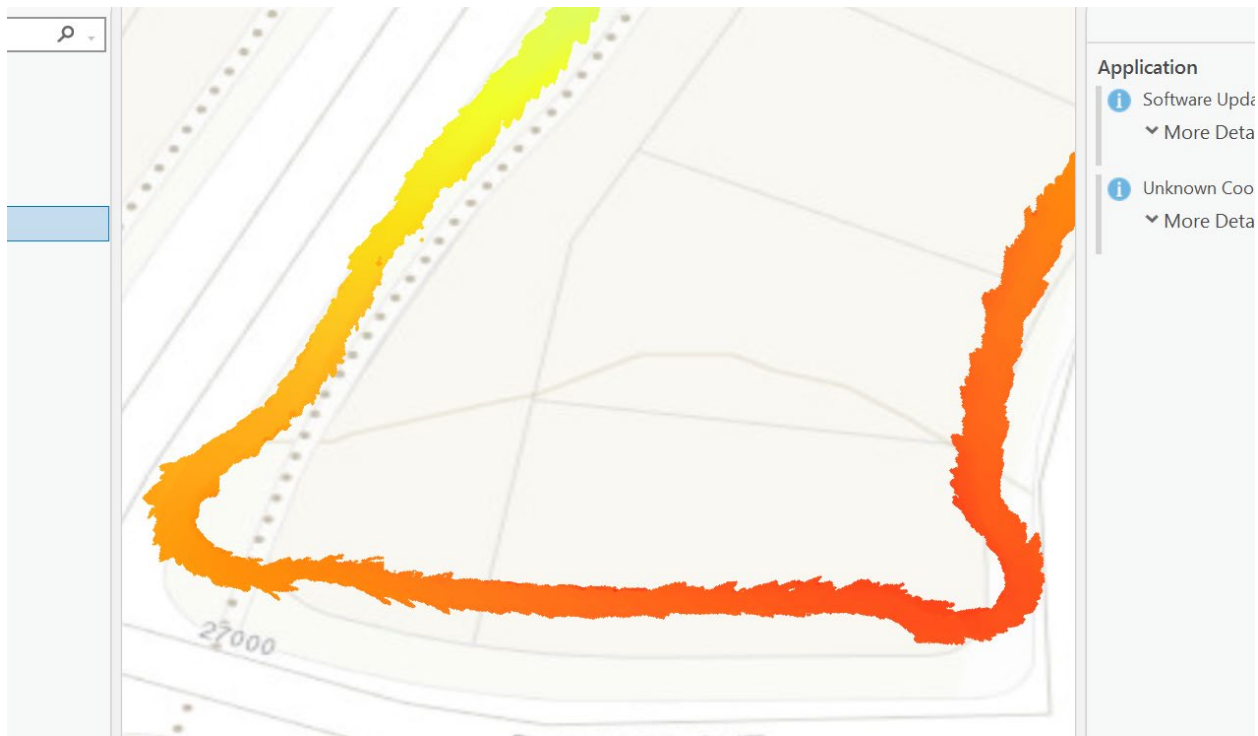
Figure 6.4 iPhone Point Cloud Dataset City Block 2 Aurora, Colorado, from ArcGIS Pro

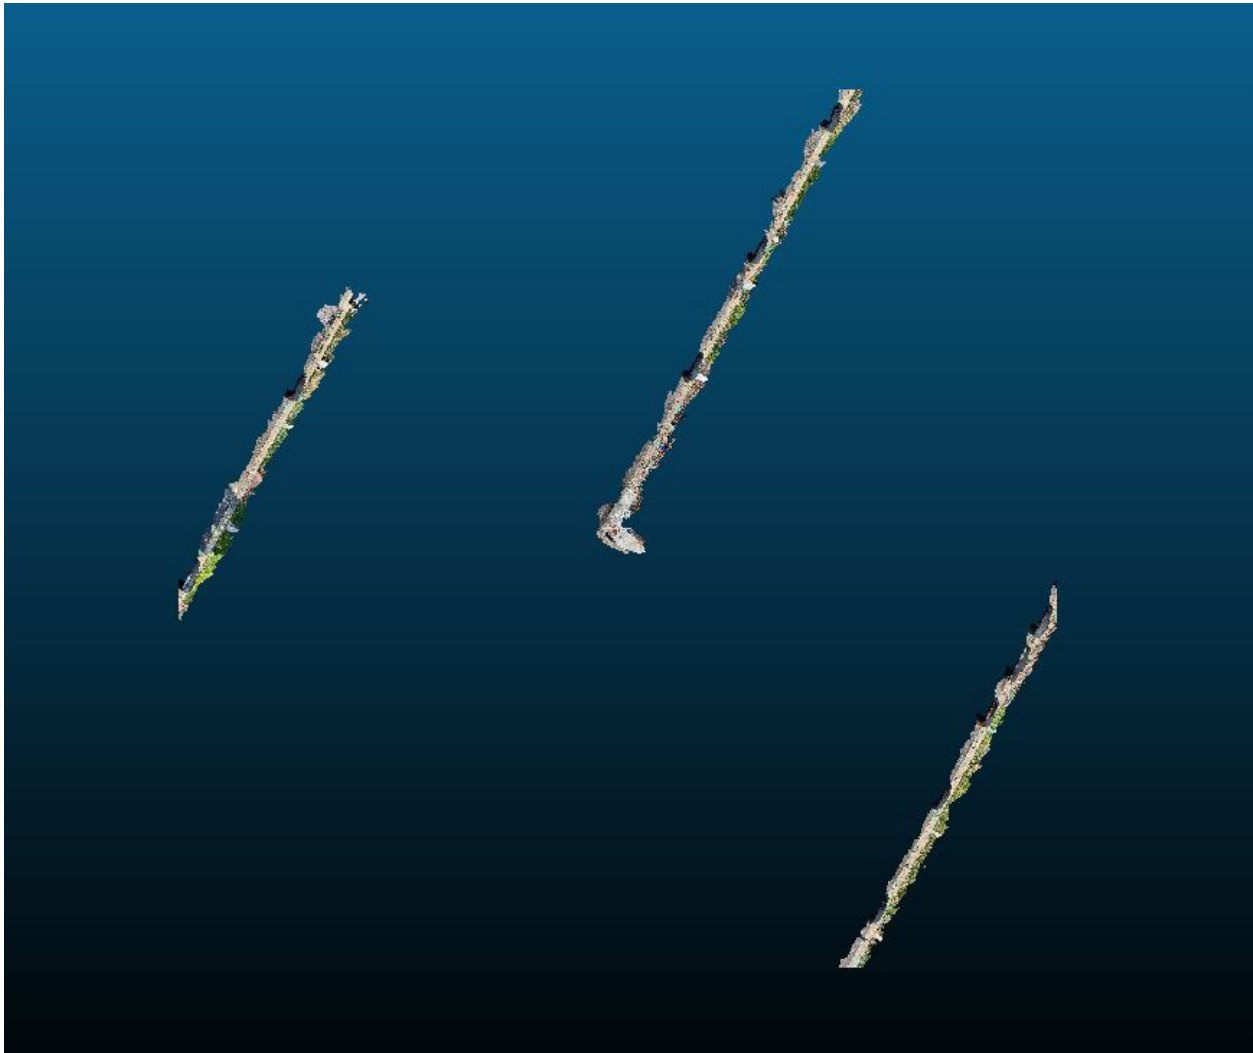
Figure 6.6 iPhone Point Cloud Dataset Sidewalk Segments from LiDAR CAD Application

shown in Figures 6.6 and 6.7 below. Furthermore, the 3D scanner application produces geo-referenced point cloud data, allowing it to be integrated into a GIS platform like ArcGIS Pro, making it more suitable for crowdsourcing due to its geo-referencing capability.

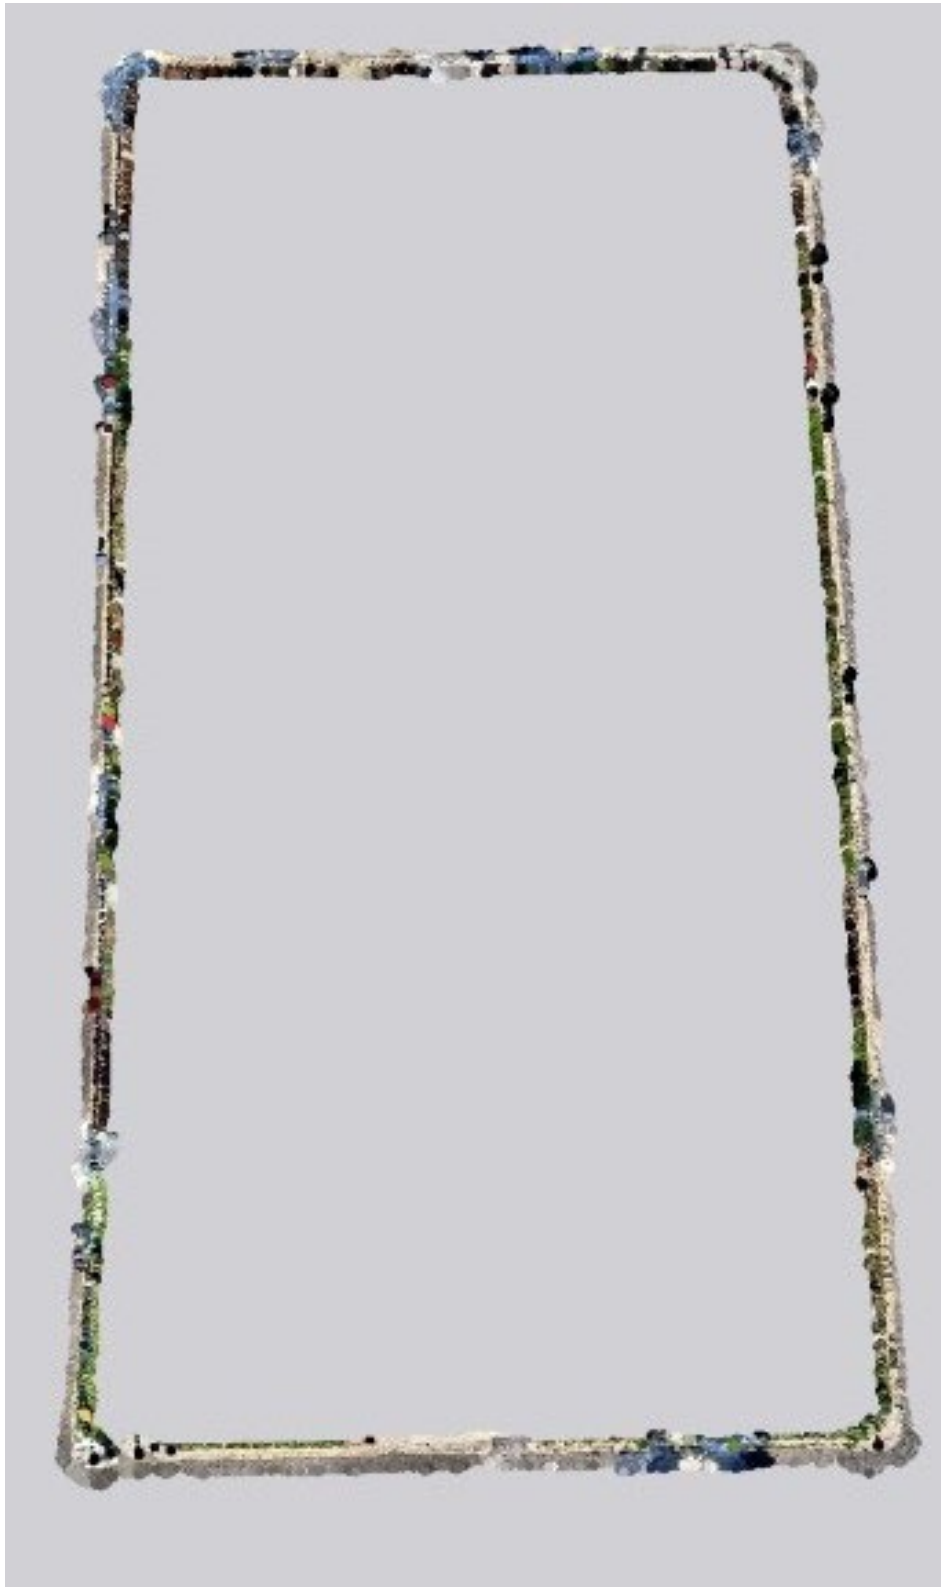
Figure 6.7 iPhone Point Cloud Dataset Whole City Block from 3D Scanner LiDAR Application

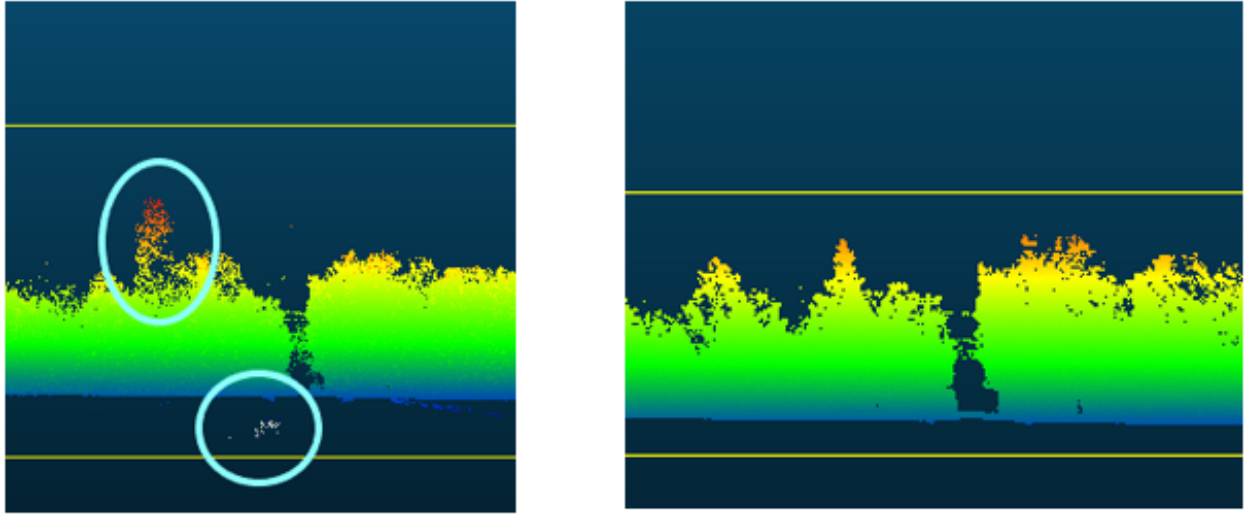
Figure 10.1 Objects Deleted with Noise Cleaning Tool

After applying the suggested settings and selecting "Remove isolated points," this process was performed on the clone layer for "sidewalk_classified1.laz.clone." As shown in Figure 10.1, the noise cleaning tool successfully removed noise and certain objects, such as trees, possibly thinning other trees as well. The next steps involved repeating the process while adjusting the settings for optimal results. For example, a radius of 0.06 with a standard deviation multiplier of 1 was found to be too aggressive, thinning out the data entirely. A radius of 0.15 with a standard deviation of 0.9 was better but still thinned the data too much. Testing a larger radius with a standard deviation of 5, followed by the same radius with a standard deviation of 1, led to better results. After further adjustments, it was found that a radius of 1.0 with a

standard deviation of 5 worked well, while other combinations either cut out too many points or did not improve the noise removal.

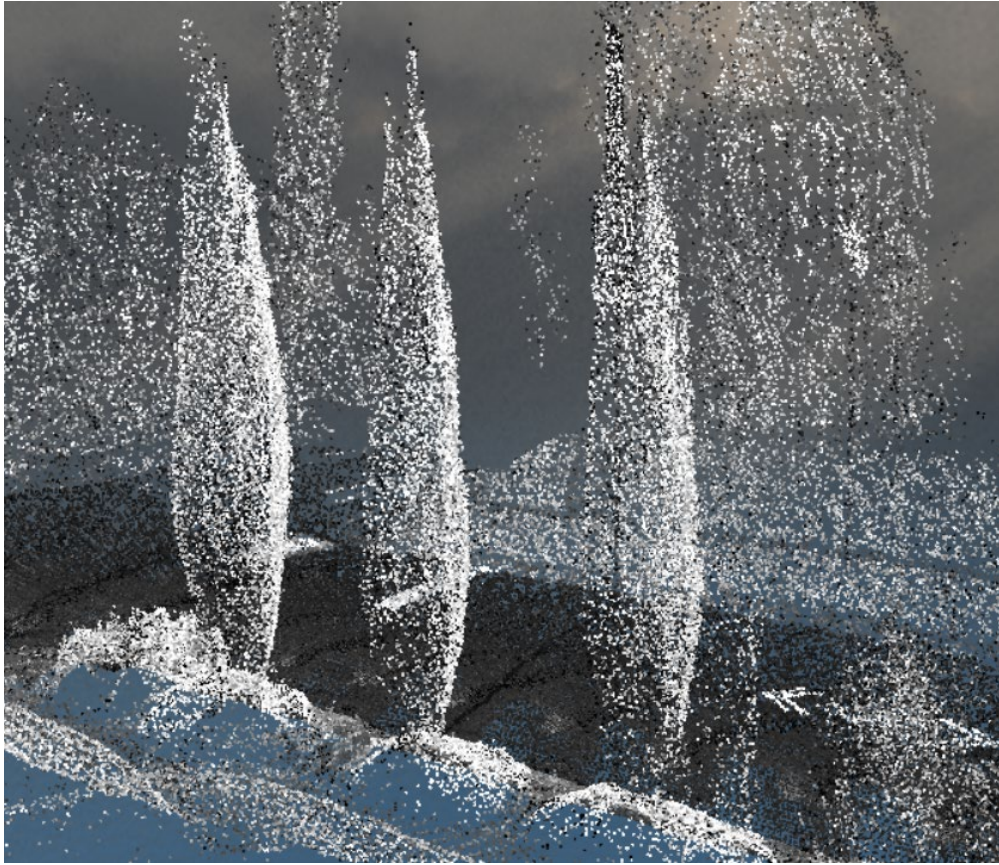
Figure 10.16 Double-Check Classification (3 dots in the top image are the 3 trees in the below image)

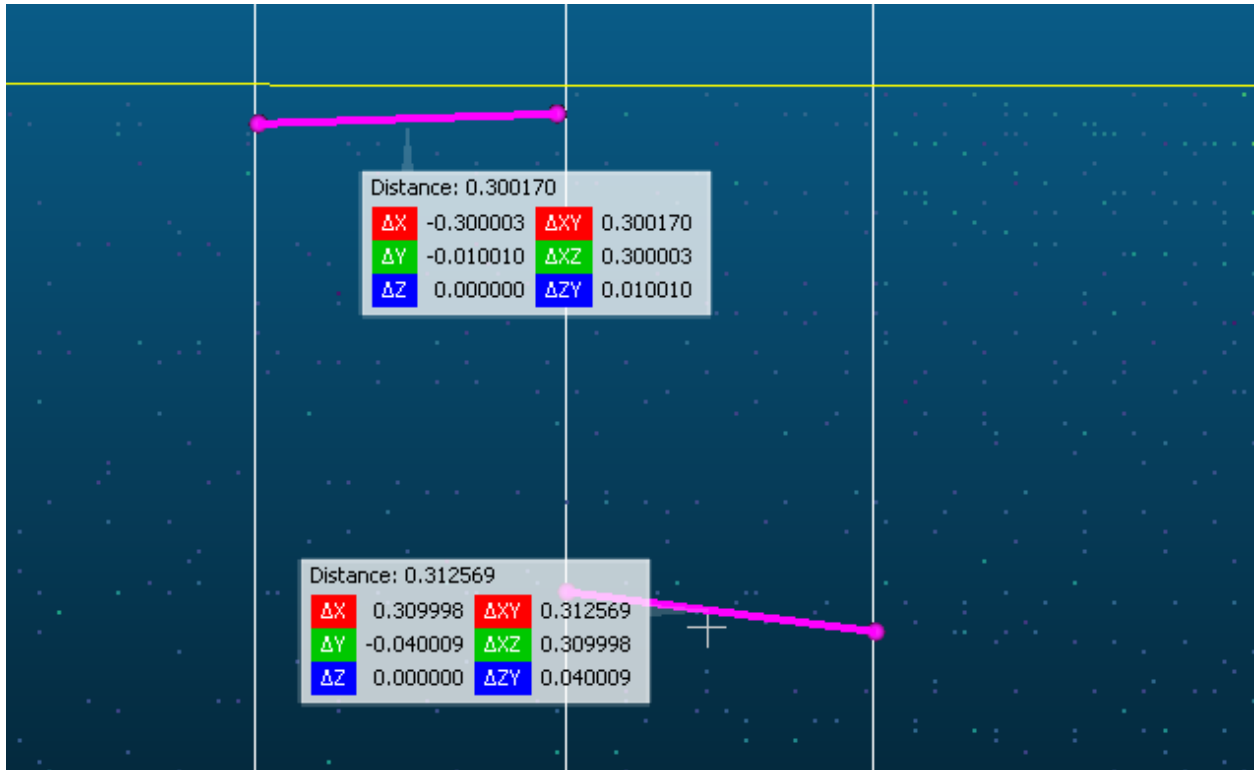
Next, clip the grid to the sidewalk polygon area. Then, create an Excel sheet to organize the grid system on the point cloud data, which will be used to measure width values and cross-slope within the grid. In Cloud Compare, clone the grid twice and orient it with a spacing of 0.31 meters from the first grid, creating a 1-foot buffer to ensure accurate data collection, as shown in Figure 10.18.

Figure 10.18 Buffering Cloud Compare Data

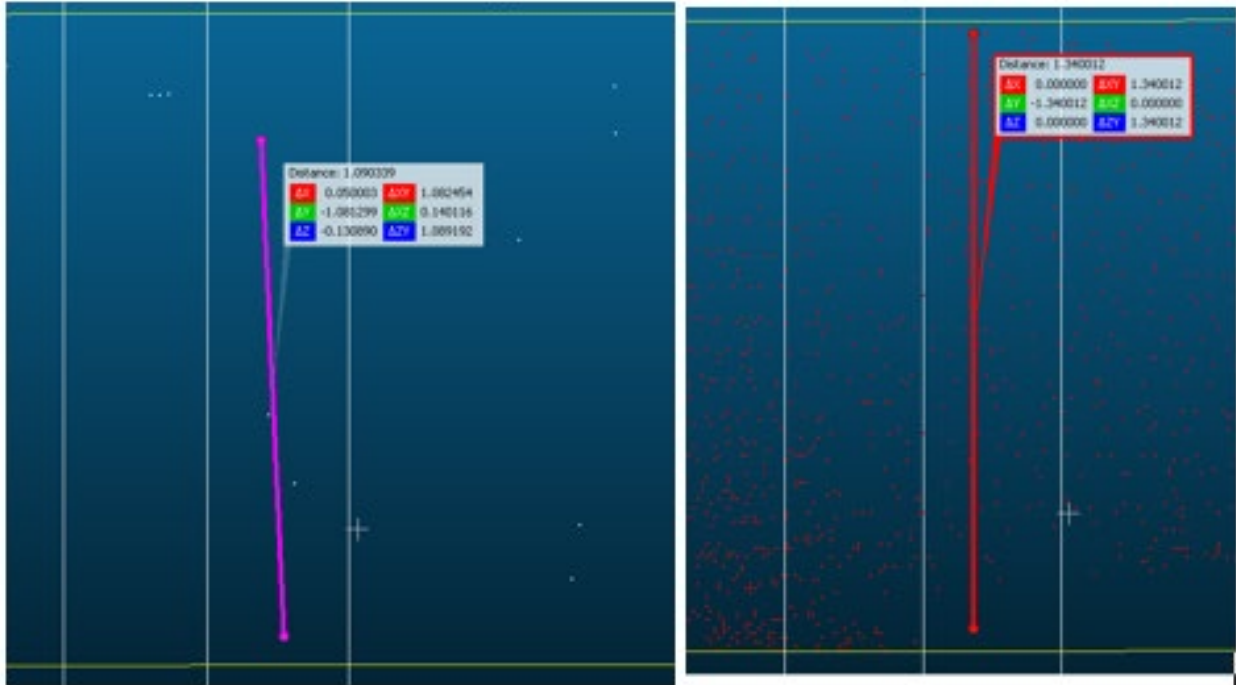
Figure 10.20 Representative LiDAR Point Cloud Data

In instances where the mobile-collected data are sparse in point clouds, choose two points where the change in x (or y for vertical sidewalks) is closest to zero. This method also applies to the sidewalk-collected data, shown as the red point cloud, with the white point cloud below representing a section of the mobile data, as seen in Figure 10.20.

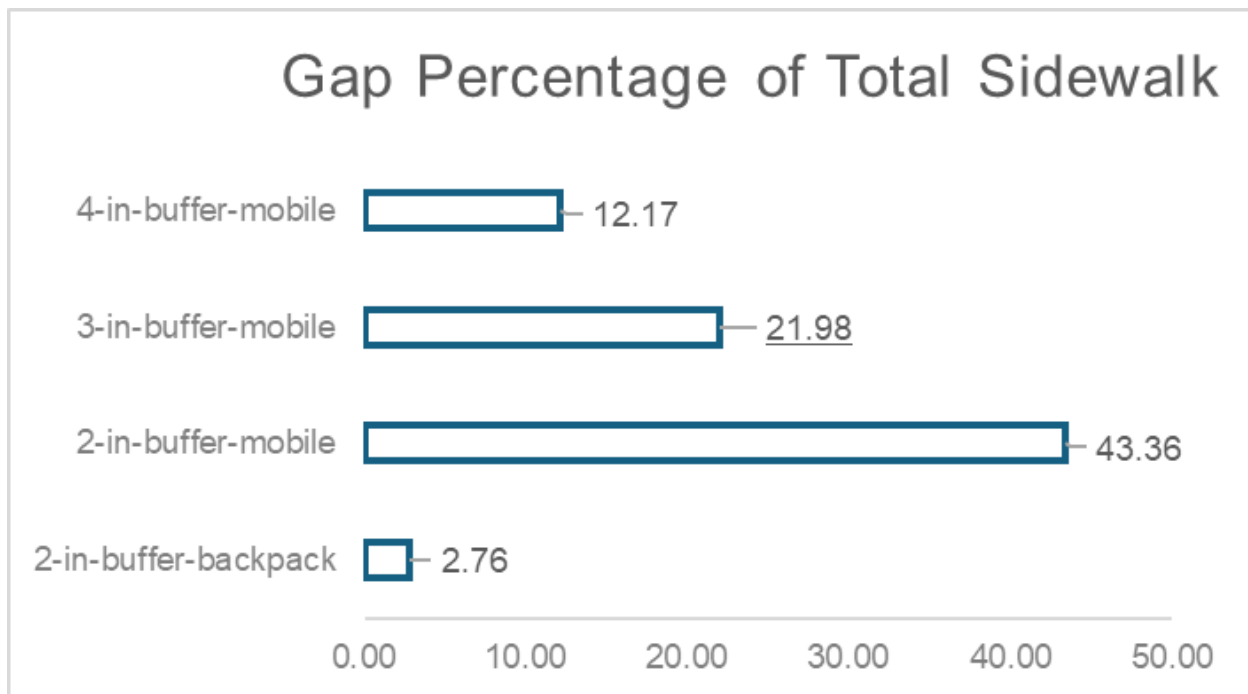
Figure 11.1 Total Percentage of Gaps within Each Layer, Given Various Buffer Sizes

There is a substantial number of sidewalk gaps in the mobile LiDAR versus the backpack LiDAR, and this is attributed to obstructions between the vehicle and the sidewalk. When the point clouds are vectorized into point shapefiles, they are given a specific diameter in buffer for each shapefile. When placing a 2-inch buffer on the backpack point cloud, it showed 2.76% in sidewalk gap data, whereas the mobile LiDAR had 43.36% of gaps with a 2-inch buffer. A 3-inch buffer on the mobile point cloud data shows 21.98% in data gaps while the 4-inch buffered mobile data has 12.17% of data gaps in the sidewalk. Essentially, the percentage of gaps in the mobile data reduces by half as the size of the buffer increases by increments of 1 inch. For this reason, the average between the 3-inch buffer and the 2-inch buffer was examined for the mobile LiDAR data, where a 2-inch buffer was analyzed for the backpack LiDAR data.

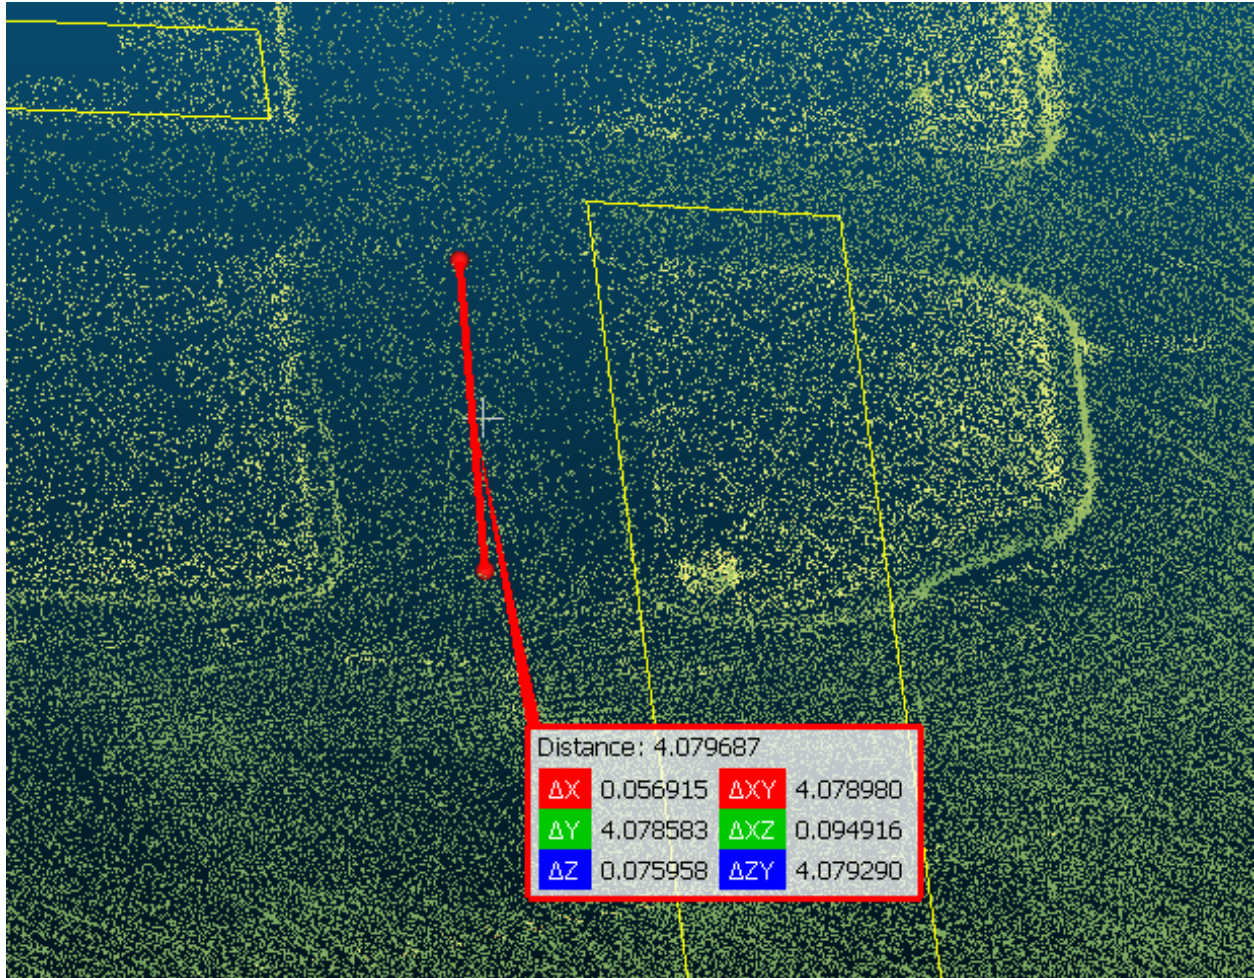
$$\text{Ratio} = \frac{\text{Change in Z}}{\text{Distance}} = \frac{0.07598}{4.079687} = 1:0.018$$

Figure 11.8 Curb Ramp Running Slope Measurement in Cloud Compare
