NEW MEXICO DEPARTMENT OF TRANSPORTATION

STRUCTURAL RETROFIT OF CORRODED METAL CULVERTS USING GFRP SLIP LINER.PHASE II.

Final Report

Report R919033

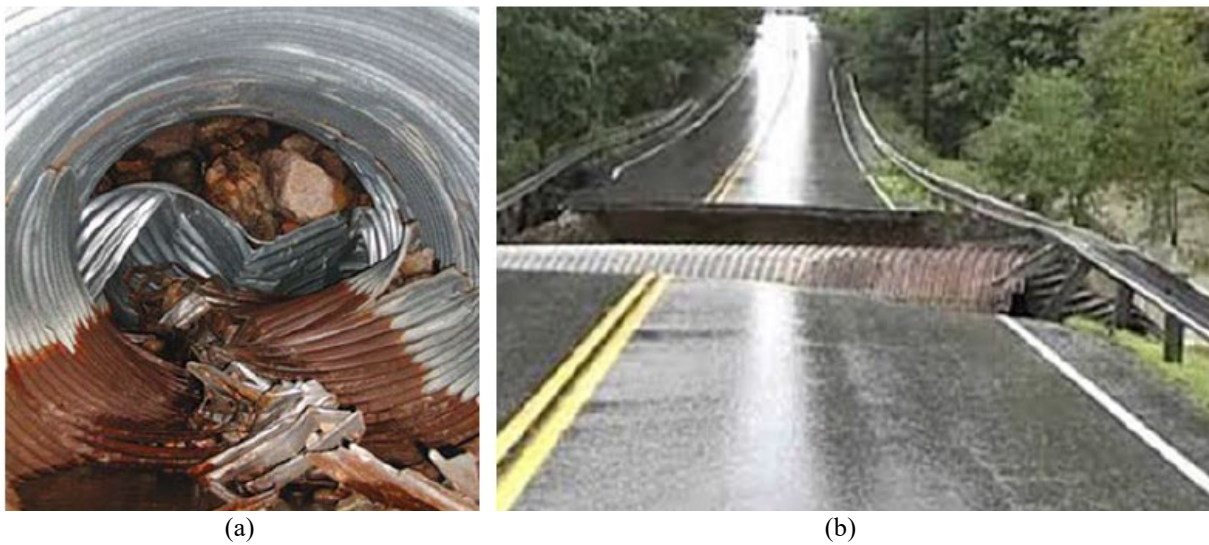
FIGURE 2 Failure of corroded metal culverts [2].

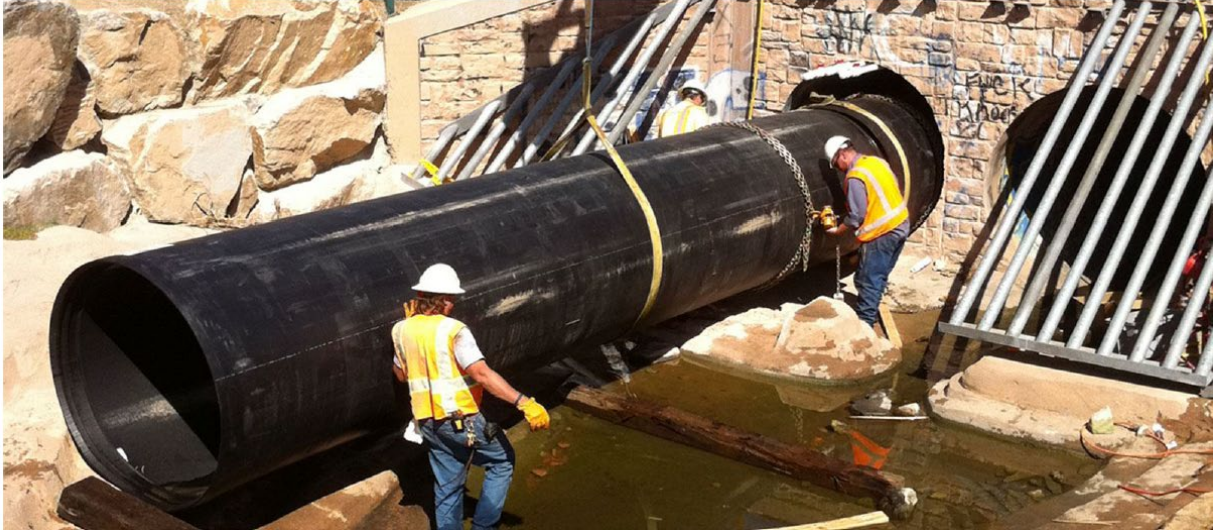
FIGURE 3 Culvert retrofit using HDPE pipes [2].

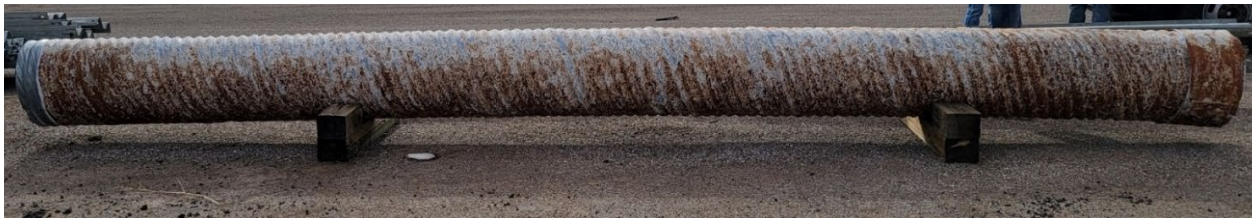
The design method was applied for future implementation on a steel CMP of 25 ft, shown in Figure 4. The steel pipe had a nominal diameter of 24 in, and an average corroded thickness of 0.05 in. The retrofitted pipe will be buried under 18 in of soil, with a slope of 0.001. A grout thickness of 1.5 inches was assumed, resulting in a GFRP outside diameter of 21 in. The culvert was provided by NMDOT in La Mesita Patrol Yard.

FIGURE 4 Corroded metal steel pipe

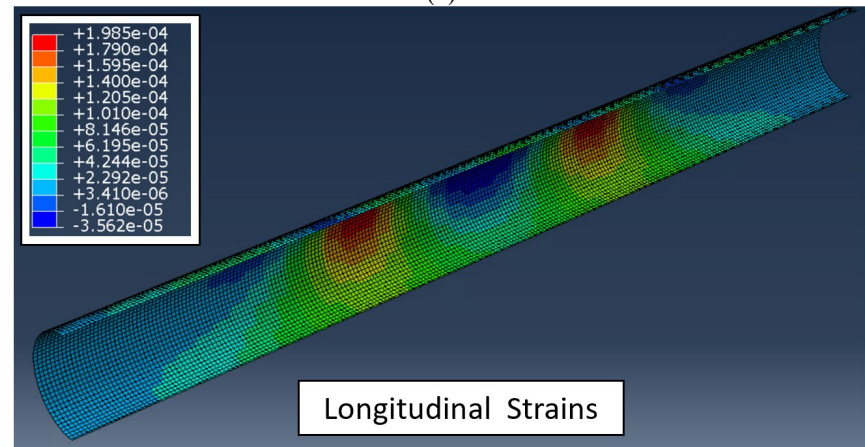
Figure 6 shows the strain results of the CMP model. As expected from the literature, the dominate response could be observed in a high level of tangential strains under wheel positions. It is also important to note that, because of the flexibility of the culvert, longitudinal strains were also present, reflecting a flexural-like response for the culvert. Figure 7 shows the strain results in the GFRP pipe of the CMP-GFRP model. It can be observed that the magnitude of strains in this model is lower than the previous model, due to the reinforcement and composite action via adding the GFRP pipe. Similar to the previous model, the tangential strains were higher than longitudinal strains.

FIGURE 6 Steel strain for CMP model. (a) tangential strains. (b) longitudinal strains.

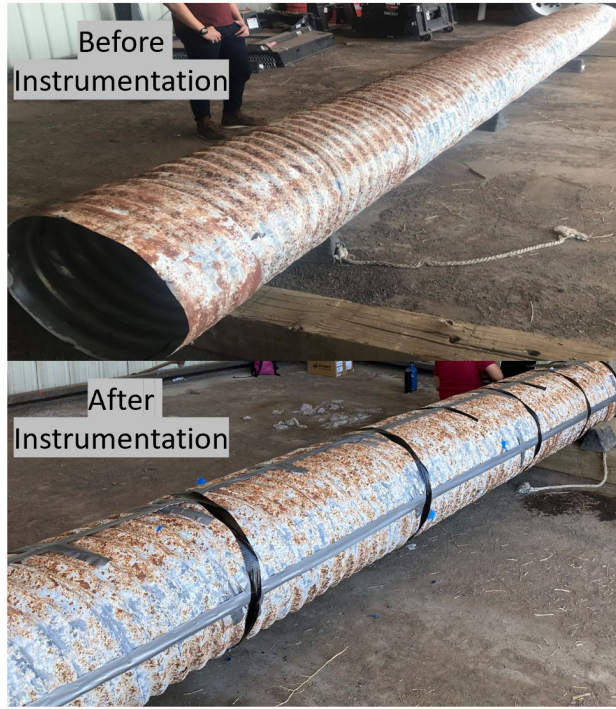
Upon arrival to the NMDOT La Masita Yard, the corroded metal culvert was moved to a shed to install the strain gauge sensors, as shown in Figures 10 and 11. The culvert pipe was cleaned from dust and rust and was ground at the planned sensor locations. The sensors were soldered on the cleaned surface. After all sensors were placed, the pipe was buried under 18 in of soil before load testing.

FIGURE 10 Corroded metal pipe before and after instrumentation

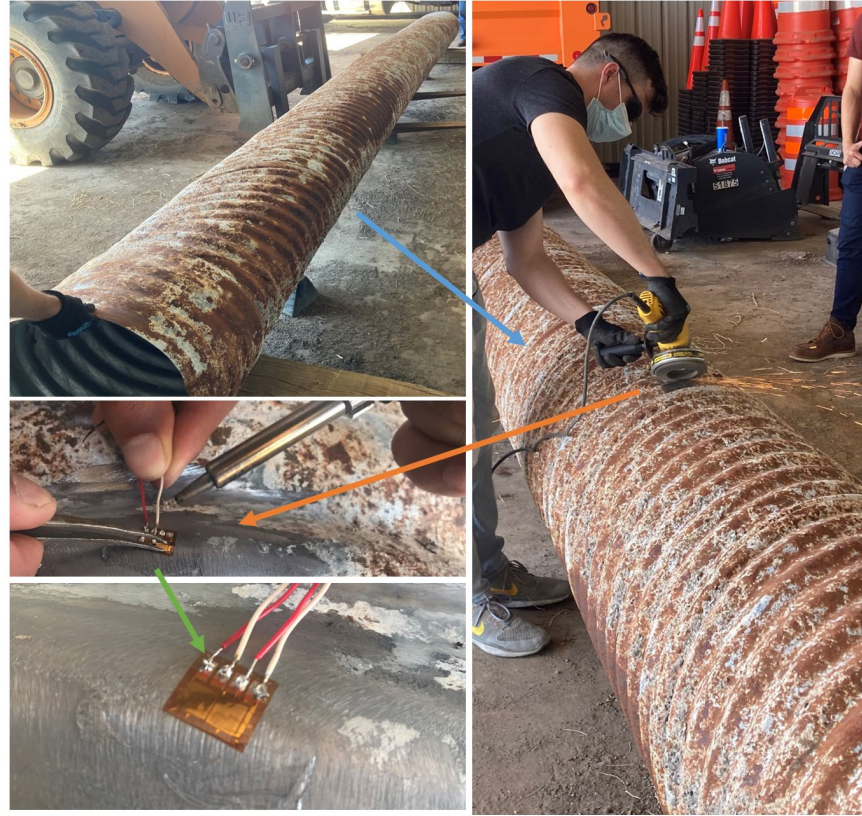
FIGURE 11 Instrumentation of corroded metal pipe

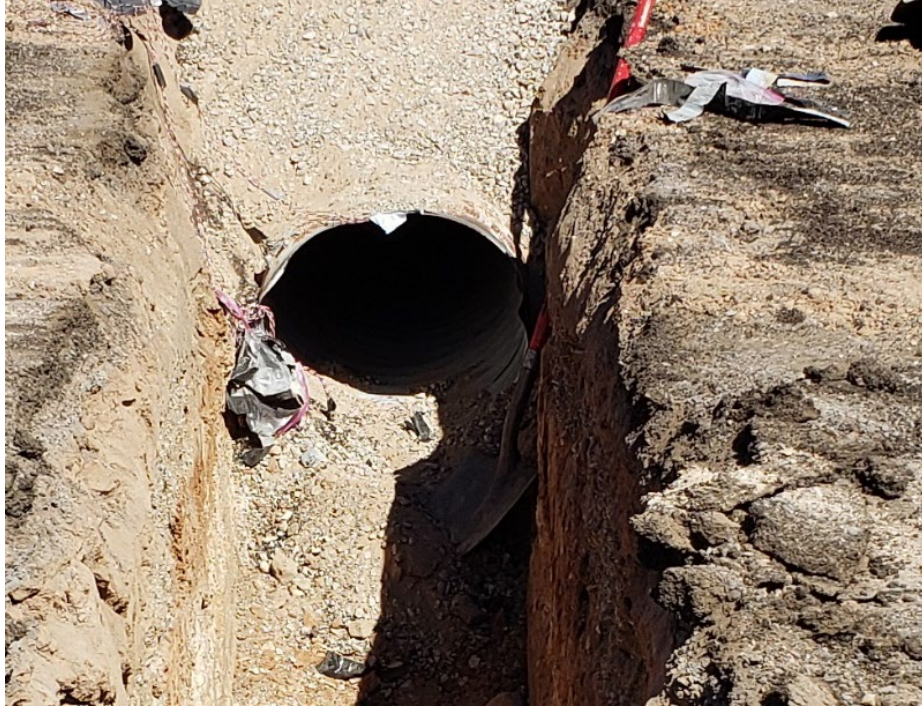
After the corroded corrugated metal pipe was buried at a depth of 18 inches, as shown in Figure 12, load testing was performed. Before testing, the truck was weighed on a weighing scale, as shown in Figures 13 and 14. First, an empty truck with a total weight of 25.75 kips traveled over the center of the culvert, with the wheels aligned with the exterior sensor arrays. The truck was then filled with sand, to a total weight of 48.55 kips, and traveled on the same path over the culvert. Finally, the loaded truck traveled near one of the ends of the culvert, with the interior wheels of the truck aligned with the exterior array of sensors. The breakdown of each wheel load is presented in Figure 15.

FIGURE 12 Buried corroded metal pipe

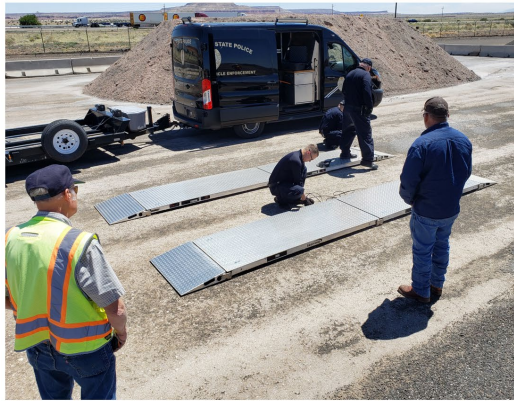
FIGURE 13 Weighing scale used to weight the test truck before and after filling it with sand. (a) scale installation. (b) scale after being wired.

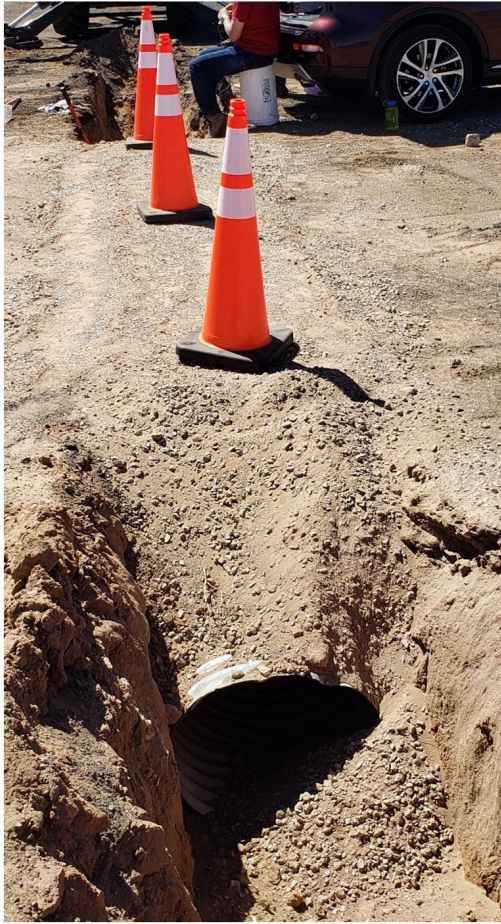
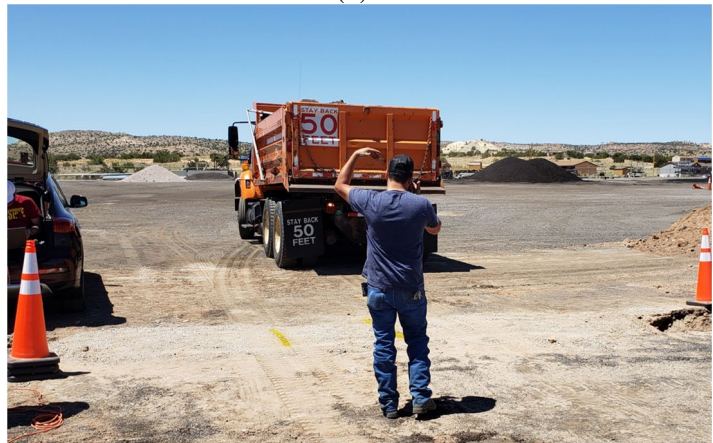
FIGURE 14 Corroded corrugated metal culvert buried (a), load testing (b) truck getting filled with sand, (c) truck passing over culvert.

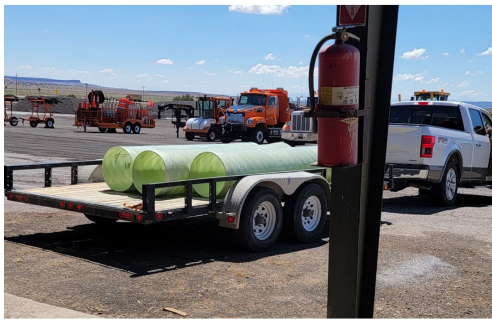
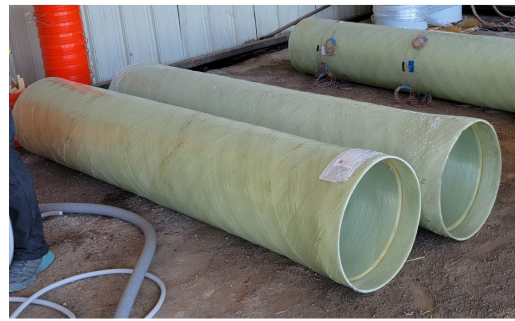
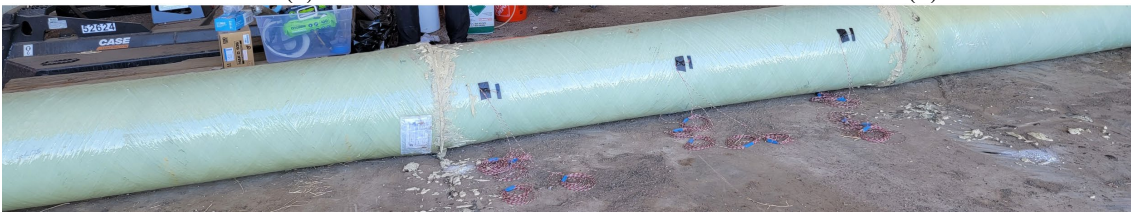
FIGURE 17 GFRP pipe (a)-(b): Transportation of 3 GFRP sections to NMDOT yard (c) instrumentation and connecting the GFRP pipe segments.

The manufactured GFRP pipe had an outer diameter of 20.125 in, and thickness of 0.5625 in, a little exceeding the required design criteria. The main reason for accepting this pipe was the reduced cost of manufacturing a pipe with this diameter since a smaller diameter pipe would have required a special mold. The GFRP pipe was delivered to the UNM team in 3 segments, each was 8 ft long, as shown in Figure 17. The middle segment was instrumented in the UNM structural laboratory, prior to moving to the NMDOT yard. Strain gauges were installed in the same locations indicated above for strain gauges installed on the corroded metal pipe.

Upon arrival at the NMDOT yard, the GFRP pipe pieces were moved to a shed to install the joints using polymer composite compatible with the GFRP material. The pipe was left for 24 hours to cure. As shown in Figure 18, after the joints cured and hardened, the wires of all sensors were secured and extended to the ends of the GFRP pipe, before the GFRP pipe was transported with a forklift to be installed for the slip-lining process.

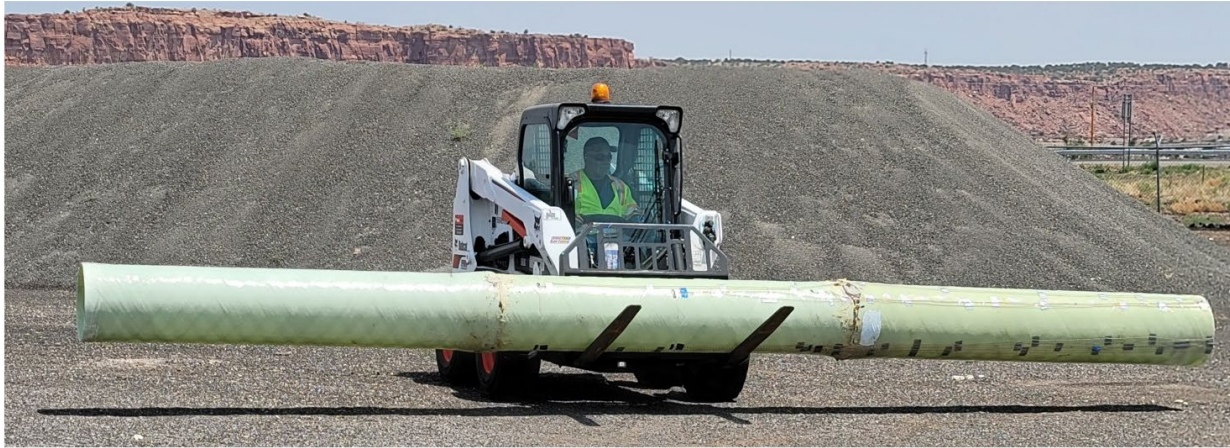
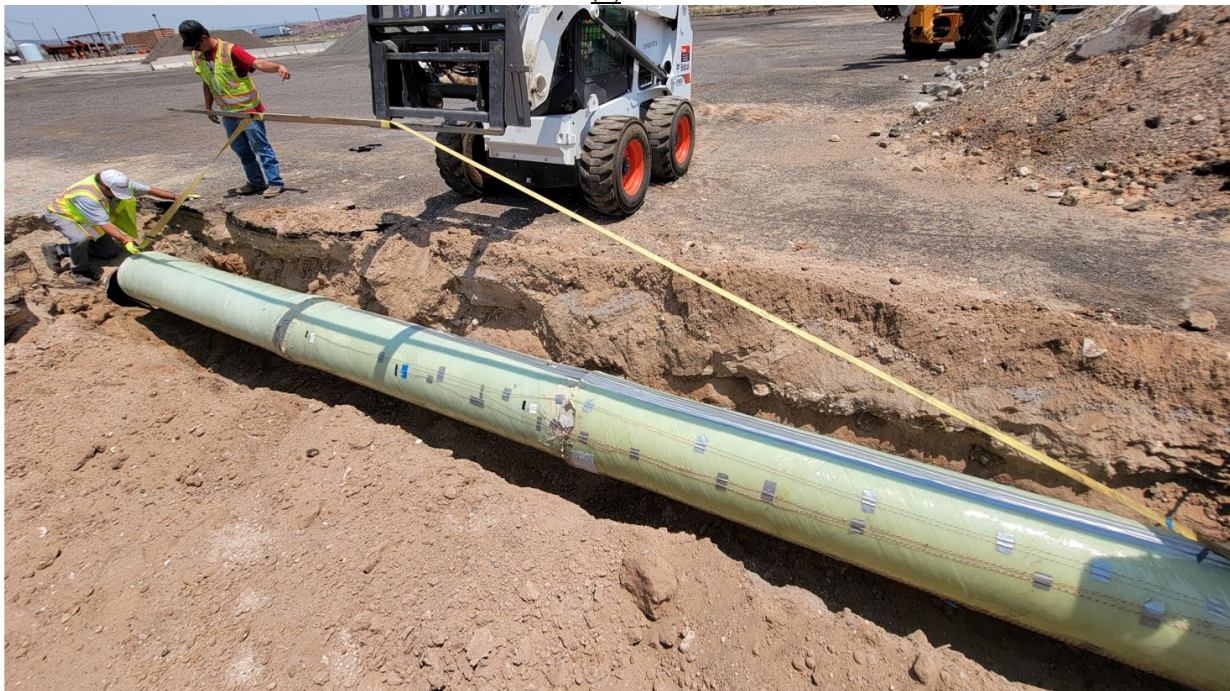
The instrumented and integrated GFRP pipe was transported using a forklift to the location of slip-lining, as shown in Figure 19. It was then carefully aligned and placed in an extended trench created ahead at the culvert front, such that it could be aligned with the buried corrugated metal pipe.

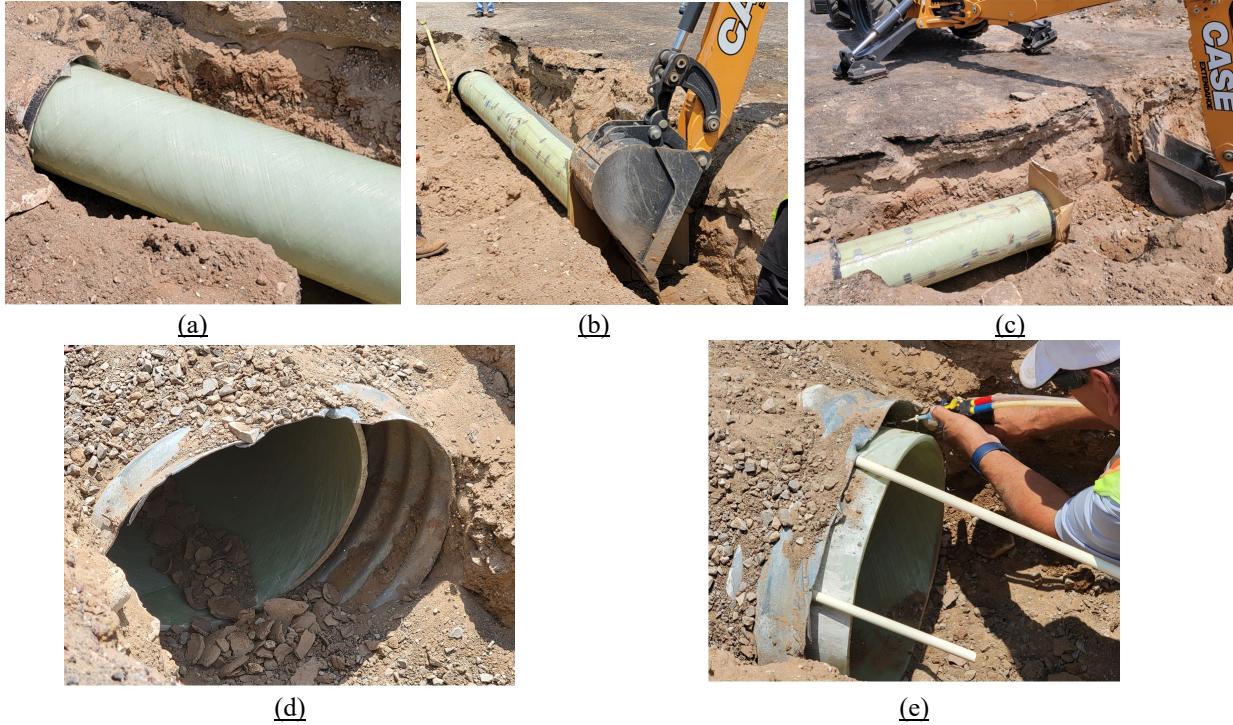
Due to the small tolerance of the GFRP diameter and the corrugated metal culvert diameter, the GFRP pipe was driven by an excavator's small bucket to slide inside the metal pipe. After the GFRP pipe was placed fully inside the corroded corrugated metal pipe, the ends were sealed with an expansive foaming agent, in preparation for grout pumping then load testing, Figure 20. After placement of the GFRP pipe, the sensor alignment was as shown in Figure 21.

FIGURE 20 (a)-(c) Slip-Lining Process driving the GFRP pipe inside the corrugated metal culvert. (d)-(e) GFRP pipe completely slid inside the corrugated metal culvert and application of the closure foam prior to grouting of the annular space.

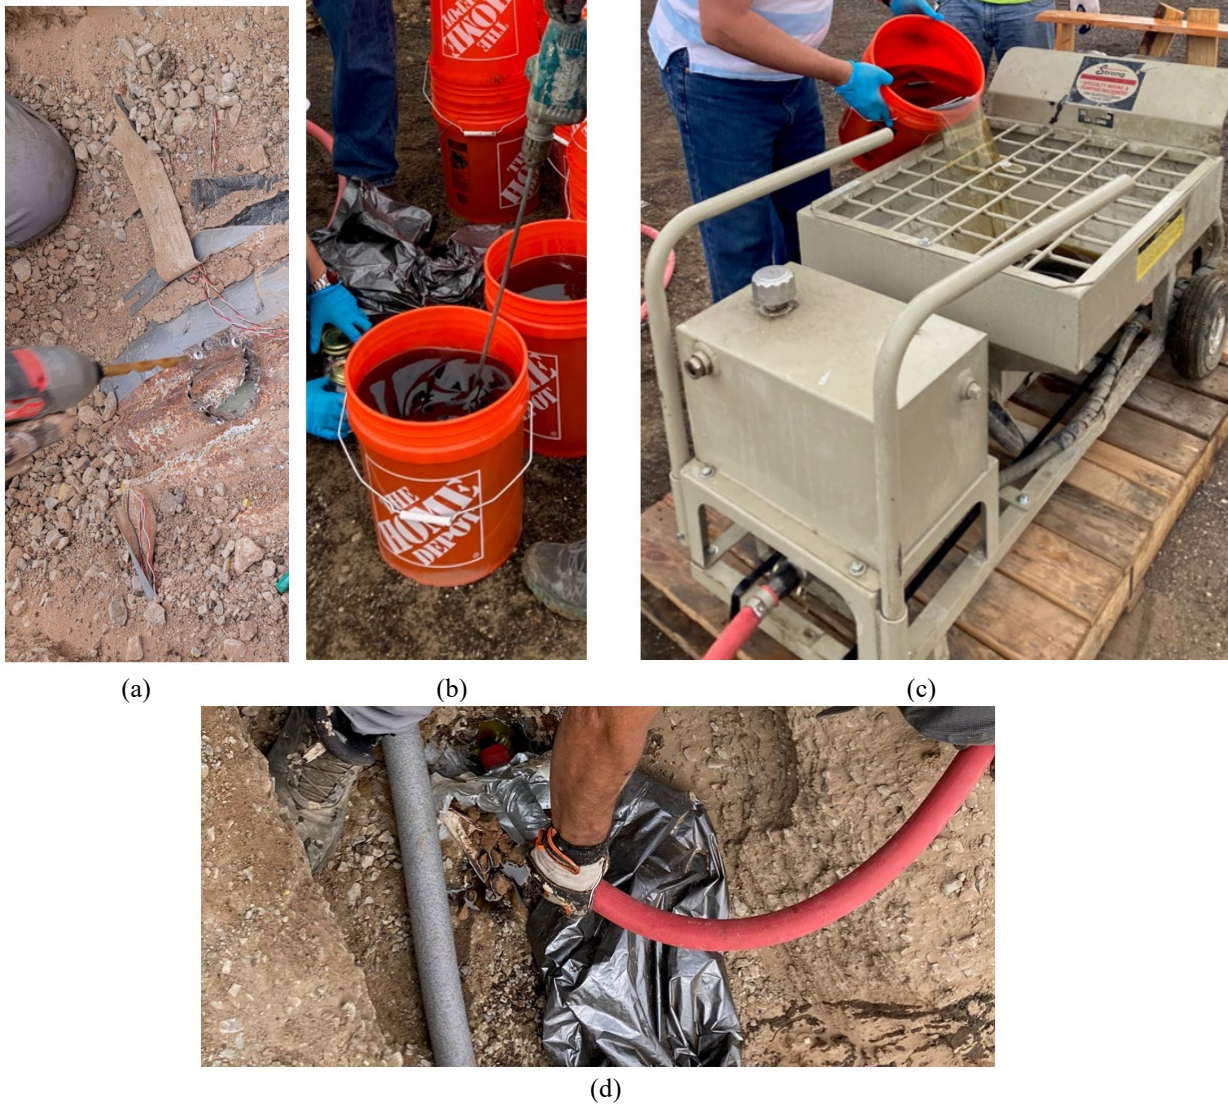
annular space was filled with the polymer. Thin rods were inserted in the annular space at different heights and ensured all the annular space was filled with the polymer.

FIGURE 22 Mixing and pumping polymer in the annular space using an opening at the middle of the span. (a) perforation to inject polymer. (b) polymer mixing. (c) polymer pumping. (d) polymer injection.
