NEW MEXICO DEPARTMENT OF TRANSPORTATION

Characterization of Unknown Bridge Foundations

Report NM13STR-02

May 2017

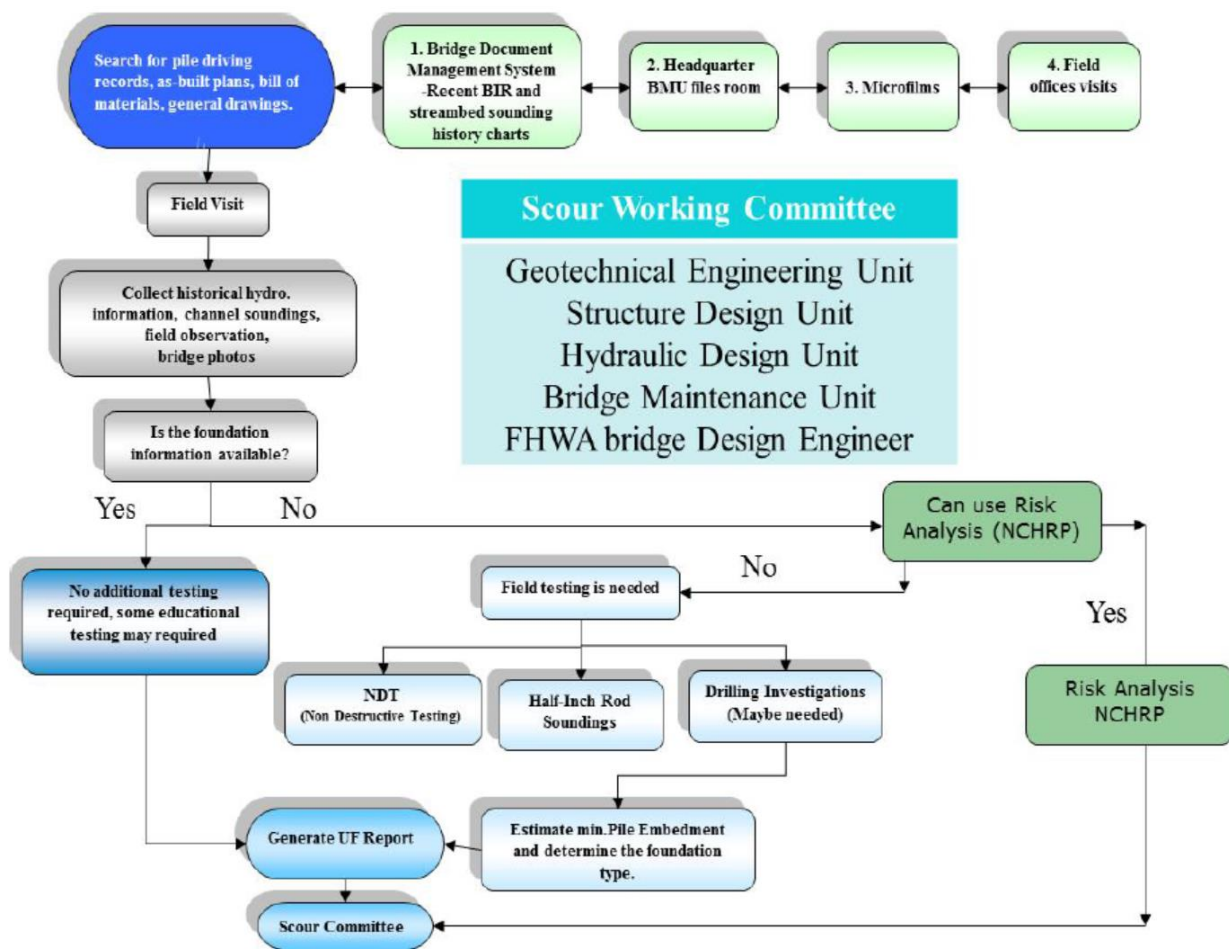
Figure 3 shows the unknown foundation process developed at North Carolina DOT for UBF in their bridge management system in 2005. The use of the risk-based management guidelines for scour was suggested in 2010 to evaluate remaining low-risk bridges with unknown foundation in North Carolina. The review of all unknown foundation bridges was completed in 2012.

FIGURE 3 Flowchart for North Carolina Unknown Bridge Foundation Process (17)

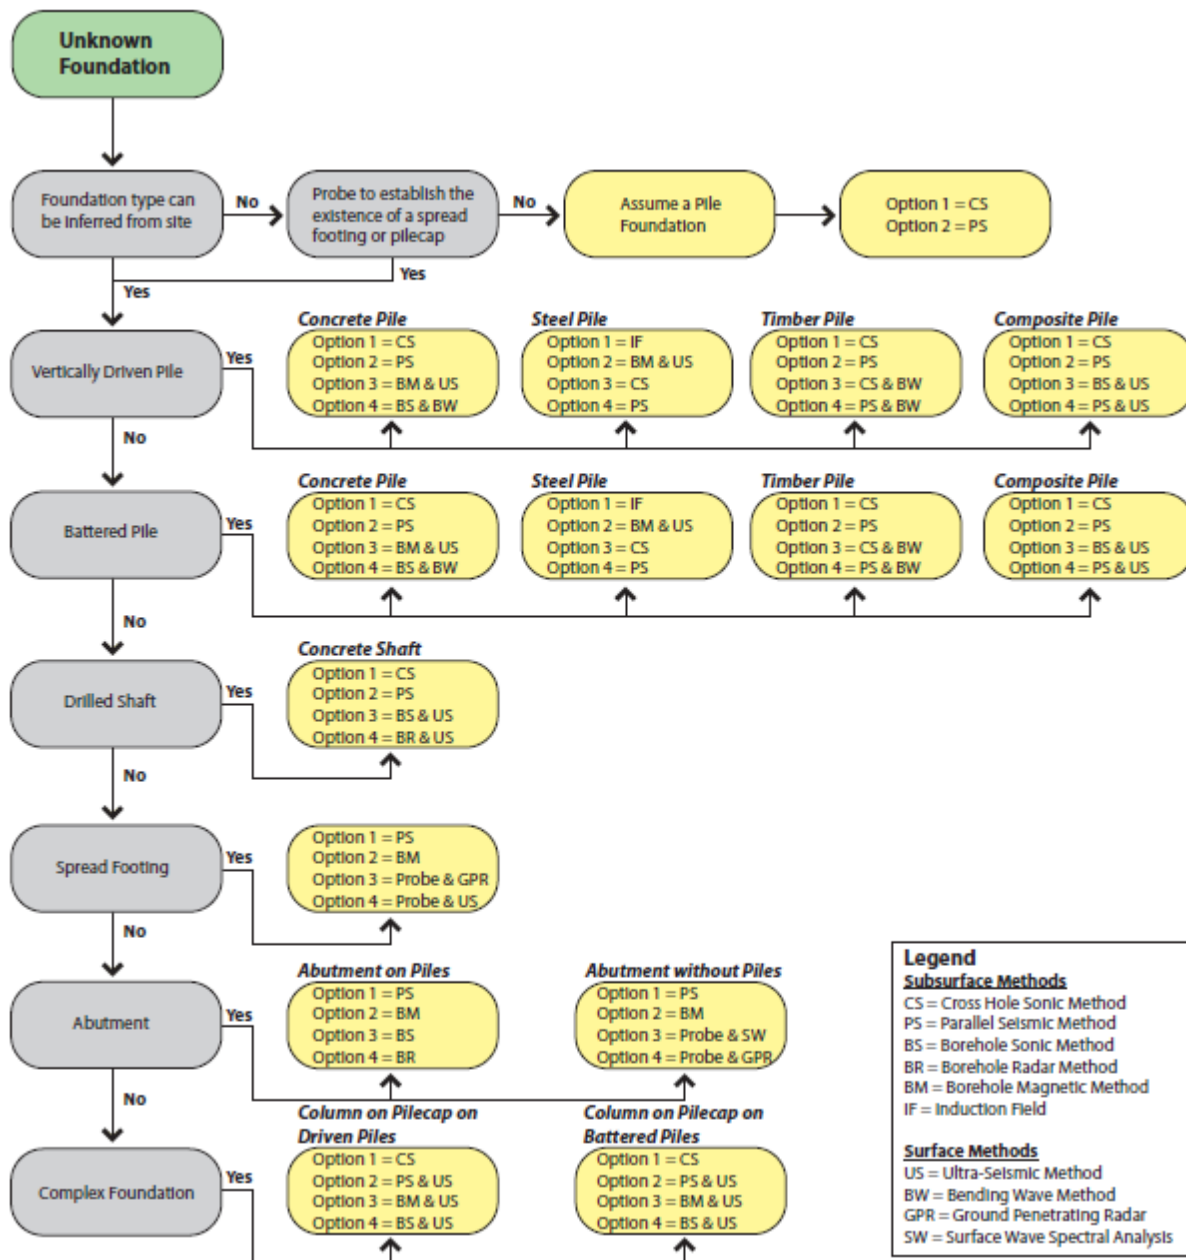
Figure 4 illustrates the appropriate application of the NDT method as suggested by Florida DOT. Here, SE/IR tests are not recommended since other methods provide much better results.

FIGURE 4 Various NDT Methods and Their Appropriate Use (1)

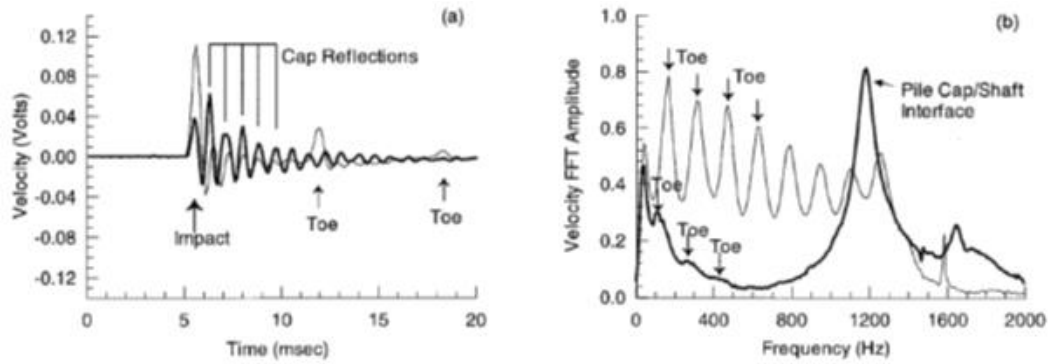
The presence of a pile cap and superstructure can undermine the success of determination of foundation depth using SE/IR tests. Two main geometric factors were reported that limit the applicability of the SE/IR method (21). They are the ratio of the intervening structure tributary area above the shaft to the drilled shaft area and the pile cap thickness to shaft diameter ratio. The result of two scenarios is shown in Figure 8. The darkened curves are the results obtained while the head is inaccessible. The light-colored curves represent the result where the pile head is accessible. With inaccessible the pile head, the length of the pile is difficult to determine. Echoes from multiple cap reflection can be seen in the velocity graph (see Figure 8a) and identifying the resonance frequencies corresponding to the reflection of the toes are difficult (see Figure 8b). However, the result is very clear with an accessible head (see light colored curves).

FIGURE 8 Effect of Accessible and Inaccessible Heads on Velocity Graph

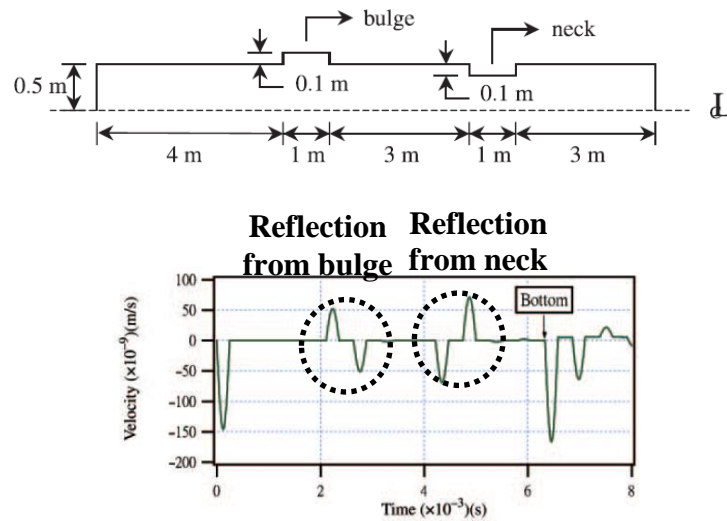
Anomalies such as consecutive bulges and necks also result in reflections between the impulse and the echo from the pile bottom on the velocity graph. Such reflections should be considered when the echo from pile bottom is sought. A study showed that the defects with sizes greater than 10–30% and 45% can be identifiable by SE and IR analyses, respectively (29). An example of a defective pile with a bulge and a neck and the corresponding velocity signal is indicated in Figure 9 (30).

FIGURE 9 Velocity Graph of a Defective Pile with a Bulge and a Neck

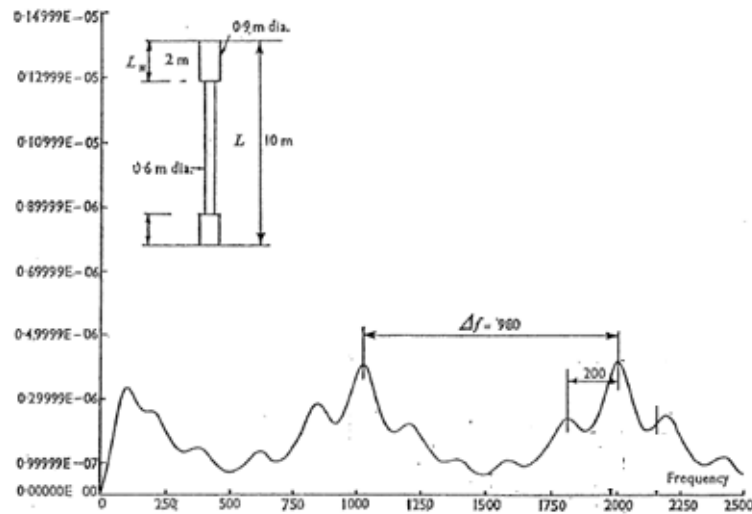
The impedance change along a pile also produces oscillation on the mobility graph. An example of a mobility graph affected by impedance change along a pile is shown in Figure 10 (31). The $\Delta f = 200$ Hz corresponds to the reflection from the pile bottom, whereas the $\Delta f = 980$ Hz corresponds to the cross-section change at 2 m below the pile top.

FIGURE 10 An Example of a Mobility Graph with Impedance Change in the Pile

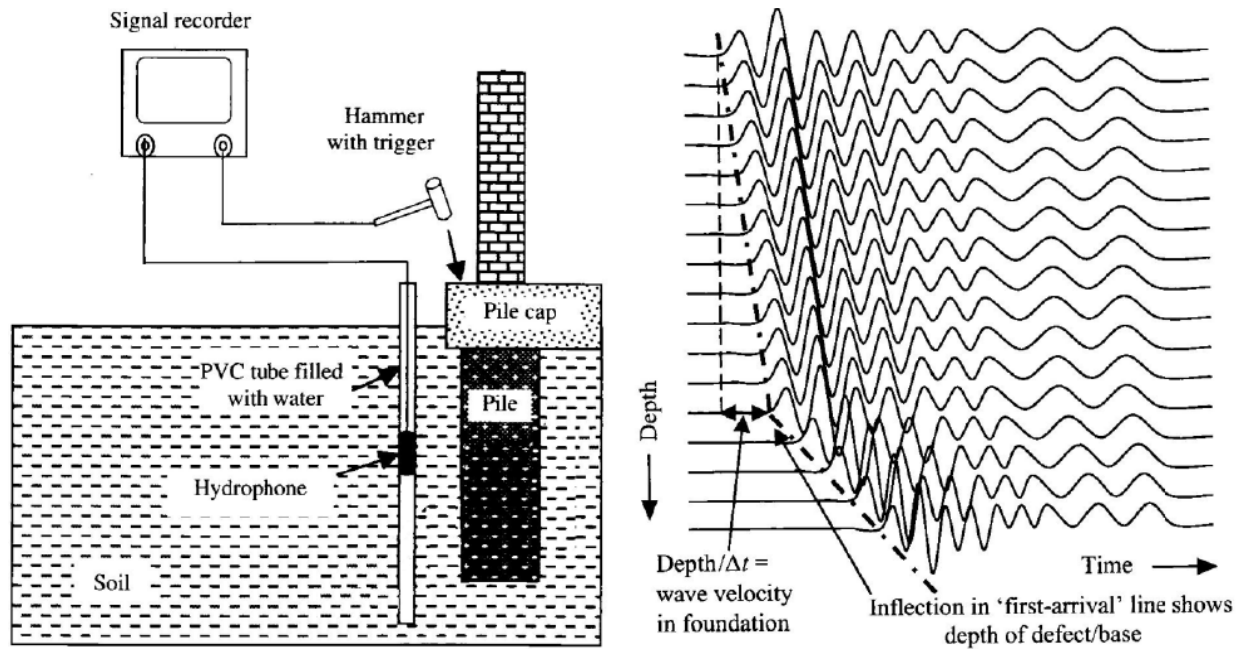
A newly developed combined Parallel Seismic and Cone Penetration Test (PS/CPT) system allows collecting soil data and conducting a PS test simultaneously during a CPT test. The new combined technique has a great advantage over conventional PS tests since no borehole is required (35). Olson et al. (36) presented details of the principles and operations of the combined (CPT+PS) system.

FIGURE 11 Typical Setup and Test Data of PS Test (12)

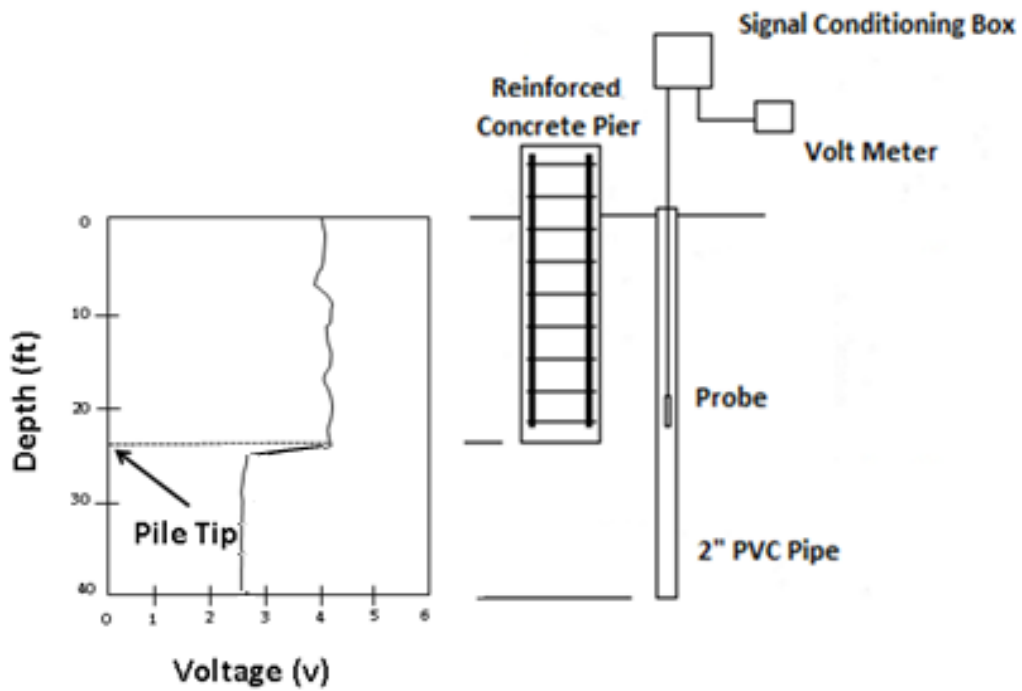
The IF method involves determining the length of the metal within the foundation by inducing an electro-magnetic field through a soil-foundation system and detecting the change of the magnetic field due to the nearby metal objects. The testing is implemented by passing a DC current through a polarized magnetic field sensor which is lowered into a PVC cased borehole adjacent to the test pile. A magnetic field is consequently induced in the pile's metal which can be detected by the probe. The depth of the foundation is determined by measuring the magnetic field strength at various depths, and identifying the changes in magnetic field strength. A typical IF setup and associated data are indicated in Figure 12.

FIGURE 12 The IF Result and a Typical IF Setup

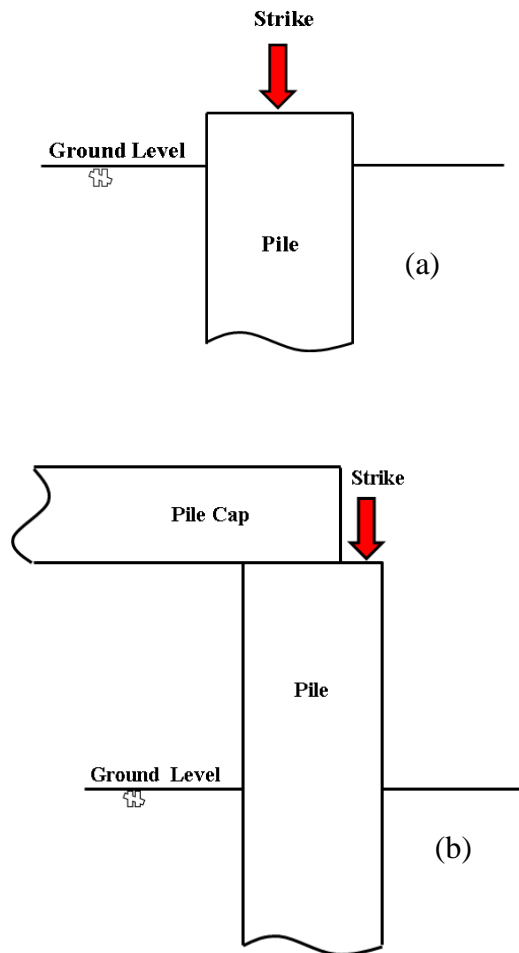
Striking Setup for Piles with Accessible Top When either the entire or a portion of the pile top is accessible, a vertical strike can be applied on the top surface of the pile as shown in Figure 13. In this case, the longitudinal P-waves travelling down the pile is generated directly.

FIGURE 13 Vertical Striking on Piles with Accessible Top

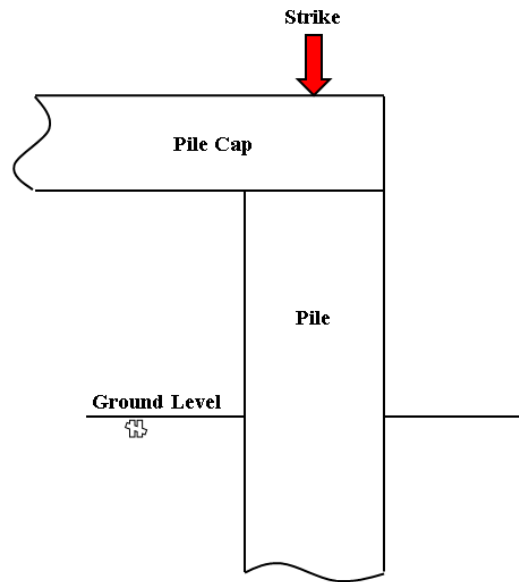
Setup for Striking on Piles with Inaccessible Top For piles with inaccessible top, the longitudinal wave can be generated by striking other parts of the foundation as shown in Figures 14 to 19. When the superstructure is not placed exactly atop the pile, longitudinal waves can be produced by striking the top surface of the pile cap as indicated in Figure 14. If the presence of the girders on the top of the pile cap does not allow striking on the pile cap top surface, other options indicated in Figures 15 to 19 can be applied.

FIGURE 14 Vertical Striking on the Top Surface of Pile Cap

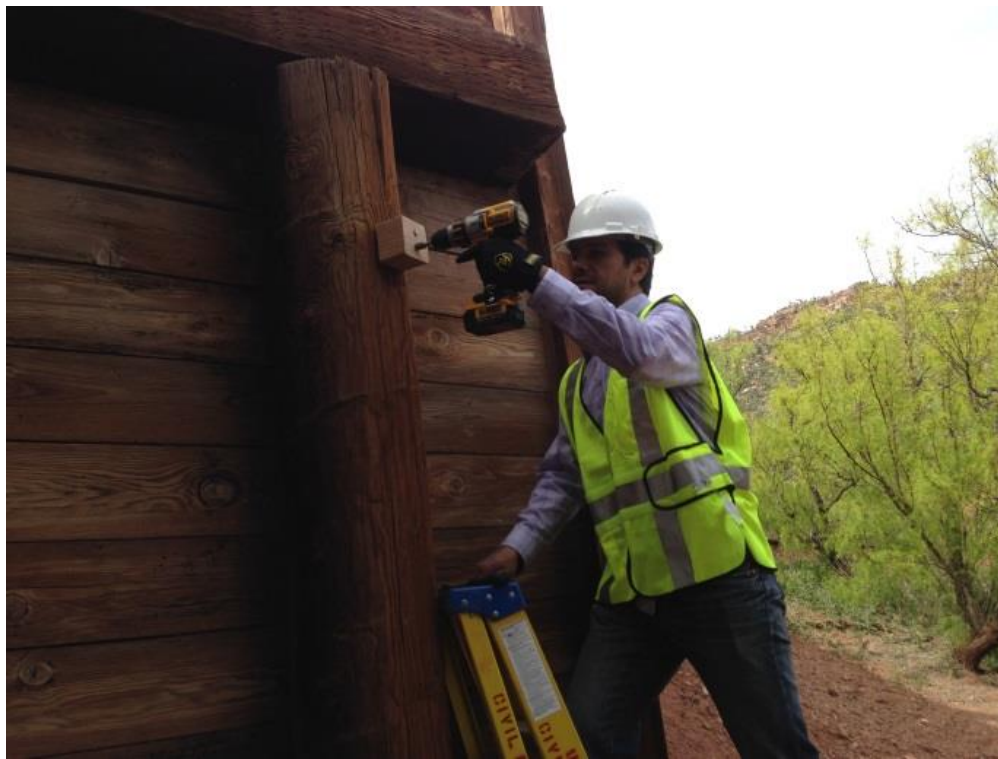
FIGURE 25 Attachment of a Wooden Striking Block onto the Test Pile

increases the contact surface between the block and the pile's side surface. The blocks must be tightly attached onto the test pile by nails or screws as indicated in Figure 25. This method will be more difficult for concrete surface since concrete screws only have a maximum embedment of 1 ¾ inch. If more embedment depth is required, threaded holes have to be installed into the concrete which will significantly increase the cost and time.

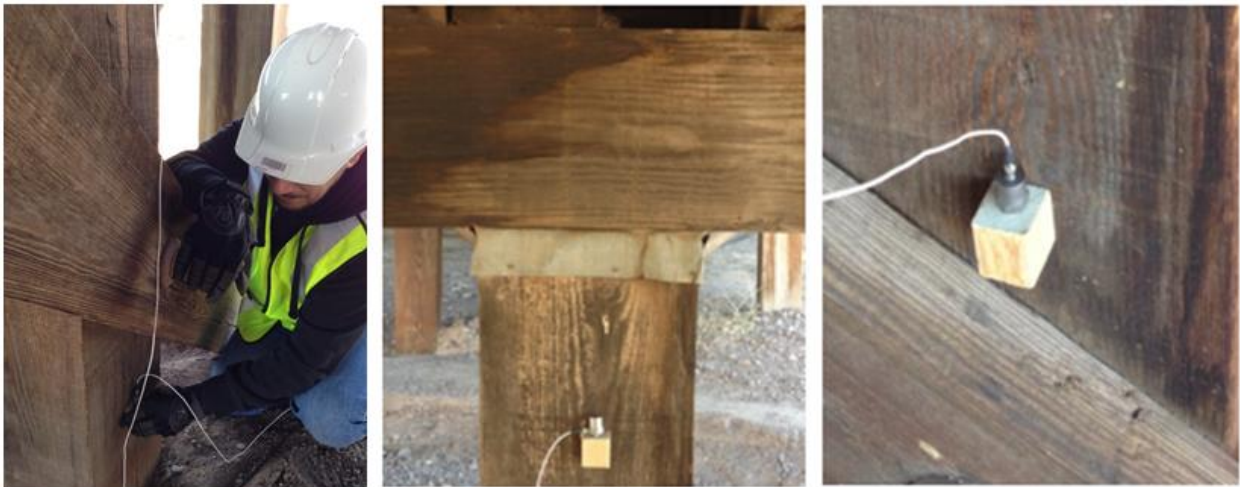
The sensor (accelerometer) can be placed atop the wing piles. If the pile top is inaccessible, the accelerometers will be mounted on wooden blocks attached onto the side of the test pile with nails, screws, or glue. The dimensions of the wooden blocks used in this project can be found in Figure 22. Examples of accelerometer attachment to the pile surface is indicated in Figure 26. If two accelerometers are used, the second accelerometer should be placed far away from the first accelerometer as possible.

FIGURE 26 Accelerometers Mounted on a Pile by Wooden Blocks.

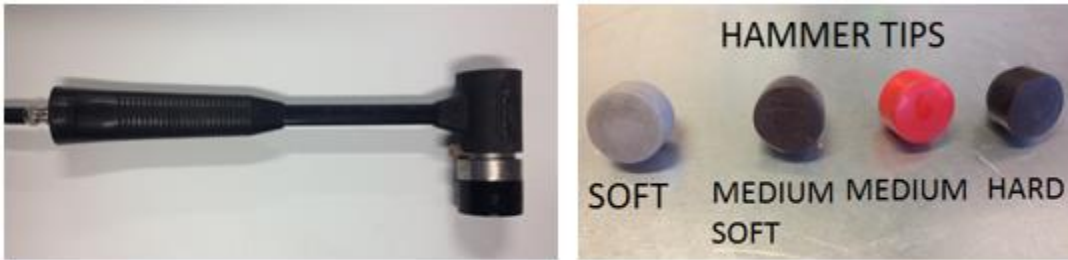
FIGURE 28 A Hammer and Four Different Tips

The equipment utilized for conducting SE/IR tests should be assembled as indicated in Figure 27. Four different hammer tips are available as shown in Figure 28.

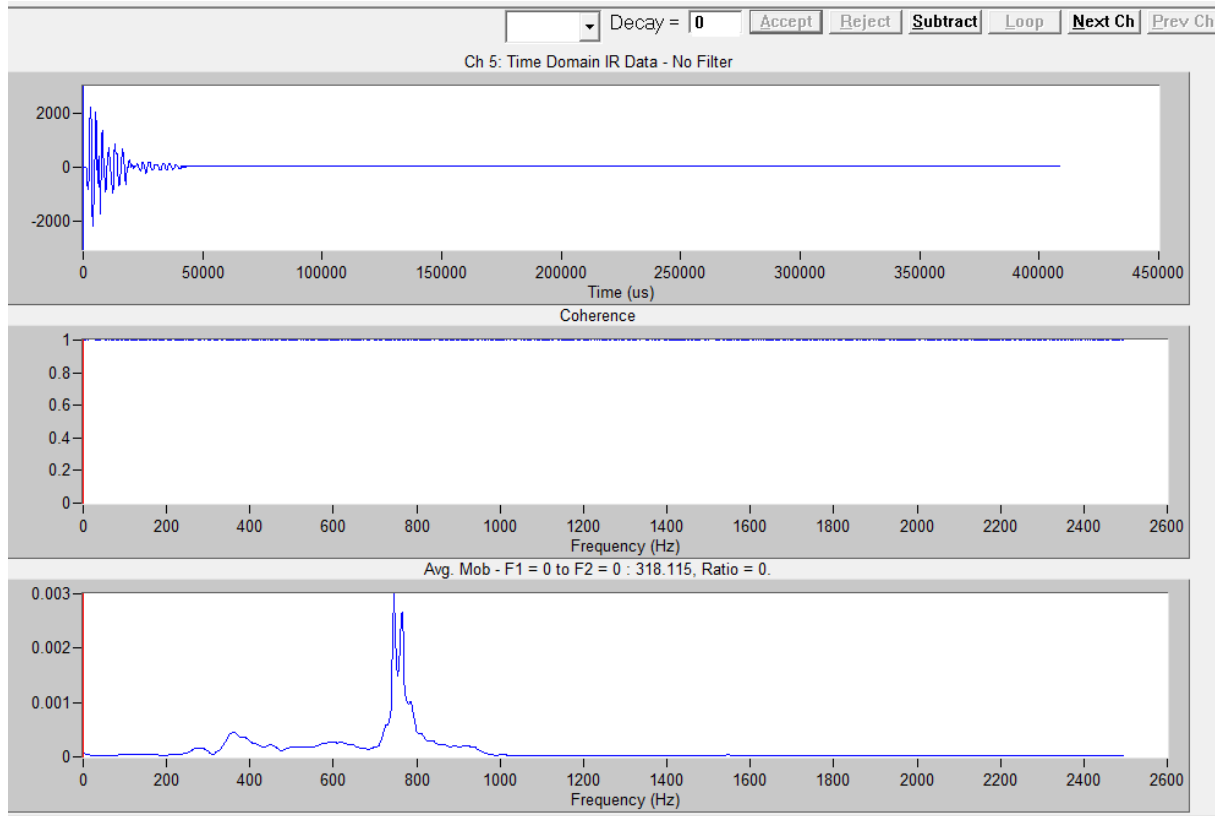
For each SE/IR test, the obtained velocity graph indicated in Figure 29 was used to determine the time difference between the impulse (source) and the echo from pile toe (Δt). Δt is used therein to represent the time difference and used to determine the pile length associated with SE analysis through Eq. 1. The software was also able to process the data and perform an IR analysis. An example of the result of an IR analysis is indicated in Figure 31. If the resonant frequencies were distinguishable in the mobility plot (bottom graph), the difference in frequency between the resonant frequencies (Δf) could be used to determine the embedment depth of a pile. Similar to Δt , Δf was used to denote the difference in frequency between the resonant frequencies in this report. Δf was used to determine the pile length associated with IR analysis through Eq. 4.

FIGURE 31 Produced Graphs from IR Analysis, Tme domain IR data (top), Coherence (middle) and Average Mobility (bottom)

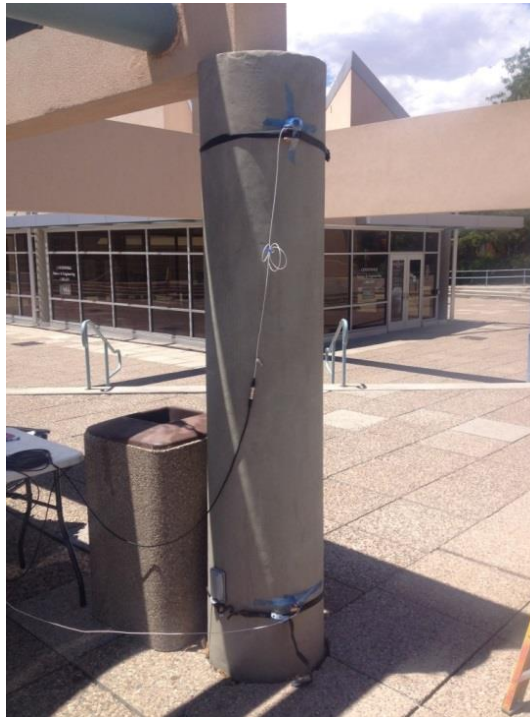
FIGURE 37 The Reinforced Concrete Column of Centennial Library on UNM Campus

Twelve SE tests were conducted on a reinforced concrete column on UNM campus shown in Figure 37. The column is one of the 3-story columns of the Centennial Engineering Library on UNM campus. The total length of the column is 43 ft. Only the top 7.5 ft of the column is visible as shown in the photo.

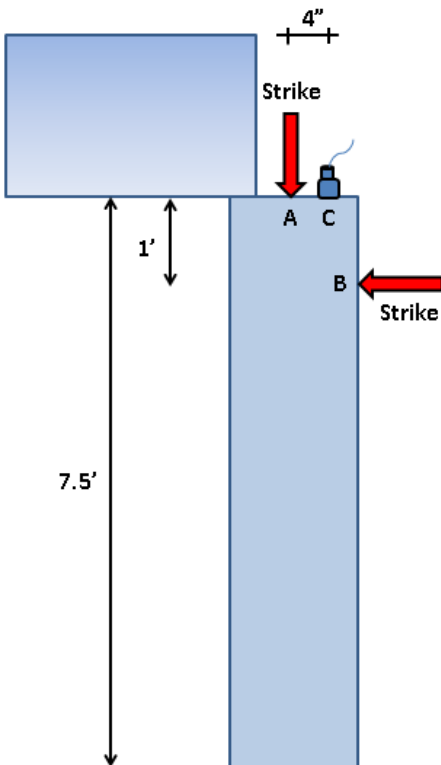
FIGURE 38 Source and Receiver Locations on the Concrete Column of Centennial Library on UNM Campus

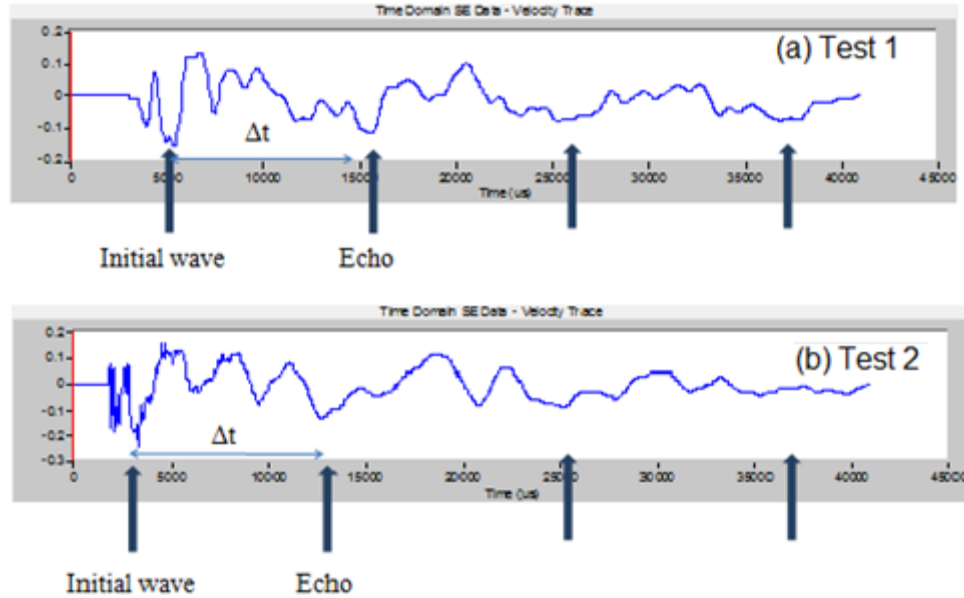
Results of Vertical Striking with Hard Tip The velocity graphs obtained from the accelerometer in Tests 1 and 2 are depicted in Figure 39. Although high frequency noise at the beginning was clearly observed in Figure 39b, the impulse and echoes were identifiable as shown as arrows in the figure. When the accelerometer was placed at least 1 ft away from the source, the high frequencies at the beginning disappeared. Therefore, accelerometers are recommended to be placed at least 1 ft from the source.

FIGURE 39 Velocity Graphs for Tests 1 and 2 on the Concrete Column of Centennial Library on UNM Campus

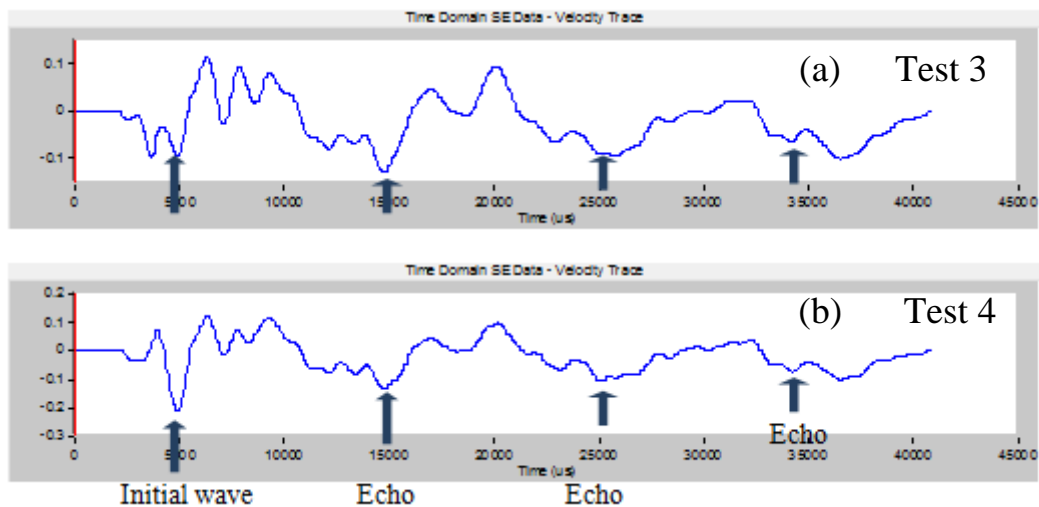
Results of Vertical Striking with Medium-hard Tip SE tests were repeated using a medium-hard tip. The velocity graphs for Tests 3 and 4 are shown in Figure 40. There are no high frequencies at the beginning of the velocity graphs. The time differences between the impulse and echo are similar to tests conducted by the hard tip (see Figure 39). Δt is still 10 ms and the calculated length is 50 ft.

FIGURE 40 Velocity Graphs for Tests 3 and 4 on the Concrete Column of Centennial Library on UNM Campus

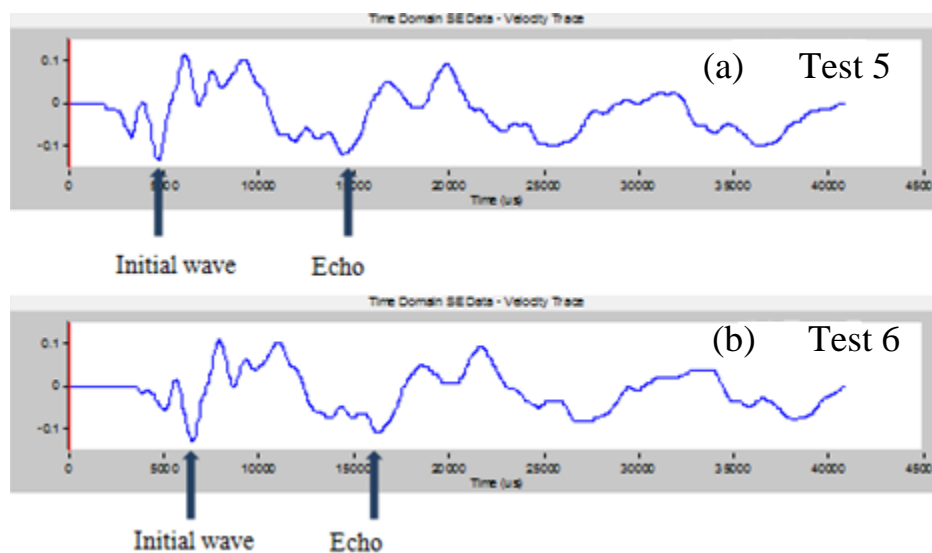
Results of Vertical Striking with Medium-soft Tip Medium-soft tip was used and the obtained velocity graphs are shown in Figure 41. Again, the results are similar to the velocity graphs using medium-hard tip (see Figure 40). In addition, no high frequency content can be found as seen in the velocity graph of hard tip (Figure 39b). Δt is still 10 ms and the calculated length is 50 ft.

FIGURE 41 Velocity Graphs for Tests 5 and 6 on the Concrete Column of Centennial Library on UNM Campus

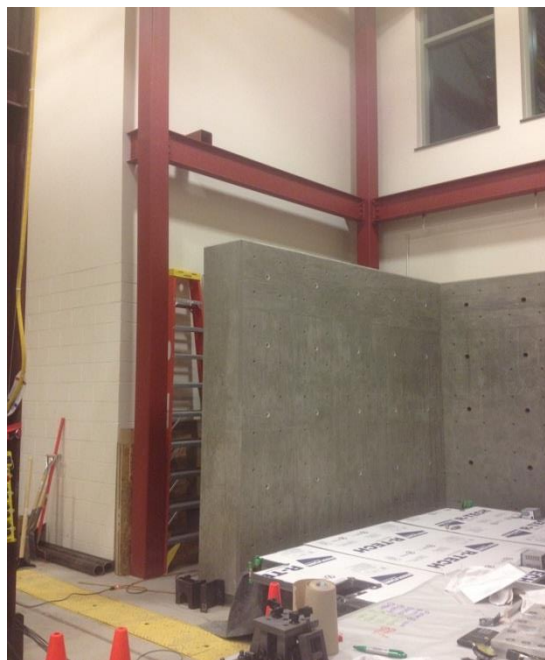
FIGURE 43 The Reinforced Concrete Wall in the Structural Lab

Since there are similarities in relative dimensions between a pier wall foundation and the reinforced concrete strong-wall at the Structural Lab of the Department of Civil Engineering at UNM (Figure 43), SE tests were conducted in the lab to study the applicability of the method on non-slender foundations. SE tests were carried out using vertical and horizontal striking with hard, medium-hard, medium-soft and soft hammer tips. Figure 44 shows the source (A~D) and the accelerometer locations (E, F and G). The accelerometer was mounted vertically on Points E, F or G. Wooden blocks were utilized to mount the accelerometers at Points F and G. Figure 49 shows the setup of one SE test.

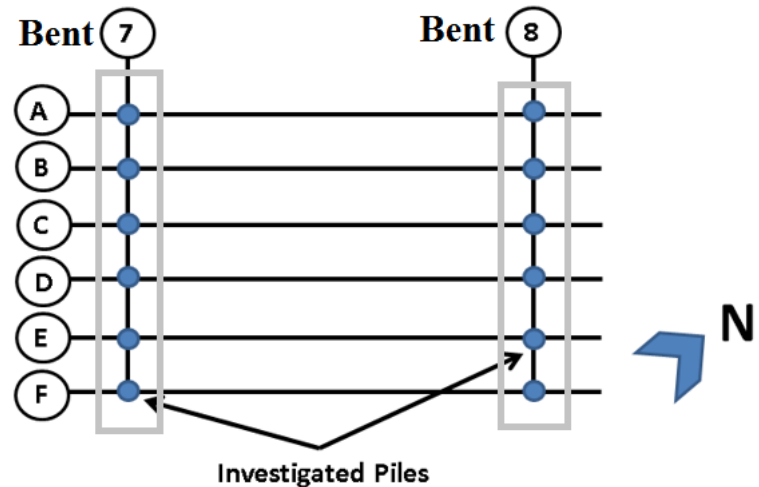
Sixteen SE tests were conducted on two timber piles at Bents 7 and 8. Figure 50 depicts the foundation plan and test piles.

FIGURE 50 Foundation Plan and Investigated Piles of Santo Domingo Bridge

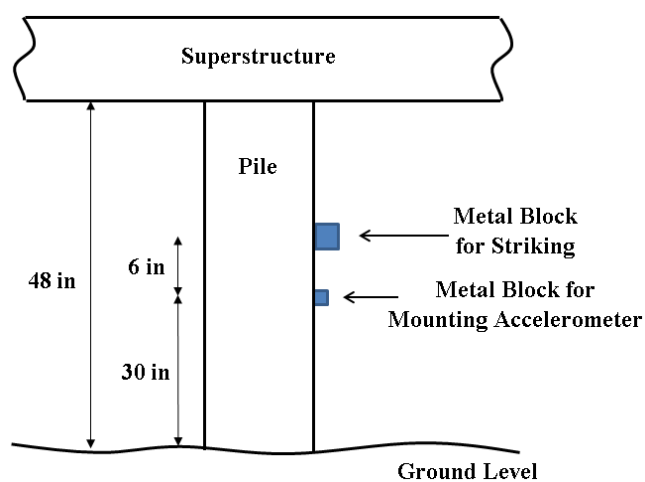
Six SE tests were performed on Pile 7-F and seven on Pile 8-E. The test setup is shown in Figure 51. Although horizontal striking did not result in interpretable velocity signals in preliminary tests, it was decided to examine if horizontal striking on the side of a pile could produce useful result in the field. Vertical striking on a metal block was used on Pile 8-E as the source. The metal block used for vertical striking was attached to the pile surface tightly. The accelerometer was attached vertically on a metal block attached to the pile. The specifications of SE tests are indicated in Table 8.

FIGURE 51 SE Tests Setup for the Santo Doming Bridge Piles (Not to Scale)

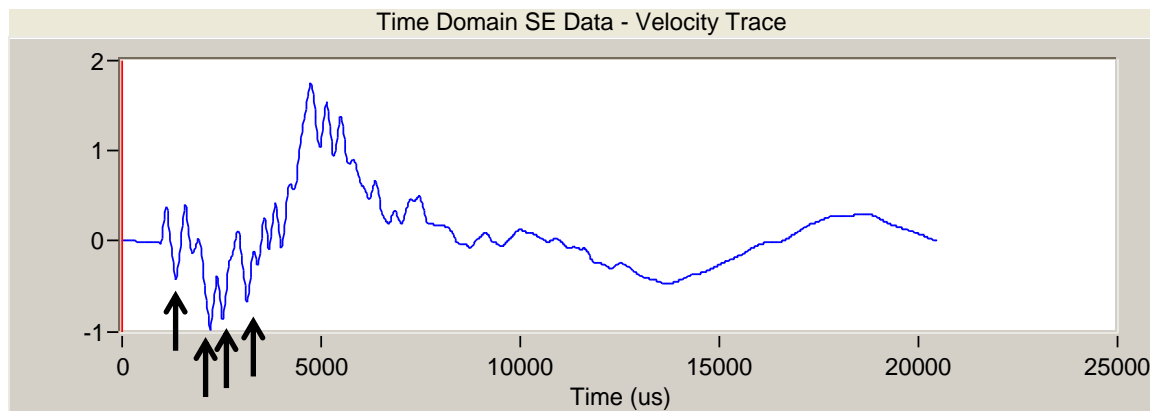
Tests 1 to 6 were performed on Pile 7-F with horizontal striking. The results were not useful and the length of the pile could not be determined. A typical velocity graph (Test 1) is shown in Figure 52. The arrows in the figure indicate the high frequency vibrations. These high frequencies may be due to the reflections of impedance change in the pile or may relate to the lateral vibration of the pile. Reflections from the pile toe were not found.

**FIGURE 52 Velocity Graph from the Accelerometer (Pile 7-F)**

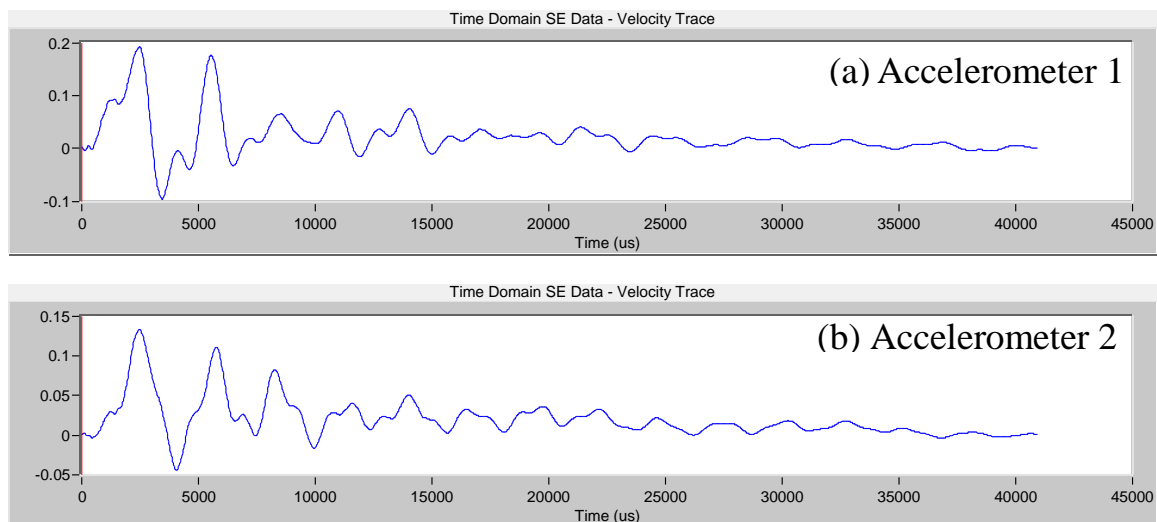
SE/IR Tests with Striking on Top of the Pile Results obtained from top striking showed that, hard and medium-hard hammer tips produced good data. However, poor results were found for medium-soft tip as shown in Figure 70. The impulse, the first largest magnitude, was expected to be a valley (compression down-going wave) and not a peak (tensile wave) as shown in this figure. The first valley was not related to the direct down-going compression wave. Since the impulse was difficult to identify, Δt cannot be determined.

FIGURE 70 Velocity Graphs of Test 3

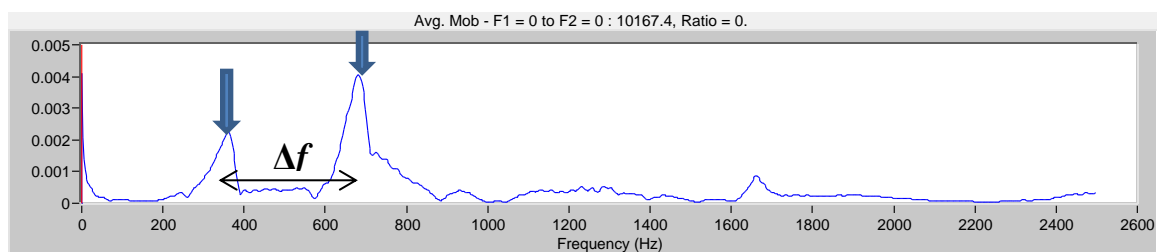
FIGURE 71 Mobility Graph Obtained from Accelerometer 1 (Test 1)

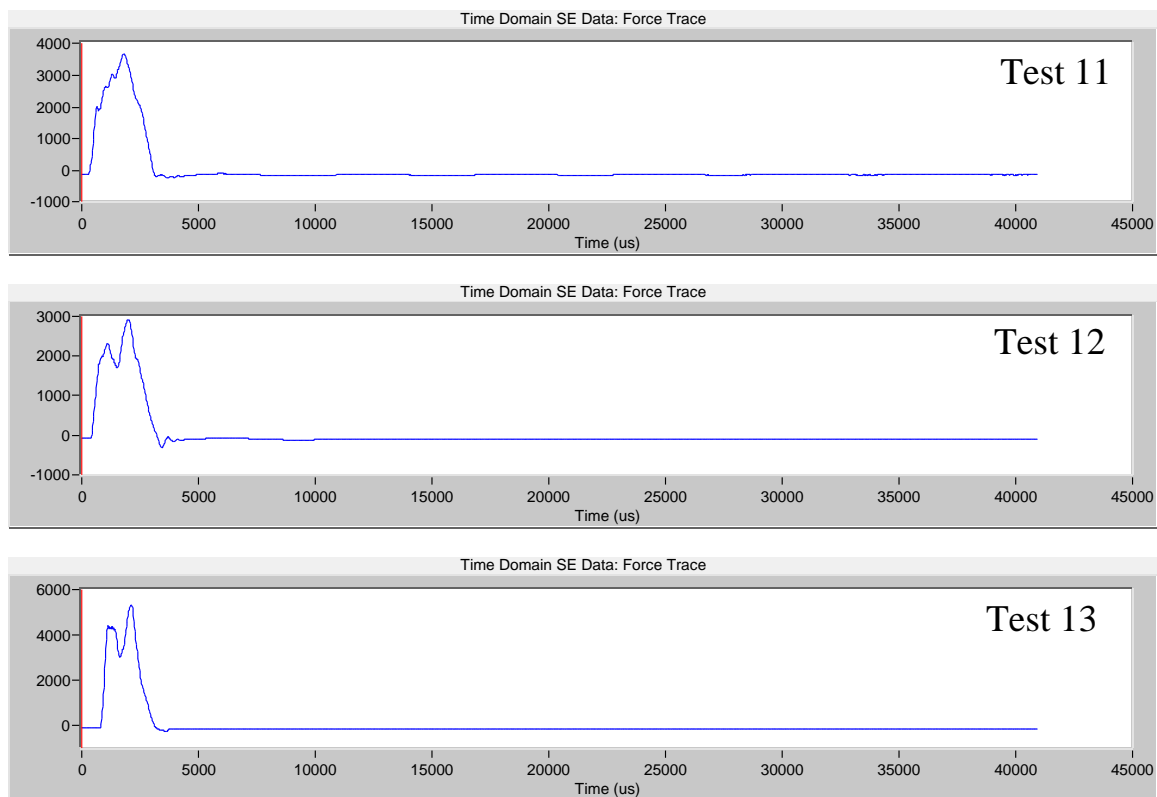
FIGURE 78 Initial Impulse from the Hammer's Force Sensor (Wooden block, Hard-tip)

SE Tests Performed with Wooden Striking Block and Hard tip Hammer SE tests were conducted by hard hammer tips in Tests 11 to 13. Since the source was applied manually, the only difference between Tests 11 to 13 was the difference between their input energies and impulse shapes (Figure 78). These source signal graphs show more regular shapes compared to sources produced by aluminum blocks (Figure 72). The corresponding velocity graphs for Tests 11 to 13 are indicated in Figures 79 to 81 respectively.

14 to 16 are shown in Figure 82; the shape of the source signal is better than that of hard tip (see Figure 78). The corresponding velocity graphs obtained from Accelerometer 1 and 2 are shown in Figures 83 to 85 for Tests 14 to 16 respectively.

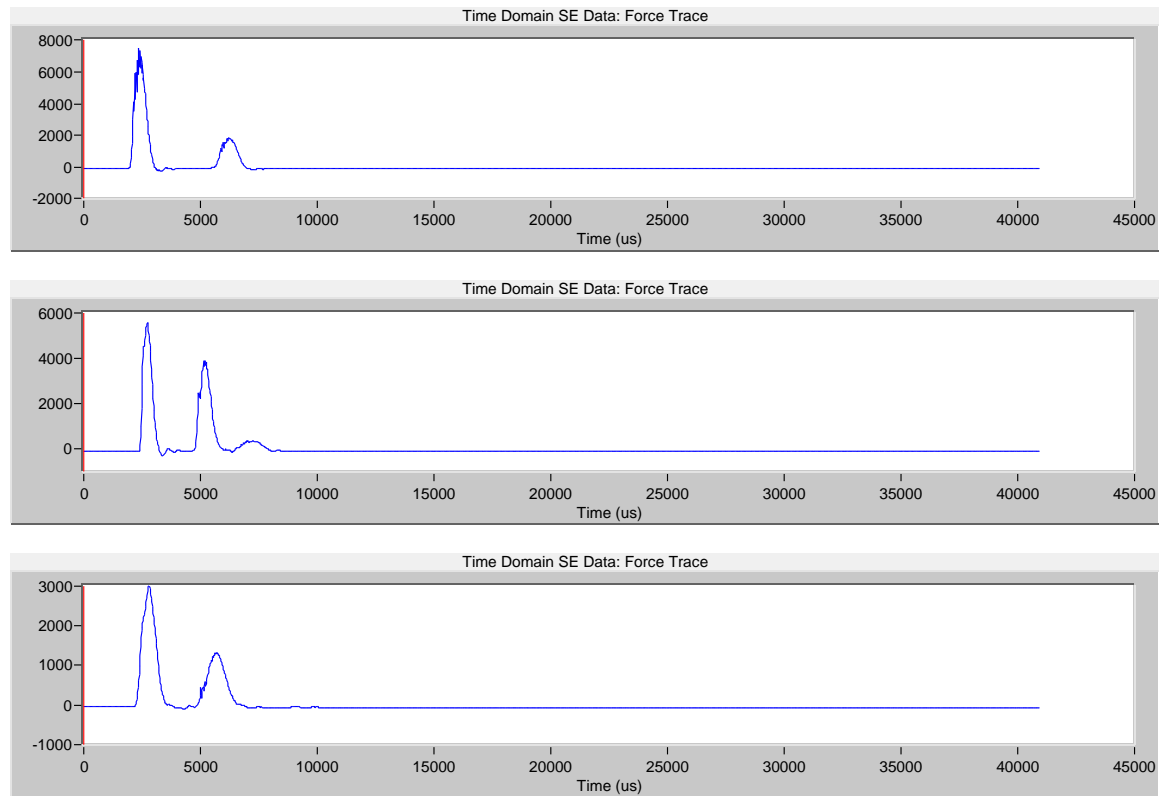
FIGURE 86 Impulse Signals Generated by Striking the Aluminum Block with Hard Hammer Tips (Tests 17 to 19)

SE/IR Tests Performed with Aluminum Striking Block In Tests 17 to 19, different energies were imparted into the piles by striking an aluminum block attached to the side of the pile with hard hammer tip. As shown in Figure 86 the impulse graphs show multiple peaks similar to the previous observations of Pile 1 (see Figure 72).

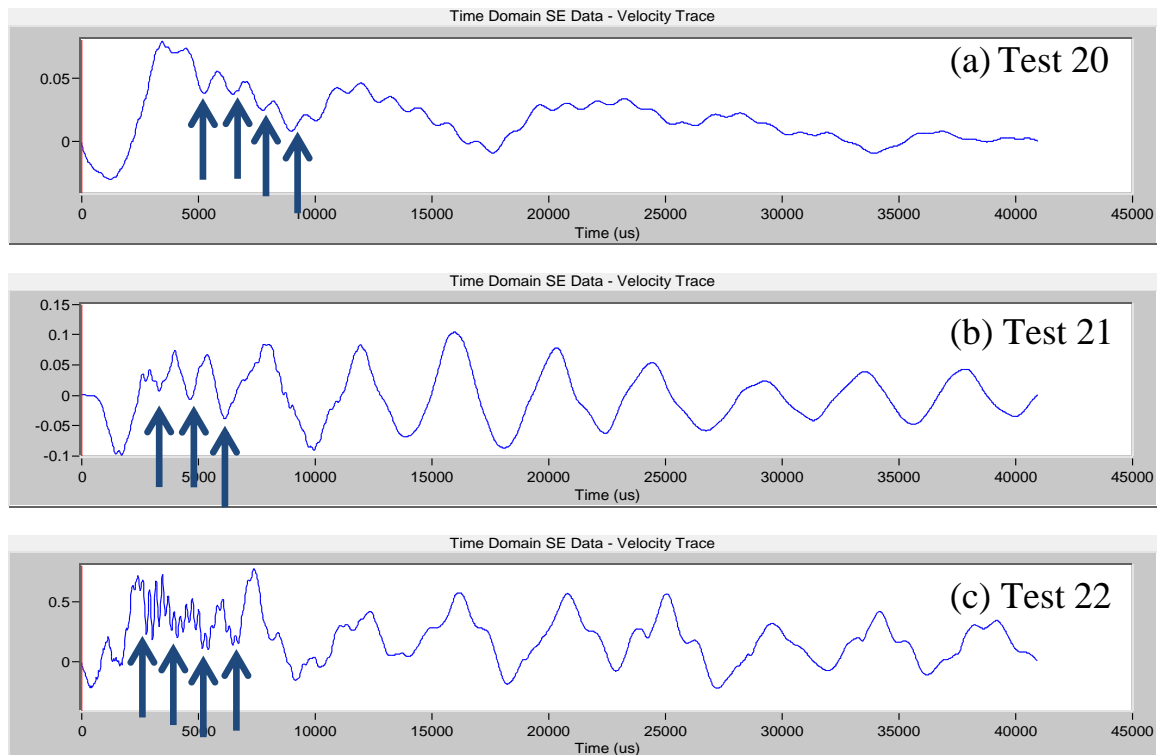
FIGURE 89 Velocity Graph Obtained from Accelerometer 1 (Tests 20 to 22)

The velocity graphs are very complicated. Closely located valleys indicated as arrows are shown in Figure 89. This is due to the presence of a huge longitudinal crack shown in Figure 90 which caused multiple internal reflections. The arrow in the figure indicates the big crack along the pile.

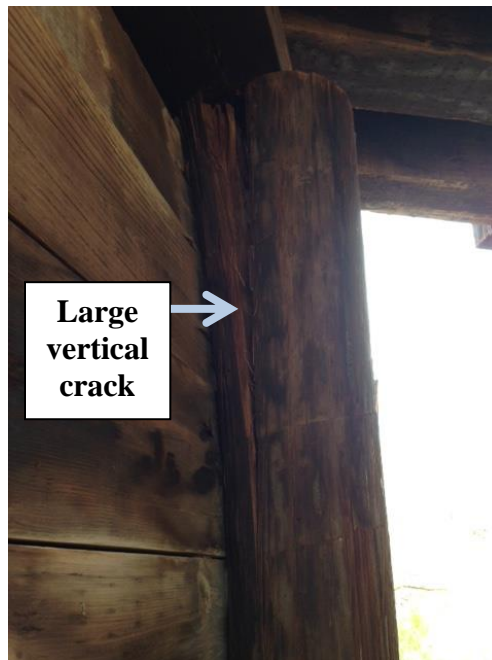
FIGURE 90 Picture of a Crack along Pile 14

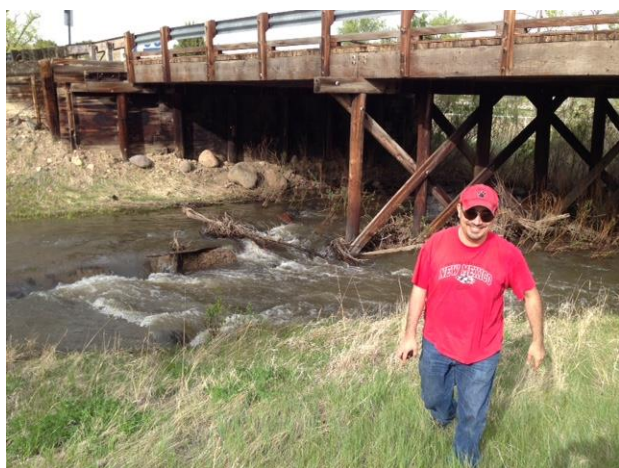
FIGURE 93 Street View of Bridge No. 1190 Showing Running Water Surrounding Intermediate Bent during the First Visit

During the first visit, the accessibility of the intermediate bent was hindered by the running river water as indicated in Figure 93. Only the piles beneath the end bents were accessible. Due to seasonal reduction in the water level, all piles beneath the intermediate bent became accessible during the second visit as indicated in Figure 94. SE tests were conducted on the intermediate piles and the piles beneath the end bents. The investigated piles are indicated in Figure 95.

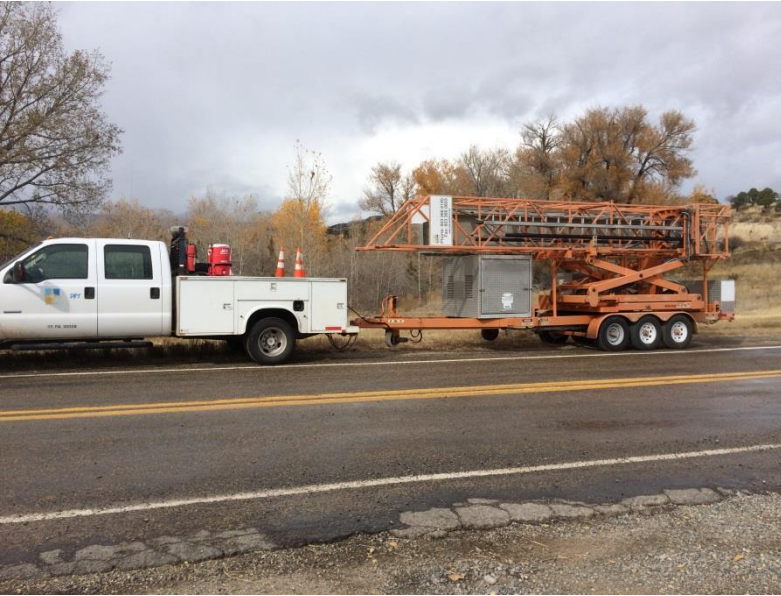
FIGURE 96 Mobile Scaffold from NMDOT District 4

A trailer-mounted inspection platform (mobile scaffold) from NMDOT District 4 was arranged at the second visit to explore the feasibility of conducting SE tests on piles with the help of the inspection platform. Figure 96 shows the mobile scaffold that was used for attaching the blocks for accelerometer and for striking. Figure 97 shows a UNM team member performing the SE test using the scaffold.

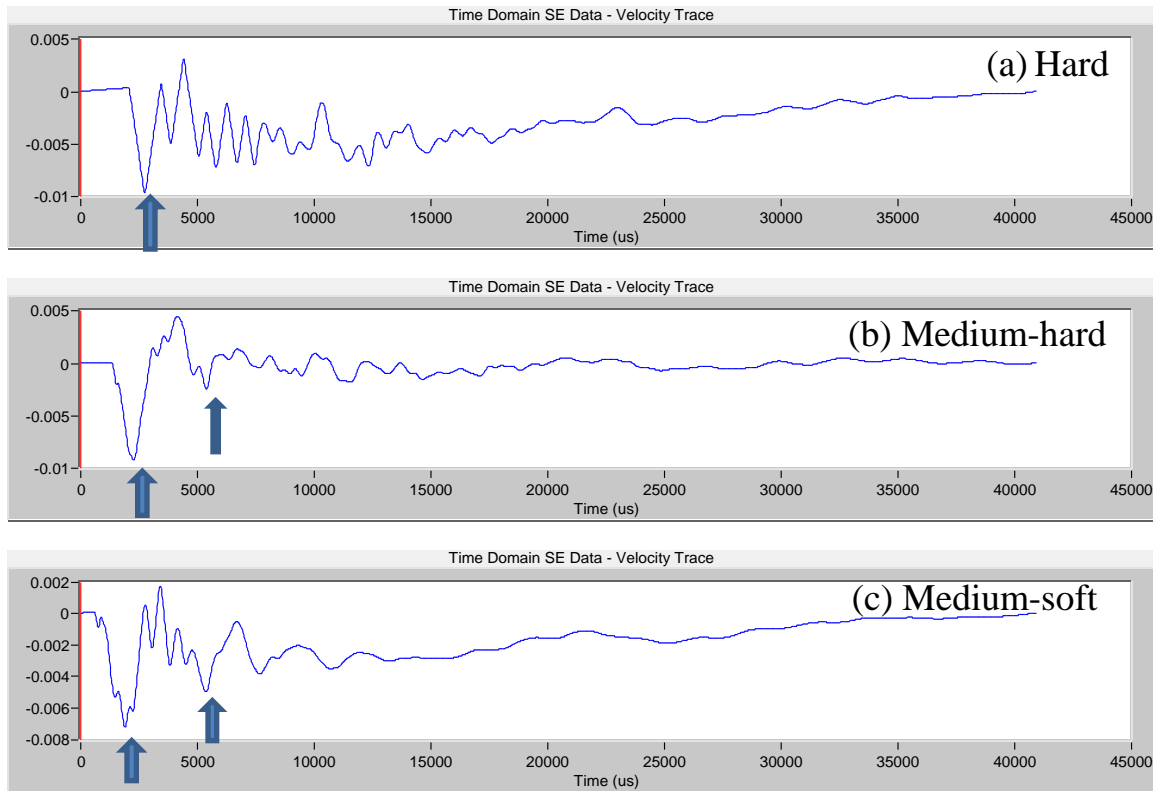
FIGURE 98 Velocity Graphs Obtained by Striking with Different Hammer Tips (Pile B)

SE Tests on Pile B The accelerometer was placed at the top of the pile since the top of this wing pile was accessible, Three different hammer tips were used. The results are shown in Figure 98. As shown in this figure, Δt can be identified for medium-hard and medium-soft hammer tips but not the hard tip. This is interesting as our experience indicates that hard tip performs better than softer tips in general. The wave velocity was assumed to be 13,160 ft/s. Table 23 lists the calculated lengths of Pile B.
