NEW MEXICO DEPARTMENT OF TRANSPORTATION

Characterization of Unknown Bridge Foundations

Report NM13STR-02

May 2017

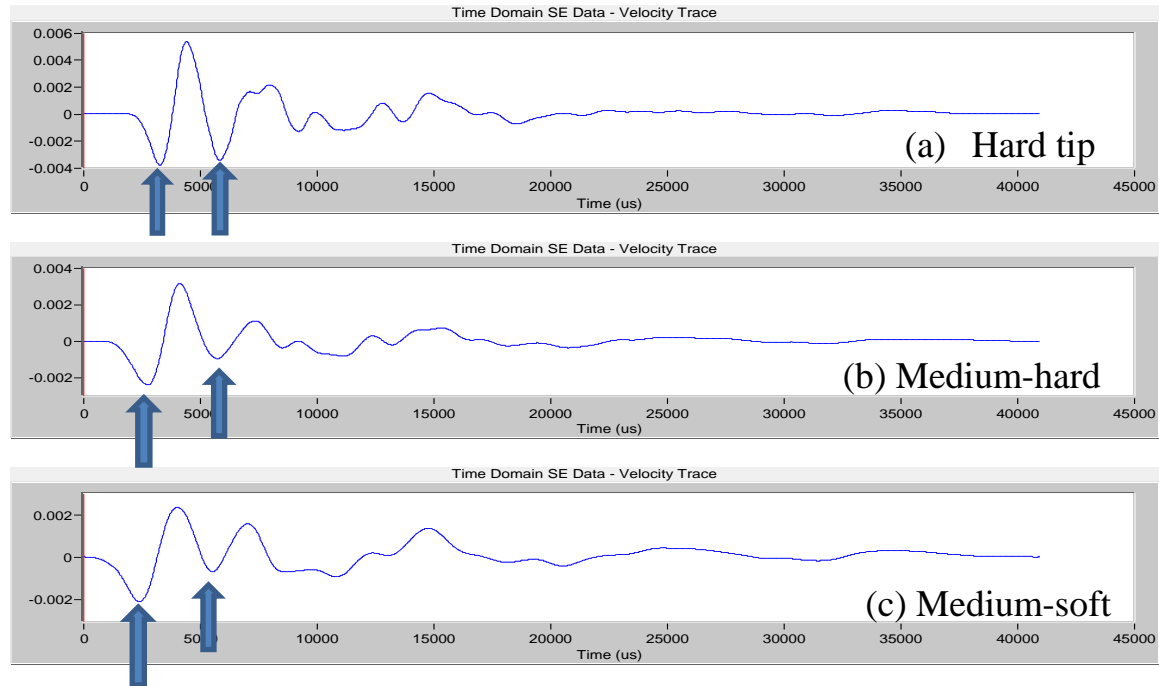
SE Tests on Pile 8 Three SE tests (10 to 12) were conducted on Pile 8 with hard, medium-hard and medium-soft hammer tips again. The top edge of the pile was accessible; therefore, the source was applied by striking the top surface. Due to the size of the pile, the accelerometer was mounted 1 ft below the top of the pile. The velocity graphs are shown in Figure 102. Recognizable impulse and echo were found in all three velocity graphs. Unlike the SE test on Pile 1, the result of medium-soft tip was acceptable when striking at the top of the pile. The estimated pile lengths are listed in Table 26.

FIGURE 102 Velocity Graphs of Pile E with Different Hammer Tips (Tests 10 to 12)

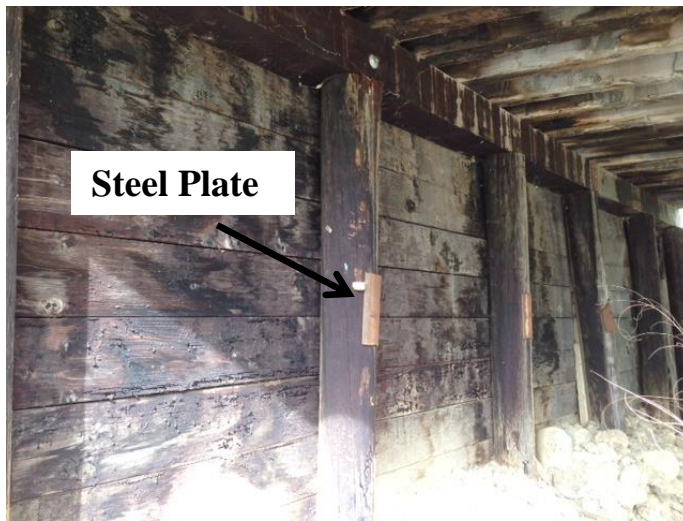
plate and pile. Energy transmitted only through the steel bolts and a complex source signal was created due to the vibration of the plate. Thus, mounting the striking block on a pile tightly and securely is very essential to yield good results.

FIGURE 103 A Steel Plate Attached to Pile 10

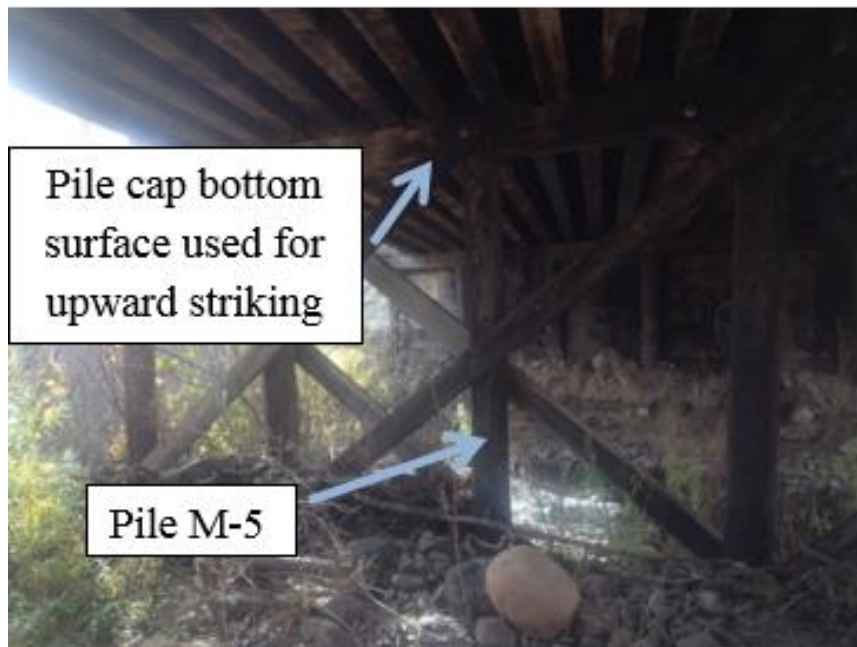
FIGURE 105 Photo of Pile M-5 and the Pile Cap

SE Tests on Piles M-5 Twenty-one SE tests were performed on this pile. Two accelerometers were mounted on the wooden blocks attached to the side of the test pile. As mentioned before, when the top of either pile or pile cap are inaccessible, upward striking on the pile cap next to the test pile can be used as the alternative mean to produce longitudinal waves along the test pile. Figure 105 shows the locations of striking on the pile cap. Upward striking on pile cap will produce a strong tensile wave accompanied by a weak reflected compression wave. The source of some SE tests was also applied through striking block. The locations of the sensor and striking block can be found in Figure 106. Cubic and wedge wooden blocks were attached onto the pile surface with screws for striking. The striking was accomplished with four different hammer tips including hard, medium-hard, medium-soft, and soft. Table 27 lists the characteristics of all SE tests conducted on Pile M-5.

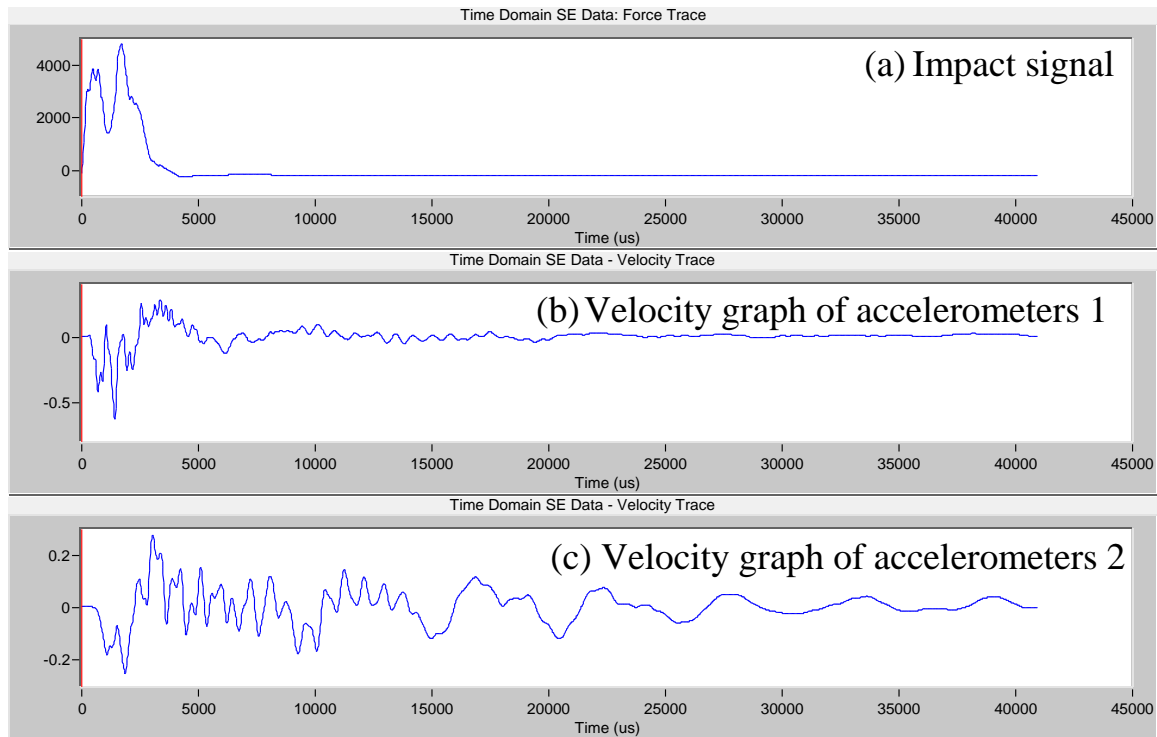
Figures 107b and 107c). When a softer hammer tip was used, the multiple peaks disappeared for the accelerometer mounted farther from the source (see Figure 108a).

FIGURE 107 Impact Signal and Velocity Graphs using a Hard Tip

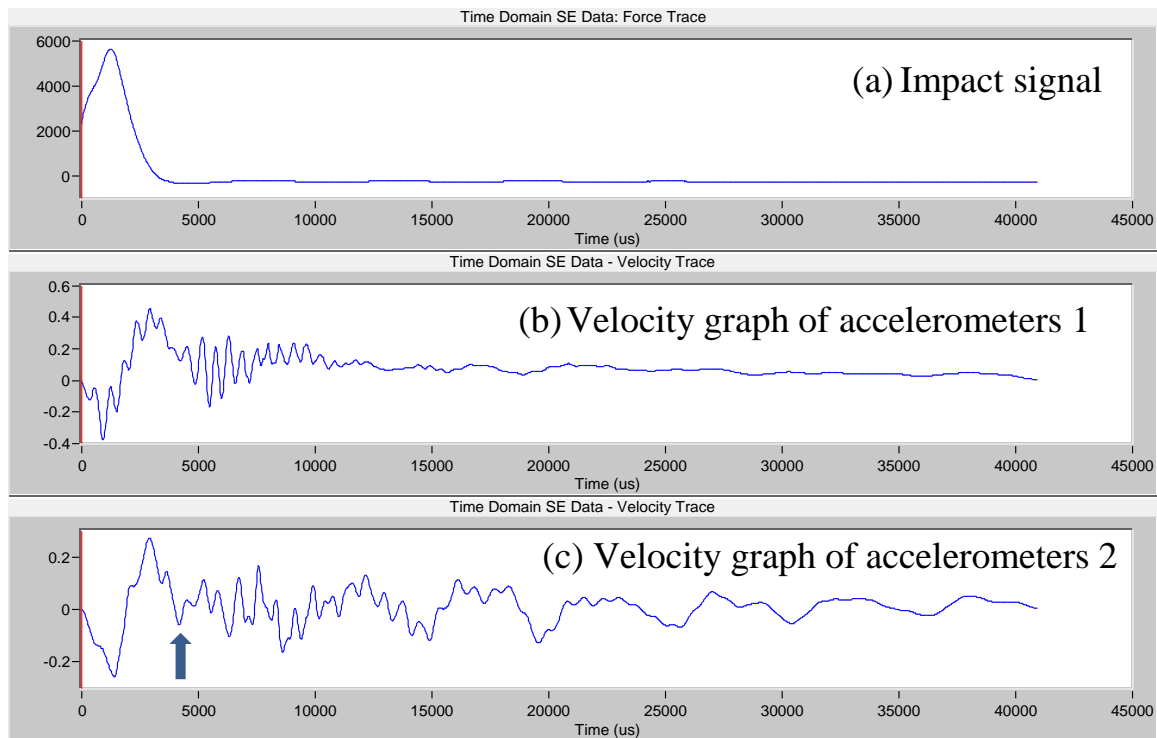
FIGURE 108 Impact Signal and Velocity Graphs Using a Medium-soft Tip

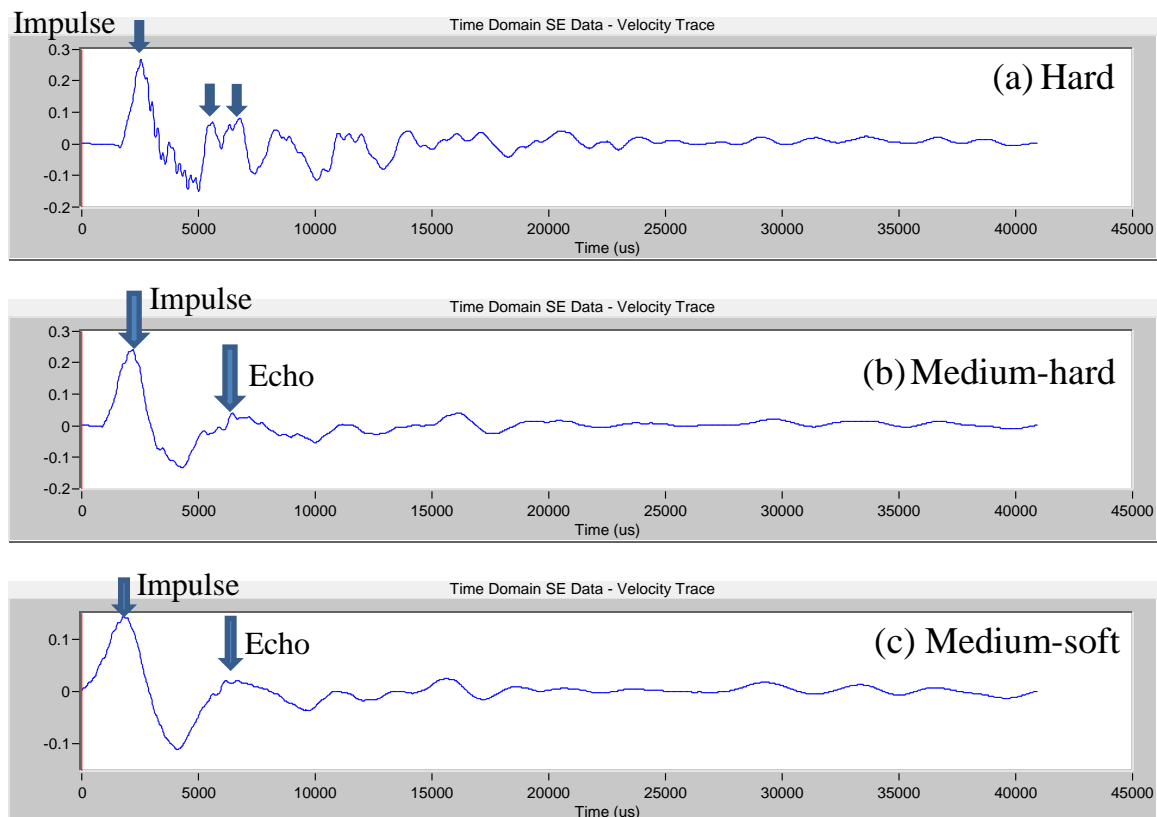
- In general, all hammer tips produced good results when there was good coupling between the striking block and the pile. However, upward striking with hard hammer tip did not produce good velocity graphs (Tests 5, 9 and 11). Figure 109 shows three SE tests with three different hammer tips. As shown in Figure 109a, there are two echoes with similar magnitudes which made it difficult to select the correct echo. High frequency vibrations were seen in the velocity graph for hard tip but not for medium-hard and medium soft tips. The softer tips produced waves with lower frequencies that resulted in better data for this particular pile.

FIGURE 109 Velocity Graphs for Various Hammer Tips Conducted on Pile M-5

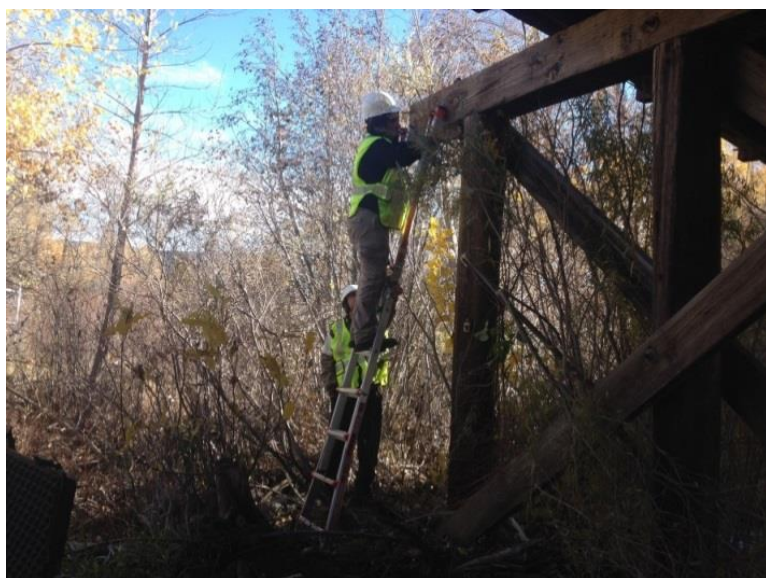
**FIGURE 111 Exterior Pile M-7 and the Pile Cap**

The results of the SE tests on Pile M-7 obtained from both accelerometers are also shown in Table 29. This result is more consistent than those of Pile M-5 (see Table 28). First, striking on the pile cap directly above the pile produced excellent results. Second, there is no interference of reflections from superstructure. As shown in Figure 111, Pile M-7 is the exterior pile with only a pile cap above the pile. There is no superstructure above the pile cap. When the source is applied by upward striking at the pile cap, the generated up-going tension wave is reflected from the cap as a down-going compression wave. More complicated superstructures produce more complicated velocity graphs. This is the reason that the results of Pile M-5 is less consistent than Pile M-7. Once again, the results show that upward striking on pile cap next to the test pile is acceptable.

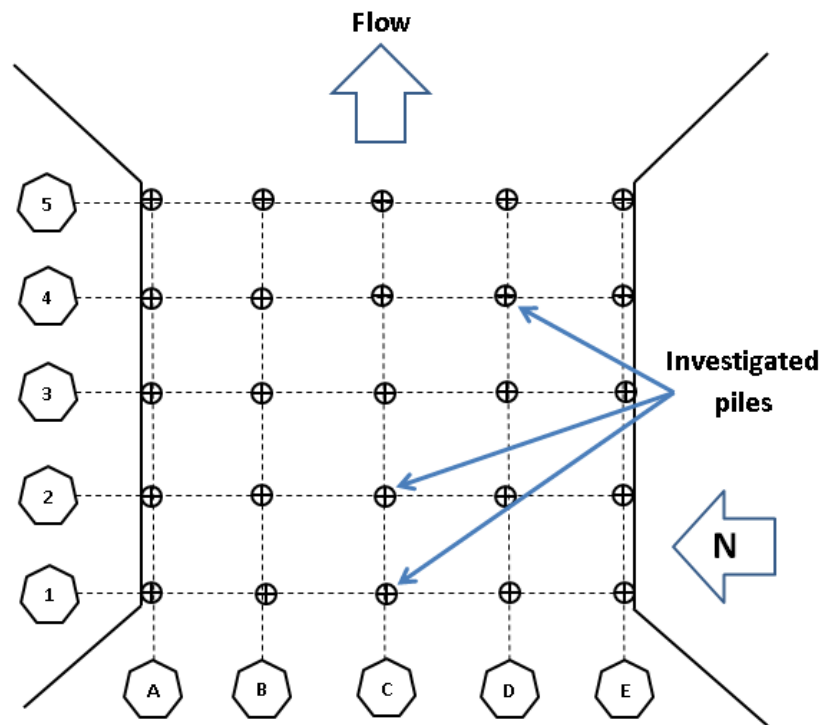
FIGURE 117 Foundation Plan and Investigated Piles of Bridge No. 1676

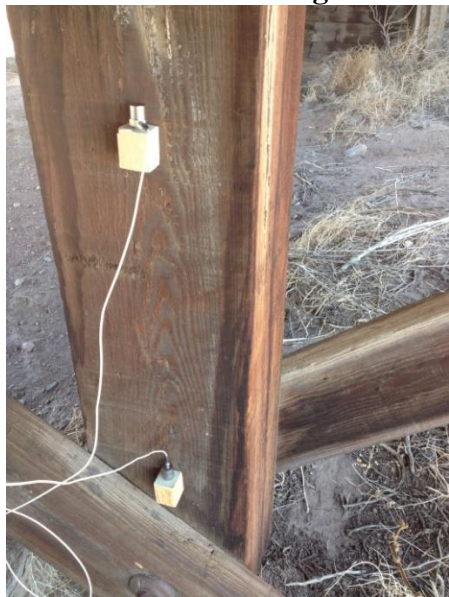
FIGURE 118 Accelerometers Attached onto a Pile

The foundation plan and the investigated piles are indicated in Figure 117. SE tests were performed on three timber piles indicated in the figure. The SE tests were done with four different hammer tips including hard, medium-hard, medium-soft, and soft. Two accelerometers were attached to the side of the piles as shown in Figure 118. The wooden blocks were glued onto the pile surface.

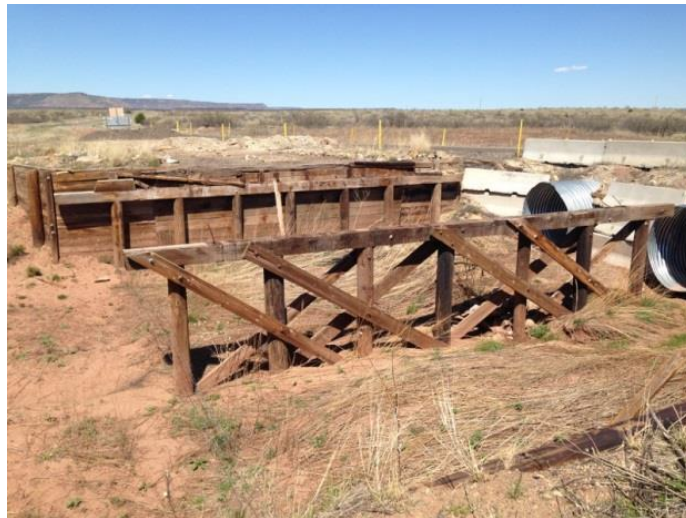
FIGURE 124 Photo of the Partially Dismantled Bridge near Route 419

The partially dismantled bridge (Bridge No. 6253) is located 64 miles east of Las Vegas. The bridge was used to be on Route 419 (coordinates 34.211303, -106.921087). Figure 123 shows the location of the bridge. Route 419 was realigned and the bridge was no longer in service. The superstructure of the bridge was removed when the research team arrived at the site. Only pile caps and round timber piles were presented as shown in Figure 124.

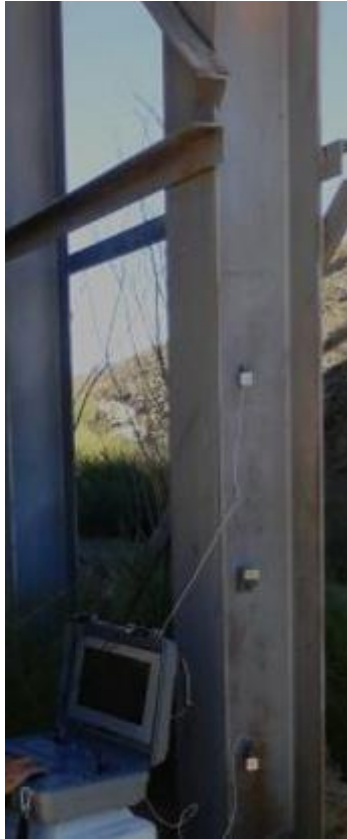
FIGURE 128 SE Test Setup for a H-pile of Bridge No. 7480

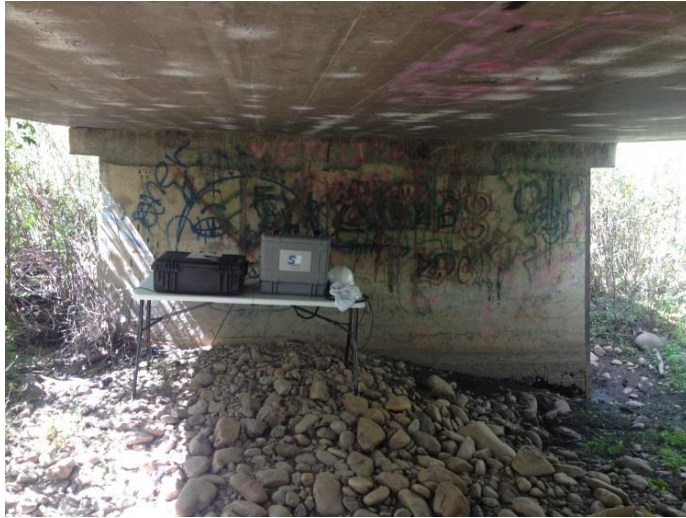
FIGURE 132 Side View of One of the Piers

In addition to the NDT tests performed on timber piles, the research team decided to conduct SE tests on concrete piers. Bridge No. 5899 in District 5 was selected for testing since there are three intermediate concrete piers. The bridge is located 66 miles north of Santa Fe on NM 111 crossing over the Rio Vallecitos as shown in Figure 130. The coordinates of the bridge are 36.49485, -106.1124972. The street and aerial views of the bridge are shown in Figure 131. The bridge is a 4-span concrete bridge supported by three intermediate concrete piers. The side view of one of the piers is indicated in Figure 132.

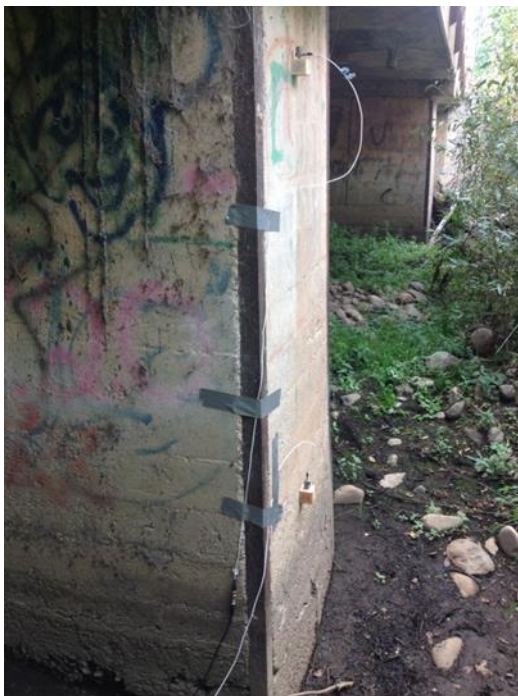
**FIGURE 134 Attached Accelerometers on the Pier Side**

The SE tests were performed with two accelerometers attached vertically to the side of the test pier as shown in Figure 134. The accelerometers were vertically mounted on the wooden blocks glued onto the pier surface.

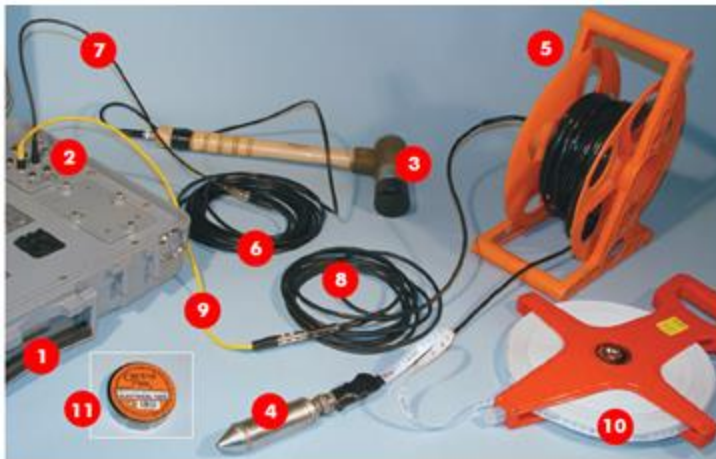
FIGURE 139 PS Equipment

Figure 139 shows the required equipment for conducting a PS test. The assembled equipment is shown in the figure. Engineers should follow the user manual of the equipment to assemble the device.

1. Olson Freedom Data PC
2. Input Module
3. Impulse Hammer
4. Hydrophone
5. Orange Reel of CSL Cable
6. BNC Cable
7. 4 Pin Adapter Cable (black)
8. Phone Plug Cable
9. 4 Pin Adapter Cable (yellow)
10. Flexible Tape Measure
11. Electrical Tape

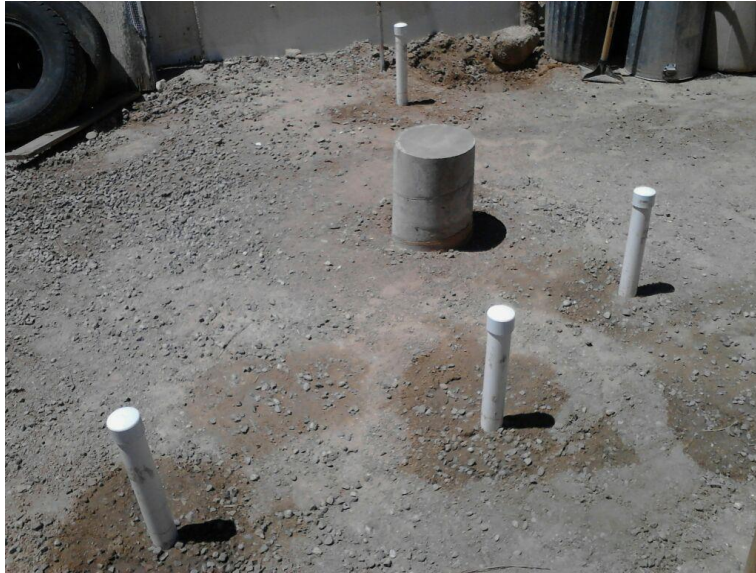
FIGURE 142 Configuration of the PS Testbed

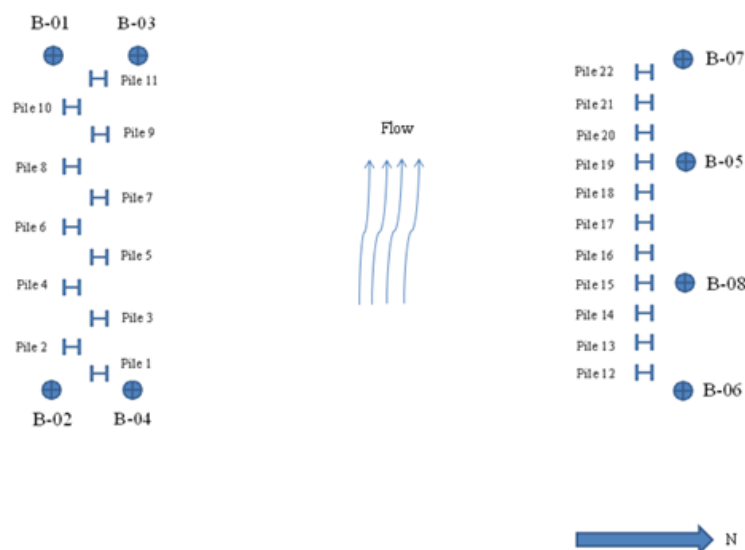
FIGURE 145 Foundation Configuration and Locations of Boreholes of Bridge No. 7480

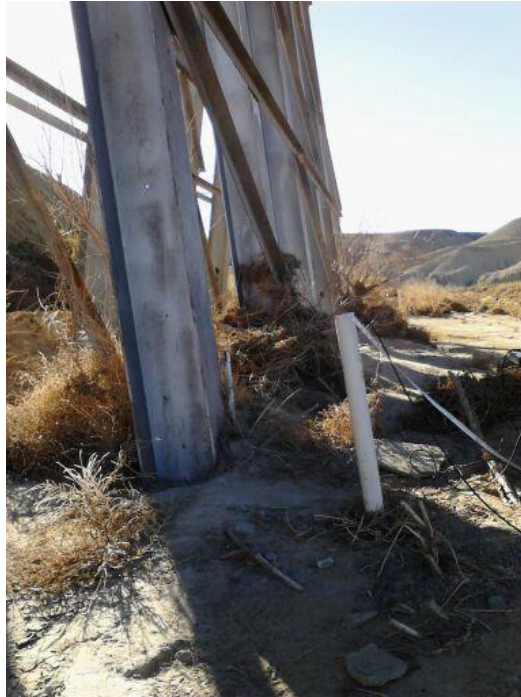
FIGURE 146 An Aligned PVC Pipe and the Adjacent Pile

Two-inch inner diameter PVC casings were placed in each boring with a water tight cap at the base and a removable cap at the top of the tube. The spacing between the PVC tube and the hole was backfilled with existing soil. Figure 146 shows a PVC pipe with its adjacent pile. Table 61 provides a summary of the depths for each borehole.

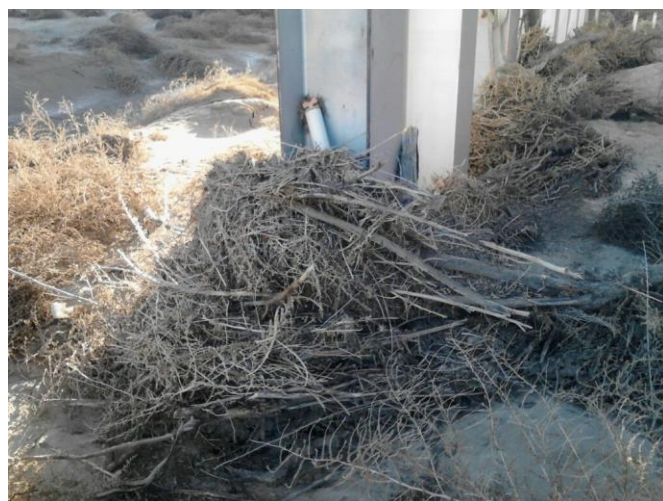
FIGURE 148 Destroyed Pipe (B-06)

The second problem was the damage of one installed PVC tube. As shown in Figure 148, the PVC pipe at B-06 was destroyed due to the movement of debris from flooding. Therefore, conducting PS test was also impossible at this borehole.

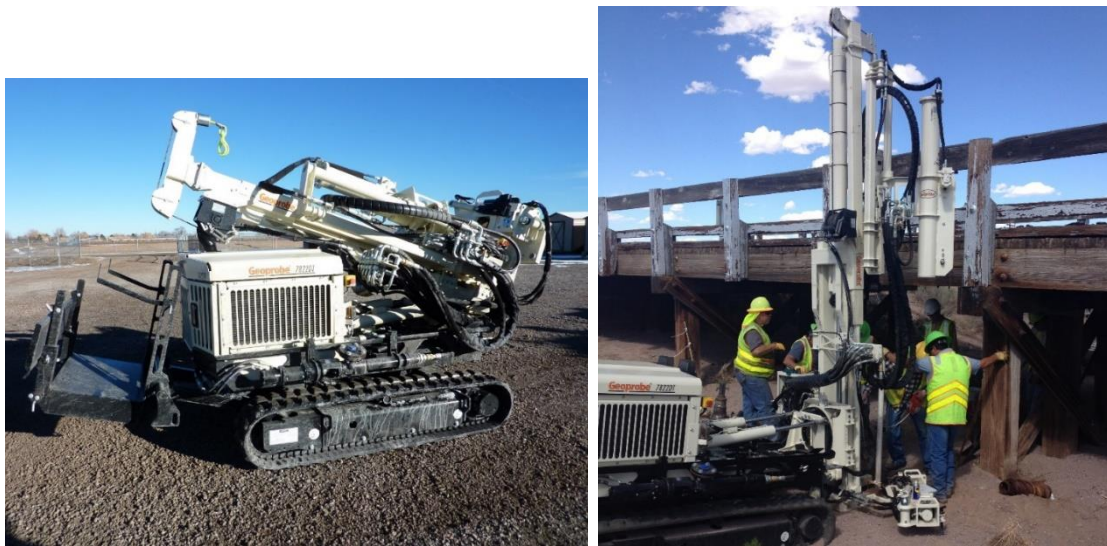
FIGURE 164 Geoprobe Model 7822DT- Low Headroom Drill Rig

Conventional PS tests were conducted on two timber piles at Bridge No. 1676. The location and foundation plan of the bridge are shown in Figures 115 and 117 respectively. The test piles were Pile B-1 and C-1. Two test borings were drilled adjacent to the timber piles by NMDOT using the Geoprobe 7822DT (purchased during this project). The plan view of the location of the boreholes is indicated in Figure 163. The low headroom drill rig and the drilling operation are shown in Figure 164.

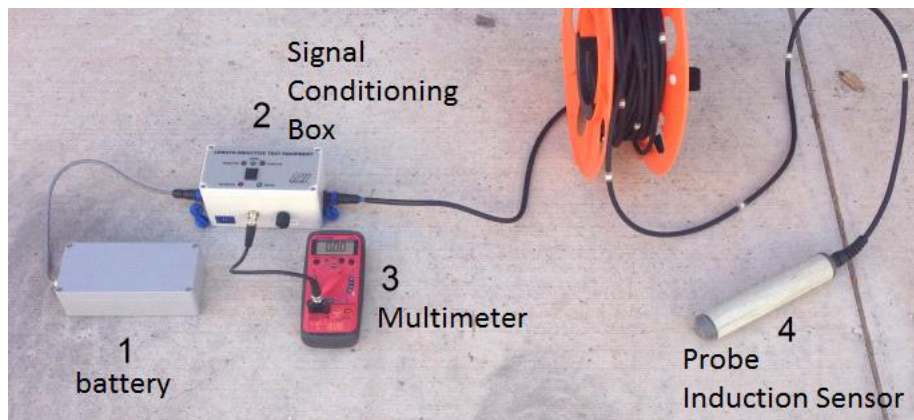
FIGURE 178 Length Inductive Test Equipment (LITE) for IF tests

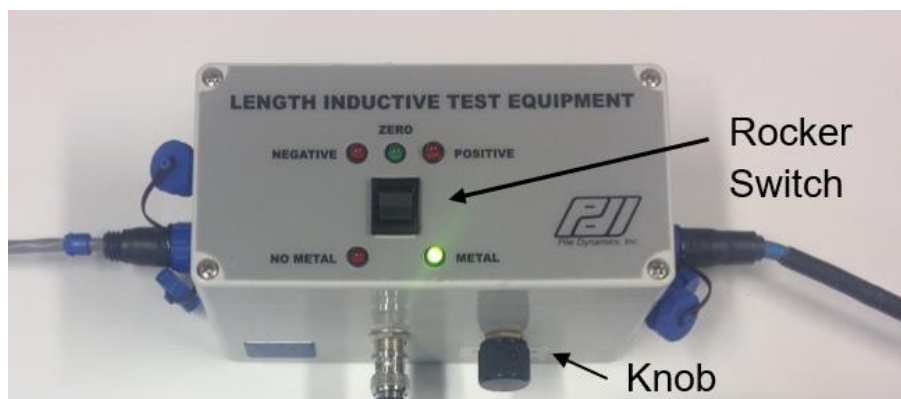
FIGURE 179 Details of Signal Conditioning Box

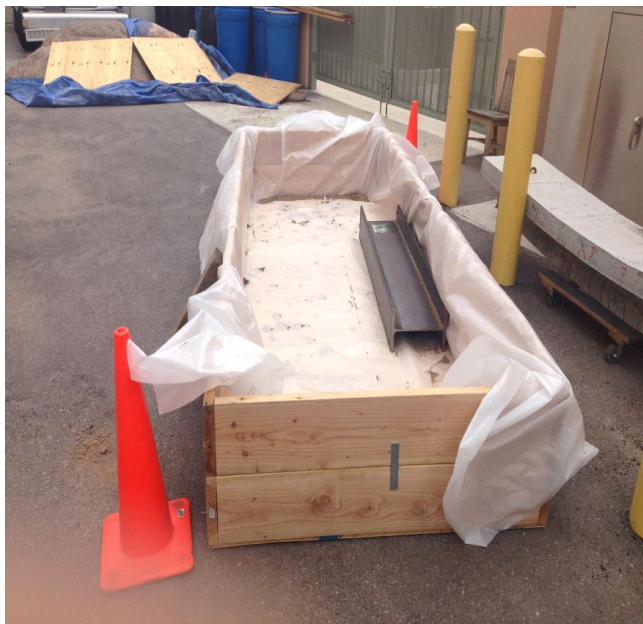
FIGURE 181 Test Configuration with Steel Beam and Wooden Box

The first testbed contained a metal I-beam placed horizontally in a wooden box full of soil as shown in Figure 181. A metal beam buried in a wood box filled with soil was a suitable prototype of a real steel foundation of a bridge. The dimensions of the wooden box were 12 ft \times 4 ft \times 18 in. The I-beam was 5 ft long, 12 in depth and an 8 in flange width. The preliminary tests were supposed to be conducted in the structural lab at UNM. However, during conducting the IF tests in the structural lab, it was revealed that the test could not be conducted on the concrete floor due to the presence of steel reinforcement. The testbed was therefore moved outdoor on an asphalt paved driveway as shown in Figure 181. Before recording the data, three PVC tubes were placed horizontally at a distance of 1, 1.5 and 2 ft respectively from the steel beam.

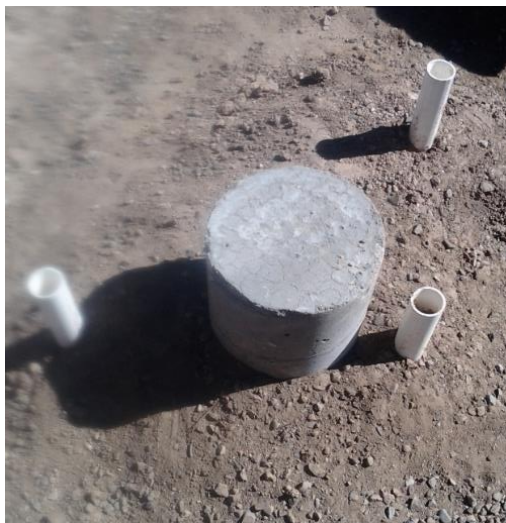
FIGURE 185 Layout of the Concrete Pier and Boreholes

A three-foot deep by one-foot diameter hole was excavated. A four-foot long, one-foot diameter reinforced concrete pier was cast in place at the test site. The pier was reinforced with 5-#5 vertical rebar and #3 ties at 6 in, as shown in Figure 184. There was 3 in clear cover to the outside of the #3 ties. Three two-inch diameter holes were then bored 6-ft into the ground. The boreholes run parallel to the concrete pier located distances of 6, 12, and 18 in from the outside edge of the pier as can be seen in Figure 185. A 2-in diameter PVC pipe was inserted in the holes to a depth of 3 ft below the bottom of the pier as shown in Figure 186. The LITE was assembled and calibrated. The Probe was inserted into the tube and the voltage readings were recorded at 1 ft intervals. The results are shown in Table 74.

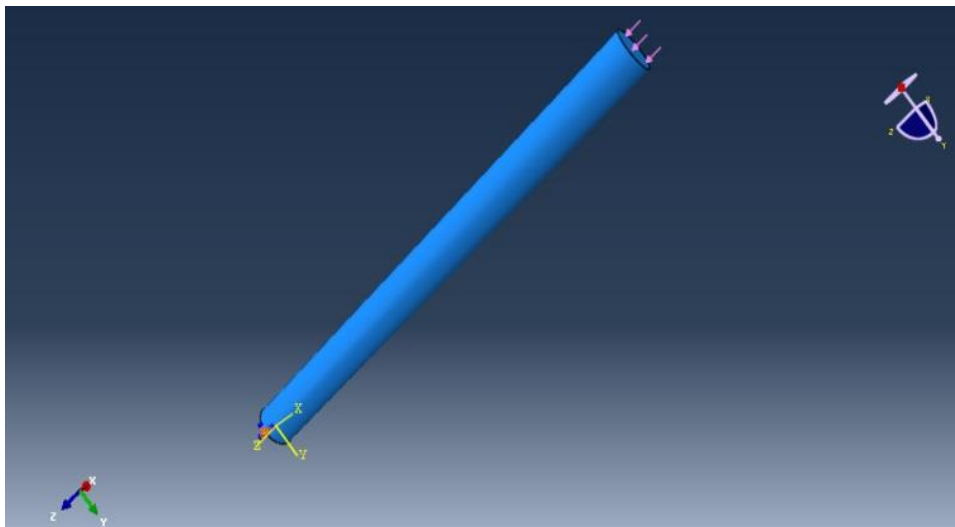
FIGURE 187 A FEM Model of a Wood Column

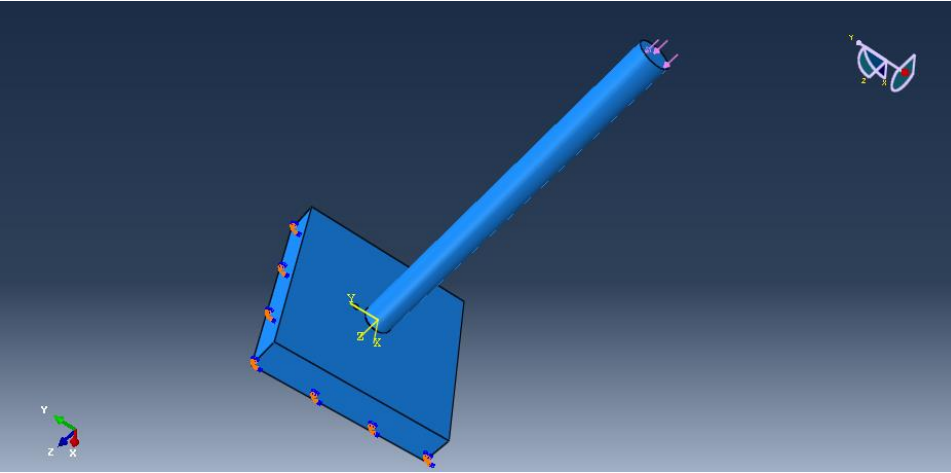
FIGURE 188 A FEM Model of a Wood Column with Foundation

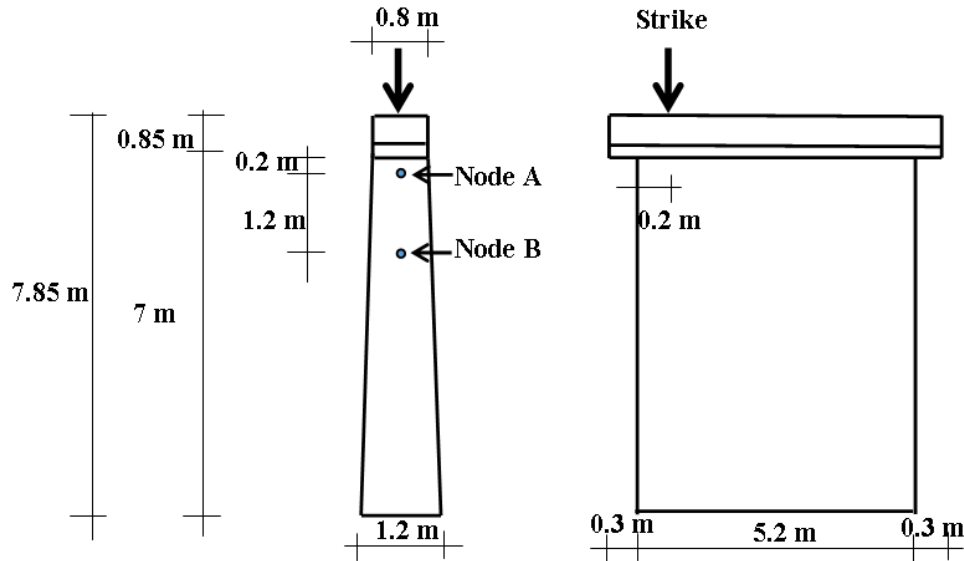
FIGURE 205 Dimensions of the Numerical Model and the Locations of the Source and Receiver

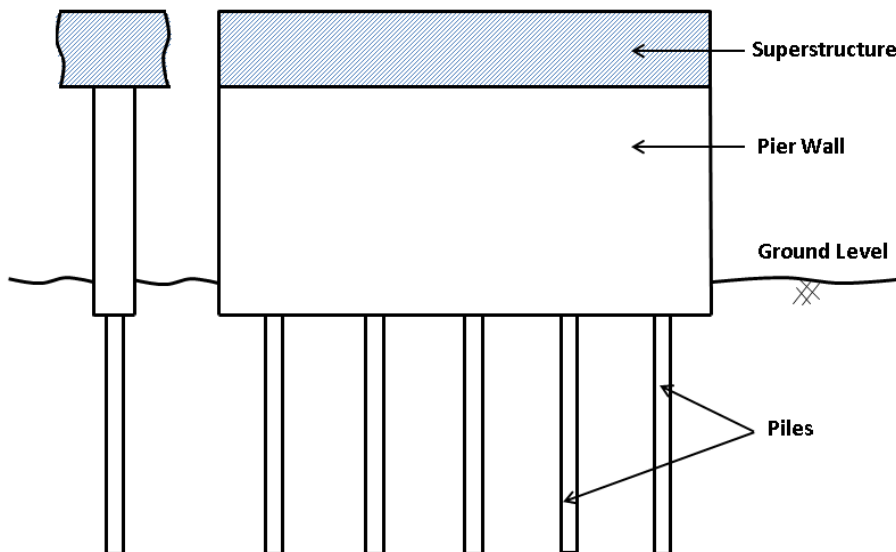
**FIGURE 220 Bridge Foundation Comprising a Pier Wall and Multiple Piles**
