Load Rating Bridges with No As-Built Plans or Non-Engineered Bridges

Final Report

JUNE 2015

1. Report No. NM13STR-01	2. Government Accession No.		3. Recipient's Catalog No.	
4. Title and Subtitle Load Rating Bridges with No As-Built Plans or Non-Engineered Bridges		5. Report Date June 2015

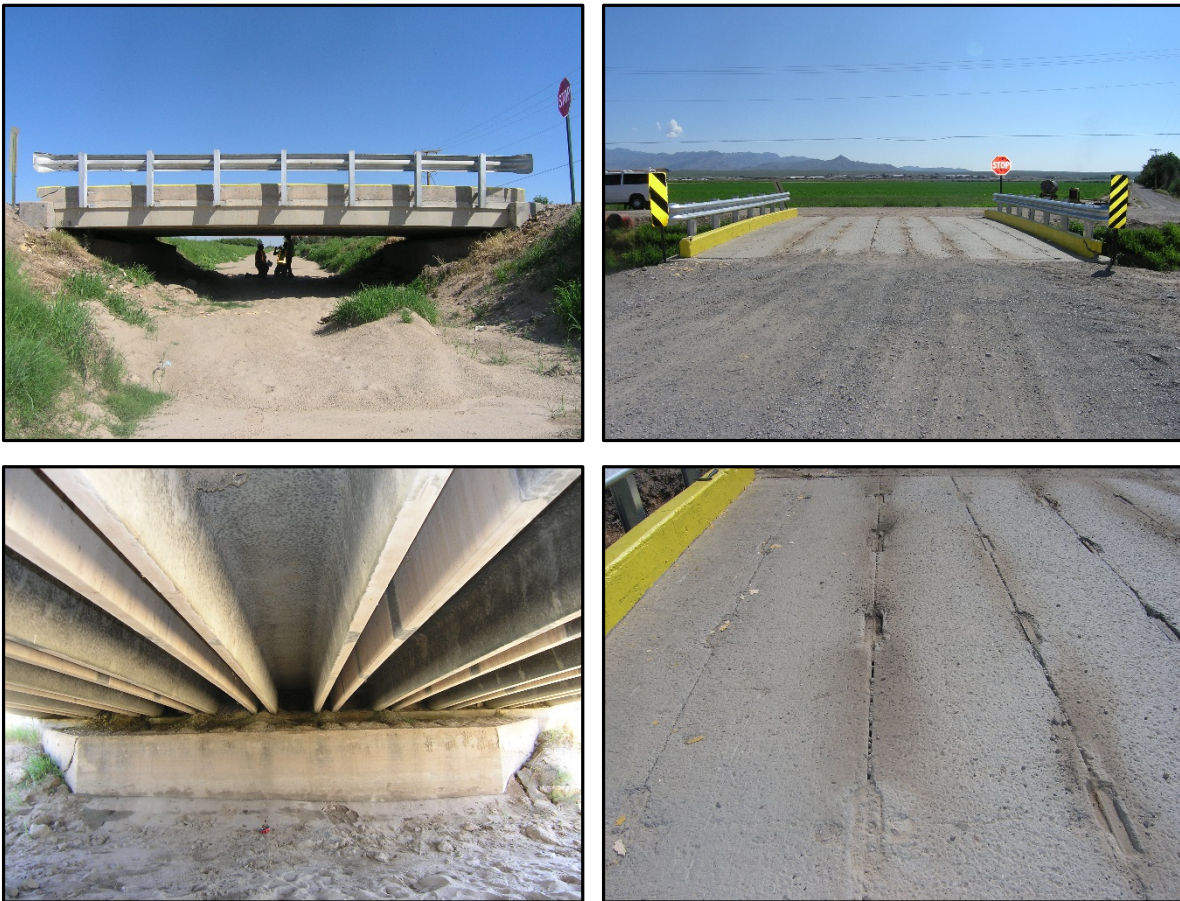
This bridge, constructed in 1974, is a single-span, prestressed concrete bridge with a 31 ft. span. The bridge consists of nine double T-beams, each of which is 33 in. wide, 19.5 in. deep, and 32 ft. long. The bridge beams are placed directly next to one another, allowing for the beam flanges to act as the deck, and the beam ends rest on 12 in. long bearing seats. Each beam has seven shear keys on the top flange at 4 ft. 3 in. center-to-center spacing and each shear key is 1 foot long and four inches wide. There is no wearing surface and the overall bridge width is 24 ft. 9 in., while the roadway width is 23 ft. 5 in. from curb to curb. The exterior beams have concrete curbs that are 8 inches wide and 13 inches deep. In addition, the exterior beams have side mounted guardrails, with W6 I-beam posts spaced at 51 in. and extending 26 in. above the concrete curb. The guardrail is 12.5 in. deep, and runs along the entire length of the bridge. Overall, the entire structure is 33 ft. 4 in. long (including the prestressed beams and backwalls) by 26 ft. 2 in. wide (based on the backwall length). The bridge carries County Road B-31 over an irrigation canal near NM-478. See pictures given in [Figure 3.1](#).

Figure 3.1. Bridge No. 7701 (prestressed concrete double T-beam) in NMDOT District 1.

Overall, the bridge is in fair condition. The most recent inspection report from November 7th, 2013, indicates a rating of 6 for the deck and superstructure, and a 6 for the substructure. The topside of the beam flanges have transverse, horizontal and map cracking up to 1/32 in. with heavy abrasion and small spalls. The exterior beams have less abrasion and damage, most likely due to less exposure to traffic. The underside of the flanges have map and longitudinal cracks up to 1/32 in. with minor spalls. Some of the longitudinal cracks are developing between the beam stems and the flanges. The stems of the beams have horizontal cracks up to 1/8 in. at the supports. Beam 6 has some vertical cracking up to 1/32 in. originated from the flange-stem transition; however, these cracks are not full depth. Beam 9 has a few spalls up to six inches by six inches with four inches of exposed shear reinforcement on the south side of the stem, near abutment one. The beams are numbered from north to south and the abutments are numbered from west to east. Overall, the beams are in satisfactory condition, as no full-depth flexural cracks were found.

The shear keys located on the top flanges of the beams all vary in condition. Each shear key consists of two steel angles, welded together with a short piece of rebar. The exterior keys are all covered with concrete and appear to be functioning properly. Between beams 4 and 5, six of the seven shear keys are broken and not functioning. In addition, the keys between beams 6 and 7 are damaged and not working well. The condition of each shear key was noted for purposes of planning the load testing. The bridge carries an Average Daily Traffic (ADT) of 511 according to the most recent inspection report; this number seems high, however, as much less traffic was observed during the recent field visits. The truck ADT was not specified in the inspection report.

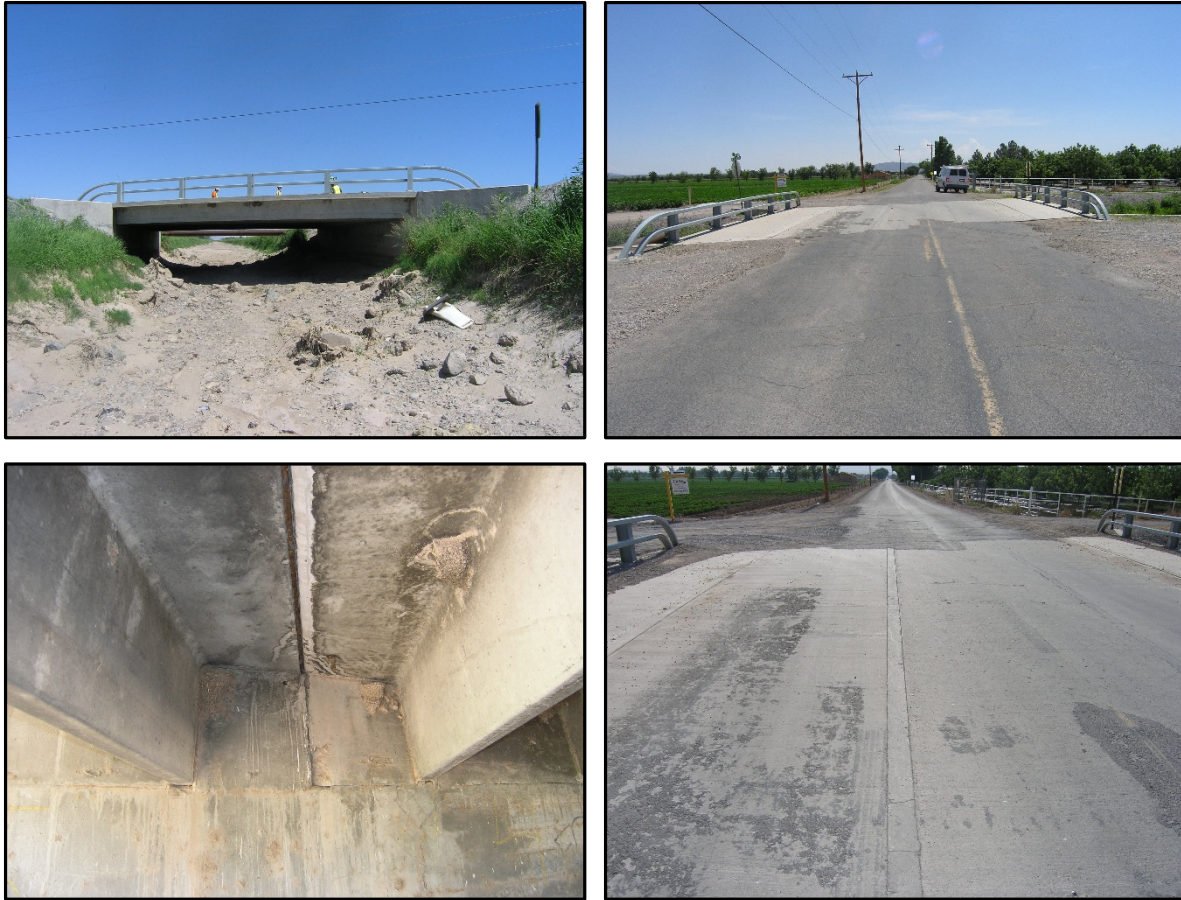
Figure 3.2. Bridge No. 8761 (prestressed concrete double T-beam) in NMDOT District 1.

The latest condition ratings are 5 for the concrete deck, 5 for the T-beam superstructure, and 6 for the substructure. The inspection report also stated that the edges of the double-tee girders have diagonal cracks at the ends. The girders are numbered 1 through 5 from south to north and the abutments are numbered 1 and 2 from east to west. Girders 1 and 5 have horizontal cracks near abutment 2 and honeycombing along the beam edges. Spalls were found on the undersides of girder 2 (3 in. by 8 in.), girder 4 (3 in. by 6 in.), and girder 5 (3 in. by 5 in.). Overall, the concrete girders are in fair condition. The concrete breastwalls have vertical cracks up to 1/16 in. with heavy scaling and minor leaching. Abutment 1 has delamination up to 20 in. by 21 in. The concrete breastwalls and abutments are in satisfactory condition overall. The bridge rails (NMDOT metal type "A") are in good condition overall with minor surface rust and paint peeling. The ADT is reported as 827 and the future ADT is 1048 (with 3% truck traffic) for year 2032.

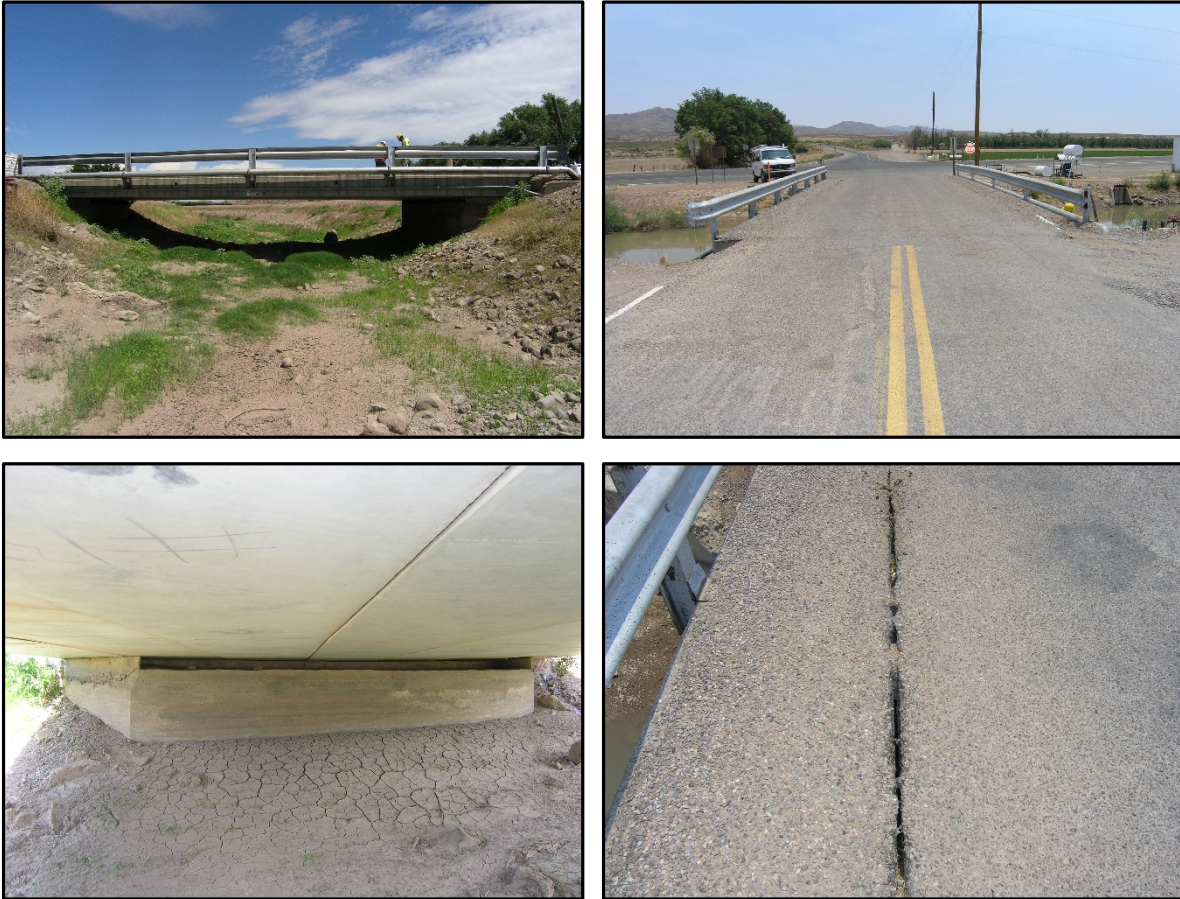
This bridge was constructed in 1966. It is a simple-span bridge with a 44.4 ft. beam length and a 6.1 ft. vertical clearance over an irrigation channel. The bridge has a 16 degree skew and seven box girders (PCI-AASHTO section type BI-36) that are 36 in. wide and 27 in. deep. The wearing surface is a 4 in. asphalt overlay and the roadway width is 21 ft. The bridge has steel rails on each side with varying spacing and number of rail posts; the north exterior beam supports seven rail posts evenly spaced at 8 ft. center-to-center and each extending 26 in. above the asphalt overlay while the south exterior beam supports five posts evenly spaced at 11.1 ft. center-to-center. The exterior beams also support two gas utility pipelines suspended from each rail post. The bridge carries County Road B-108 near NM-185. See pictures given in [Figure 3.3](#).

Figure 3.3. Bridge No. 7722 (prestressed concrete box girder) in NMDOT District 1.

From the latest inspection report (dated 1/16/2014), the deck, superstructure, and substructure were all rated a 6. The topsides of the girders are unobservable due to the asphalt overlay and the undersides have map cracks up to 1/32 in. with minor to moderate leaching and honeycombing. The girders are numbered from north to south and girder 6 has a spall located close to midspan that is 24 in. long by 2 in. wide with an exposed prestressing strand (3/8 in. diameter) over a distance of 13 in. The vertical faces of the exterior girders have minor vertical and map cracks up to 1/32 in. with honeycombing. The asphalt material is falling through the joints between all the girders. The gap is 2 1/8 in. between girders 1 and 2 and 1 1/4 in. between girders 6 and 7 (note

that the gap measurements were taken from the underside of the bridge). Overall, the bridge is in satisfactory condition. The metal bridge rails are also in fair condition overall (with minor to heavy surface rust, minor traffic damage, and paint peeling) but the north rail is not attached at the northwest corner of the structure. The approach roadway has transverse and map cracks up to 1/4 in., wheel rutting, minor to moderate raveling, and an overall rough riding surface.

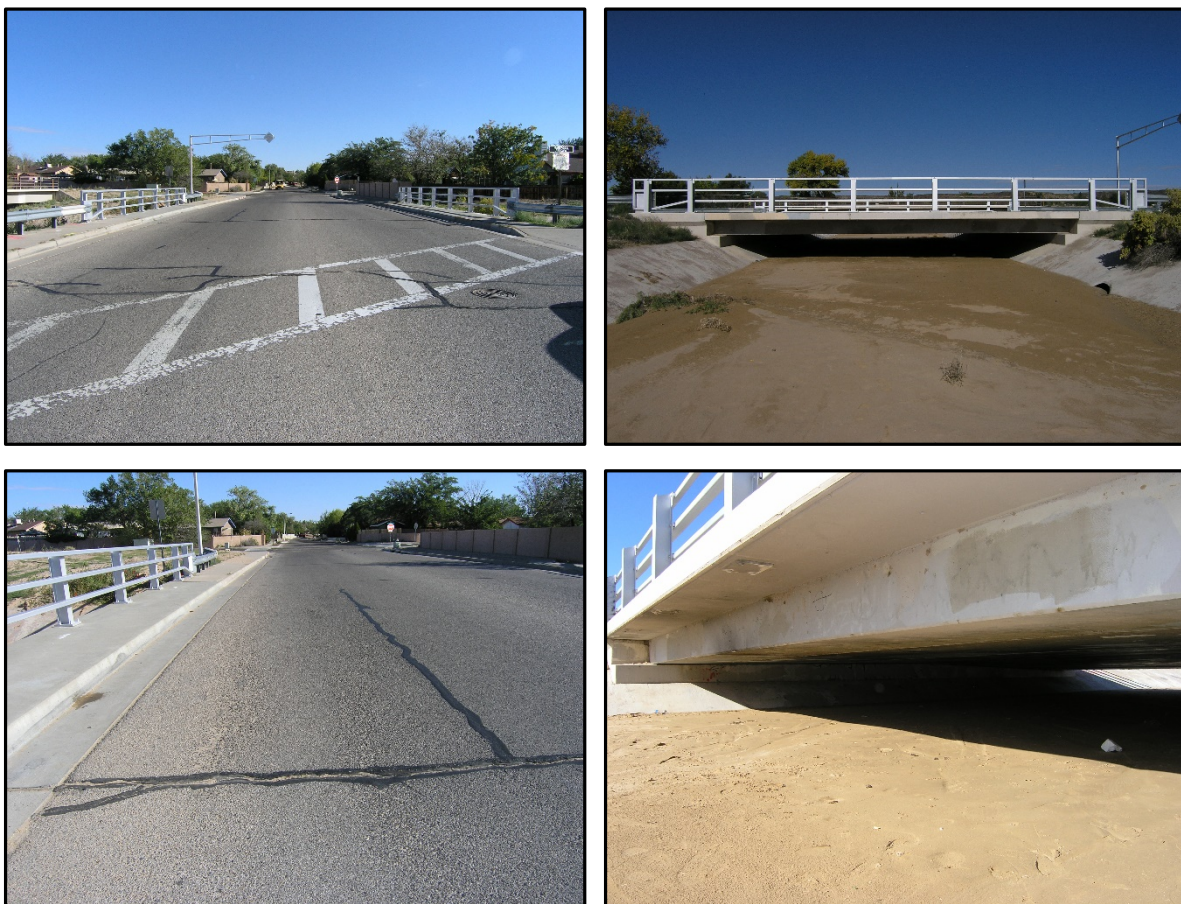
Bridge 8825 was constructed in 1990 and is located in Bernalillo County, Albuquerque, NM. It is a simple-span bridge with a maximum span length of 42.0 ft. and vertical clearance of 3 ft. over Mariposa Arroyo. The superstructure consists of ten prestressed concrete box girders (section type 5B20) which are 60 in. wide and 20 in. deep. The roadway has a 3 in. thick asphalt overlay and a curb-to-curb width of 44.0 ft. The concrete curbs are 10 in. thick and 6 ft. wide, and extend past the exterior beams a distance of 3 ft. on each side. The curbs support 50 in. tall guardrail with W8x24 posts evenly spaced at 9 ft. 4 in. that are connected by three HSS 5X3 horizontal members spaced 12 in. apart. The bridge carries Mojave Street near the intersection with Homestead Drive. See pictures given in [Figure 3.4](#).

Figure 3.4. Bridge No. 8825 (prestressed concrete box girder) in NMDOT District 3.

According to the latest inspection report (dated 11/6/2013), the bridge is regularly inspected on a 24 month interval and the sufficiency rating is 99.9%. The deck and superstructure were given condition ratings of 6 and the substructure was rated a 7. No signs of bridge widening were observed. The topsides of the box beams are unobservable due to the asphalt overlay. The overlay has transverse cracks at both ends of the bridge and longitudinal reflective cracks over the beam

joints which have been sealed. On the underside, the beams showed leaching with heavy water stains at the longitudinal joints and some rust stains. A minor spall was found on the west beam measuring 3 in. x 3 in. The steel bridge rail has been repainted and the northwest anchor is damaged. The current ADT is 587 and the projected ADT is 697 for the year 2031.

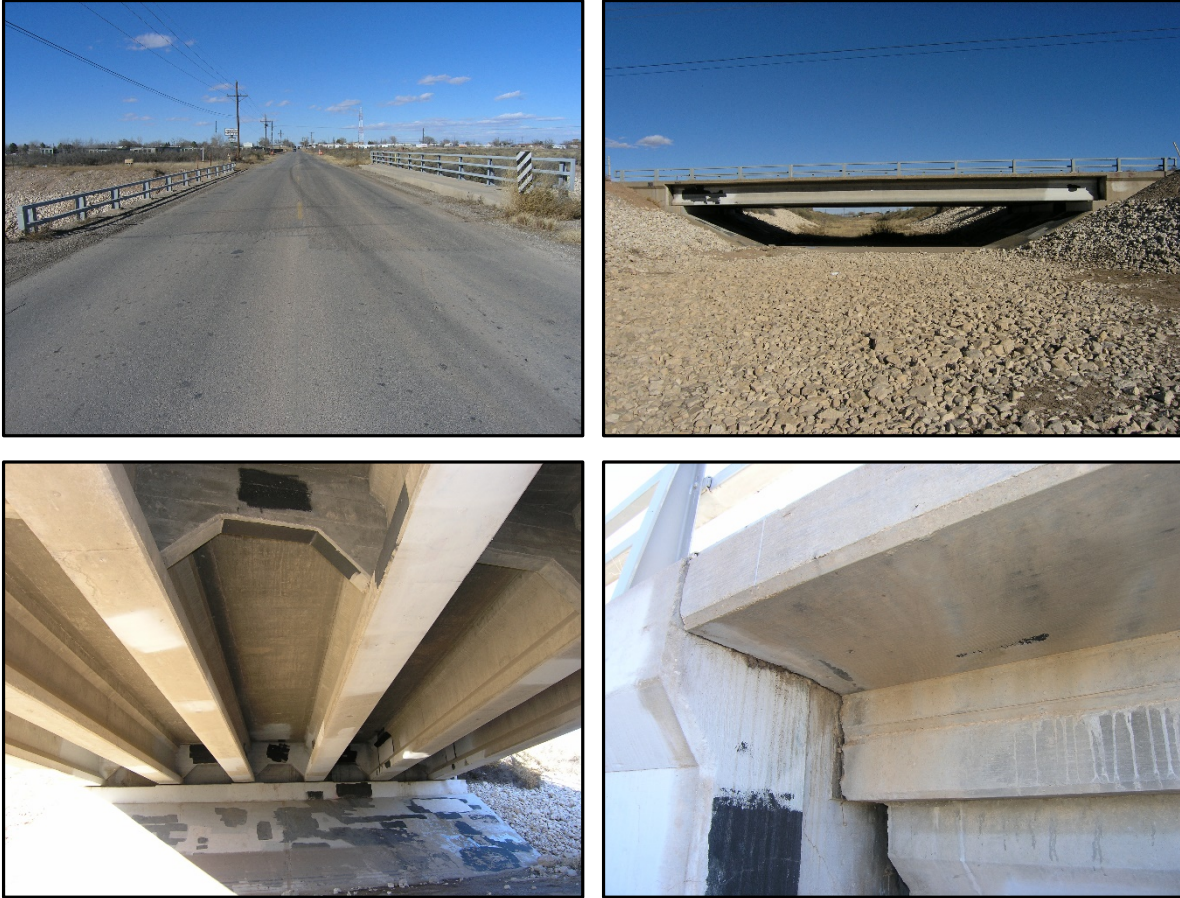
Figure 3.5. Bridge No. 8588 (prestressed concrete I-girder) in NMDOT District 2.

Overall, the bridge is in fair condition. The most recent inspection report (dated 8/13/2014) has ratings of 5 for the deck, and 6 for the superstructure and substructure. The topside of the deck has spalled areas with exposed rebar. The edges of the deck have hairline vertical, transverse cracks and regions of heavy scaling (mainly on the west side). The underside of the deck has hairline transverse cracks with light leaching, as well as areas of honeycombing; there is also evidence of patchwork on the underside. In addition, the inspectors noted that the majority of the deck is delaminated. The bridge girders have transverse and vertical cracks up to 1/32 in. near the supports. Girders one, four and six have spalls up to 4 in. by 6 in. with some exposed corroded rebar. The concrete diaphragms have small transverse and vertical cracks, with 1 in. x 1 in. popouts, exposed snap ties, and honeycombing up to 1 ft. x 1 ft. The average daily traffic (ADT) is listed as 1232, while the future ADT for the year 2033 is 1432; the truck ADT is estimated as 20%.

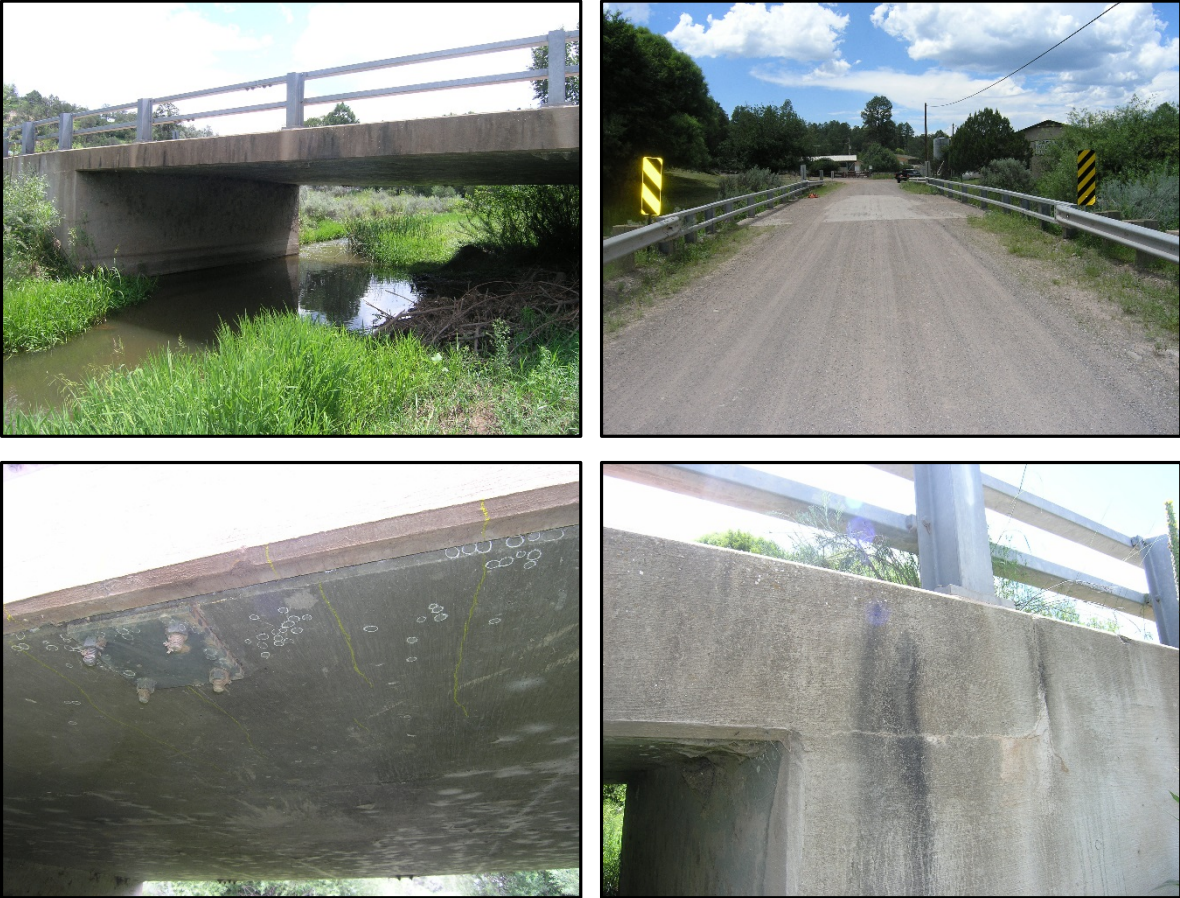
Figure 3.6. Bridge No. 8676 (reinforced concrete slab) in NMDOT District 1.

In general, the bridge is in good condition. The most recent inspection report from March 7th, 2013, indicates a rating of 7 for the deck, superstructure, and substructure. The top side of the slab has map, longitudinal, and transverse cracking up to 1/16 in. with small “D” (i.e., hairline) cracks near the approaches. The slab edges have vertical cracks up to 1/32 in. toward the middle of the span and at 6-in. to 12-in. spacing. The underside of the slab has diagonal and longitudinal

cracking up to 1/32 in. as well. In addition, the slab bottom has minor leaching and honeycombing. Despite not having a wearing surface, the concrete slab has no major issues. The bridge carries an ADT of 156, with a future ADT of 199, which appears high based on the recent field visit. The truck ADT was given as 3% in the latest inspection report.

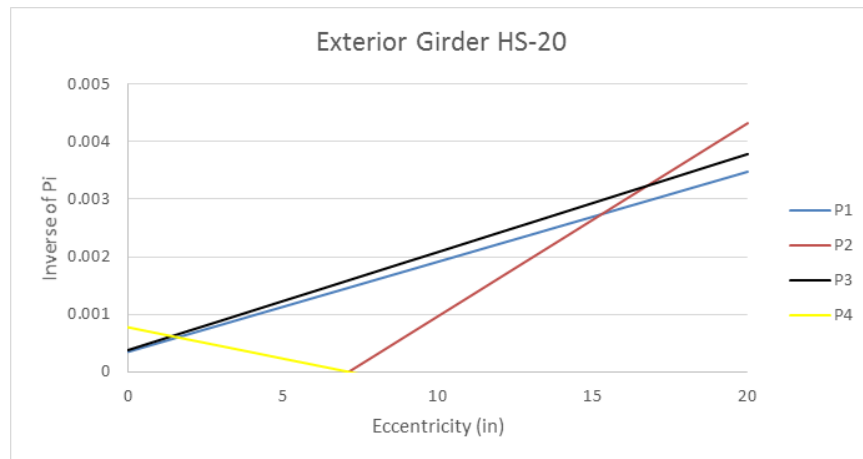
Figure 4.3. Magnel diagram for exterior beam under HS-20 design truck (Bridge 8761).

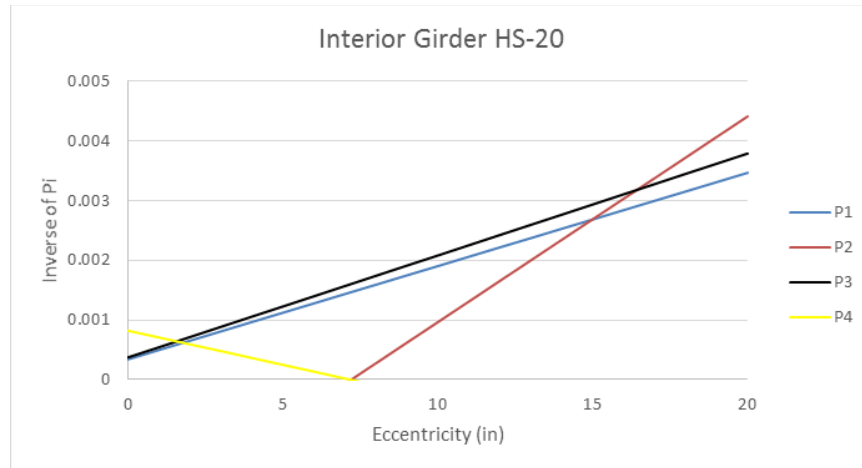
Figure 4.4. Magnel diagram for interior beam under HS-20 design truck (Bridge 8761).

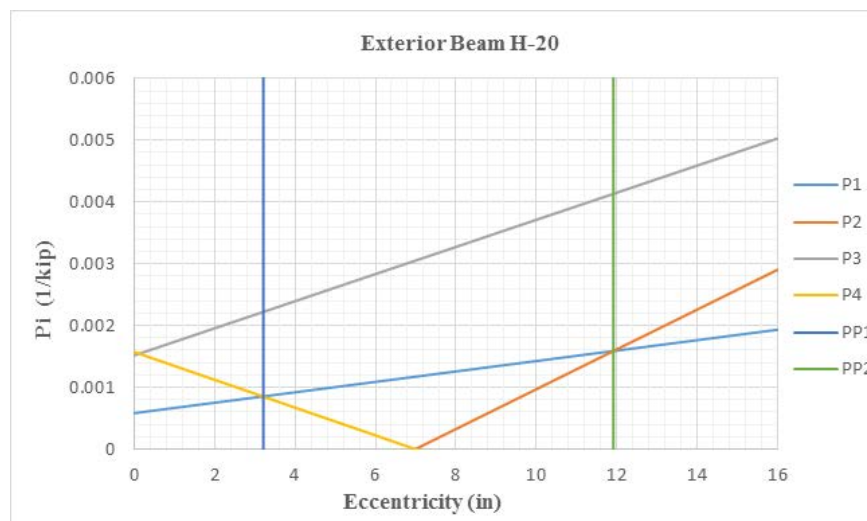
Figure 4.6. Magnel diagram for exterior beam under H-20 design truck (Bridge 7722).

Figures 4.6 and 4.7 show the Magnel diagrams for an exterior and interior beam, respectively, of Bridge 7722 under H-20 loading. As for the other bridges, the Magnel diagram analysis for Bridge 7722 was done to determine feasible solutions for the reciprocal of the initial prestressing force and eccentricity. Four inequalities were formulated based on the code requirements for the mid-span top and bottom stresses under initial and service load conditions, and then plotted to determine the region of valid solutions. This region of valid solutions is defined by the four intersection points of the inequality equations. Due to the geometry of the box beams, only two of these intersection points were found, contrary to the four points customary for other types of cross sections. Although the amount of prestressing force may be computed from these two points, the estimated force and the amount of steel corresponds to the highest level of prestressing and thus, will be unconservative. It was decided to vertically project the two points onto line P3 to obtain the smallest prestressing force which translates to a conservative estimate of the number of strands. Lines PP1 and PP2 shown in Figures 4.6 and 4.7 are the lines of projection. The high and low initial prestressing forces were then computed from the P3 expression at the points of intersection with lines PP1 and PP2, and further used to determine the effective prestress force P_e , area of steel A_s , and the number of strands.

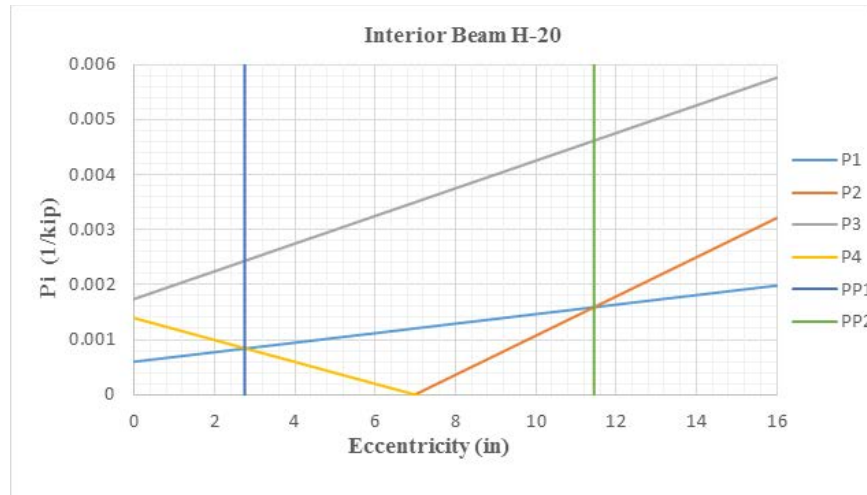
Figure 4.7. Magnel diagram for interior beam under H-20 design truck (Bridge 7722).

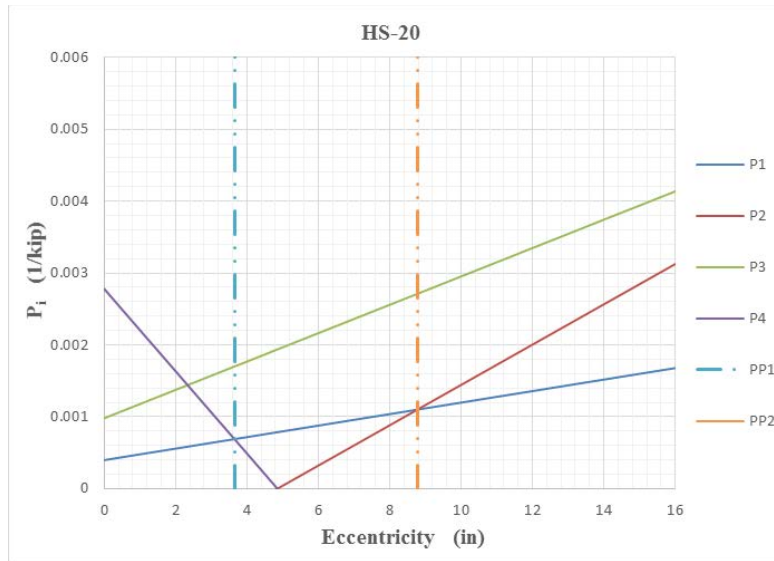
Figure 4.9. Magnel diagram for interior and exterior beams under HS-20 design truck (Bridge 8825).

Figure 4.9 shows the Magnel diagram for an exterior and interior beam of Bridge 8825 under HS-20 loading. Similar to Bridge 7722, only two of the intersection points were found, contrary to the four points customary for other types of cross sections. The high and low initial prestressing forces were computed from the P3 expression at the points of intersection with lines PP1 and PP2, and then used to determine the effective prestress force (P_e), area of steel (A_s), and the number of strands. Table 4.8 summarizes the Magnel diagram results for all three design trucks. Note that the maximum eccentricity (assuming 2 in. of cover to the center of the strand) is 8.8 in. and the strand area is 0.144 in². The amount of prestressing steel was finally selected based on HS-20 truck loading which amounted to 16 strands for both the exterior and interior beams.

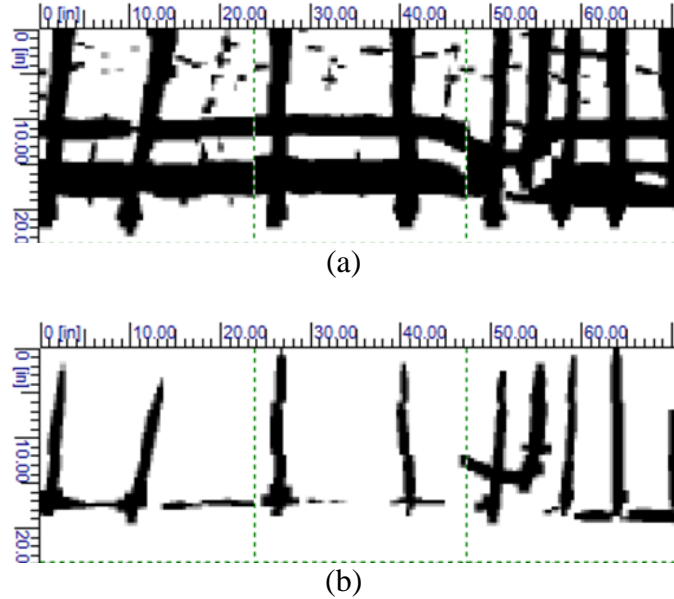
Figure 5.8. Blockscans on inside face of north exterior beam stem of Bridge 8761 at depth ranges of (a) 5 inches and (b) 2 inches.

has two legs and thus, the double T-beam is reinforced with a two-legged stirrup in each stem. The rehabilitation plans specified the required shear steel to be $0.33 \text{ in}^2/\text{ft}$ for a distance of 2 ft. from the beam ends and $0.14 \text{ in}^2/\text{ft}$ for the remaining 30.67 ft. of the beam length. As mentioned previously, the Ferrosan detected #3 vertical bars spaced at 12 in. which amounts to a shear steel area of $0.11 \text{ in}^2/\text{ft} * 4 = 0.44 \text{ in}^2/\text{ft}$ which exceeds the specified area of $0.33 \text{ in}^2/\text{ft}$.

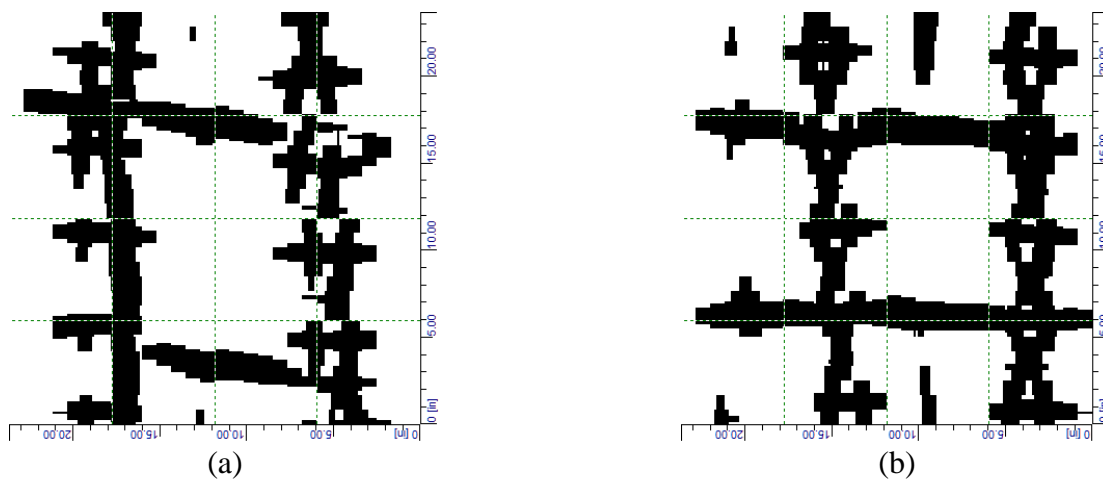
Figure 5.19. Imagescans at 2 in. depth range on soffit of bottom flange near (a) midspan and (b) abutment (Bridge 8588).

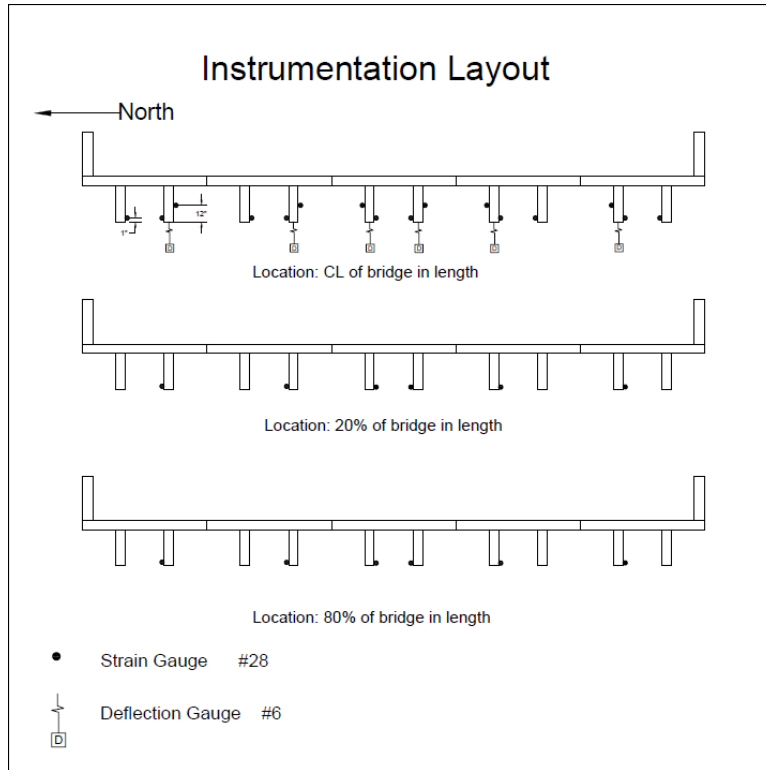
Figure 7.7. Instrumentation layout for diagnostic load testing (Bridge 8761).

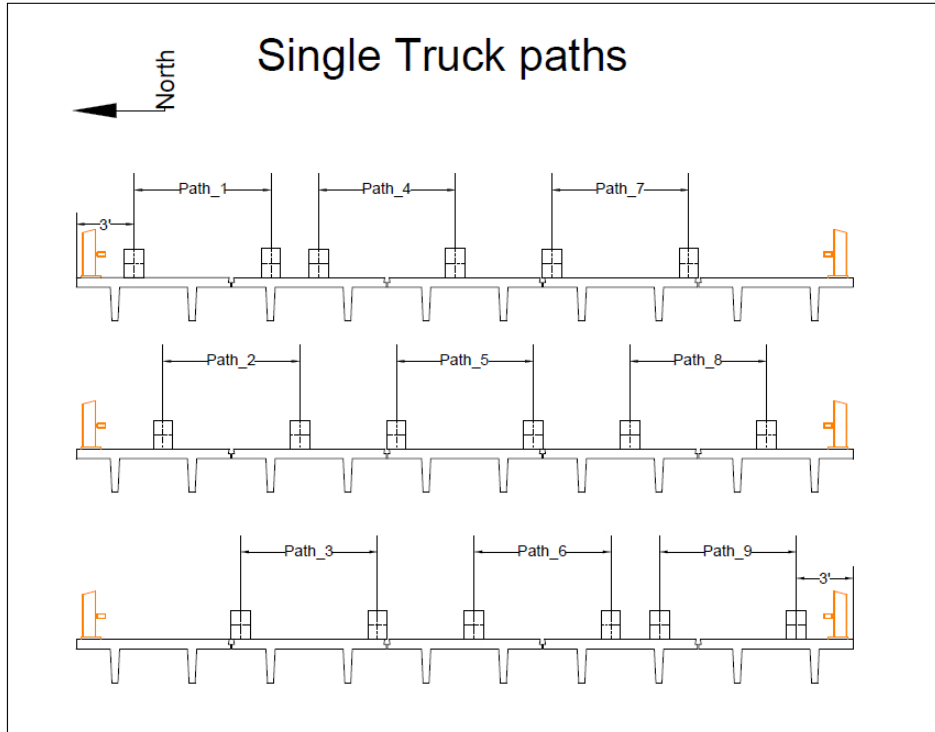
Figure 7.8. Transverse truck paths 1 through 9 for first phase of diagnostic testing (Bridge 8761).

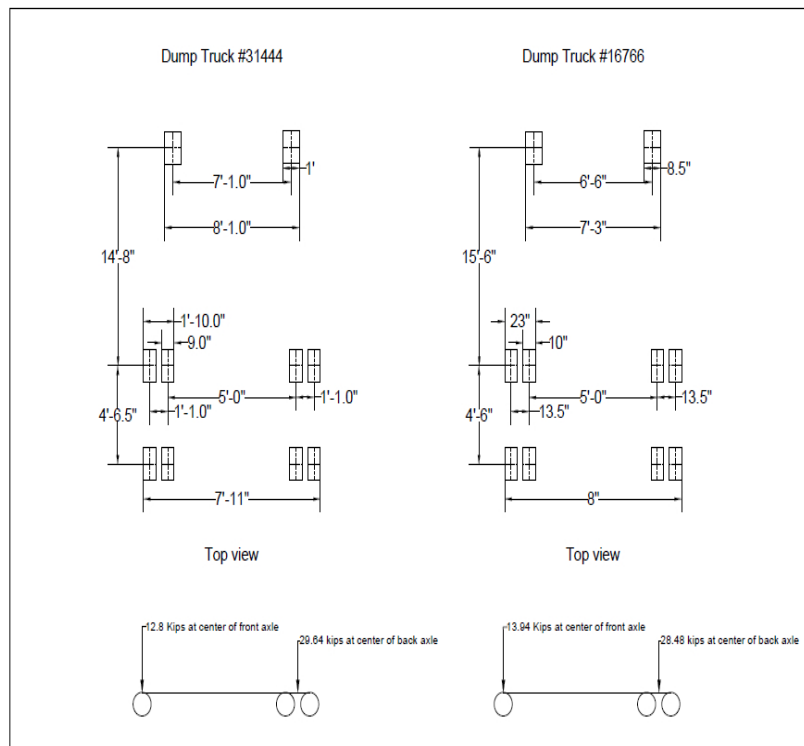
Figure 7.9. Axle configurations and weights of diagnostic test trucks (Bridge 8761).

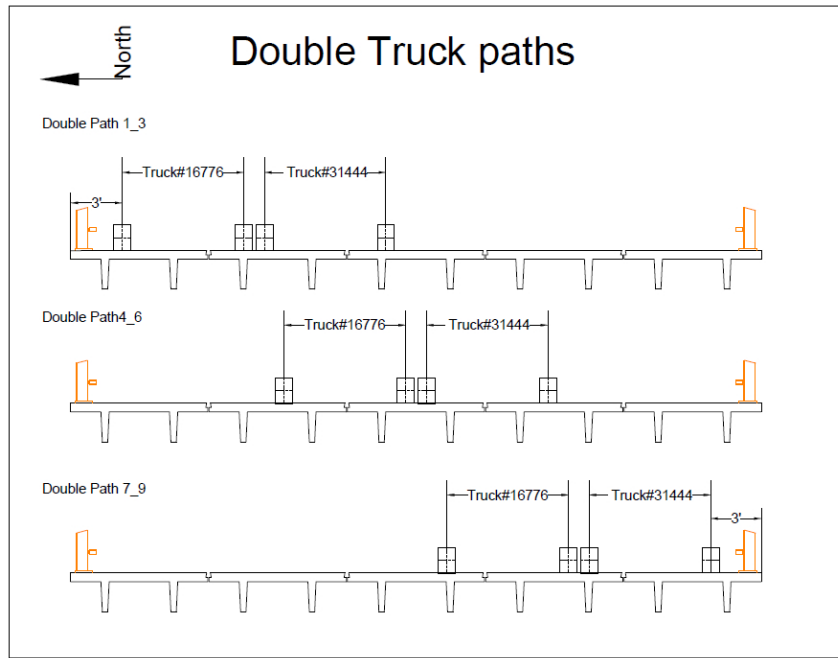
Figure 7.10. Transverse truck paths 1-3, 4-6, and 7-9 for second phase of diagnostic testing (Bridge 8761).

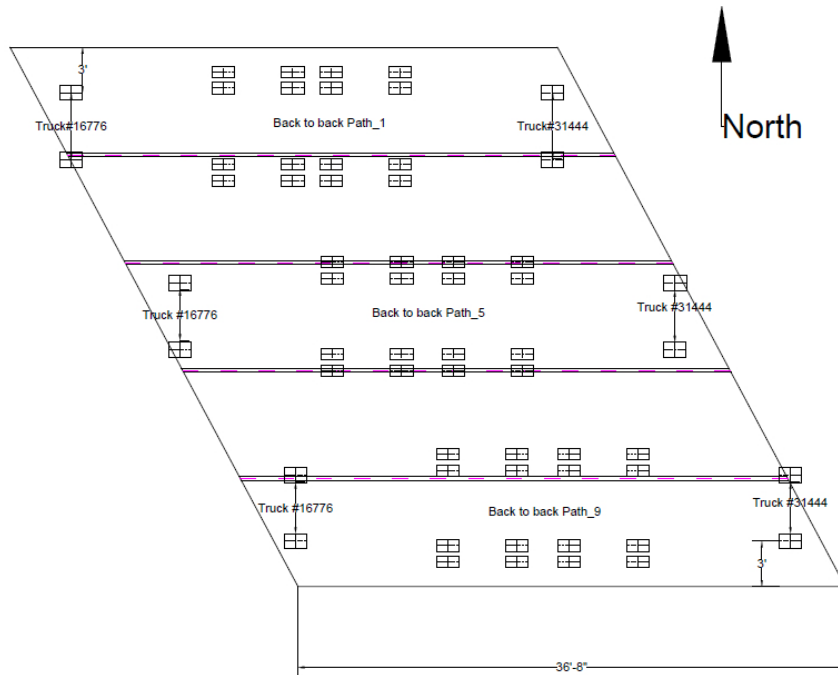
Figure 7.11. Truck positions for third phase of diagnostic testing (Bridge 8761).

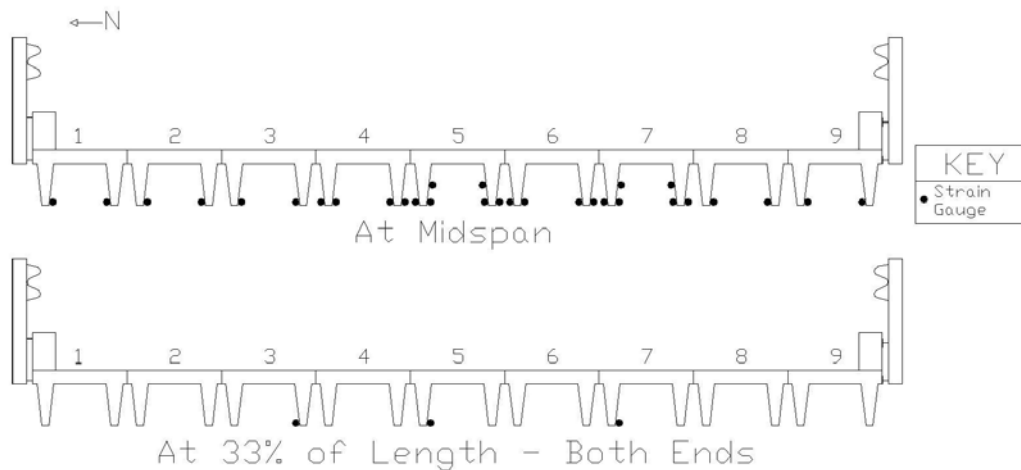
Figure 8.1. Instrumentation layout for proof load testing (Bridge 7701).

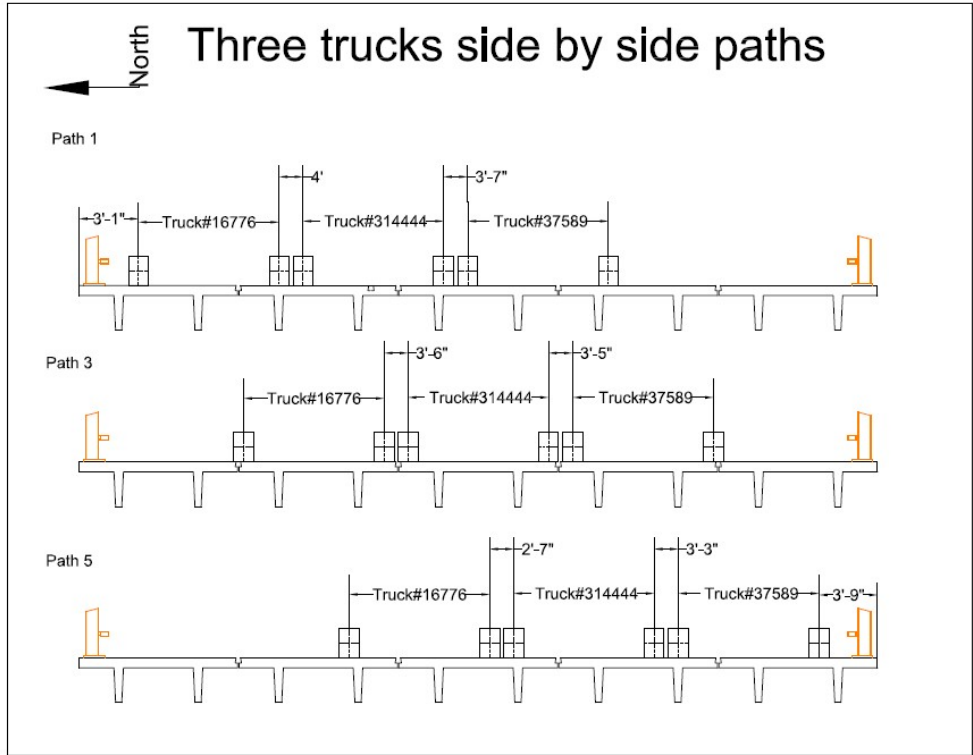
Figure 8.4. Transverse truck paths 1-3-5, 3-5-7, and 5-7-9 for second phase of proof testing (Bridge 8761).

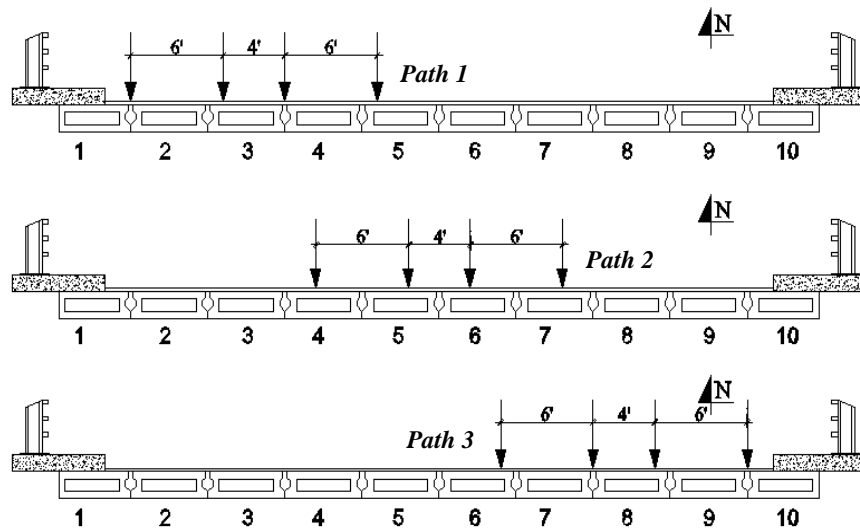
Figure 8.10. Transverse truck paths 1, 2, and 3 for second phase of proof testing (Bridge 8825).

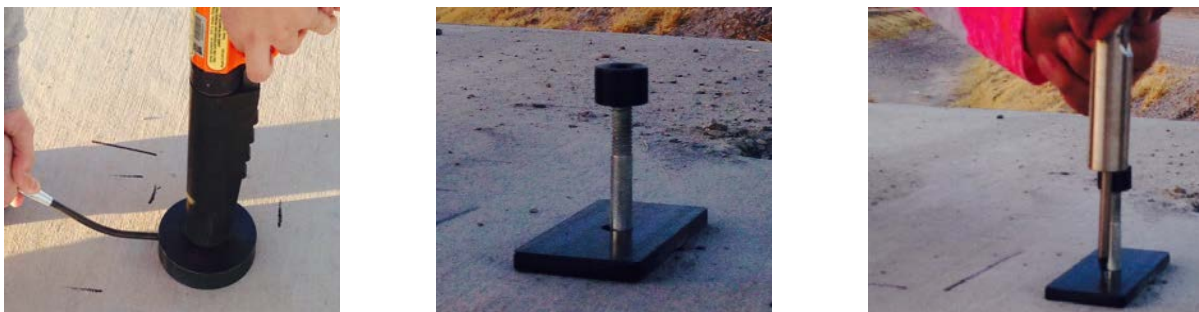
Figure A.8 Windsor probe penetration test

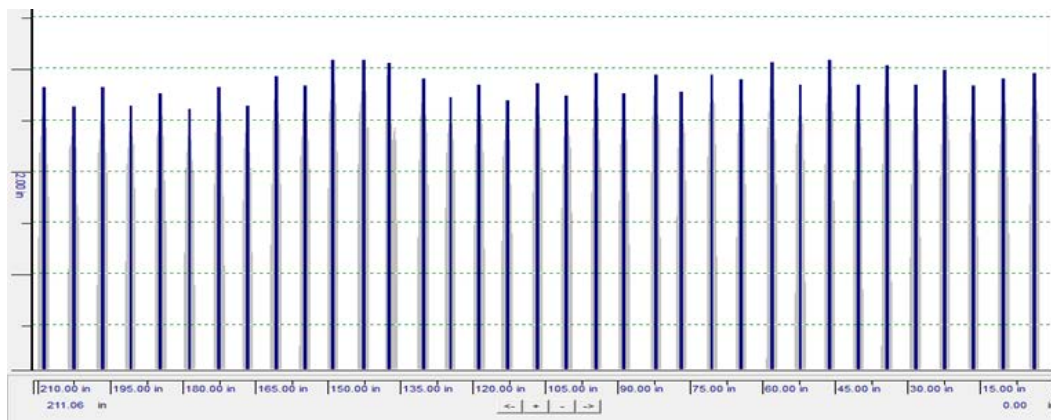
Figure A.10 Typical quickscan results for reinforced concrete slab bridge.

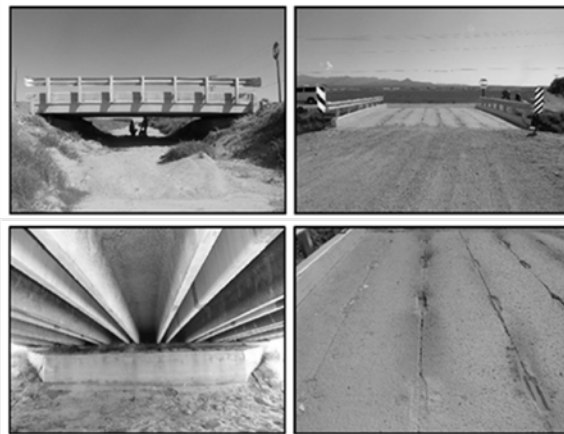
Figure 1: Prestressed Concrete Double-Tee Beam Bridge in Southern New Mexico

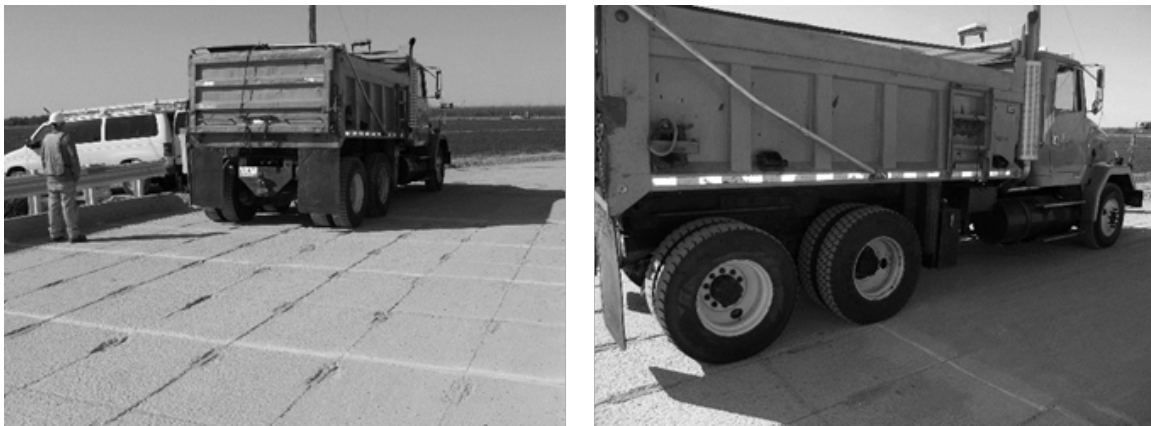
Figure 4: Truck positioning during test phase one

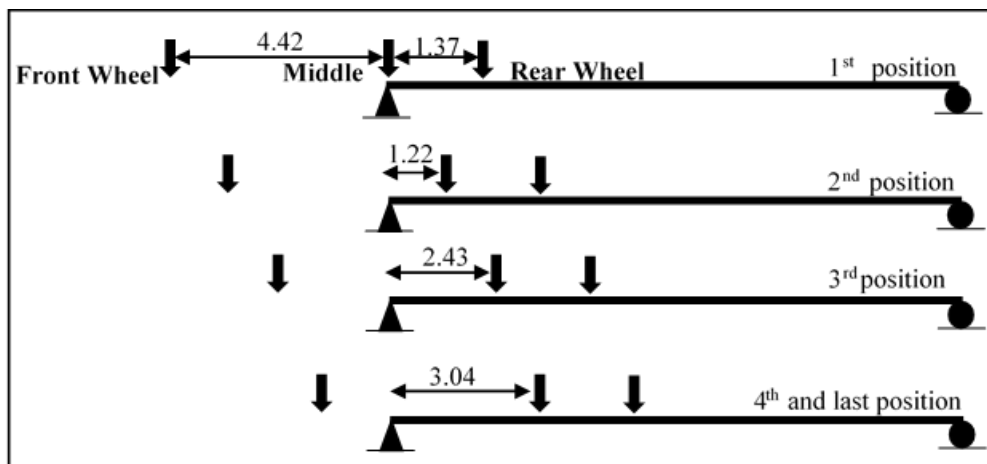
Figure 6: Longitudinal truck position steps for phase two

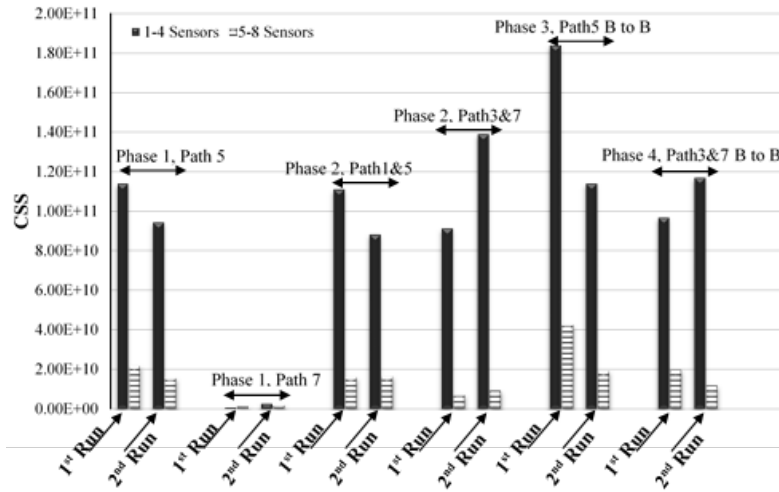
Figure 8: Cumulative Signal Strength for all test phases

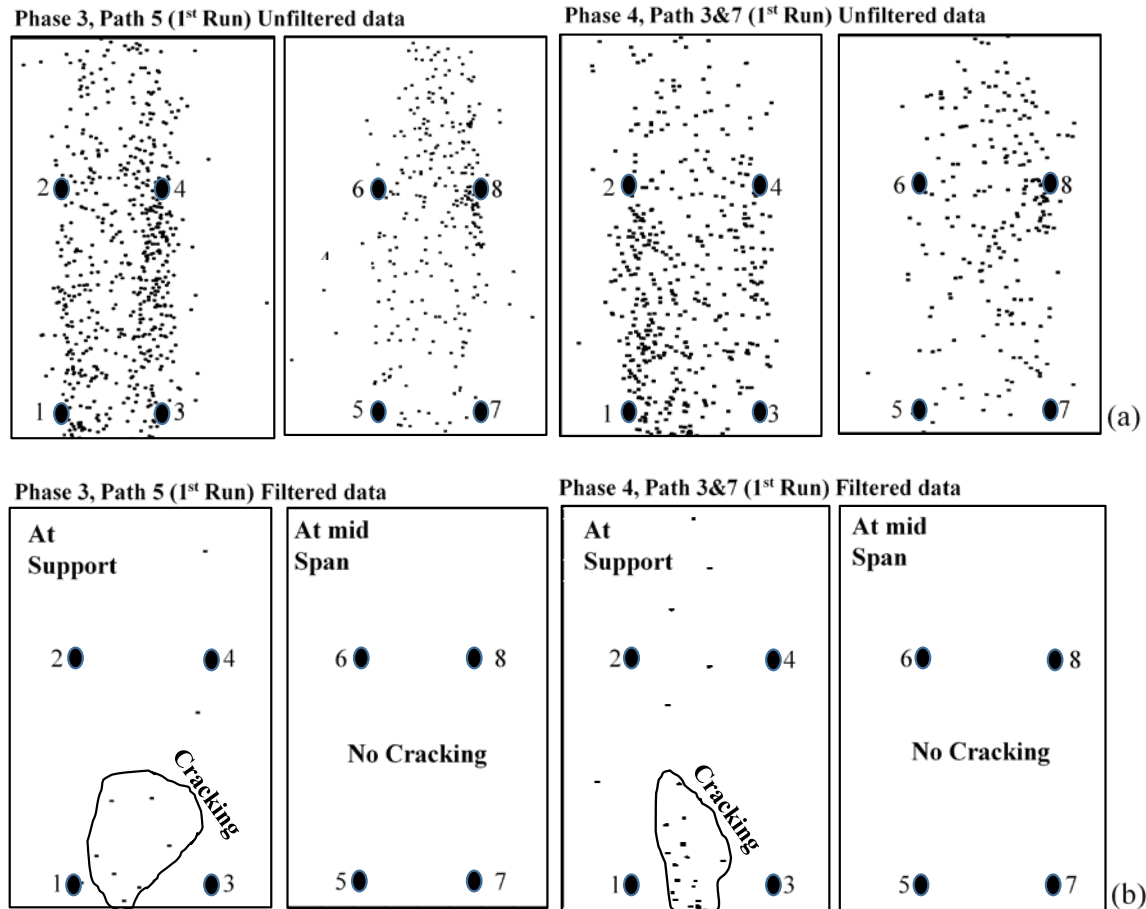
Figure 10: AE source location: (a) unfiltered data, and (b) filtered data

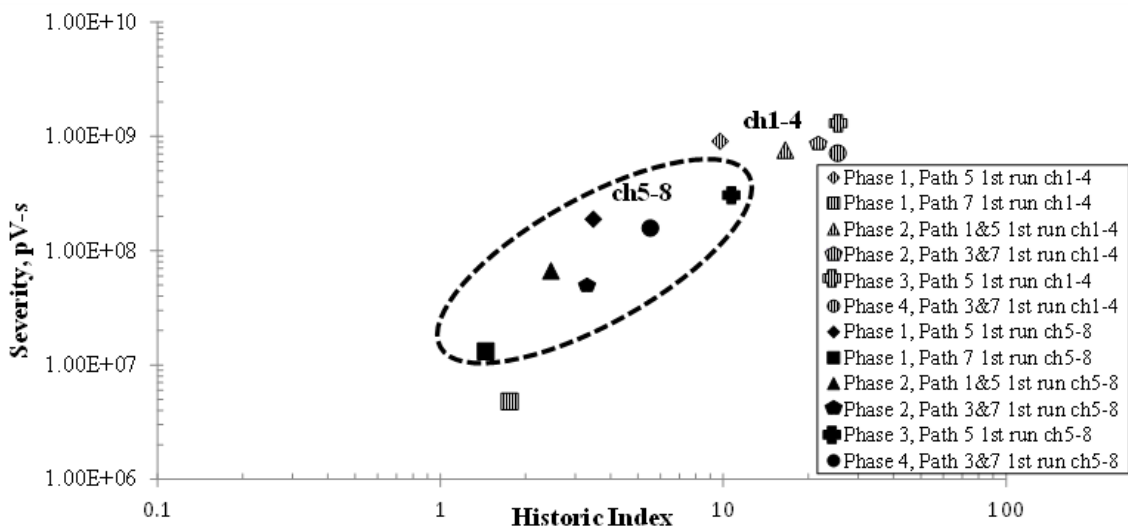
Figure 11: Intensity Analysis condition assessment charts
