Evaluation of Manual Thermal Brake Screening Systems

Report Number: KTC-25-07

Research Report

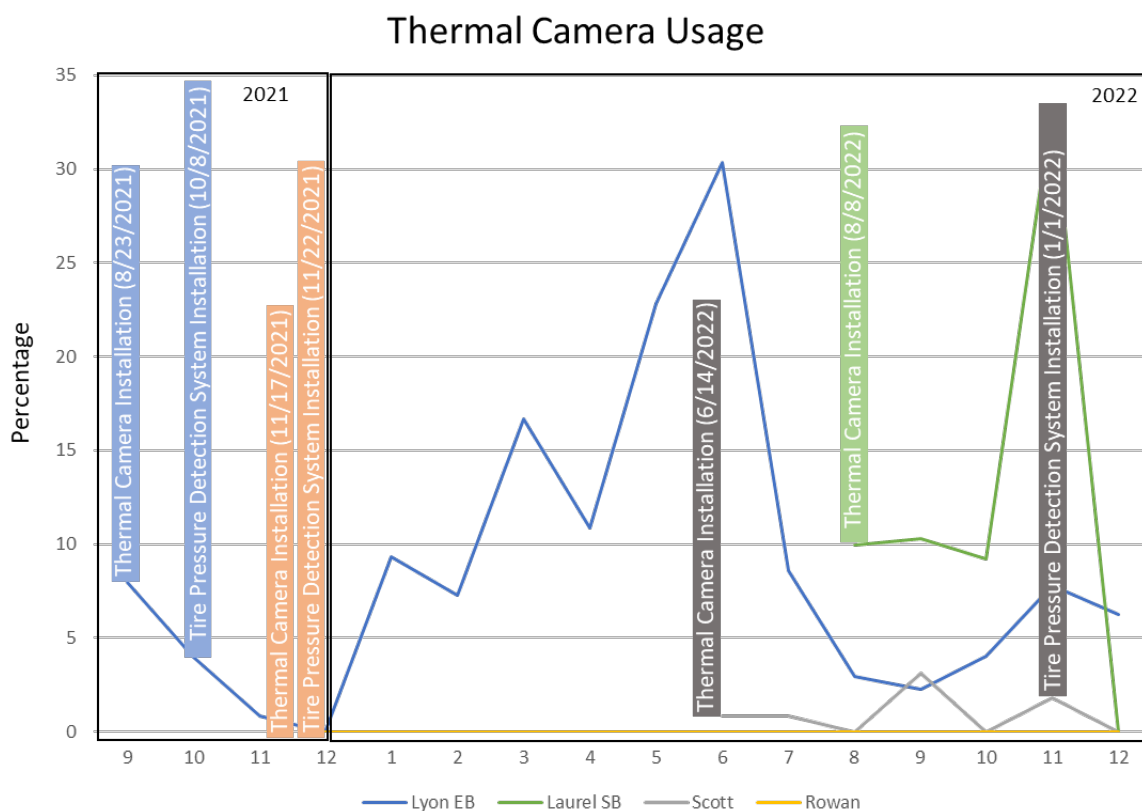
weigh station. Figure 2.1 shows the usage rate at weigh stations since the installation. Among the four weigh stations, Lyon (EB) and Laurel (SB) County inspectors used the thermal camera images to screen vehicles for level 1 inspection at a meaningful rate. However, Scott County did not report the use of the system often, and Rowan County did not report its use at all since installation.

Figure 2.1 Thermal Camera Usage Rate for Level 1 Inspections

The system was installed at Laurel County (SB) in August 2022, and training was provided the following month. As mentioned by a trainer, it took a while for inspectors to gain proficiency, and the usage significantly increased in November. Over thirty% of the level 1 inspections used thermal camera images in the prescreening process. The sudden decrease in the usage in December may need to be excluded as there was only one level 1 inspection in

December, which may affect the significance of the usage rate in the month. Laurel County (SB) did not have a tire pressure detection system during the evaluation period, leaving inspectors to rely heavily on thermal camera images to identify tire-related issues. Scott County shows similar usage patterns to Rowan County. The usage rate has never been significant since the installation, and the availability of the tire pressure detection system at the station would not help inspectors to use thermal camera images over the tire pressure detection system for tire-related issues.
