Modified Fiber Reinforced Concrete Repairs for Corroded Steel Beam Ends

Final Report VTRC 26-R15

Virginia Transportation Research Council
Charlottesville, Virginia

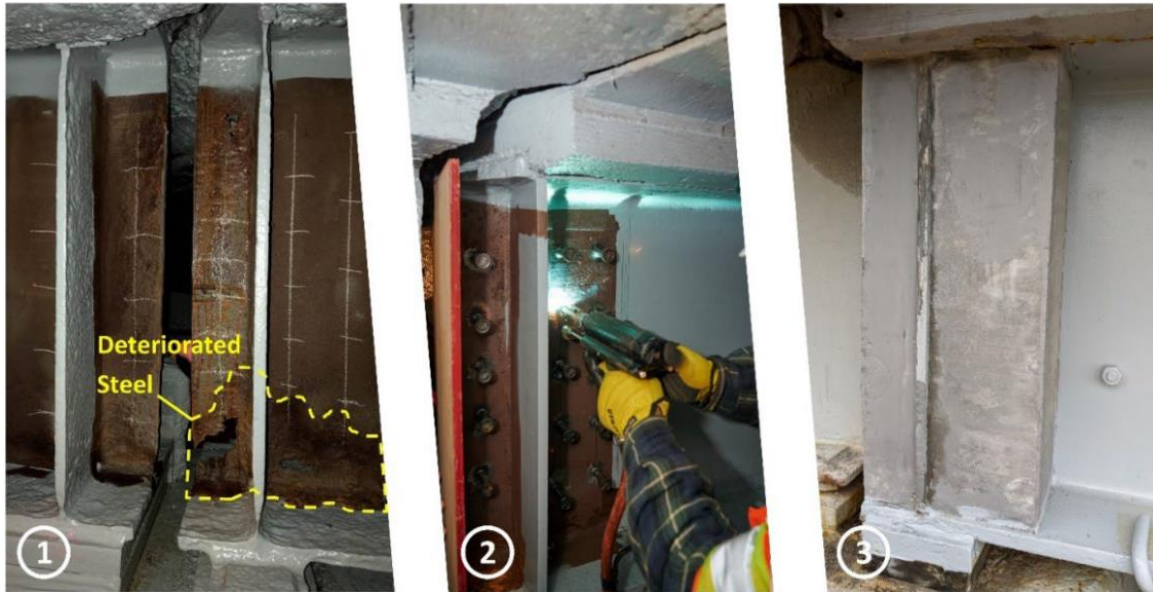
Figure 2. Photos Showing Installation of Ultra-High-Performance Concrete Beam End Repair (Haber et al., 2022)

From the mid-2010s to the early 2020s, the University of Connecticut conducted numerous research studies with the Connecticut Department of Transportation (DOT) on a practical repair strategy in which shear studs were welded to undamaged sections of the corroded steel beam and then ultra-high-performance concrete (UHPC) was cast around the corroded steel beam end (Figure 2). In this way, UPHC provides an alternate load path to bypass the corroded portion of the steel beam. This research included laboratory testing on small-scale specimens (Kruszewski et al., 2018; Zaghi et al., 2016), medium-scale beam specimens (Zmetra et al., 2017), and large-scale beam specimens, as well as finite element analysis (McMullen, 2019). This repair method addresses only corrosion damage in the beam web. It does not address corrosion damage to the beam bottom flange.

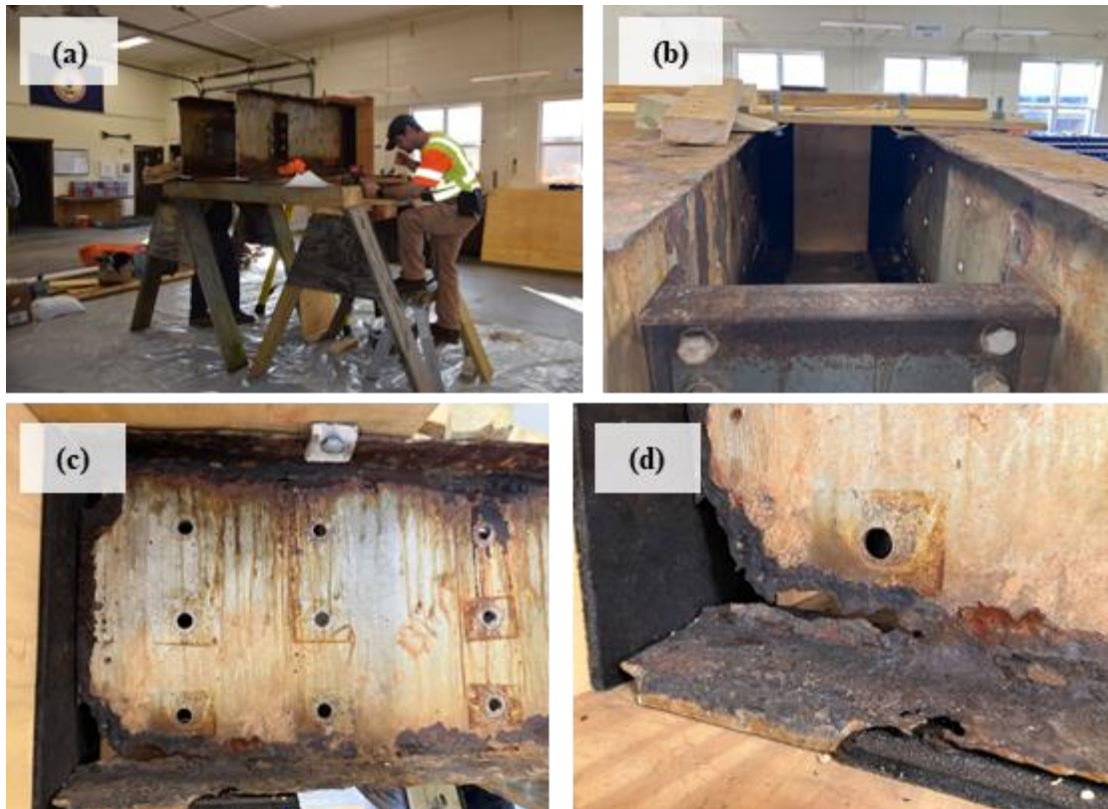
Figure 5. Photos of the Mockup Test Setup: (a) Overall View of Two Retired Bridge Beams; (b) Closeup View Between Beams; (c) Side View of One Beam; (d) Closeup of Corrosion Damage to One Beam

with a timber deck. The two beams were placed on wooden sawhorses to simulate beam ends on an actual bridge. The district work crew also provided threaded rods with washers and nuts, lumber for constructing formwork, and bags of prepackaged VHPC for simulating the repair. Both partial- and full-depth repairs were performed in the mockup. Figure 5 shows photos of the steel beams used in the mockup test setup.

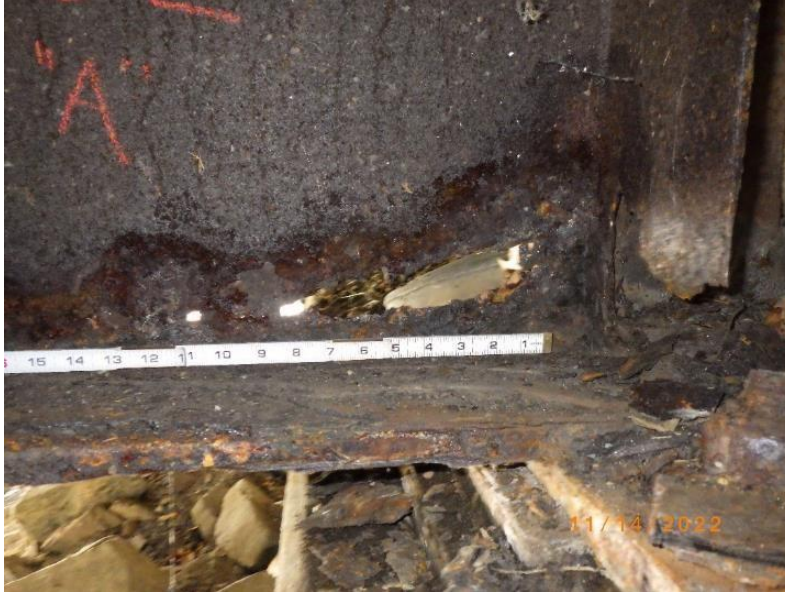
Figure 6. Example of Beam End Corrosion Damage on Bristow Road Bridge Before FRC Repairs

Researchers performed an initial implementation project for using FRC beam end repairs in the VDOT Northern Virginia District in September 2024. This initial VDOT implementation was performed on the Bristow Road Bridge (Federal ID 14306), which carries Bristow Road/Route 619 over Cedar Run near Brentsville, Virginia. All five bridge beam lines had experienced corrosion damage at both abutments with leaky joints. Therefore, plans were made to construct repairs at all 10 beam ends. Figure 6 shows an example of the extensive corrosion at one of the beam ends on the Bristow Road Bridge before FRC repairs.

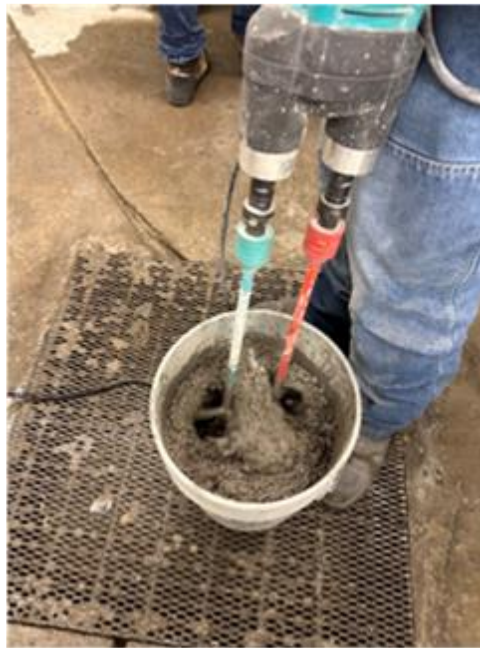
Figure 7. Mixing Engineered Cementitious Composite with Dual Paddle Mixer for Small-Scale Durability Samples

The small-scale durability samples were constructed in VTRC's concrete laboratory. The ECC used in the samples had a short set time of 30 minutes and a range of water content according to the product technical datasheet. Therefore, the maximum water content was used to provide better workability. The ECC was mixed using a dual paddle drill mixer, as Figure 7 shows. Casting the small-scale specimens was successful without any issues.

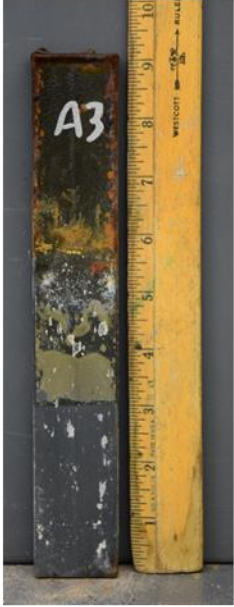
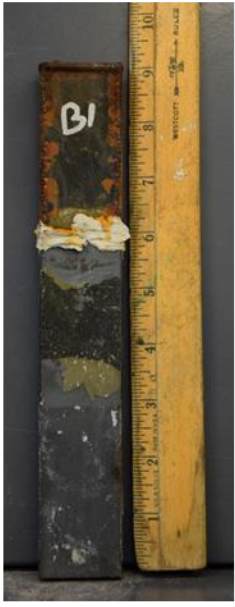
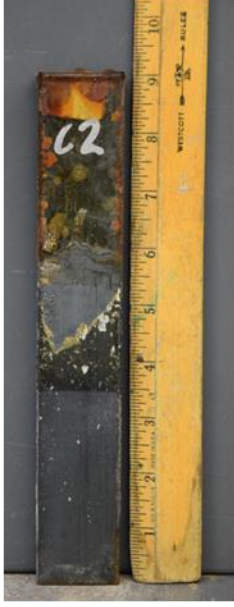
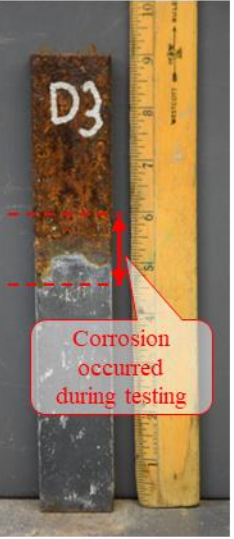
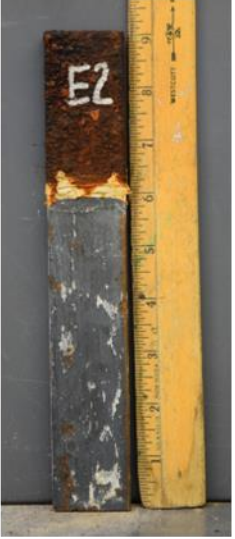
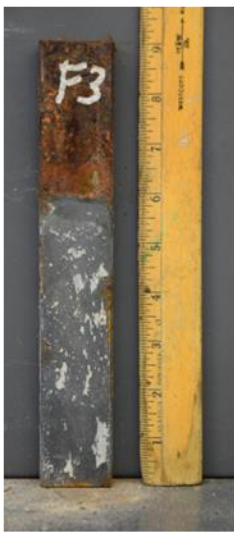
Nothing at Steel-FRC Edge Interface	Caulking at Steel-FRC Edge Interface	Epoxy Coating at Steel-FRC Edge Interface
Epoxy-Coated Steel Surface

Uncoated Steel Surface

Figure 8. Photos of the Steel Plates After Removal from Engineered Cementitious Composite for Each Sample Type After Durability Testing

After the different treatment options (shown in the test matrix in Table 1) were applied and allowed to cure, the durability testing commenced and lasted for 6 weeks. As described previously, the samples were cut open using a water jet. Then, the portion of the steel plates previously embedded in ECC was examined to determine the extent of saltwater moisture penetration between the steel and ECC edge interface. Figure 8 shows representative photos of the steel plates after removal from the ECC for each sample type after the durability testing was complete.

All the photos in Figure 8 include a ruler for scale and to aid in indicating corrosion to the portion of the steel plate embedded in ECC. Because the bottom 6 inches of each steel plate were embedded in ECC, the 6-inch marking on the ruler can be used as a reference point. Any material above that mark on the steel plate was expected to have corroded because it was exposed during the durability testing. Any material below that mark on the steel plate was embedded in the concrete. Thus, corrosion on that portion of the steel plates indicates that saltwater penetrated between the steel-ECC edge interface to cause the corrosion.

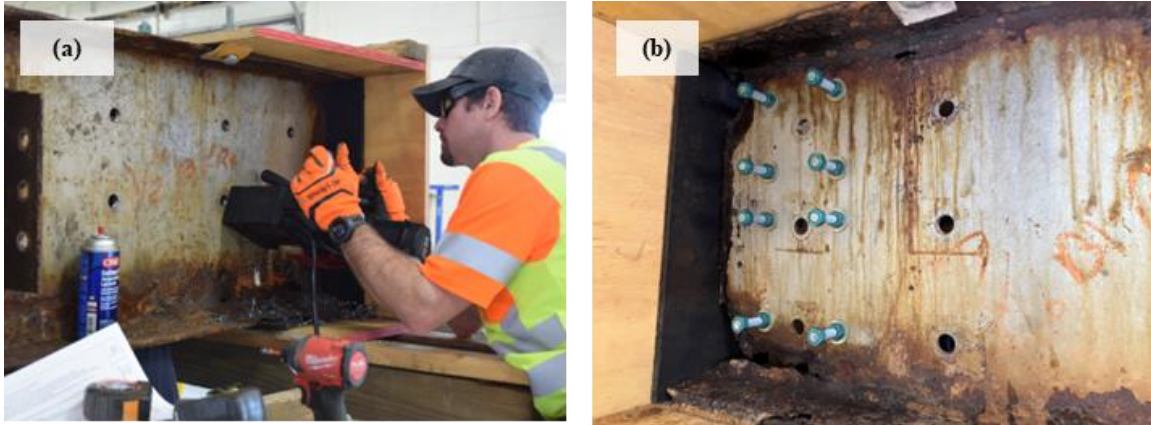
Figure 9. Installation of Threaded Rods During Mockup: (a) District Work Crew Member Using Magnetic Drill to Drill Holes; (b) Threaded Rods After Being Installed into a Beam Web

The mockup test began with the district work crew using a magnetic drill to drill holes into both beam webs. VTRC and the district work crew had agreed on the locations of the holes. After all the holes were drilled, threaded rods were inserted into the holes, and nuts and washers were placed on either side of the beam web. The nuts were tightened using a socket wrench, which required the full effort of a district work crew member. An additional nut was placed on each end of the threaded rods to simulate the head of a shear stud to prevent the FRC panel from pulling out from the threaded rods. Figure 9 shows photos of the magnetic drill and the threaded rods after being installed into a beam web.

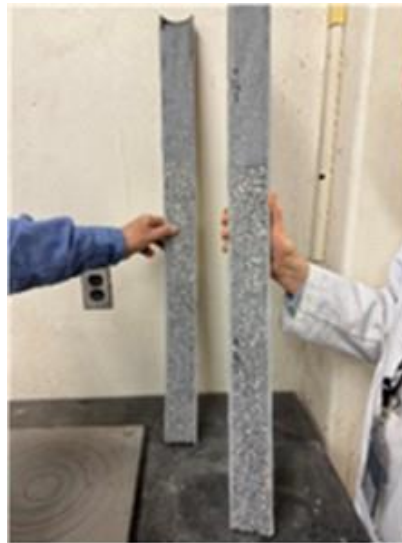
Figure 12. Mixture with Extra Water and High Slump Flow of 30 Inches Exhibited Segregation

Segregation of fibers and aggregates was observed when excessive water, about 20% more than recommended (0.6 gallon per bag), was used. This amount of water is the same used in the mockup testing. Figure 12 shows one of the VHPC tubes after being cut open. The high slump values of 30 inches, which were obtained with extra water, were shown to cause settlement of fibers. This observation suggests that high flow values should be avoided. On the other hand, VHPC mixtures with low flow values had difficulty passing through the 3-inch diameter tube, suggesting that low flow values should also be avoided. Therefore, an optimal amount of water should be added to the mix to balance segregation and flowability. This optimal amount may be slightly higher than the maximum amount of water recommended by the manufacturer and can be determined by trial batching.

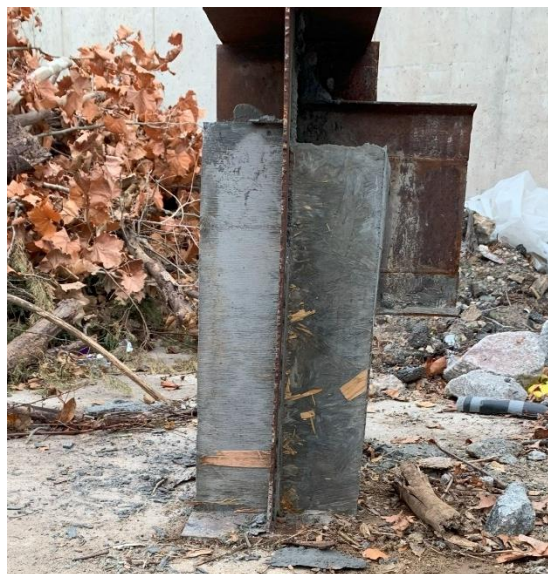
Figure 15. Photo of the Mockup Specimen Constructed Before the Bristow Road Bridge Repairs

Because it was their first implementation of an FRC beam end repair, the VDOT Northern Virginia District elected to conduct a mockup specimen before installing the VHPC beam end repairs on the Bristow Road Bridge. This mockup consisted of a beam end cut out from a retired bridge. Formwork was constructed on both sides of the beam web, then VHPC was placed on one side of the web, and typical concrete was placed on the other. The district noted that this mockup was an additional expense to the project but believed that the learning opportunities encountered during the mockup were worth the additional expense. Figure 15 shows a photo of the mockup specimen.

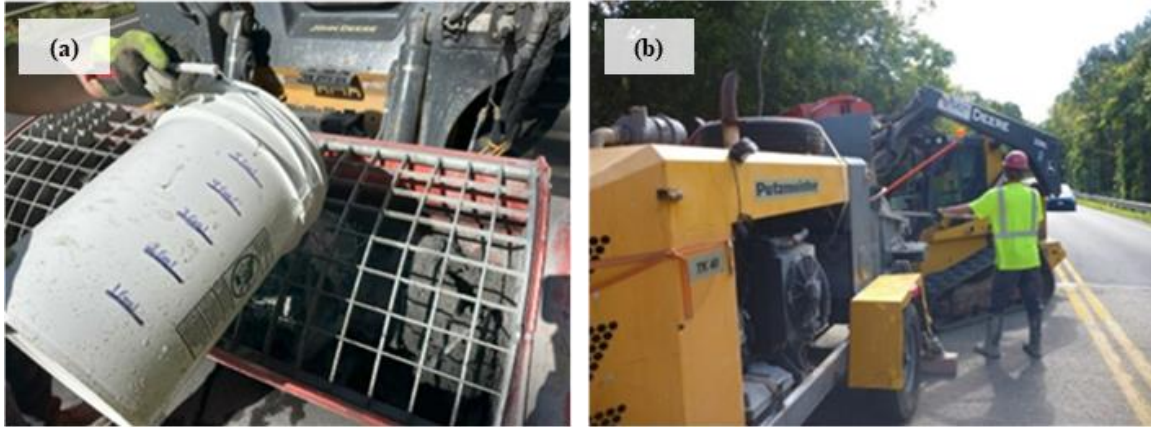
Figure 17. Photos of Bristow Road Bridge Repair Fiber Reinforced Concrete Installation: (a) High-Shear Mixer; (b) Trailer Pump

Prepackaged VHPC was mixed with water and steel fibers using a high-shear 15.6-cubic-foot mixer (Figure 17a). A trailer pump was also rented to facilitate transporting the mixed VHPC from the mixer to the beam ends (Figure 17b). Approximately 1 cubic yard (130 bags) of VHPC was mixed in multiple batches. The capacity of the mixer was about 54 bags per batch. To ensure proper mixing and prevent segregation, each batch was limited to a maximum of 32 bags. To ensure thorough mixing, increments of 10 bags were added to the required water amount. At the final mixing stage, 2% steel fibers (2.8 pounds per bag) were incorporated, requiring two 44-pound bags of steel fibers. Although the recommended maximum water content was 0.5 gallons per bag, the desired flowable mix for pumping and placement was not achieved. The water content was then increased to 0.56 gallons per bag, which resulted in a highly flowable and pumpable mixture. Delivering the VHPC materials into each of the beam end formwork was accomplished with a 2-inch diameter hose (Figure 18).

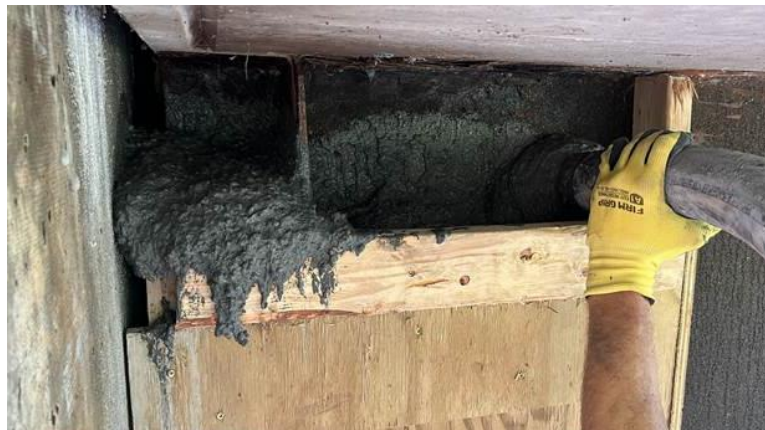
Figure 18. Photo of Bristow Road Bridge Repair Installation Showing Pumping Very High-Performance Concrete Mixture into Formwork

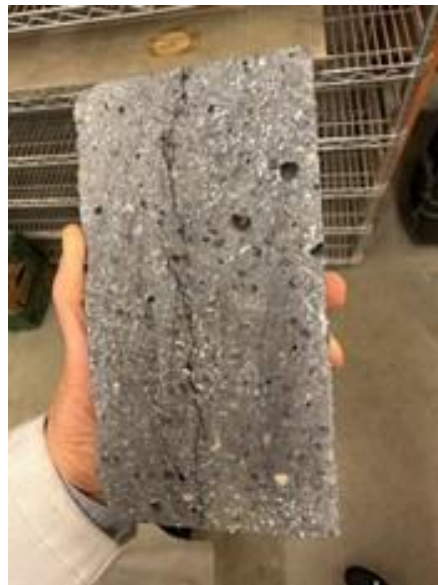
Figure 20. Well-Distributed Steel Fibers in Very High-Performance Concrete Used in Bristow Road Bridge Repairs

Test cylinders were taken to the VTRC concrete laboratory and tested for the compressive and splitting tensile strengths. The average 28-day compressive strength was 13,770 psi, exceeding the required minimum strength of 12,000 psi, and the average 28-day splitting tensile strength was 1,990 psi, exceeding the minimum of 1,400 psi specified in Virginia adjacent member connections. One of the tested cylinders was cut vertically to determine the distribution of the steel fibers (Figure 20). The distribution of fibers was uniform in the cylinder, indicating that the addition of 12% more water than recommended by the manufacturer did not cause fiber settling or strength reduction.
