1. Report No. FHWA/TX-05/0-4162-3		2. Government Accession No.		3. Recipient's Catalog No.	
4. Title and Subtitle DEVELOPMENT OF LOW-DEFLECTION PRECAST CONCRETE BARRIER				5. Report Date January 2005

# **DEVELOPMENT OF LOW-DEFLECTION PRECAST CONCRETE BARRIER**

Report 0-4162-3  
Project 0-4162  
Project Title: Evaluation of Barrier Systems  
and Placement Issues

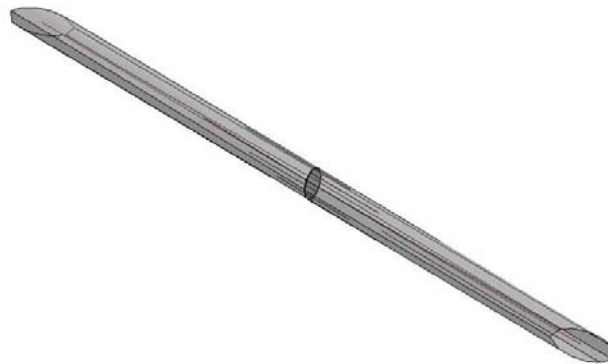
**Figure 2. Finite Element Representation of Guide Pipe in Cross-Bolted Connection.**

The cross-bolt connection was modeled by using shell elements to create rigid, cylindrical shafts to represent the pipe sections embedded in the concrete through which the cross bolts pass. The model of these shafts is depicted in [Figure 2](#). These shafts were placed inside the concrete barrier segments at their appropriate locations and rigidly constrained to the concrete such that motion of the shafts relative to the barriers was prohibited (see [Figure 3](#)).

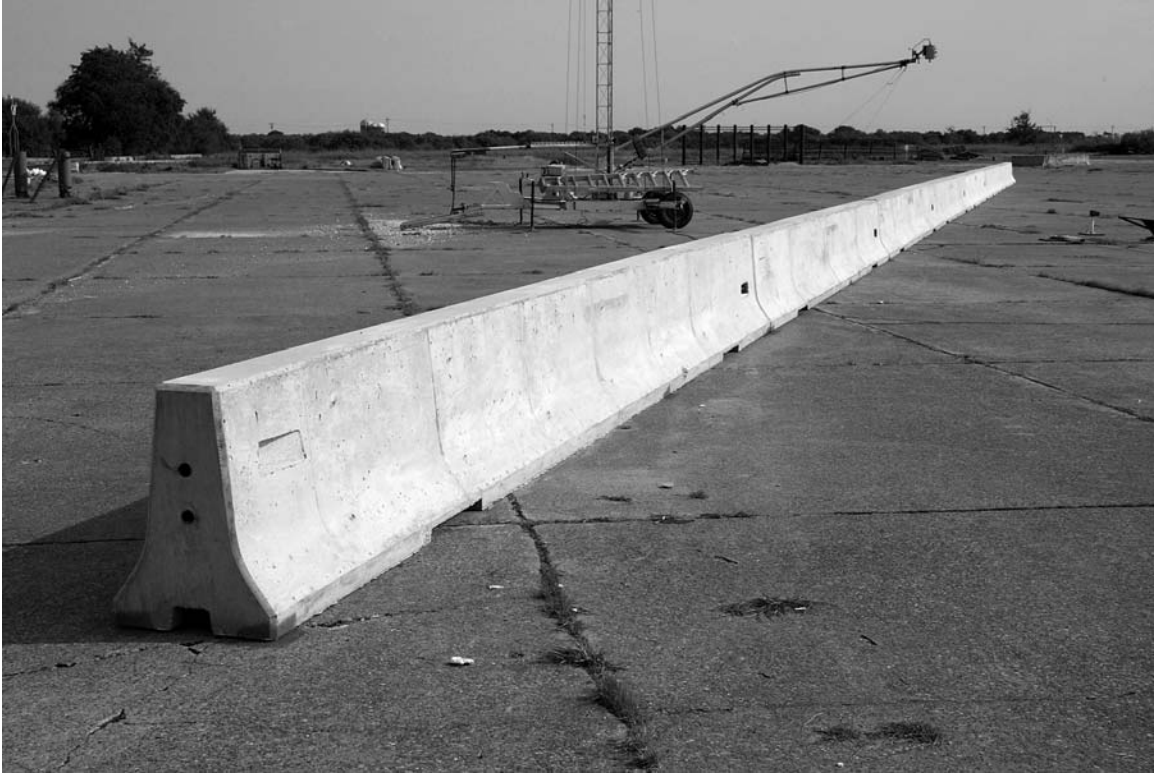
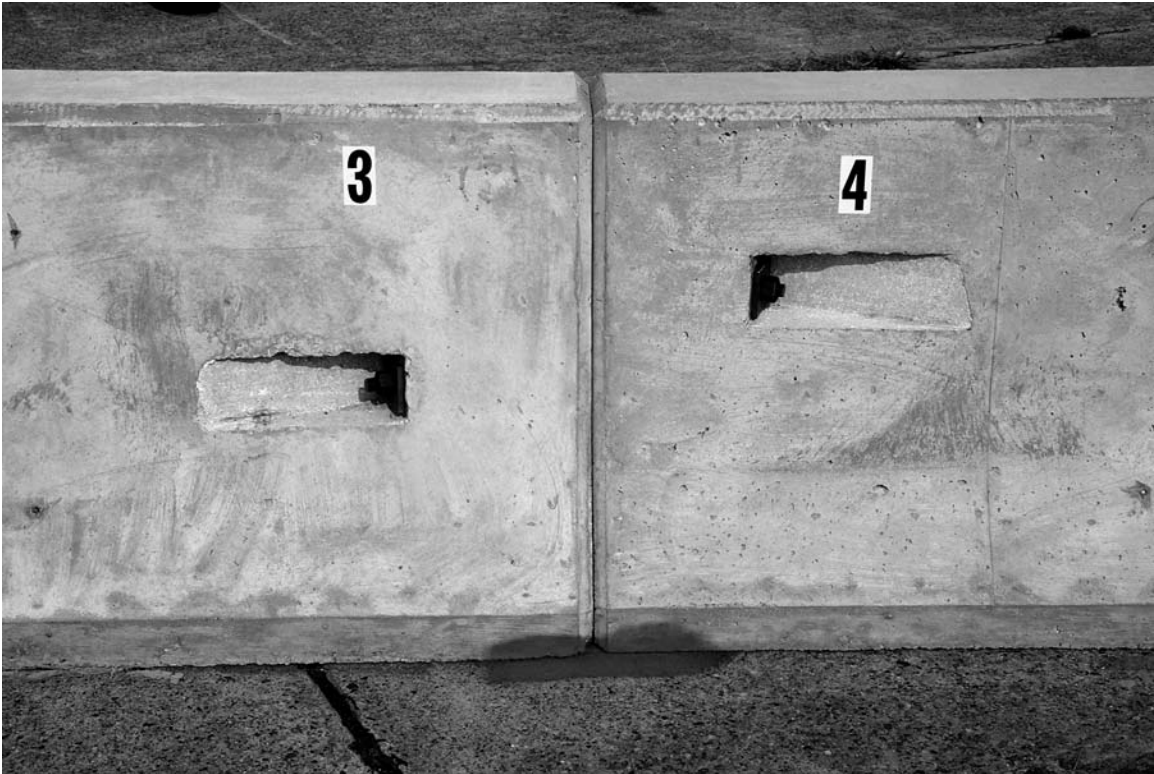
**Figure 11. Cross-Bolt, F-Shape Precast Concrete Traffic Barrier before Test 441623-1.**

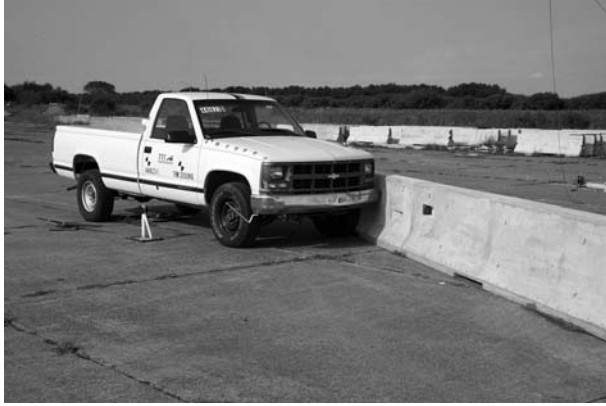
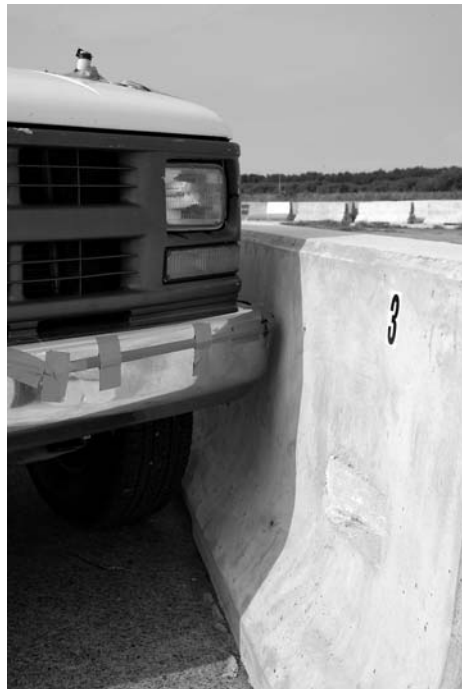
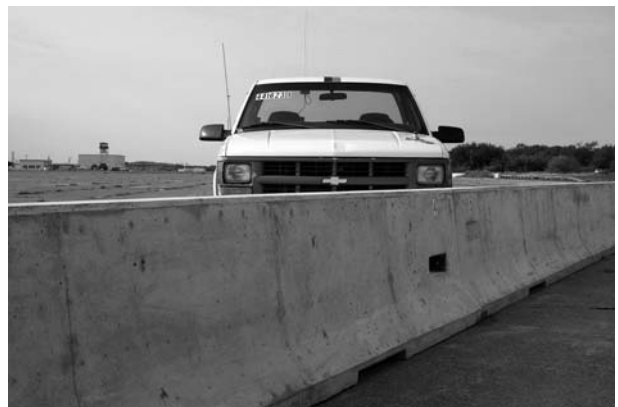
**Figure 12. Vehicle/Installation Geometrics for Test 441623-1.**

A 2000 Chevrolet 2500 pickup truck, shown in Figures 12 and 13, was used for the crash test. Test inertia weight of the vehicle was 4531 lb (2057 kg), and its gross static weight was 4531 lb (2057 kg). The height to the lower edge of the vehicle bumper was 16.3 inches (415 mm), and the height to the upper edge of the bumper was 25.0 inches (635 mm). Appendix B, Figure 19, gives additional dimensions and information on the vehicle. The vehicle was directed into the barrier installation using a cable reverse tow and guidance system, and was released to be free-wheeling and unrestrained just prior to impact.

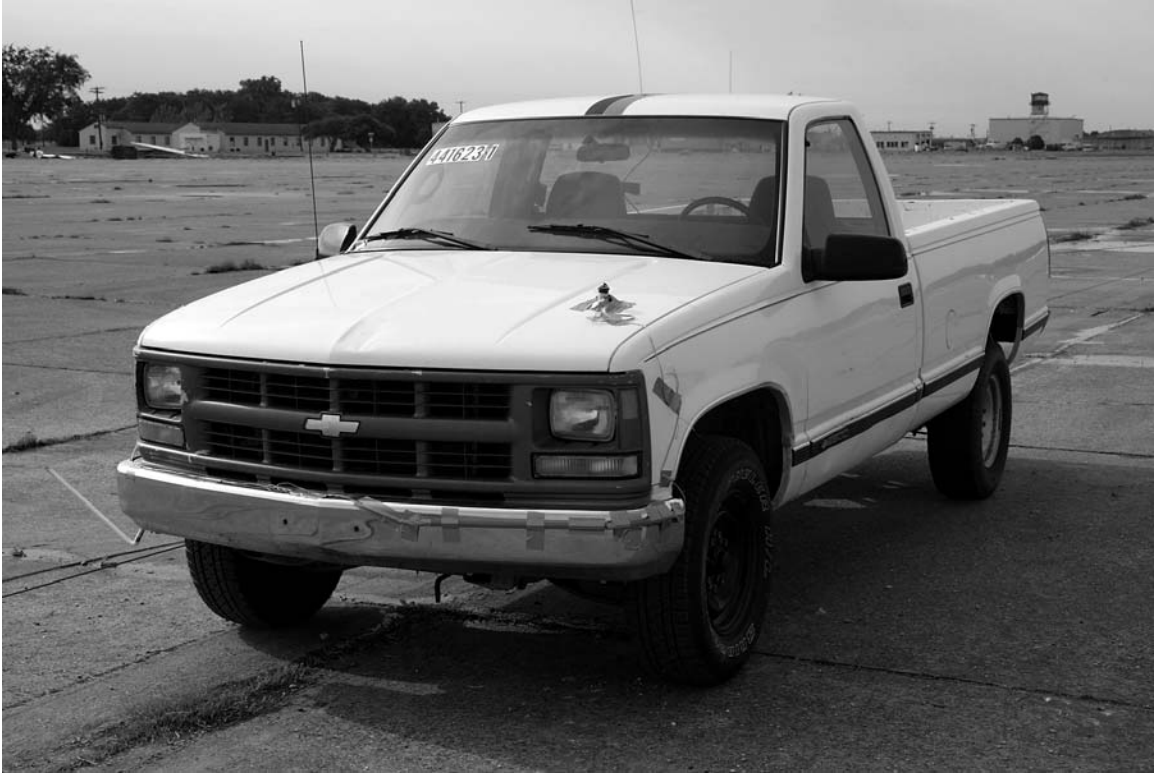
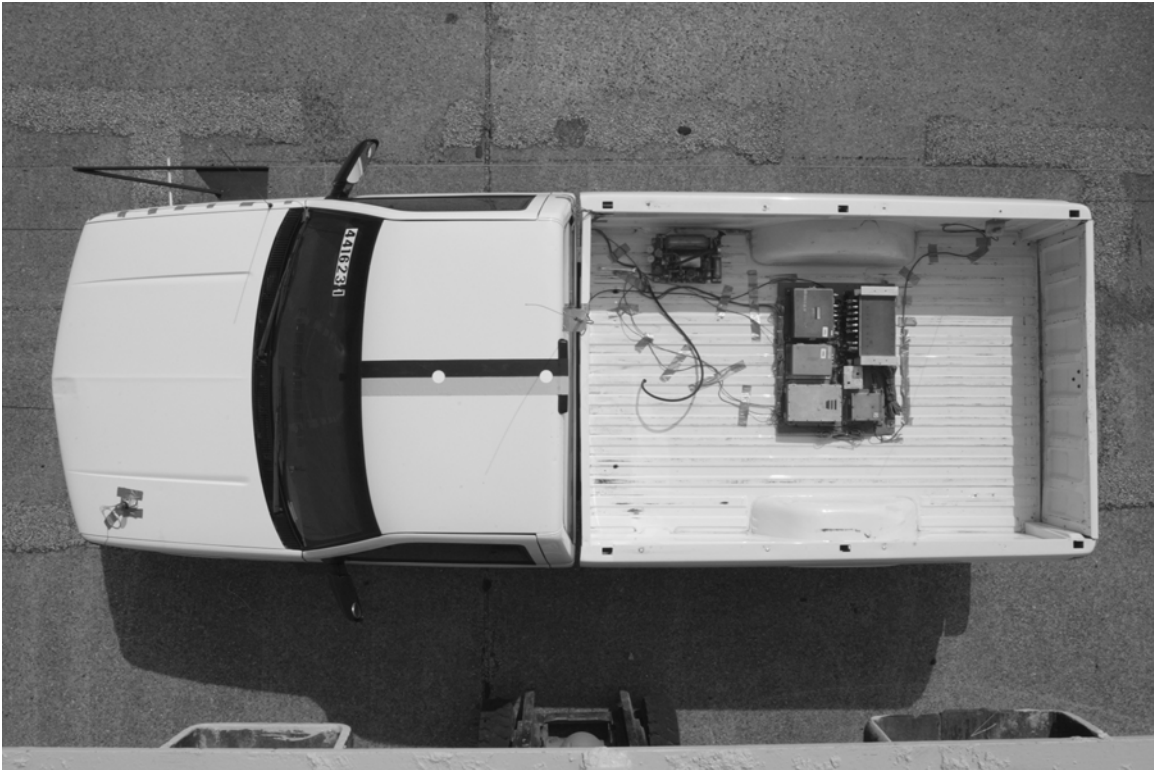
**Figure 13. Vehicle before Test 441623-1.**

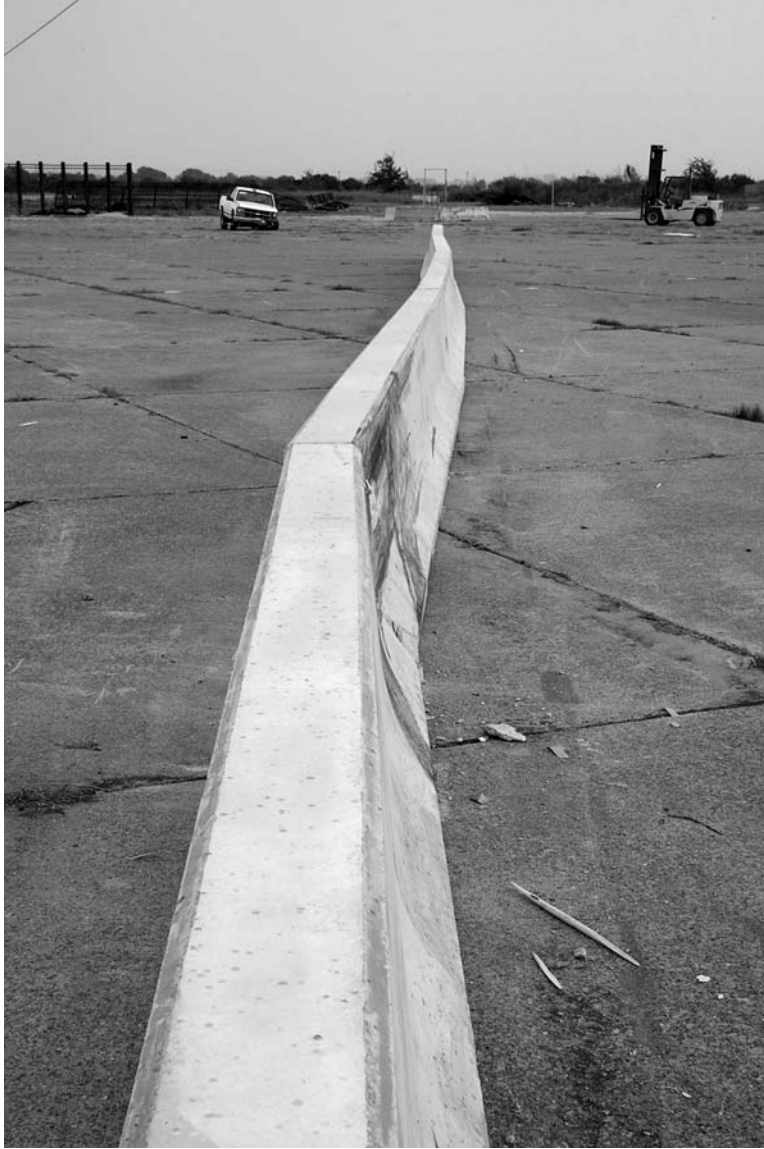
**Figure 14. After Impact Trajectory for Test 441623-1.**

The free end of segment 1 was pushed toward the field side 0.6 in (15 mm), and the joint between segment 1 and 2 was pushed toward the traffic lanes 0.4 in (10 mm) with no damage at the joint. The joint between segment 2 and 3 was separated 0.2 in (5 mm) and was pushed toward the field side 2.0 in (50 mm). Both segment 2 and 3 had some spalling of concrete on the field side of the joint, and the bolts were very slightly deformed but reusable. The joint between segments 3 and 4 was separated 0.47 in (12 mm) and pushed toward the field side 18.1 in (460 mm). Segment 3 was cracked at 8.1 in (205 mm) from the end nearest joint 4 near the top and radiating into the field side. The end of segment 4 was cracked at its base near its joint with segment 3. The bolts at joint 3-4 were deformed, and the threads were stretched. The joint between segments 4 and 5 was pushed toward the field side 4.9 in (125 mm). Both segments had cracks near the top and at the base on both the traffic side and the field side. The joint between segments 5 and 6 was pushed toward the field side 1.4 in (35 mm). The base of segment 6 was cracked on the traffic side and the field side. The joint between segments 6 and 7 was pushed toward the field side 0.6 in (15 mm), and there was no damage. The free end of segment 7 did not move. During initial impact, the vehicle was in contact with the installation 20.2 ft (6.2 m). The vehicle contacted the installation again 4.3 ft (1.3 m) upstream of joint 6-7 and slid off the

end of the barrier for a total secondary contact of 34.3 ft (10.5 m). Maximum dynamic deflection during the test was 19.0 in (483 mm), and maximum permanent deflection was 18.1 in (460 mm). Damage to the concrete barriers is shown in Figures 14 and 15.

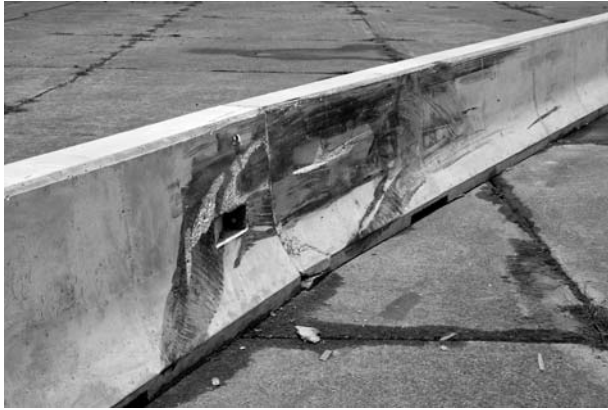
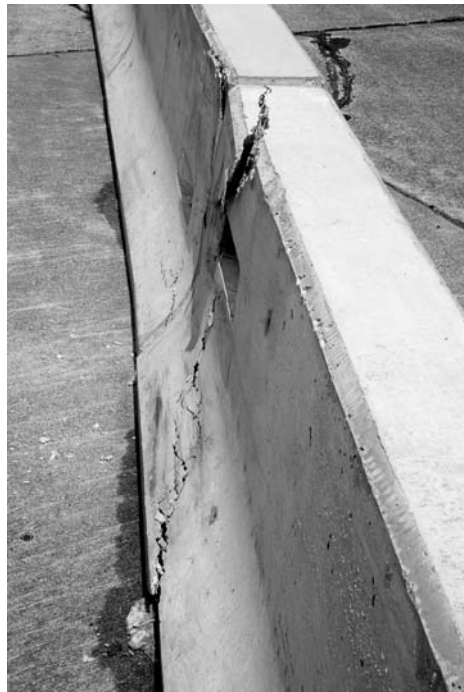
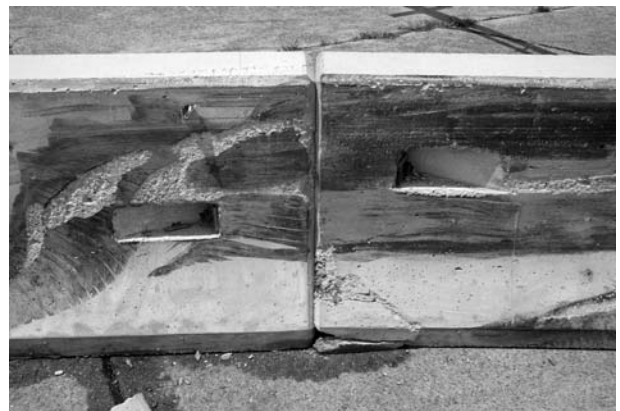
**Figure 15. Installation after Test 441623-1.**

After the test, the nuts on the cross bolts in the impact region were removed with an impact wrench. After the nuts were removed, the bolts could be readily removed by hand without having to move or reposition the barrier segments in any way. The two bolts at the joint directly downstream from impact (i.e., the joint between segments 3 and 4) required replacement. The other bolts were reusable. Of the four barrier segments damaged in the impact, two could be readily repaired and reused while two would likely need to be replaced.

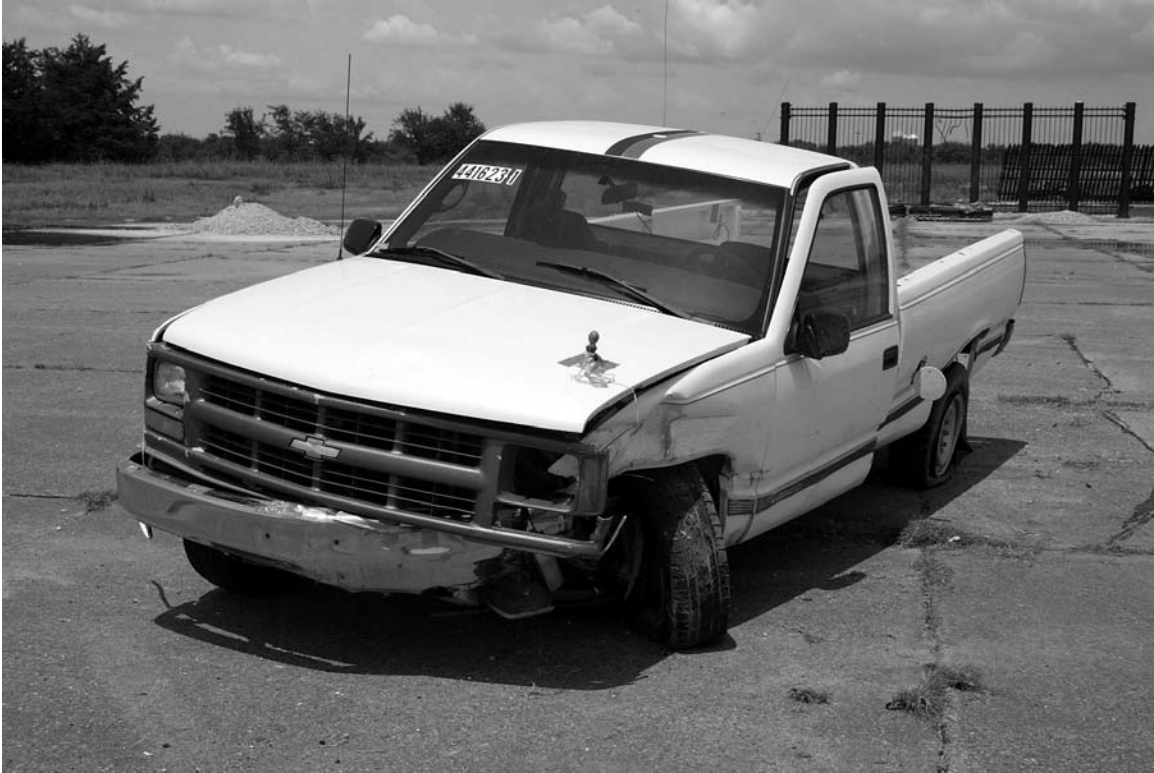
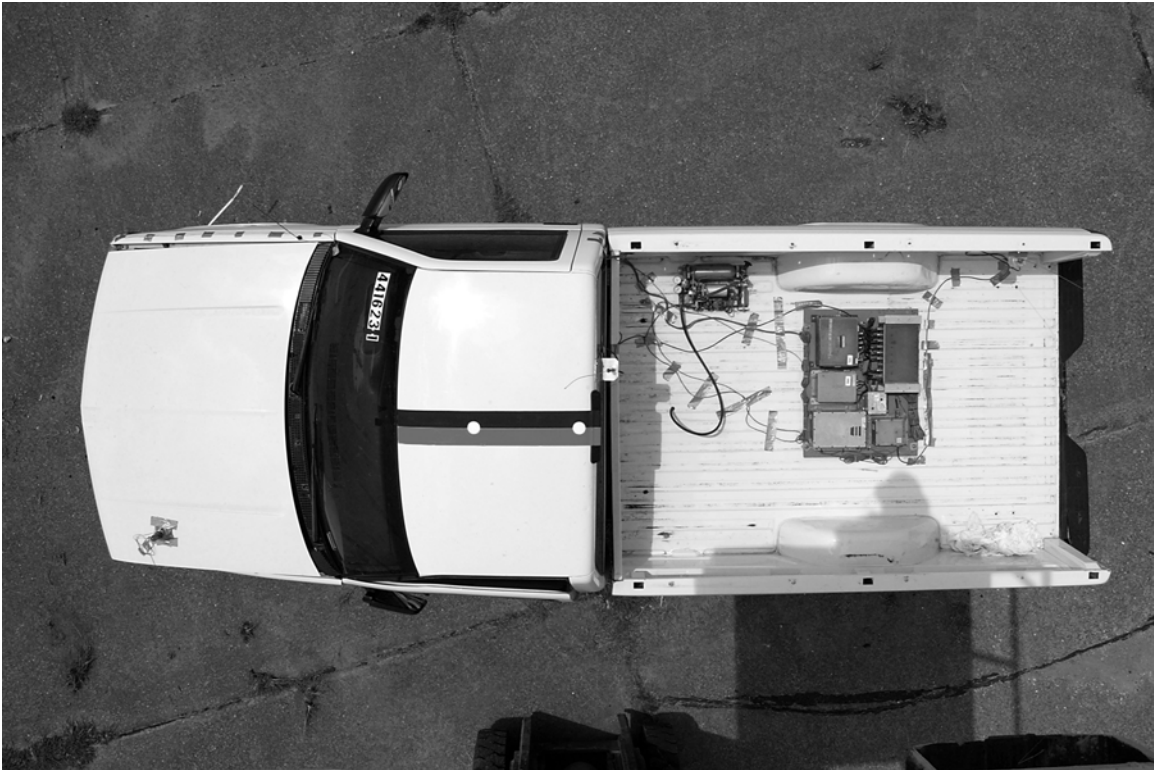
**Figure 16. Vehicle after Test 441623-1.**

Damage to the pickup is shown in Figure 16. Structural damage was imparted to the left upper and lower A-arm, left frame rail, and the floor pan. The inner and outer rim of the left front tire separated at the welds, and the tire was deflated. Also damaged were the front bumper, hood, grill, radiator, fan, left door, left front quarter panel, and left exterior bed. The tailgate separated from the pickup, the left rear wheel rim was deformed, and the tire was deflated. Maximum exterior crush to the vehicle was 17.7 in (450 mm) in the side plane at the left front corner of the vehicle near bumper height. Maximum occupant compartment deformation was 2.6 in (65 mm) just to the left of the center of the floor pan, near the transmission tunnel. Photographs of the interior of the vehicle are shown in Figure 17. Exterior vehicle crush and occupant compartment measurements are shown in Appendix B, Tables 4 and 5.

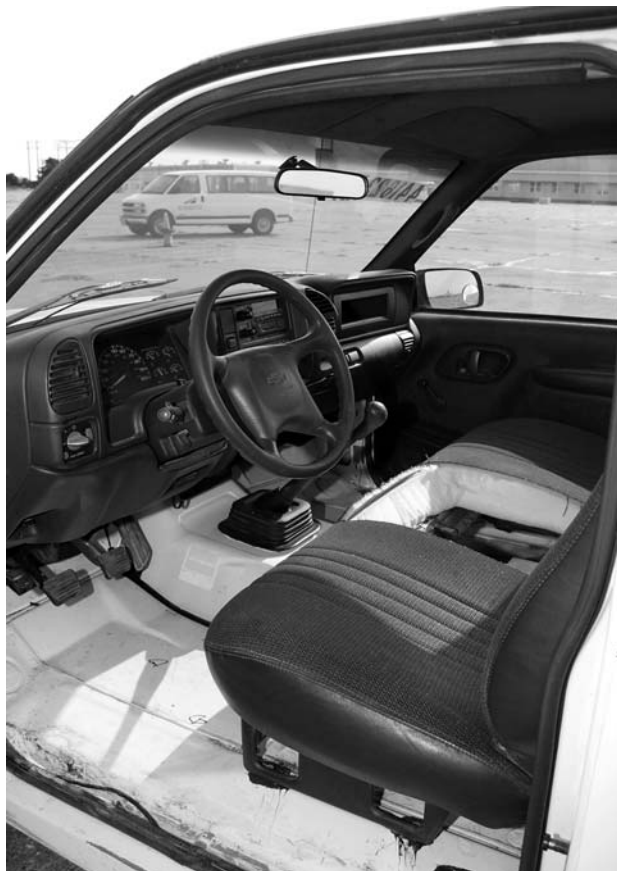
**Figure 17. Interior of Vehicle for Test 441623-1.**

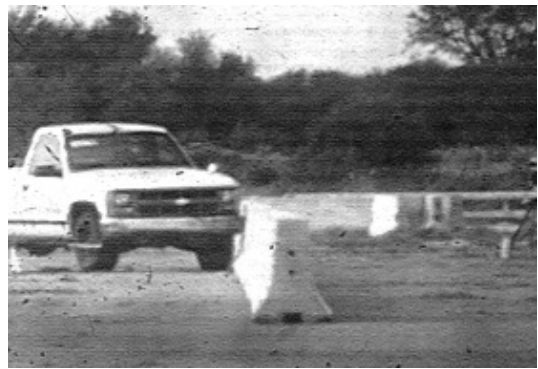
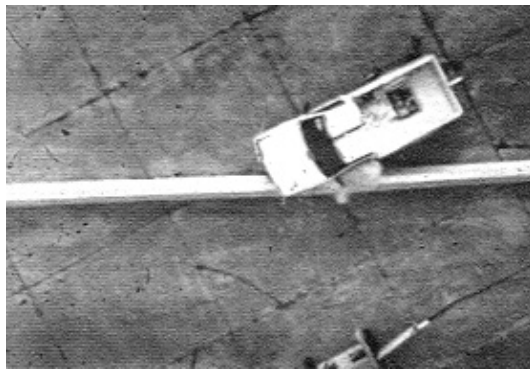
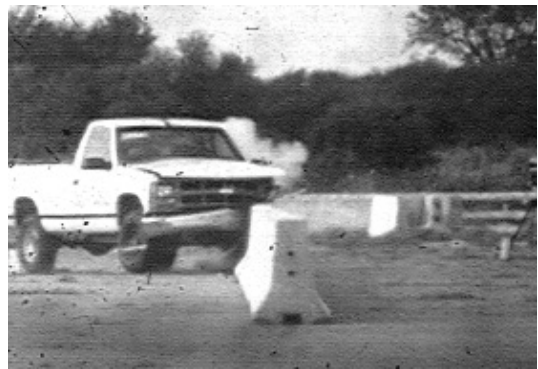
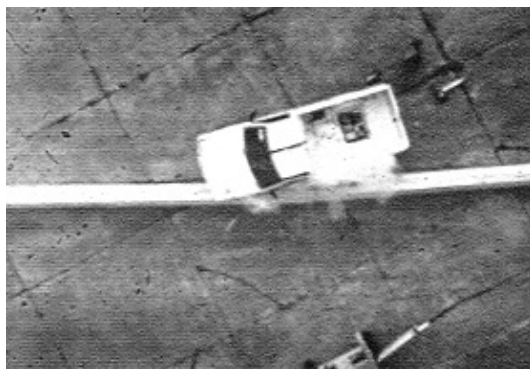
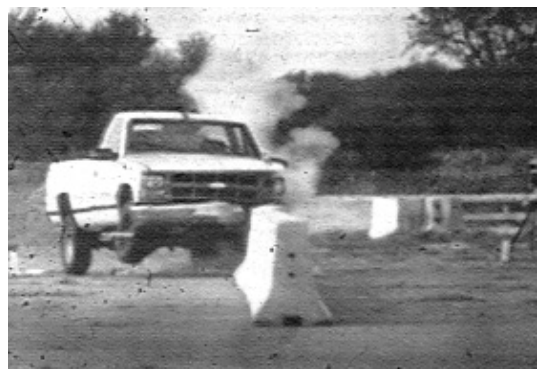
**Figure 20. Sequential Photographs for Test 441623-1  
(Overhead and Frontal Views).**

The pickup truck, traveling at a speed of 62.3 mi/h (100.3 km/h), impacted the concrete barrier installation 4.2 ft (1.27 m) upstream of joint 3-4 at an impact angle of 25.7 degrees. At 0.010 s after impact, the left front tire of the vehicle began to ride up the face of the barrier, and by 0.032 s, the left front corner of the vehicle reached joint 3-4. The vehicle began to redirect at 0.064 s, and the right front tire lost contact with the ground surface at 0.087 s. At 0.219 s, the vehicle was traveling parallel with the barrier at a speed of 54.1 mi/h (87.0 km/h). The rear of the vehicle contacted the barrier at 0.226 s. At 0.404 s, the vehicle lost contact with the barrier while traveling at a speed of 51.6 mi/h (83.1 km/h) and an exit angle of 5.1 degrees. As the vehicle continued traveling along the barrier, there was a secondary impact with the installation 4.3 ft (1.3 m) upstream of joint 6-7 at 1.414 s. The vehicle slid off the end of segment 7, yawed counterclockwise, and came to rest with the front of the vehicle facing toward the barrier installation, 247.5 ft (75.4 m) downstream of impact and 27.5 ft (8.4 m) behind the traffic face of the barrier. Sequential photographs of the test are presented in Appendix C, [Figure 20](#).

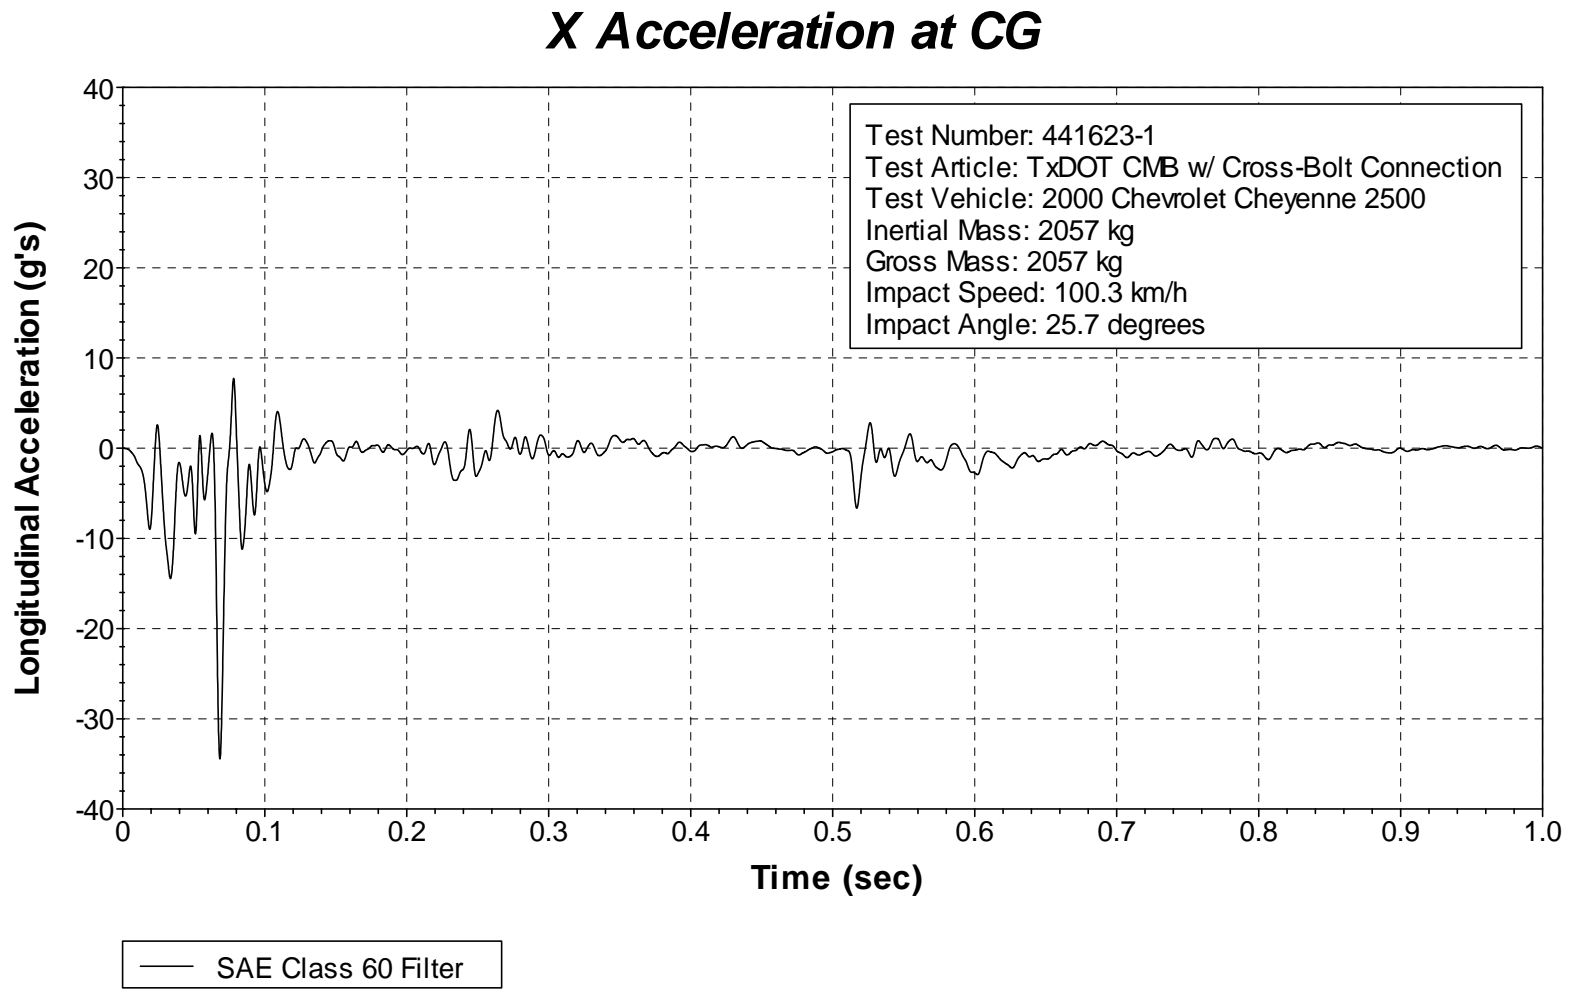
**Figure 22. Vehicle Longitudinal Accelerometer Trace for Test 441623-1  
(Accelerometer Located at Center of Gravity).**

Data from the triaxial accelerometer located at the vehicle center of gravity were digitized to compute occupant impact velocity and ridedown accelerations. Note that only the occupant impact velocity and ridedown acceleration in the longitudinal axis are required from these data for evaluation of criterion L of *NCHRP Report 350*. In the longitudinal direction, occupant impact velocity was 16.1 ft/s (4.9 m/s) at 0.094 s, maximum 0.010-s ridedown acceleration was -3.7 g's from 0.514 to 0.524 s, and the maximum 0.050-s average was -7.6 g's between 0.026 and 0.076 s. These data and other information pertinent to the test are presented in Figure 18. Vehicle angular displacements and accelerations versus time traces are shown in Appendix D, Figures 21 through 27.
