**FATIGUE STRENGTH OF FILLET-WELDED TRANSVERSE
STIFFENERS WITH UNDERCUTS**

Research Report 0-4178-1

Research Project 0-4178

FILLET WELD DETAILING FOR STIFFENER

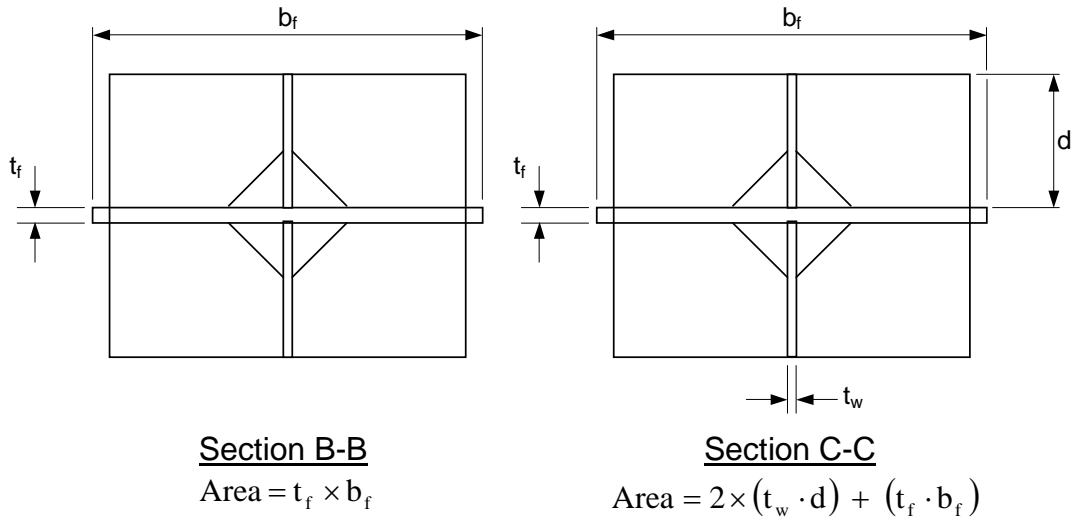
Figure 2-8: Area Used For Calculating Nominal Stress

All specimens were tested under cyclic loading at a nominal stress range, S_R , of 20 ksi (138 MPa) at section C-C shown in Figures 2-6 and 2-8. The stress range is the difference between the minimum and maximum nominal stresses. The minimum and maximum nominal stresses across section C-C were 5 ksi (34.5 MPa) and 25 ksi (172 MPa), respectively. These nominal stresses were calculated by dividing the applied axial load on the specimen by the area of the web and flange plates shown in Figure 2-8, Section C-C. The lower stress limit corresponded to an axial load of 35 kips (156 kN), whereas the upper stress limit was produced by an axial load of 175 kips (778 kN). It should be noted that the stress range at section B-B shown in Figures 2-6 and 2-8 is higher than the stress range at section C-C due to the smaller area. The stress range at section B-B is 26.7 ksi (184 MPa).

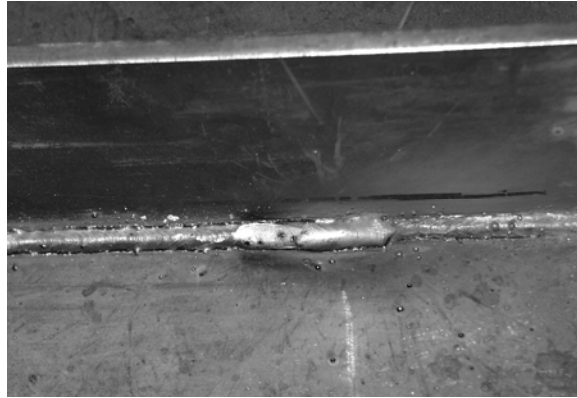
Figure 2-14: Weld Start-Stop Repair

The welding sequence varied throughout the project relative to each specimen type. This variation was due to the efforts to eliminate defects that occurred at weld starts and stops. Figure 2-14 shows a photo of a start-stop that was repaired by grinding and rewelding the web-to-flange weld. Stiffener and flange undercuts were intentionally created during the welding process to produce undercuts as large as possible.

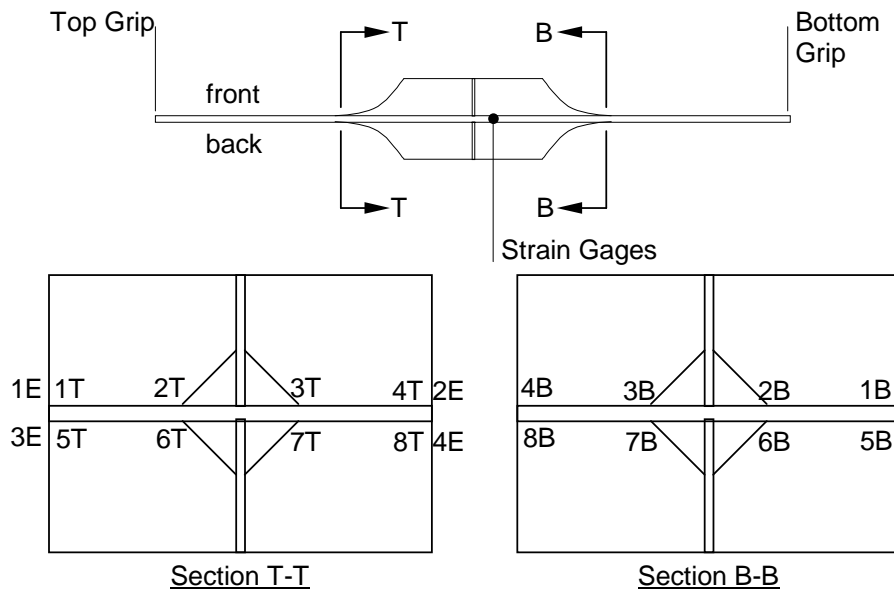
Figure 2-30: Specimen B Undercut Identification

Table 2-2 lists the stiffener-undercut dimensions corresponding to the locations in Figure 2-30. It should be noted that small undercutting occurred at the exterior stiffener locations 1, 4, 5, and 8. The stiffener-undercut sizes were consistent among the three specimens. The average length of the undercuts was approximately 0.16 in. (4 mm), and the average height was 0.052 in. (1.3 mm). The average depth was 0.044 in. (1 mm).

Table 2-3 lists the flange undercut dimensions corresponding to the “E” locations in Figure 2-30. Figure 2-31 illustrates the dimensions that were measured for the specimen B flange undercuts. It should be noted that the flange undercuts were considered more detrimental to the fatigue life of the specimen than the exterior stiffener undercuts because of their direct orientation to loading. Average measured values were consistent among all three specimens. The average length of the flange undercuts was approximately 0.5 in. (13 mm), and the average depth was over 0.125 in. (3 mm). The average width of the flange undercuts was 0.072 in. (2 mm).
