1. Report No. FHWA/TX-05/0-4185-3	2. Government Accession No.	3. Recipient's Catalog No.	
4. Title and Subtitle PERFORMANCE ASSESSMENT BY USING NONDESTRUCTIVE TESTING		5. Report Date June 2003 Rev. February 2004 Second Rev. August 2005 Third Rev. February 2006

PERFORMANCE ASSESSMENT BY USING NONDESTRUCTIVE TESTING RESULTS

The project will be completed in 5 years. Test sections were built on IH-20 in Harrison County and nine different types of overlay were placed in December 2001. Test sections will be monitored for 4 years by the Center for Transportation Research (CTR) at The University of Texas at Austin. The HWTD was utilized to determine the laboratory performances of the samples. The HWTD results and the field performance of the overlays on continuously reinforced concrete pavement (CRCP) will be gathered and compared at the end of the project. The field performance will be observed using NDTs. Falling weight deflectometer (FWD), portable seismic pavement analyzer (PSPA), and rolling dynamic deflectometer (RDD) are the types of NDT devices that will be utilized. In addition, visual pavement condition surveys will be performed at the end of each year. Field performance will b

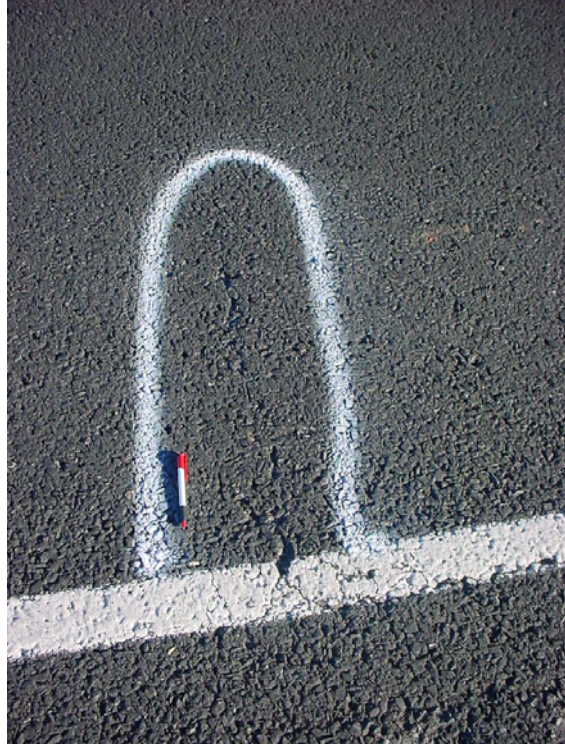
Figure 3.1 Low-level transverse crack

Low: Cracks with low severity or no spalling; mean unsealed as width of 1/4" or less. (See Figure 3.1)

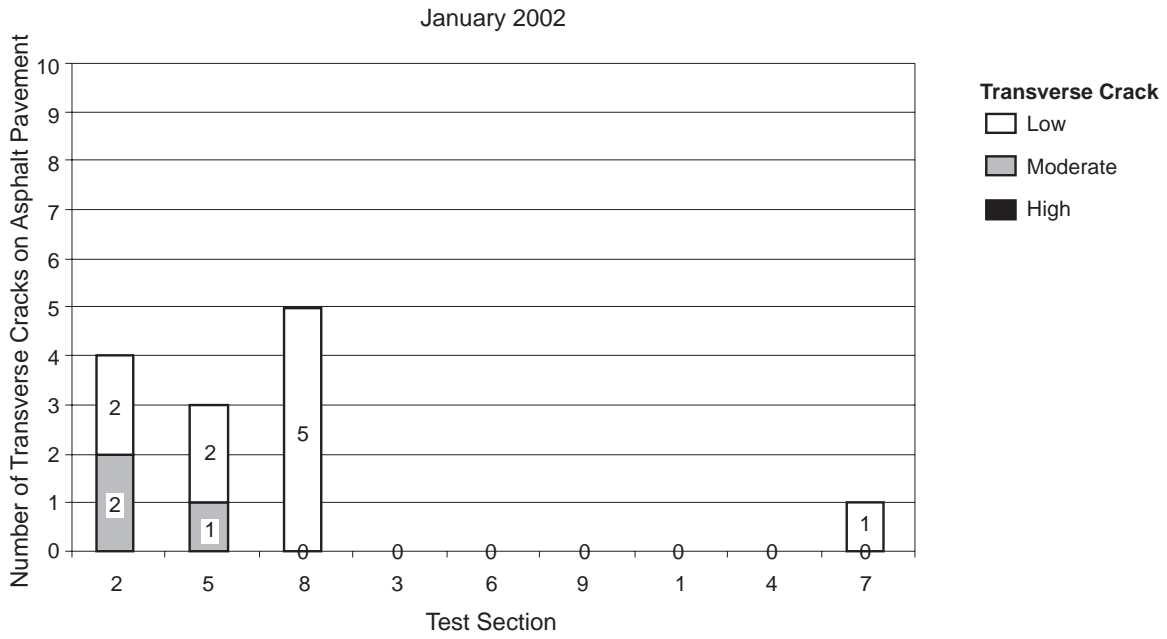
Figure 3.4 Number of transverse cracks on asphalt pavement detected on January 2002 survey

In Figures 3.4 and 3.5, the numbers of transverse cracks on asphalt concrete overlay on January 2002 and November 2002 are shown. The comparison of these figures clearly shows that for all sections except Section 3, the number of distresses increased from January 2002 to November 2002.

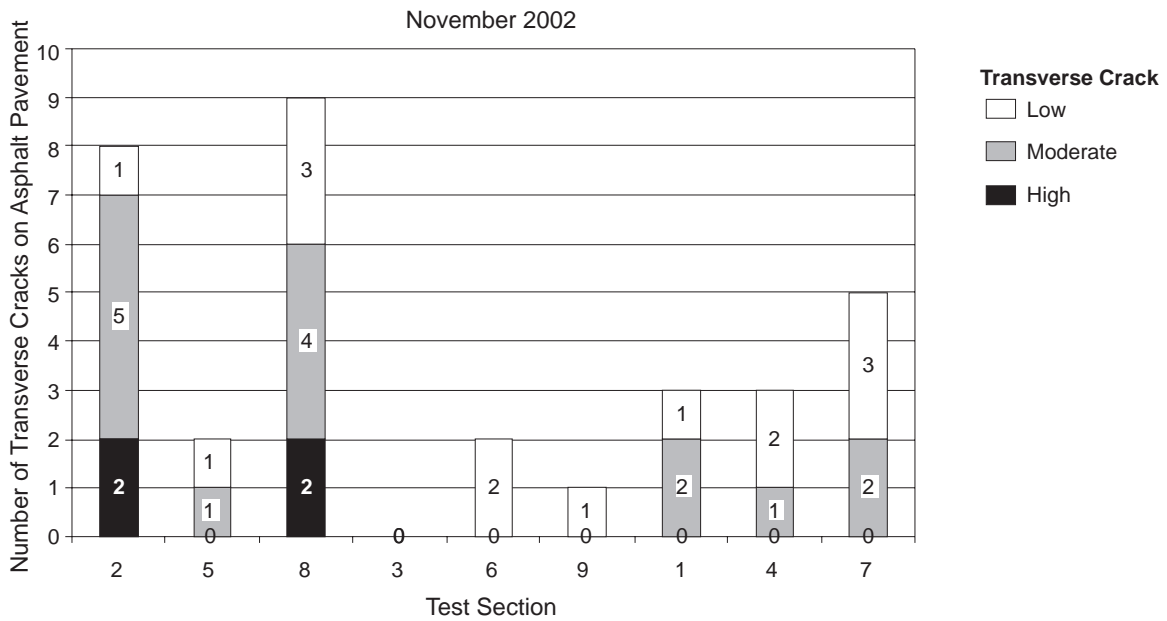
Figure 3.5 Number of transverse cracks on asphalt pavement detected on November 2002 survey

In both Figures 3.5 and 3.6 it is seen that the maximum number of cracks occurred on the asphalt sections that include sandstone and the minimum number of cracks occurred on the sections that include quartzite. The total number of cracks that occurred in the sections with gravel aggregate is in between the total number of cracks that occurred in the sections with sandstone and quartzite aggregates. These observations show that the type of aggregate used in the test sections seems to affect the crack formation on the pavement with time, and that the best results are achieved on the sections where quartzite was used. In Figure 3.6 it can be seen that until November 2002 the best performance in terms of transverse cracking was seen in Section 3 (Superpave with quartzite aggregate), where no cracking was observed so far.

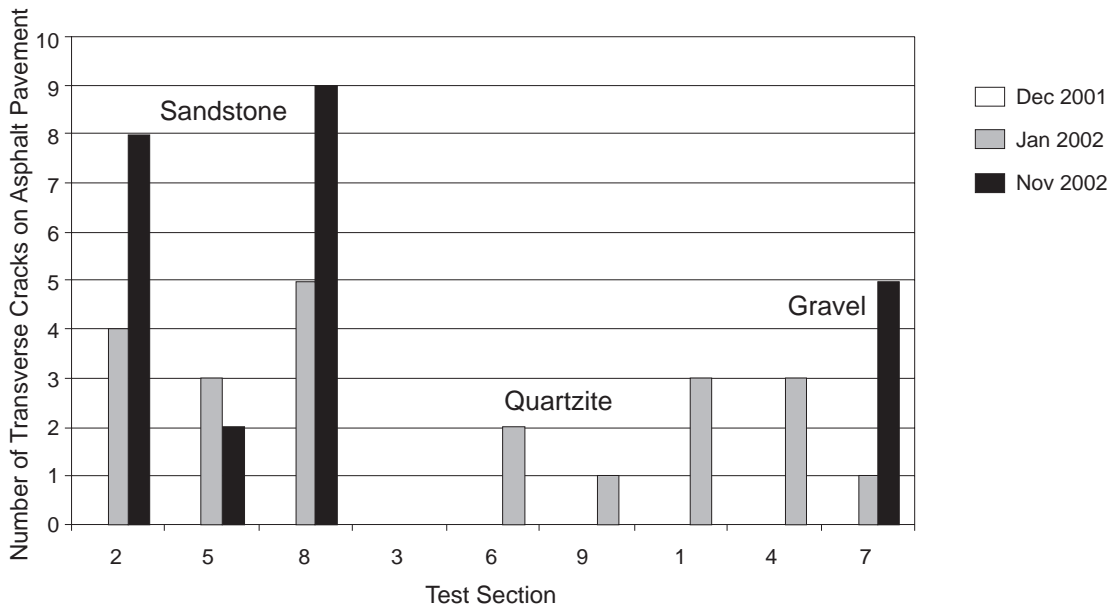
Figure 3.6 Number of transverse cracks on asphalt pavement for each section at different surveys

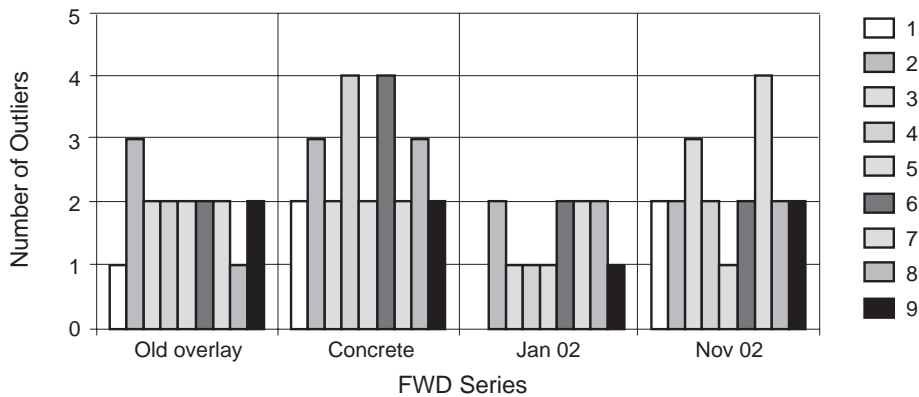
Figure 5.4 Number of outliers identified on the nine sections

Figure 5.4 illustrates and ranks the number of outliers apparent on each of the nine sections evaluated for the different FWD series. From this figure it is clear that the greatest number of irregular deflections were apparent from the FWD tests on the concrete pavement after milling the old overlay. It is interesting to note that there was a marked decrease in the number of irregularities after the construction of the new overlay (January 2002) but that the irregularities apparent increased in November 2002. Note that there were no outliers identified for Section 1 in January 2002.

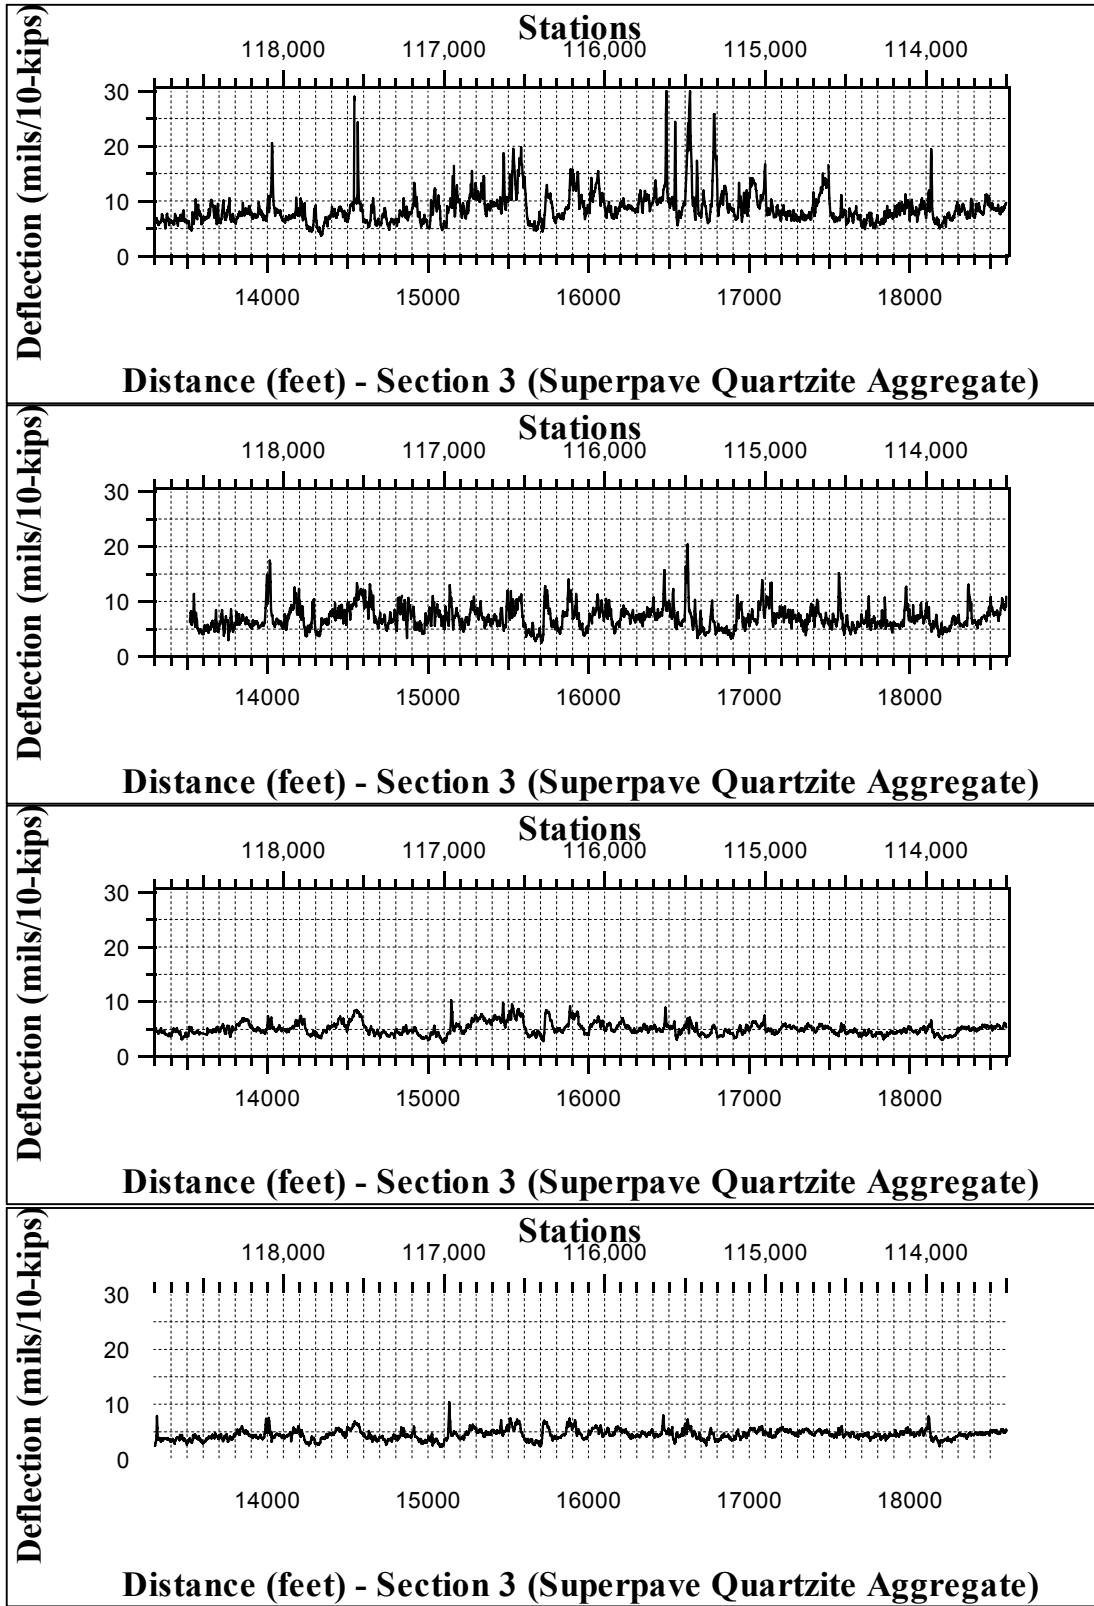
Figure 6.2 RDD deflection profile for Section 3 along Interstate Highway 20

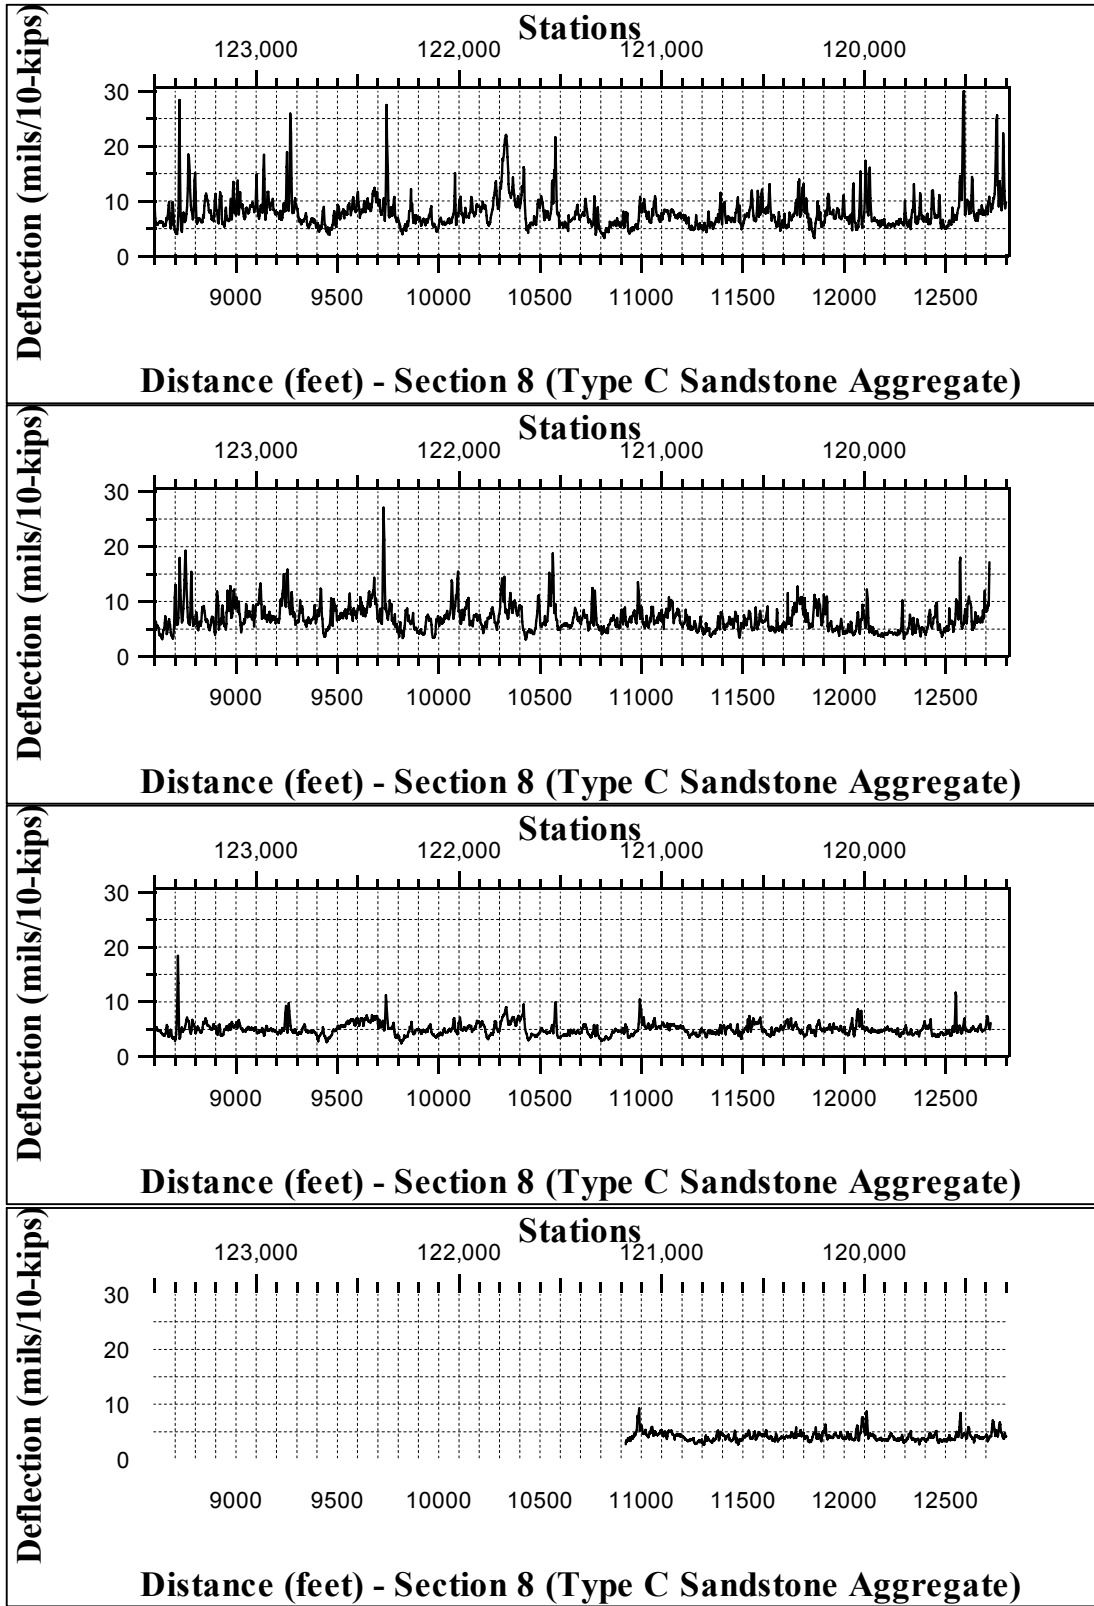
Figure 6.3 RDD deflection profile for Section 8 along Interstate Highway 20

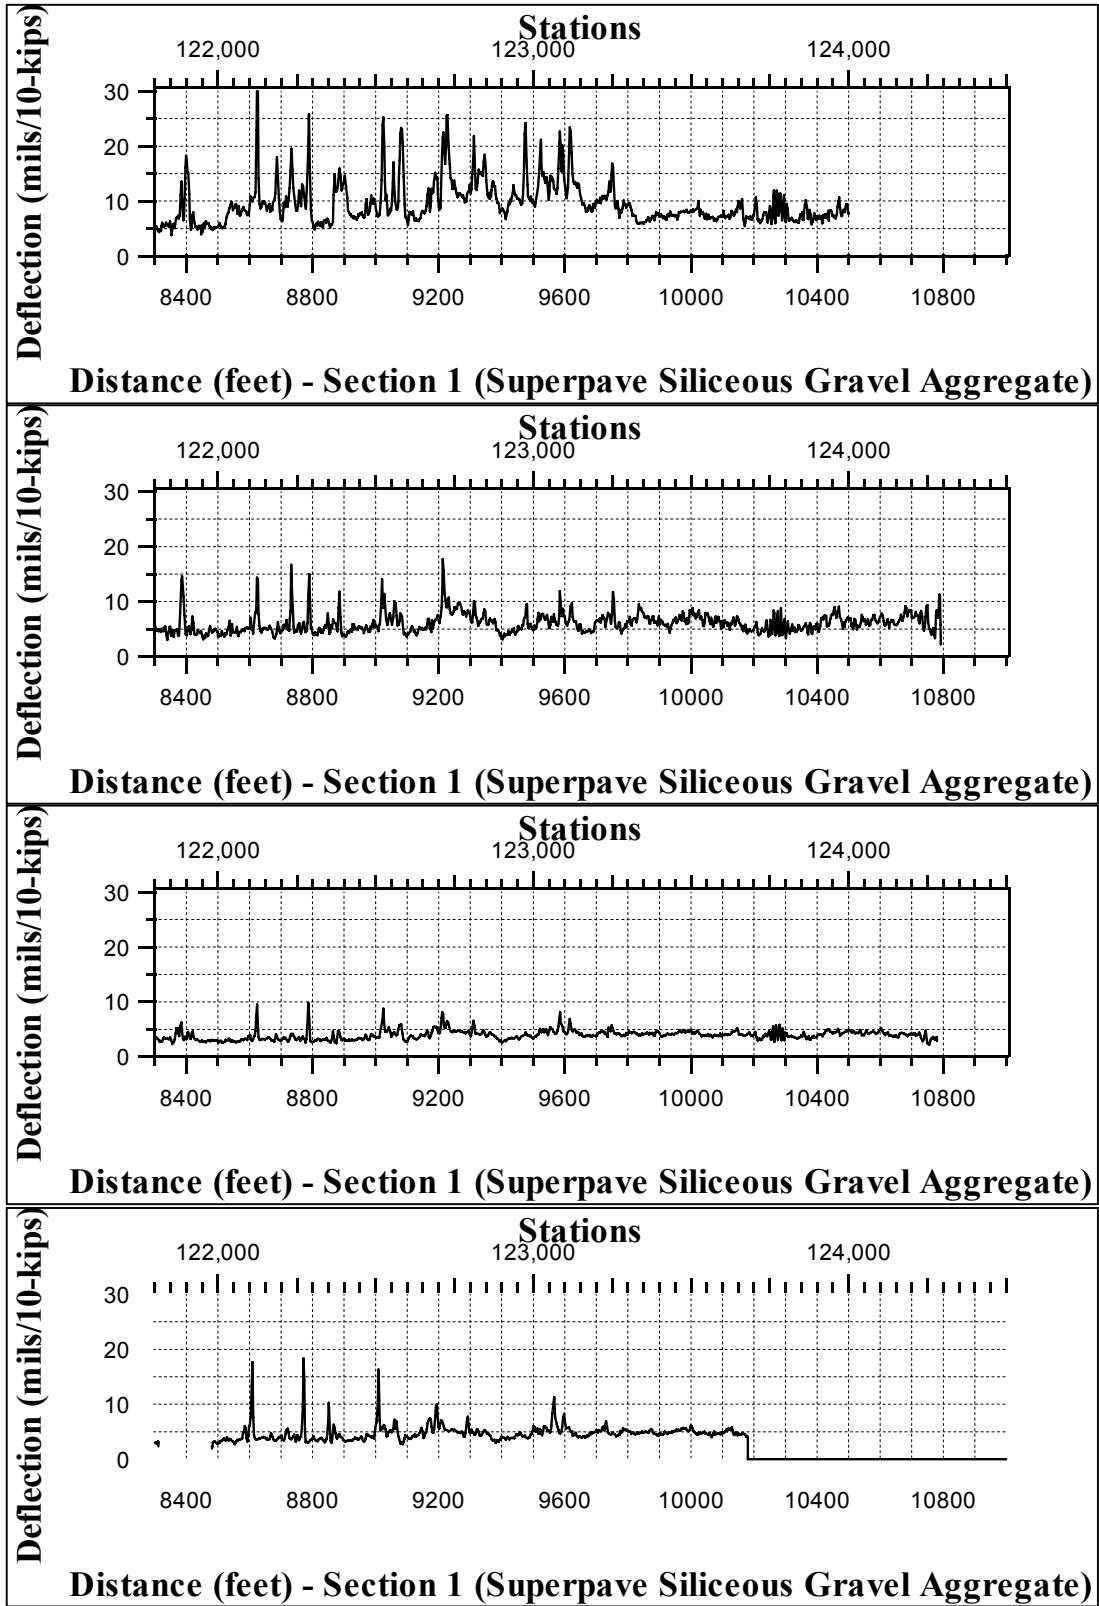
Figure 6.8 RDD deflection profile for Section 1 along Interstate Highway 20

Based on the sensor #1 deflection profiles shown in Figures 6.6 to 6.14, the summary statistics for the different mix design were calculated and shown in Table 6.3. The same information is also shown graphically in Figure 6.15.

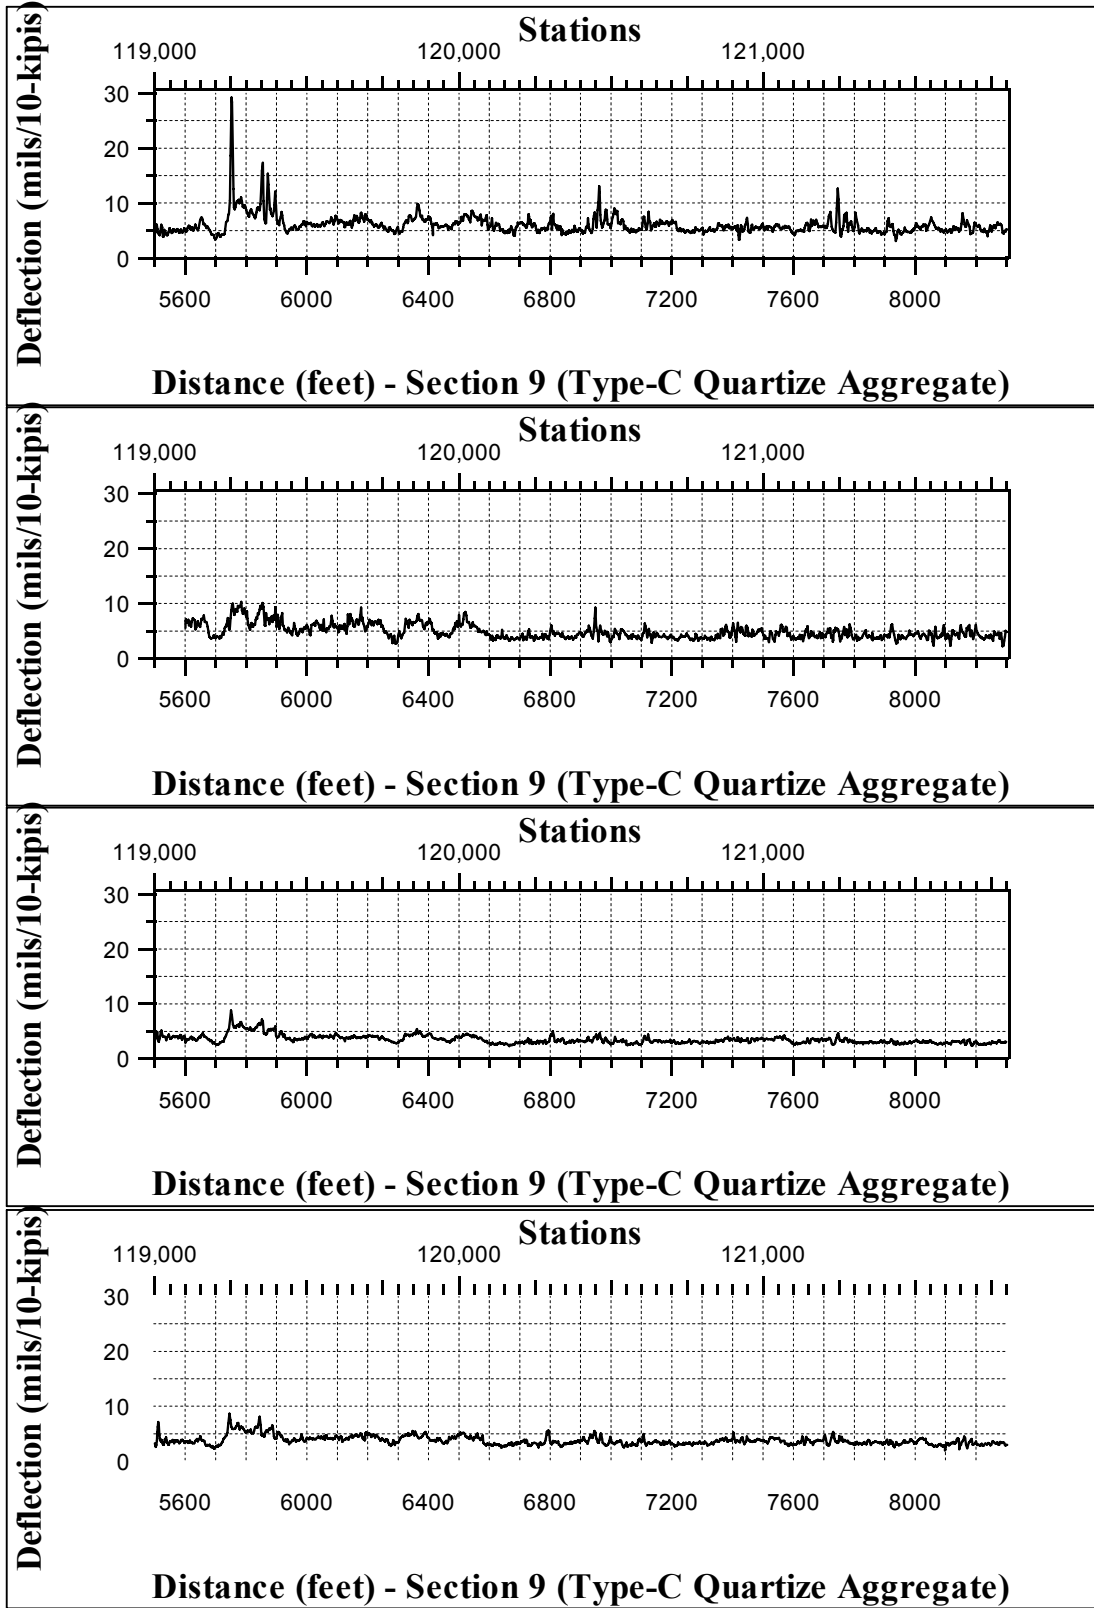
Figure 6.9 RDD deflection profile for Section 9 along Interstate Highway 20

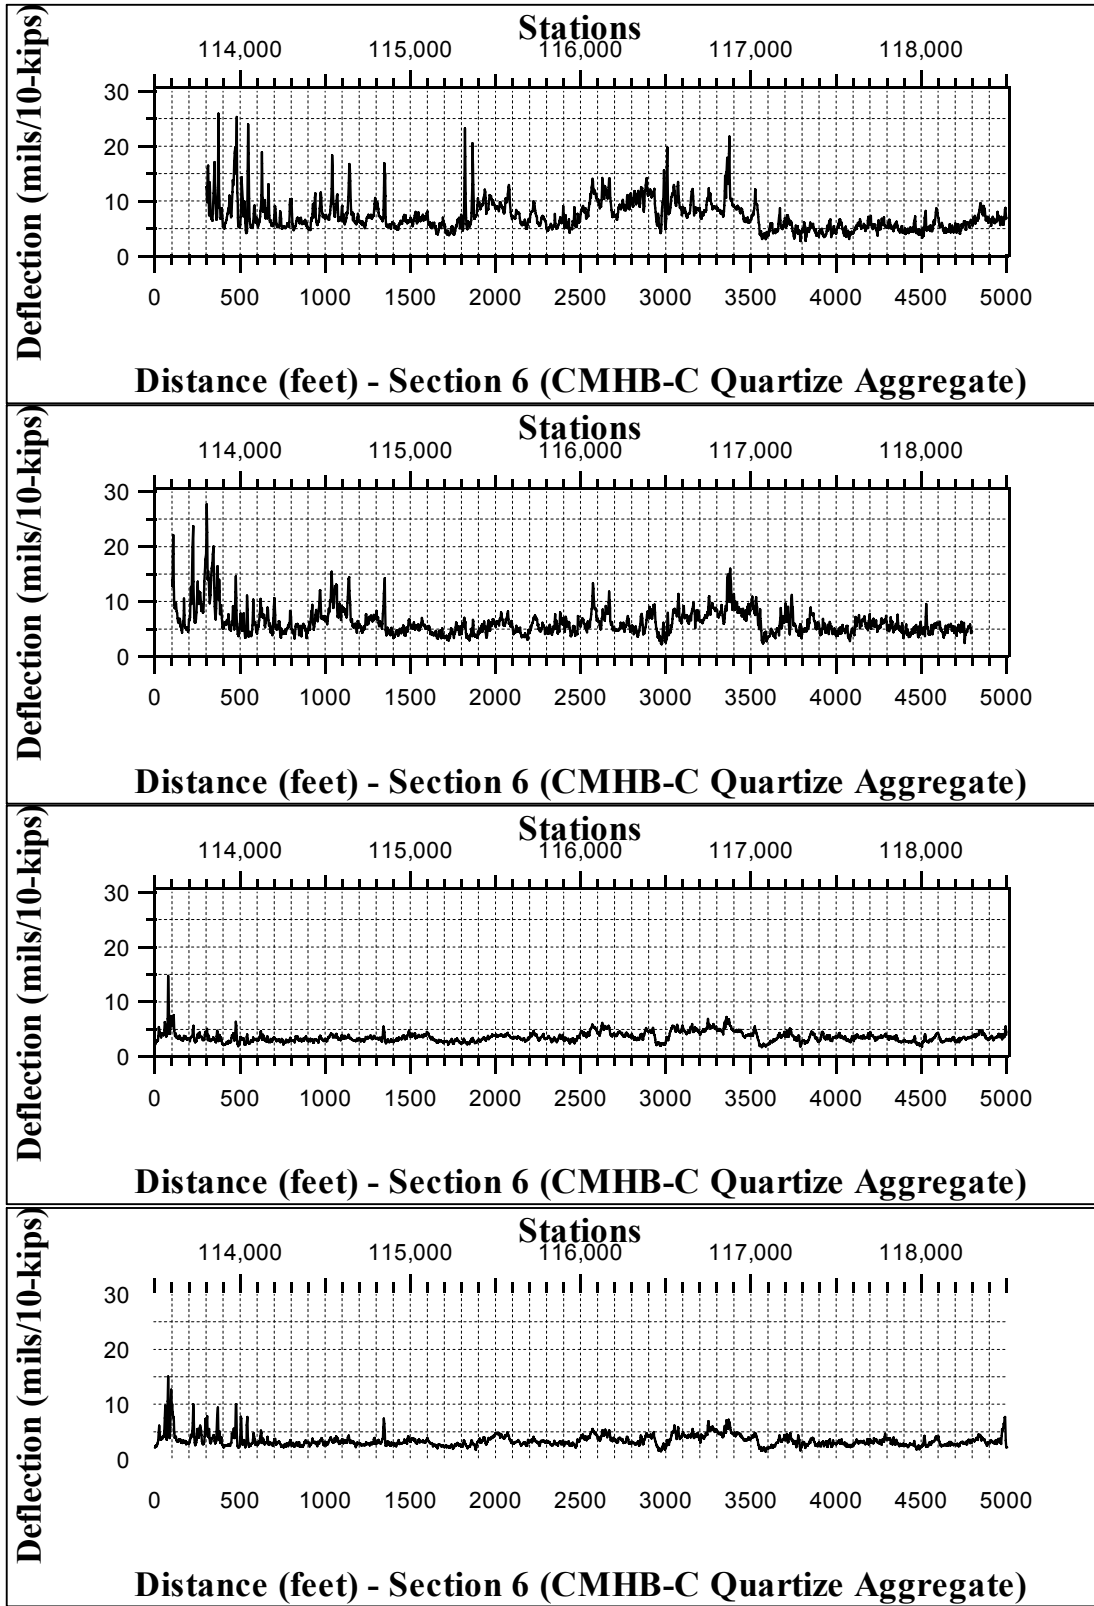
Figure 6.10 RDD deflection profile for Section 6 along Interstate Highway 20

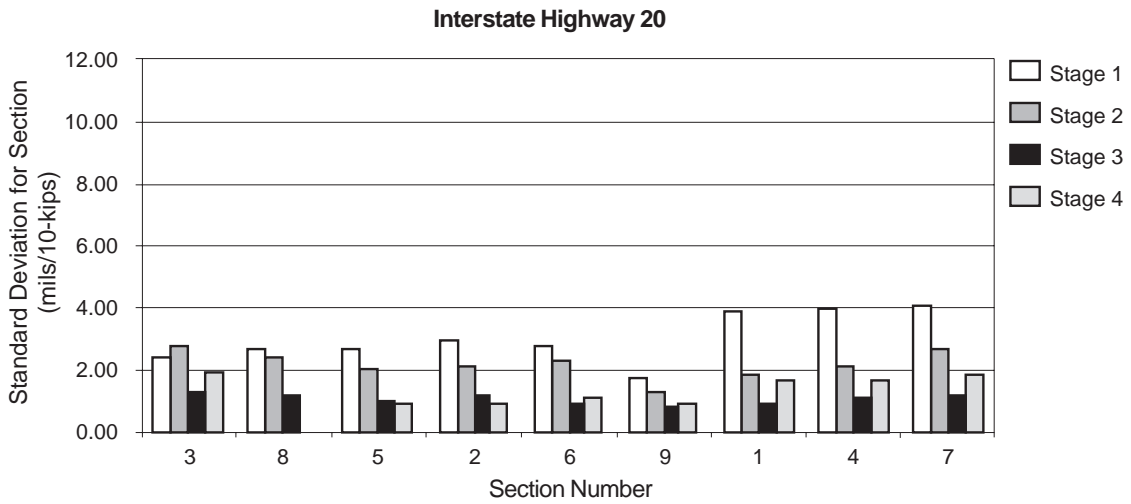
a) Mean Displacement

b) Standard Deviation

Figure 6.11 Summary statistics of the RDD continuous deflection profile
