## Condition Assessment of Bridge Deck Using Various Nondestructive Evaluation (NDE) Technologies

By Nenad Gucunski and Hooman Parvardeh, *Center of Advanced Infrastructure and Transportation, Rutgers University*

On October 6 and 7, 2014, the Long-Term Bridge Performance (LTBP) Program team performed a third round of inspection of the Virginia Pilot Bridge, which had been selected for pilot testing of the LTBP Protocols. The Virginia Pilot Bridge carries U.S. Route 15 over Interstate 66 in Haymarket, VA (figure 1). NDE technologies were used to perform a detailed condition assessment of the deck with respect to corrosion, delamination, and concrete quality. This was the third assessment of this bridge deck over the last 5 years; previous assessments were performed in September 2009 and August 2011.

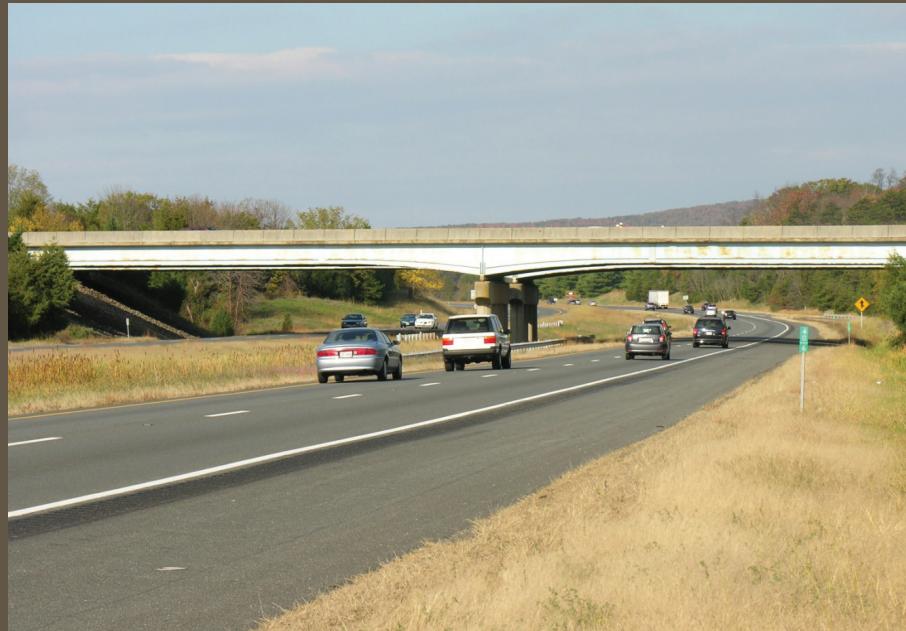
Figure 1. The Virginia Pilot Bridge carrying U.S. Route 15 over Interstate 66 in Haymarket, VA.

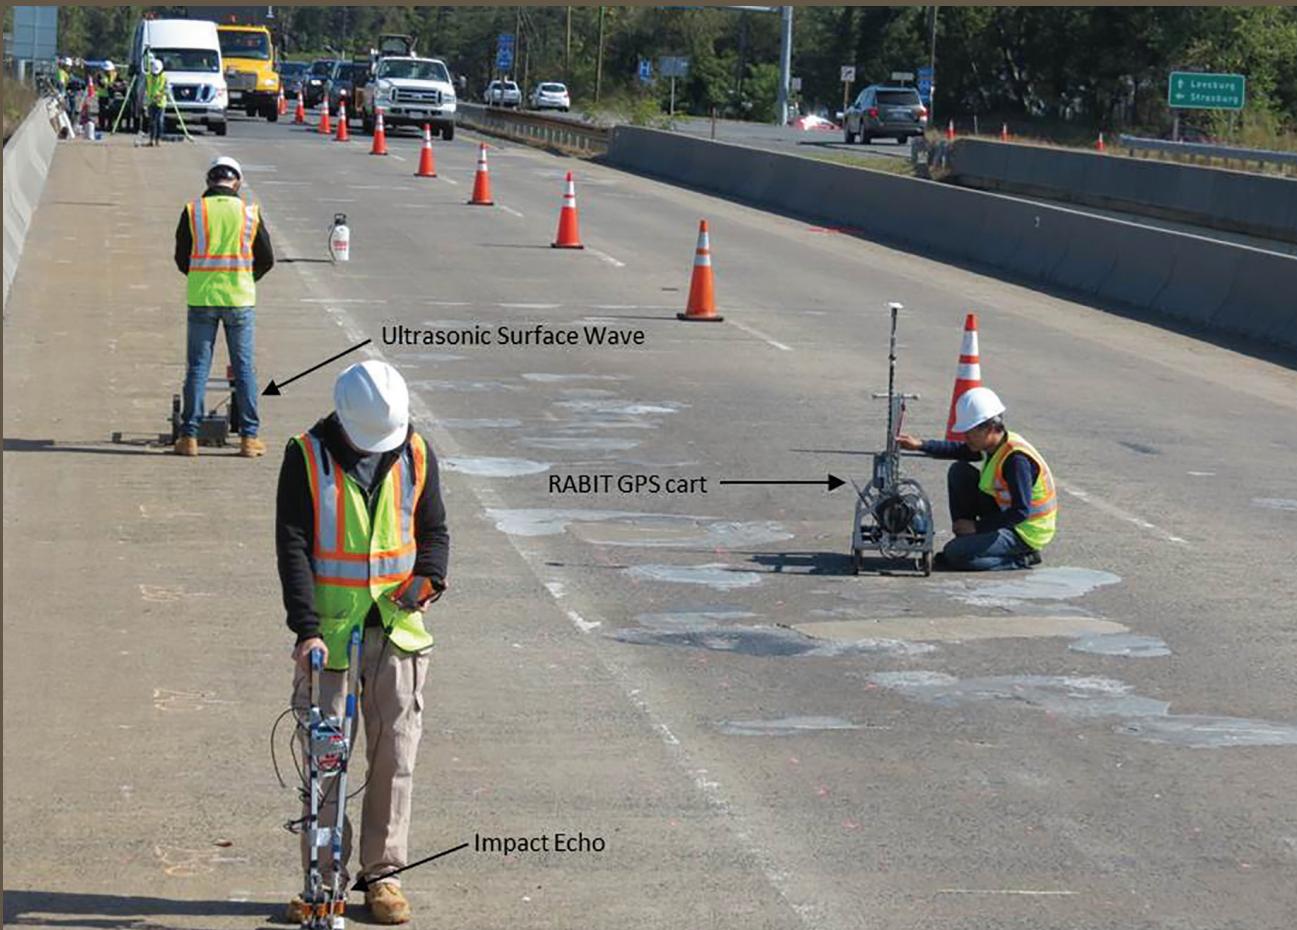
The data collection (figure 2) was conducted on a 2- by 2-ft grid.

Figure 2. Data collection on the deck of the Virginia Pilot Bridge.

12-ft lanes, a 10-ft-wide right shoulder, and a 4-ft-wide left shoulder, making the total deck area about 11,000 ft<sup>2</sup>. After 35 years of service, the whole bridge is scheduled for replacement in 2015, and this assessment was a unique, last opportunity to evaluate the deck condition prior to demolition. Figure 2 clearly shows a bridge deck that has gone through numerous repairs.

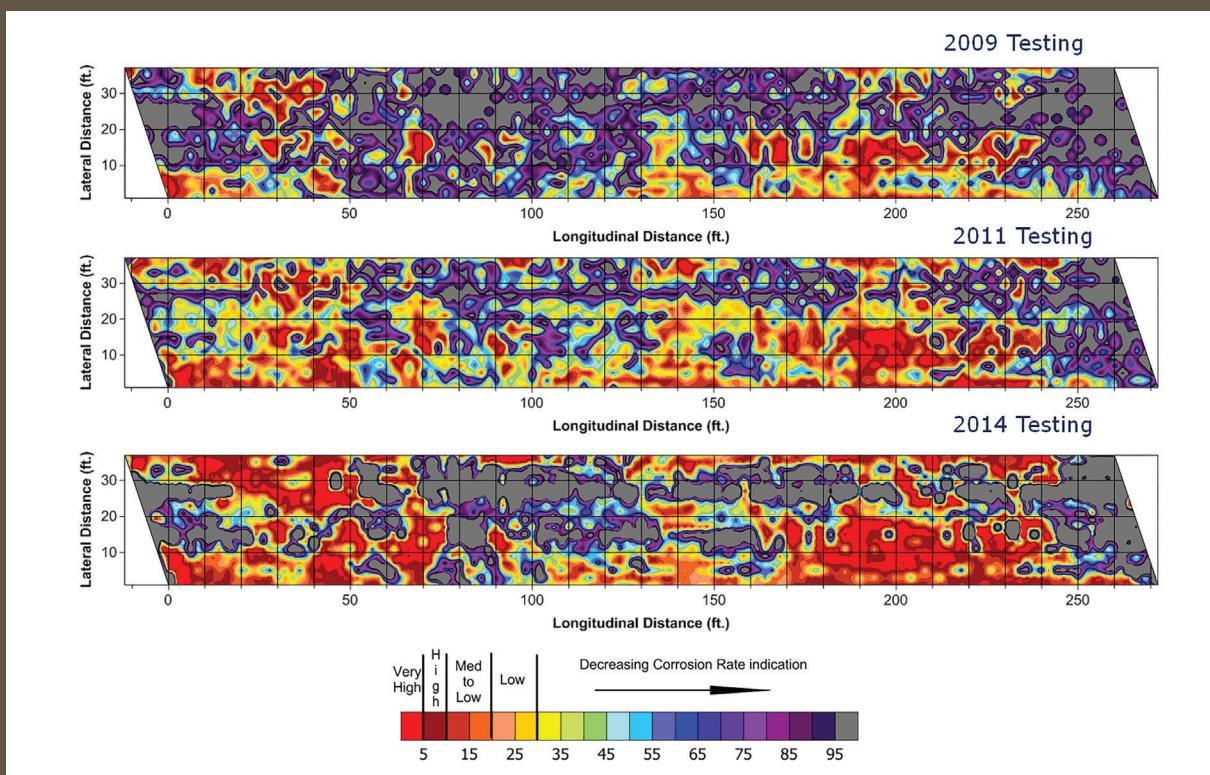
The results from three of the deployed technologies are shown herein as an example. The selected assessment results unambiguously confirmed rapid progression of deterioration during the 5-year period. The ER condition map (figure 3) describes the corrosive environment, which was becoming more aggressive and encompassing larger areas with every new measurement. The increase in the aggressiveness of the corrosive environment is directly reflected in the rate at which reinforced steel corrodes, increasing the likelihood of deck delamination and spalling.

Figure 3. Electrical resistivity condition maps from the 2009, 2011, and 2014 surveys.

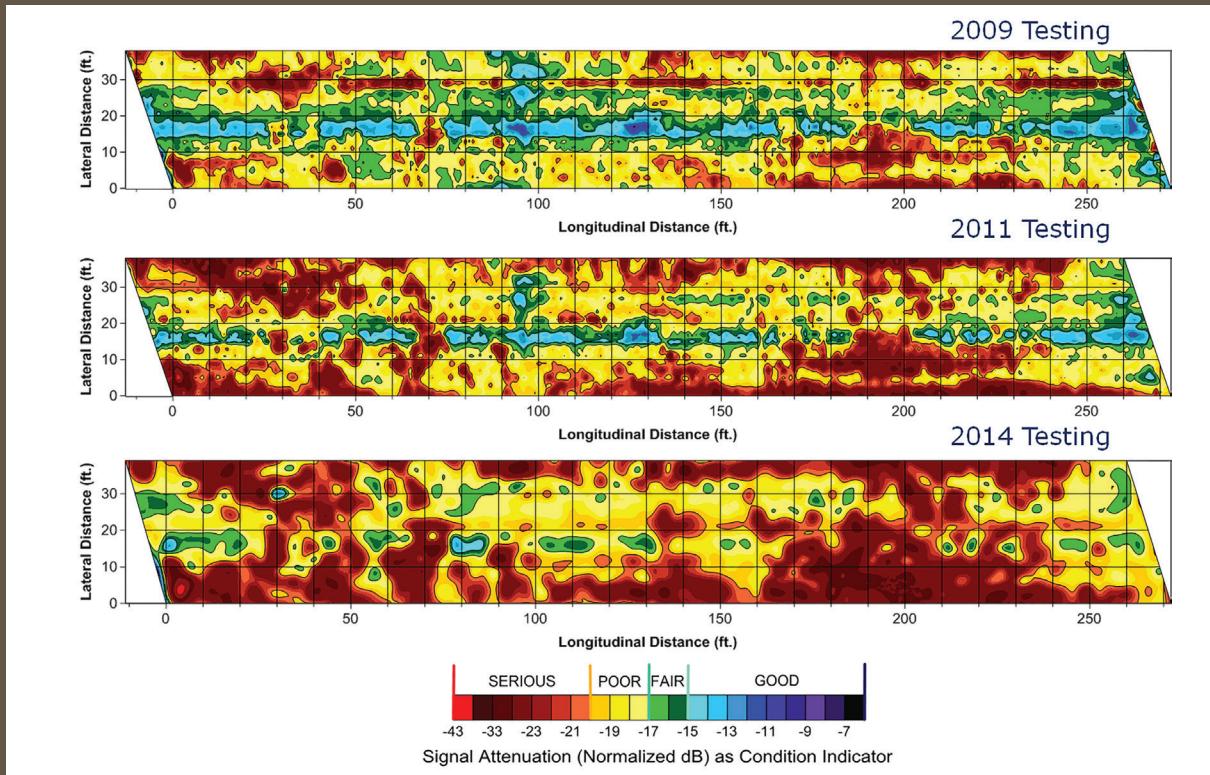
The condition maps from the three GPR assessments paint a similar picture of deterioration progression (figure 4). Strong attenuation of the GPR signal in the zones plotted in hot colors (reds and yellows) is an indication of a highly corrosive environment and likely indicates the presence of cracks and delamination. The condition maps from the three IE assessments clearly show progression of delamination (figure 5). The zones in red color show delaminated areas on the bridge deck. The condition maps from the other NDE technologies further support these results in both the deterioration progression and affected areas identified.

Figure 4. GPR condition maps from the 2009, 2011, and 2014 surveys.

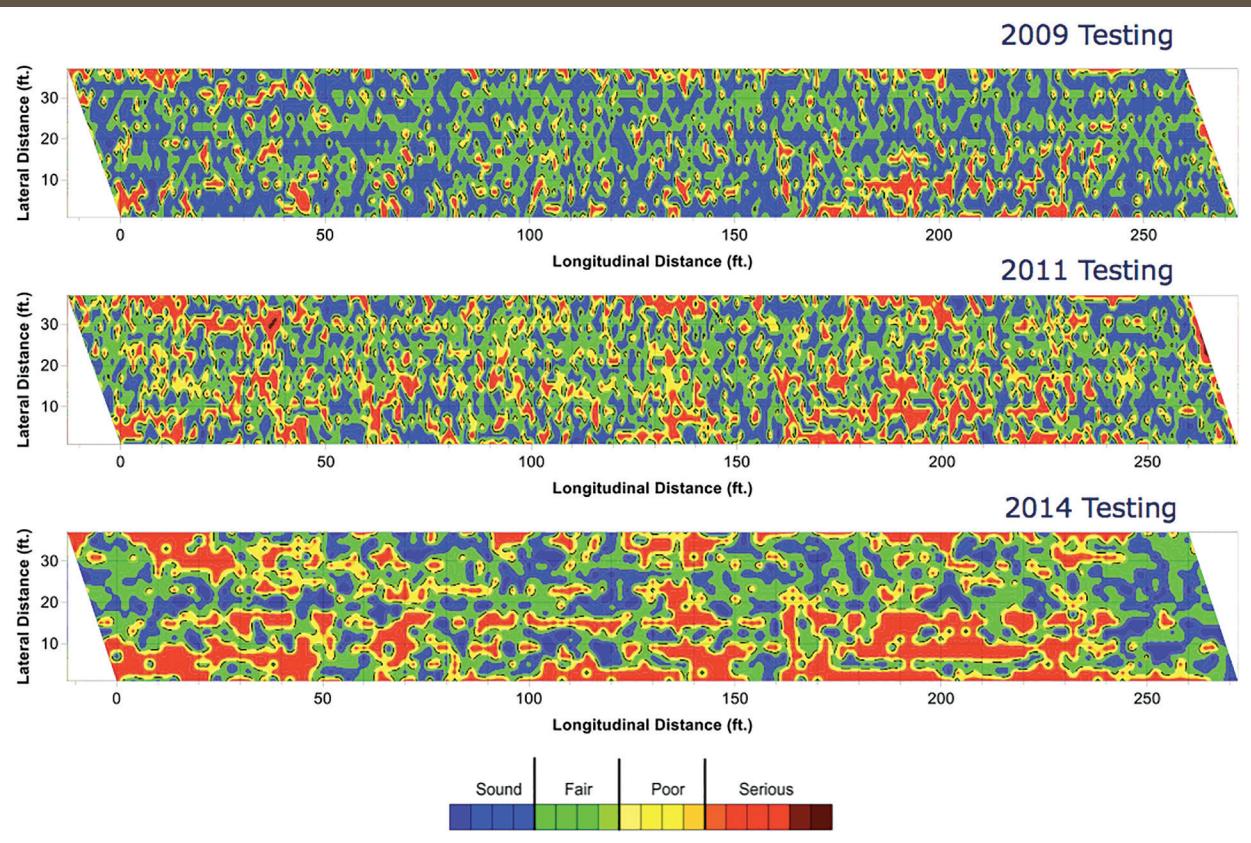
Figure 5. IE condition maps from the 2009, 2011, and 2014 surveys.

Table 1 shows the corrosion, delamination, and concrete quality NDE condition assessment for the three surveys. The delamination condition of the assessed bridge deck dropped from 70 (2009) to 60 (2011) and then to 40 (2014), indicating a very rapid progression of deck delamination. The combined

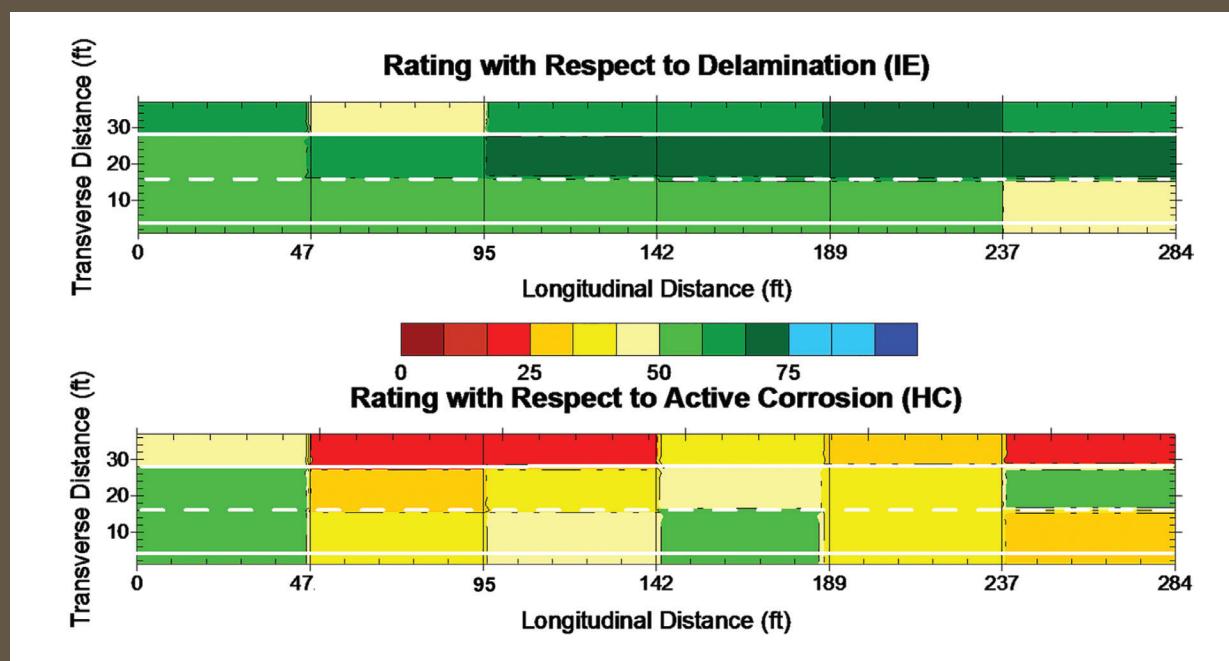
Figure 6 shows the color-coded result of this calculation based on data from 2009 testing. The top part shows the result based on IE, and the bottom part corresponds to HCP. The figure divides the bridge deck into different segments.

Figure 6. Segmentation grading of the deck based on IE and HCP data from 2009.

The best illustration of the quantitative nature of NDE results is the calculated condition assessment, a weighted average of percentages of the deck area in various states of deterioration on a scale of 0 to 100. For example, delamination is calculated as an average of three assigned weight values: good or no signs of delamination (100), initial or incipient delamination (50), and fully developed delamination (0).

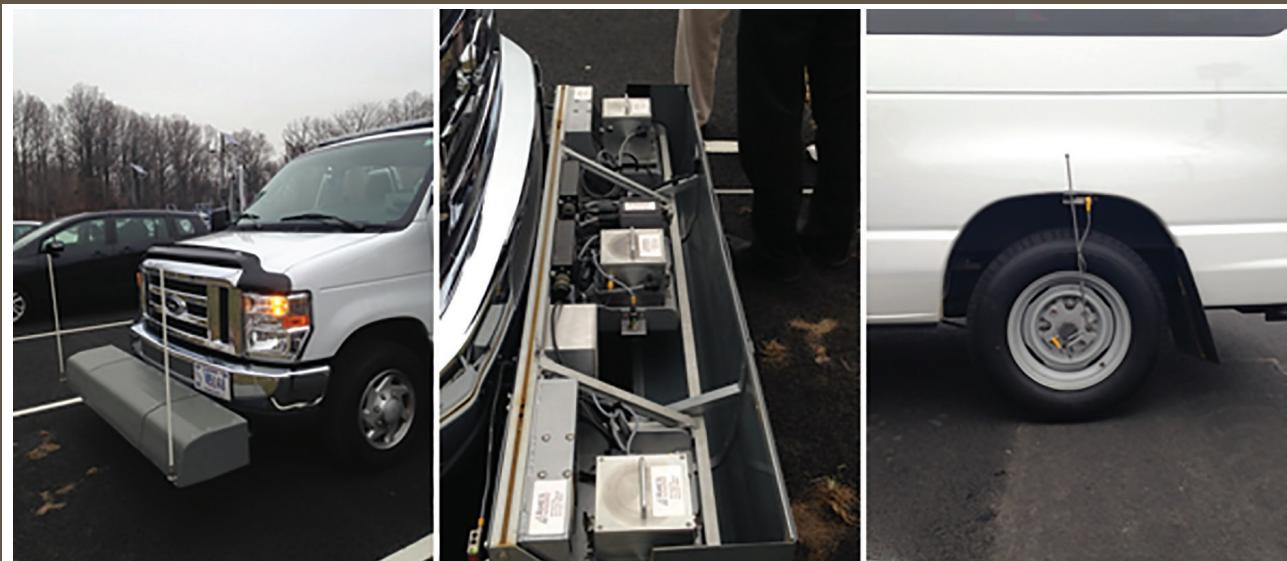
Figure 9. Inertial profiler vehicle (left), sensor bar with cover open (center), and distance measurement instrument (right).

Traditionally, inertial profilers have been used to track pavement assets, but FHWA had not tested bridges using the technology. A pilot study was therefore initiated to develop a draft protocol that outlines the procedures for measuring the profile of bridge approaches. The protocol was then tested at a few bridge sites. The results provide a road profile for different wheel paths in two different directions, with demarcations noted for the bridge ends (figure 10). Focusing at the bridge approaches from this site, the profiler can clearly distinguish the transition (figure 11). Further data processing to correct for grade will allow engineers to quantify the bump at the end of the bridge. This quantification can be used in conjunction with other bridge performance data to better define tolerable service limits.

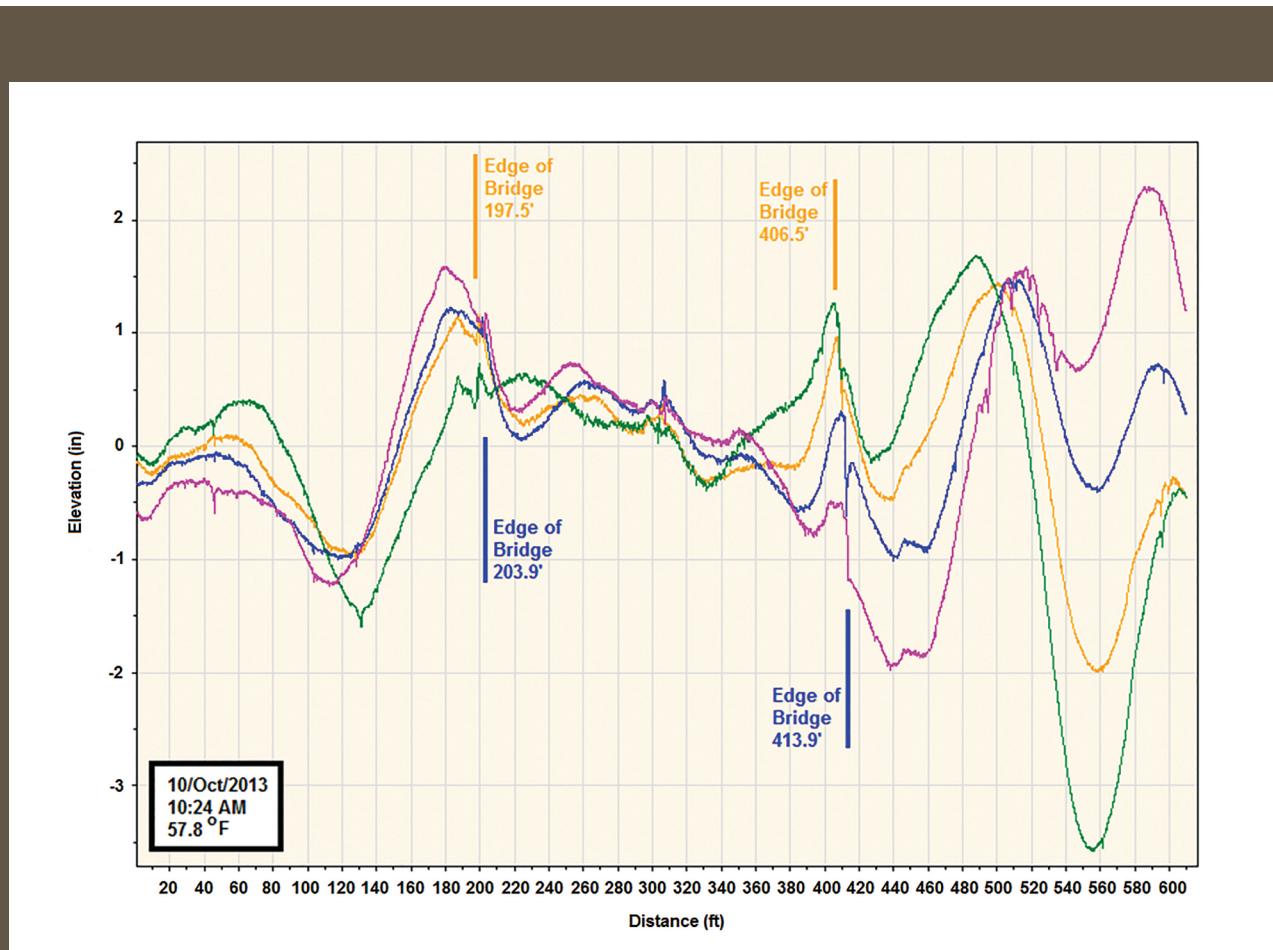
Figure 10. Measured bridge and approach profiles with bridge locations marked.

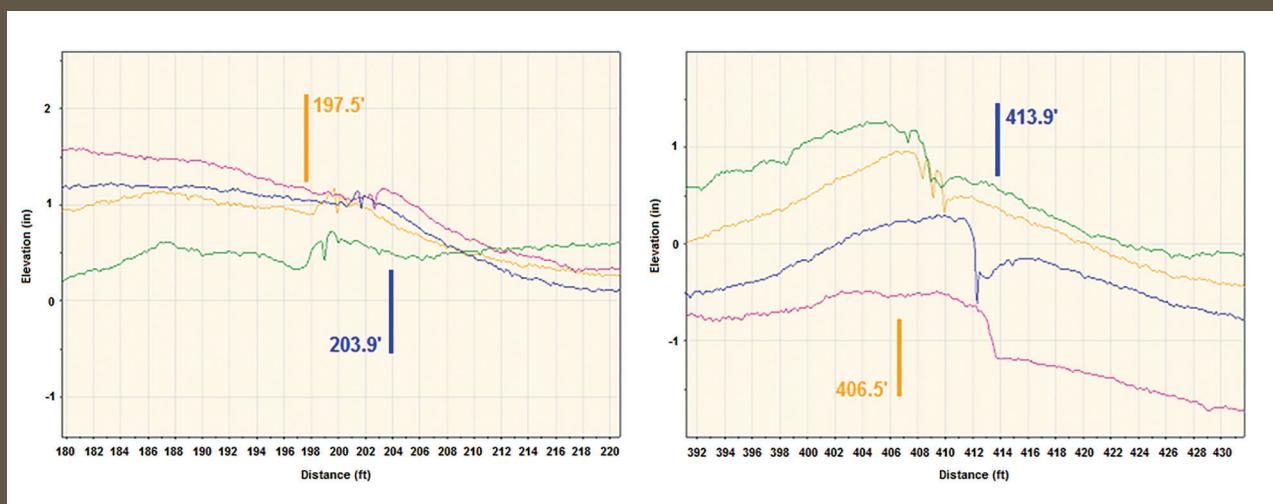
Figure 11. Bridge transition profiles with bridge end locations marked.

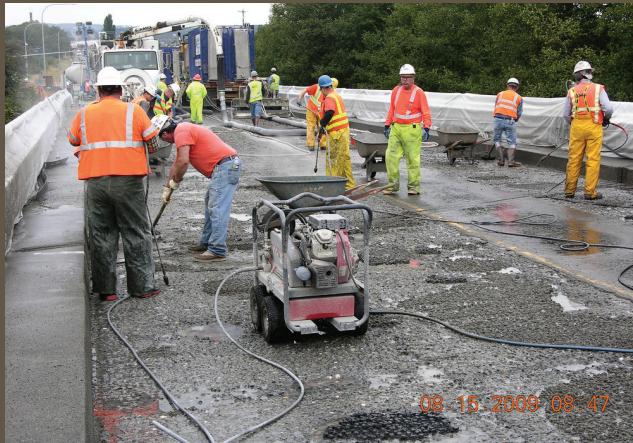
Figure 1. SR532 near Stanwood, WA during construction.
