Evaluating Electrical Resistivity as a Procedure to Aid in Characterizing Subsurface Conditions Measurements in State DOTs

Final Report | September 2024

Evaluating Electrical Resistivity as a Procedure to Aid in Characterizing Subsurface Conditions

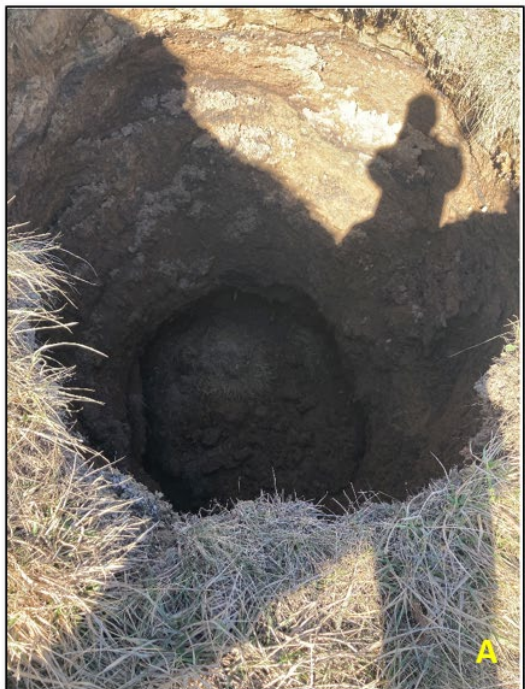
Figure 4: a- Suspected mine shaft opening on US 63 south bound near shoulder, March 2021.

The ER investigation was triggered due to surface activity that took place from 2020 to 2021, Figure 3. In August of 2020, STA 1345+00 to 1344+00 in the southbound lane experienced subsidence in the range of 1-3 inches. In March of 2021 a suspected sinkhole six foot in diameter appeared near the southbound lane shoulder, and five months later in September of 2021, another subsidence occurred on the northbound lane at STA 1353+00 to 1355+00, Figure 4.

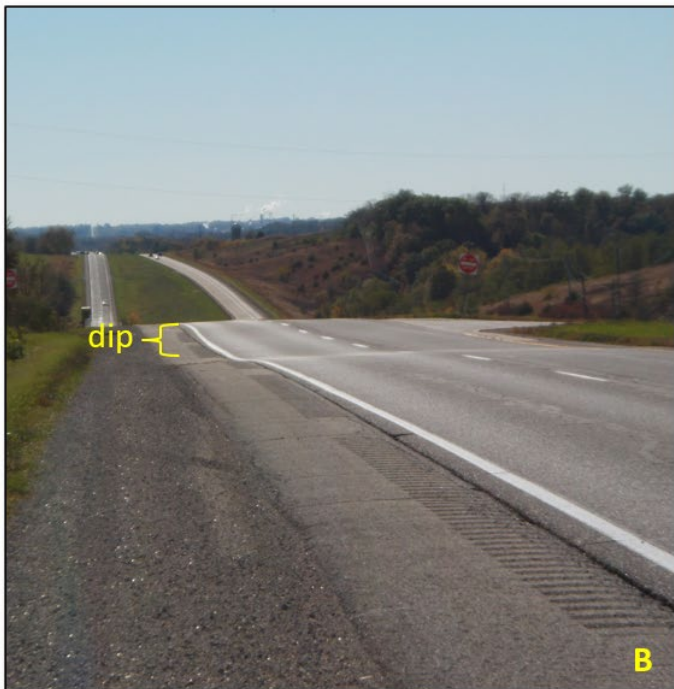
Figure 4: b- Subsidence on US 63 north bound, September 2021.

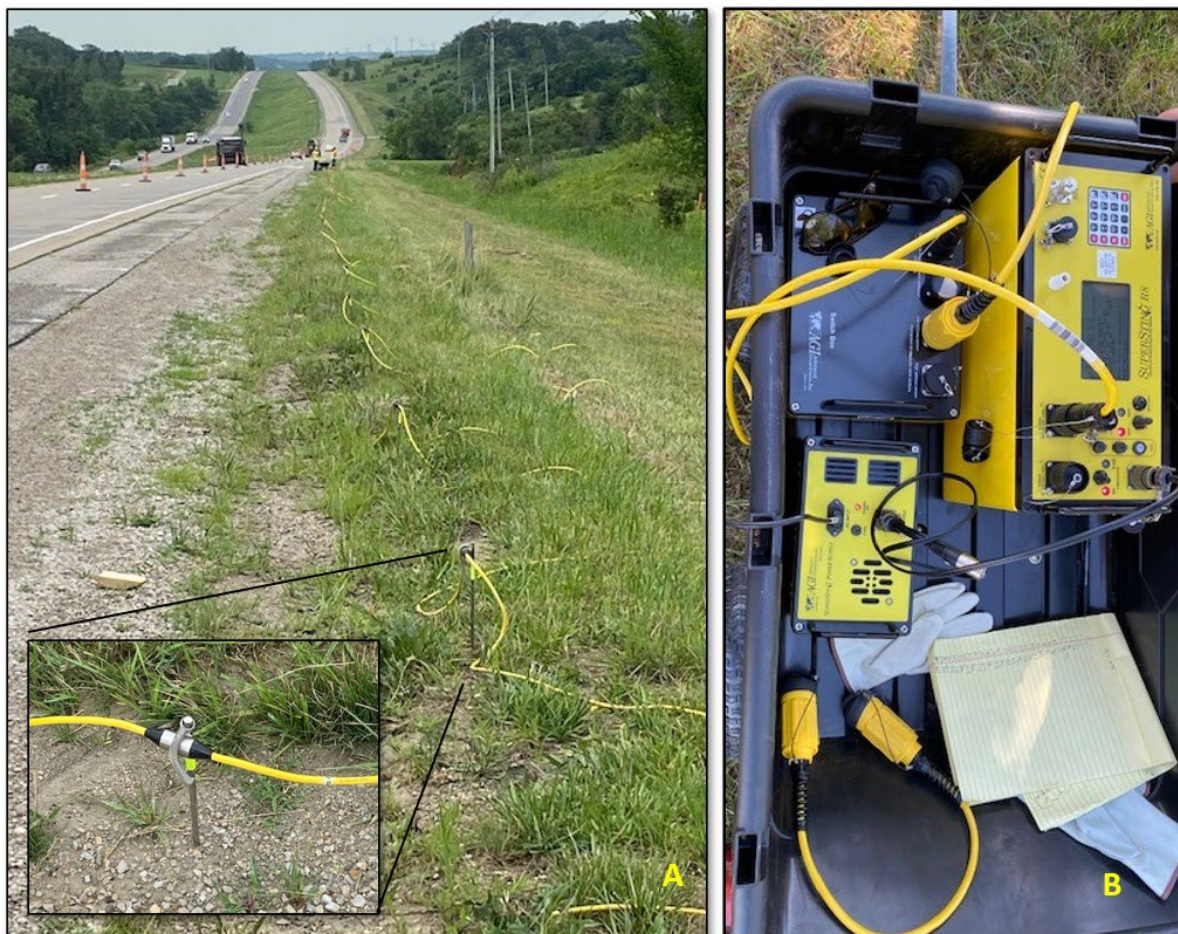
Figure 7: **A.** View of ER survey line showing location near US 63 and electrode spacing of 13 feet between each electrode. A close-up view of a single electrode is shown in the lower left corner. **B.** AGI Super Sting unit, the set up was transported in a field cart.

Stakes and electrode cables were placed at the survey lines with a spacing of 13 ft, Figure 7A. At this electrode spacing, subsurface anomalies as small as 6.5 ft. could be distinguished. Based on the length of the lines, data would be collected at a depth of 200 ft. Before the surveys, each line was walked to identify visible features that may affect the survey data. No features were seen that would have caused anomalous readings. However, precipitation experienced during some surveys could have introduced noise to the data.

A Super Sting Electrical Resistivity geophysical unit from Advanced Geosciences Inc., Figure 7B, was then run on each line. The collected data were processed by inversion in the Advanced Geosciences, Inc. program EarthImager 2D. To account for field topography, terrain files were created by capturing elevations at the electrodes with LiDAR maps and applied to the survey data. The resulting models were analyzed to locate potential anomalies and features indicative of subsurface voids and mine workings. Any identified anomalies and features were marked for emphasis.
