AGGREGATE SUBGRADE THICKNESS DETERMINATION

PHYSICAL RESEARCH REPORT NO. 154
August 2009

Illinois Department of Transportation

Experimental Features Project IL 03-01

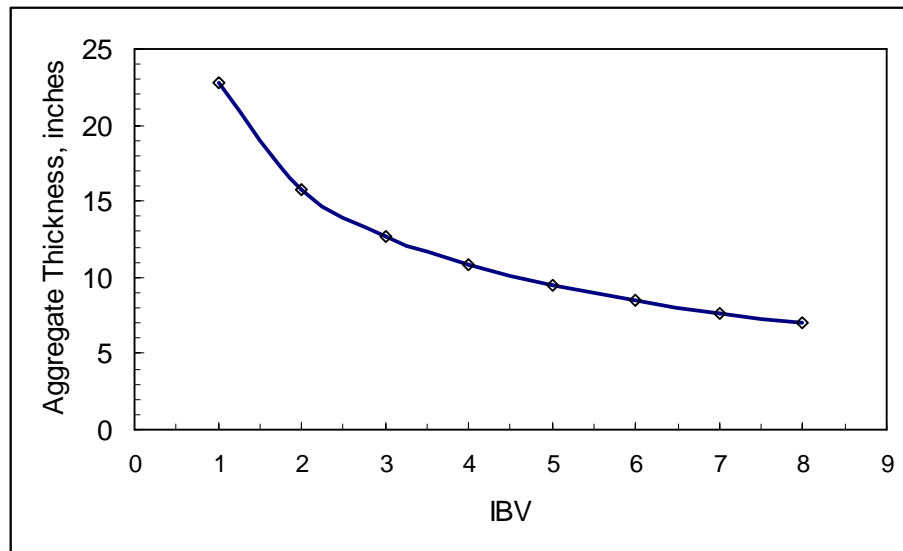
Figure 1. Aggregate Thickness Recommendations Based on Thompson et al.

When using Equation 1 to determine aggregate thickness for a range of IBV, Thompson et al. considered an equivalent single wheel load of 12,000 lb and 5000 passes. Based on the combination of the finite element analysis results and repeated load studies, the results were multiplied by 60 percent to achieve the recommended thickness. Figure 1 graphically shows the results for a range of subgrade IBV assuming an 80 psi tire contact pressure.

Figure 1 has been used by IDOT since 1982 to determine appropriate improved subgrade thickness, and the most recent edition of the Subgrade Stability Manual (IDOT, 2005)

reaffirms this chart's use. The minimum 12-inch improved subgrade thickness requirement is based on the assumption that most Illinois soils have an in-situ moisture content wet of optimum resulting in an in-situ IBV around 3 (IDOT, 2002). Figure 1 indicates an IBV of 3 requires a thickness of 12 inches. Although aggregate properties are not directly input, both Thompson et al. and the Subgrade Stability Manual (IDOT, 1982/2005) discuss the importance of aggregate properties to performance. They recommended a minimum Illinois Bearing Ratio (IBR) of 15 to 20 and an aggregate with low moisture sensitivity. Low moisture sensitivity was characterized by having crushed materials with a lower fines content having a low Plasticity Index (PI).

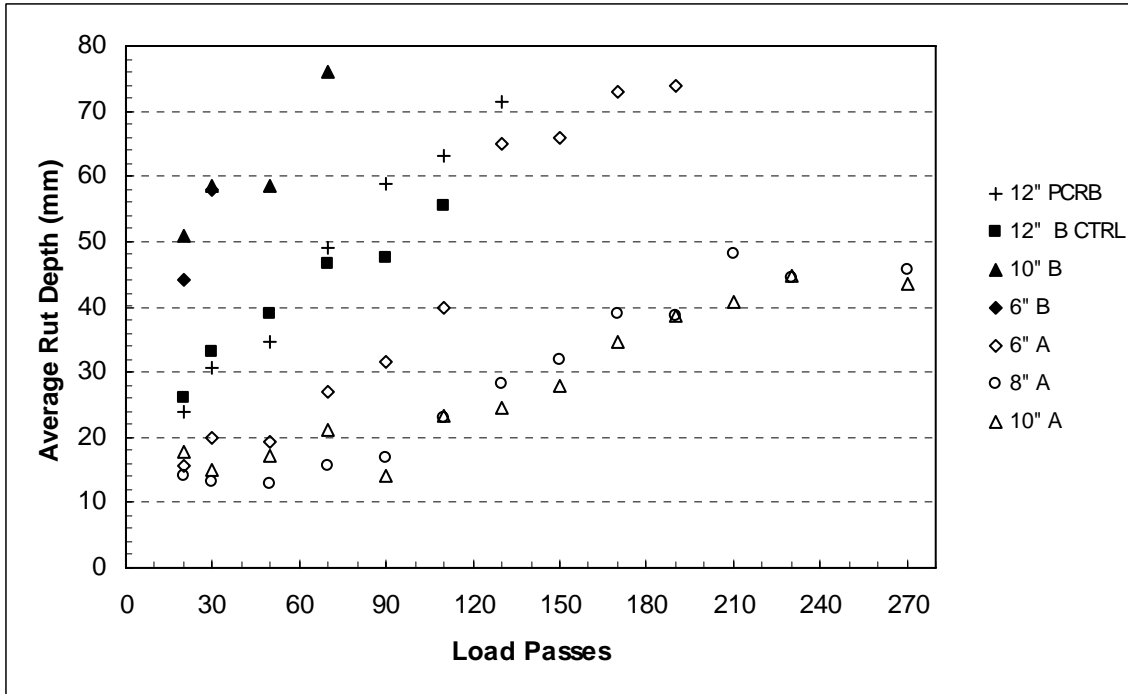
Figure 5. Crushed Limestone CA-6 Rut Depth versus Load Passes with no Geotextile

The data shown in Figure 5 indicates Type A materials outperform Type B materials. The rutting observed within the 12-inch Type B CLS control section was similar to that observed within the uncrushed gravel and RAP CLS control locations. However, the Type A material outperformed the control material at every thickness down to 6 inches. The oversize material capped with Type B material performed only slightly better than the control. With the exception of the 8-inch Type A CLS, all of the materials exceeded the maximum 0.5-inch (12.5 mm) rut depth allowed by IDOT policy (IDOT, 2005). Complete rutting data is shown in Appendix C.

The data shown in Figure 7 show a significant improvement in Type B CLS performance as load passes increase when compared with the no-geotextile data shown in Figure 5. When a geotextile is used, the Subgrade Stability Manual allows a one-third reduction in aggregate thickness (IDOT, 1982/2005). As a result, the control location consisted of 8 inches of Type B materials rather than the 12 inches used in the no-geotextile sections. The data indicates the sections with geotextile limited rutting to the required 0.5-inch (12.5 mm) maximum for less than 30 load passes.

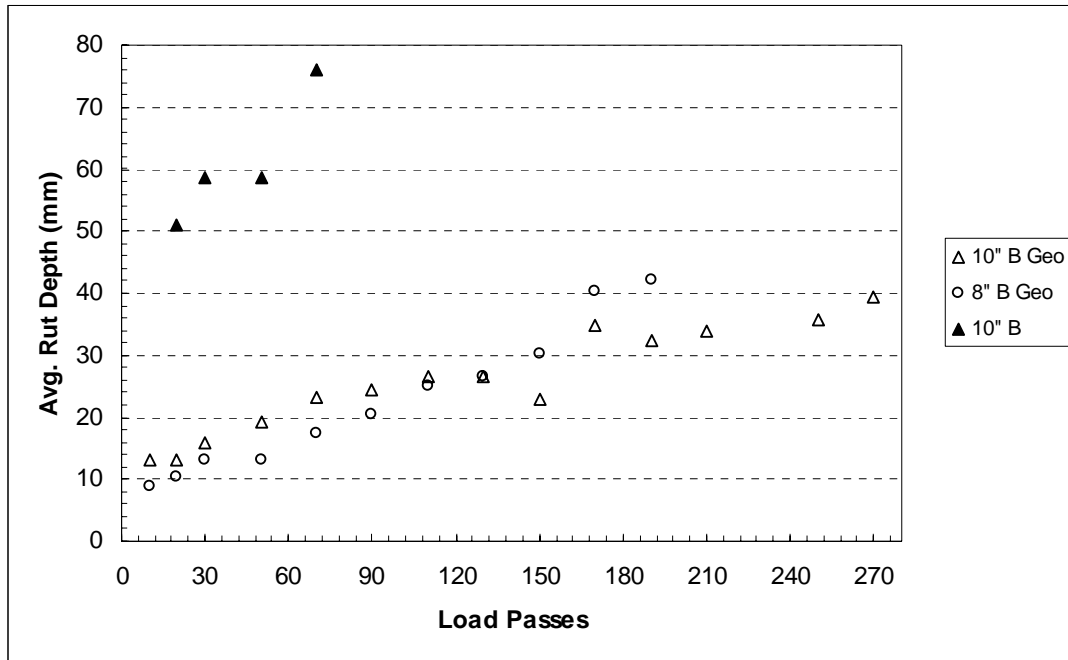
Figure 8. Type B CLS With and Without Geotextile Rut Depth vs. Load Passes

The data in Figure 8 shows the geotextile significantly improved the performance of Type B CLS. However, the data may be misleading. One reason the rutting data with geotextile is significantly lower than without geotextile is the lack of any observed edge effects within the geotextile test section. The lack of edge effects may be a result of better edge compaction within the geotextile section. However, it cannot be determined whether this is a result of construction variability or a benefit of using geotextile. The data for Type A materials in Figure 9 may provide a more accurate representation of the effect of geotextile.

Figures 8 and 9 below provide a clearer comparison between performance with and without geotextile. Figure 8 shows Type B materials and Figure 9 shows Type A materials.

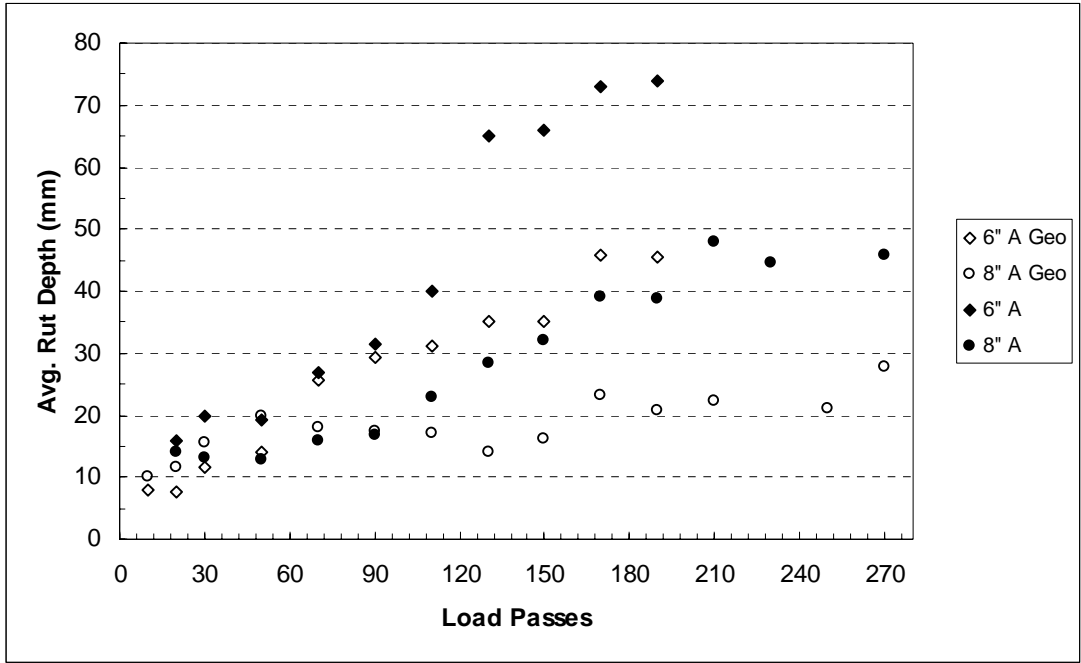
Figure 9. Type A CLS With and Without Geotextile Rut Depth vs. Load Passes

Figure 9 indicates there was no real benefit to using geotextile when the number of load passes was less than 90. Because there was no significant difference in rut depth at fewer than 90 passes, reinforcement was likely not the mechanism by which the geotextile was functioning. Given the relatively high IBV of 4.9, it is unlikely there was sufficient deflection to mobilize significant strength of the woven fabric material. After 90 passes, the fabric may have helped to prevent intrusion of the aggregate into the underlying subgrade.

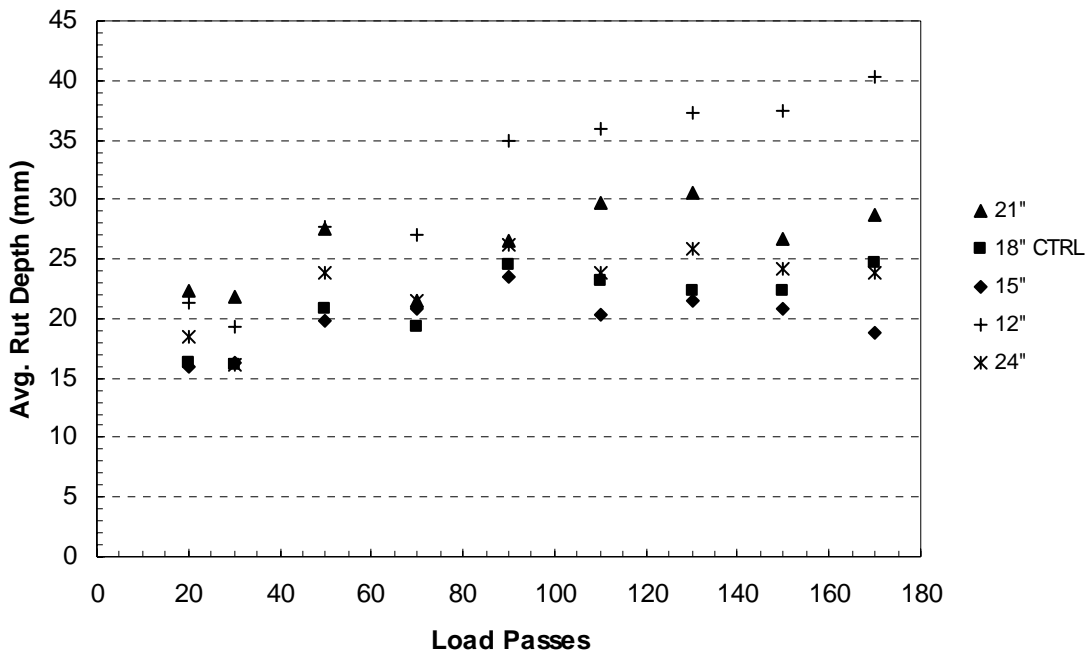
Figure 10. Rut Depth vs. Load Passes for CLS Oversize Materials Capped with CA-6

The number of load passes shown in Figure 10 was limited to 170. At loadings greater than 170, the rut width began to increase because of truck tracking variability. This increase in rut width began to interfere with measurements because it exceeded the straightedge width. This resulted in an apparent reduction in rut depth with increasing loading, which is not possible. Complete rutting data is shown in Appendix C.

The data in Figure 10 shows the rutting after 20 passes already exceeded the minimum 12.5 mm requirement. This result was similar to all the previously discussed test segments. Because of the relatively high IBV in relation to aggregate thickness, a majority of the rutting deformation is likely to have occurred within the aggregate layers themselves. The data shows some unexpected trends. One would expect rutting to increase with decreasing aggregate thickness. This was obvious with the 12-inch thick test location, but with the thicker test locations, there seemed to be no correlation between aggregate thickness and rutting. For example, the 21-inch thick test location consistently performed worse than the 15-inch, 18-inch and 24-inch locations, and the 15-inch test location outperformed the 24-inch location. This reinforced the hypothesis that the rutting was more a function of aggregate properties and uniformity of construction.

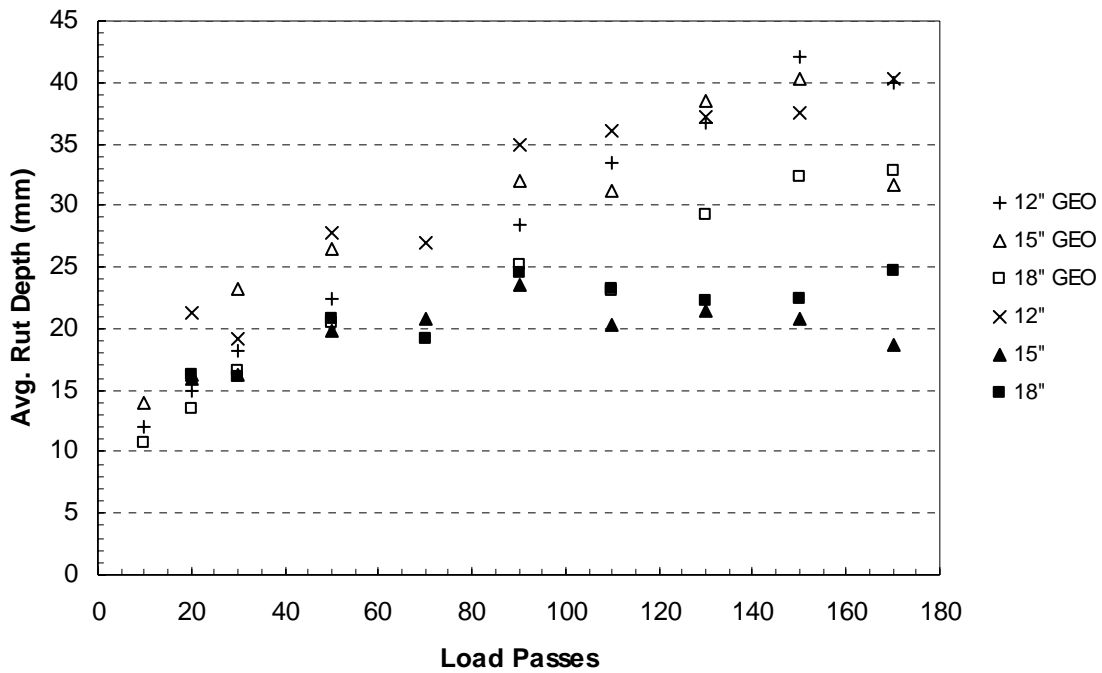
Figure 11. Oversize CLS Capped with CLS CA-6 With and Without Geotextile Rut Depth vs. Load Passes

The data in Figure 11 shows there was no benefit to using a geotextile in this case. The IBV was not low enough to allow the geotextile to act as reinforcement. The variation in rut depth between the geotextile and no geotextile locations was probably due to variations in construction.

Figure 11 compares rutting with and without geotextile.

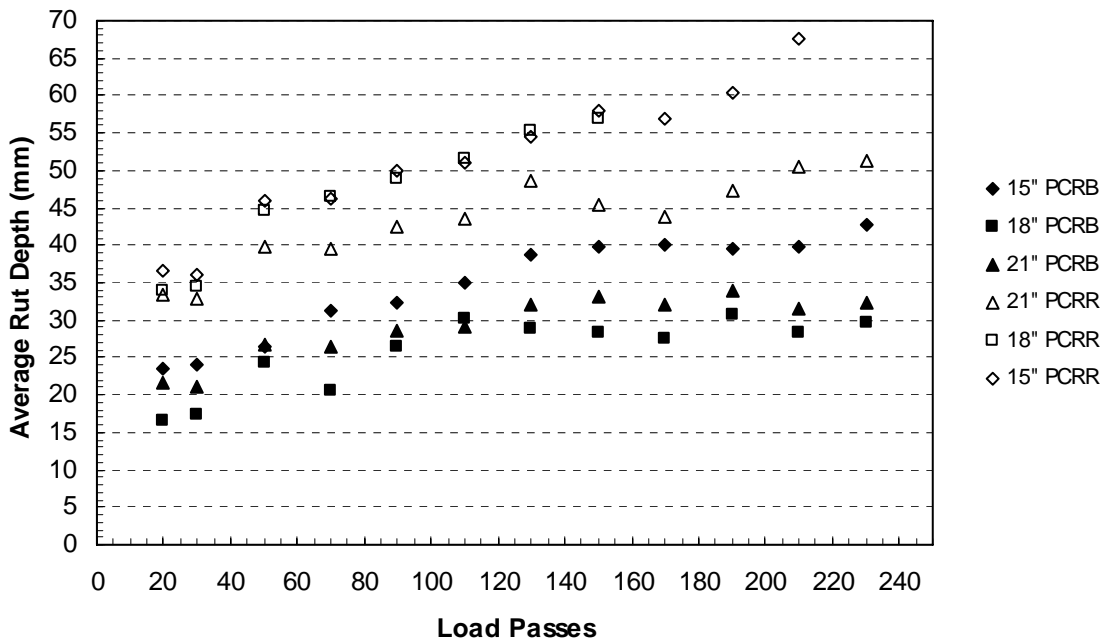
Figure 12. Rut Depth versus Load Passes for RAP and CLS CA-6 Capping Materials

The data in Figure 12 shows the CLS CA-6 outperformed RAP as a capping material. Unfortunately, no field measurements of cap density or moisture content were obtained. Compaction was to the satisfaction of the Engineer. Again the CA-6 gradation may perform better because of the additional fines content as discussed in Section 2.4.2.

Test segments consisting of oversize material capped with RAP (PCRR) and Type B CLS CA-6 (PCRB) were also constructed on the southbound lanes. Unfortunately because the subgrade IBVs are greater than 3, these sections do not provide useful data regarding aggregate thickness. However, they do provide a comparison between the performance of a RAP cap and a CLS CA-6 cap. The RAP used in this area was the coarser combined base and surface millings. Figure 12 shows rut depth versus load passes for oversize material capped with RAP and CA-6.

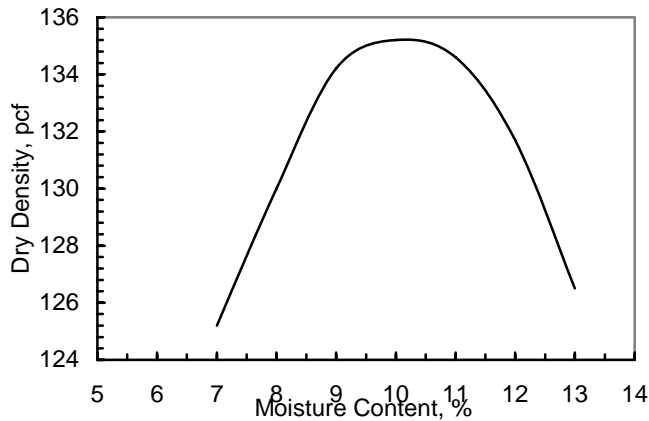
Moisture-Density Relationship
Subbase Granular Material, Type A
SDD = 135.2 pcf @ 9.6% OMC

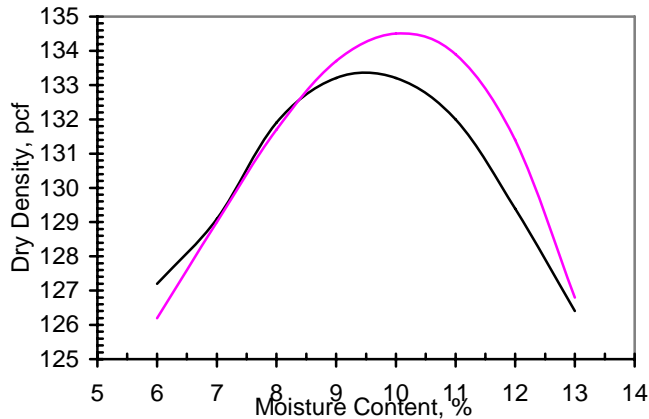
Moisture-Density Relationship
Subbase Granular Material, Type B (CLS)
 NBL SDD = 133.3 pcf @ 9.3% OMC
 SBL SDD = 134.5 pcf @ 10.0% OMC

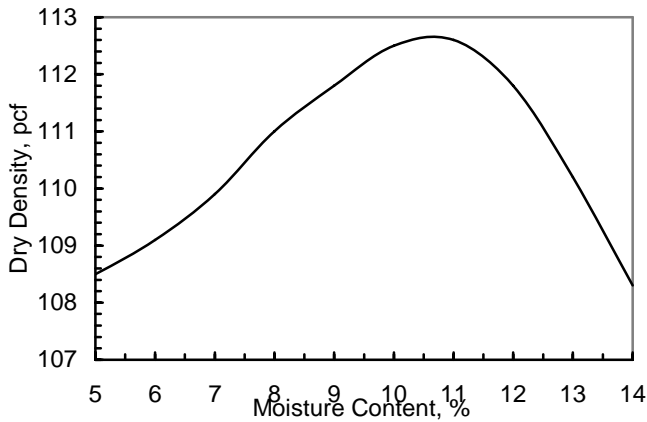
Moisture-Density Relationship
Subbase Granular Material, Type B (CLS)
#1 SDD = 112.7 pcf @ 10.5% OMC

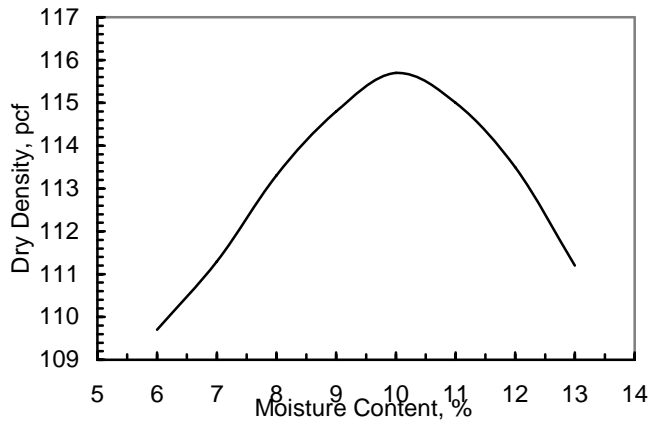
Moisture-Density Relationship
Subbase Granular Material, Type B (CLS)
#1 SDD = 115.8 pcf @ 10.1% OMC
