U.S. Department  
of Transportation  
**National Highway  
Traffic Safety  
Administration**

DOT HS 813 701

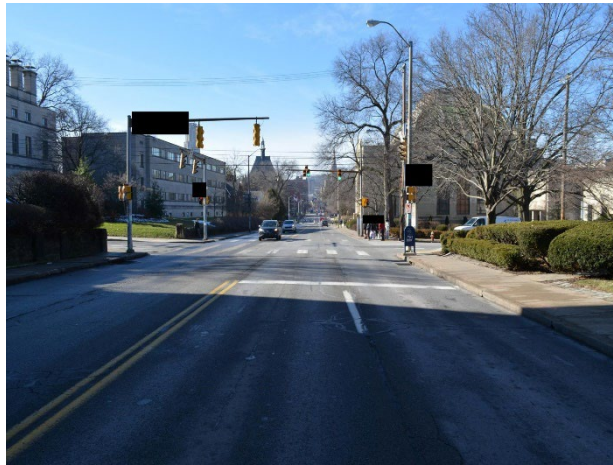
*Figure 2. The ambulance driver's view, looking west. Note visual obstructions to the left.*

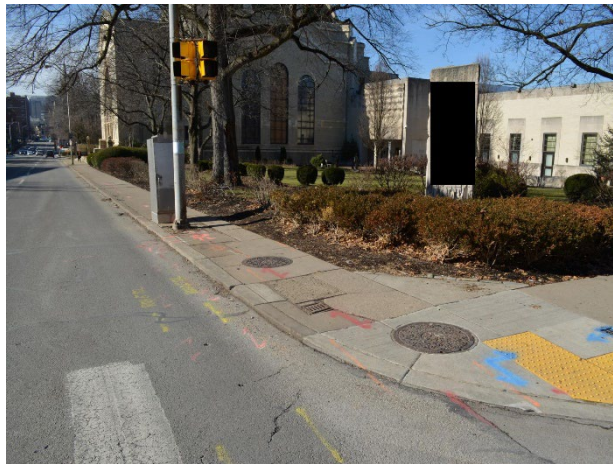
*Figure 4. Looking northwest at the pole and tree associated with Events 2 and 3*

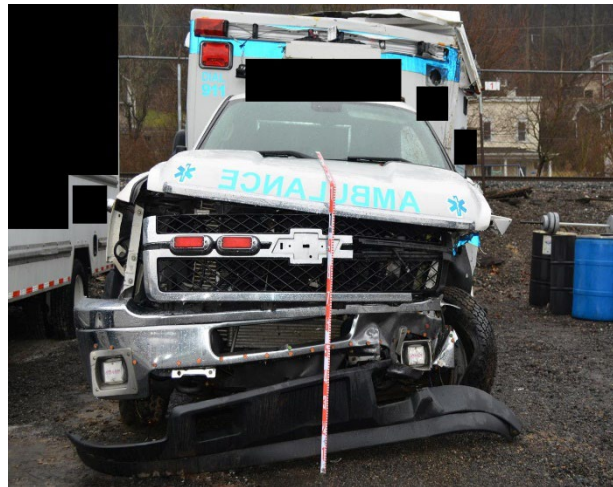
*Figure 6. Front view of the ambulance*

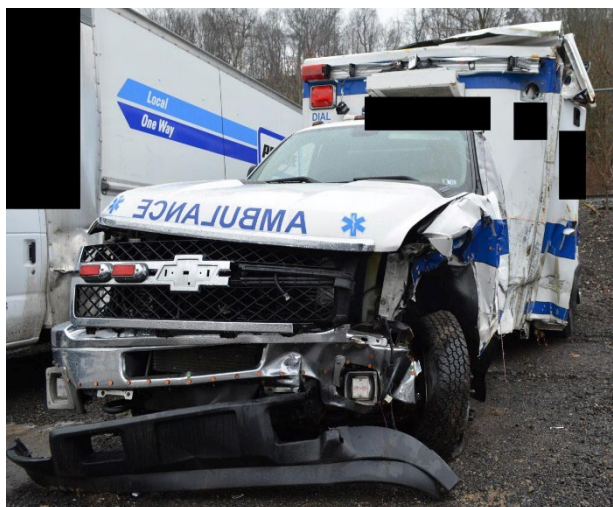
*Figure 7. Left oblique view of the ambulance showing damage from Event 1*

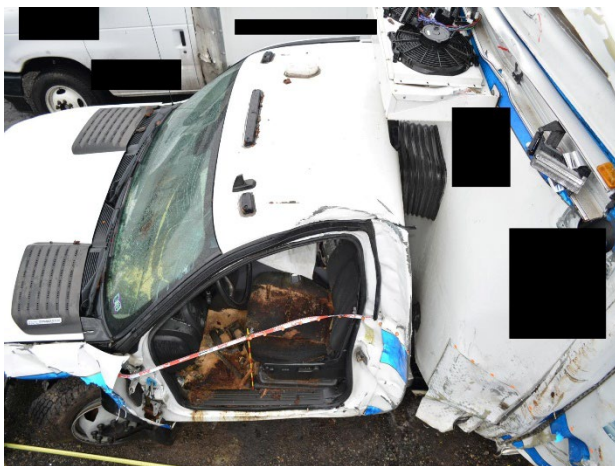
*Figure 8. Top view of the damage to the cab  
(Event 2)*

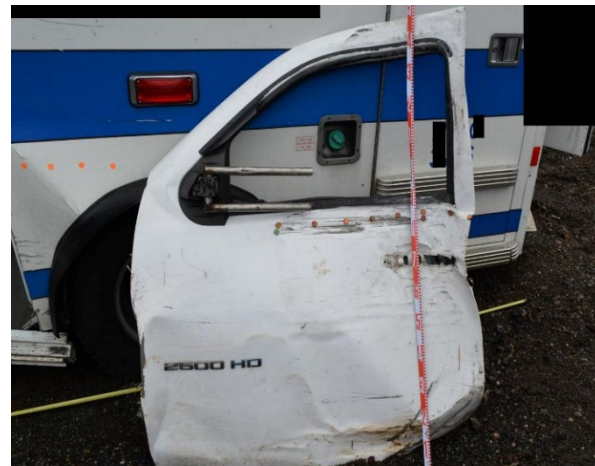
*Figure 9. View of the driver's door and the  
pole damage*

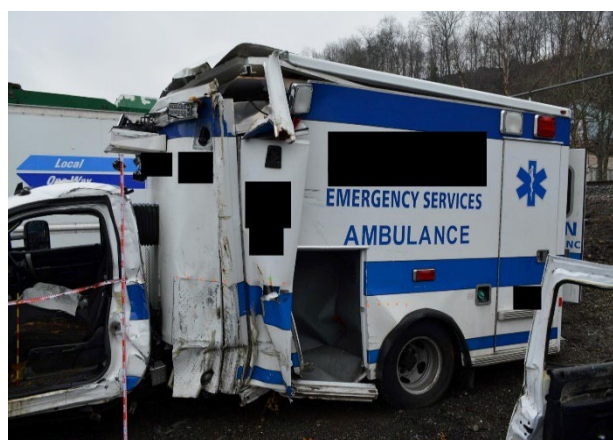
*Figure 10. Damage to the patient compartment  
(Event 3)*

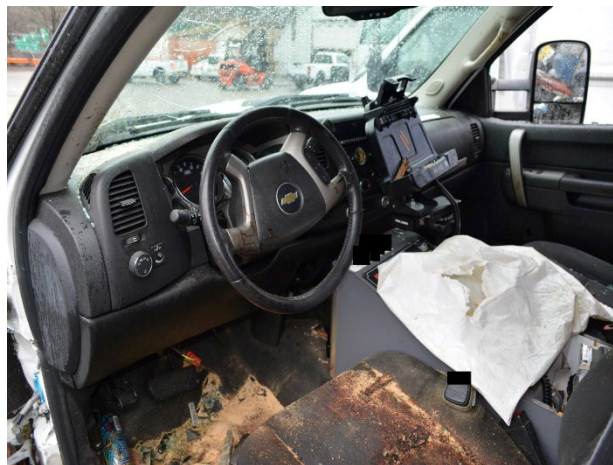
*Figure 11. View of the ambulance's driver side*

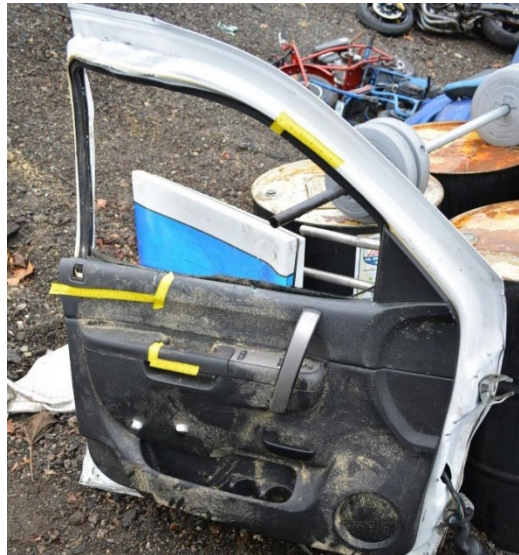
*Figure 12. View of the driver's interior door*

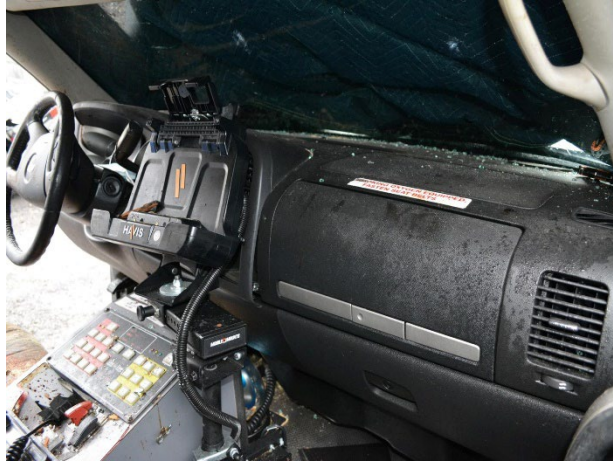
*Figure 14. View of the passenger's side and computer mount*

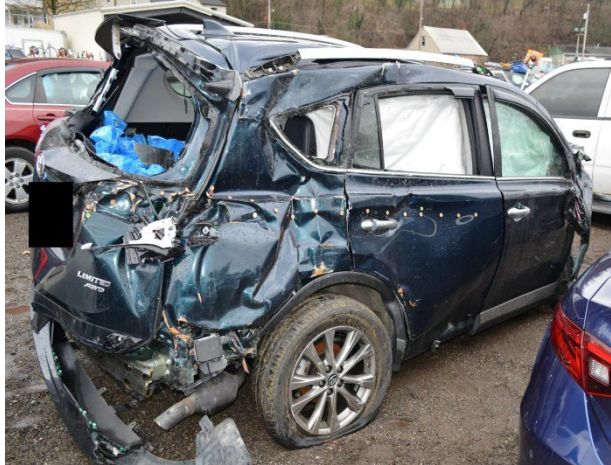
*Figure 20. Damage to the right rear of the Toyota from Event 4*
