***EXTERIOR SOUND LEVEL  
MEASUREMENTS OF SNOWCOACHES  
AT YELLOWSTONE NATIONAL PARK***

April 2010  
Final Report

Prepared by:  
U.S. Department of Transportation  
Research and Innovative Technology Administration  
John A. Volpe National Transportation Systems Center  
Environmental Measurement and Modeling Division, RVT-41  
Cambridge, MA 02142

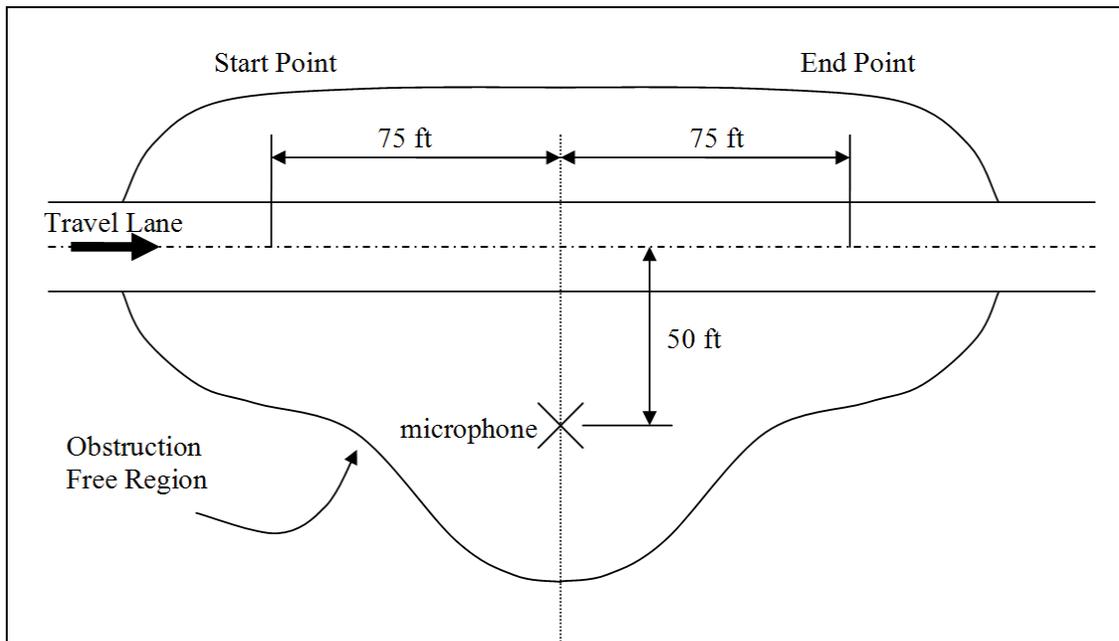
Figure 2. SAE J1161 Measurement Area Layout

the OSV without penetration and with no more than 3 inches of loose snow on top of the packed snow. An illustration of measurement area requirements is provided in Figure 2.

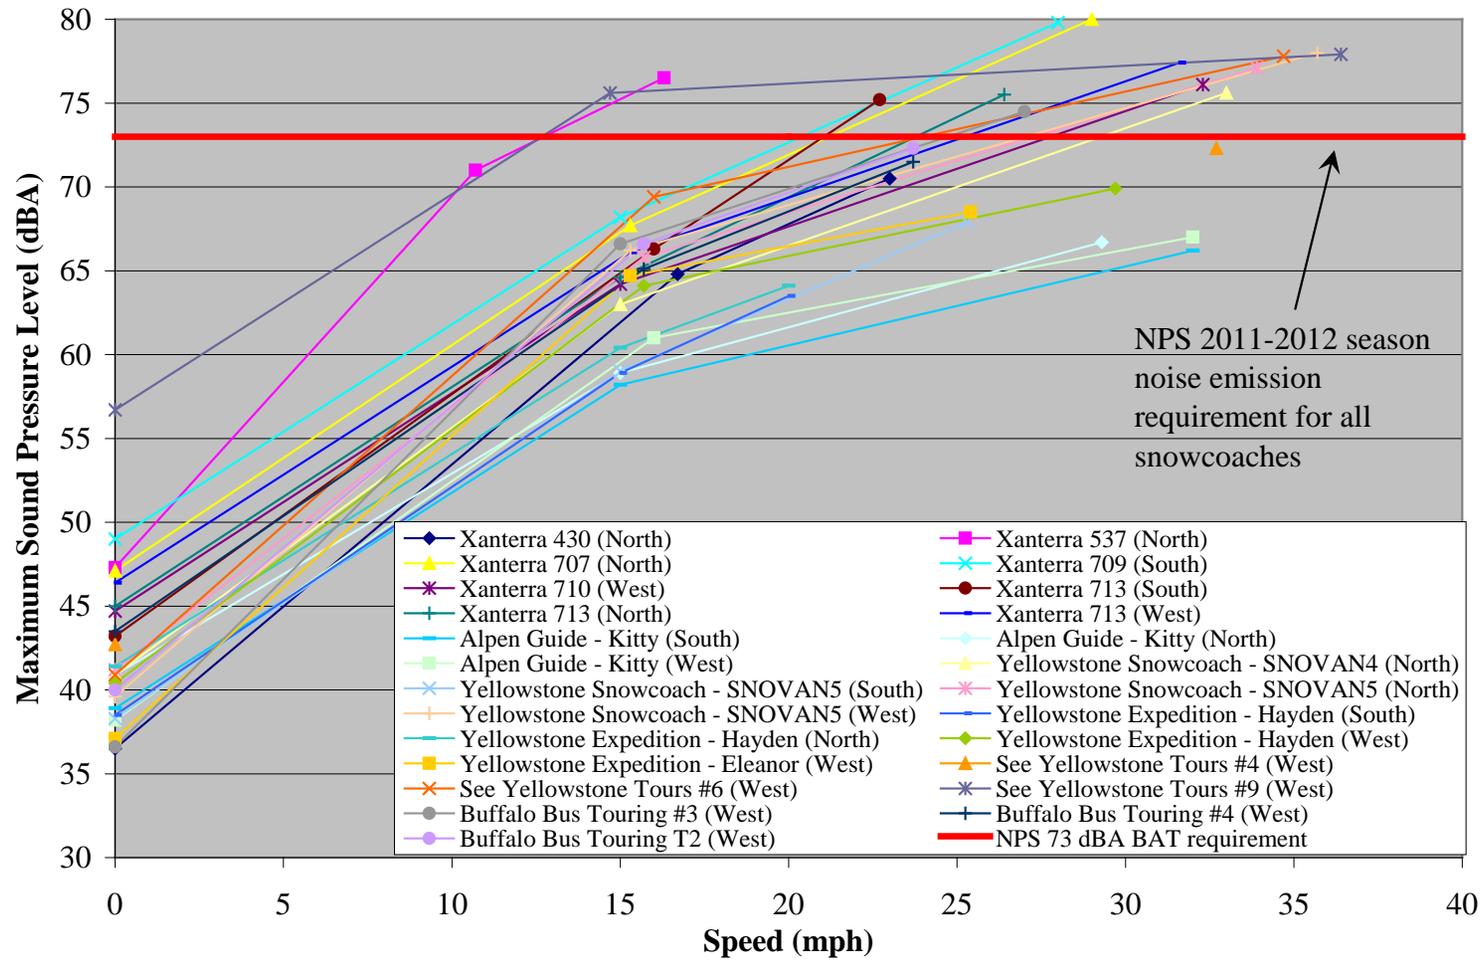
Figure 3. Sound Level vs. Speed<sup>1</sup> for All Snowcoaches

The pass-by sound levels for low and high speeds were combined with idle sound levels to generate noise versus speed relationships as shown in Figure 3. It should be noted that evaluating the curves, based on idle, low and high speeds, is an imperfect method. Measuring more points would create a more realistic representation of the snowcoaches noise characteristics, but is cost prohibitive and impractical. Previous vehicle studies<sup>10</sup> have shown

that an increase in speed versus sound level should roughly follow an increasing monotonic curve. This relationship would allow us to qualitatively describe gross site differences.

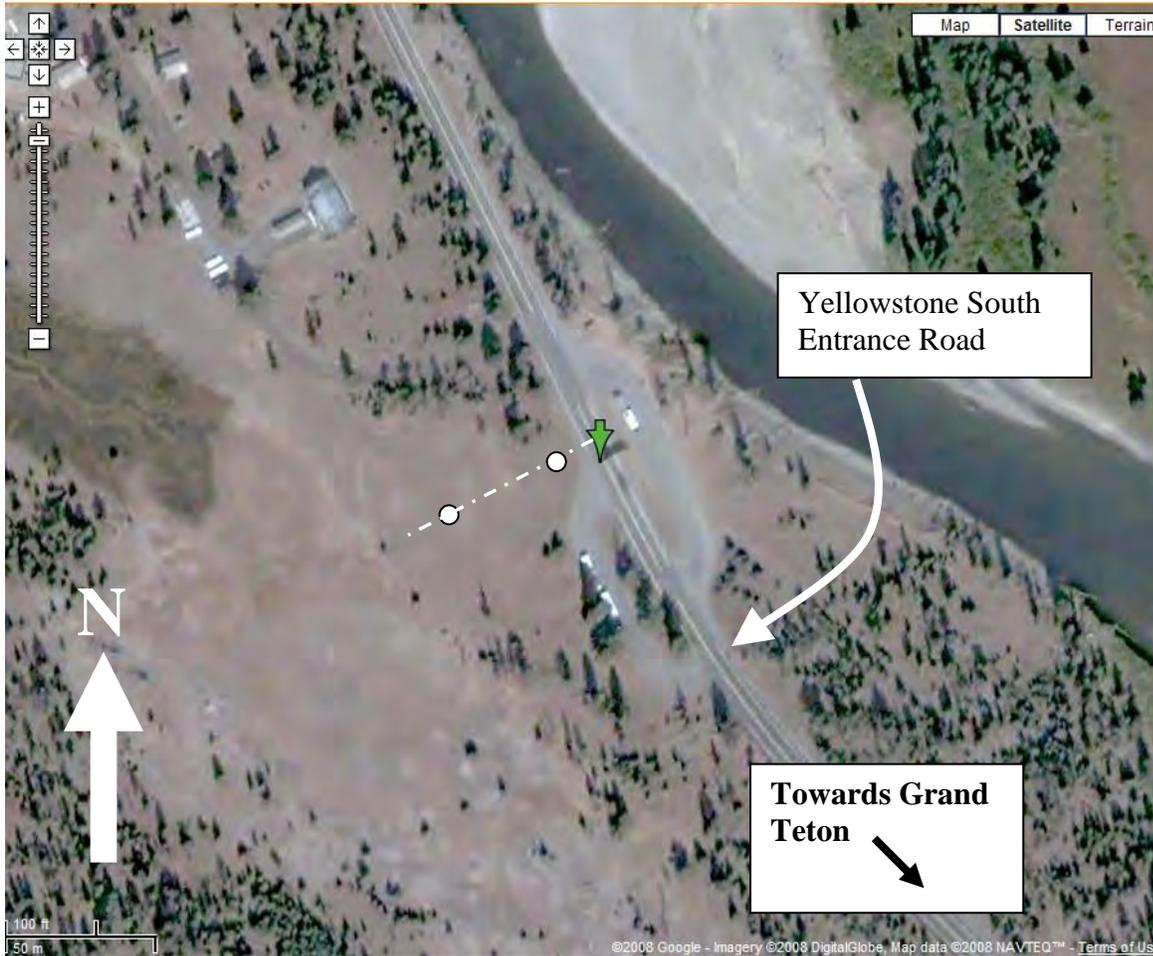
Figure 5. Aerial Photo of the South Measurement Site (44.133, -110.66503)<sup>\*</sup>. White dots indicate approximate location of microphones.

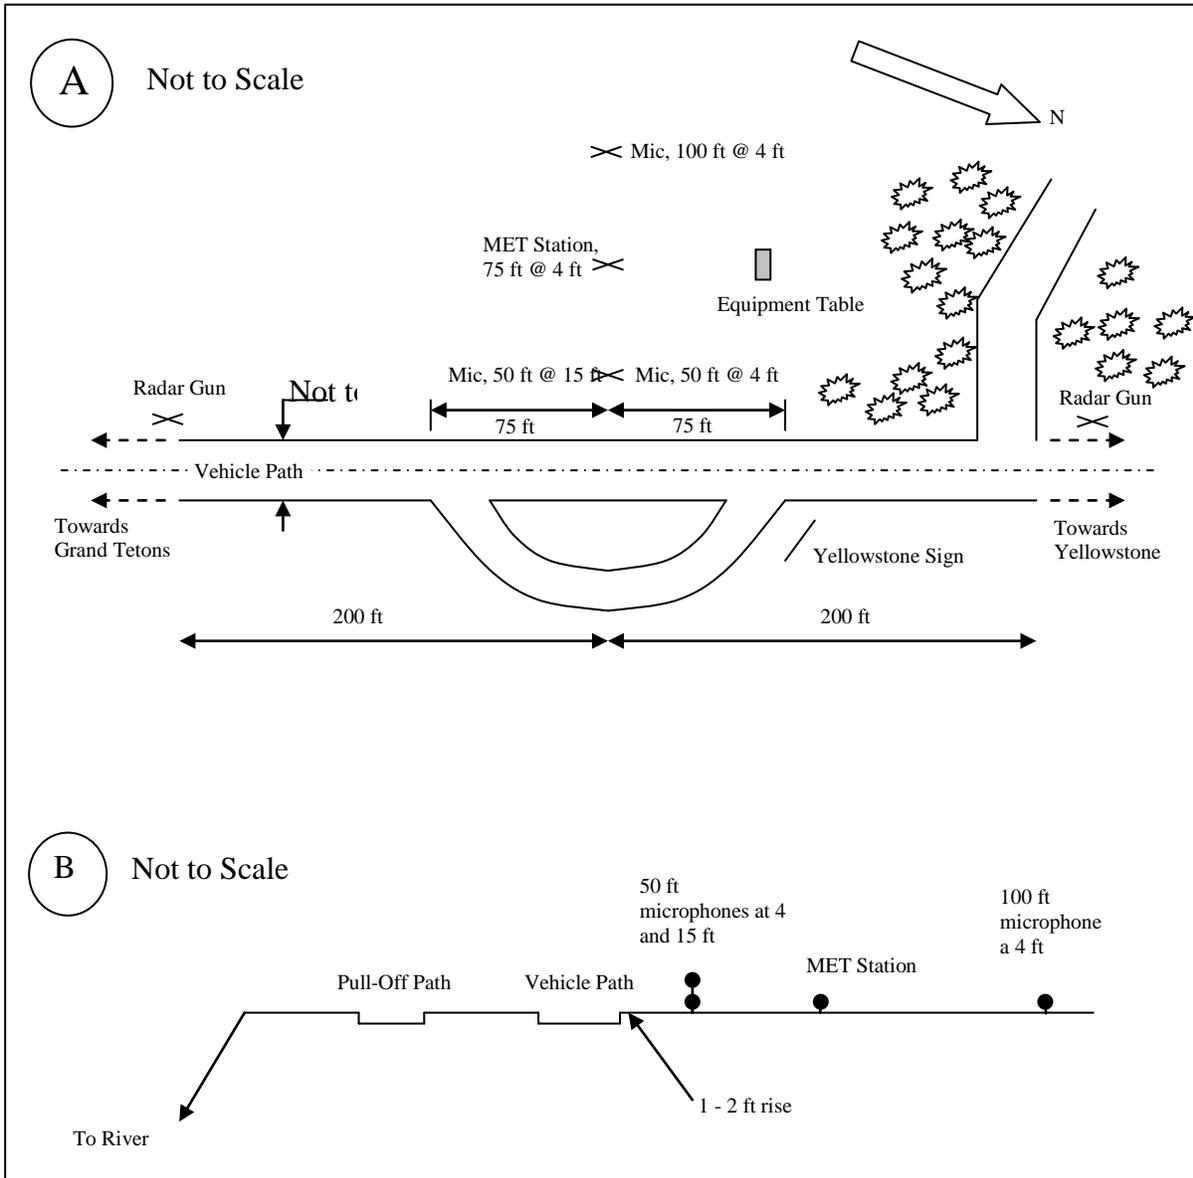
Figure 6. South Measurement Site Sketch – (A) Aerial View, (B) Profile (Not to Scale)

guidance in the SAE standards. Unfortunately, this could not be remedied. Section 4 discusses the implications of the occlusion in more detail.

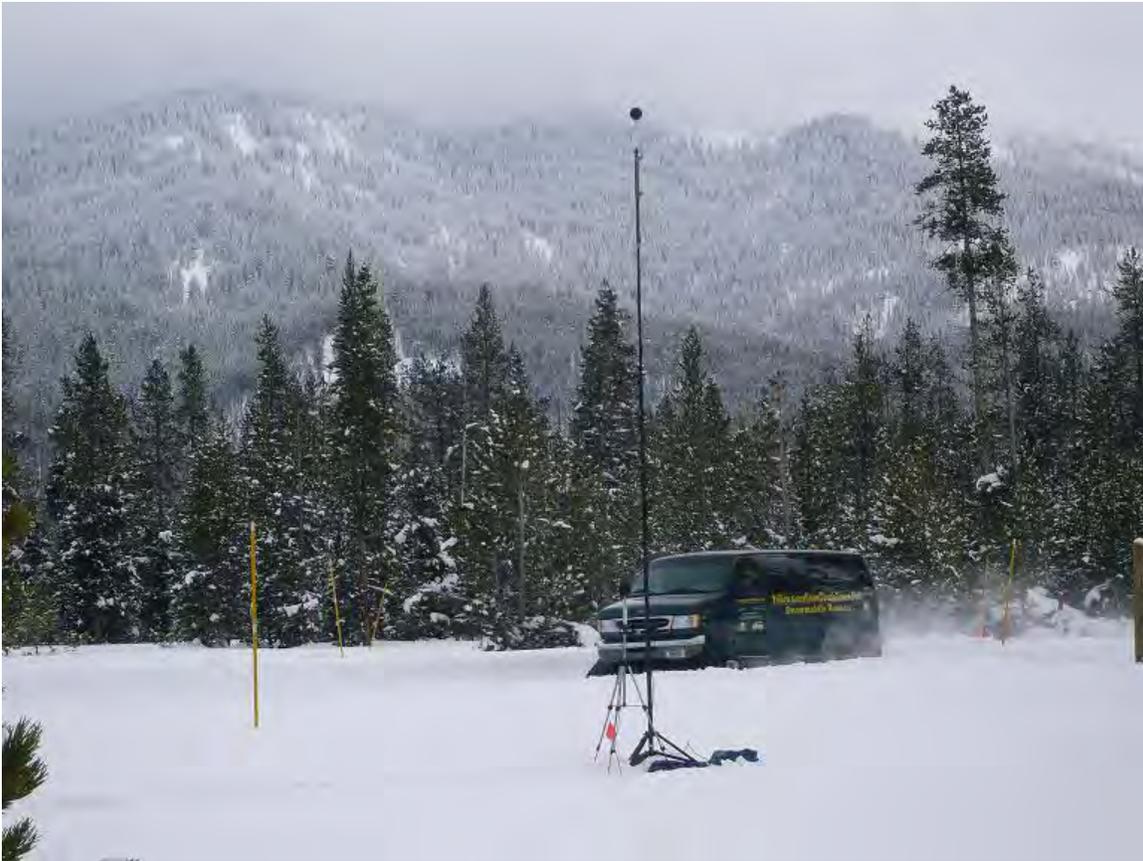
**Figure 7. South Entrance Line-of-Sight from Microphone to Tracks**

Aside from the difference in snow height between the track and the microphone locations, the only other obstruction was the presence of evergreen trees on the north end of the measurement area. These trees were dispersed and, when listening to pass-by events, they were not observed to affect the sound levels at the 50 foot microphone.

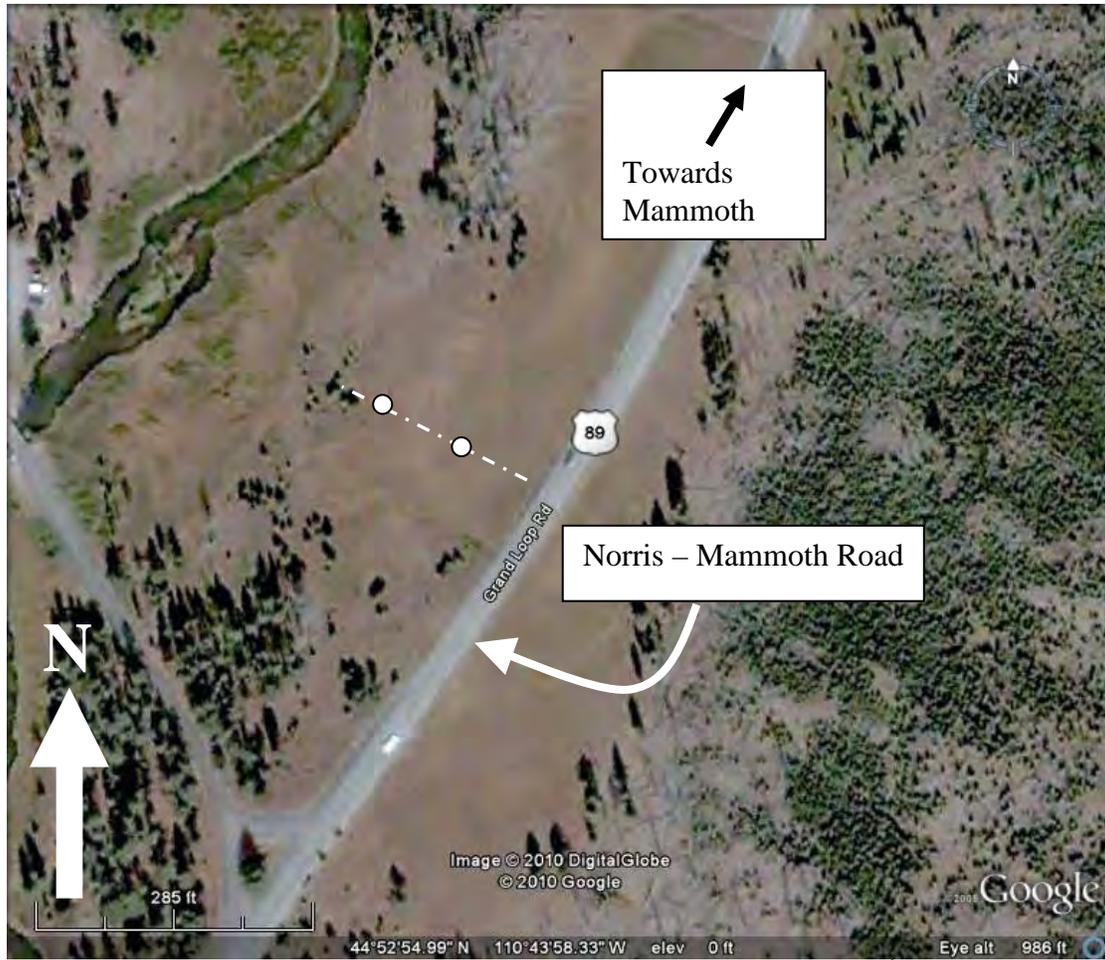
Figure 8. Aerial Photo of the North Measurement Site (44.881942, -110.732869)\*. White dots indicate approximate location of microphones.

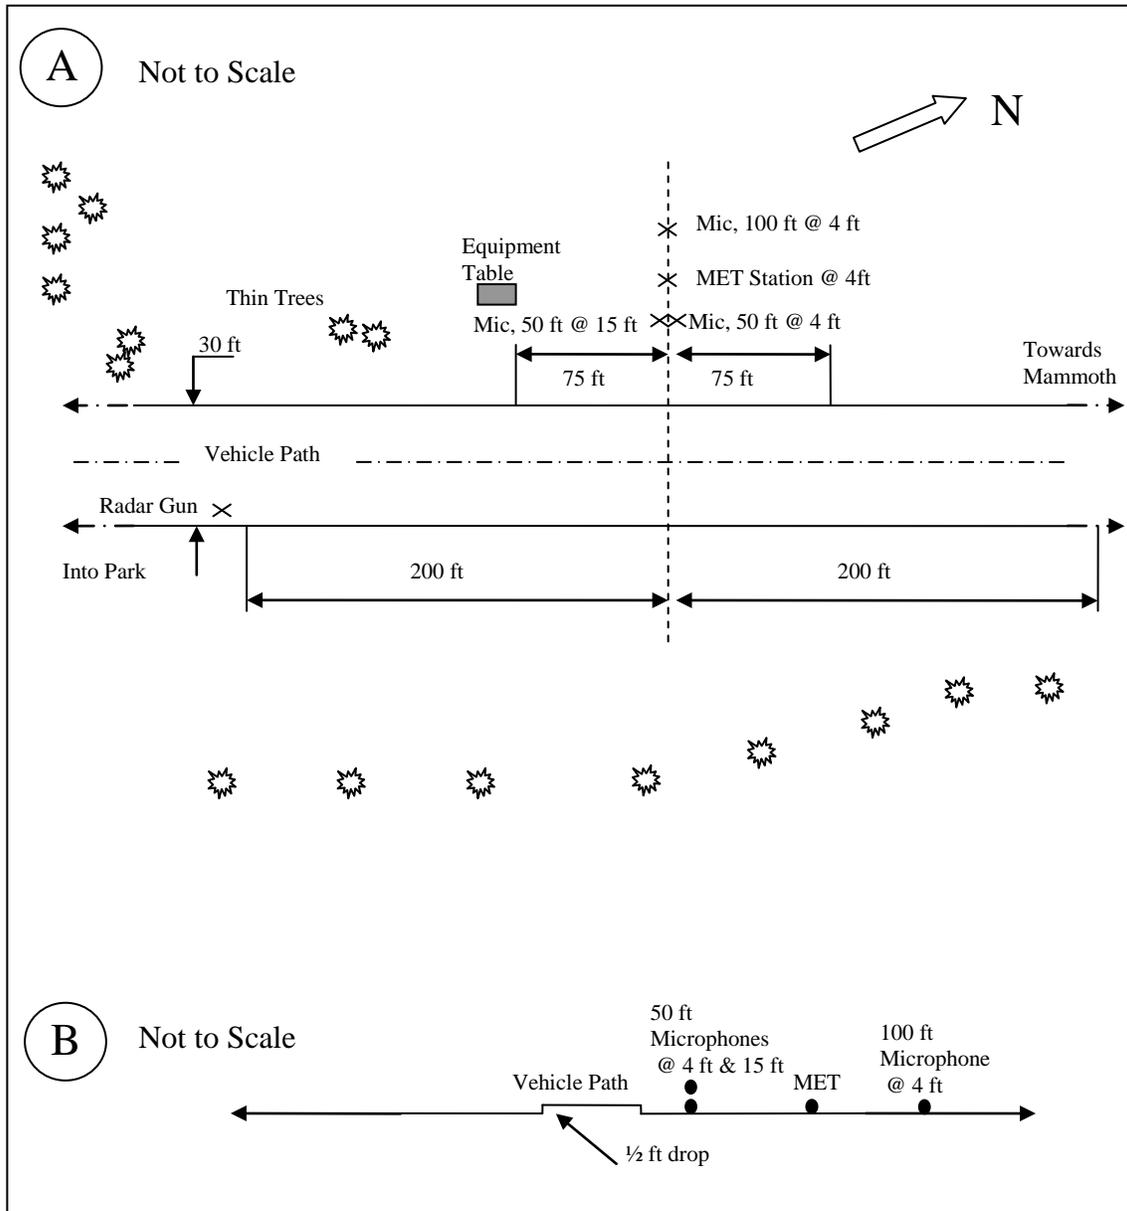
Figure 9. North Measurement Site Sketch – (A) Aerial View, (B) Profile (Not to Scale)

Microphones were set up to the west of the track in the region free of trees. A sketch of the site showing the aerial view and profile is provided in Figure 9. The location of the equipment is indicated in Figure 9A.

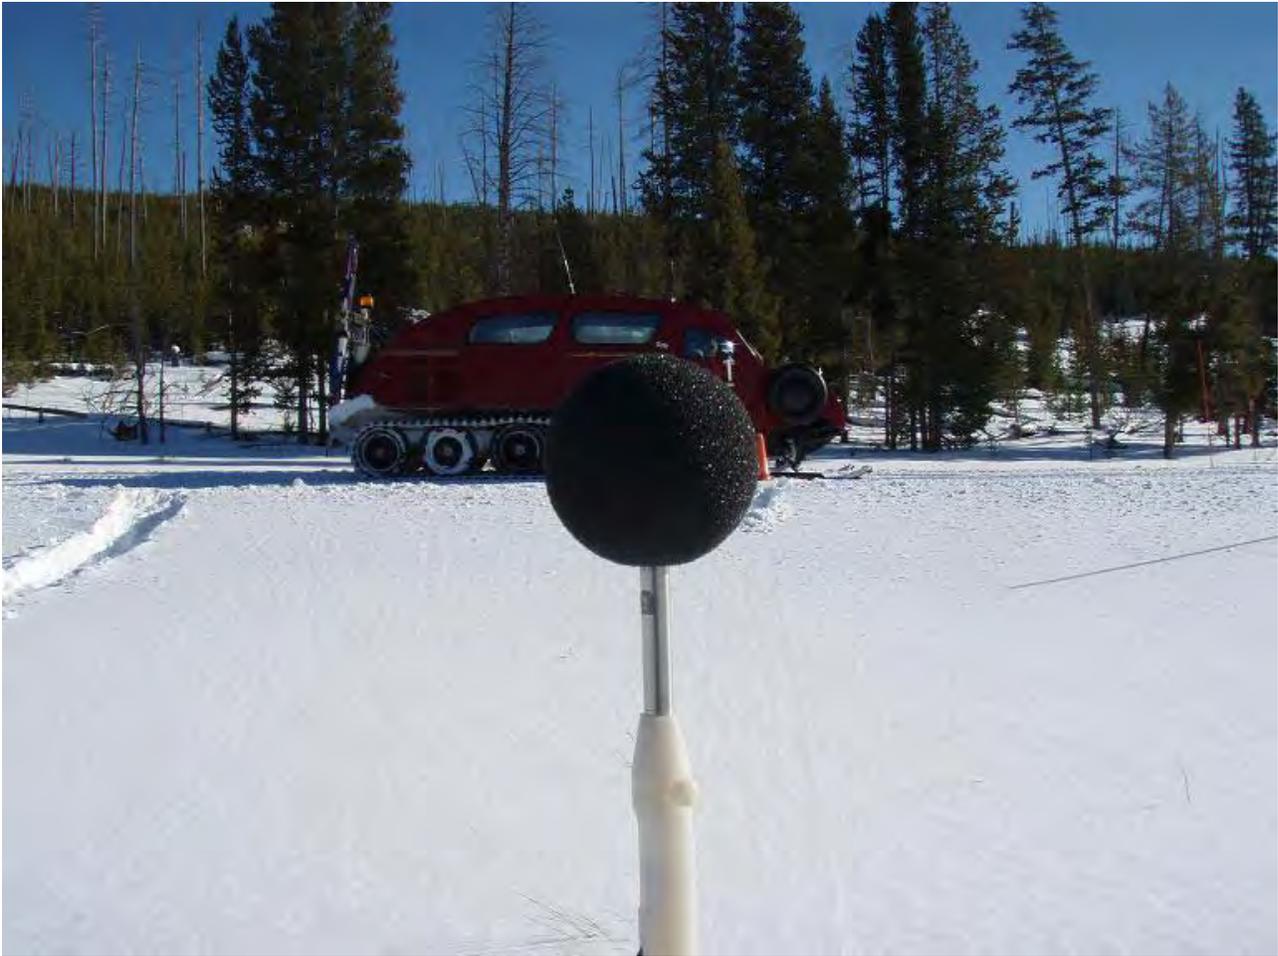
**Figure 10. North Entrance Line-of-Sight from Microphone to Tracks**

The track surface at the north entrance is elevated about one half foot relative to the adjacent snow cover. This allowed for a clean LOS between the microphone and snowcoach. A view of the LOS from microphone to snowcoach is presented in Figure 10.

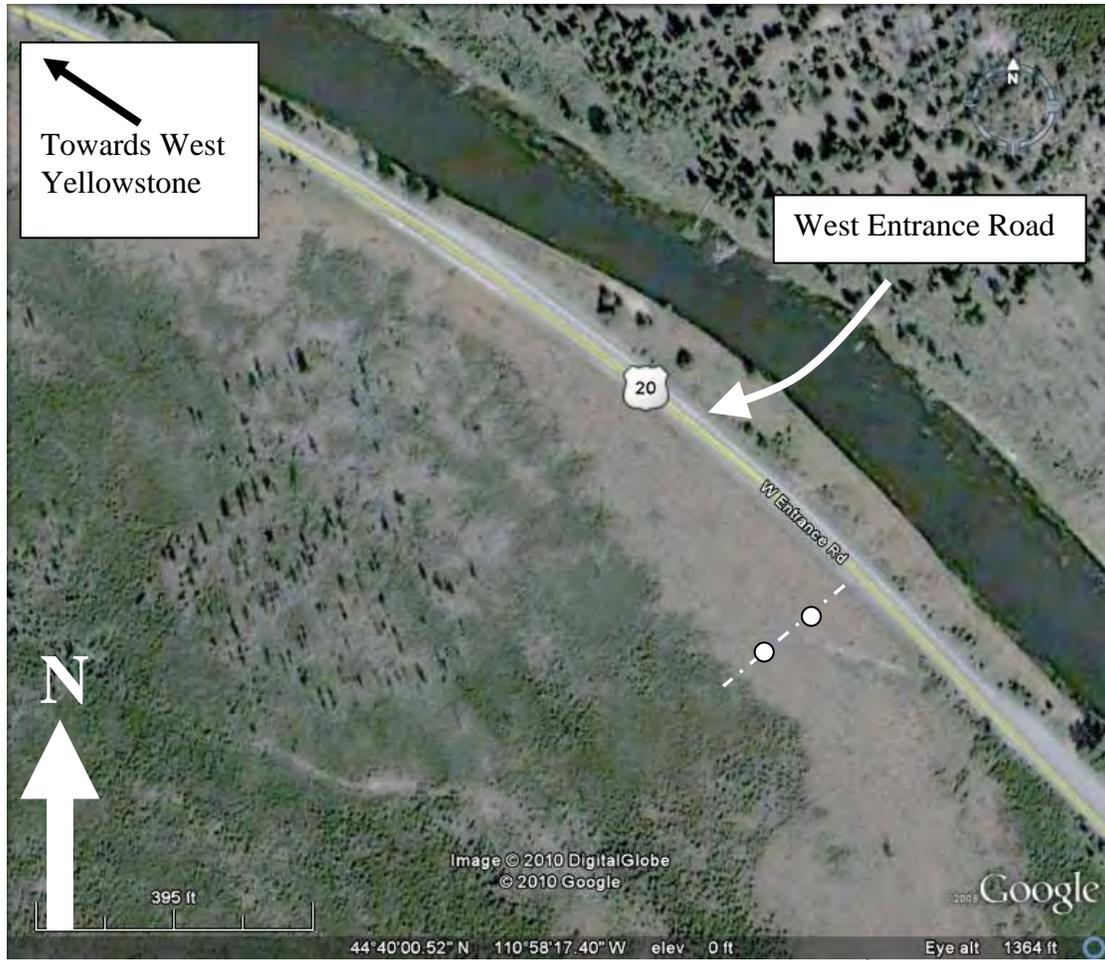
**Figure 11. Aerial Photo of the West Measurement Site (44.6667, -110.9702)\*. White dots indicate approximate location of microphones.**

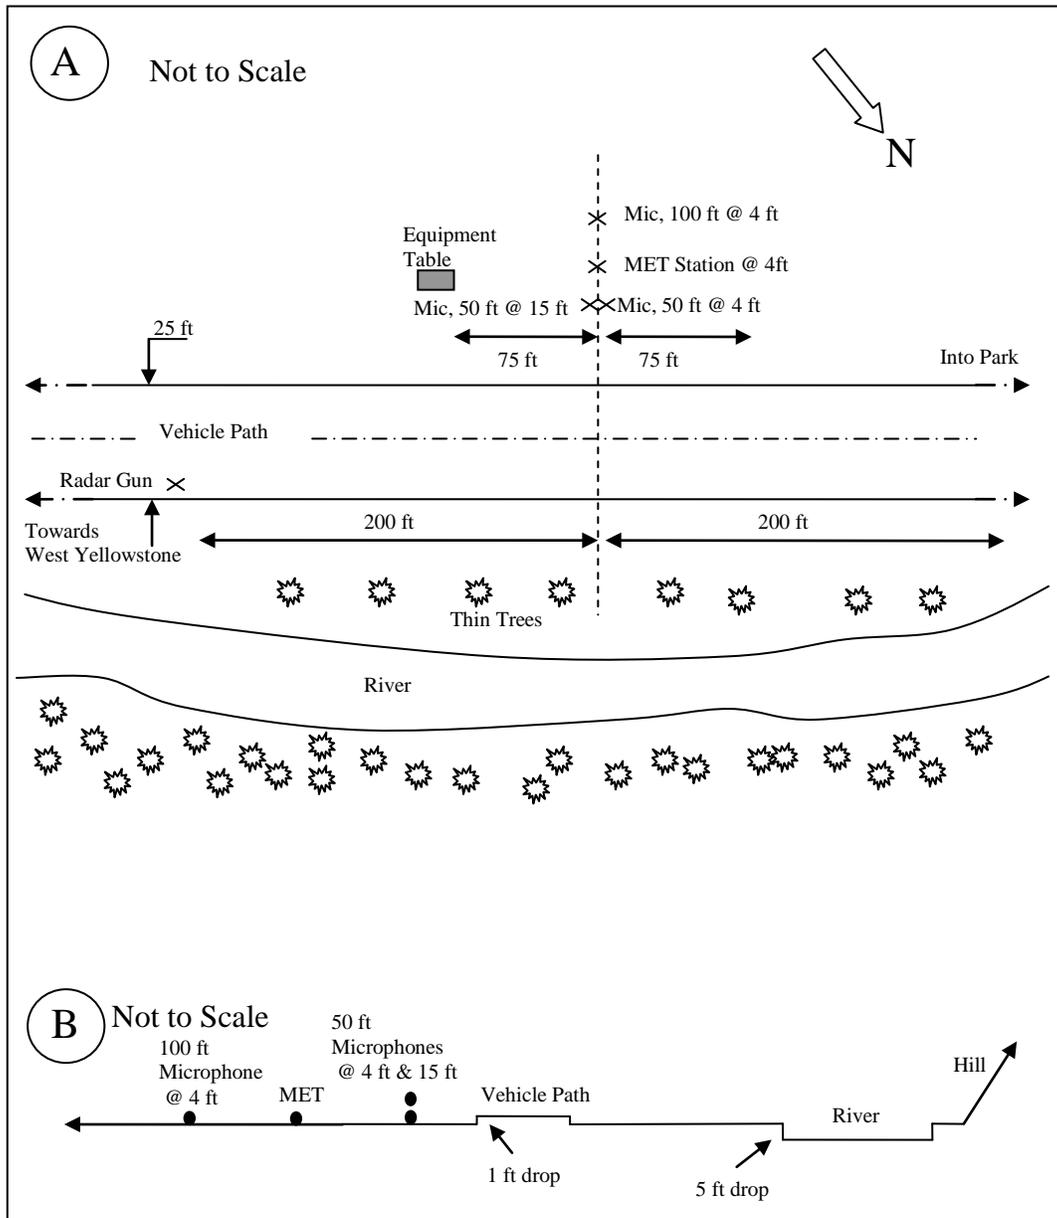
Figure 12. West Measurement Site Sketch – (A) Aerial View, (B) Profile (Not to Scale)

Microphones were set up to the south-west of the track in the region free of trees. A sketch of the site showing the aerial view and profile is provided in Figure 12. The location of the equipment is indicated in Figure 12A.

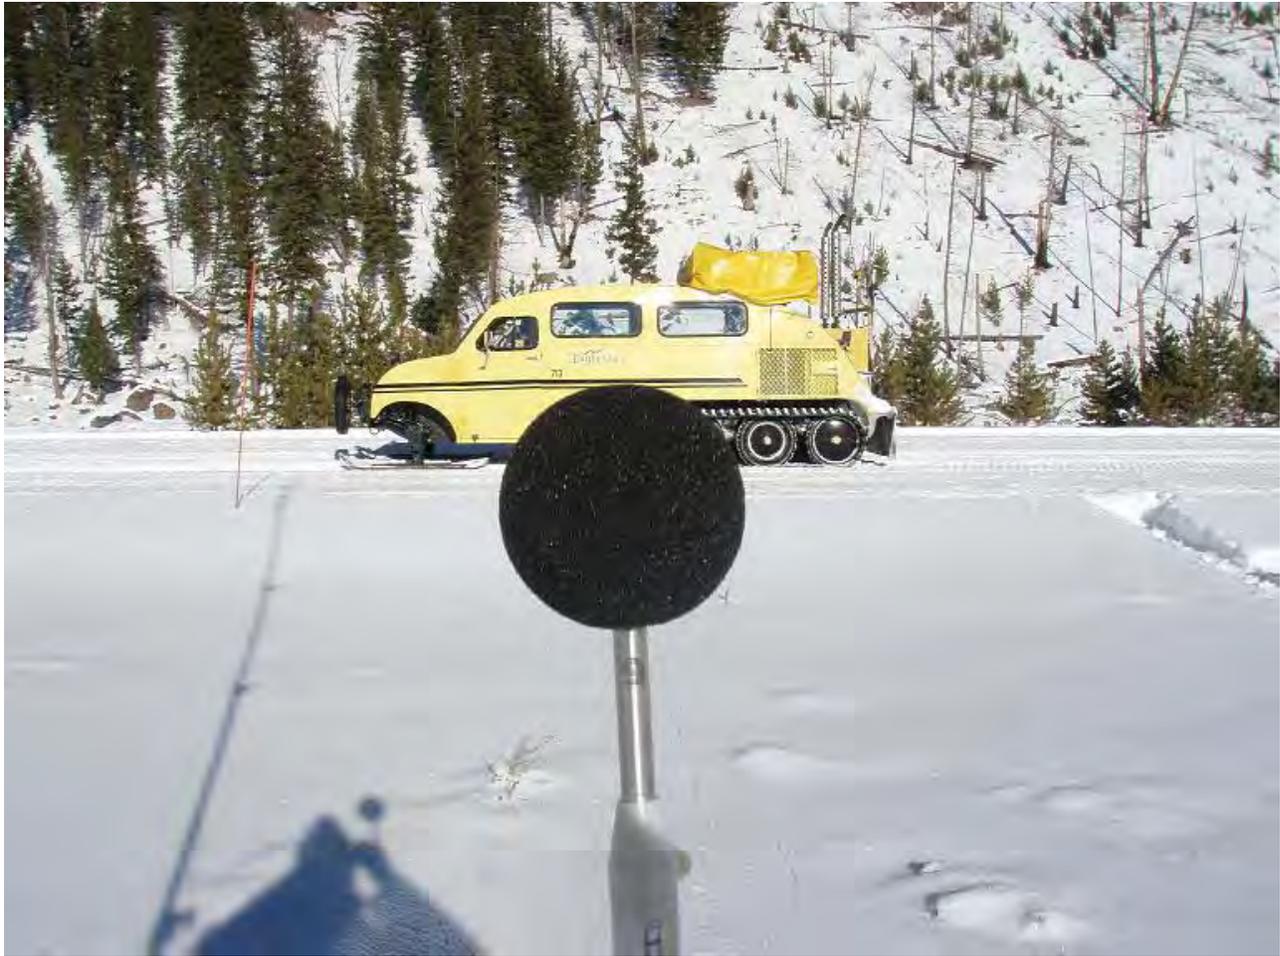
**Figure 13. West Entrance Line-of-Sight from Microphone to Tracks**

There were 2 obstructions to note at this site. The first obstruction is the scattered evergreen trees on the northeast side of the vehicle path. These did not affect the measured data. The second obstruction to note is the hill on the northeast side approximately 320 feet from the vehicle path. Due to the hill being covered with acoustically absorptive snow and scattered evergreen trees, reflection of sound can be neglected.

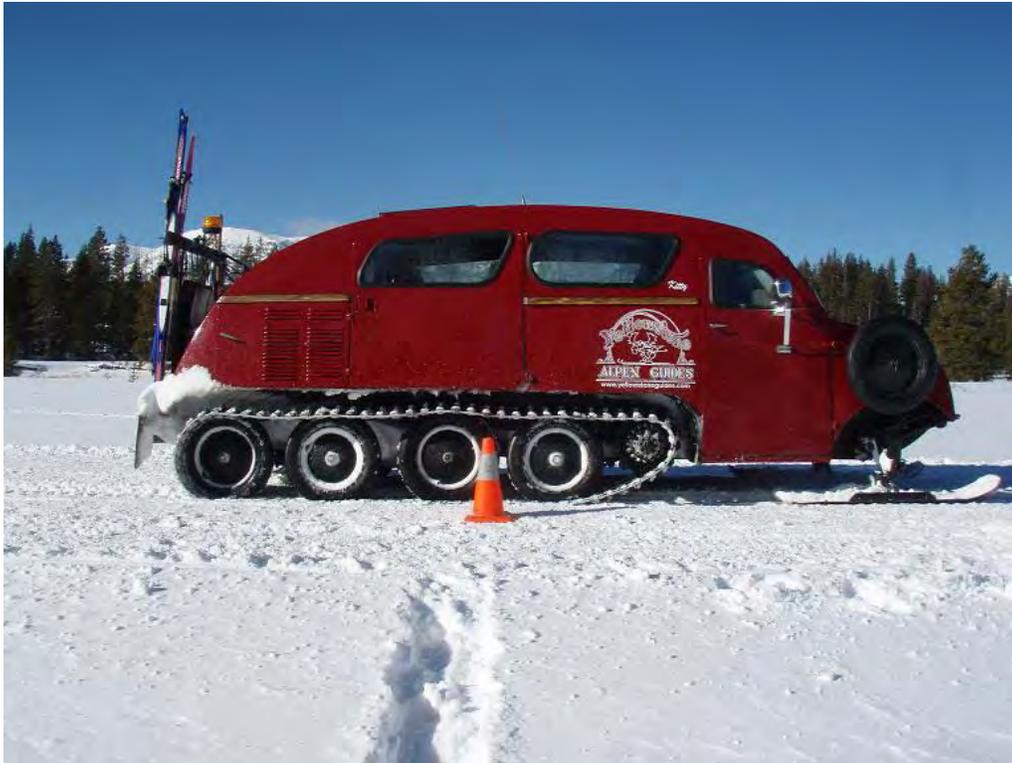
**Figure 14. Purpose Built Bombardier B-12 with Tracks and Skis (Alpen Guide – Kitty)**

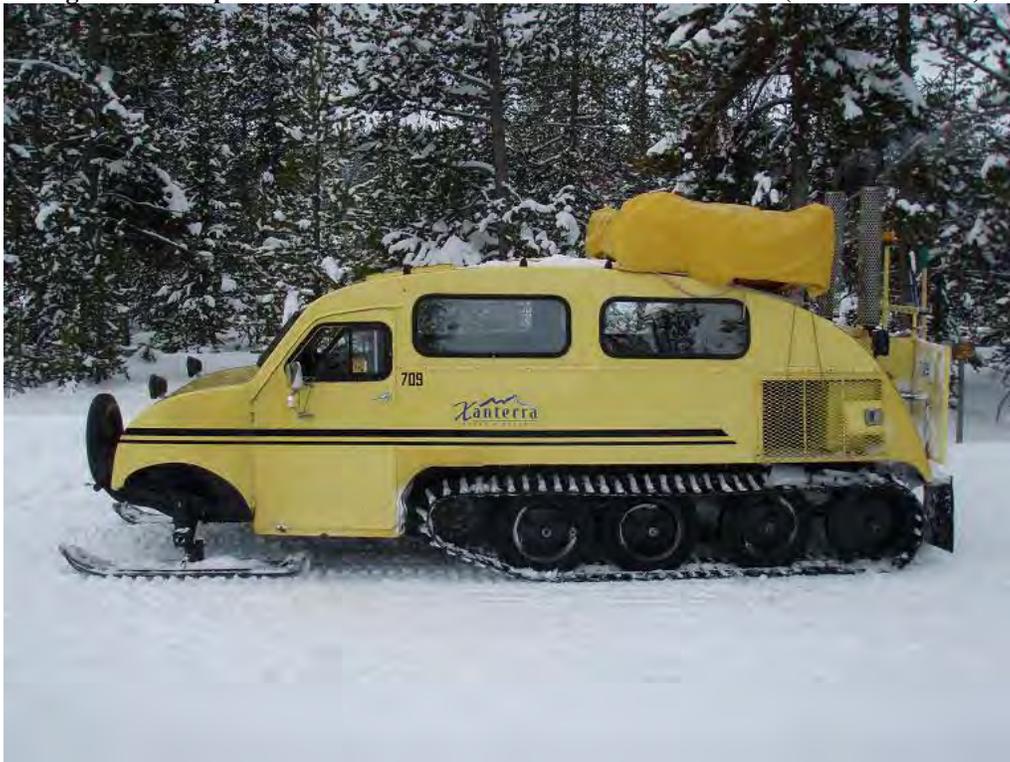
**Figure 23. Purpose Built Bombardier B-12 with Tracks and Skis (Xanterra 709\*)**

\* It should be noted that the Xanterra models 707, 709, 710, and 713 were equipped with a tarp on the top to cover the storage rack. This tarp did not produce any noticeable noise, i.e. including flapping, during the measurements.

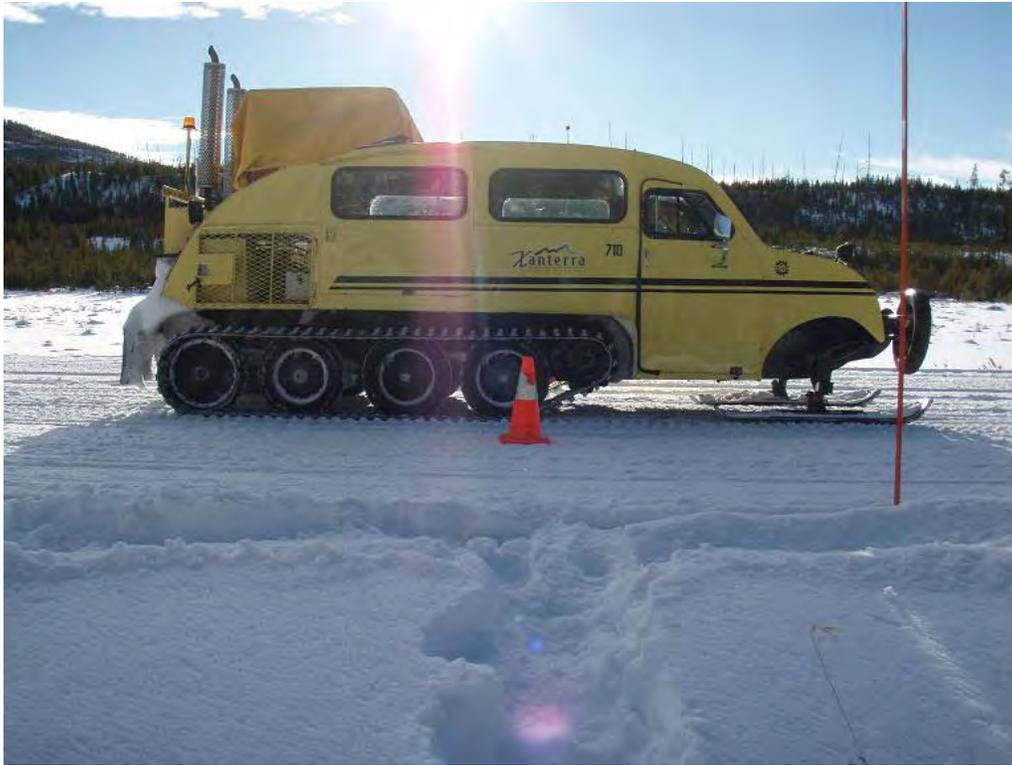
**Figure 24. Purpose Built Bombardier B-12 with Tracks and Skis (Xanterra – 710\*)**

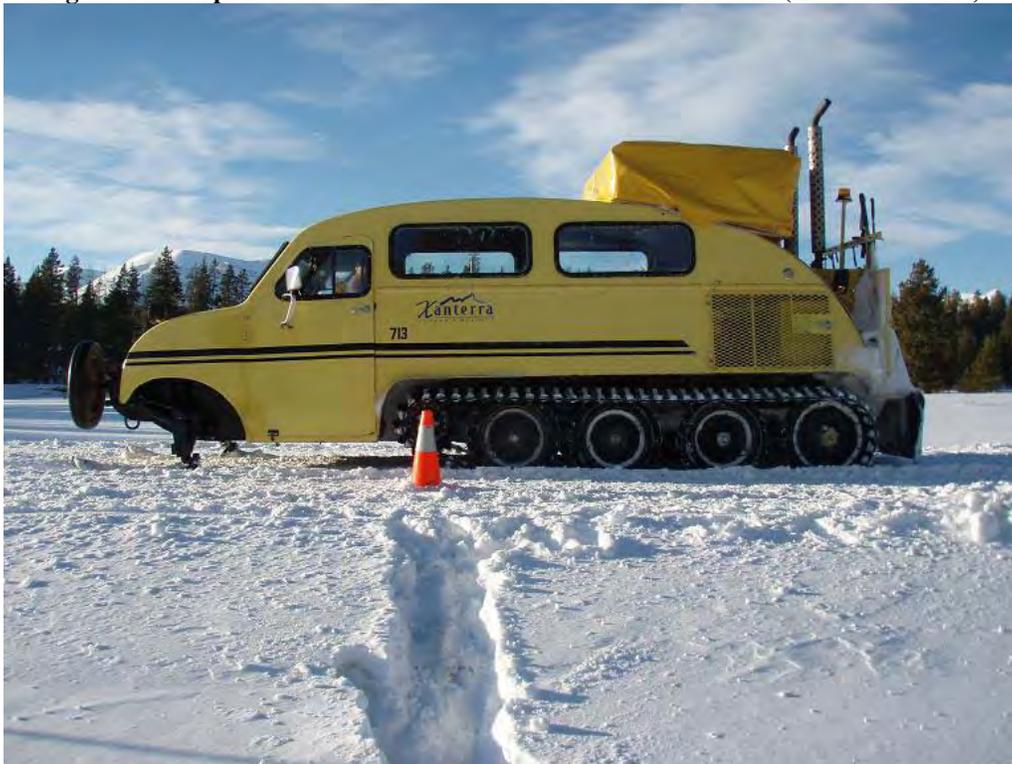
**Figure 25. Purpose Built Bombardier B-12 with Tracks and Skis (Xanterra – 713\*)**

\* It should be noted that the Xanterra models 707, 709, 710, and 713 were equipped with a tarp on the top to cover the storage rack. This tarp did not produce any noticeable noise, i.e. including flapping, during the measurements.

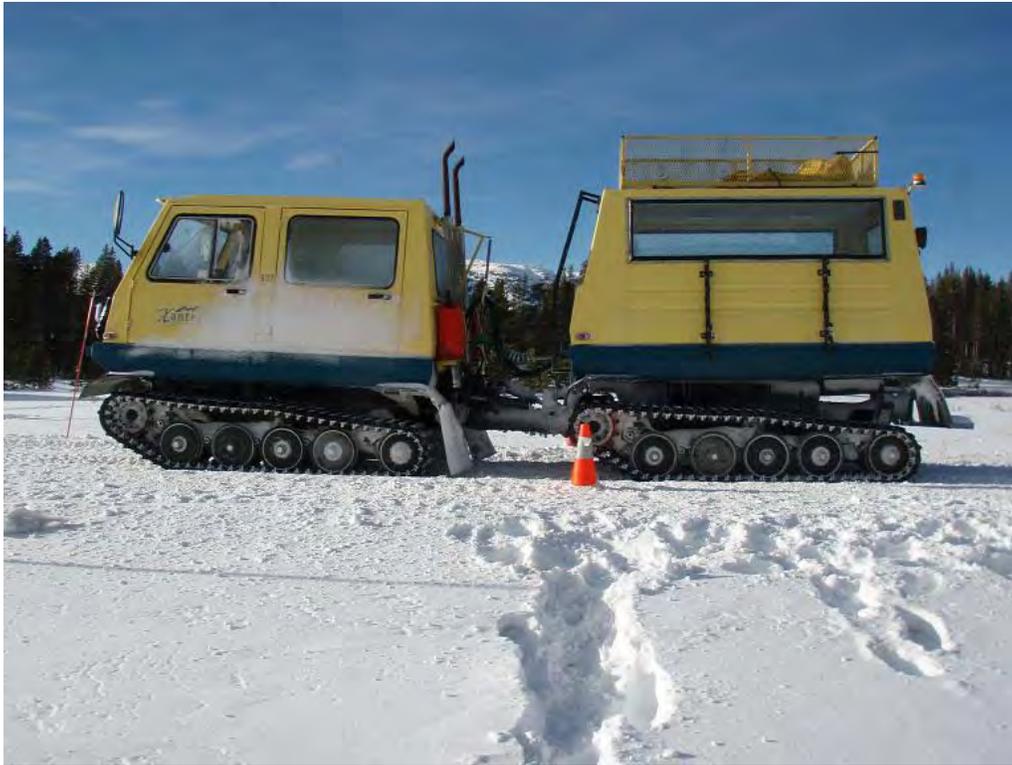
**Figure 26. Purpose Built Pirnoth Powder Tour Cat TR with Rubber/Tracks (Xanterra Pirnoth – 537)**

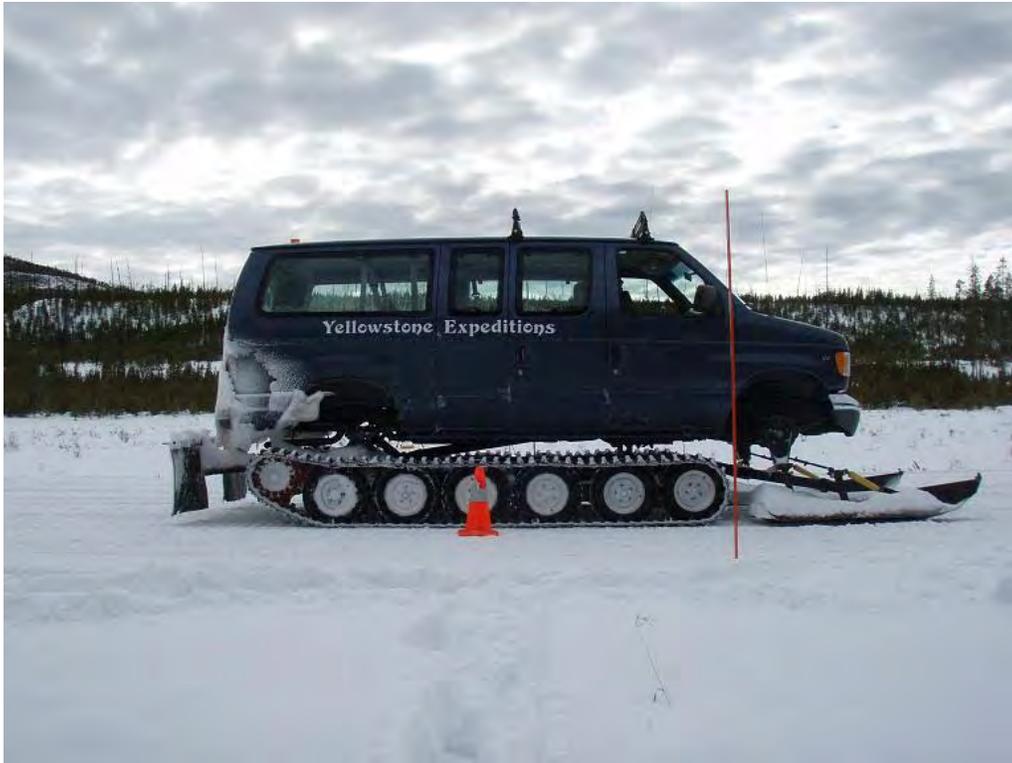
Figure 28. Converted Ford E150 van with Snowbuster (Yellowstone Expeditions – Eleanor)

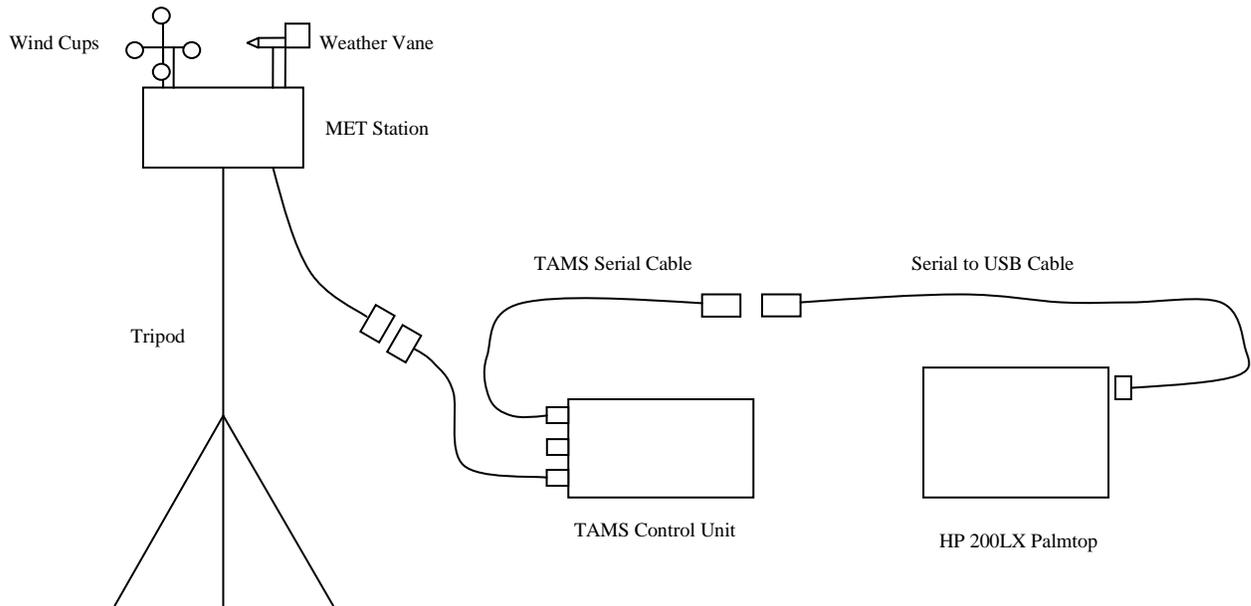
**Figure 33. TAMS Setup**

A Qualimetrics Transportable Automated Meteorological Station (TAMS) was used to measure wind speed, wind direction, relative humidity, barometric pressure, and air temperature at one-second intervals. A complete TAMS system consists of a sensor unit and a control / display unit that displays real time meteorological data. These battery-powered stations are portable and well suited for remote sampling. Table 10 shows the metrics collected and the operating accuracy, Figure 33 presents a block diagram of the system. The unit’s sensors were placed on a tripod at a

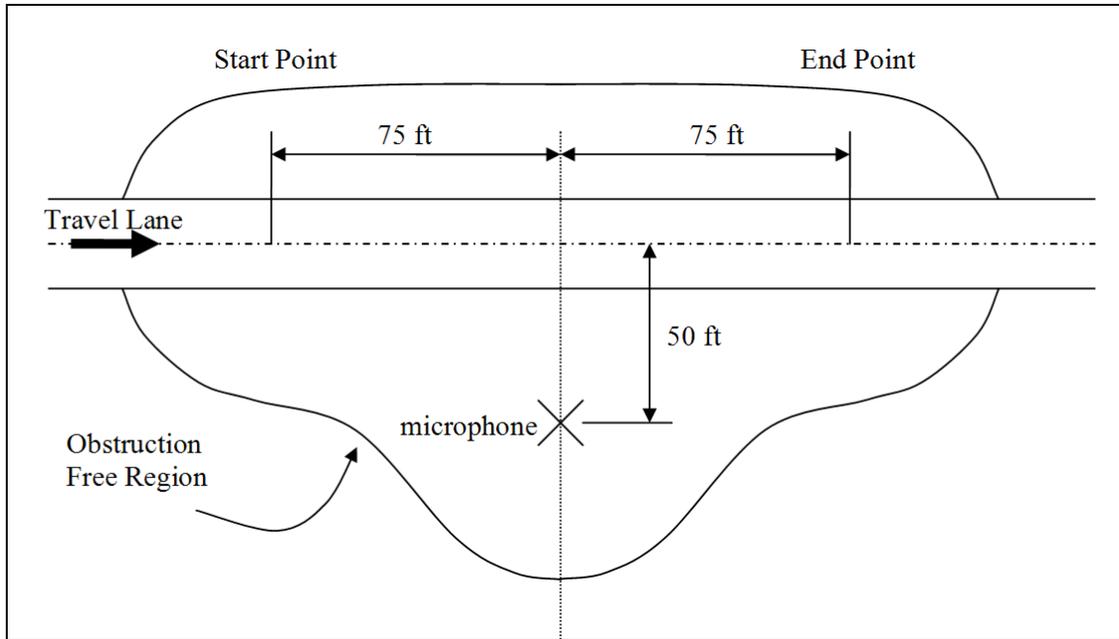
Figure 34. SAE J1161 Measurement Area Layout

SAE J1161 specifies a methodology for the measurement of exterior operational sound levels for snowmobiles. This methodology has been used in this study as snowmobiles and OSV's have similar propulsion systems, namely tracks and skis and are used at similar speeds in the parks. The measurement area is required to be an open region of packed snow at least 2 inches deep which is free of reflecting surfaces. The snowpack is required to be sufficient to support the OSV without penetration and with no more than 3 inches of loose snow on top of the packed snow. An illustration of measurement area requirements is provided in Figure 34.

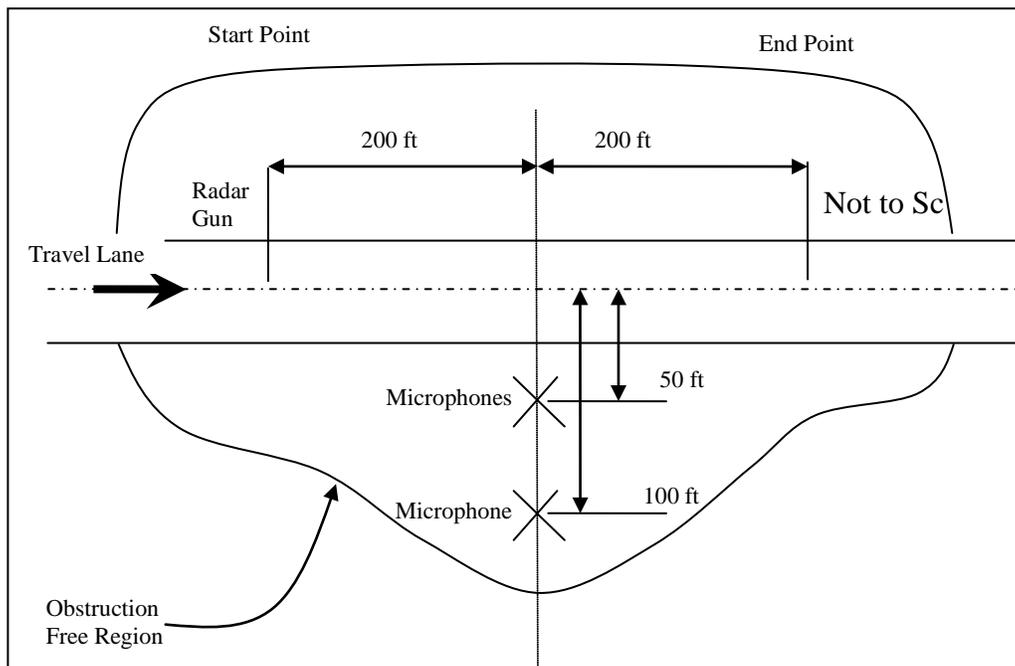
Figure 35. Extended Measurement Area Layout

A third microphone was positioned 50 feet from the center line of travel lane at a height of 15 feet above the snow cover. This microphone provided a measurement that was less influenced by the ground cover and any LOS occlusions between the microphone and the vehicle's track/snow interface.

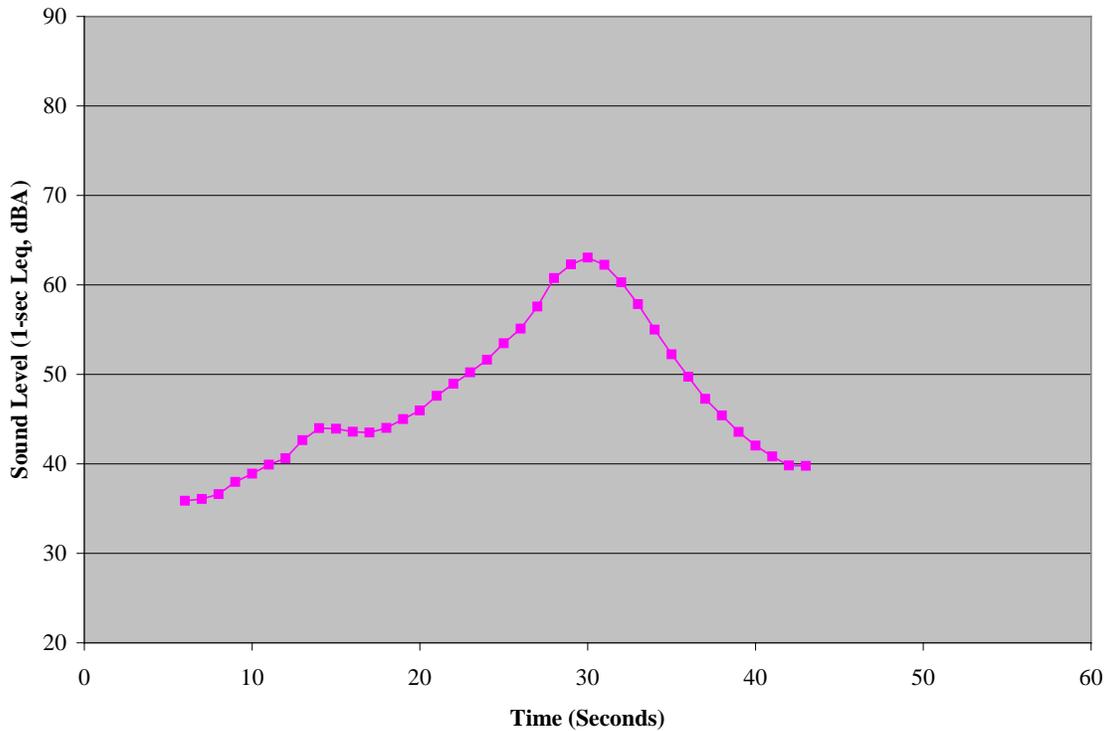
Figure 36. Yellowstone Snowcoach (SNOVAN4) Van, Left Side at Low Speed (15 mph)

An example sound level time history for the Yellowstone Snowcoach (SNOVAN4) Gasoline Econoline snowcoach operating at low speed (15 mph) pass-by is shown in Figure 36. The underlying data are 1-second, equivalent sound levels  $L_{Aeq,1sec}$ . This figure shows the general pattern observed for pass-by events: values increase as the snowcoach approaches the microphone center line; there is a peak region; values then decrease as the snowcoach travels away from the microphone center line. Another important feature to observe is that the peak sound level is at least 10 dBA greater than the lowest approach and lowest departure sound levels. This minimum 10 dBA criterion was maintained throughout the study and ensures that a clean pass-by was acquired and that analyses using these data will not be unduly contaminated with sound sources other than the vehicle under study. An example time history profile is given in Figure 37 for a high speed (33 mph) pass-by of the Yellowstone Snowcoach – SNOVAN4 snowcoach.
