***EXTERIOR SOUND LEVEL  
MEASUREMENTS OF SNOWCOACHES  
AT YELLOWSTONE NATIONAL PARK***

April 2010  
Final Report

Prepared by:  
U.S. Department of Transportation  
Research and Innovative Technology Administration  
John A. Volpe National Transportation Systems Center  
Environmental Measurement and Modeling Division, RVT-41  
Cambridge, MA 02142

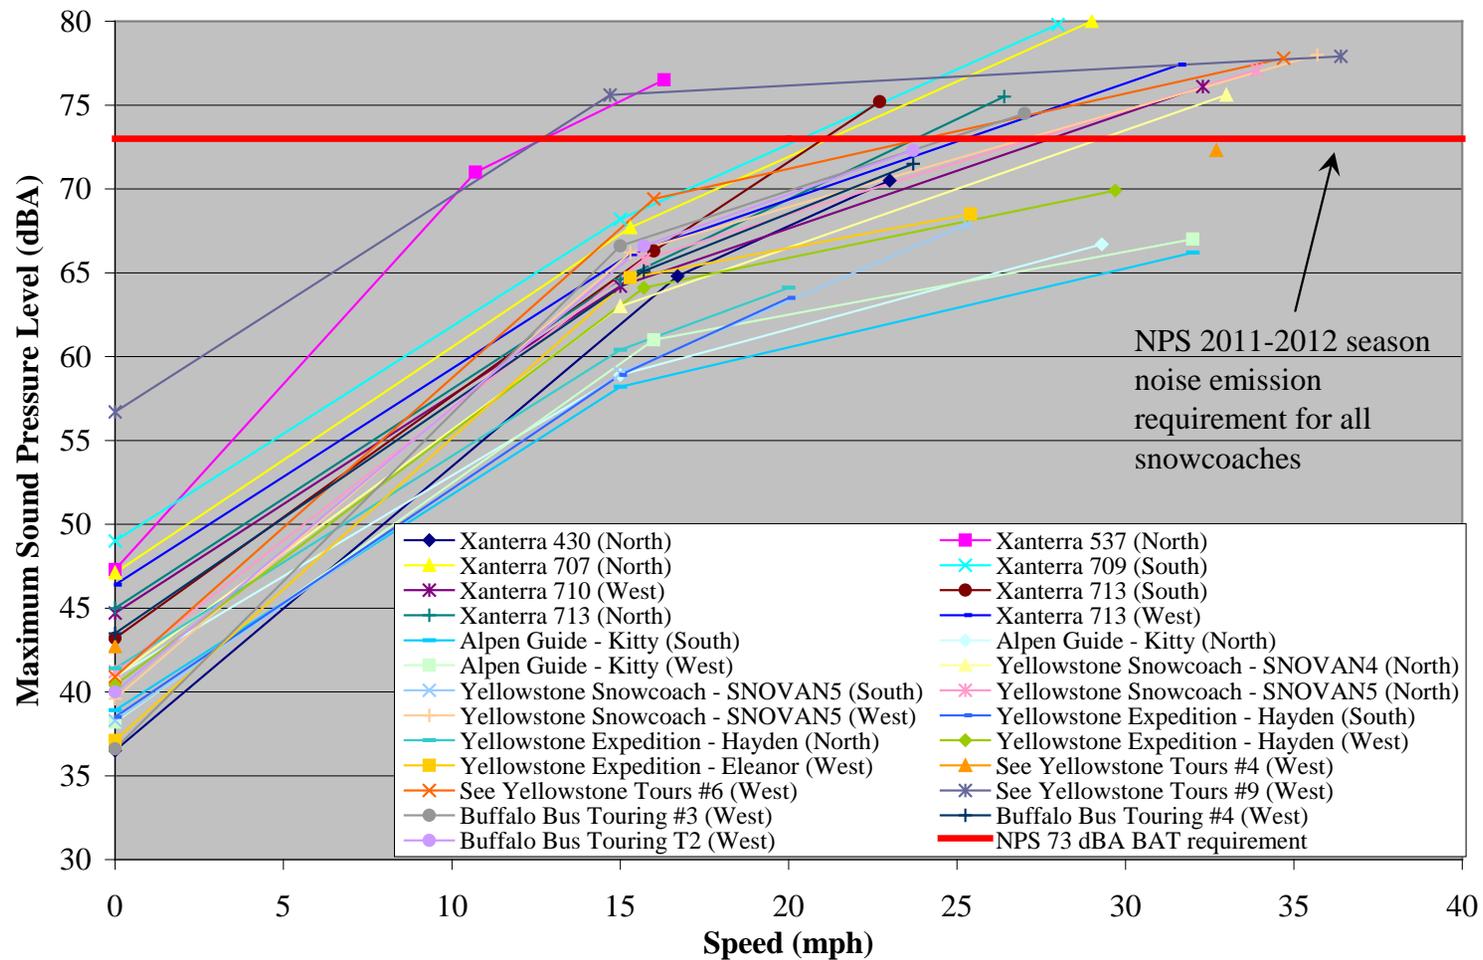
Figure 39. Maximum Sound Level vs. Speed\* for All Snowcoaches

The pass-by sound levels for low speeds and high speeds were combined with idle sound levels to generate sound level versus speed curves as shown in Figure 39. This figure presents the data from Table 14 through Table 16 graphically for easier comparison as a function of speed. It should be noted that evaluating the curves, based on idle, low and high speeds, is an imperfect method. Measuring more points would create a more realistic representation of snowcoach noise characteristics, but is outside the scope of this project. Previous vehicle studies<sup>10</sup> have shown that an increase in speed versus sound level should roughly follow an increasing monotonic curve. This relationship would allow us to qualitatively describe gross site differences.

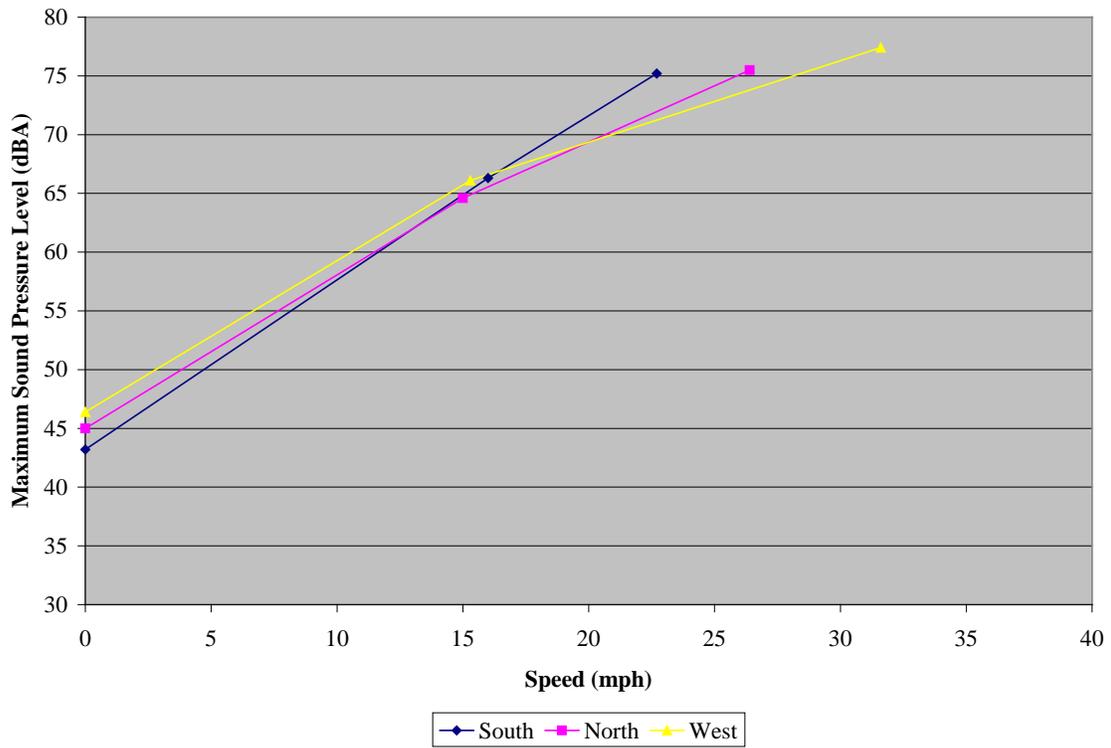
Figure 42. Maximum Sound Level vs. Speed for Xanterra 713

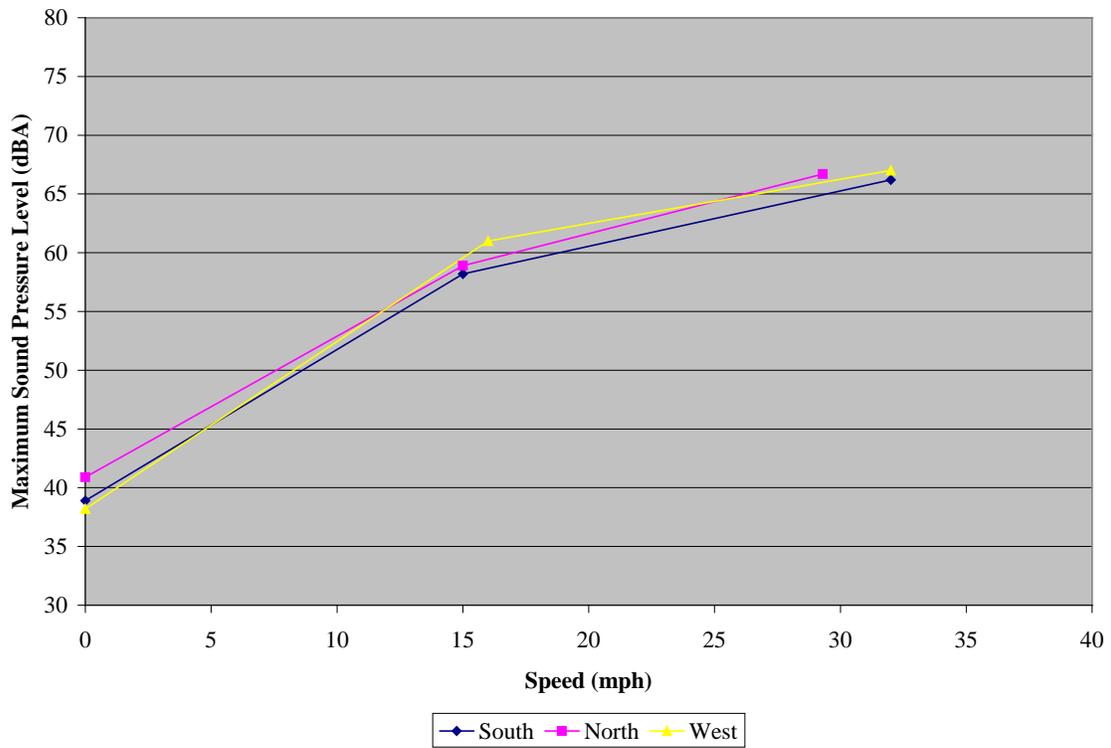
Figure 43. Maximum Sound Level vs. Speed for Alpen Guide - Kitty

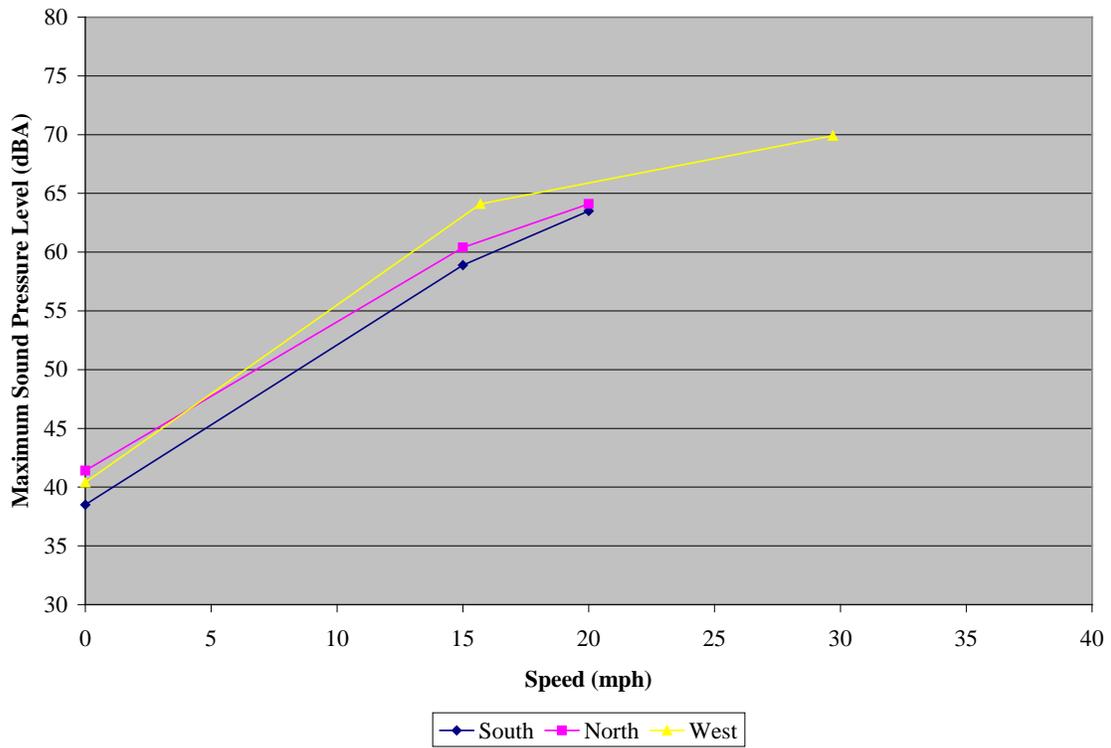
Figure 44. Maximum Sound Level vs. Speed for Yellowstone Expedition – Hayden

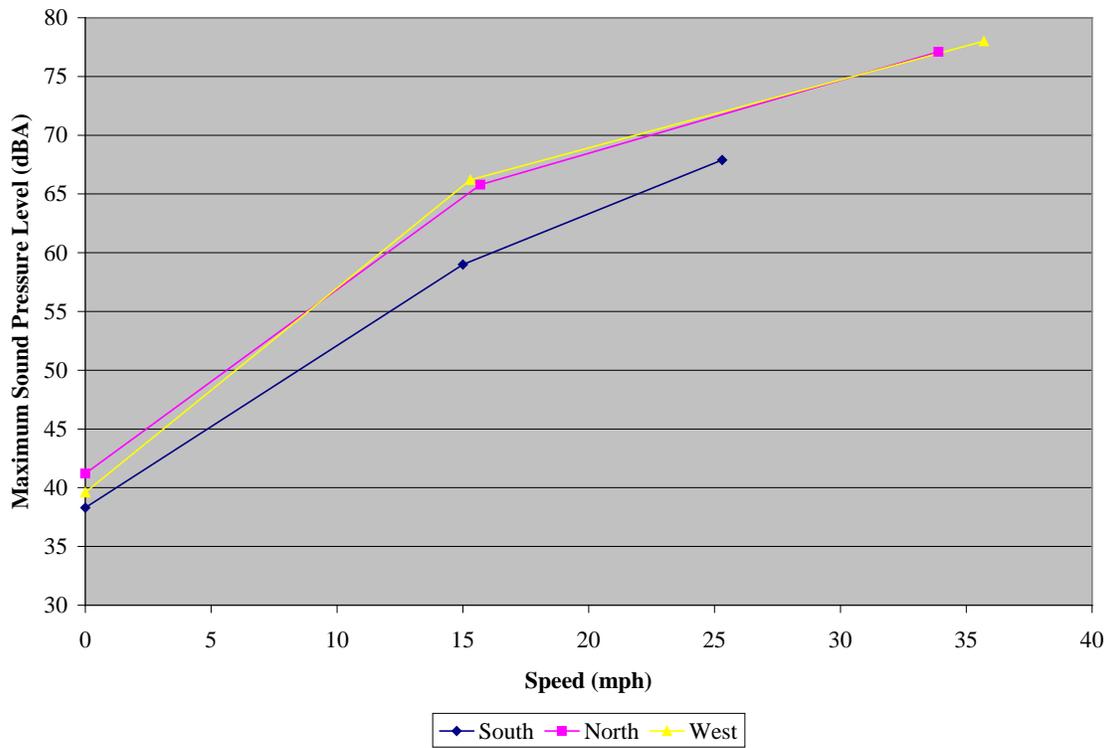
Figure 45. Maximum Sound Level vs. Speed for Yellowstone Snowcoach – SNOVAN5

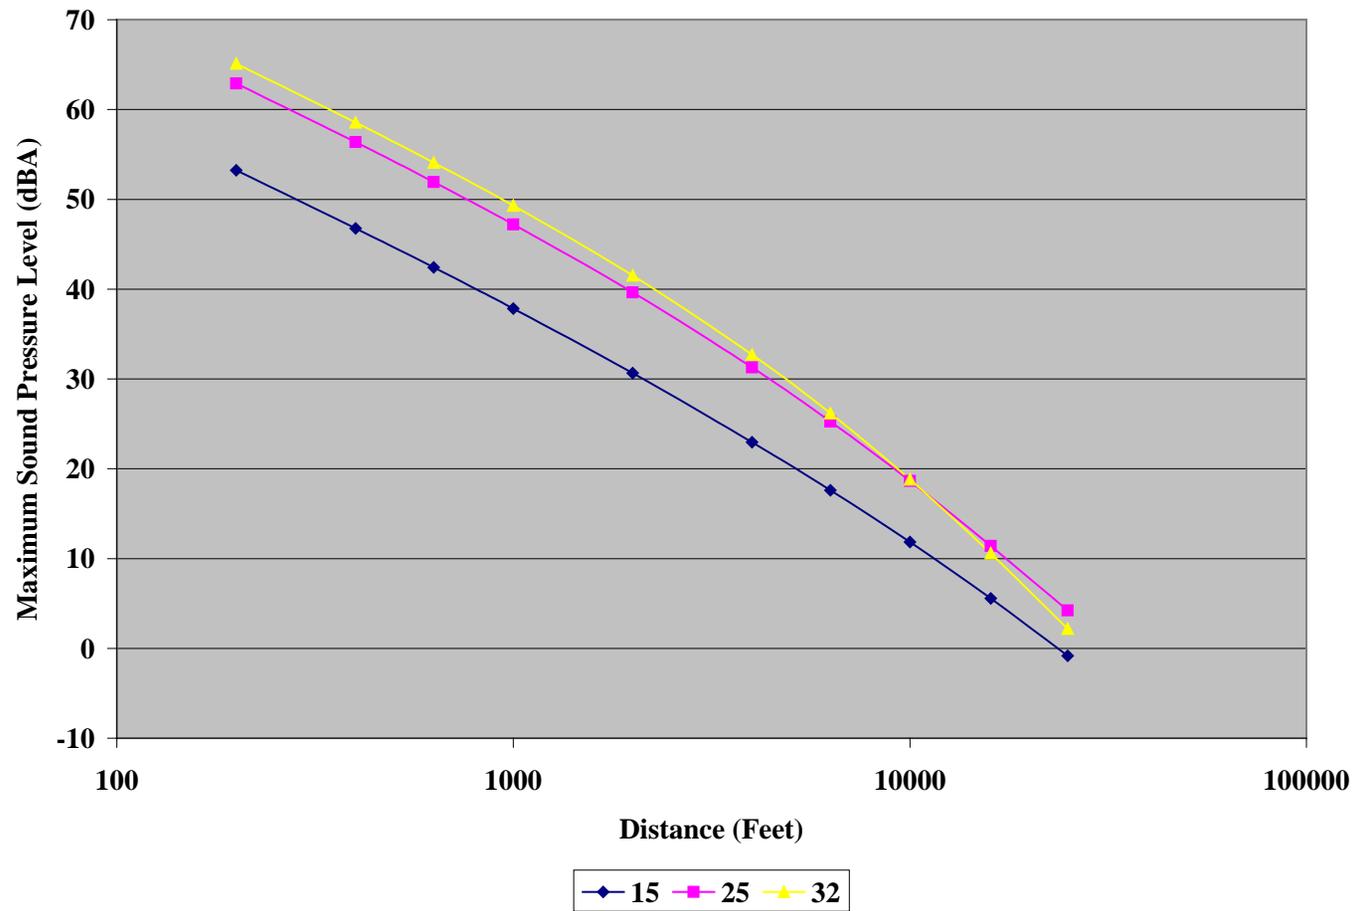
Figure 46. Xanterra 713 Maximum Sound Pressure Level Noise-Distance Curves

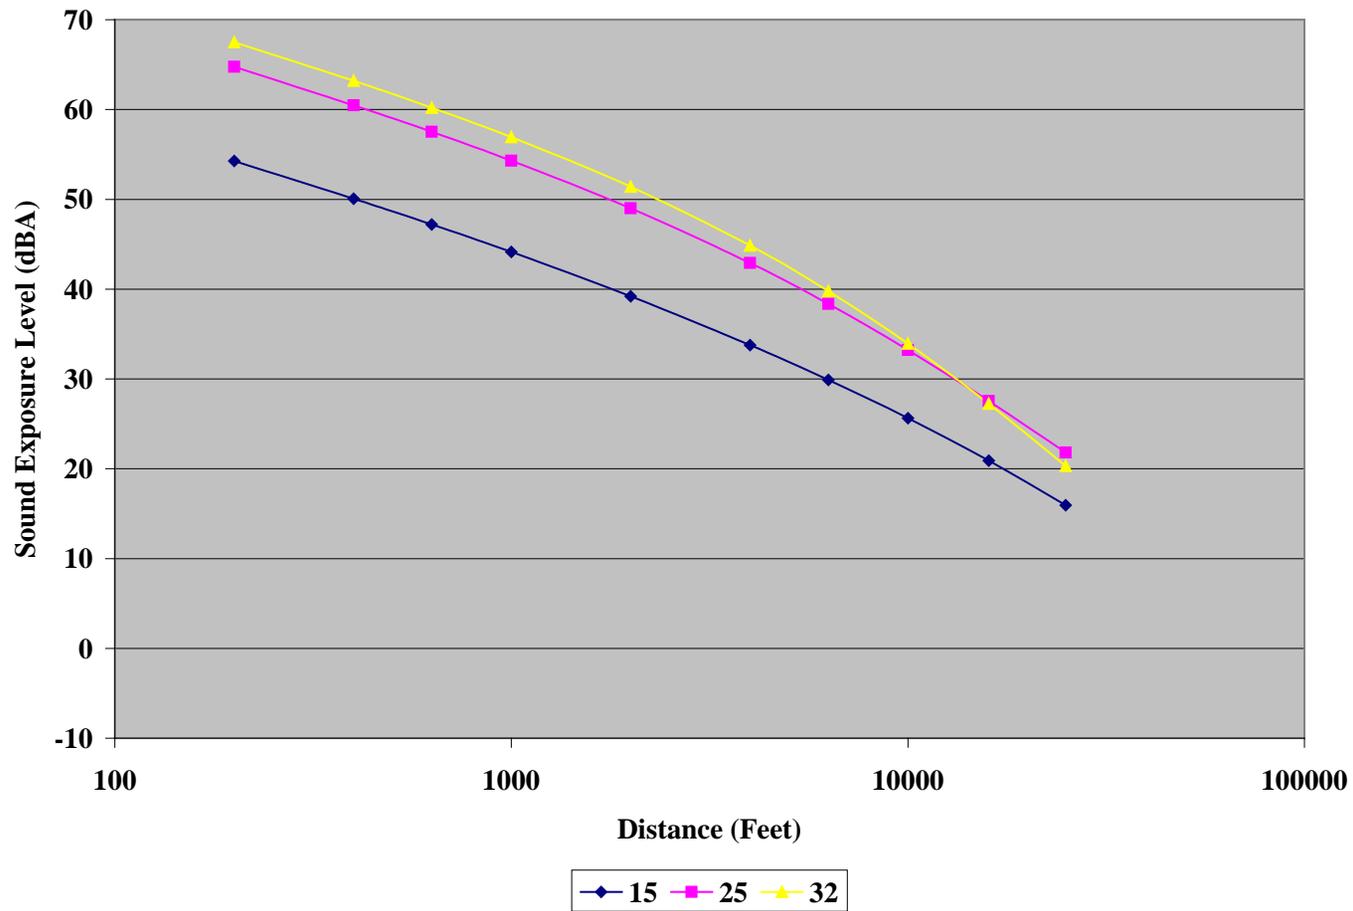
Figure 47. Example Low Speed SEL Noise-Distance Curves

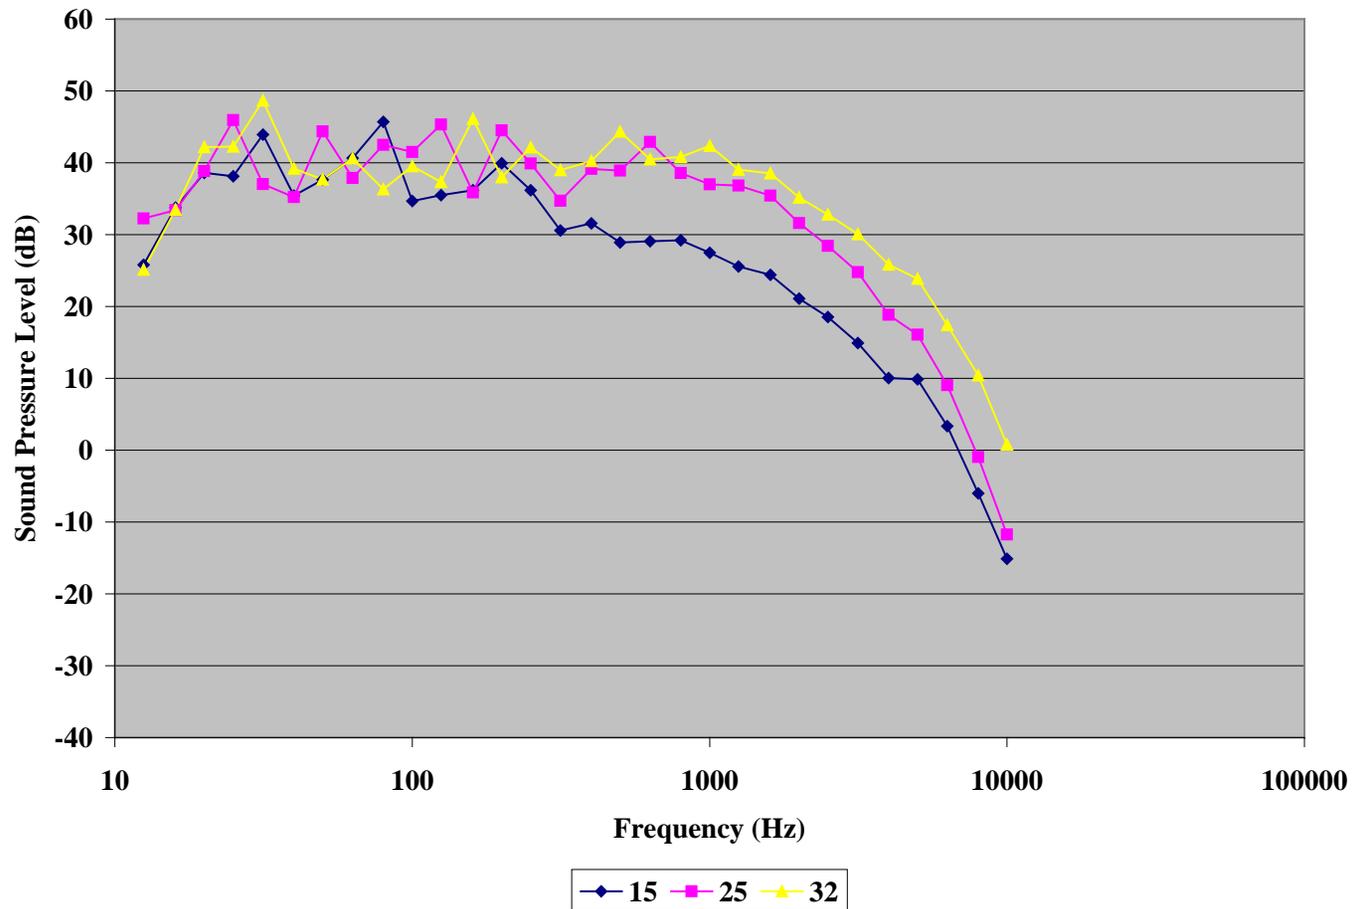
Figure 48. Xanterra 713, 1000 Feet, Maximum Spectra
