1. Report No. FHWA/TX-03/4413-1	2. Government Accession No.	3. Recipient's Catalog No.	
4. Title and Subtitle ADVANCE WARNING OF STOPPED TRAFFIC ON FREEWAYS: CURRENT PRACTICES AND FIELD STUDIES OF QUEUE PROPAGATION SPEEDS		5. Report Date October 2002 Resubmitted: June 2003

**ADVANCE WARNING OF STOPPED TRAFFIC ON FREEWAYS:  
CURRENT PRACTICES AND FIELD STUDIES OF  
QUEUE PROPAGATION SPEEDS**

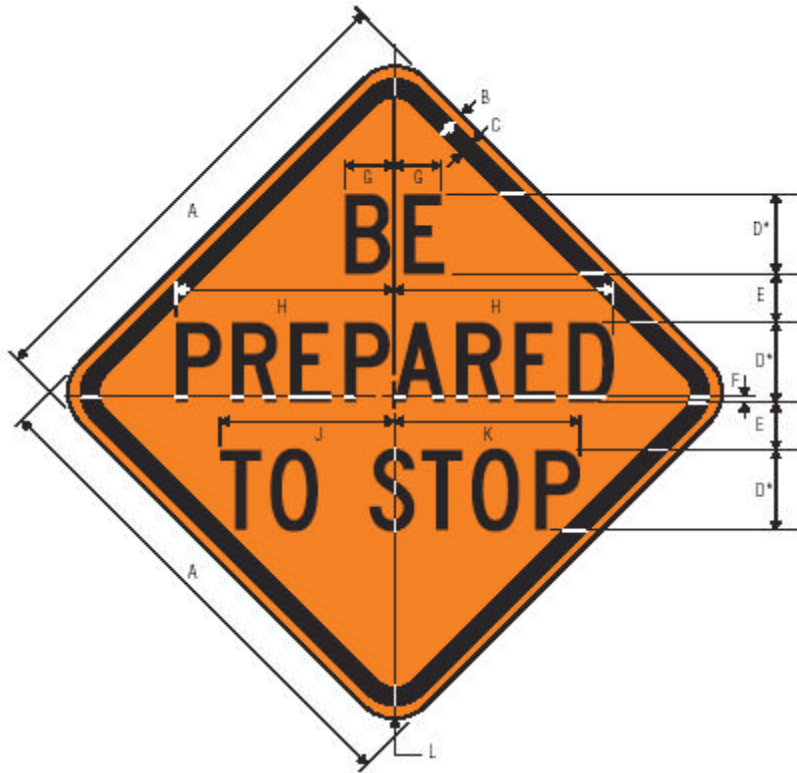
Figure 2-3. Be Prepared to Stop Sign (W20-7b) – 2000 MUTCD Edition.<sup>20</sup>

Guidance from the Millennium Edition of the *Manual on Uniform Traffic Control Devices*<sup>20</sup> indicates that the **BE PREPARED TO STOP** (W20-7b – [Figure 2-3](#)) sign “may be used to warn of stopped traffic caused by traffic control signals or in areas that regularly experience traffic congestion.” As an option, the MUTCD states flashing beacons may supplement the sign. The MUTCD further states that “if the sign is interconnected with a queue detection system, the W20-7b sign should be supplemented with a **WHEN FLASHING** plaque.” [Figure 2-4](#) shows the **SLOW TRAFFIC AHEAD** sign that also has some application for queue warning.

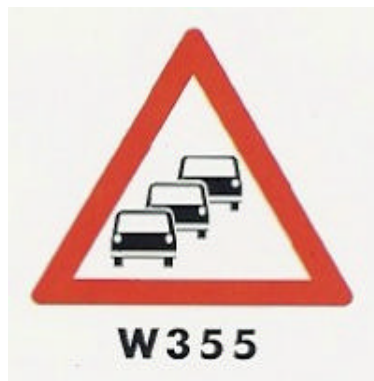
**Figure 2-5. New Zealand Warning Sign for Slow or Stopped Traffic Ahead.**<sup>23</sup>

In New Zealand, the W355 warning sign (Figure 2-5) is used to alert drivers to a possible hazard due to slow or stopped traffic on the roadway ahead caused by limited visibility due to roadway alignment or traffic density.<sup>23</sup> Furthermore, the explanation of the sign meaning from the Internet stated, "it may require that the driver significantly reduce speed or stop."

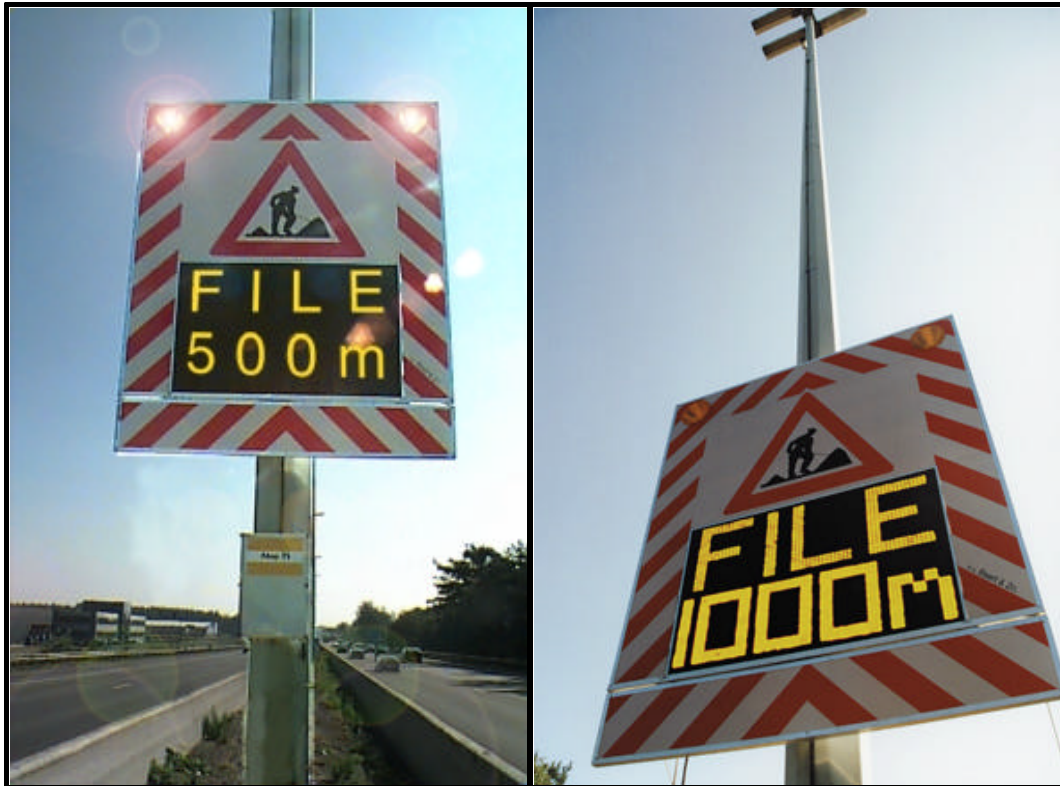
Figure 2-7. Activated VMS Panels in the Queue Detection and Warning System.<sup>27</sup>

- Detection and Warning: a monitoring camera, directed to the traffic on the E313 freeway, is used to detect the queue. This video detection camera measures the speed of traffic and the occupancy of each traffic lane. The occupancy is a number between 0% and 100% indicating how many seconds per minute a part of the traffic lane is being occupied. An occupancy of 0% indicates that there is no traffic at that detection station. The occupancy during normal flow is generally below 20%. When traffic is driving slowly, occupancy values are typically over 50%. When traffic is completely stopped, the occupancy is 100%. The E313 system thresholds for queue detection are, speed below 50 km/h (31 mph) in one or more lanes; and occupancy over 50%. When these thresholds are met, the video detector immediately passes an alarm on to the controller unit. The controller unit responds by activating the upstream VMS panels at 500 m (1640 ft) with the message **FILE 500 m** (translation: the word FILE means queue) and a second set of VMS panels at 1 km (0.62 mile) with the message **FILE 1000 m** (Figure 2-7). This design provides the road user warning 1 km (0.62 mile) before reaching the queue.

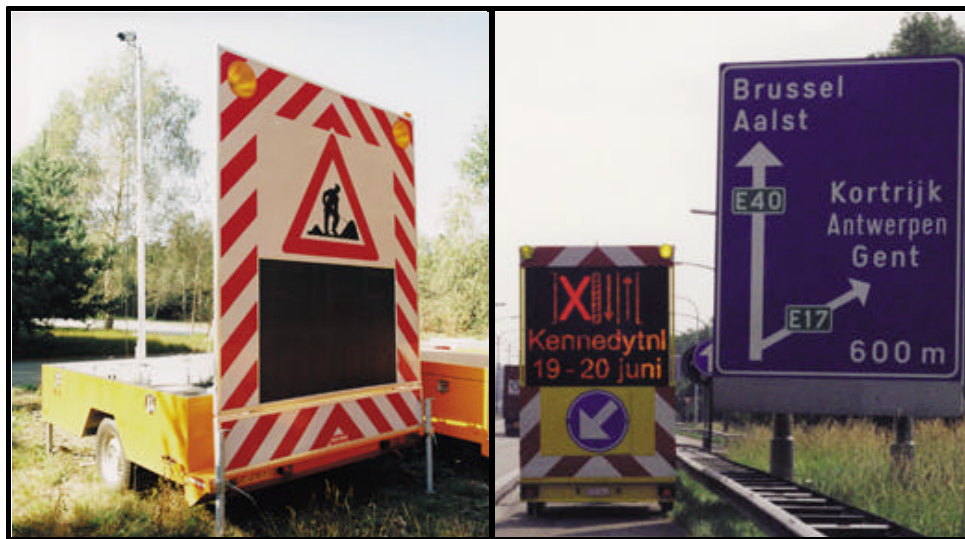
Figure 2-8. Trailer-Mounted VMS for Queue Detection and Warning.<sup>27</sup>

- Execution: this detection system is used in both directions on the E313 freeways from Antwerpen to Hasselt. Eighteen VMS panels were mounted on posts in the median every 500 m (1640 ft) in the direction of Hasselt and 12 panels mounted on median posts and 6 on portable trailers (Figure 2-8) in the direction of Antwerpen. Two of the trailers are equipped with the extra capability of allowing the police at Antwerpen to retrieve live images of the cameras. Two other trailers are equipped with a system that counts the cars and can classify them automatically into categories (motorcycle, car, and truck). The average speed of the traffic is also detected. This information is transmitted to a central computer at a monitoring facility in Antwerpen. When the construction project is complete, the panels can be removed and used elsewhere.

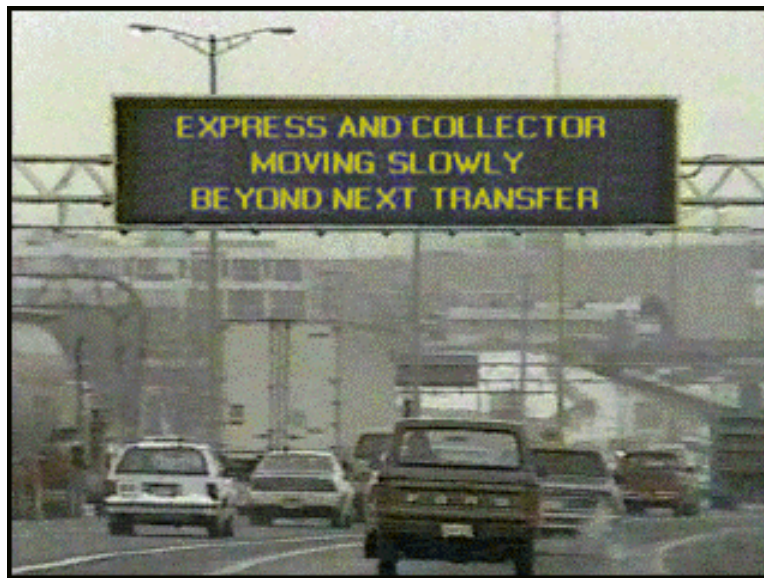
**Figure 2-9. Large VMS Display in the Toronto Area.**<sup>28</sup>

The Ministry of Transportation Ontario (MTO) has deployed several systems to detect and warn motorists of traffic conditions ahead. The COMPASS system in the Toronto metropolitan area utilizes large VMSs to advise travelers approaching adverse traffic conditions (Figure 2-9). The

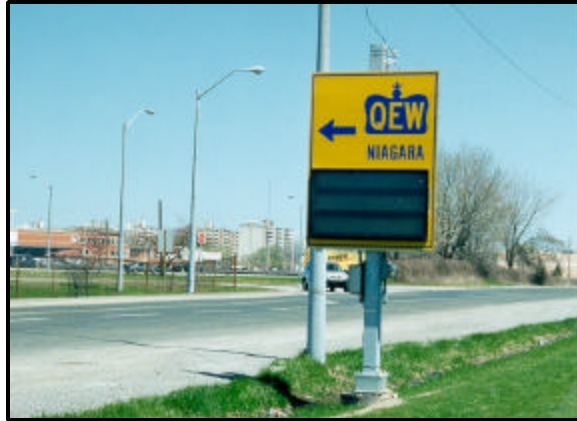
Figure 2-10. Arterial Advisory Sign with VMS Panel.<sup>28</sup>

The operation of the QWS is relatively simple. When the differential speed between two microwave detection stations is high, upstream motorists are advised accordingly through dedicated elements. The system uses portable VMSs for the queue warning on the freeway mainline sections and arterial advisory signs (AAS) on a number of local roads that access the freeway. There are two types of AASs: (1) VMS panel; or (2) static sign with indicator beacons, which provide motorists an indication of traffic conditions on the QEW. [Figure 2-10](#) shows one of the VMS panel AAS near an entrance ramp. A rendering of the AAS with indicator beacons is provided in [Figure 2-11](#).

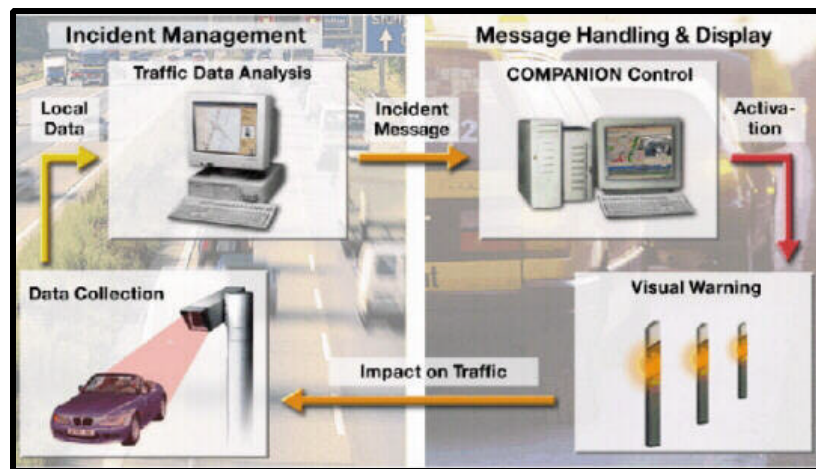
Figure 2-13. Flowchart of COMPANION System Detection and Warning Process.<sup>36,37</sup>

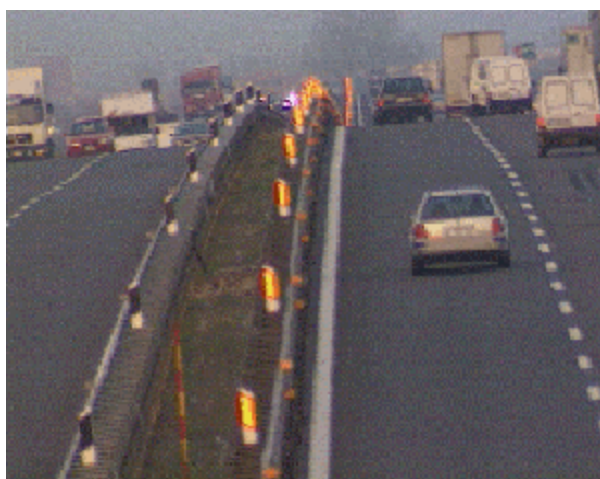
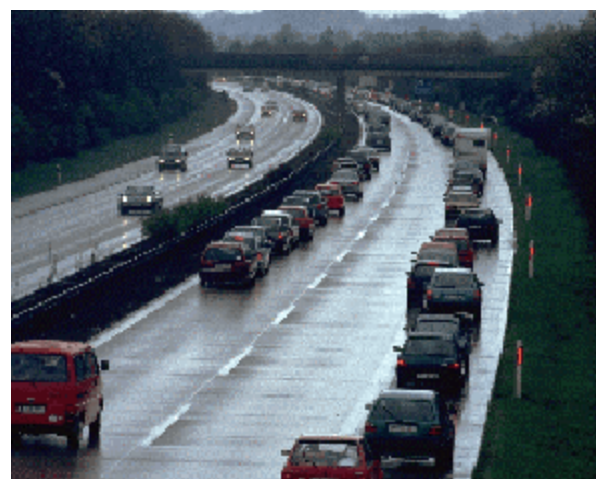
Italian median installation

German outside shoulder installation

Figure 2-14. Pictures of COMPANION System Installations in Italy and Germany.<sup>36,37</sup>

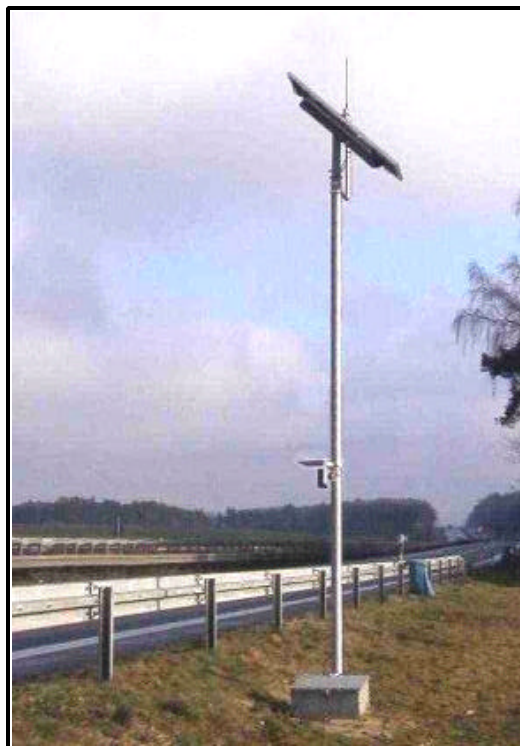
Figure 2-15. Infrared Detection Station in Germany.<sup>38</sup>

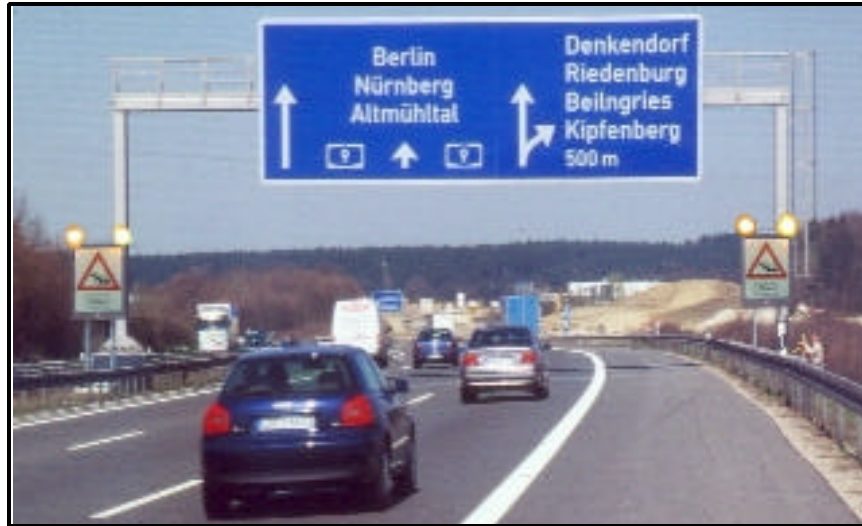
Figure 2-16. Mobile Traffic Jam Warning System on Autobahn 9.<sup>38</sup>

The first construction-based system is located on Autobahn 3 in a construction zone near the Hosbach junction. The second construction-based system is installed on Autobahn 9 near the Greding junction. Both of these applications utilize a mobile traffic jam warning system (MTJWS). All system components (detectors and variable message signs) have an independent power supply by photovoltaic. Active infrared detectors positioned on the side of the road measure traffic queue data (Figure 2-15). The traffic condition information acquired by the system detectors is processed in the central module, converted to signal commands according to a predefined control matrix and then directed to the displaying modules. Finally, road users are dynamically informed about the current traffic conditions on the road ahead (e.g., length of the queue) by sets of VMSs positioned to the left and right of the road, respectively (Figure 2-16). A picture of the border queue warning system on Autobahn 12 is provided in Figure 2-17.

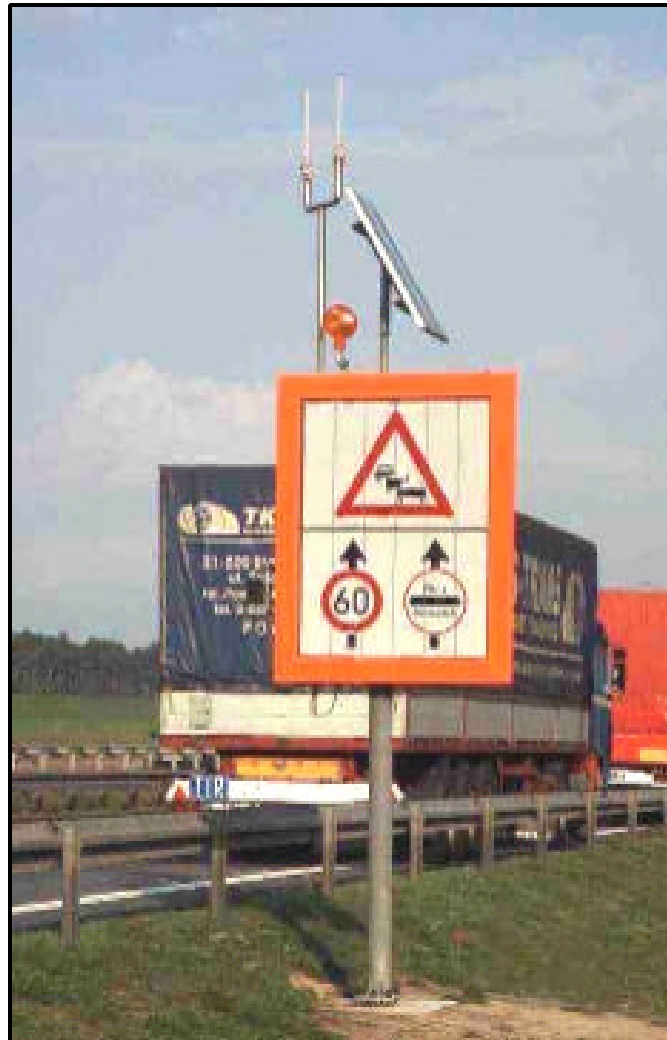
Figure 2-17. Mobile Traffic Jam Warning Sign near the Germany/Poland Border.<sup>38</sup>

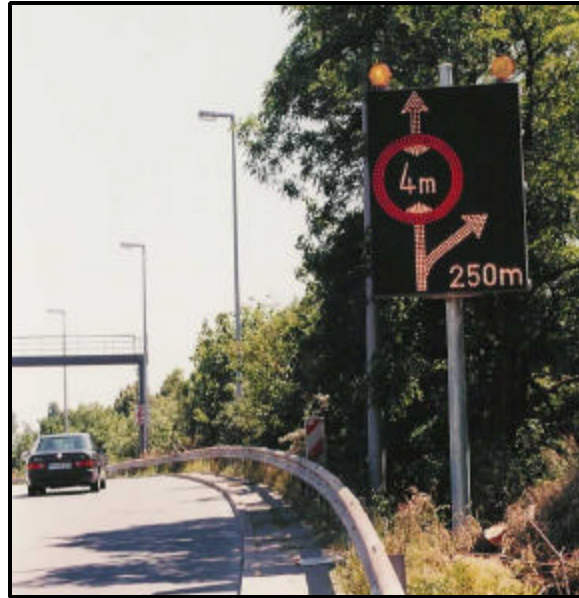
**Figure 2-18. Small Roadside VMS on Autobahn 100 in Germany.**<sup>39</sup>

German officials have equipped several other roads with advance motorway control, including queue detection and warning systems. Autobahn 100 in Berlin is one of the busiest motorways. Almost 19 km (11.8 miles), the Autobahn 100 loops around the entire western section of downtown Berlin. The Siemens corporation has recently installed several components that provide motorists with advance warning of slow and/or stopped traffic ahead.<sup>39</sup> The detection portion of the Autobahn 100 system utilizes video cameras for queue detection. The queue warning components include small VMS with flashers (mounted both roadside and in the median — [Figure 2-18](#)), variable speed limit signs (flip-panel technology — [Figure 2-19](#)), and lane control signals ([Figure 2-20](#)).

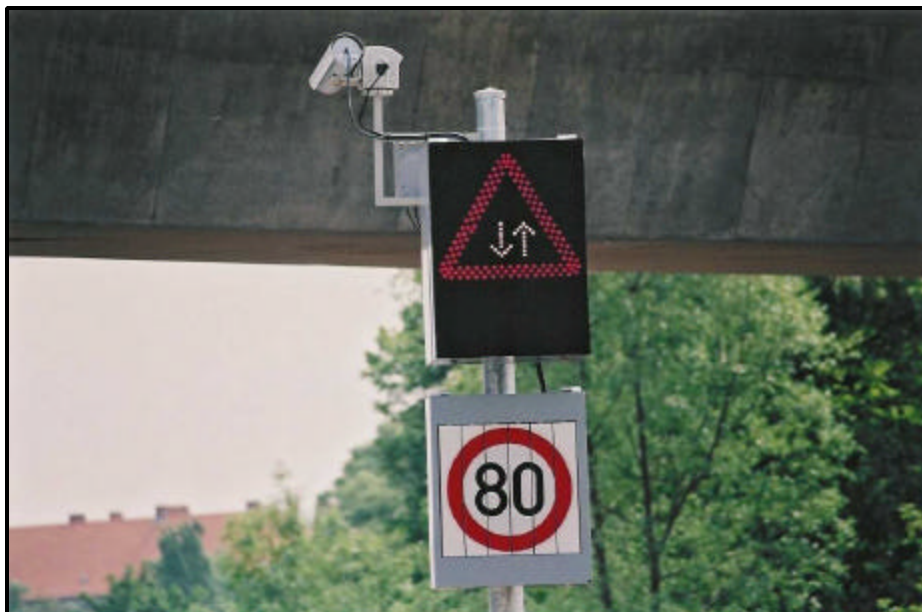
**Figure 2-19. Variable Speed Limit Sign on Autobahn 100 in Germany.**<sup>39</sup>

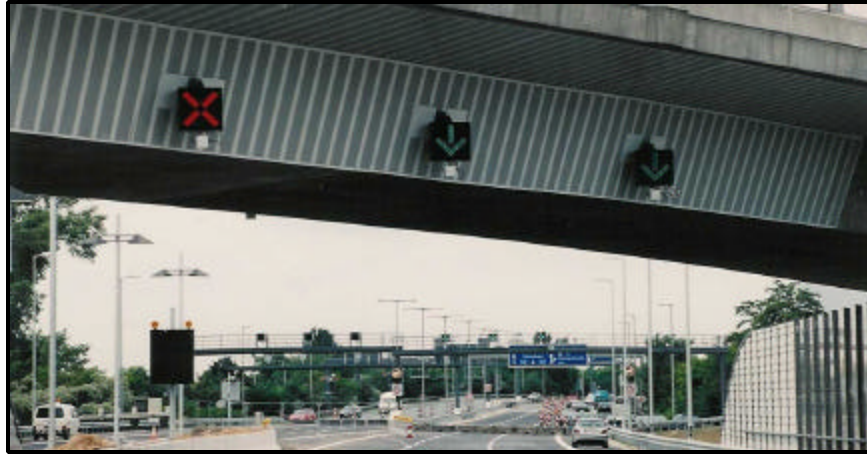
**Figure 2-20. Bridge-mounted Lane Control Signals on Autobahn 100 in Germany.**<sup>39</sup>

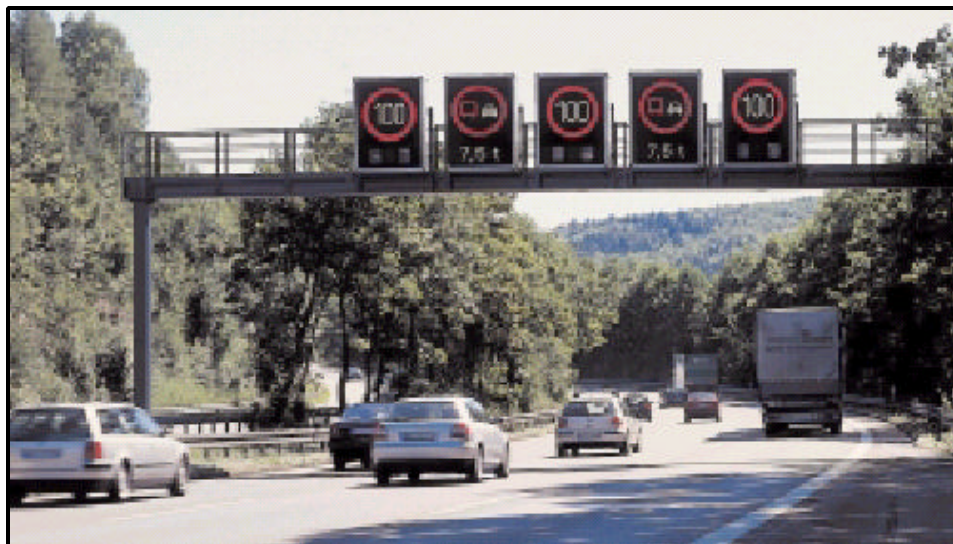
**Figure 2-21. Overhead Gantry with Multiple VMSs on Autobahn 92 near Munich.**<sup>40</sup>

The Siemens corporation has also installed advanced technologies on the Autobahn 9 and Autobahn 92 motorways on the north side of Munich.<sup>40</sup> In addition to some of the components pictured in Figures 2-18, 2-19, and 2-20, the system near Munich also utilizes overhead gantries with VMSs to warn motorists of queues ahead (Figure 2-21). This system also detects queues using video-based technology.

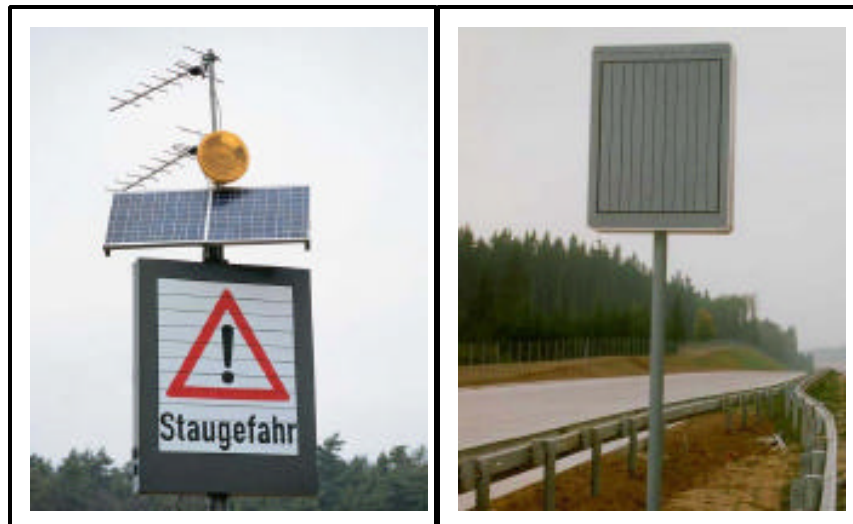
Figure 2-23. Variable Prism Panel Signs Used for Queue Warning in Germany.<sup>38</sup>

Figure 2-22 provides a graphical representation of a QWS with multiple queue warning signs and overhead detection (NOTE: translations – STAU = queue, triangle with exclamation point = danger, and Staugefahr = queue danger). Figure 2-23 shows this system deployed in the field with a variable prism panel sign with the congestion warning displayed and solar panel, and a variable prism panel sign with neutral display without the solar panel.

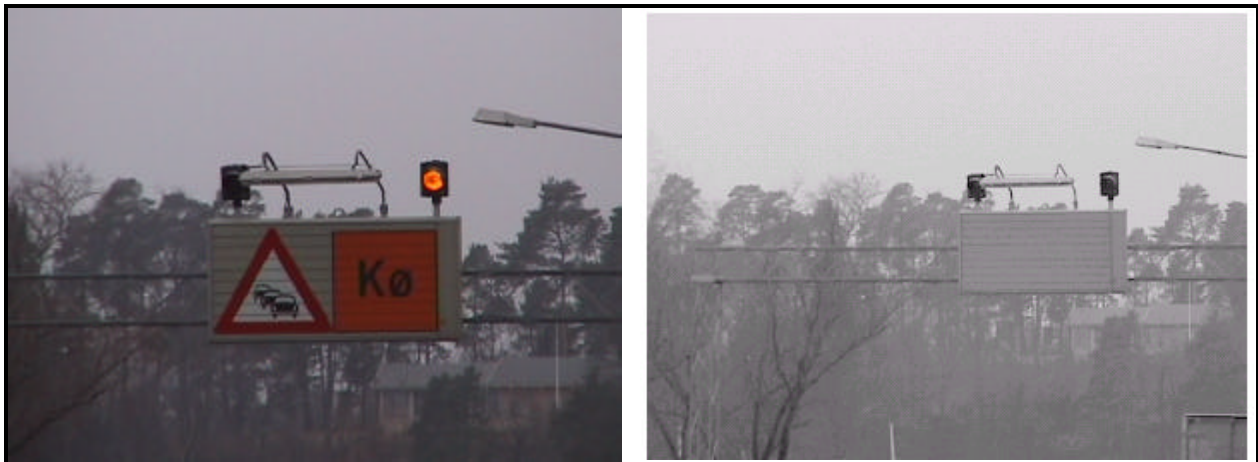
Figure 2-26 provides an example of the typical queue warning VMS used in the Oslo QWS. The left panel of Figure 2-26 shows the sign with the queue warning and flashers activated. The right panel of Figure 2-26 shows the sign without any queue warning.

**Figure 2-26. Oslo Queue Warning Signs.<sup>44</sup>**

The PRA designed the system so that queue detection is cancelled when the speed of traffic is higher than 30 km/h (19 mph) or the zone occupancy is lower than 30% for more than 20 seconds. A queue warning is issued only when there is a queue present immediately after passing the VMS. In other words, there is no queue warning when the queue starts before or adjacent to the VMS. The driver is at that time already in queue and does not need to be warned about queues ahead. Also, if a queue is detected at one or more of the cameras that are placed after the VMS, and not at the camera adjacent to the VMS, a queue warning is displayed at the VMS.

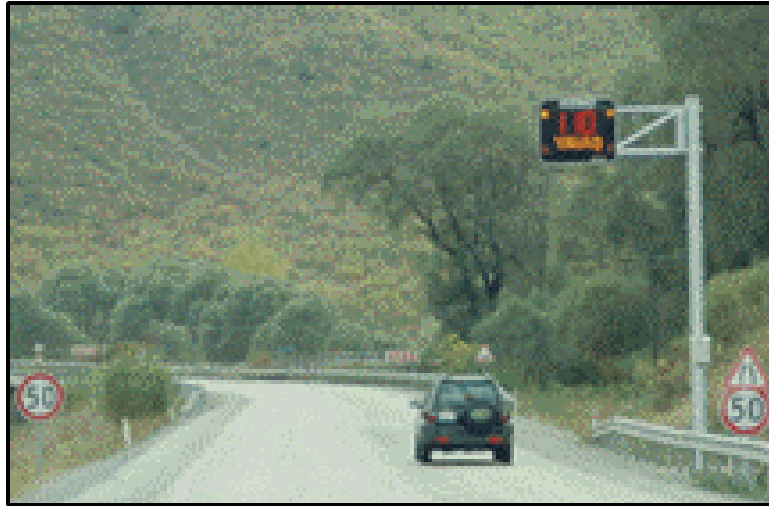
Figure 2-29. Doppler Radar Speed Warning System on Turkish Motorway.<sup>47</sup>

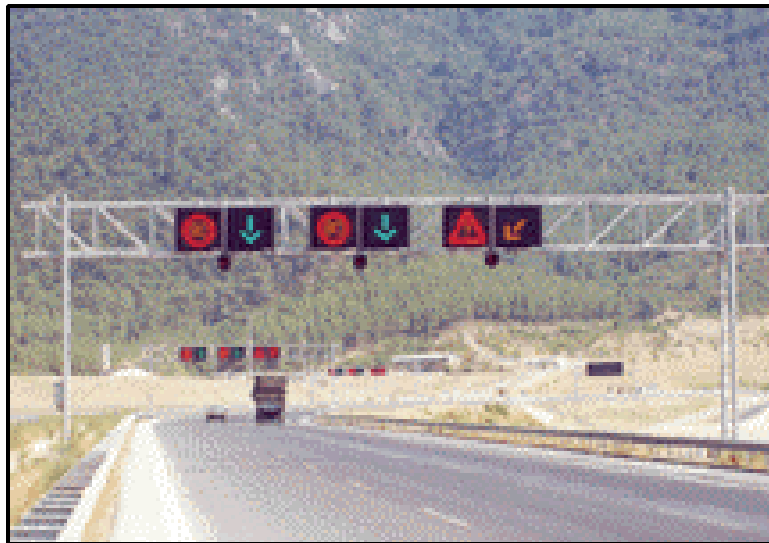
Figure 2-30. Example of Variable Traffic Sign Display on Turkish Motorway.<sup>47</sup>

- Figure 2-30 provides an example of a typical VTS approaching a tunnel entrance.
- c) Mobile Variable Message Sign – This system is trailer-mounted and is used to dynamically warn drivers about traffic conditions (road, weather, etc.). A mobile variable message sign with a queue warning (i.e., three cars inside a triangle) is shown in Figure 2-31. Figure 2-31 also shows a sign with speed limit and text messages.

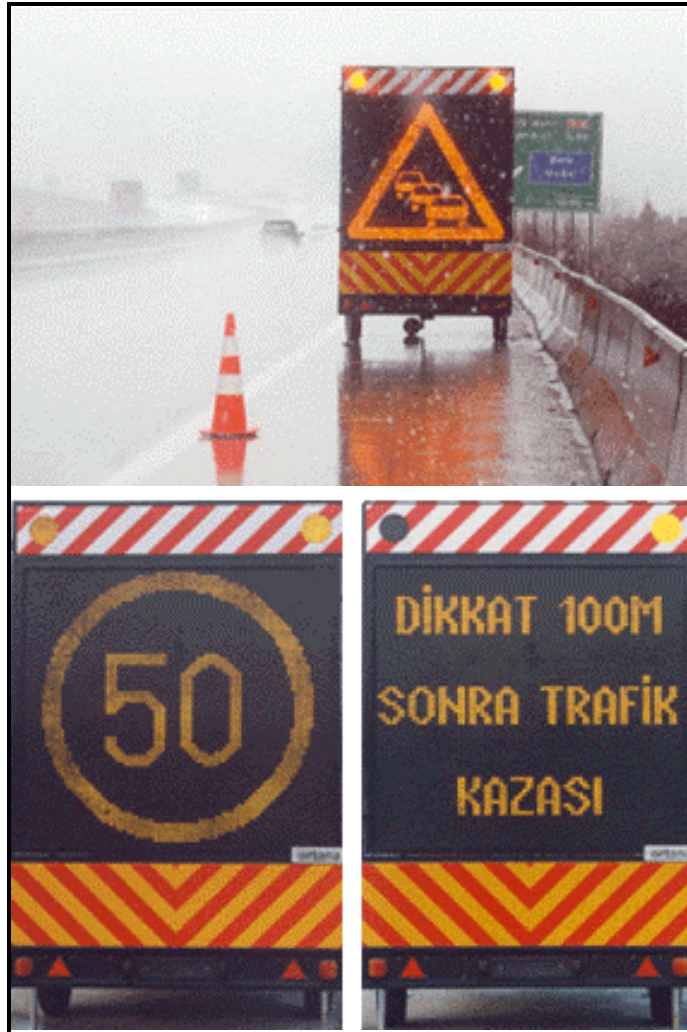
**Figure 2-31. Mobile Variable Message Sign Trailers on Turkish Motorways.**<sup>47</sup>

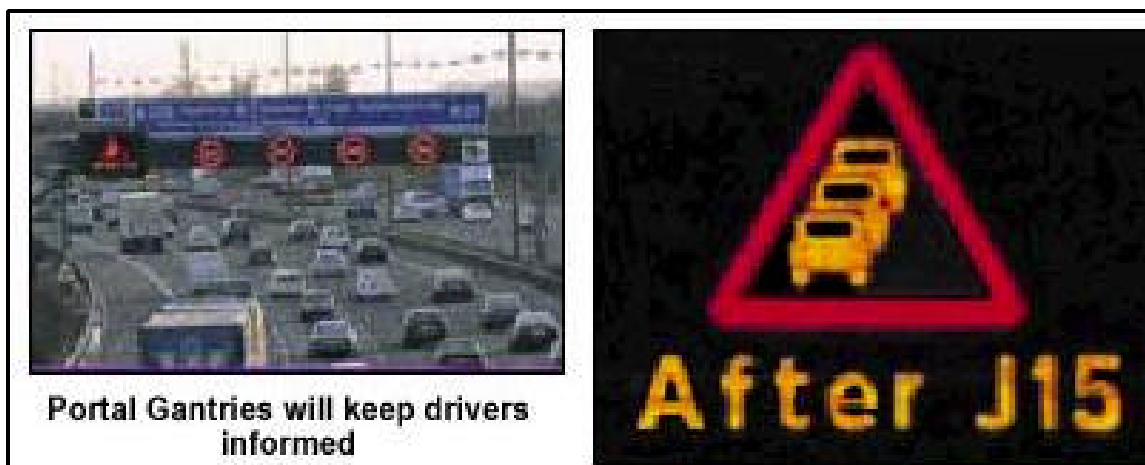
Figure 2-32 gives an example of the overhead gantries that include both a VMS component capable of displaying text and pictogram messages and electronic advisory speed limit signs over each driving lane. In this case, reduced speed limits are displayed over the driving lanes and a queue warning (pictogram with three cars inside a red triangle) is displayed over the outside shoulder. Furthermore, drivers are told of the approximate location of the queue by providing a crossroad reference (e.g., after J15). The HA also has deployed advisory speed limit signs, called matrix signals, in the median area instead of on an overhead gantry.

**Figure 2-32. VMS and Advisory Speed Limit Gantry in the United Kingdom.<sup>8</sup>**

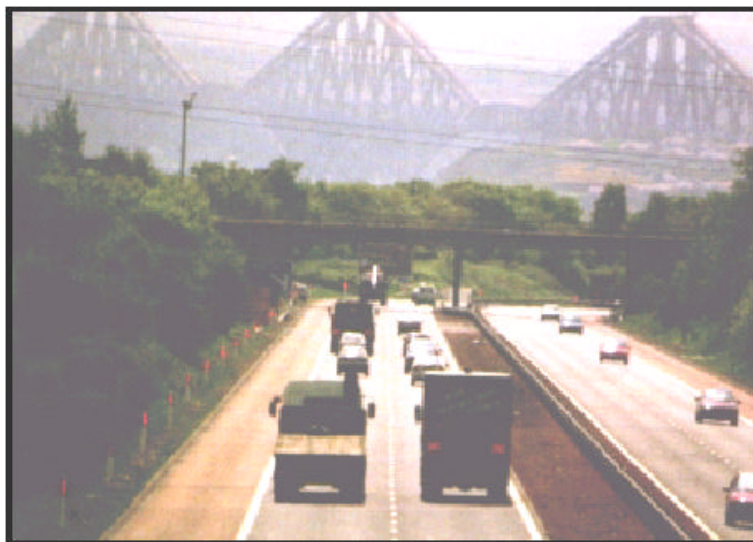
**Figure 2-33. COMPANION System in Scotland.**<sup>51</sup>

**Scottish System:** In January 1998, Scottish transportation authorities deployed and tested a version of the COMPANION system previously documented on a 4 km (2.5 mile) stretch of southbound M90.<sup>51,52</sup> The site consists of 68 COMPANION posts located at 50 m (164 ft) spacing installed along the outside shoulder (Figure 2-33). The M90 is the main route from the north of Scotland to Edinburgh. It experiences recurrent congestion from the Forth River Bridge to Junction 2 and beyond. A sweeping bend to the south along this section also reduces the visibility for drivers.

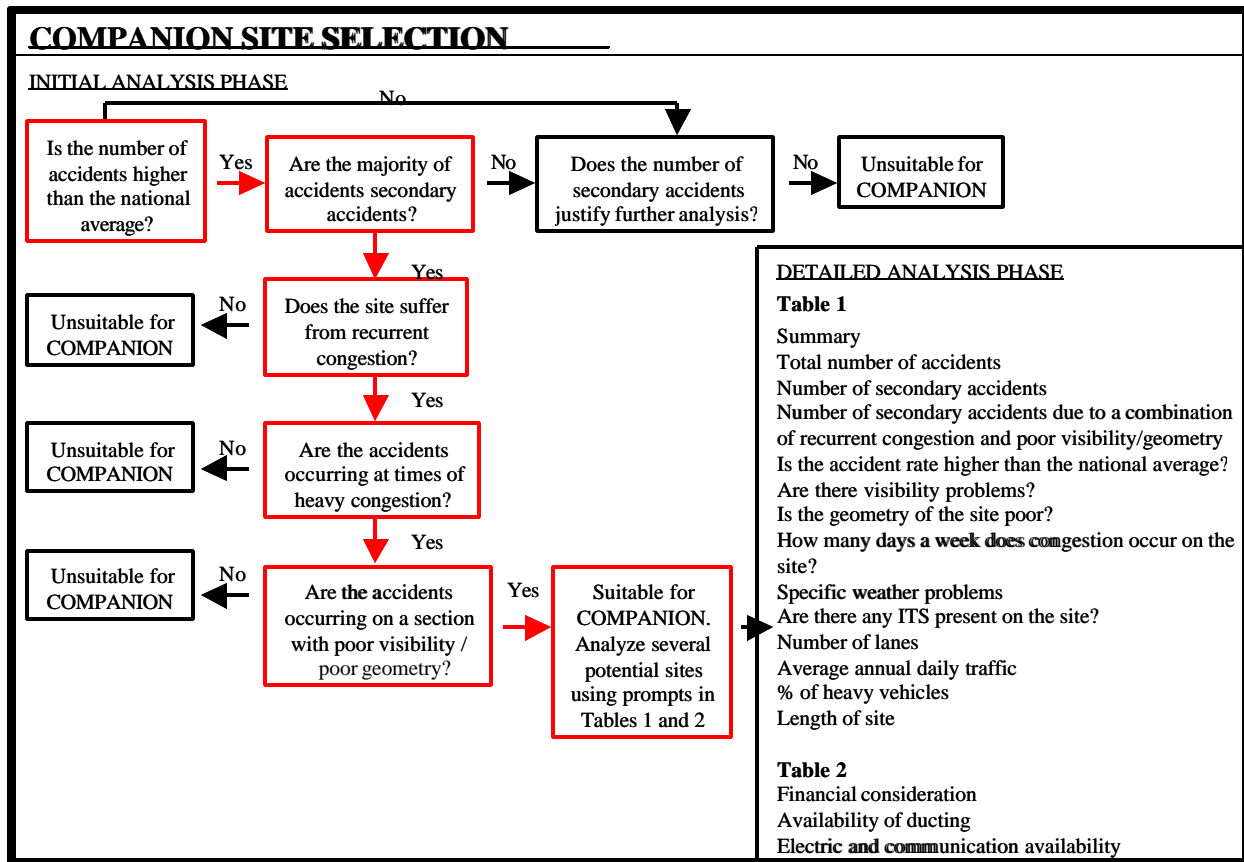
Figure 2-34. COMPANION Site Selection Flowchart.<sup>51</sup>

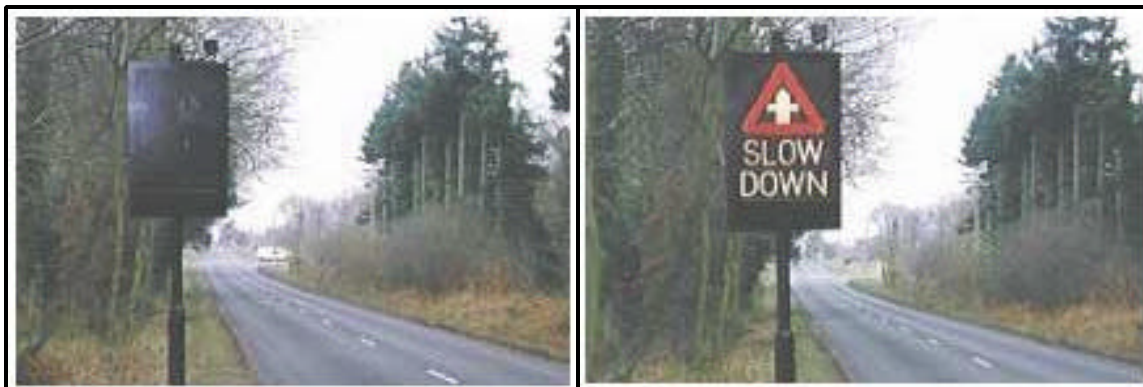
Figure 2-35. Example of Vehicle-Activated Warning Sign for Rural Application.<sup>53</sup>

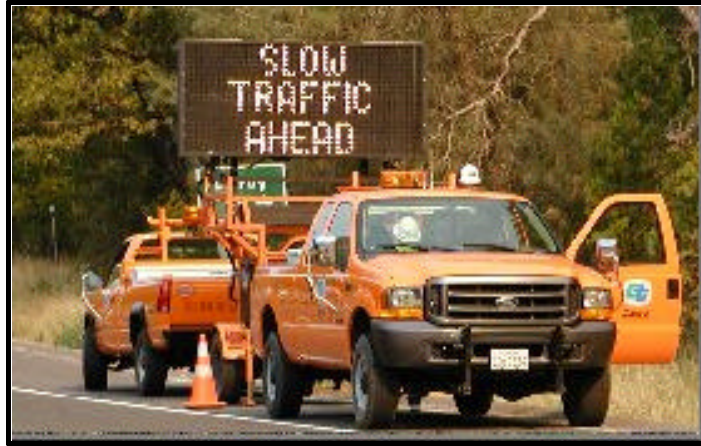
**Figure 2-37. Picture of Caltrans TMT Vehicle with Slow Traffic Ahead Message Displayed.**<sup>62</sup>

An electronic mail correspondence with Tarbell Martin, Chief of the Caltrans District 11 TMC in San Diego, provided additional information on how TMT vehicles are utilized for queue monitoring and management on freeways.<sup>62</sup> TMT units were used for five days during the week of the Northridge Earthquake in January 1994. Their purpose was to guard the severely damaged IH 5/IH 14 interchange in the upper San Fernando Valley north of Los Angeles. During that week all six freeways approaching the interchange had at least one of the San Diego-based TMT trucks deployed giving the message **SLOW TRAFFIC AHEAD PREPARE TO STOP** on their VMS. The units stayed approximately one-quarter mile behind the end of the queue. As a result, there were no secondary collisions in the queued traffic approaching the interchange during that weeklong period. The San Diego TMT does not handle recurrent commuter congestion, only incidents or incident generator locations.

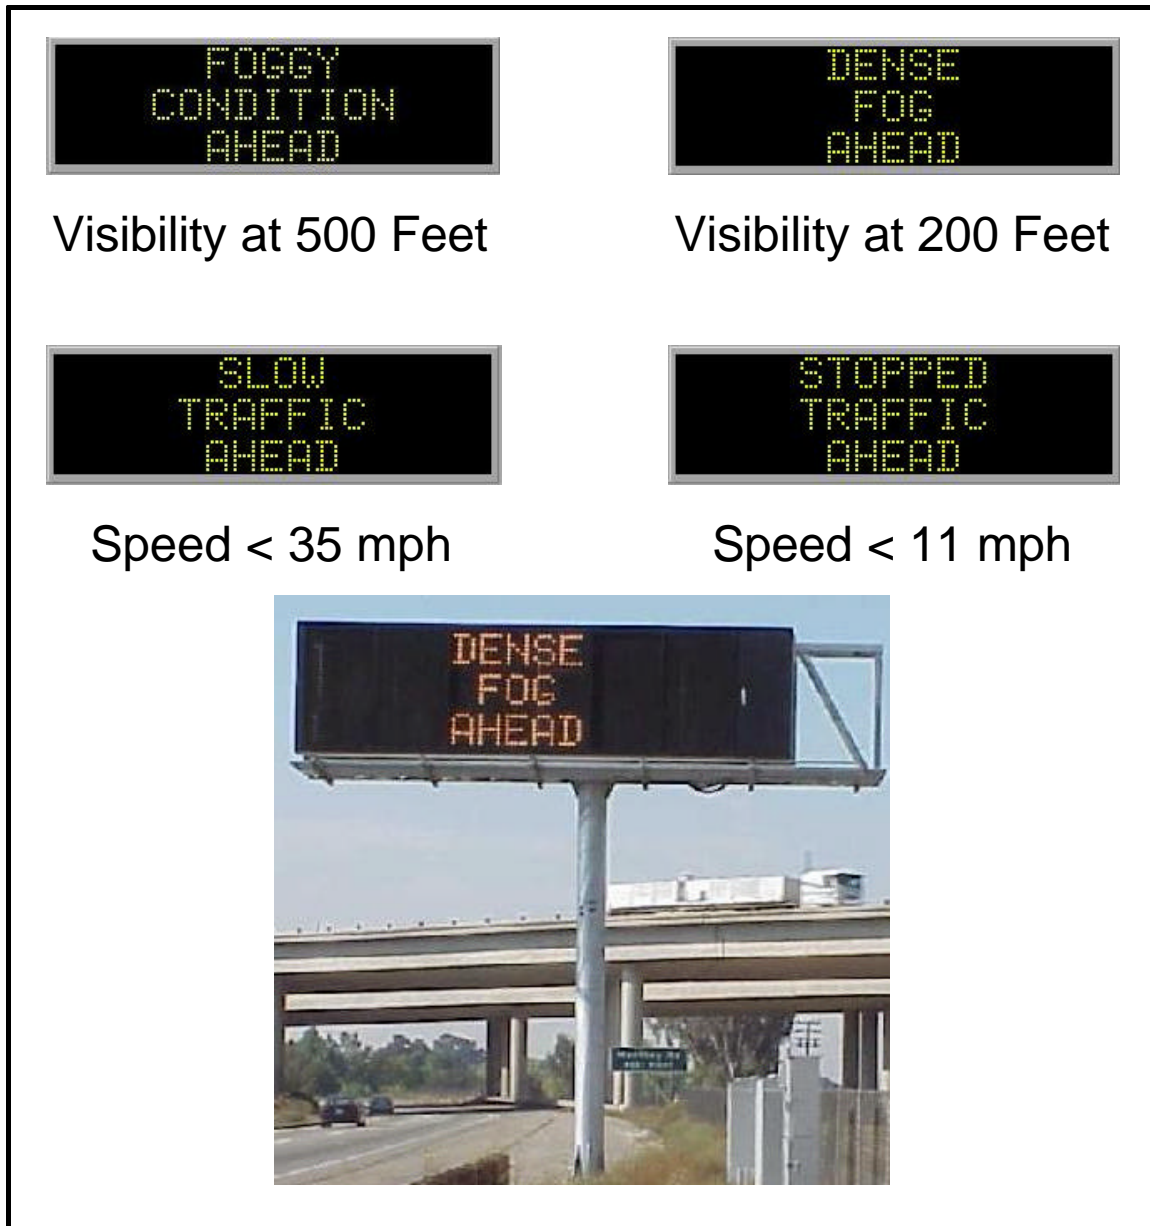
**Figure 2-38. Caltrans Automated Warning System Example Sign Messages.**<sup>63</sup>

A Caltrans press release for the Operation Fog program provided additional information about how CAWS operates.<sup>64</sup> The system automatically informs drivers, via the VMS, of speeds that would be safe for roadway conditions ahead. When visibility is 0 to 100 ft, the message **Dense Fog Ahead** appears to alert the motorist of conditions ahead. When visibility drops to 201 to 500 ft, **Foggy Conditions Ahead** is displayed. When traffic speeds are 11 to 35 mph, the message **Slow Traffic Ahead** is shown. When vehicle traffic speeds drop between 1 to 10 mph, the message **Stopped Traffic Ahead** is programmed to appear on the VMS (Figure 2-38). In the event of a collision during foggy conditions, speed messages override the fog messages. Caltrans TMC operators can manually override the system as necessary for highway emergencies, advisories, construction, and maintenance work.

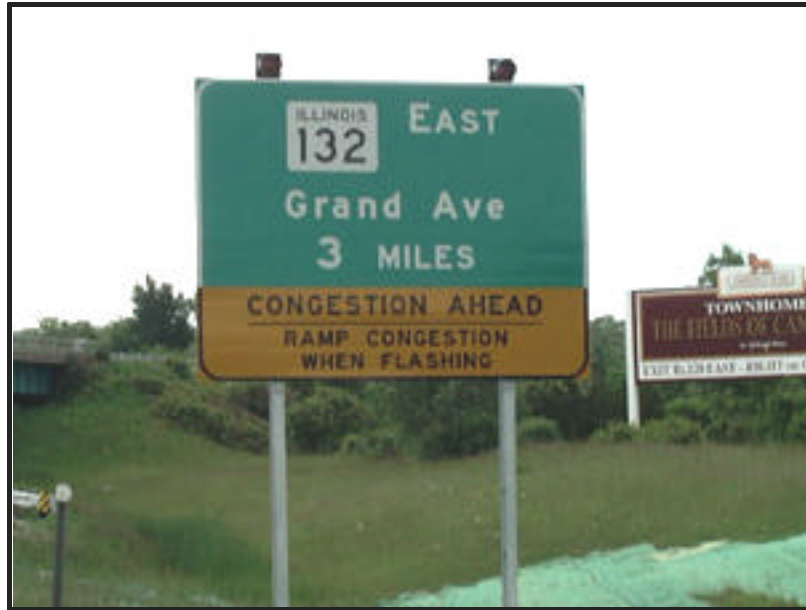
Figure 2-41. Grand Avenue Congestion Ahead Warning Sign.<sup>75</sup>

**Exit Ramp Queue Warning System:** The Illinois Tollway Authority (ITA) implemented an exit ramp queue warning system to alert northbound traffic of queuing and congestion on the exit ramp from the Tri-State Tollway to eastbound Grand Avenue.<sup>75</sup> ITA officials completed the exit ramp QWS on May 15, 2001. In addition to the QWS, work in this location included bottleneck improvement on the existing shoulder on the northbound Tri-State Tollway exit ramp to eastbound Grand Avenue. The ITA converted the shoulder into a 12-ft auxiliary lane and built a new 10-ft shoulder to help prevent traffic from queuing back onto the Tollway (Figure 2-40). The system detection of queuing on the ramp is based upon travel speeds on the ramp, with a threshold set for activating the warning system. When speeds on the ramp decrease to this level or below, the detector activates flashing beacons on two signs located just north of Washington Street and just south of Belvidere Road. Figure 2-41 shows one of these warning signs, which has an orange legend with black text on the bottom that reads **CONGESTION AHEAD – RAMP CONGESTION WHEN FLASHING**. The flashing beacons are clearly visible for a minimum distance of one-quarter mile when illuminated and will flash at a rate of 50 to 60 times per minute, with the lights flashing alternately.

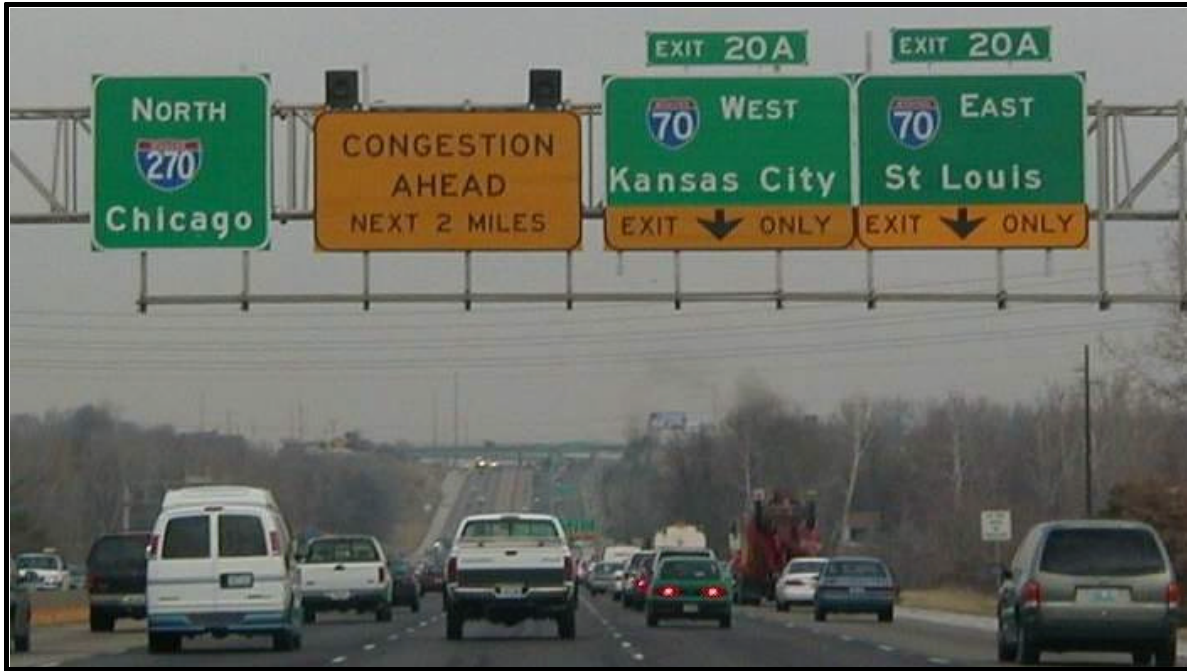
Figure 2-42. Congestion Ahead Warning Sign in St. Louis, Missouri.<sup>81</sup>

An Internet search revealed a link to a page with pictures of freeway signs throughout the state of Missouri.<sup>81</sup> Two pictures of signs that warn of congestion were on this site. [Figure 2-42](#) shows a sign in St. Louis on northbound IH 270 approaching the IH 70 interchange. This sign has an orange background with black text that reads **CONGESTION AHEAD – NEXT 2 MILES**. The sign also has flashing amber lights mounted on the top left and right corners. [Figure 2-43](#) shows a sign located in the Grandview Triangle interchange in the south Kansas City metropolitan area. This sign has an orange background with black text that reads **CONGESTION AHEAD**. The sign also has a flashing amber light centered on the top of the sign and is solar-powered.

Electronic mail correspondence with Daniel Bruno, Traffic Operations Engineer in District 6 of the Missouri DOT, revealed additional information about the sign pictured in [Figure 2-42](#).<sup>82</sup> Mr. Bruno is a member of the Missouri DOT statewide sign manual group and typically gets involved in some form or another with most of the unique signing issues. Mr. Bruno provided background information into the selection of the **CONGESTION AHEAD** message, the need for the special warning sign, and results of a collision study at this St. Louis location.

The Missouri DOT installed the congestion ahead sign and flasher in 1998 as a short-term solution prior to the ITS roll-out in St. Louis called Gateway Guide. The sign is designed to inform out-of-town motorists of the impending congestion that frequently occurs on northbound IH 270. The LED flashers were installed to draw motorist attention to the sign during those times when congestion was most likely to be present. Based on previous studies, as well as field observations, the pre-timed flashers were set to activate during the hours when congestion was typically present. Additionally, a push button was installed for field personnel to use so that the flashers may be activated outside of programmed hours as necessary. The sign and flashers caused a 31% reduction in collisions during the first 3 months after its installation, but that number reduced to around 15% once some motorists became immune to its presence.

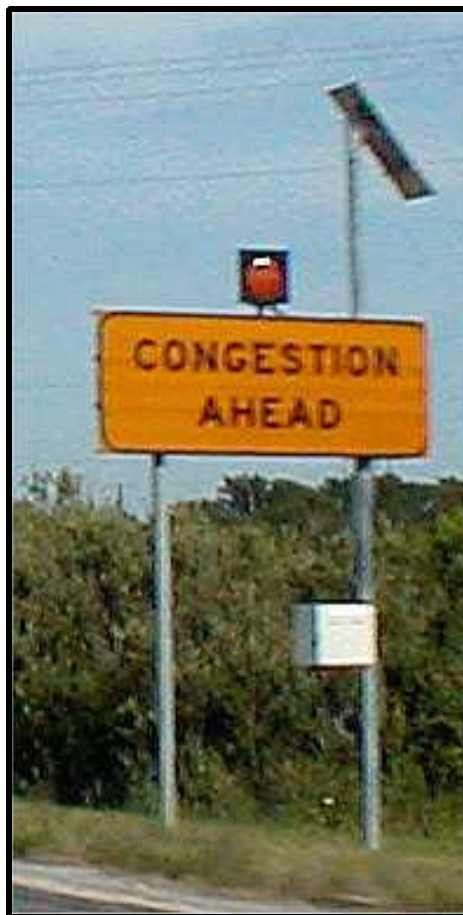
Figure 2-43. Congestion Ahead Warning Sign in Kansas City, Missouri.<sup>81</sup>

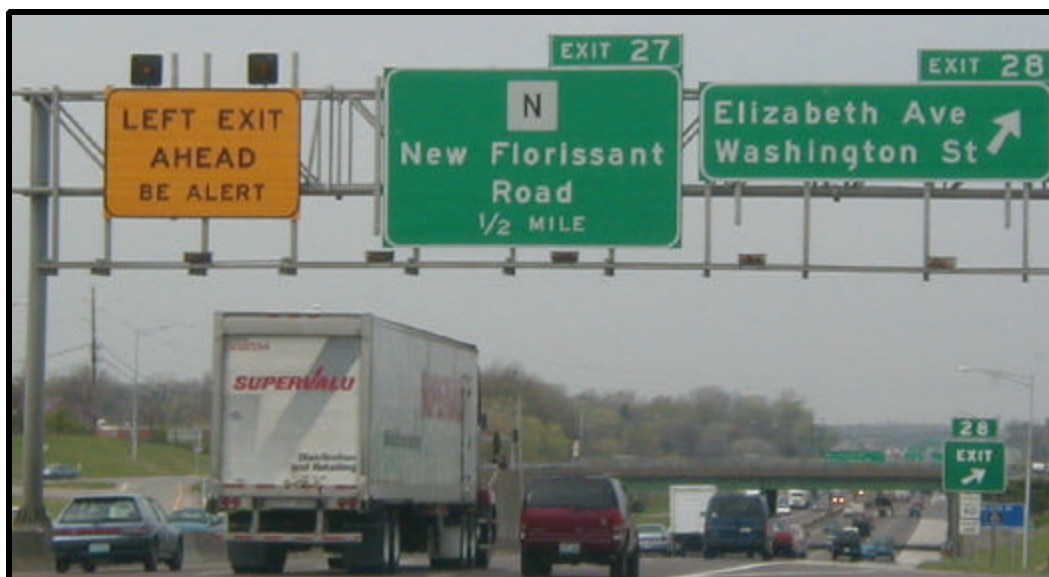
Figure 2-44. Left Exit Warning Sign in St. Louis, Missouri.<sup>81</sup>

In a related matter, the Missouri DOT has another similar installation in St. Louis on westbound IH 270 east of IH 170 in north St. Louis County. The sign reads **LEFT EXIT AHEAD – BE ALERT** and it was installed, along with pre-timed flashers, as a result of a massive multi-fatal collision in 1999. [Figure 2-44](#) shows a picture of this sign (orange background with black text). The sign is intended to warn motorists of routine congestion in the left lanes approaching the left-hand exit. This sign is temporary in nature, as the entire interchange will be reconstructed for two years beginning in late Spring 2002, making all ramps right-hand entry and exit.

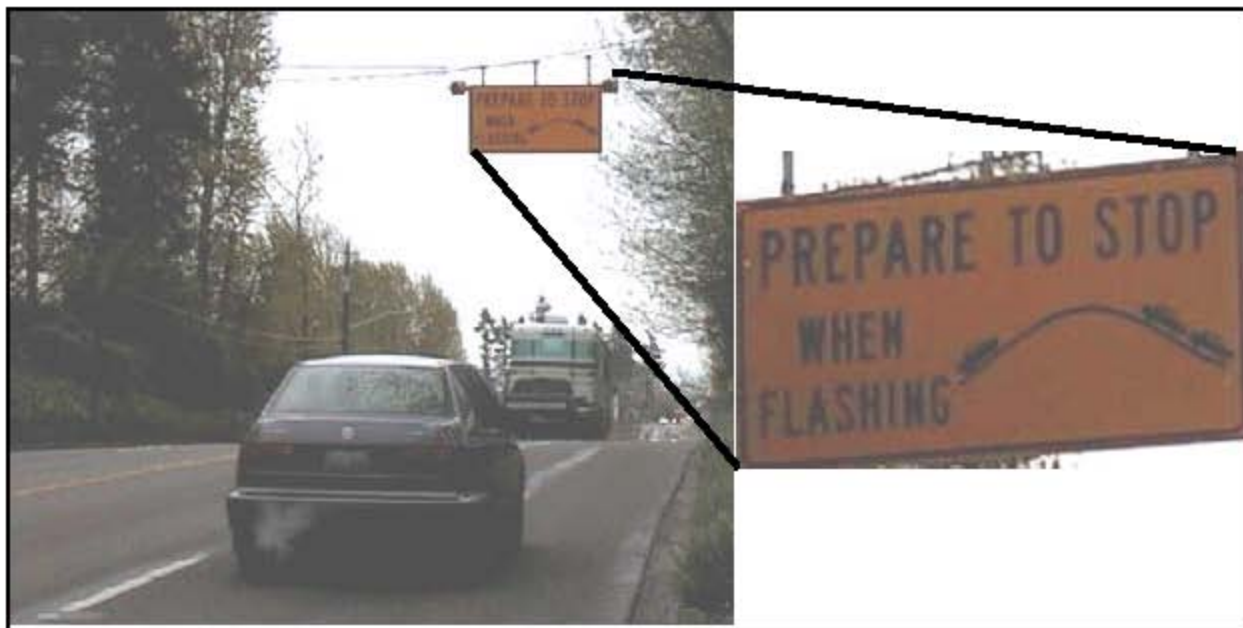
Figure 2-46. Picture of King County Queue Warning Sign near Elementary School.<sup>91</sup>
