1. Report No. FHWA/TX-03/4413-1	2. Government Accession No.	3. Recipient's Catalog No.	
4. Title and Subtitle ADVANCE WARNING OF STOPPED TRAFFIC ON FREEWAYS: CURRENT PRACTICES AND FIELD STUDIES OF QUEUE PROPAGATION SPEEDS		5. Report Date October 2002 Resubmitted: June 2003

**ADVANCE WARNING OF STOPPED TRAFFIC ON FREEWAYS:  
CURRENT PRACTICES AND FIELD STUDIES OF  
QUEUE PROPAGATION SPEEDS**

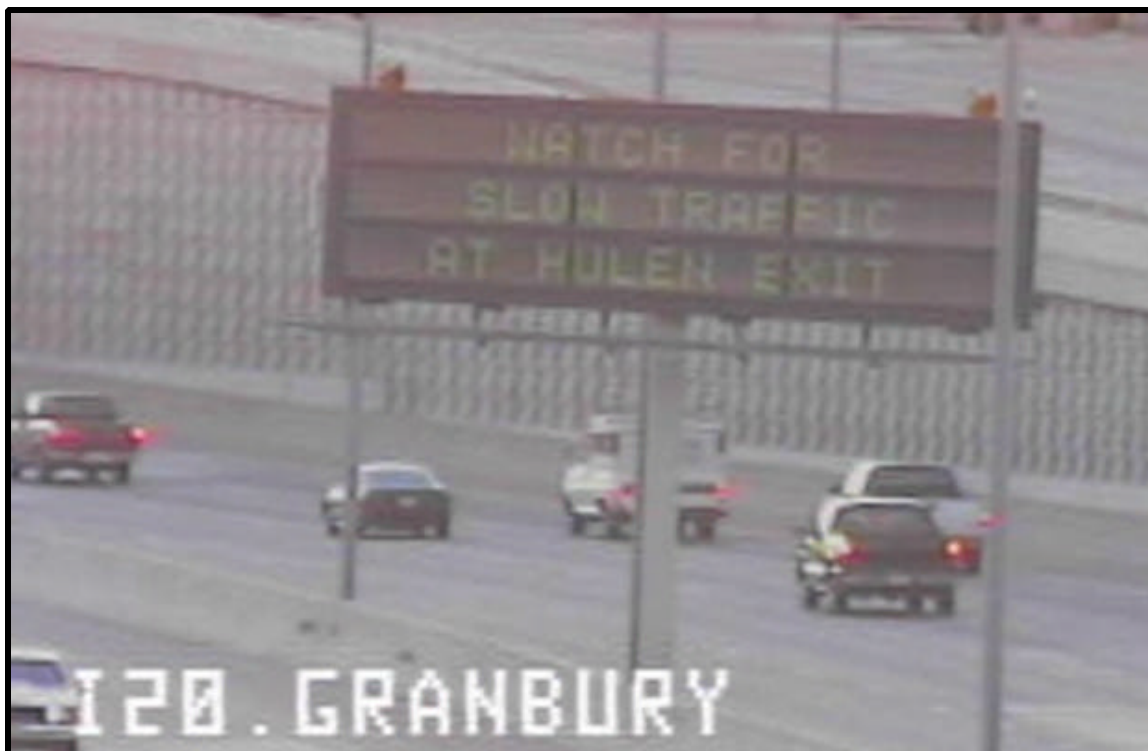
**Figure 2-49. Warning Message on VMS About Potential Queue Spillback at the Hulen Exit Ramp.**<sup>94</sup>

Realizing the hazard created by a lane of traffic queuing back onto the main lanes, TxDOT began to utilize the permanent VMSs on westbound IH 20 to warn motorists of the potential queue at the Hulen exit ramp. [Figure 2-49](#) provides a picture taken from one of the TransVISION cameras of the VMS with the Hulen warning message being displayed.<sup>94</sup> TransVISION operators displayed the message **WATCH FOR SLOW TRAFFIC AT HULEN EXIT** at the VMS located at James (2.5 miles from the Hulen exit) and at Granbury (0.5 mile from the Hulen exit). The operators also have the capability to activate yellow flashers on top of the VMSs to attract additional attention to the sign if they verify queue spillback onto IH 20.

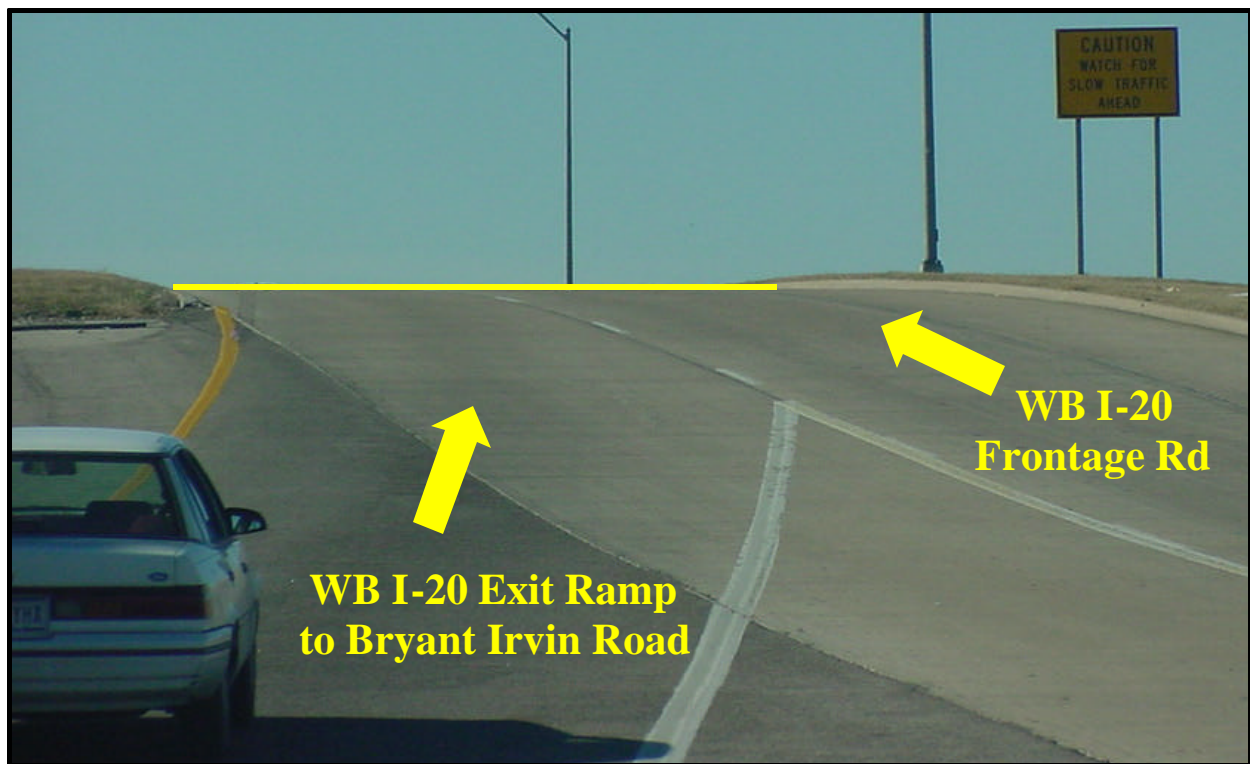
**Figure 2-50. Looking West from Westbound IH 20 Exit Ramp to Bryant Irvin Road.**

**Westbound Interstate 20 Frontage Road at Bryant Irvin Boulevard:** The next major interchange on IH 20, located approximately 1.5 miles west of Hulen Street, is Bryant Irvin Road. As was the case at the Hulen interchange, there is considerable development and the corresponding traffic demand at Bryant Irvin Road. In this case, the problem is not exit ramp spillback onto the IH 20 main lanes; rather, there is a driveway just over the crest of the hill on the westbound IH 20 frontage road. TxDOT has addressed this situation by installation of traditional warning signs to alert motorists on both the westbound Bryant Irvin exit and westbound IH 20 frontage road to the potential for slow traffic ahead. [Figure 2-50](#) shows a picture looking west from the IH 20 exit ramp toward Bryant Irvin. The sign in the upper right corner of the picture warns motorists **CAUTION WATCH FOR SLOW TRAFFIC AHEAD**. The line in the picture across the westbound IH 20 frontage road represents the crest of the vertical curve that restricts the sight distance of motorists to vehicles on the other side. Motorists slowing down to make a right turn into this driveway create an additional hazard for high-speed traffic. Another picture, provided in [Figure 2-51](#), shows a view of the westbound IH 20 frontage road looking east from near the signal at Bryant Irvin Road. This view gives further perspective on the rolling terrain and potential for a motorist traveling too fast over the curve to have trouble stopping.

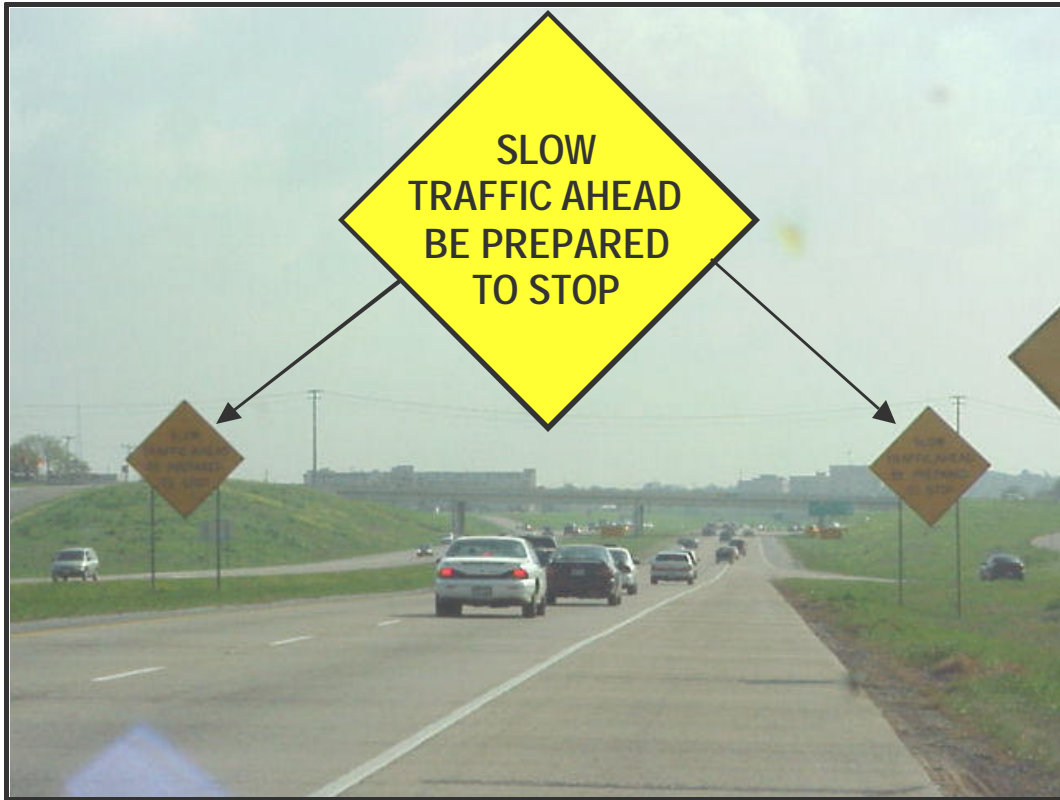
**Figure 2-52. Southbound SH 121 Prior to Harwood Entrance – Slow Traffic Ahead Warning Signs.**

The first set of signs, pictured in [Figure 2-52](#), is located just prior to the Harwood entrance ramp to southbound SH 121, approximately 1.2 miles from the SH 183 merge. These large (estimated as 96 in. by 96 in.) yellow diamond signs have black text that reads **SLOW TRAFFIC AHEAD BE PREPARED TO STOP**. The second set of signs, shown in [Figure 2-53](#), is located just after the Harwood entrance ramp to southbound SH 121, about 1 mile from the SH 183 merge. These yellow rectangular signs (estimated as 48 in. tall by 96 in. wide) have black text that reads **CAUTION WATCH FOR SLOW TRAFFIC AHEAD**. These signs also have yellow flashers mounted on each side that constantly flash throughout the day in a bounce mode. A final warning sign, pictured in [Figure 2-54](#), is located on the right side of southbound SH 121 just before the Murphy overpass (approximately 0.33 mile before the SH 183 merge). This yellow diamond sign, estimated as 48 in. by 48 in., has black text that reads **SLOW TRAFFIC AHEAD BE PREPARED TO STOP**.

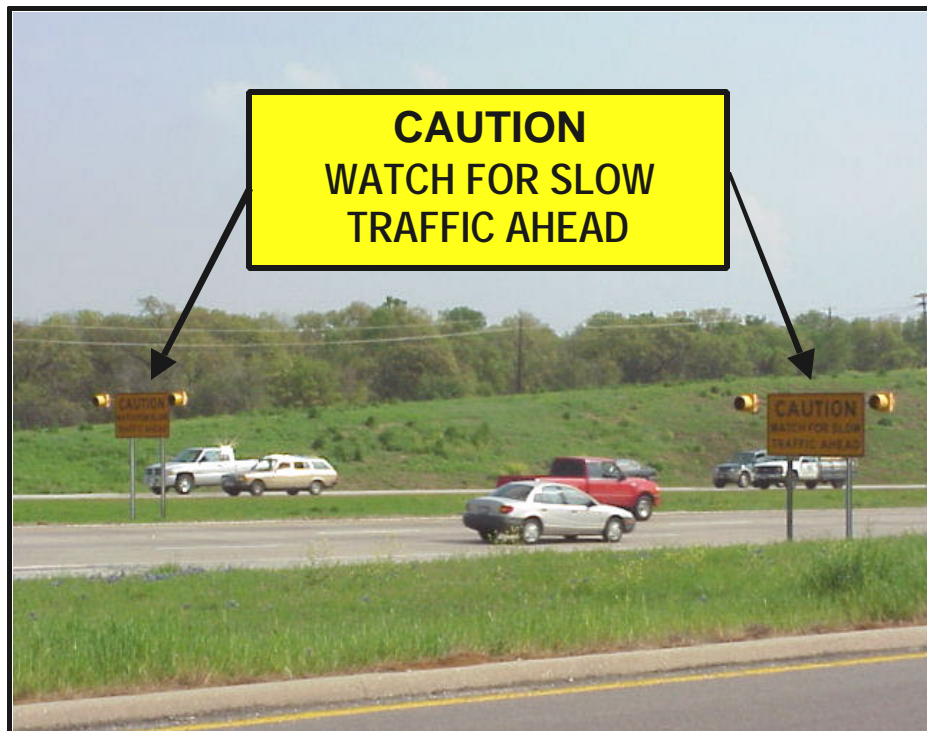
**Figure 2-53. Southbound SH 121 after Harwood Entrance – Caution Flashing Warning Signs.**

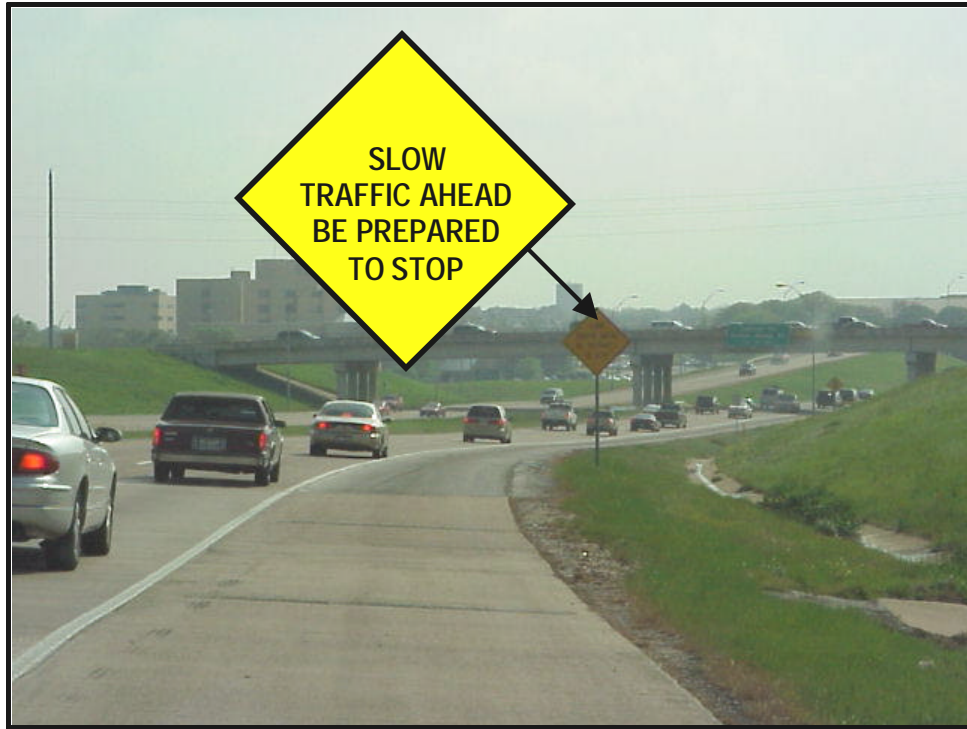
**Figure 2-54. Southbound SH 121 near Murphy Overpass –  
Slow Traffic Ahead Warning Sign.**

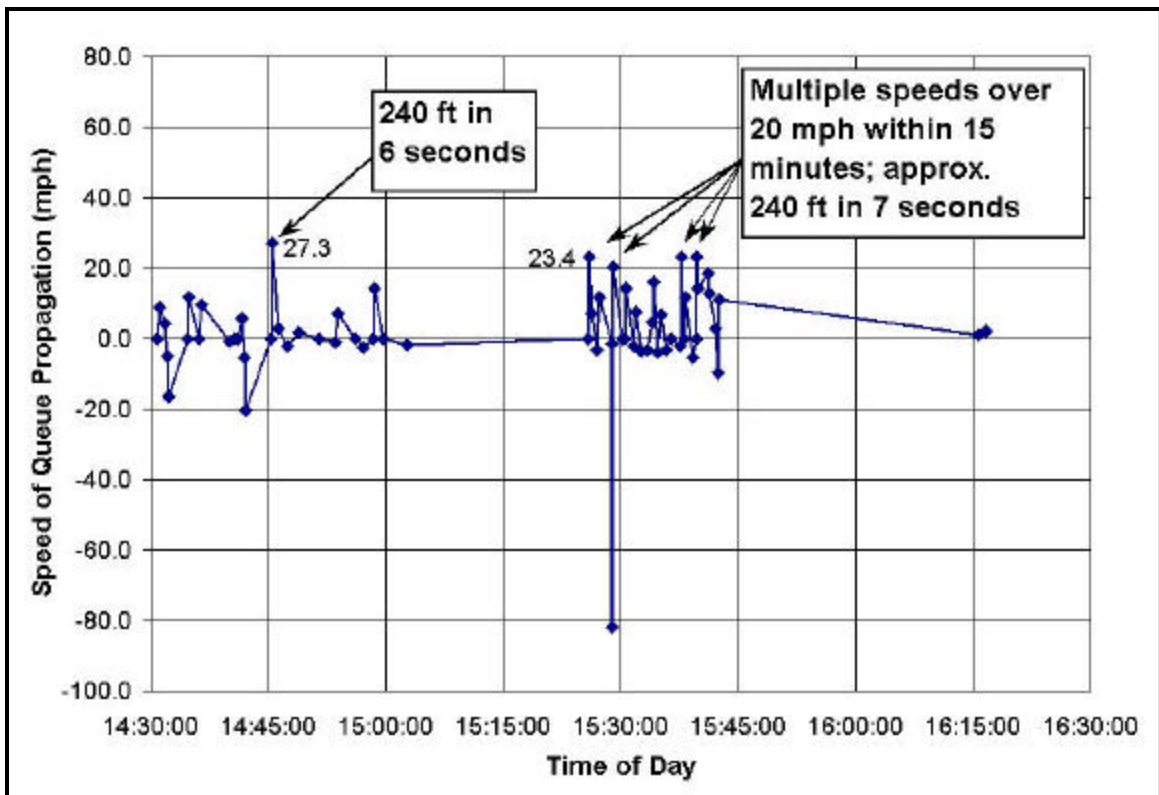
Figure 3-4. US 75 Queue Propagation Data – Lane 1 of 4.

Researchers plotted speed versus time of day graphs for data pertaining to the northbound US 75 study site. This information was collected and plotted by lane. For this research study, lane 1 always referred to the inside median lane, with subsequent lanes numbered outward. [Figure 3-4](#) shows an example of this type for northbound PM peak data on US 75 for one of the data collection days. [Figure 3-4](#) shows the variation in observed speeds for queue development for lane 1; [Figures 3-5](#) through [3-7](#) show the remaining lanes, and [Figure 3-8](#) shows all lanes together.

Of note in Figure 3-4 is the prevalence of multiple spikes of queue propagation speeds in excess of 20 mph, between about 3:25 to 3:40 PM (about 15 minutes). There is one spike earlier, around 2:45 PM, where the queue propagated at a rate of 27 mph. These changes reflected queue growth of 240 ft within 7 or 6 seconds, respectively, in lane 1. Areas where the line is “flat” reflect areas where, for a variety of reasons, data were not available. The most common reason for the data gaps was that there was no congestion during those timeframes, or that data collection and reduction could not take place during those timeframes because the queue tail was too difficult to geolocate (sometimes due to foreshortened camera views) or because it was not visible on camera. Figure 3-5 shows a spike of over 55 mph in lane 2, where queues grew 245 ft in 3 seconds. Figure 3-8 shows the variability of experiences approaching drivers might have depending upon their time of arrival at the queue tail and their lane of travel.

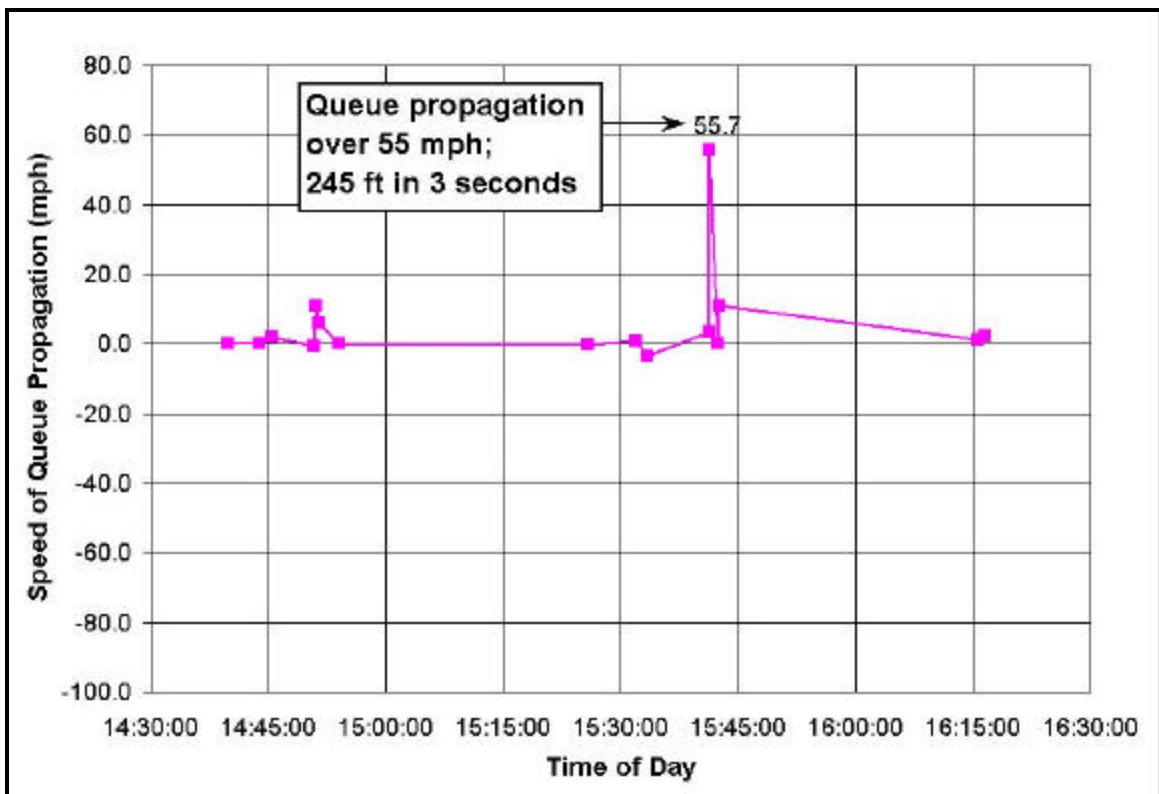
Figure 3-5. US 75 Queue Propagation Data – Lane 2 of 4.

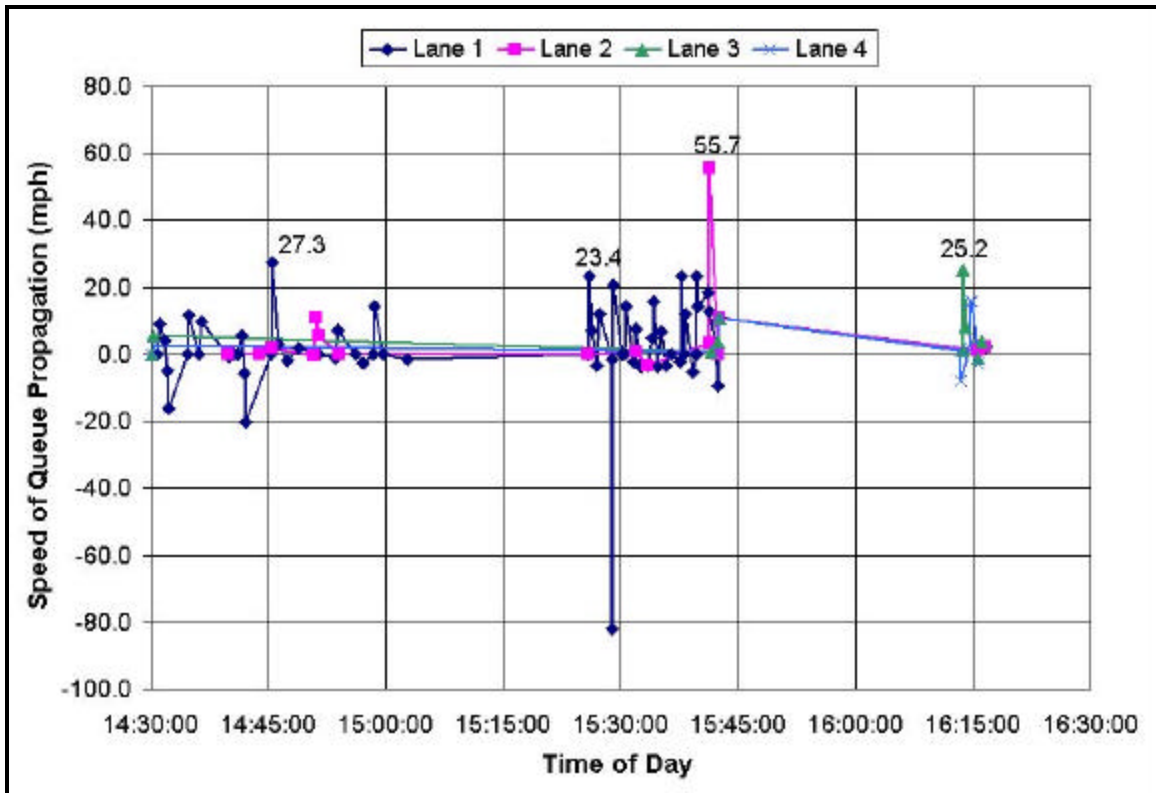
**Figure 3-8. US 75 Queue Propagation Data – All Lanes.**

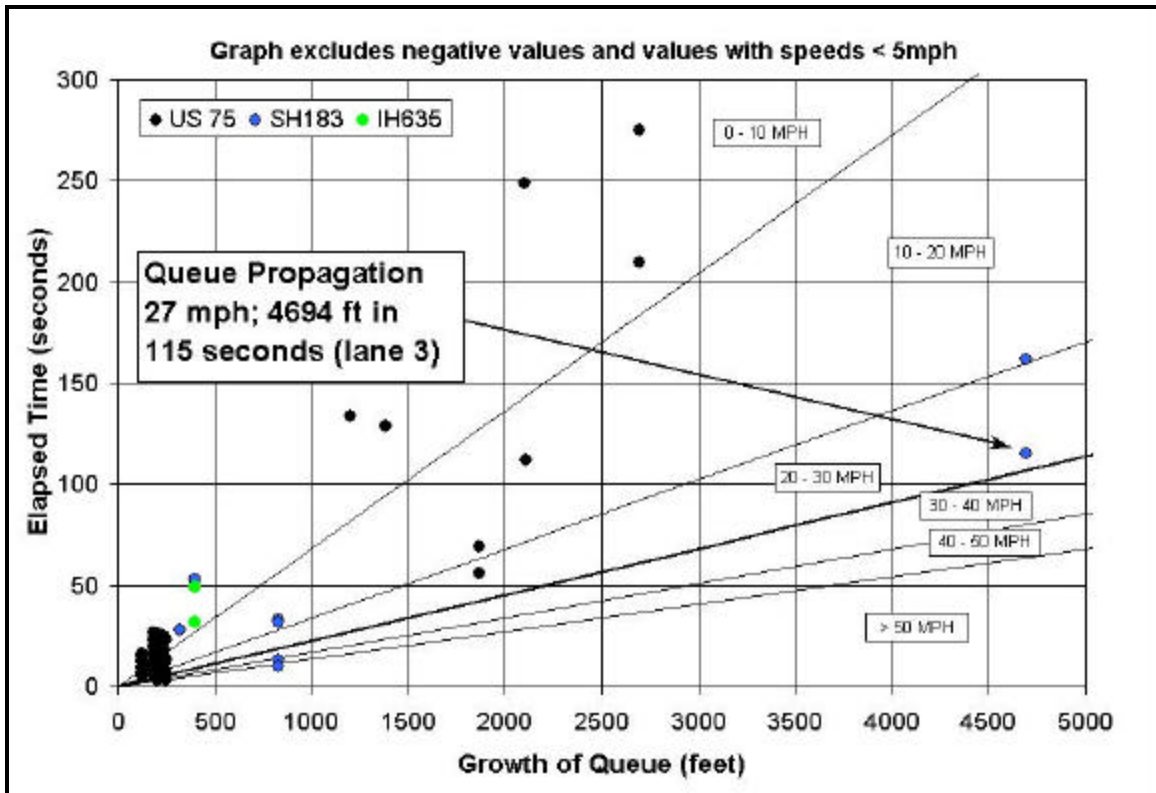
**Figure 3-9. Queue Propagation Data for Recurrent Congestion Studies – View 1.**

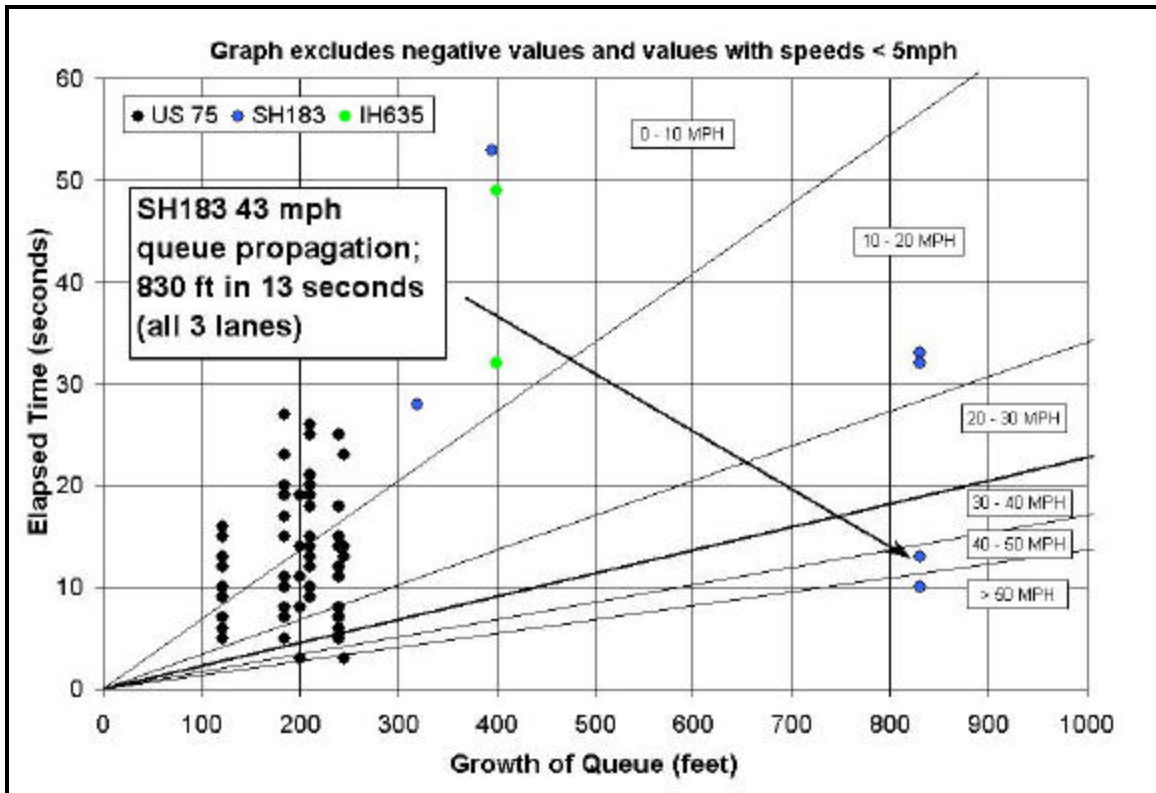
Figure 3-10. Queue Propagation Data for Recurrent Congestion Studies – View 2.

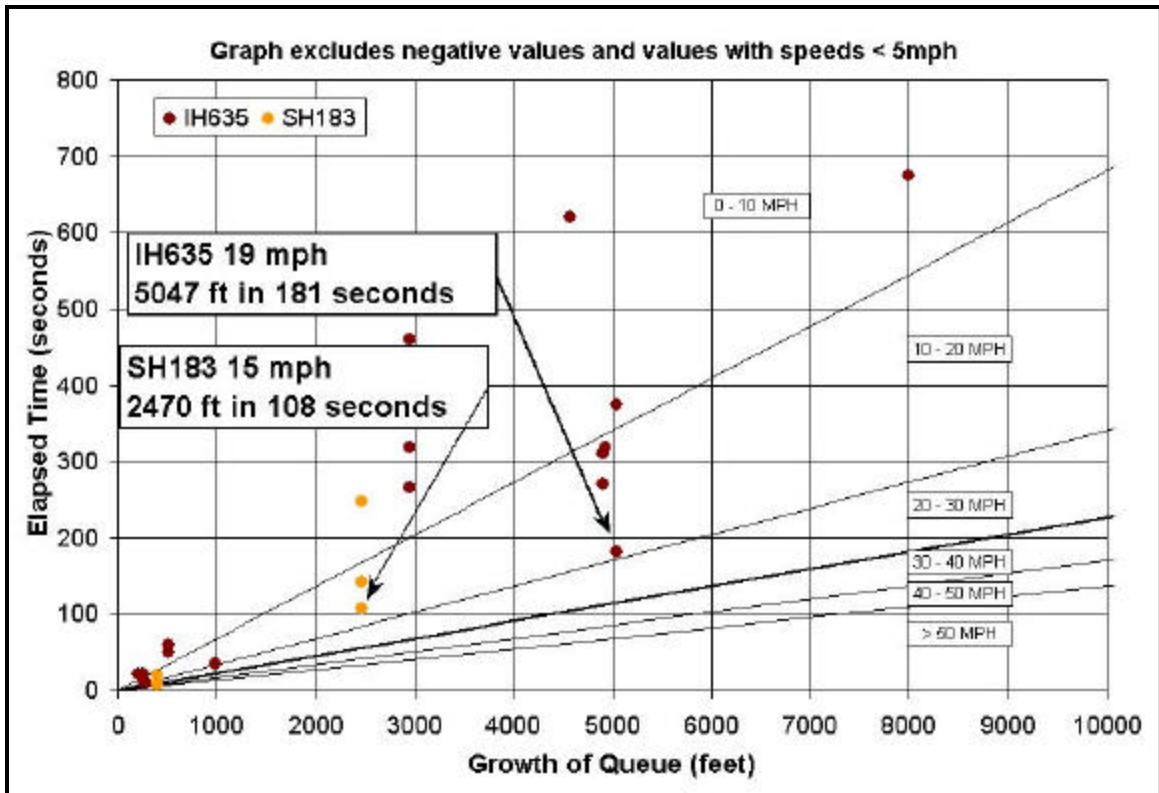
Figure 3-12. Queue Propagation Data for All Incident Studies – View 1.

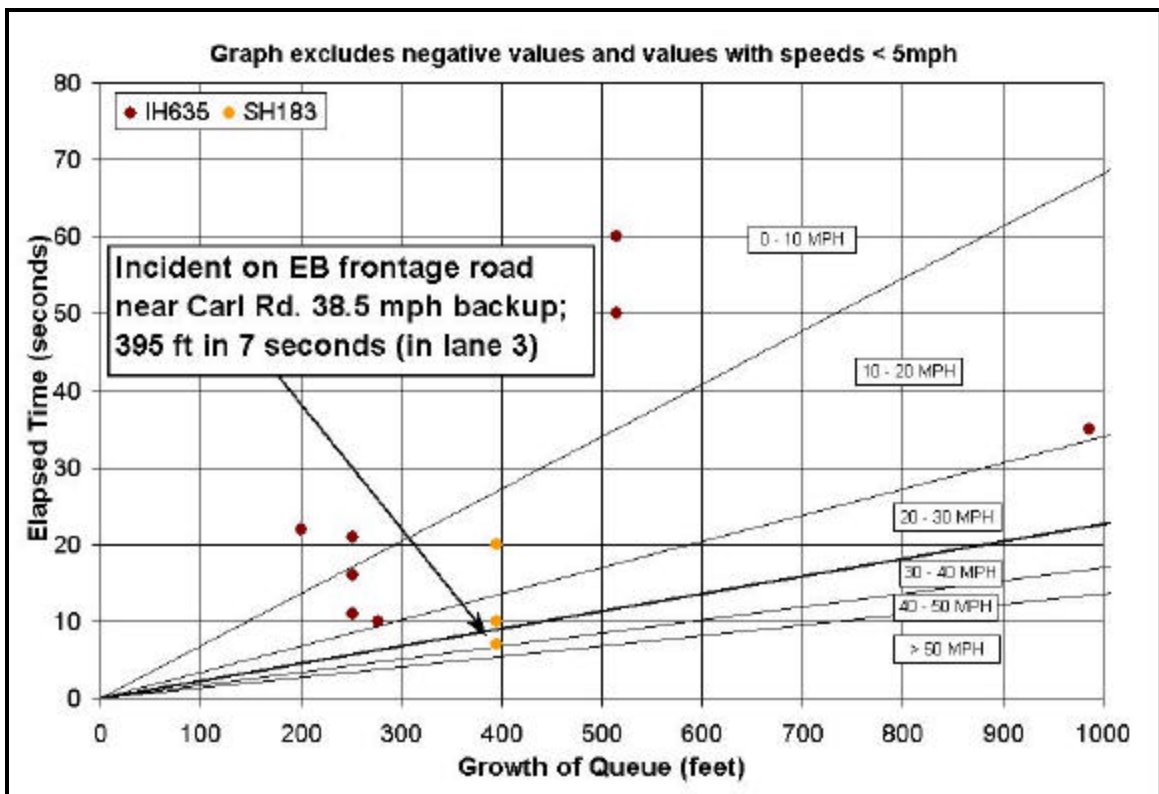
Figure 3-13. Queue Propagation Data for All Incident Studies – View 2.
