# **SAFENCE WIRE ROPE MEDIAN BARRIER**

**Construction Report  
September 2005**

## **CONSTRUCTION REPORT**

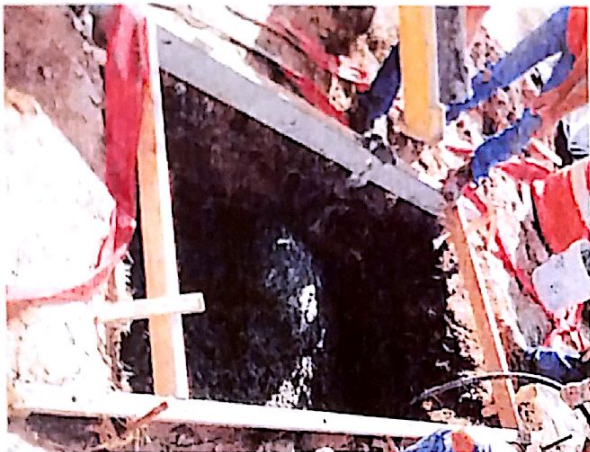
**Fig. 1a:** Concrete is poured into the cable anchor.

Installation of the Safence cable barrier was completed on September 24, 2004 by MidState Traffic Control construction company. The cable anchors are concrete foundations measuring 5'-6" x 3' x 6'. The top of the foundation is placed at ground level. All cables are anchored by the single foundations at each end of the test section. See Figure 1(a-d) for anchor placement. An additional slab (41'-0" x 8' x 6") was formed and placed around the foundation hole for sand impact attenuator barrels. See Figure 2(a-b).

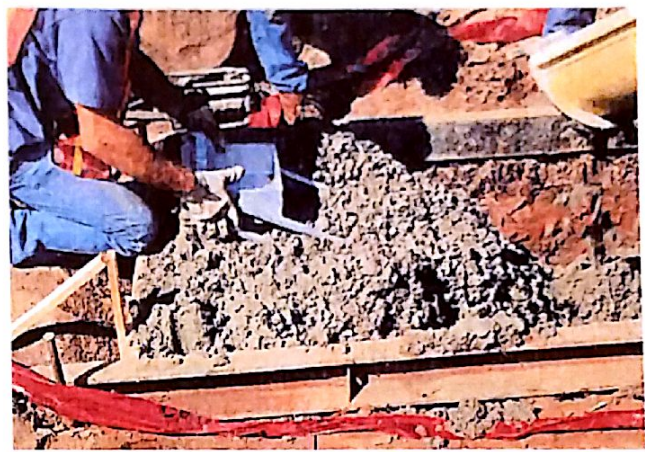
**Fig 1b:** Placement of anchor plate in fresh concrete.

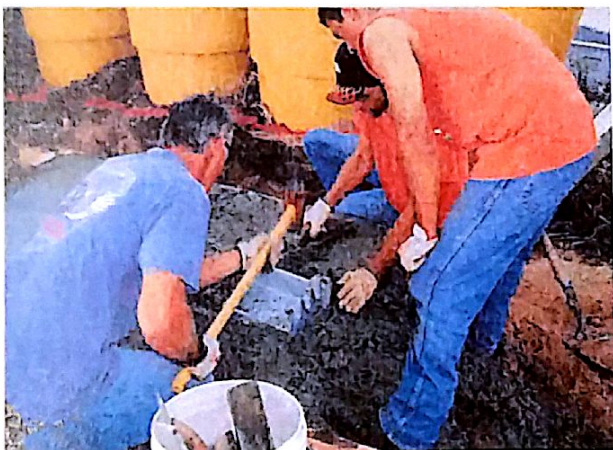
**Fig. 1c:** Anchor plate is set in place.

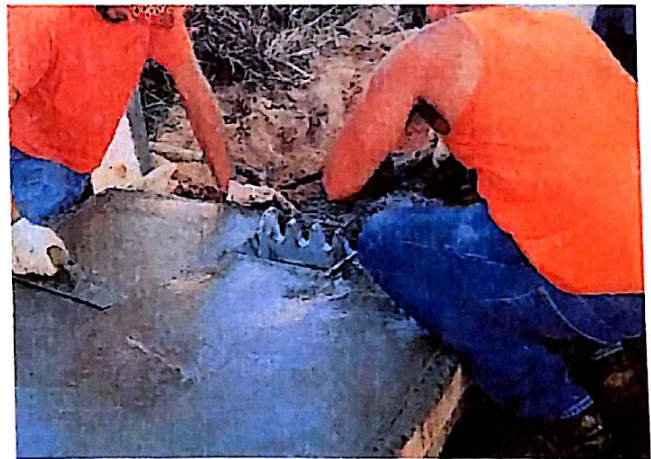
**Fig. 1d:** Cable anchor concrete is finished.

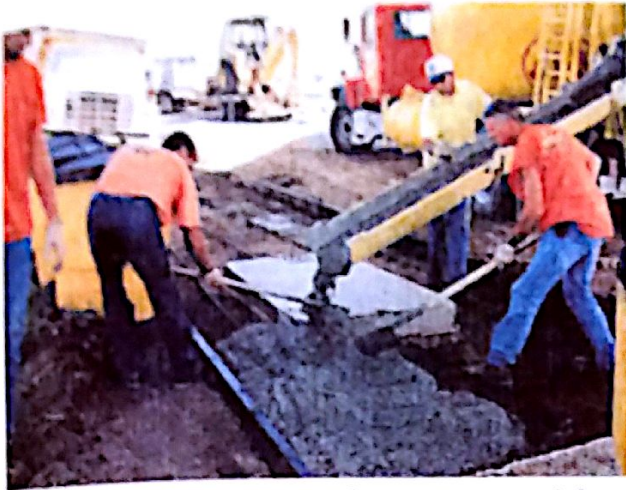
**Fig. 2a:** Placing concrete for attenuator slab.

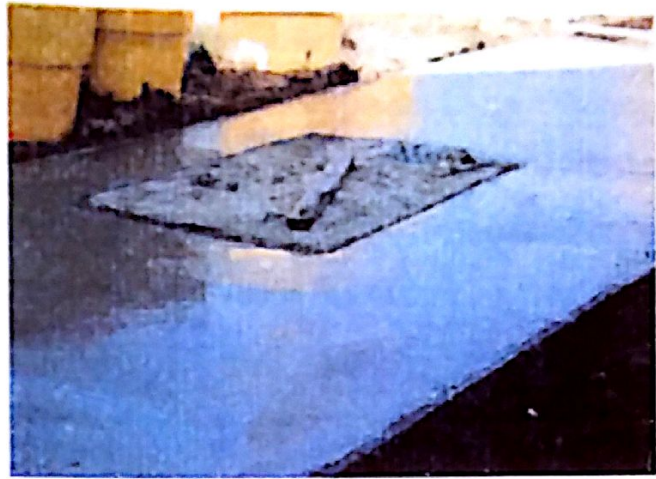
**Fig. 2b:** Finished attenuator slab.

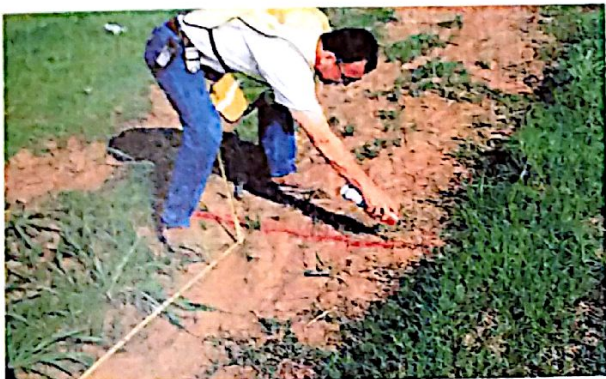
**Fig. 3a:** Marking linear position of post base.

The location of the support posts were hand surveyed with a tape measurer and string line. The post spacing was set at 10 feet. The foundation hole for the post hole was pile driven in by a GRT, Utilicorp truck. See figure 3(a-d). The driver was a solid steel shaft that measured 12 inches in diameter. The holes were each driven to two feet in depth.

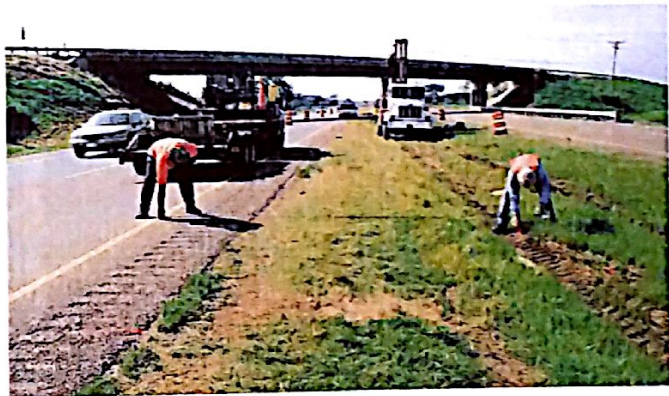
**Fig. 3b:** Marking post offset from edge of pavement.

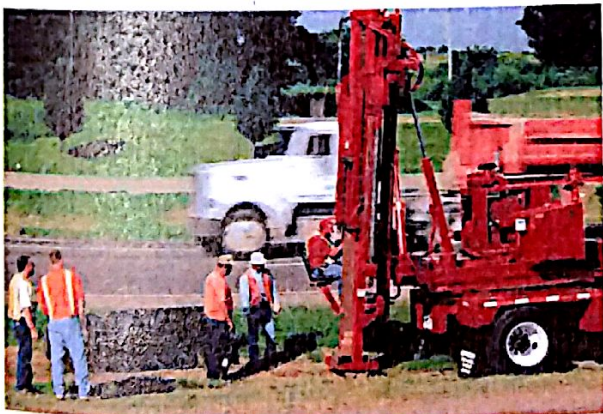
**Fig. 3c:** Compacting soil to form post base holes.

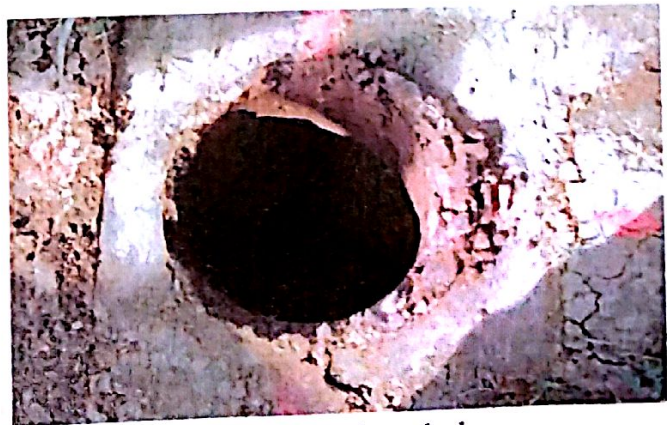
**Fig. 3d:** Completed post base hole.

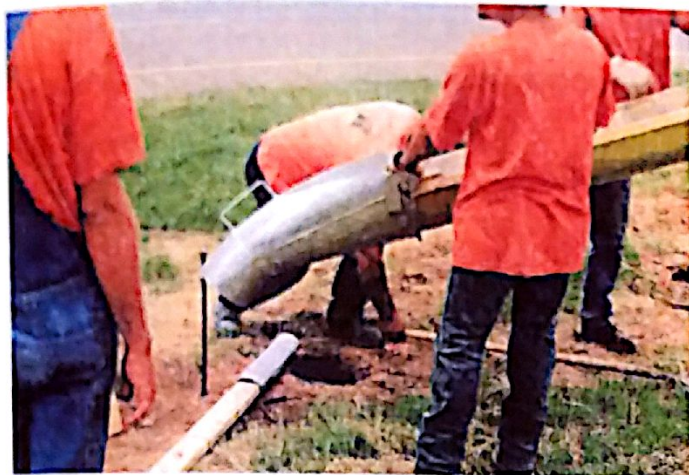
**Fig. 4a:** Placing concrete for post bases.

A string line was used for setting the alignment of the post sleeves while the concrete was placed. Concrete was poured into the hole and square reinforcement ring was placed in the concrete, approximately half way down. A "2 X 4" piece of wood was used to "force the post sleeve into the fresh concrete so that the top of the sleeve was the same as the surrounding soil. The concrete was then hand finished and the concrete was cured for two days. See figure 4(a-e)

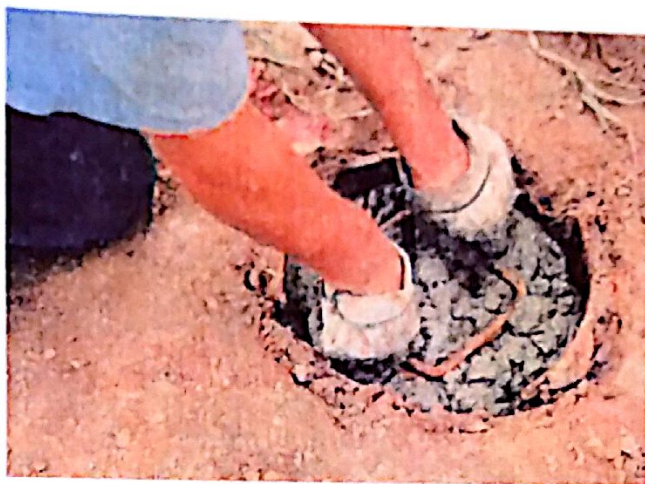
**Fig. 4b:** Placing reinforcing steel into base.

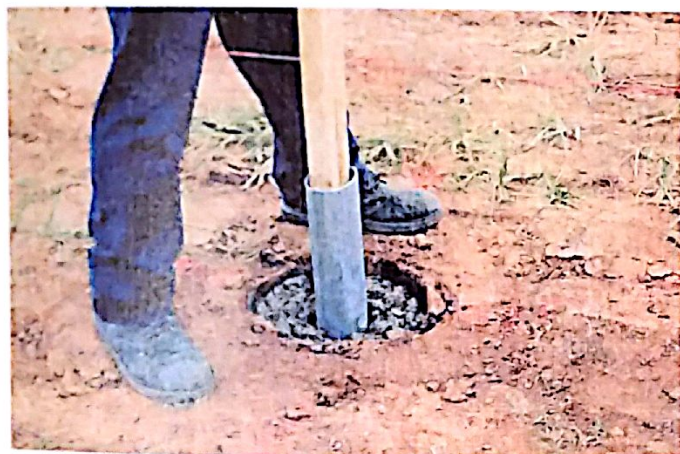
**Fig. 4c:** Placing post sleeve into concrete base.

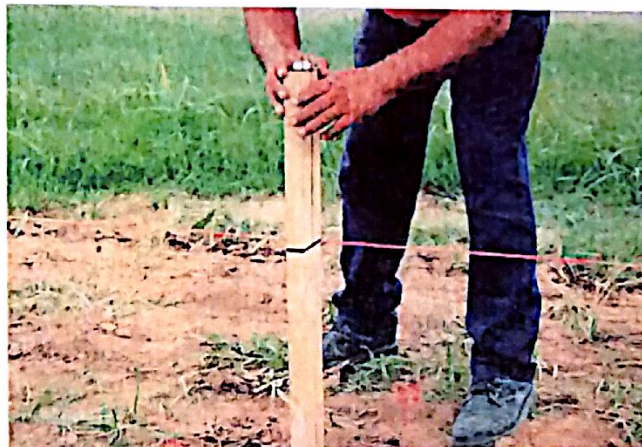
**Fig. 4d:** Using bubble level and string line to set post position and alignment.

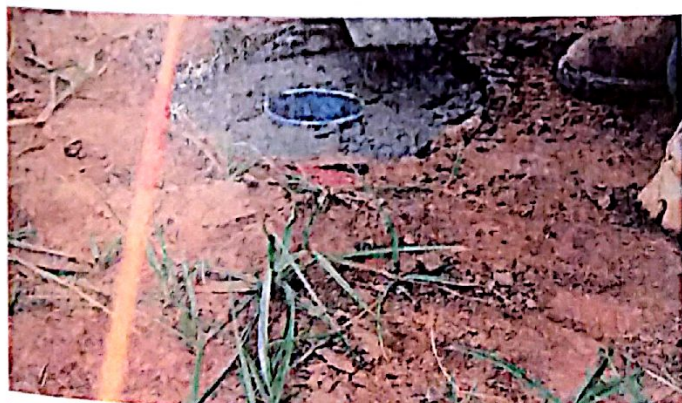
**Fig. 4e:** Finishing the post base.

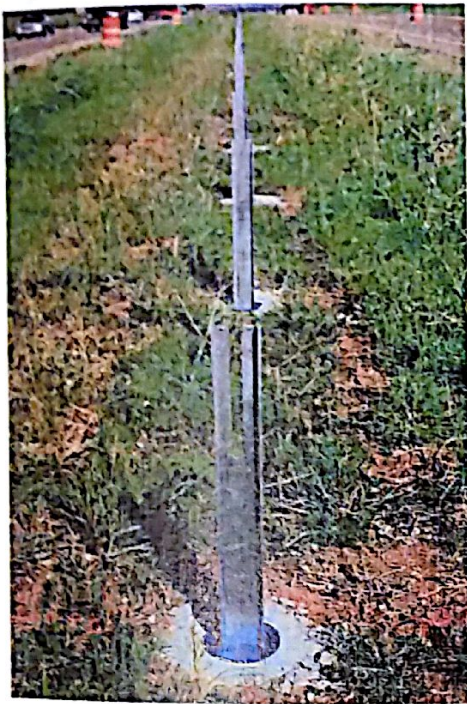
**Fig. 5a:** Posts and base caps in position ready for cable placement.

After the two day set, the bottom caps were placed on the posts, and the posts were set in the metal sleeves. The first, or bottom, cable was then screwed to the anchor and strung through the posts. The Cable was pre-cut in 1000 foot lengths which were joined by rigging screws. After the first cable was placed, a metal spacer was placed into every post. This procedure was repeated, until all four strands of cable were placed. Then a blue cap was placed on the post. The cables were tensioned at the rigging screws by a hand powered apparatus. Then the rigging screw would be adjusted and the apparatus was removed. This adjustment was made at each rigging screw on every strand of cable. See figure 5 (a-o).

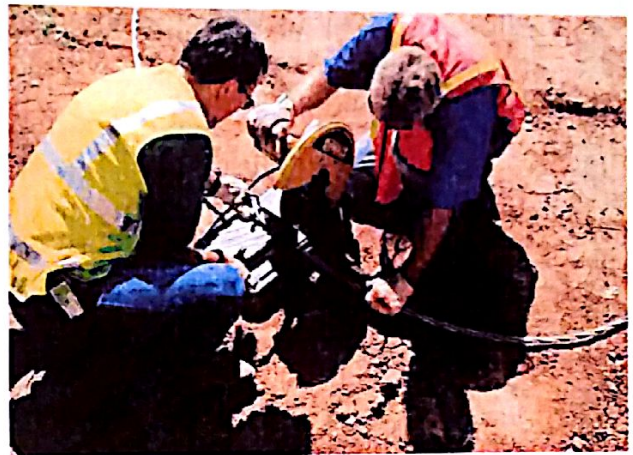
**Fig. 5b:** Cutting cable for end fitting.

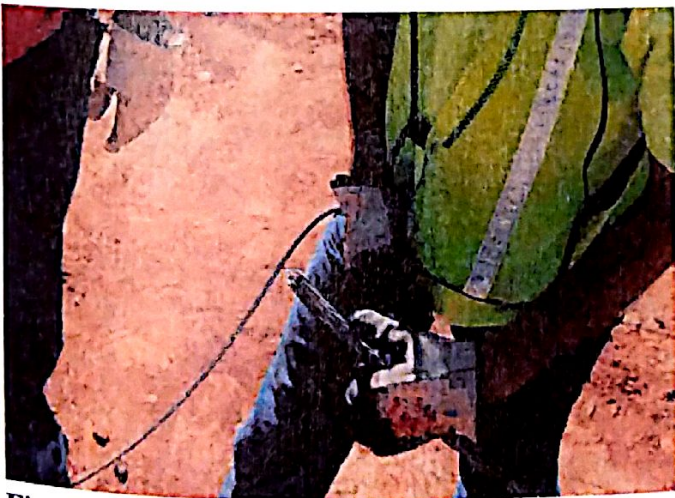
**Fig. 5c:** Attaching check rope.

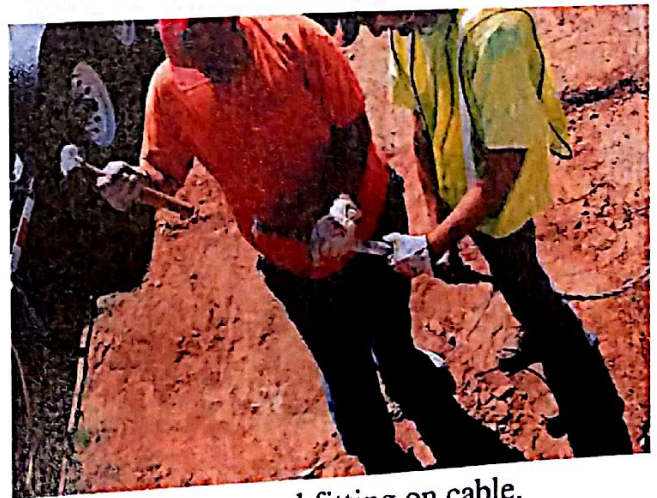
**Fig. 5d:** Placing end fitting on cable.

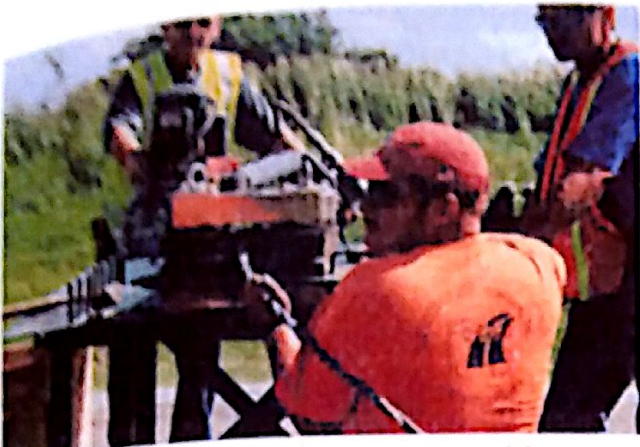
**Fig. 5e:** Crimping end fitting onto cable.

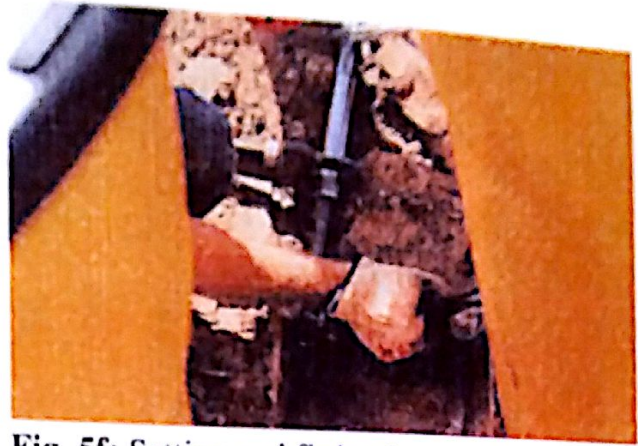
**Fig. 5f:** Setting end fitting into anchor.

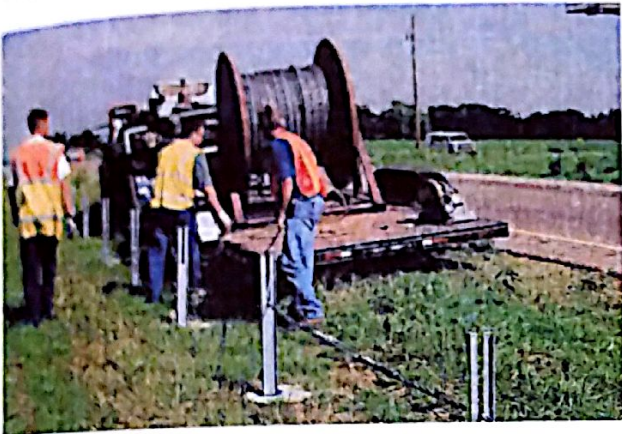
**Fig. 5g:** Placing bottom cable into posts.

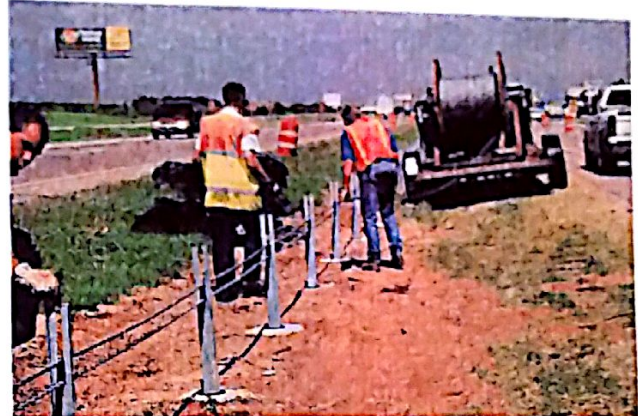
**Fig. 5h:** Placing second cable and inserting spacers for third cable.

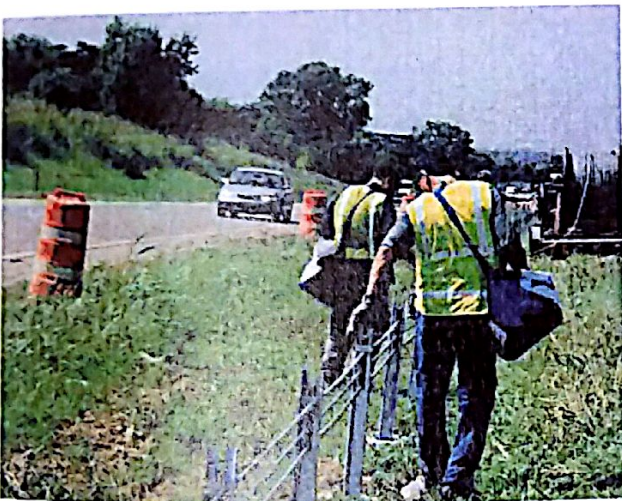
**Fig. 5i:** Placing stiffening frame between the third and top cables.

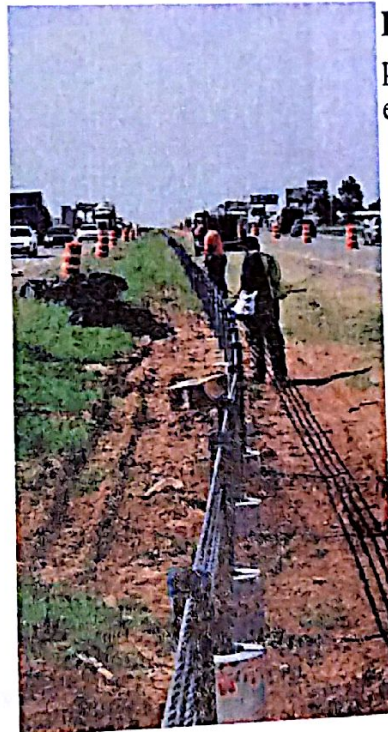
**Fig. 5j:** Placing plastic caps on every post.

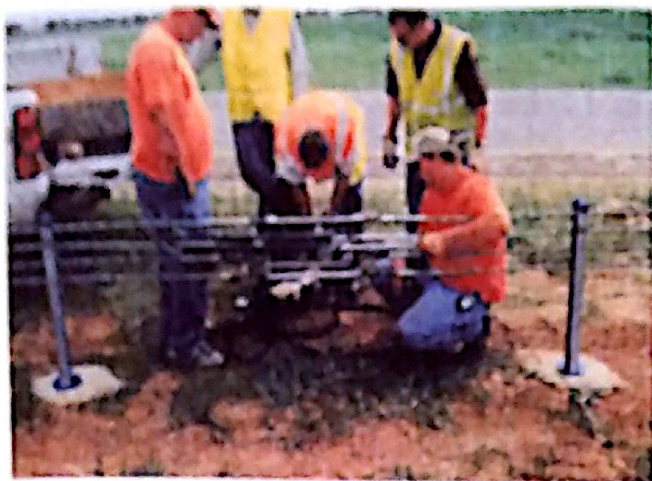
**Fig. 5k:** Tensioning cable three.

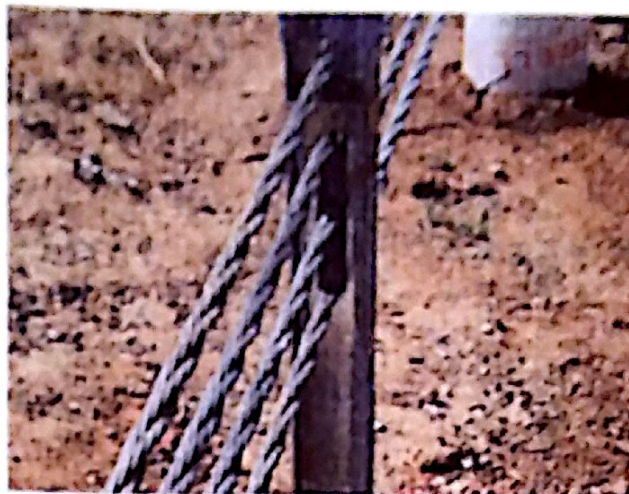
**Fig. 5l:** Close-up of finished post assembly.

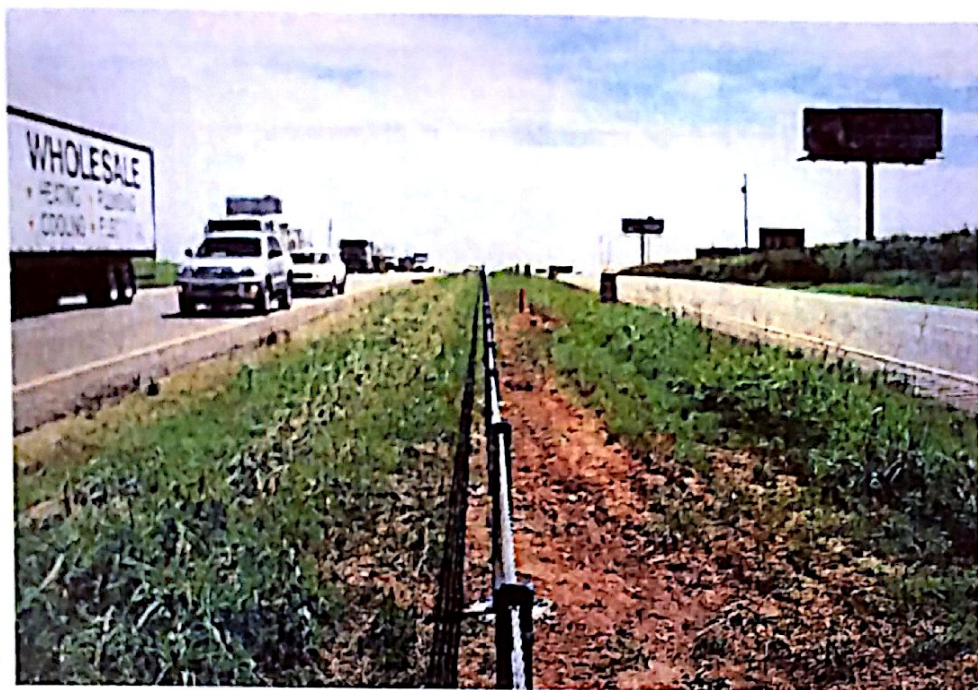
**Fig. 5m:** Fully assembled and tensioned Safence Cable Barrier System in place on I-35 in Mc Clain County.

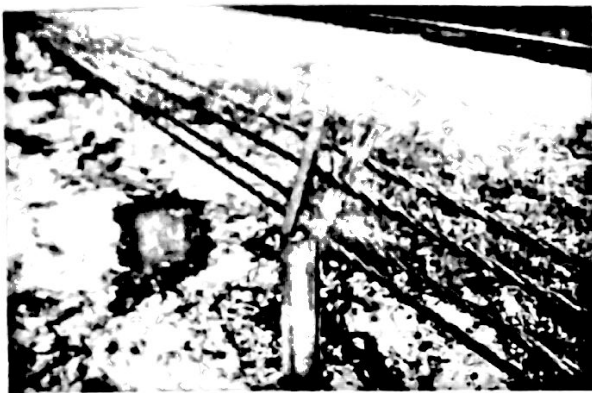
The Safence Cable Barrier System was hit on several occasions and the structure of the system proved adequate each time. Each time the barrier was hit, the posts folded over as intended and the cables stretched slightly upon impact but did not break under tension. See figure 6 (a-f).

**Fig. 6a:** Posts have broken away after vehicle collision with fence, but the cable remains intact.

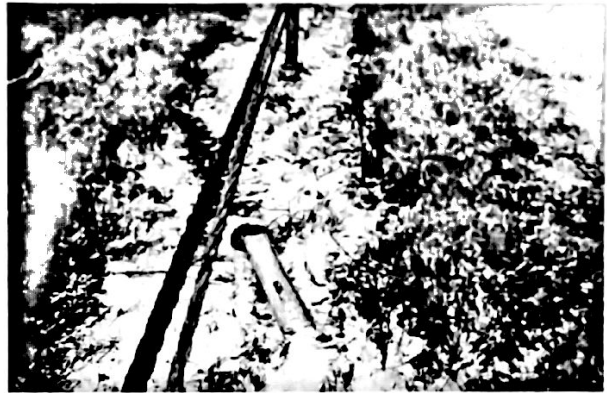
**Fig. 6b:** Close-up of post folded down while cable remains intact.
