**SCHOOL OF CIVIL AND  
ENVIRONMENTAL ENGINEERING  
OKLAHOMA STATE UNIVERSITY**

**PERFORMANCE OF EXPERIMENTAL APPROACH  
EMBANKMENTS AT SALT FORK RIVER  
BRIDGES ON U.S. 177**

Report No. FHWA/OK-97(04)

June, 1997

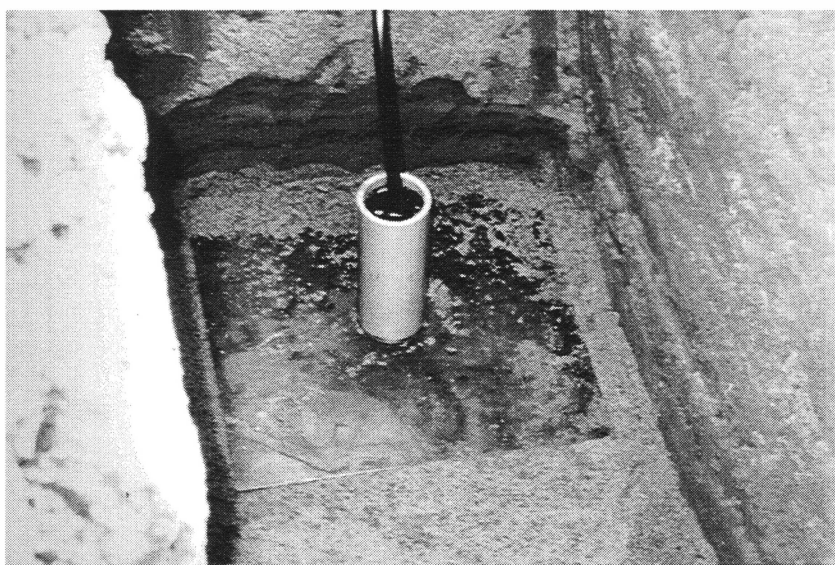
Figure 10. Installation of Amplified Liquid Settlement Gages

The settlement gages were placed in 2 ft by 2 ft (0.61 m by 0.61 m) holes, Figure 10, and covered with sand. Excess tubing was laid in the hole to provide extra length during settlement. Inside the backfill area, the tubing was placed in a plastic conduit that ran from the centerline settlement gage to the offset gage, to the west wingwall, and then up to the junction box.

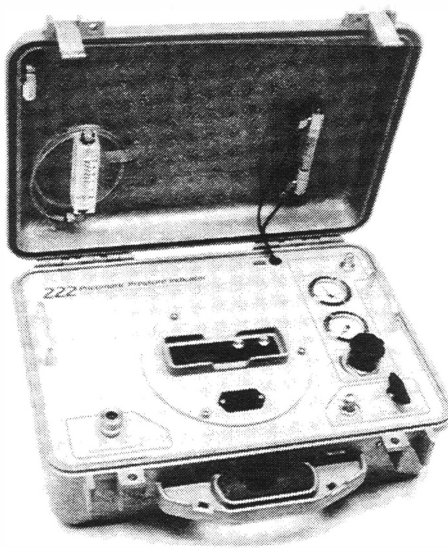
Figure 13. Pressure Indicator

The Pressure Indicator is a portable device the size of a small suitcase used to measure settlement from the amplified liquid settlement gages and total lateral earth pressure from the total pressure cells, Figure 13. It contains a supply of nitrogen used as the controlled air pressure source for the input connections of settlement gages and pressure cells. All readings are taken when the flow meter in the Pressure Indicator reads 0.1 SCFH (standard cubic ft per hour). A flow meter is also used for hookup to the outlet side of the instrument being read to confirm a continuous flow of air from the Pressure Indicator to the measuring device and back to the Pressure Indicator. This ensures proper air flow for accurate readings. A digital liquid crystal display pressure gage measures applied pressure which is then recorded onto data sheets.

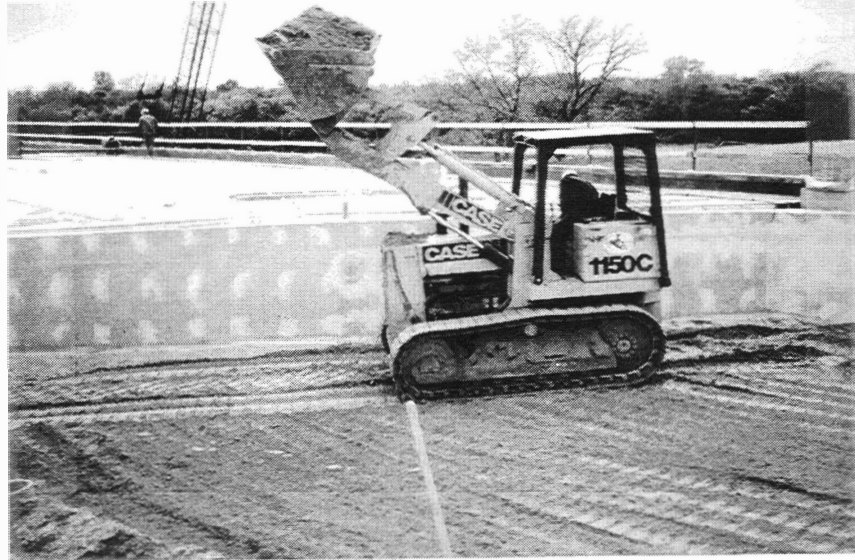
Figure 15. Compaction of Unclassified Borrow for Approach Embankment at North Abutment, Bridge A

compaction. Density requirements were not met. The next day, backfill compaction was completed using a Case 1150C tracked front end loader with a full scoop and simply driving over the 1 ft (0.3 m) lifts as shown in Figure 15. The loader passed over the backfill twice, once in a direction parallel to the abutment wall and once parallel to the centerline. The area approximately 2 ft (0.6 m) away from the walls was compacted using a walk behind pad vibrator, Figure 16. The following Monday was rainy and work resumed on Tuesday, May 2. Because of a series of rain days, the backfill compaction was finally completed on Wednesday, May 10, with a construction time of 4 days and a cost of \$1500.

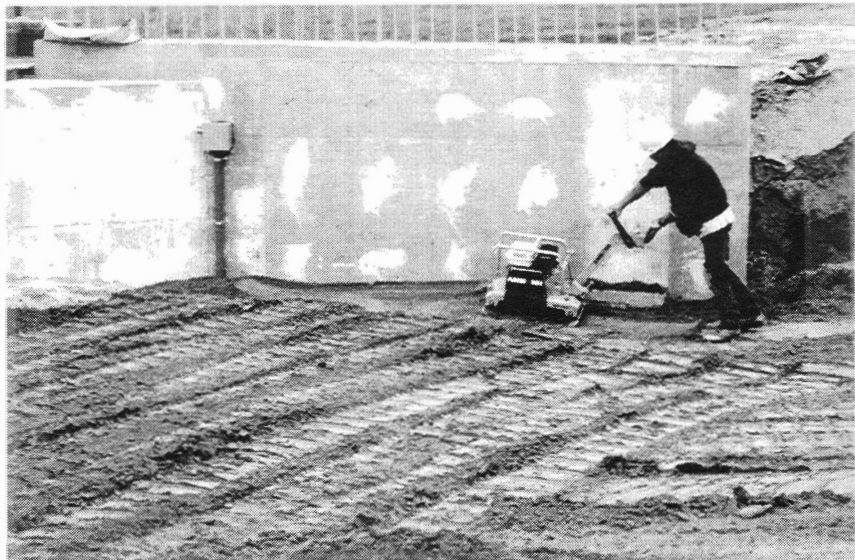
Figure 16. Compaction of Granular Backfill Adjacent to Abutment Wall at North Abutment, Bridge A

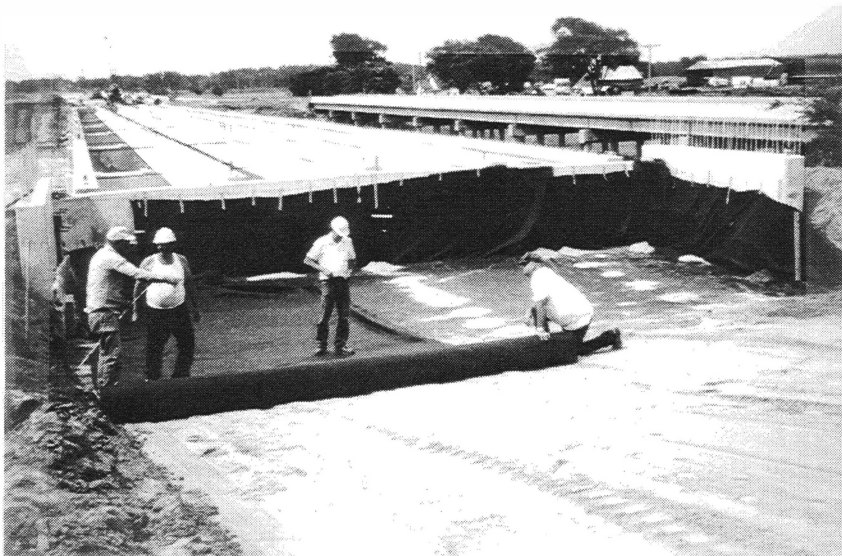
Figure 18. Placement of Geotextile Layer, South Abutment, Bridge B

Construction geotextile reinforced granular backfill began on Monday, May 22, and consisted basically of repeating five steps for each of the eight lifts: lay the textile, place and spread the sand, water, compact, and fold over the flaps. Figure 18 shows the placement of the geotextile. Laying the geotextile was similar to laying carpet. Rolls of textile 12 ft (3.7 m) wide were rolled in the direction perpendicular to the face of the wall (north to south). Excess fabric (approximately 6 ft (1.8 m)) was temporarily attached to the abutment and wing walls to later

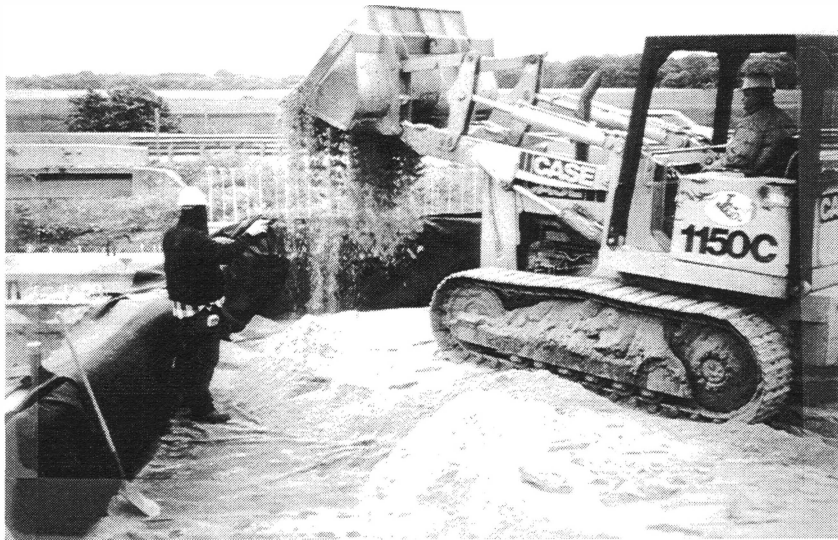
Figure 19. Placement of Granular Backfill on Geotextile,  
South Abutment, Bridge B

Next, the sand was placed using a tracked front end loader, Figure 19. The front end loader dumped sand from the south to the north to avoid direct contact to the geotextile by the machinery. Once all the material was placed, a total of six men distributed the material to create a 12 in. (30.5 cm) thick loose lift.

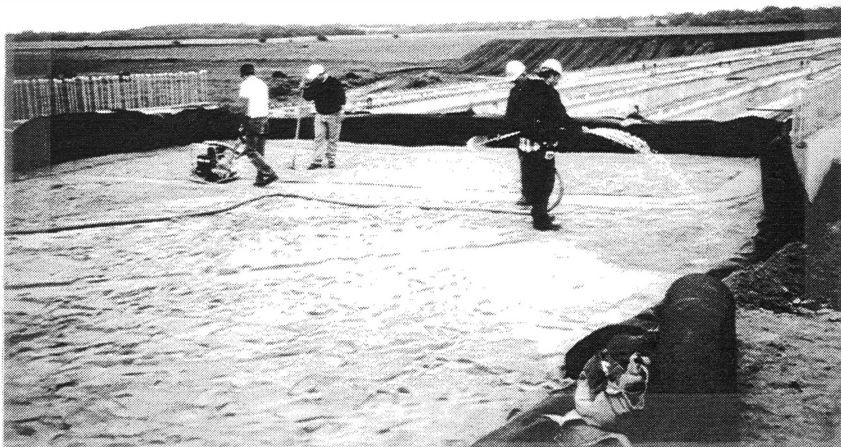
Figure 20. Compaction of Granular Backfill,  
South Abutment, Bridge B

Compaction with a walk-behind vibrator followed, Figure 20. The weather had been rainy during the week and the sand was already moist, but to reach saturation extra moisture was applied using a water truck. A five horsepower walk-behind pad vibrator achieved adequate densities with one, or sometimes two, passes. Density readings were taken with a Troxler nuclear density/moisture gage. After density was achieved, a small mound descending away from the wall was pushed up using concrete spreaders around the perimeter of the three walls. The flaps were then brought down from hanging on the walls and laid on top of this grade as seen in Figure 21.

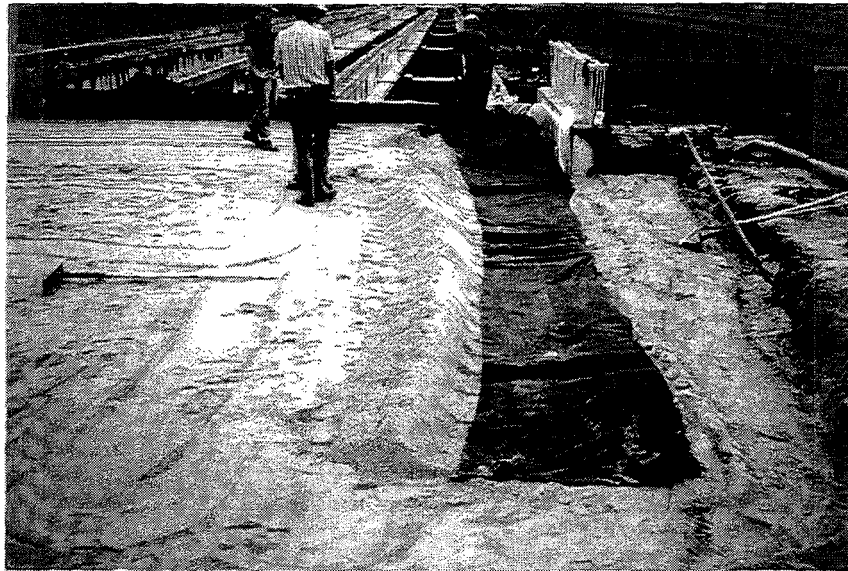
Figure 21. Trench in Granular Backfill for Roll-Back of Geotextile, South Abutment, Bridge B

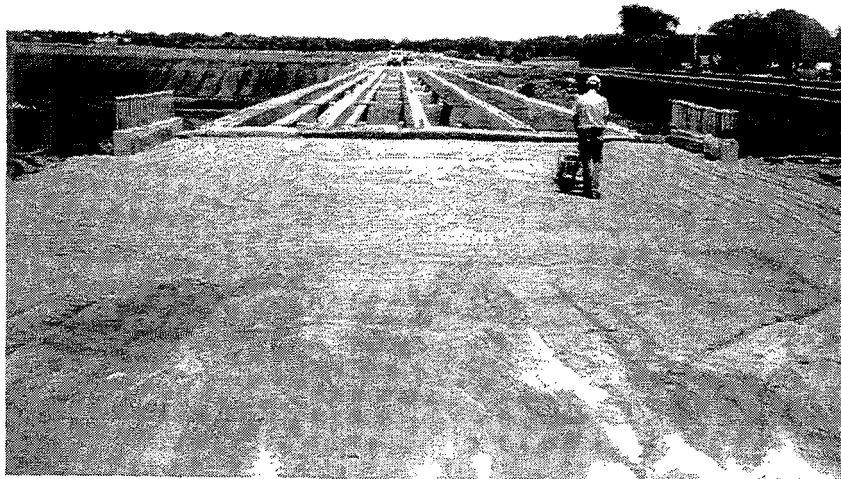
Figure 22. Placement of Final Lift for Geotextile Reinforced Wall, South Abutment, Bridge B

This process continued until eight lifts were completed, Figure 22, on Thursday, June 1. With an average of four men for spreading and the equipment mentioned, completion took 104 man-hours. The time for each lift gradually increased since the area of the lift increased with the slope of the backfill volume. The estimated cost was approximately \$25,000 for installation over a 5-day period.

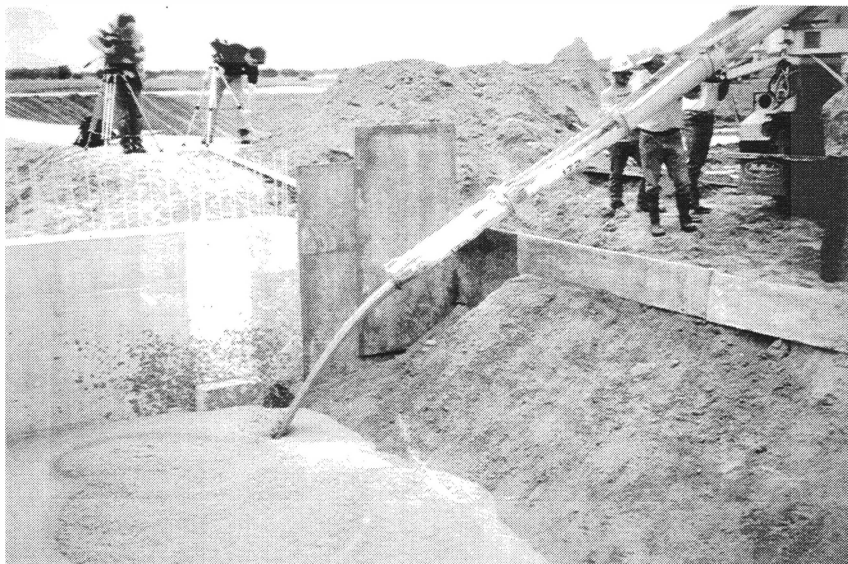
Figure 24. Placement of CLSM, North Abutment, Bridge B

Pouring the CLSM backfill involved ready-mix concrete trucks backing up to the forms and releasing the backfill material down the chute directly into the excavated volume, Figure 24. Two trucks were able to simultaneously unload. Twenty-three loads of nine cubic yards each were dumped for a total of 207 cubic yards ( $158.3 \text{ m}^3$ ) in 4.5 hours on Friday, May 12. Figure 25 shows the completed backfill. Besides pouring, the only labor involved was using a vibrator near the abutment wall-wingwall corners and leveling with a concrete float. Total time for this construction was 2 days at a cost of \$14,560.

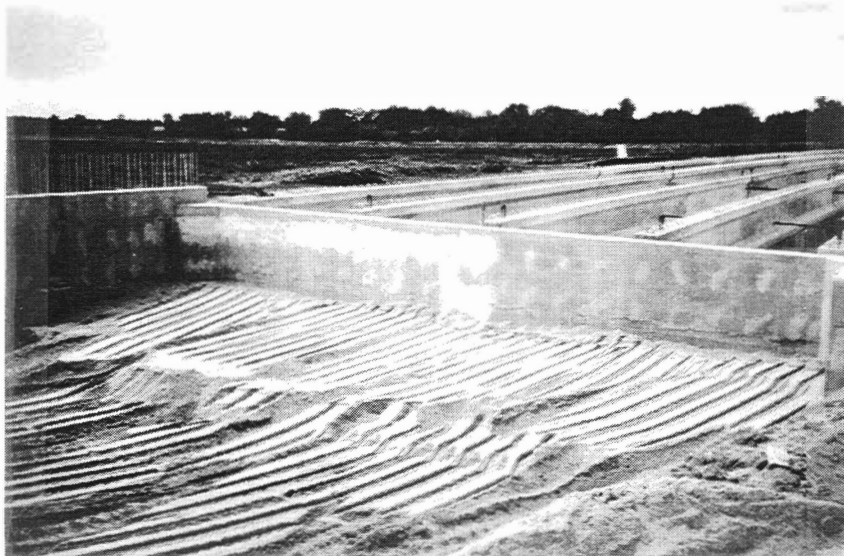
Figure 26. Placement of Granular Backfill for Dynamic Compaction, South Abutment, Bridge C

The construction began on Friday, May 12, and ended on Thursday, May 18. Lifts of granular backfill 2 ft (0.6 m) thick were spread and then sprayed with water, Figure 26. Then a tracked crane dropped a 4 ft (1.2 m) cube of concrete as shown in Figure 27. The weight of the cube was estimated at 4 tons (3629 kg). It was dropped from heights of 8 ft (2.4 m). The drop configuration was from the edge of the wing wall to the center and from the abutment wall back. Impact areas overlapped half of the previous impact. This procedure followed through the next three lifts. Control of the drop height and pattern improved after the first lift was completed which resulted in more consistent heights closer to the specifications and efficient overlapping. A walk behind pad vibrator densified the perimeter and then densities were taken. If density was sufficient, material for the next lift was brought in with a front-end loader. A final "ironing" pass was used to compact the surface materials, Figure 28.

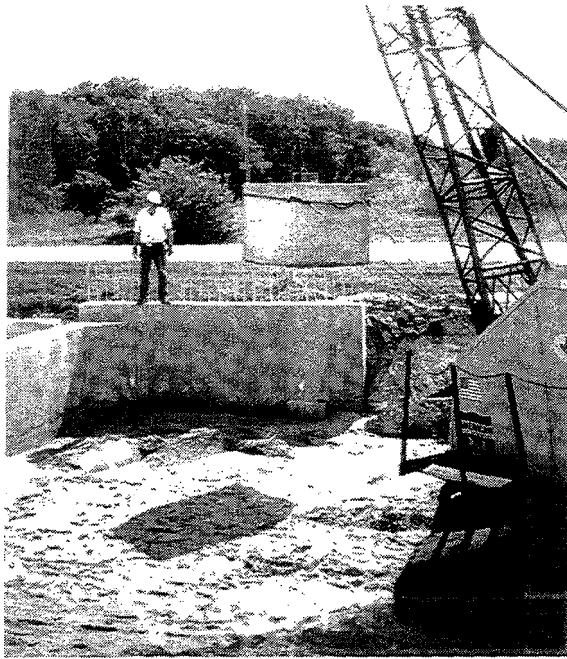
Figure 27. Dynamic Compaction of Granular Backfill, South Abutment, Bridge C

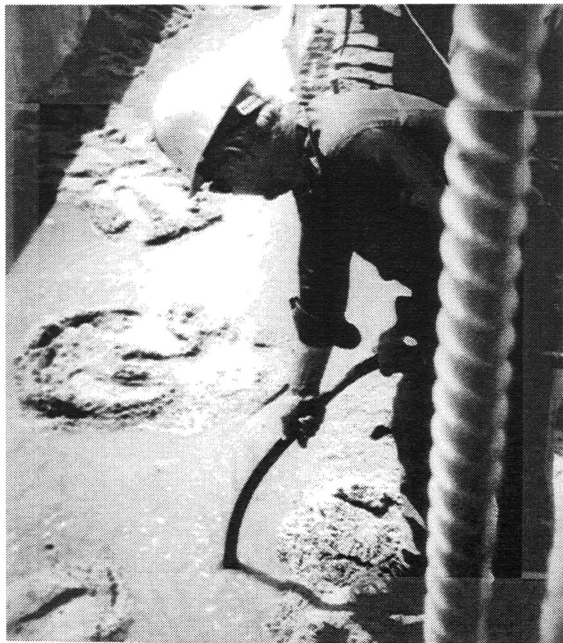
Figure 30. Flooding and Vibration of First Lift of Granular Backfill, North Abutment, Bridge C

Figure 29 shows the construction that began on Friday, May 12, with the placement of the first 4 ft (1.2 m) lift. First, the granular material was placed and spread with a front end loader. Then the lift was flooded with water from a water truck and a hand-held concrete vibrator was inserted to the approximate depth of the lift at approximate 1 ft (0.6 m) spacing over the whole backfill area to create a 1 ft (0.6 m) grid pattern, Figure 30. Densities were then checked using a Troxler density/moisture gage. The first round of testing after completion of the first lift revealed that the densities were low. On the following Monday, vibration of the first lift was repeated and all subsequent densities were sufficient. The second 4 ft (1.2 m) lift was placed and the backfill was flooded and vibrated twice and completed on Tuesday, May 16.
