1. Report No. FHWA/TX-06/0-4502-2	2. Government Accession No.	3. Recipient's Catalog No.	
4. Title and Subtitle CONTINUED EVALUATION OF MICROCRACKING IN TEXAS		5. Report Date November 2005

CONTINUED EVALUATION OF MICROCRACKING IN TEXAS

Report 0-4502-2
Project 0-4502
Project Title: Microcracking Stabilized Bases during
Construction to Minimize Shrinkage

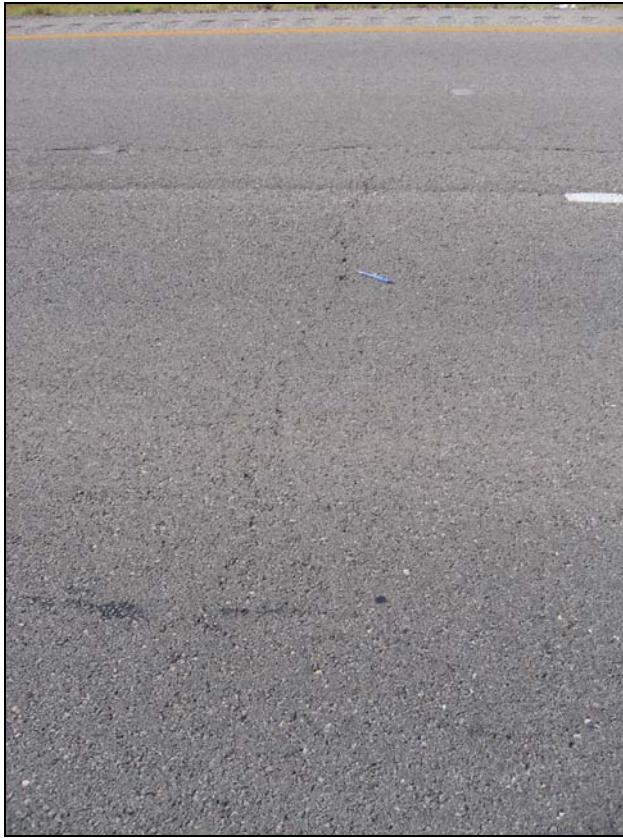
Figure 1.1. First Longitudinal and Transverse Crack on SH 47 NB.

In this section, two locations of longitudinal cracking exist, with one transverse crack in the outside lane (OL). [Figure 1.1](#) shows the first longitudinal crack and the transverse crack, which intersects the longitudinal crack. Given the straightness and location of this 180 foot longitudinal crack, it may be resultant from a construction joint in the base.

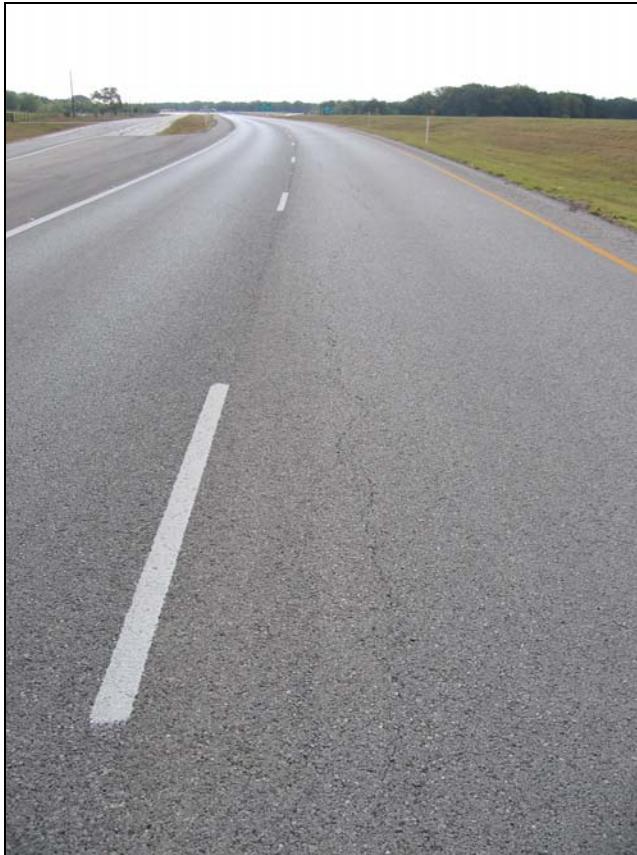
Figure 1.2. Second Longitudinal Crack in SH 47 NB.

The second longitudinal crack in this section exists in the inside lane near the end of the section and is 135 feet long. [Figure 1.2](#) shows the crack. Given its meandering nature, it is not believed to be due to a construction joint.

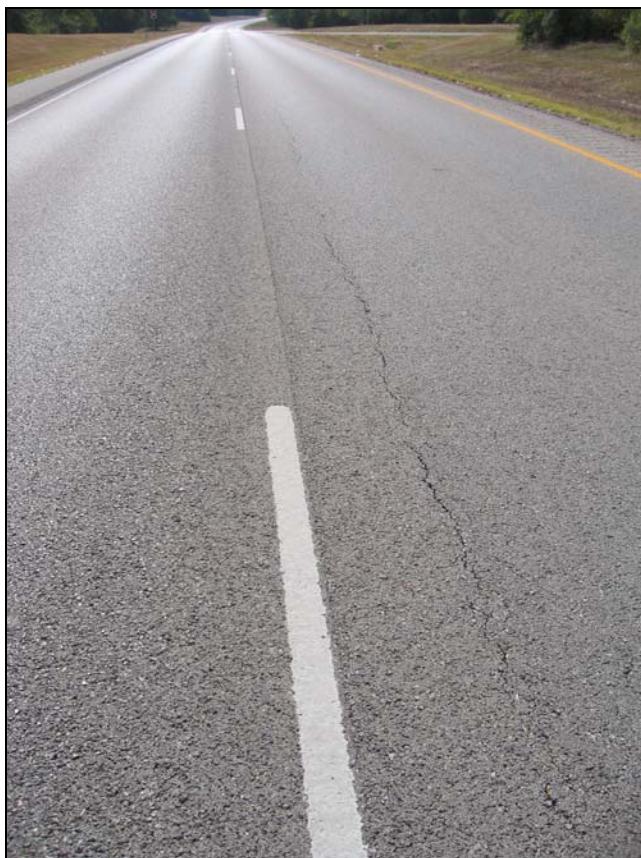
Figure 1.3. Longitudinal Crack in SH 47 NB from STA 1163.70 to 1163.10.

In this section, no transverse cracking exists. A 60 foot longitudinal crack exists from 1163.70 to 1163.10 in the inside lane, shown in [Figure 1.3](#). Given its location, this crack may be at a longitudinal construction joint in the base. A second longitudinal crack 38 feet in length, shown in [Figure 1.4](#), exists in the inside lane from 1161.33 to 1160.95. This crack may be caused by shrinkage cracking in the subgrade reflecting up through the base and HMA layers.

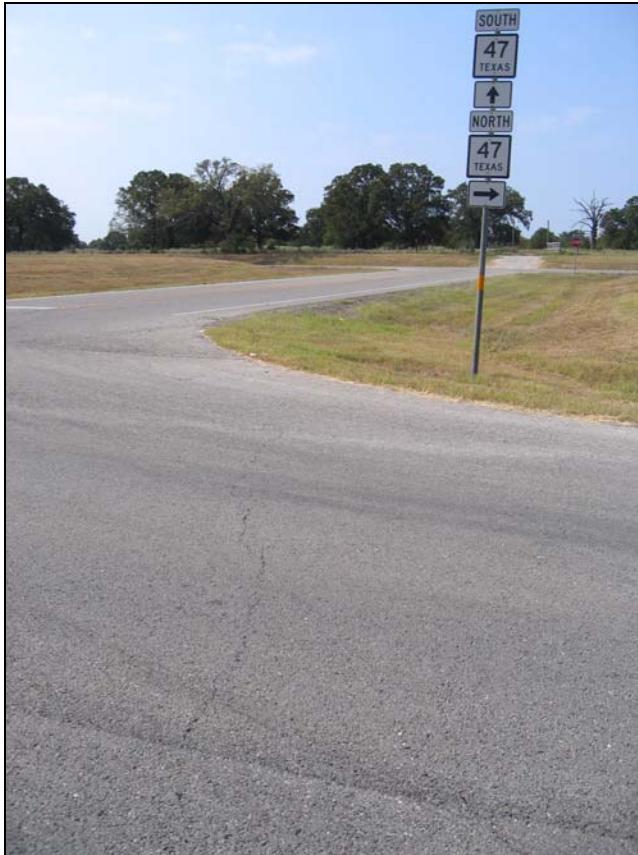
Figure 1.5. Transverse Crack at STA 1124.84 in SH 47 NB.

In this section a transverse crack 16 feet in length exists at STA 1124.84. This crack appears classical of reflective cracking from the CTB. [Figure 1.5](#) shows the crack.

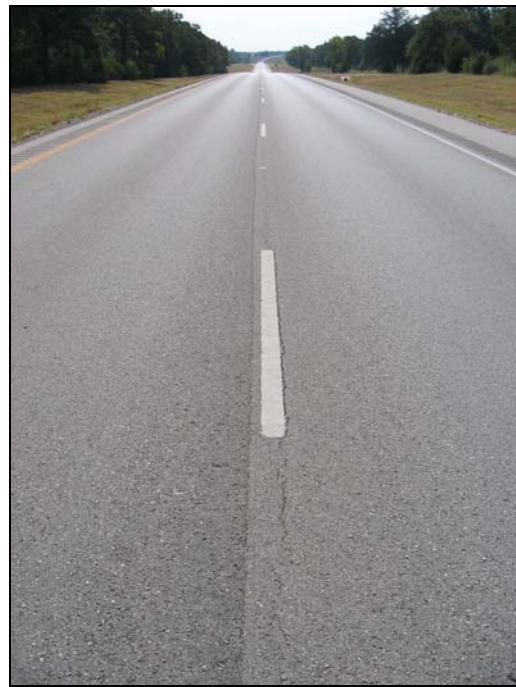
Figure 1.6. Distress on SH 47 SB from STA 2142.52 to 2143.06.

This section exhibits the worst performance of all the SH 47 test sites. This site has approximately 3 times the amount of cracking per area of pavement and approximately 11 times the transverse cracking as the next closest section in terms of crack statistics. Earlier surveys ([1](#)) showed a portion of this section had distress before any of the other sites. The location of the initial distress has worsened, and several other locations within the section now have visible distress in the HMA. [Table 1.2](#) summarizes the distresses seen in this section, and Figures [1.6](#) through [1.17](#) show representative photos of the distresses.

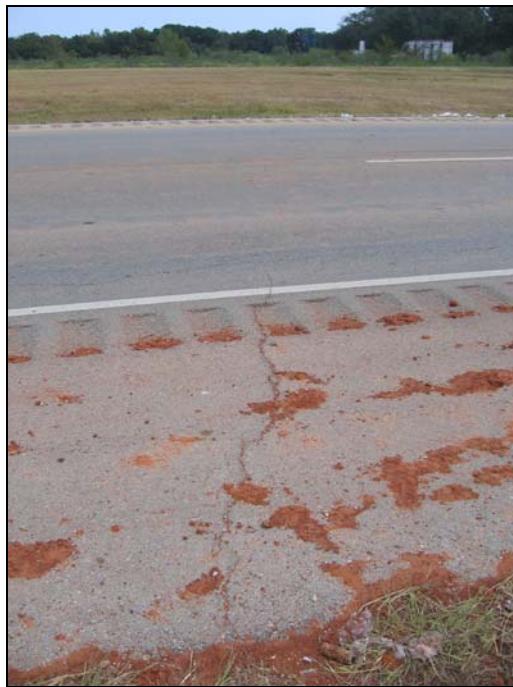
Figure 1.18. Cracking in SH 47 SB from STA 2289.69 to 2290.11.

In this section the only distress noted was the initiation of block cracking in the outside lane from STA 2289.69 to 2290.11, shown in [Figure 1.18](#), and a 94 foot longitudinal crack possibly resulting from the construction joint from 2289.79 to 2290.73.

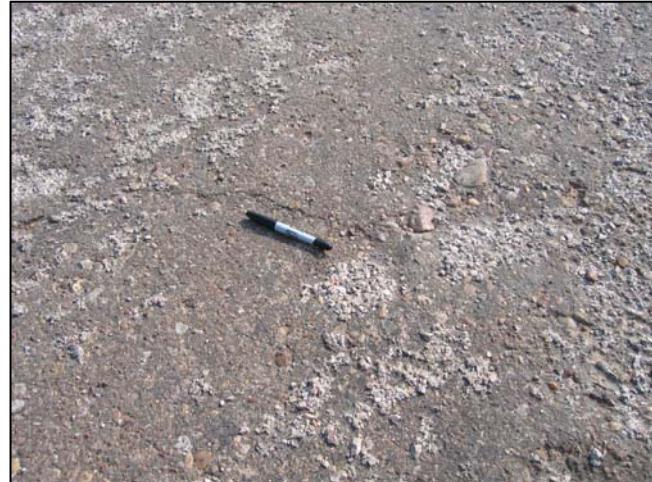
Figure 2.4. Reduction in Crack Severity by Microcracking.

Another previously noted benefit of microcracking is reduction in crack severity. As observed previously, sections microcracked continue to exhibit an overall reduction in crack severity, as shown in [Figure 2.4](#).

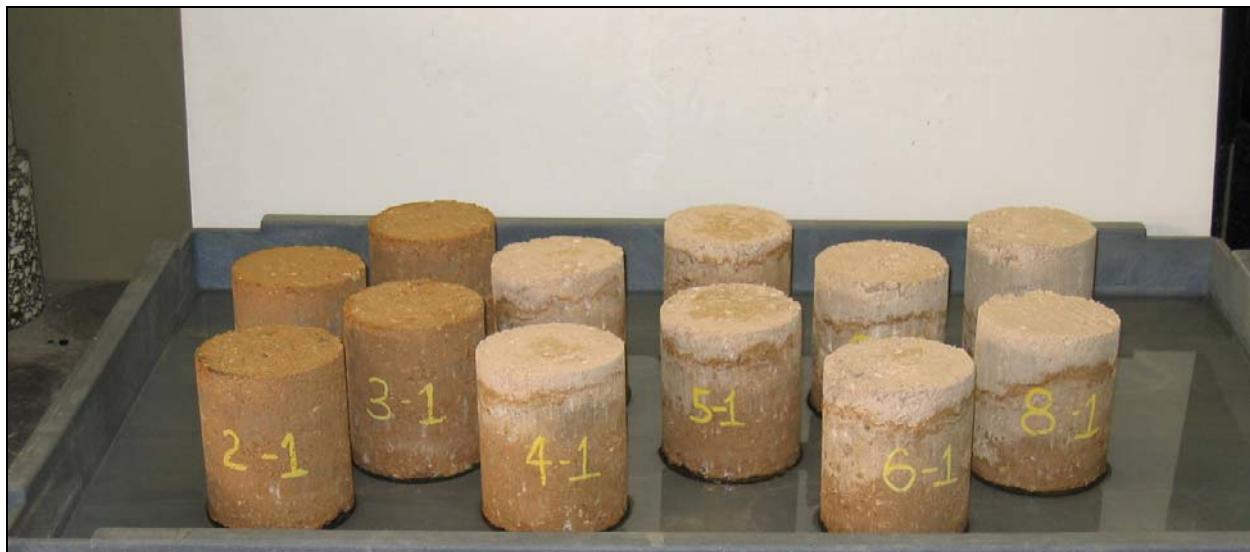
TxDOT provided the optimal moisture content of 7.1 percent and maximum dry density of 133.5 pcf. The TTI laboratory recombined test specimens according to the gradation shown in [Table 3.1](#) then tested specimens in duplicate in the design tests. [Table 3.2](#) shows the results from the mix design tests. Based upon a mix design criteria of at least 300 psi after seven days curing and a final dielectric value less than 10 after the Tube Suction Test, the recommended design cement content was 4 percent. While consideration was given to recommending 3.5 percent due to the high seven-day strengths, the decision to proceed with 4 percent was made based upon the Tube Suction Test. As [Figure 3.1](#) shows, after the Tube Suction Test the height of capillary rise in specimens treated with 4 percent still was quite near the surface of the specimen. The high strength of this material at the cement content required to pass the moisture susceptibility test makes the material a good candidate for microcracking in the field.

**Figure 3.1. Texas Crushed Stone Cement-Treated Base after Tube Suction Test.**
(l to r: 2, 3, 4, 5, 6, and 8 percent cement)

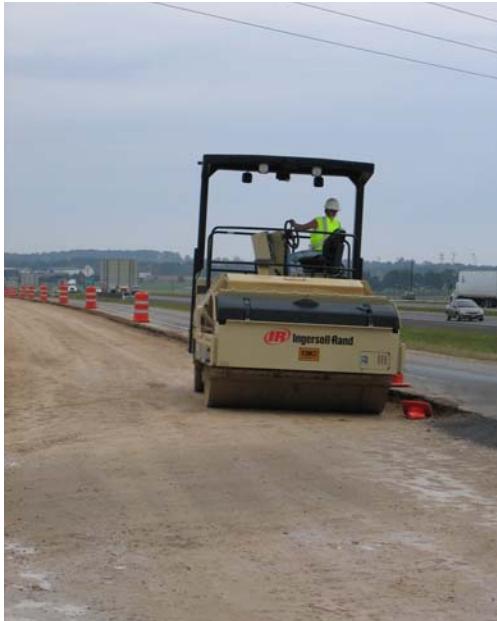
Figure 3.4. Microcracking IH 45 SB OL on December 6, 2004.

The research team conducted the first FWD survey from STA 1079 to STA 1086+50 on December 3, 2004, after one day curing. The average base modulus at this time was only 90 ksi, so no microcracking was performed on that day. During the rest of the base construction in December, the FWD was not available, so the research team used the PFWD to monitor the base stiffness for microcracking. Based upon data in the field and prior recommendations for using the PFWD to control microcracking (1), only the sections with four days curing time were microcracked on December 6. [Table 3.4](#) shows these results, which indicated the average base modulus was reduced by 38 percent from the PFWD calculations. [Figure 3.4](#) shows microcracking in progress in this section.

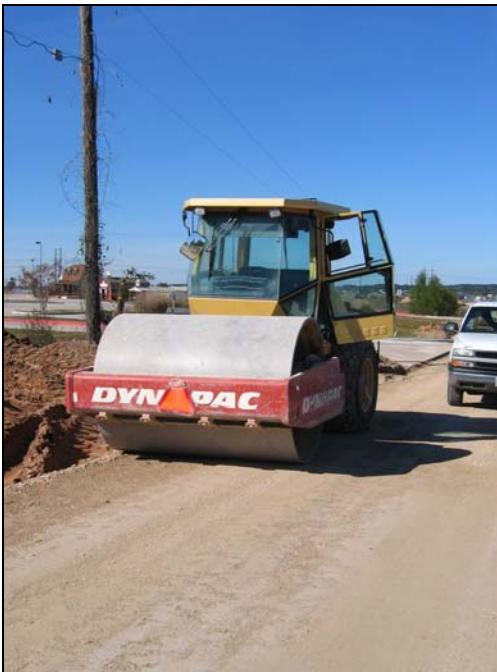
Figure 3.5. Microcracking IH 45 SB OL on December 7, 2005.

On December 7, 2004, the sections from STA 1088 to 1099+50 had cured for four days and were microcracked. [Figure 3.5](#) shows the microcracking in progress, and [Table 3.5](#) shows the PFWD data used to control the process.

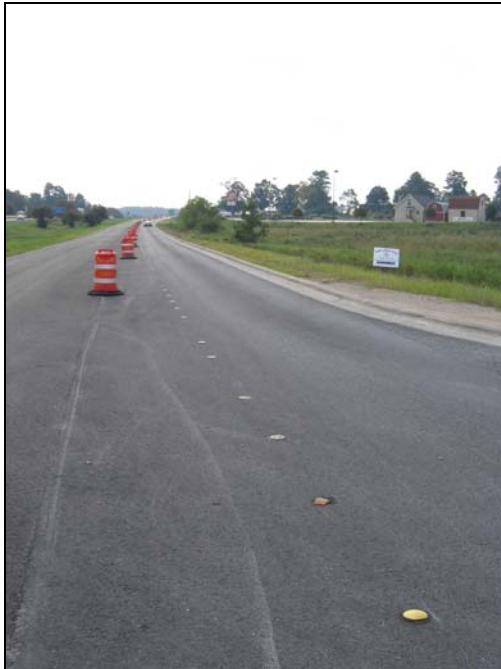
Figure 3.6. Looking South from Veterans Memorial Parkway in Microcracked Section, August 2005.

In August 2005, TTI returned to the project site to look for evidence of any shrinkage cracking. Additionally, FWD was collected. TTI focused on the southbound outside lane, because this section was the oldest and also includes the control section. [Figure 3.6](#) shows part of the microcracked section, and [Figure 3.7](#) shows the control section. No signs of transverse cracking were seen. This was expected since the section was only eight months old and had 5 inches of HMA surfacing. [Table 3.10](#) shows summary FWD results from 48 drops in the microcracked sections and 13 drops in the control section. Given the variability in observed values, no difference in modulus exists among the microcracked or control sections. Additionally, the backcalculated base moduli values are substantially high. Factors that could help explain these high values are incorrect layer thicknesses or the possibility of higher cement content in the field mixture. Efforts to verify the base thickness with ground-penetrating radar (GPR) were unsuccessful because no reflection was observable from the bottom of the base. Information on depth checks during construction was not available in time for this report. No field samples were collected during construction for strength tests, so it is unknown how the cement content of the field mix compared to the specified target.
