DOT HS 813 714

# **Special Crash Investigations: On-Site Rollover Crash Investigation; Vehicle: 2019 Chevrolet Equinox; Location: California; Crash Date: October 2022**

**Special Crash Investigations**  
**On-Site Rollover Crash Investigation**  
**Case Number: DS23001**  
**Vehicle: 2019 Chevrolet Equinox**  
**Location: California**  
**Crash Date: October 2022**

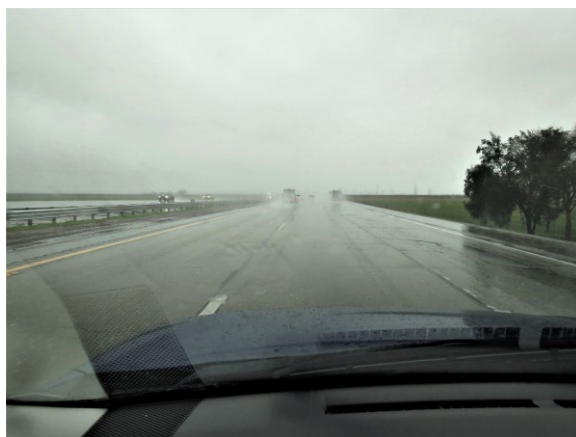
The crash site was on the southbound lanes of an interstate highway with a posted speed limit of 113 km/h (70 mph). The roadway had three concrete paved lanes in the southbound direction delineated by dashed white painted lines and raised ceramic reflectors (Figure 3). The left edge was bordered by a solid yellow painted edge line with raised ceramic reflectors, an asphalt shoulder with a milled-in rumble strip, dirt center median, and a metal guardrail. The right edge was bordered by a solid white painted edge line, an asphalt shoulder with a milled-in rumble strip, and a descending dirt embankment leading to a wire fence and drainage ditch. The travel lanes were 3.7 m (12 ft) wide; the left shoulder was 1.8 m (6 ft) wide, and the right shoulder was 3.0 m (10 ft) wide. The wire fence was 10.7 m (35 ft) to the right of the right shoulder. The roadway was straight and level. The crash occurred during dark, clear, and dry conditions. A crash diagram is included at the end of this report.

*Figure 3. Crash site looking south*

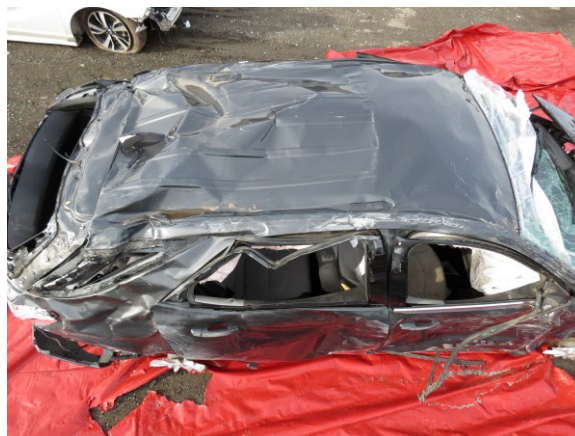
Several impacts caused direct and induced damage to the front, back, top (Figure 4), bottom, left, and right planes of the Chevrolet. The left-front tire was flat and de-beaded, the right-side wheels were fractured and off the vehicle, and the right-front tire was flat, de-beaded and cut. The left wheelbase was reduced by 5 cm (2 in) and the right wheelbase was unchanged. The front grille, headlight assemblies, bumper fascia, and front trim were detached and the radiator was out of place. The left and right side-view mirrors were missing.

*Figure 4. Rollover damage, the 2019 Chevrolet Equinox*

There was lateral damage from roof side rail to roof side rail and measured 120 cm (47.2 in). It was distributed longitudinally from the windshield header to the backlight header and measured 230 cm (90.6 in). Maximum vertical crush to the greenhouse measured 20 cm (7.9 in) and was located on the right roof inboard of the right C-pillar at 30 cm (11.8 in) forward of the right rear axle and 20 cm (7.9 in) to the left of the right roof side rail. Maximum lateral crush measured 14 cm (5.5 in) and was located on the right roof side rail at 5 cm (2 in) forward of the right rear axle and 30 cm (11.8 in) aft of the right C-pillar. The CDC for the Chevrolet in Event 3 was 00TDDO3.

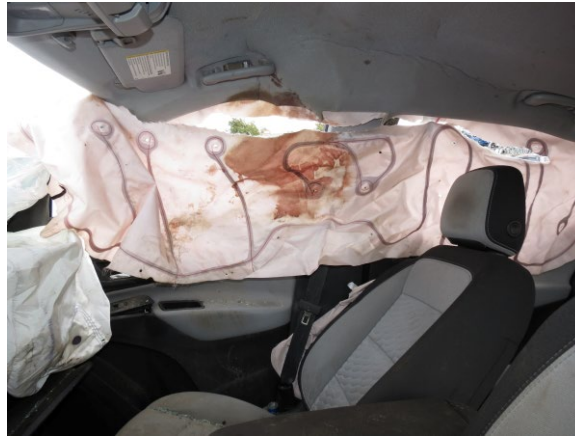
*Figure 5. Right IC air bag, the 2019 Chevrolet Equinox*

The Chevrolet had frontal and outboard seat-mounted side-impact air bags for the front row, and combination side-impact/roll-sensing IC air bags (Figure 5) for both rows. According to a vehicle history report, it was involved in a crash with deployments of the driver's frontal air bag and both IC air bags approximately 4 months and 469 ignition cycles prior to the rollover crash and those air bags were replaced.<sup>6</sup> The IC air bags were deployable in rollover crashes. Five air bags deployed in this crash. The left and right IC air bags and the seat belt pretensioners deployed during the rollover, and the driver's and passenger's frontal air bags and front passenger's seat-mounted side-impact air bag deployed in a right-side impact following the rollover. The air bags appeared to have deployed normally. The right IC air bag, front row section, had blood deposits on the face and appeared to have been cut lengthwise during post-crash activities. The other deployed air bags were unremarkable.

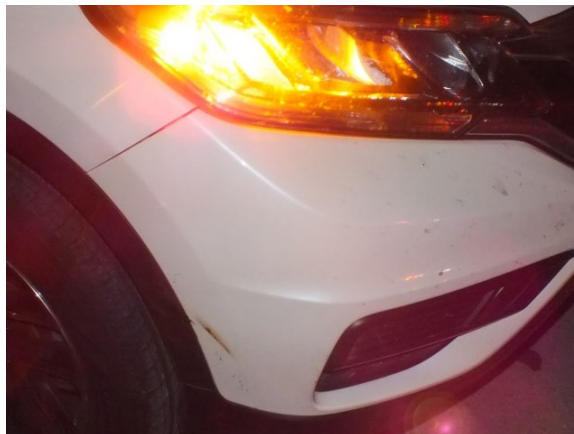
The Honda had minor damage in the right-front quadrant described as a tire rub mark on the right-front fender (Figure 6). Based on police photos, the estimated CDC for the Honda in Event 1 was 06RFES01. The vehicle was driven from the scene.

*Figure 6. Right plane damage, the 2016 Honda CR-V (police photo)*
