Improved Detailing in Steel Bridges to Prevent Constraint-Induced Fracture

A Report on Research Sponsored by
The Federal Highway Administration

Structural Engineering and Engineering Materials
SM Report No. 169
December 2025

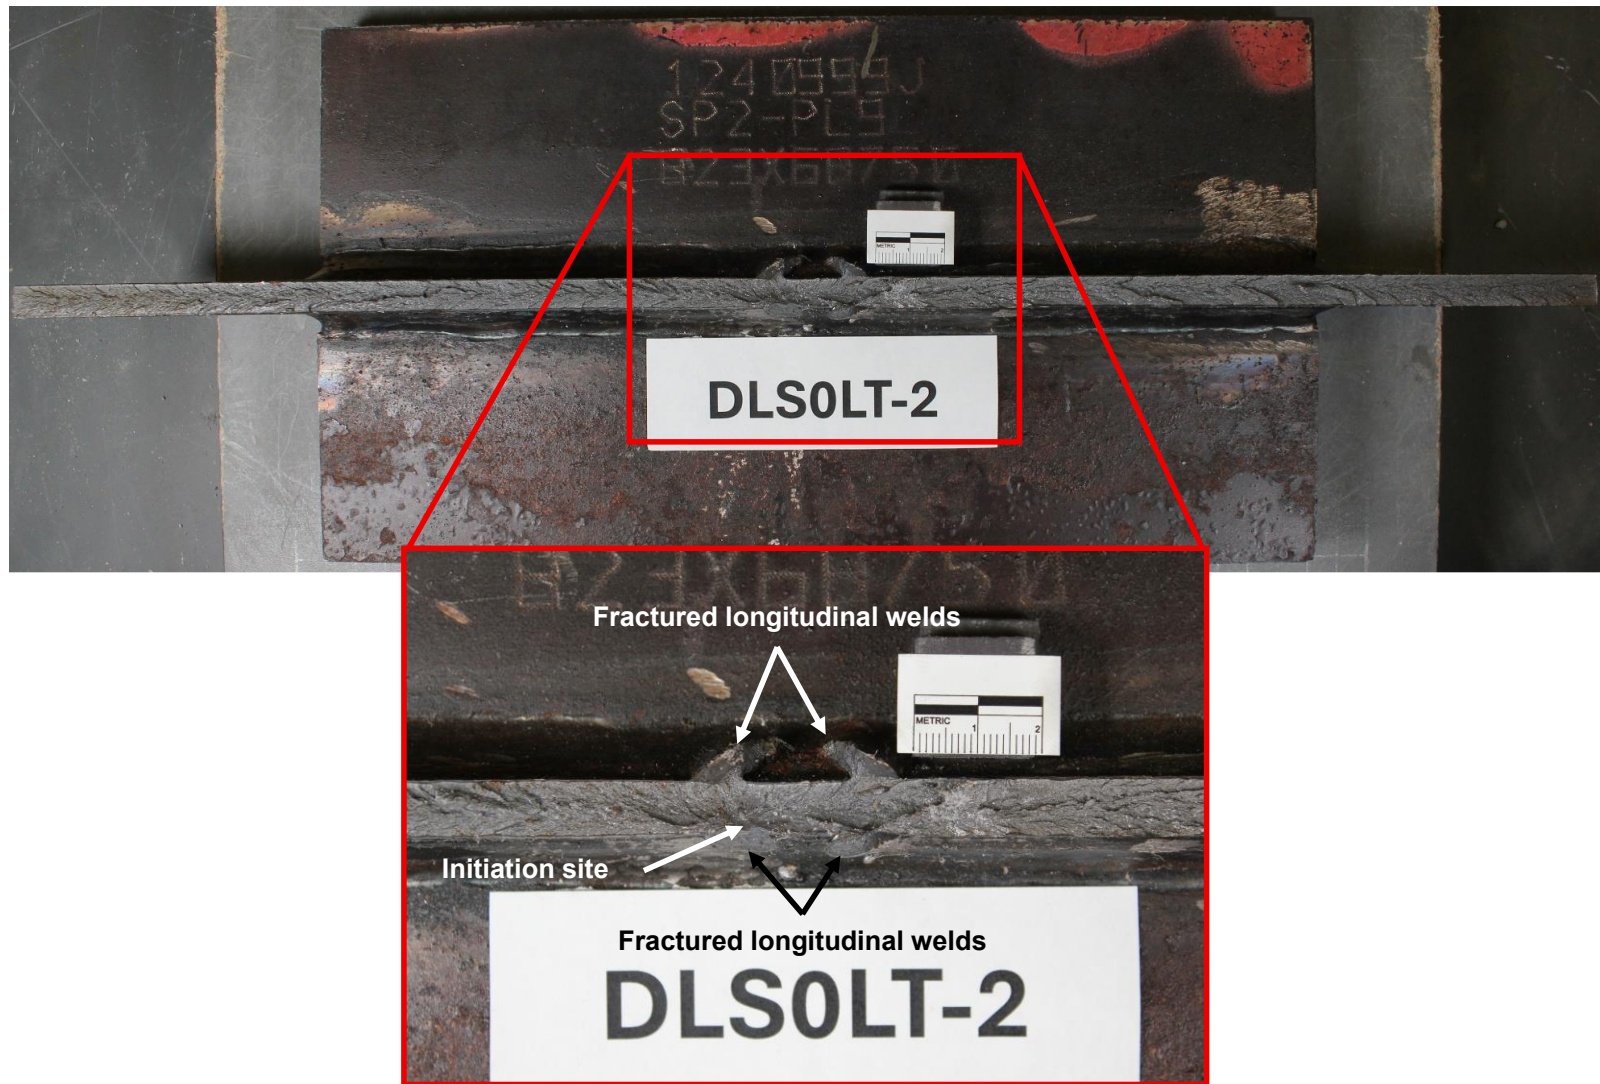
Figure 71. Photograph. DLS0LT-2: transverse-stiffener side of fracture.

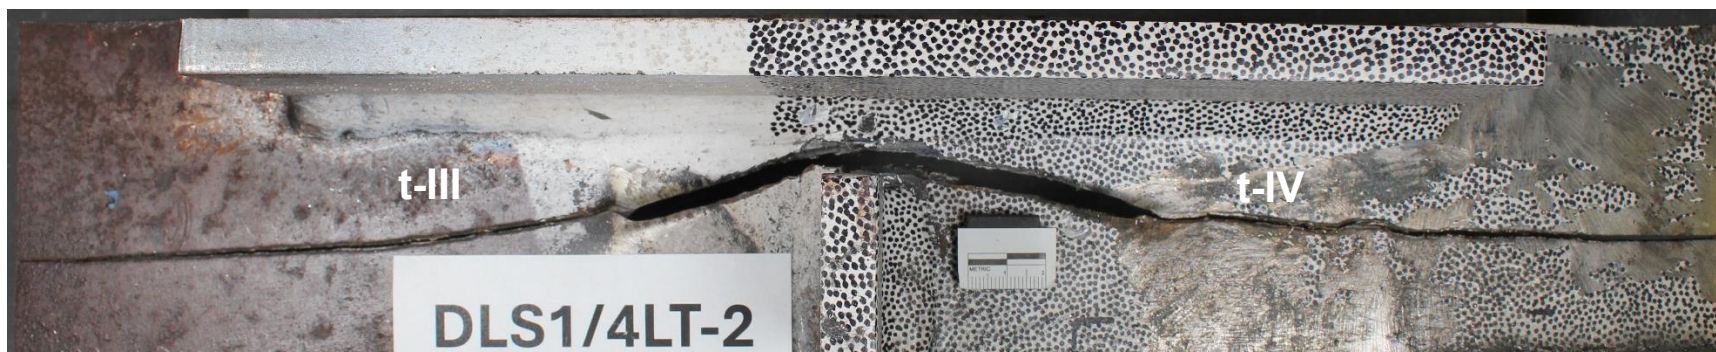
Figure 76. Photograph. DLS1/4LT-2: top view of fractured specimen.

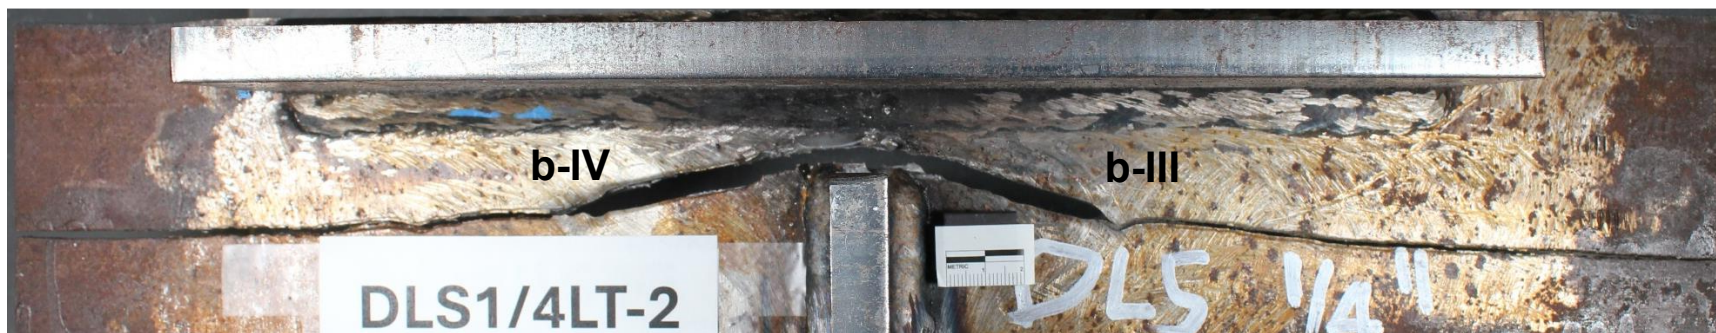
Figure 77. Photograph. DLS1/4LT-2: bottom view of fractured specimen.

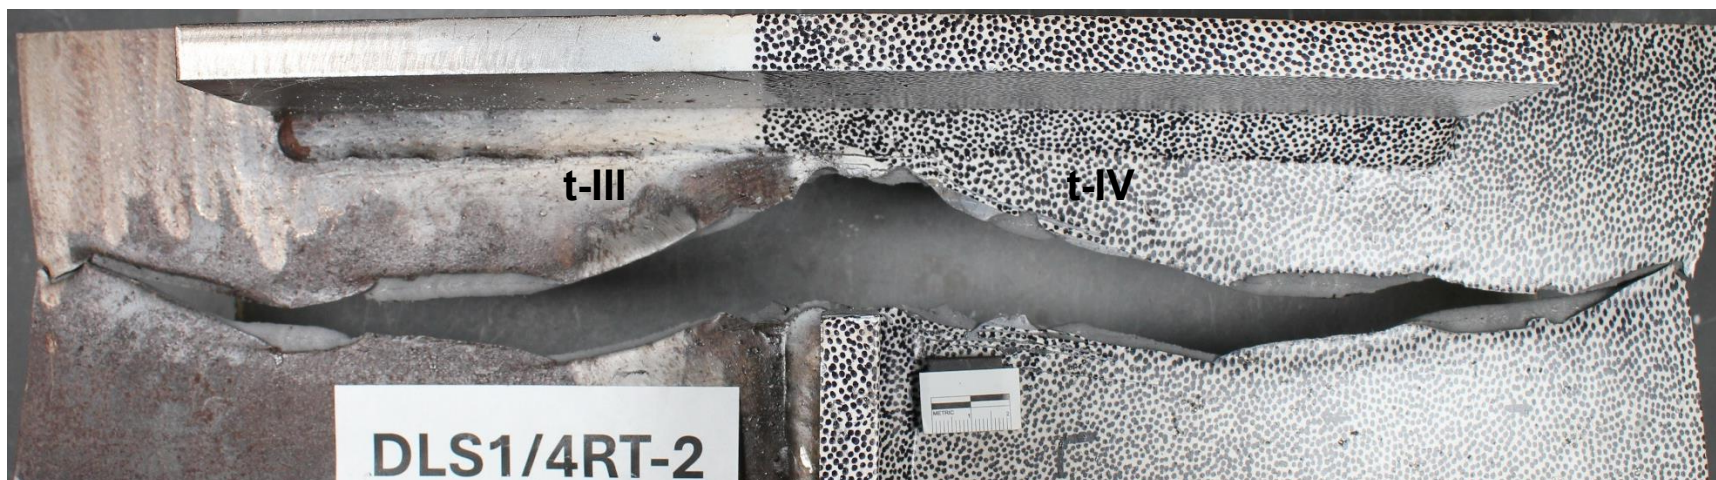
Figure 80. Photograph. DLS1/4RT-2: top view of fractured specimen.

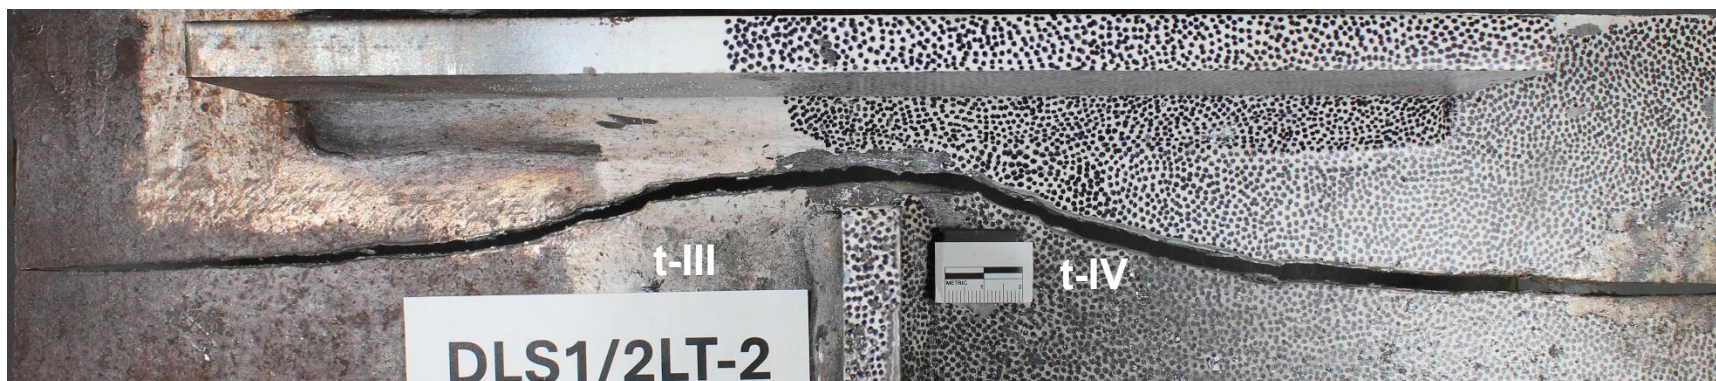
Figure 90. Photograph. DLS1/2LT-2: top view of fractured specimen.

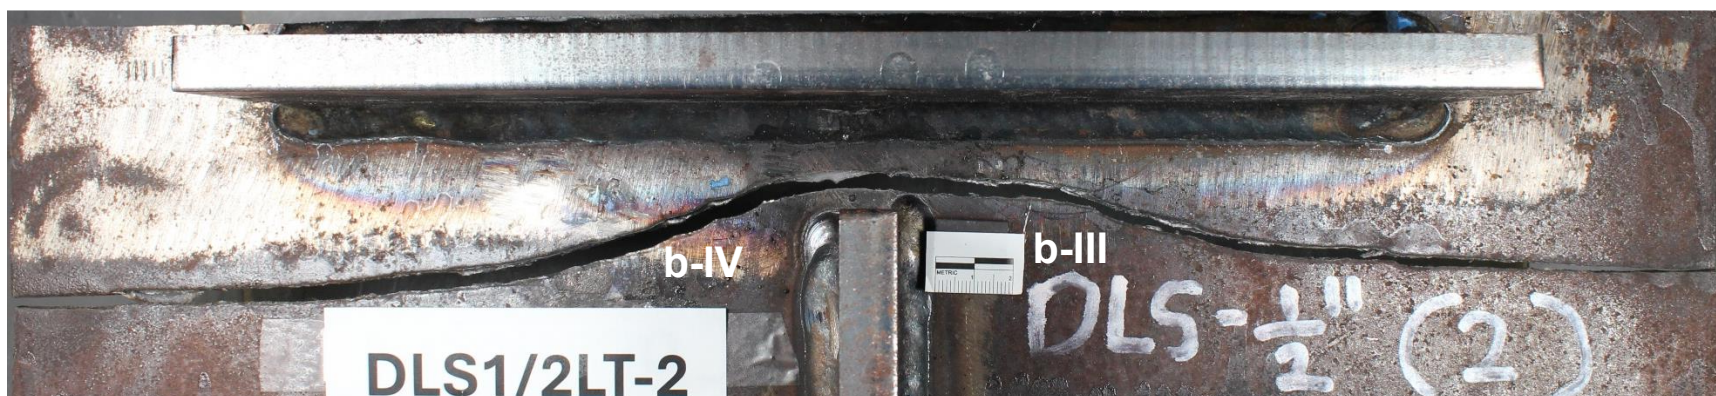
Figure 91. Photograph. DLS1/2LT-2: bottom view of fractured specimen.

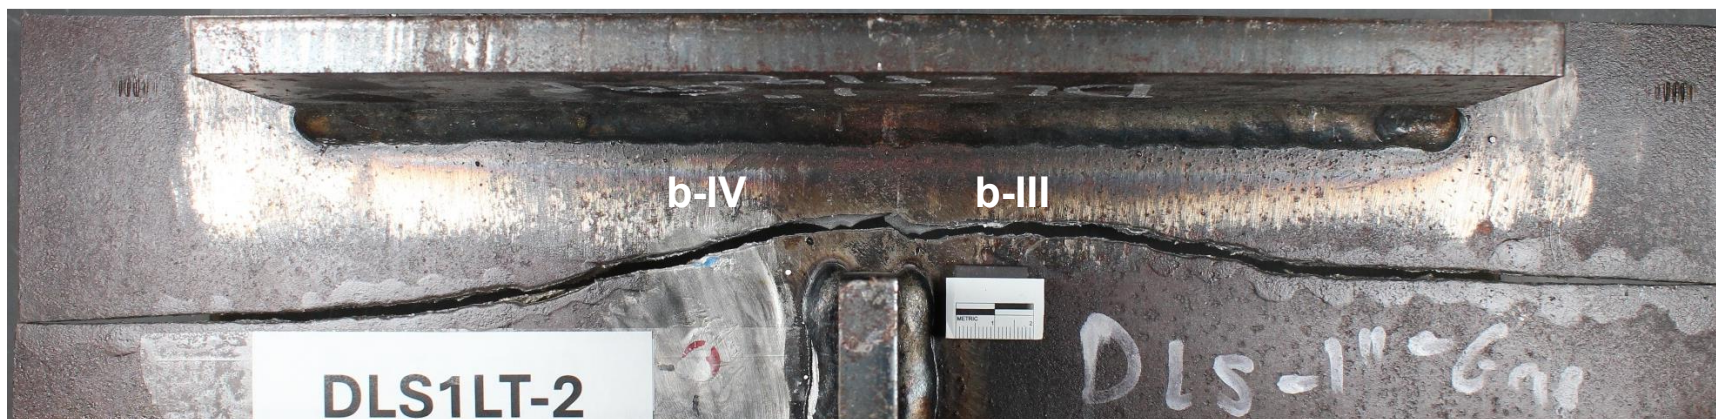
Figure 97. Photograph. DLS1LT-2: bottom view of fractured specimen.

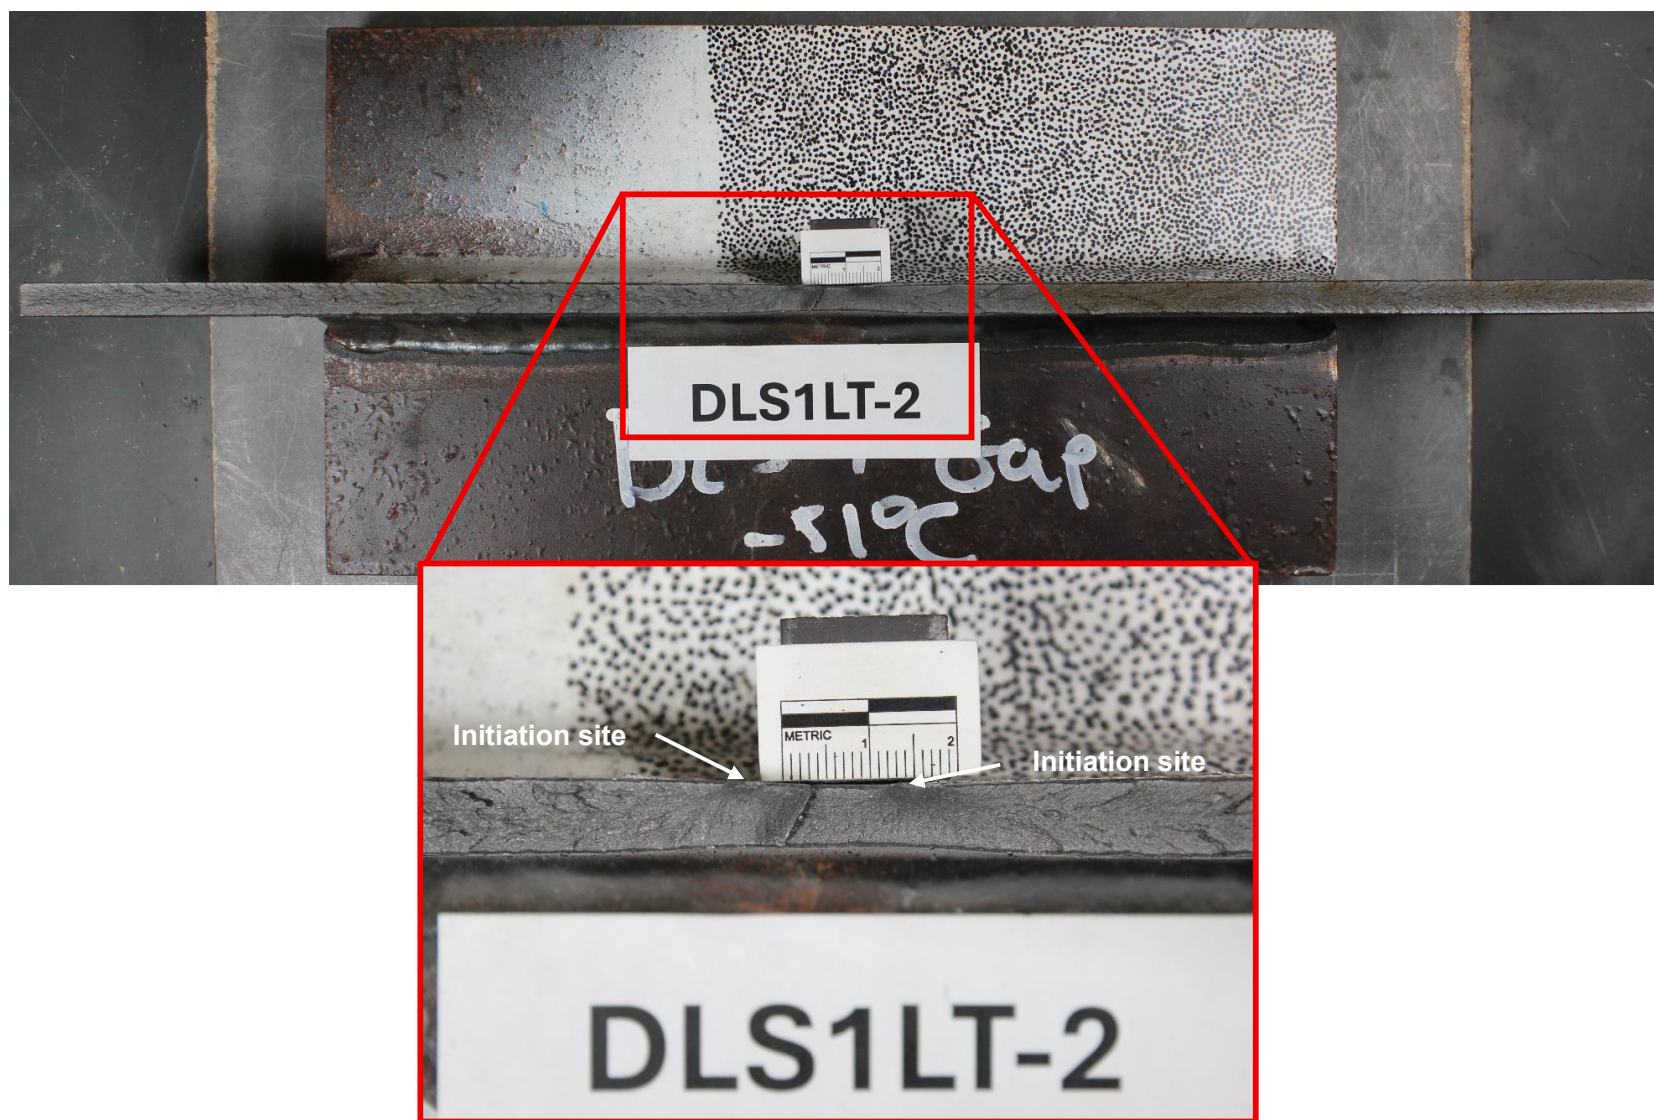
Figure 98. Photograph. DLS1LT-2: transverse-stiffener side of fracture.

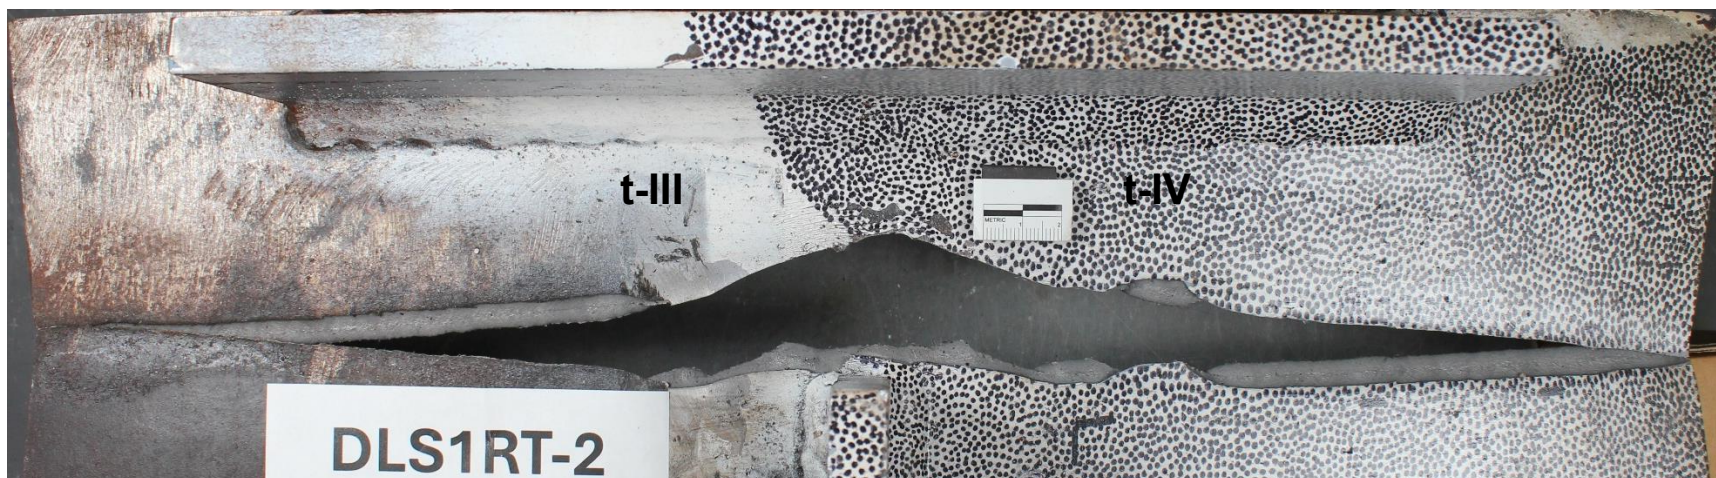
Figure 100. Photograph. DLS1RT-2: top view of fractured specimen.

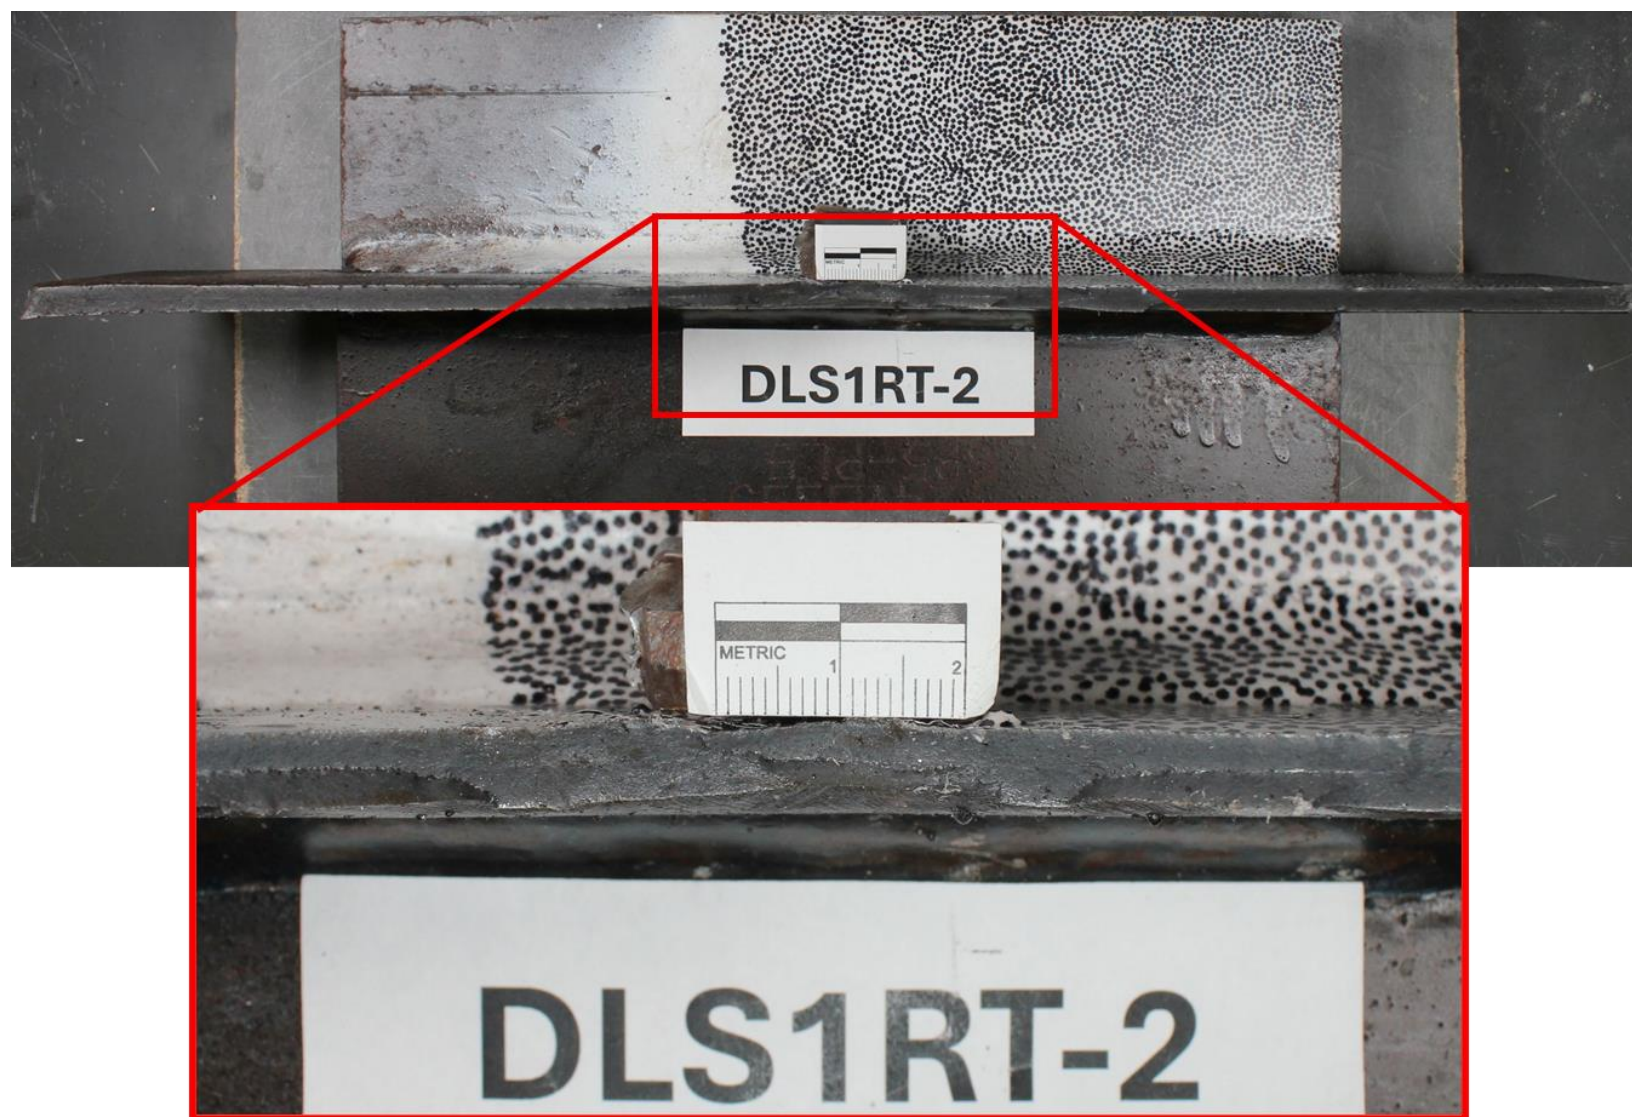
Figure 102. Photograph. DLS1RT-2: transverse-stiffener side of fracture.
