# FINAL REPORT

Multifunctional  
Geosynthetic-Based  
Stabilization  
to Increase Coastal  
Infrastructure Resilience

SPTC Project Number: CY1-TTI-02

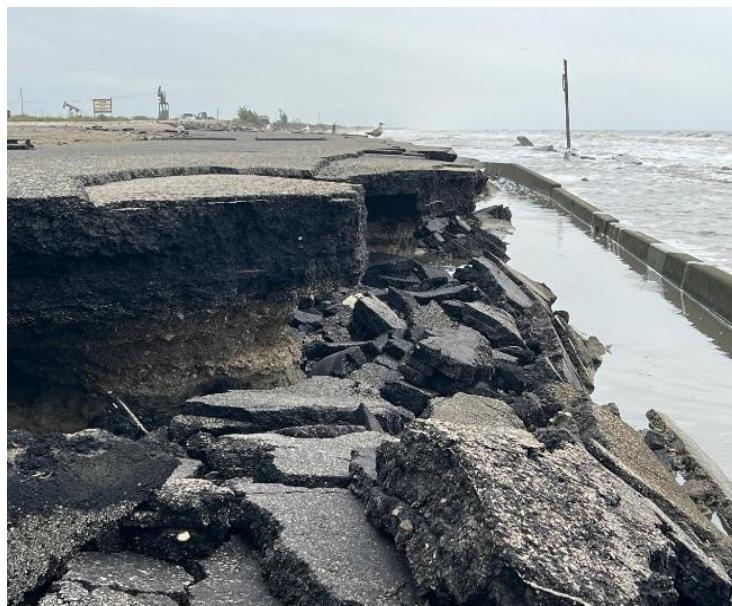
**Figure 1. Highway embankment slope failure in a coastal area**

One of the dangers to geotechnical structures caused by storm surge and precipitation is soil saturation, which is particularly dangerous to slopes, as it reduces their stability and may cause failure. Jafari and Puppala (2018) noted that one of the factors which influence the probability of slope failure is the intrusion of moisture into the soil. The effects of highway embankment slope failures are severe and far-reaching beyond the immediate human costs, as they can disrupt the flow of commerce, isolate communities, and bring about significant costs for clearance and rebuilding.

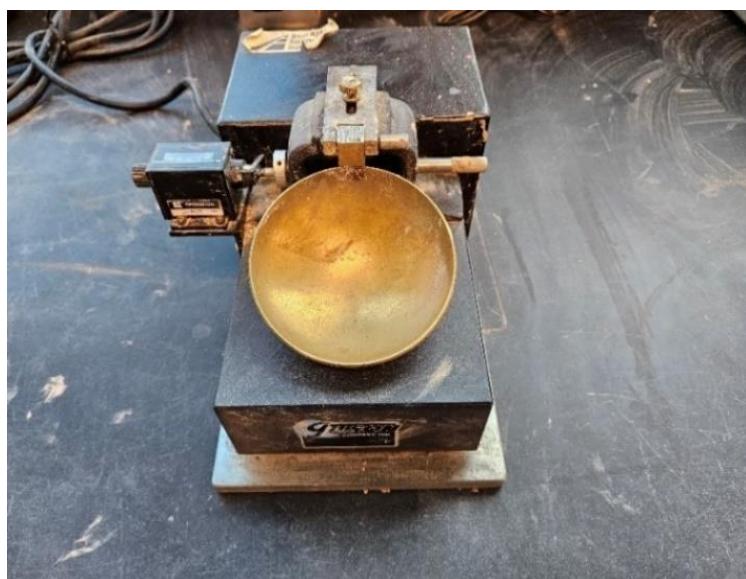
Figure 2. Casagrande device used for the liquid limit test

The Atterberg limits of soil are fundamental indicators of a soil's consistency and its behavior under varying moisture conditions. Two types of tests were performed with the objective of determining the liquid and plastic limits of the soil, as well as the plasticity index. The liquid limit and plastic limit values were determined using ASTM 4318 method. The plasticity index value was determined by deducting the plastic limit from the liquid limit. These test results are summarized in the Table 1.

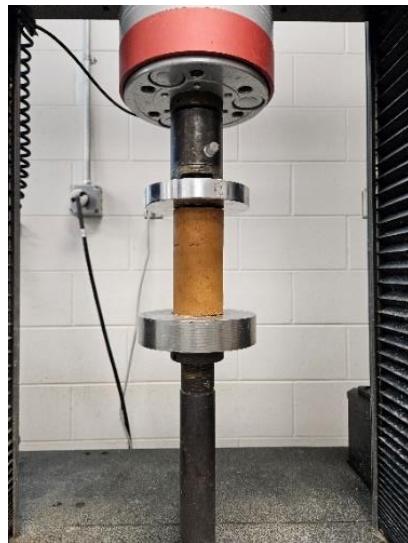
**Figure 5. UCS Sample before test**

A unconfined compressive strength (UCS) test was conducted on the device shown on Figure 5 to determine the unconfined compressive strength of the soil. The test was done according to ASTM 2166 method. Soil specimens were compacted at 90% of maximum dry density and corresponding moisture content on wet side of the Proctor compaction curve. The test yielded a UCS value of 93 kPa.

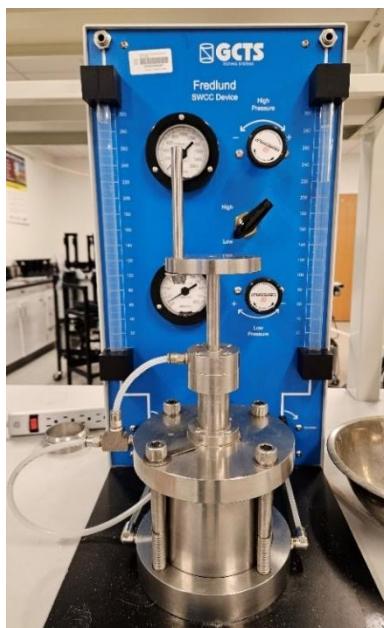
**Figure 6. Fredlund device used in SWCC test**

The Soil Water Characteristic Curve (SWCC) describes the relationship between the amount of water in a soil and matric suction. This curve is required to simulate water distribution and flow in partially saturated soils (Tuller et al, 2004). The SWCC was obtained through the combination of data from two different test methods. Suction values between 0 and 450 kPa were obtained through a Fredlund SWCC device (Figure 6) whereas, SWCC data for suction values over 450 kPa were obtained using a WP4C Dewpoint Potentiometer (Figure 7).

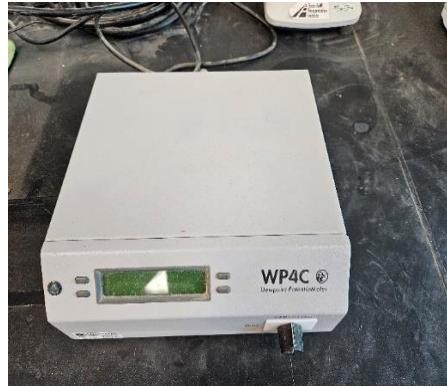
**Figure 7. Potentiometer used in SWCC test**

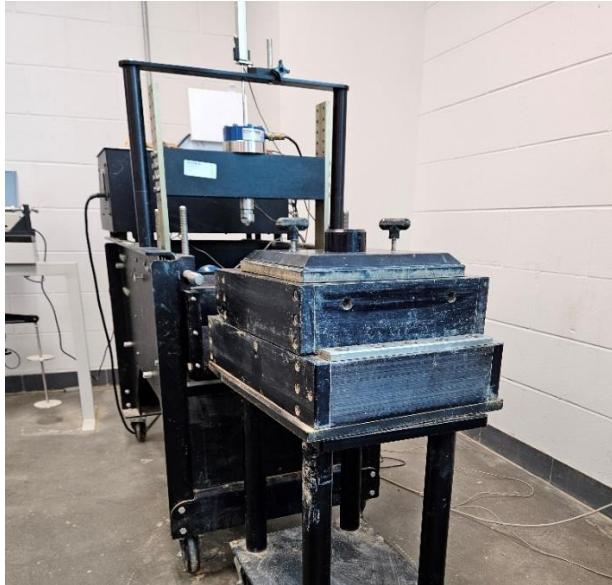
**Figure 10. Large Scale Direct Shear Test Setup**

The equipment used for the large-scale interface tests includes a top and bottom shear box, horizontal and vertical load cells, an electrical cabinet, Linear Variable Differential Transformer (LVDT), and a control panel (Figure 10). The system is connected to a computer that is used to manage its operations. Both load cells are equipped with LVDT transducers, which measure linear displacements in the direction in which they are placed. The shear box, consisting of an upper and lower section, measures 305 mm (12 in) square with a total height of 203 mm (8 in). During the shearing phase, the lower section is moved horizontally while the upper section is restrained from vertical and horizontal movement. The soil sample in the lower box can be inundated by enclosing it within a sealed chamber. Additionally, the equipment's design accommodates the installation of moisture and suction sensors within the soil sample during testing.

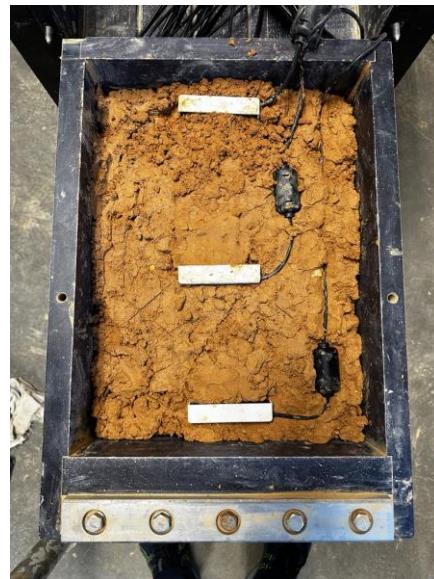
**Figure 11. Moisture sensors placed in the bottom box**

During the compaction of the second layer, three moisture sensors were placed in the bottom box approximately 2.5 cm below the interface, as shown in Figure 11. Once the sensors were positioned, compaction of the second layer was completed. Holes were punctured in the wicking geotextile so it could be fastened to the top box with screws, as depicted in Figure 12. The top box was then placed on top of the bottom box, with the geotextile tightly positioned at the interface (Figure 13). About 15 centimeters of the geotextile was left outside the box and exposed to the external environment to facilitate capillarity drainage. The soil in the top box was then compacted in two layers (Figure 14), and the top cap was placed above it.

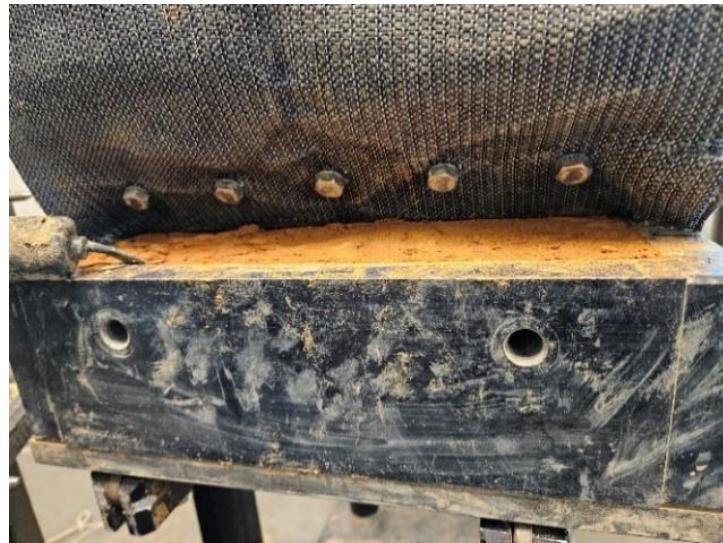
**Figure 12. Geotextile fastened to top shear box**

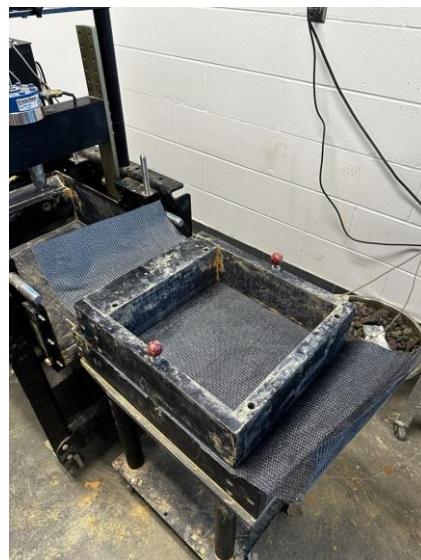
**Figure 13. Wicking geotextile clamped to the shear box**

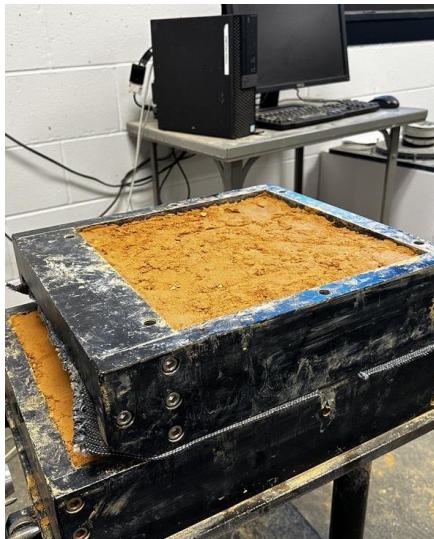
**Figure 14. Soil following compaction**

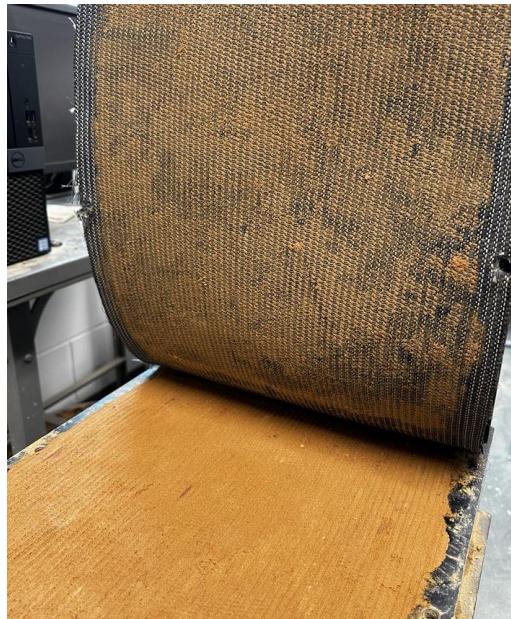
**Figure 23. Grooves from geotextile in soil after test**

The cohesion intercept of soil without geotextile was found to be 40 kPa, higher than the geotextile interface adhesion value of 13 kPa. However, the friction angle at the soil-geotextile interface was greater than the friction angle of the control soil. This indicates that the strength of the soil with geotextile is lower than that of the soil without it when normal stress is below 120 kPa, but higher when normal stress exceeds 120 kPa. The higher friction angle of the soil reinforced with wicking geotextile as compared to the control soil was likely because of interlocking of the wicking fibers and the soil, which took place during the shearing stage. Indentation of geotextile on the soil were visible after the test was completed (Figure 23).
