DOT/FAA/CT-95/25  
DOT-VNTSC-FAA-95-10

# Strain Fields in Boeing 737 Fuselage Lap Splices: Field and Laboratory Measurements with Analytical Correlations

Final Report  
June 1995

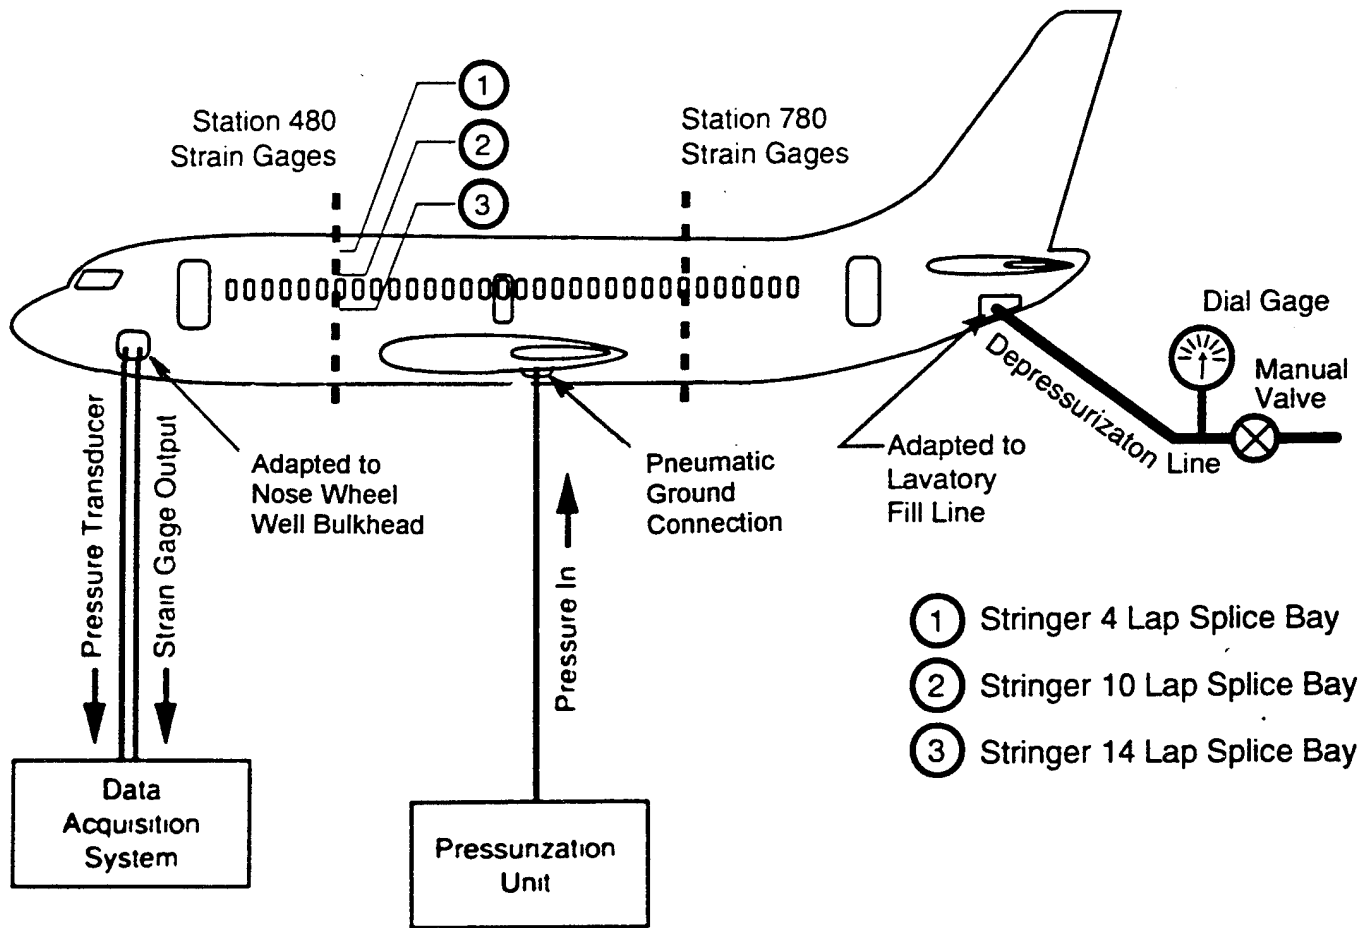
Figure 2.1. AANC 737 Strain Monitoring Test Set-Up.

For reference during the following discussion, a schematic of the entire test set-up is shown in Figure 2.1.

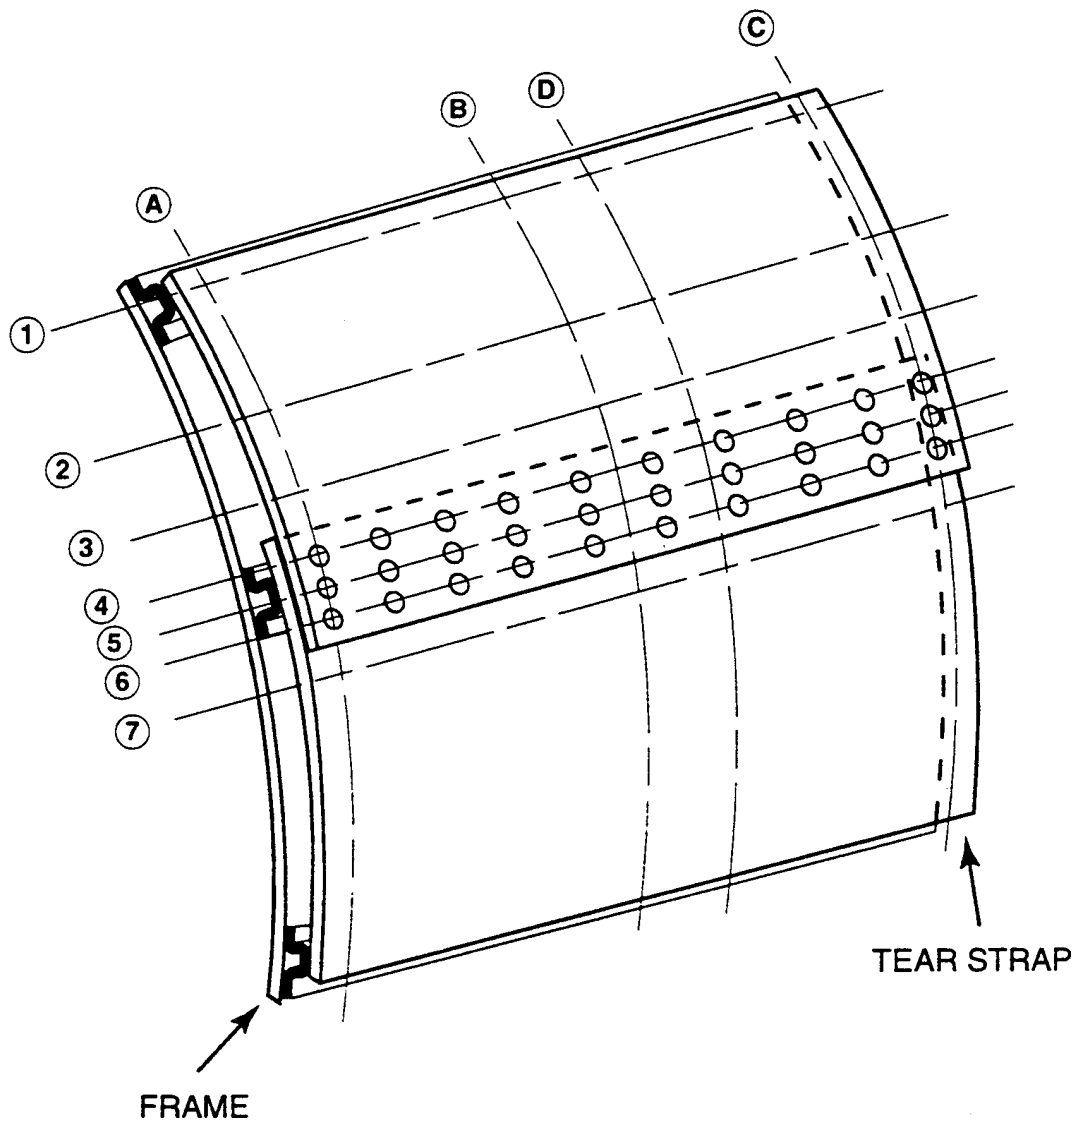
Figure 2.5. Specific Strain Gage Locations Within Selected Lap Splice Bays.

Specific strain gage locations were selected within a given lap splice bay to resemble the strain gage layouts in the Foster-Miller [4] and NASA [5] tests which allowed for direct comparisons of strains. Seven (7) circumferential positions were identified (refer to Figure 2.5):

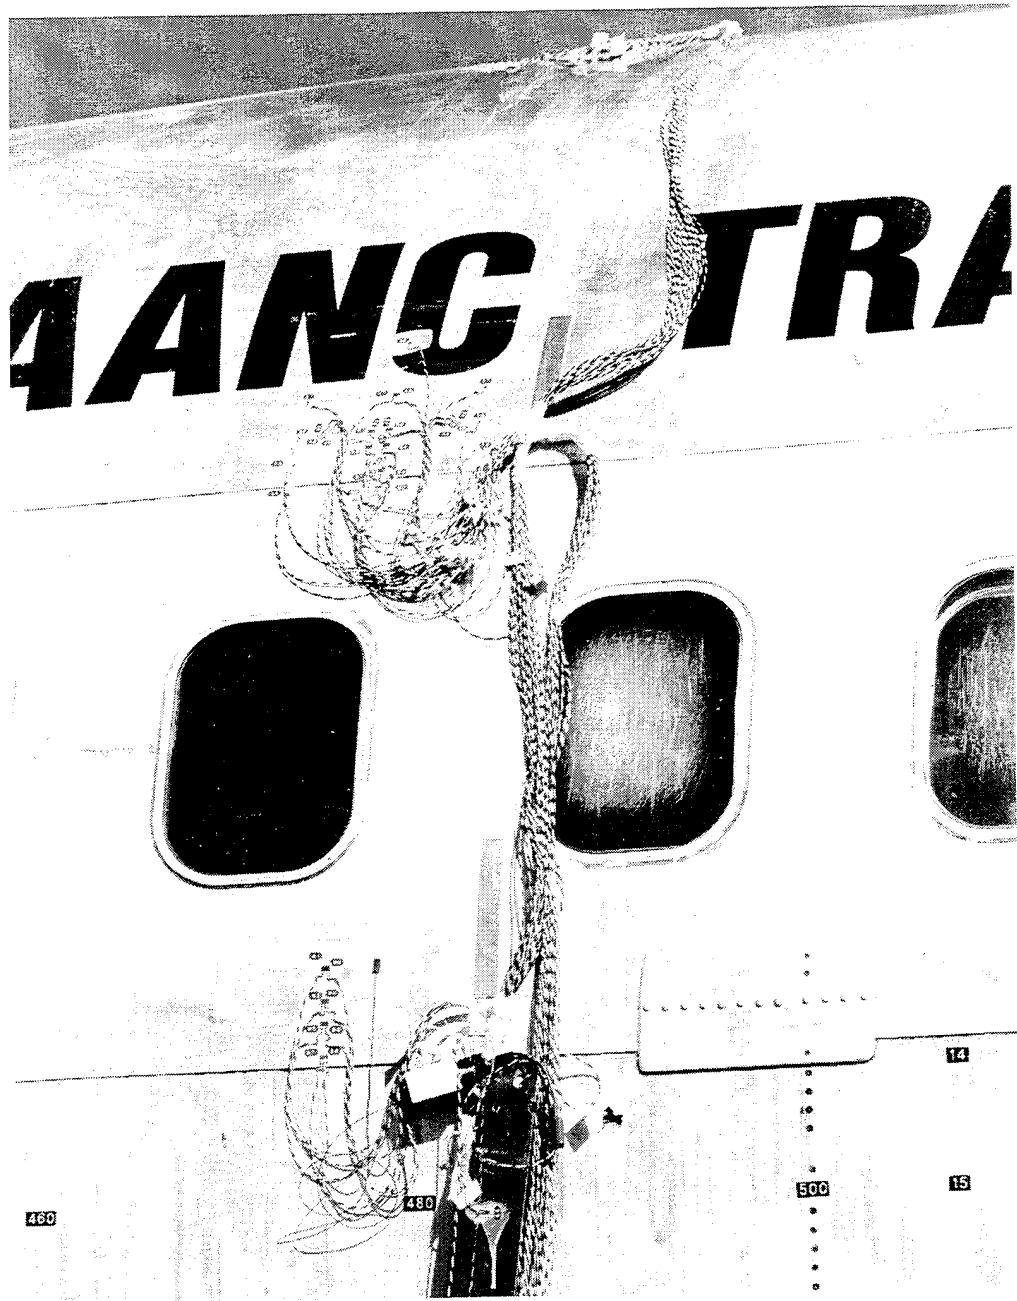
*Figure 2.7. View of Instrumented Lap Splice Bays Above and Below the Window Between Body Stations 470 and 480.*

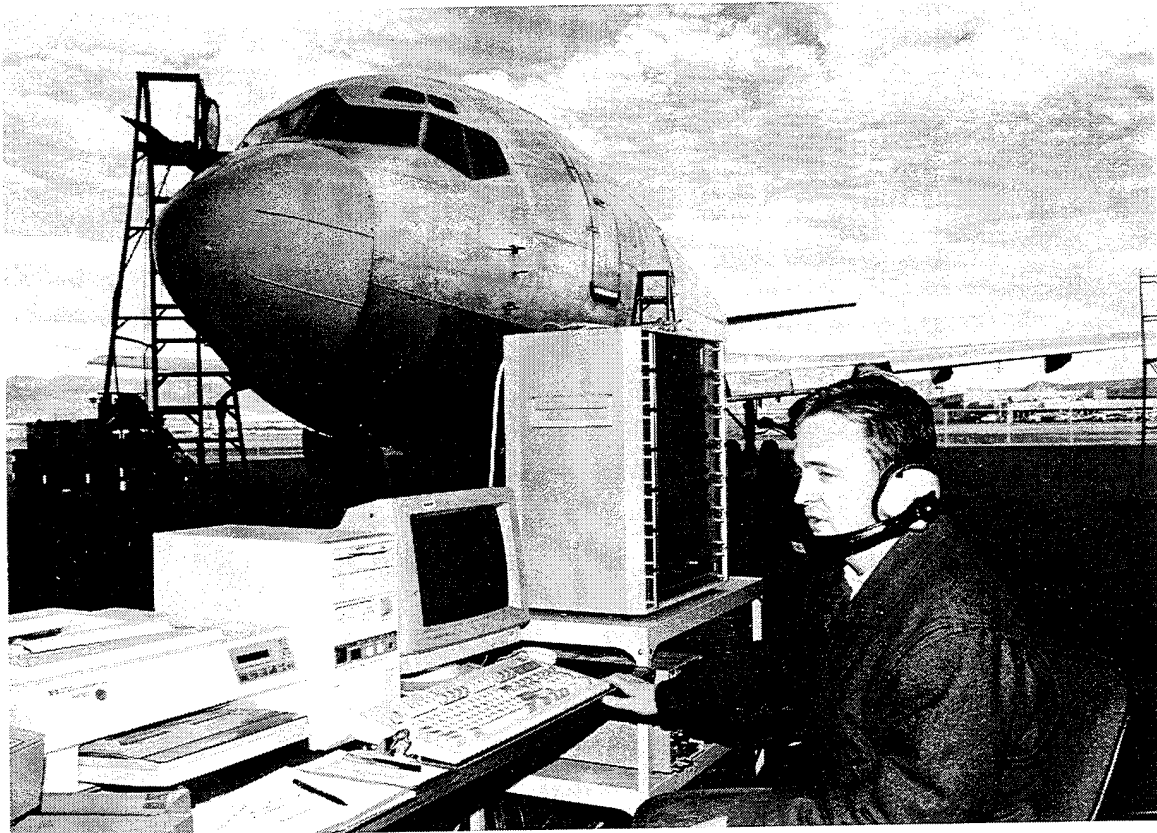
*Figure 2.10. Portable Data Acquisition System.*

The hardware for data acquisition was controlled by a personal computer with Disk Operating System (DOS). The system provided power up to 100 strain gage channels - in quarter, full- or half-bridge configurations - and 20 full-bridge transducers. The system also contained a controller to provide logic and timing commands to the data scanner and to digitize the signal received from the scanner. The data acquisition system was capable of scanning 30 channels per second. Entry of all test data was automated using manufacturer supplied software. Figure 2.10 shows a photograph of the data acquisition system positioned next to the AANC B737 aircraft. The computer operator shown in the photograph is using an intercom system which linked the data acquisition personnel with the cockpit personnel (fuselage pressure control) and the test equipment personnel (Ground Power and Airstart Unit control).

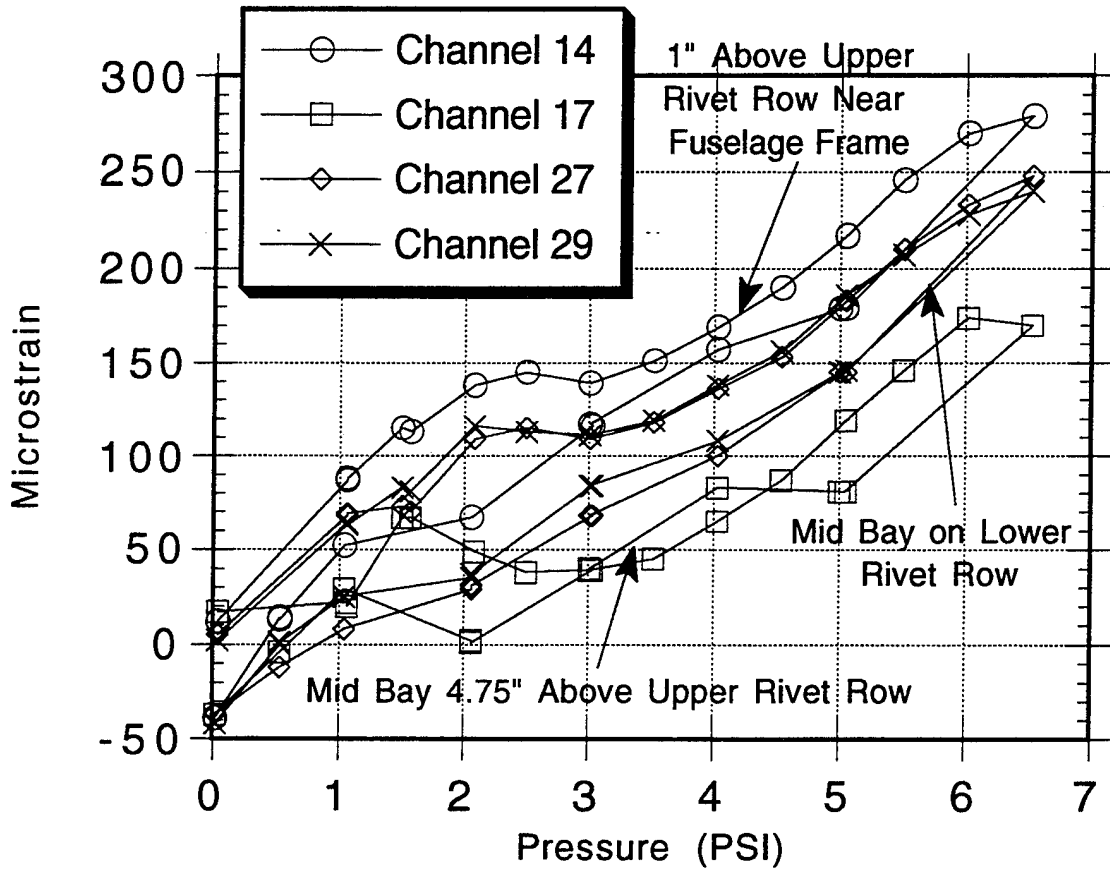
Figure 3.19. External Skin Longitudinal Strains at S-4L, BS475.  
 (Refer to Figure A.4.)

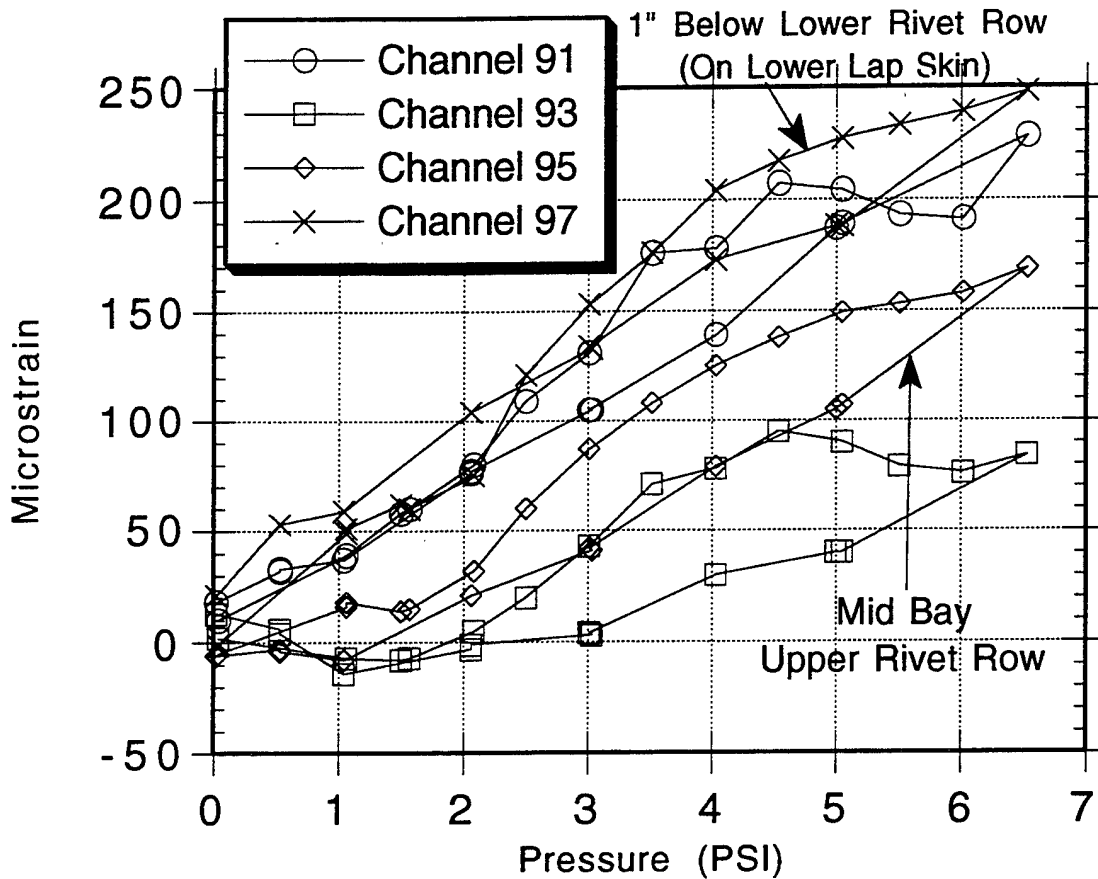
NOTE: In this figure, "midbay" refers to the longitudinal location halfway between the tear strap and the frame. In the text, this location is referred to as the "midline."

Figure 3.23. External Skin Longitudinal Strains at S-10L, BS785.  
(Refer to Figure A.11.)

- (3) Figures 3.21 to 3.23 compare the longitudinal strains measured along the midline in three different lap splice bays. The general strain profiles and magnitudes were the same forward and aft of the wing, and above and below the window. Otherwise, no significant trends were observed.

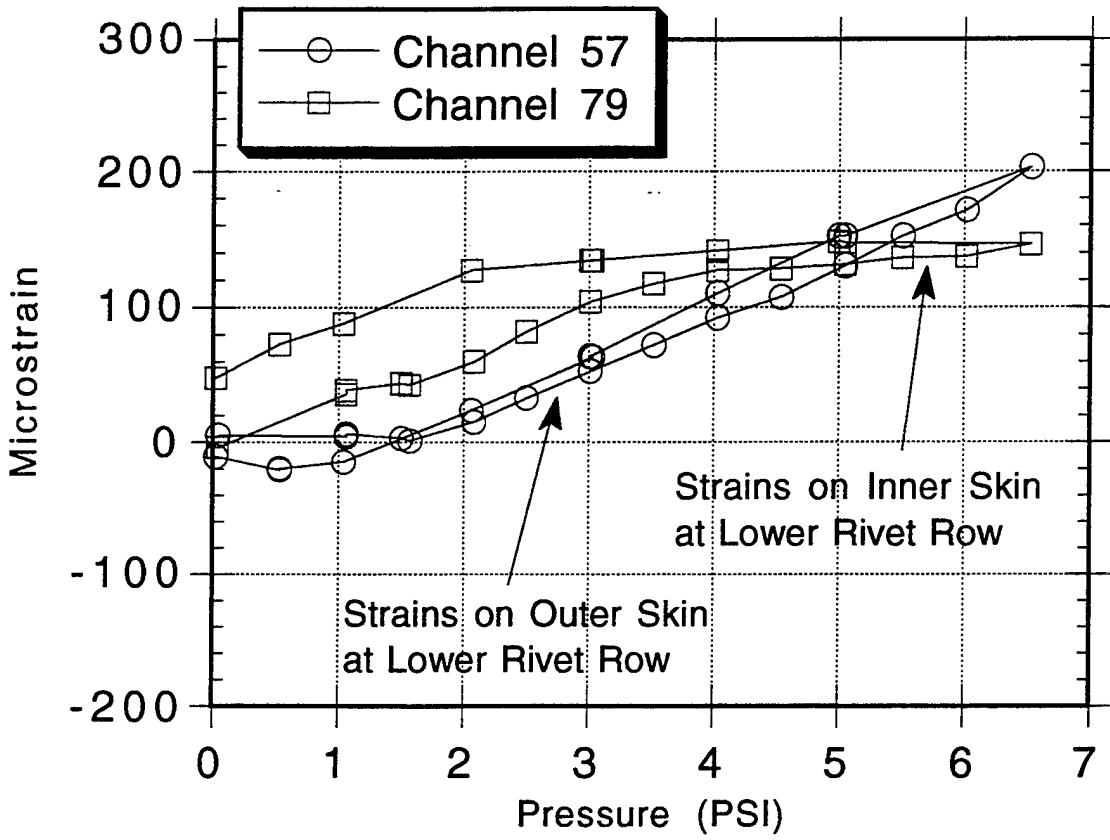
Figure 3.34. Longitudinal Strains in Lower Rivet Row on Inner and Outer Lap Skins at S-10L, BS475. (Refer to Figure A.5 and A.8.)

The maximum strains are approximately 900  $\mu\epsilon$  in the hoop direction and 250  $\mu\epsilon$  in the longitudinal direction. These results show that the lower rivet row of the inner skin experiences the same peak strains as the upper rivet row of the outer skin. Thus, these two areas should be treated similarly in fatigue and damage tolerance analyses.

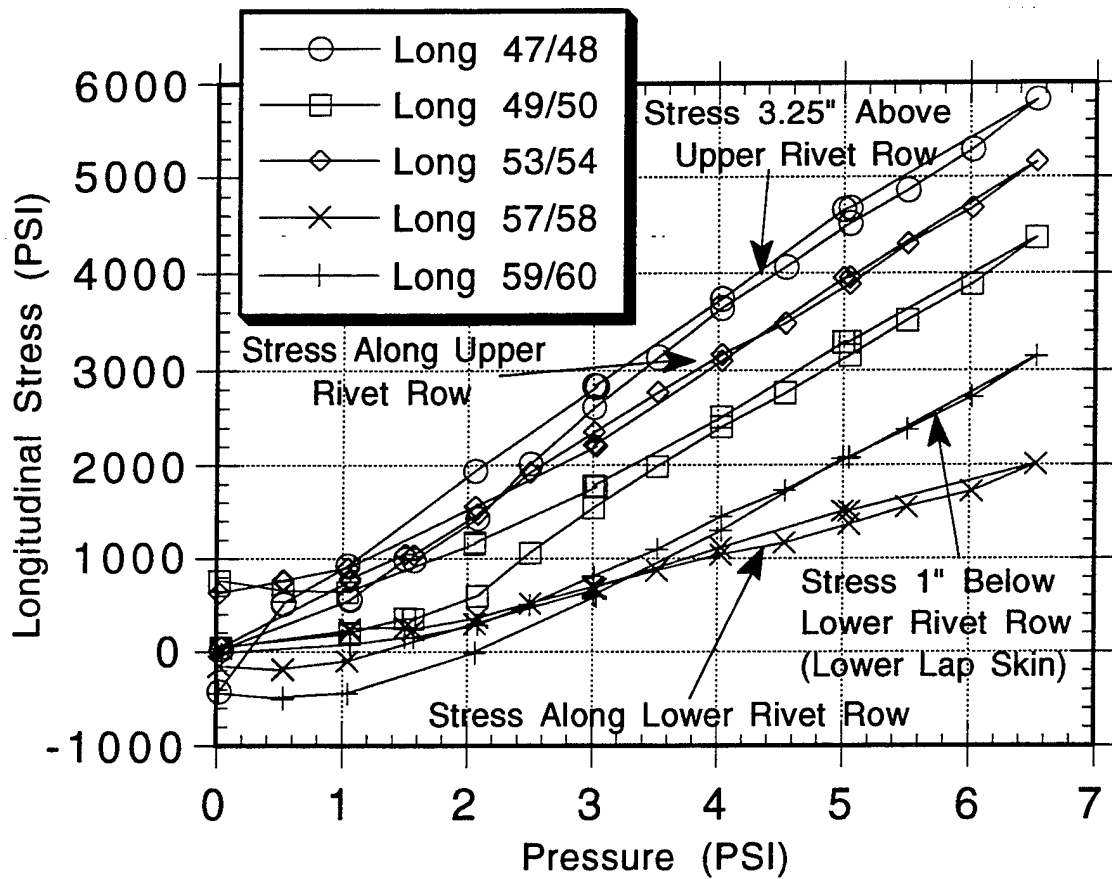
Figure 3.44. External Longitudinal Stresses at S-10L, BS475.  
(Refer to Figure A.5.)
