Materials-Based Methods to Improve Rumble Strip Durability

Dan Swiertz, Principal Investigator
Asphalt Materials, Inc.
Portage, WI

Final Report NRRRA202503

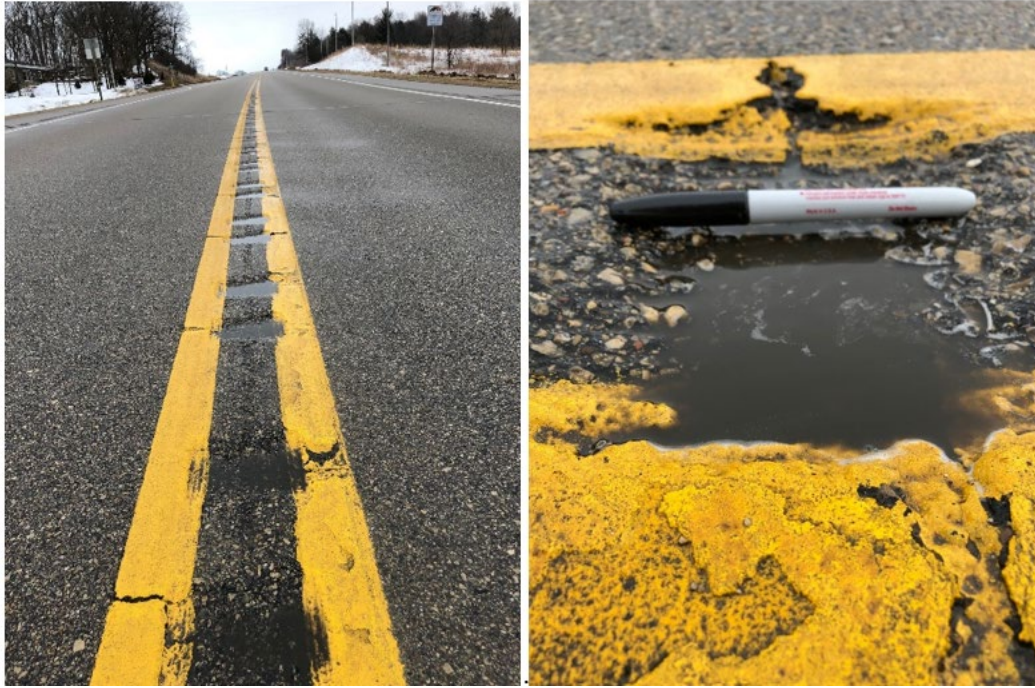
Figure 2.18: CLRS Exhibiting Water Retention During Thaw Event in Wisconsin. Author Photo.

Several studies have addressed concerns regarding the impact of milled rumble strips on pavement performance or durability (DeCarlo et al., 2023). The longitudinal paving joint in asphalt pavements, and the area surrounding the joint, is often prone to premature and accelerated deterioration. Several underlying factors have been attributed to this phenomenon, but the consensus is that comparatively low pavement density at and near the joint area results in increased air and water permeability, which in turn manifest in various pavement distresses (Bahia et al., 2021). Performance concerns arise from the fact that CLRS are being milled into an already susceptible area of the pavement. Furthermore, the milling operation may allow for increased water and air infiltration by removing the seal provided by the asphalt residue coating the aggregate and fracturing some of the aggregate. Additionally, since CLRS are recessed relative to the surrounding pavement, they provide a small reservoir for water (or ice) to be held for extended periods (Figure 2.18).

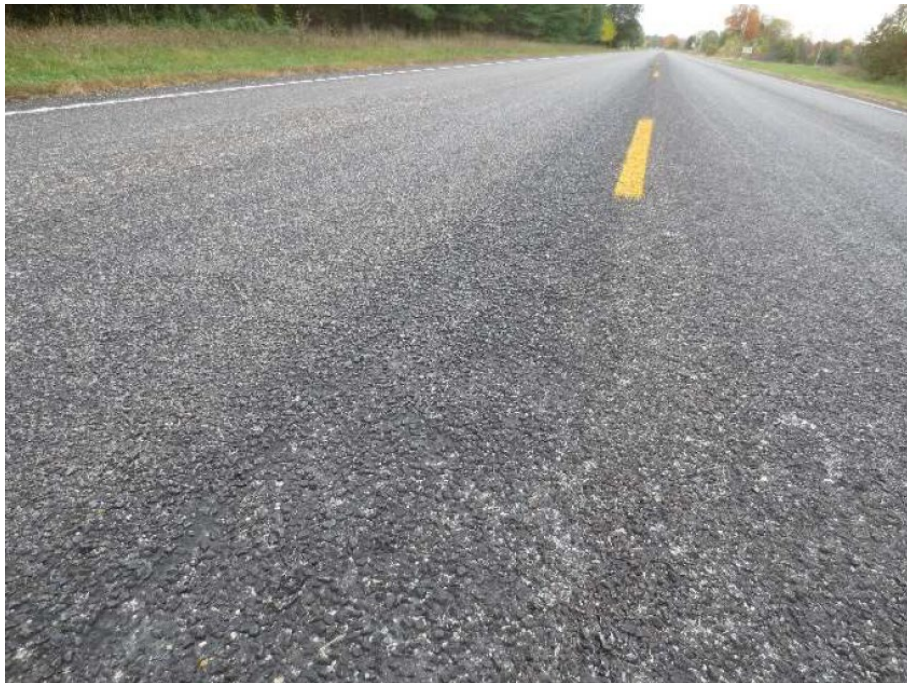
Figure 2.19: Example of a Sinusoidal CLRS With Chip Seal Application. From (Donavan, Janello, Rochat, & McKenna, 2024).

The same study evaluated several project locations that had a chip seal applied to the already milled sinusoidal CLRS. The researchers observed that the CLRS area was difficult to distinguish from the rest of the pavement surface: the chip seal had nearly masked the surface profile change of the CLRS. An example from that report is shown below. Two different sinusoidal CLRS geometries had been chip sealed when the researchers attempted to measure functionality.

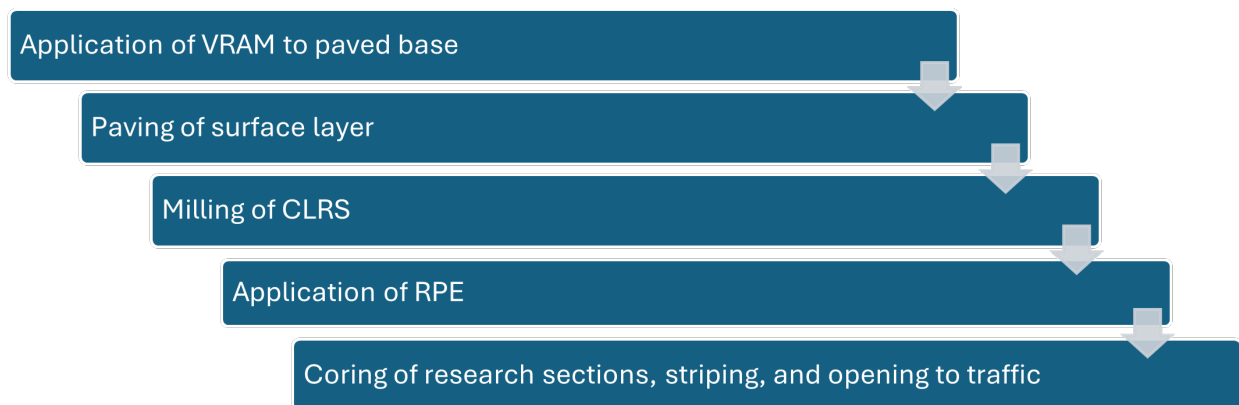
Figure 5.6: Construction Process Sequencing.

Despite differences in location, length and pavement structure, the construction sequencing for each of the three projects was similar for the surface layer. In general, sequencing followed the staging plan laid out in Figure 5.6 below, with more detailed descriptions following.

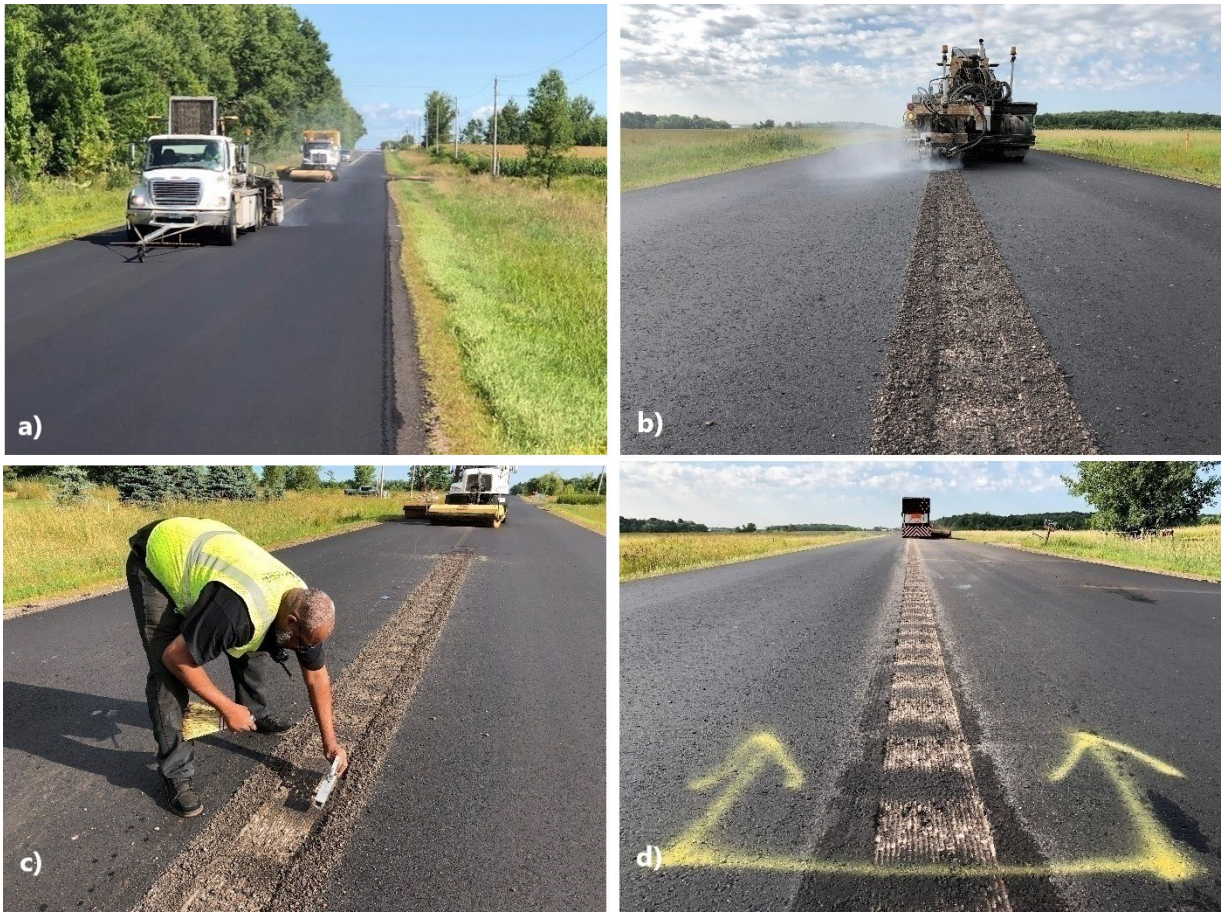
Figure 5.9: Installation of CLRS Including Milling Operation (a and b), Checking Dimensions (c), and Cleaned Surface. WisDOT Sinusoidal CLRS are Shown (d).

CLRS were milled into the cold surface following mainline paving. Both standard and sinusoidal geometries are installed using a similar milling process: the joint is cold milled centering the CLRS on the construction joint. The pavement is swept of debris and the geometry of the CLRS is checked for adherence to standard. For this research contractors familiar with the CLRS milling operation were utilized. CLRS milling operation and quality assurance typical of this project are shown in the Figure 5.9.

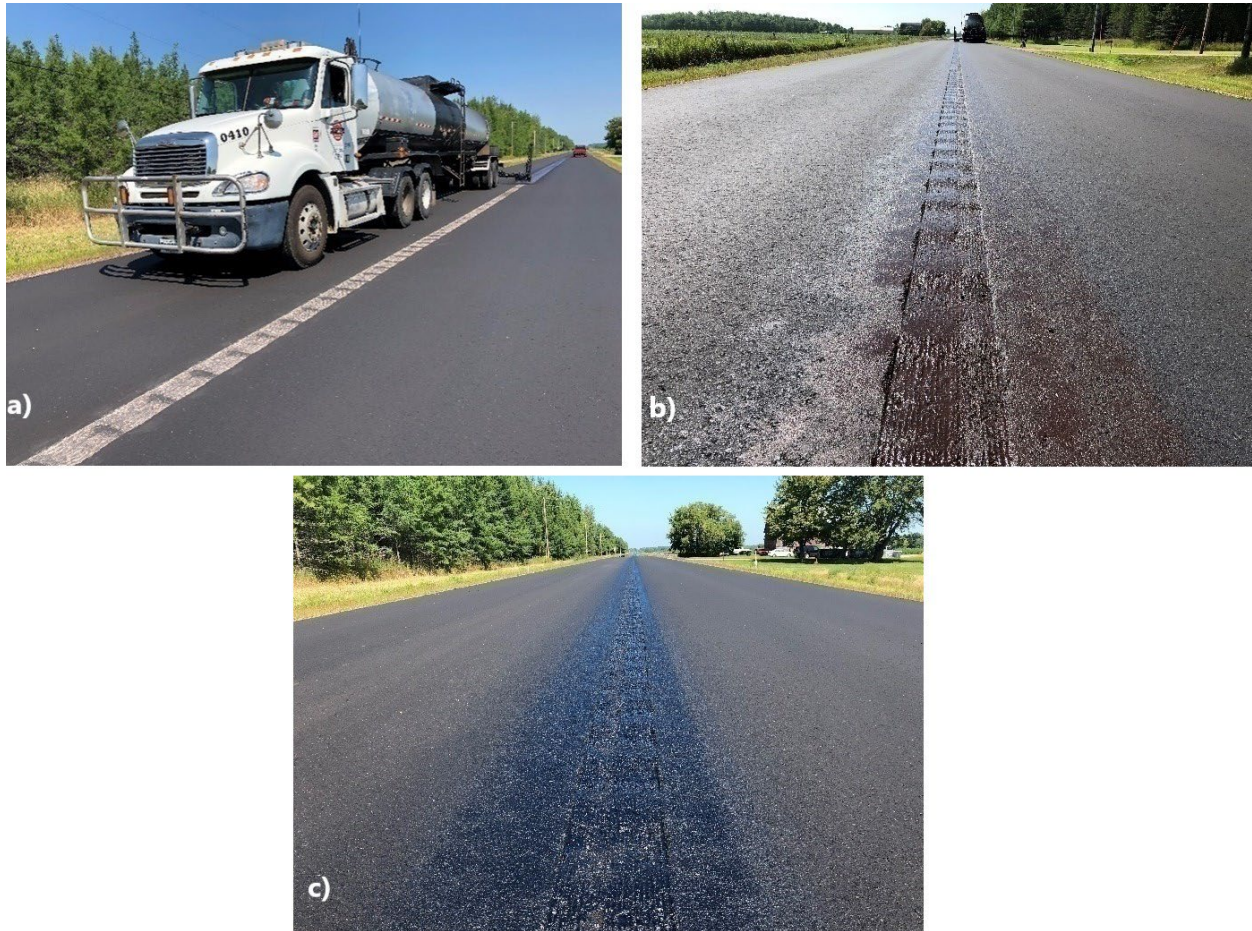
Figure 5.10: RPE Application Over CLRS, Centerline Application Alternative (a), Freshly Applied RPE (b), and Fully Dried Ready for Striping (c).

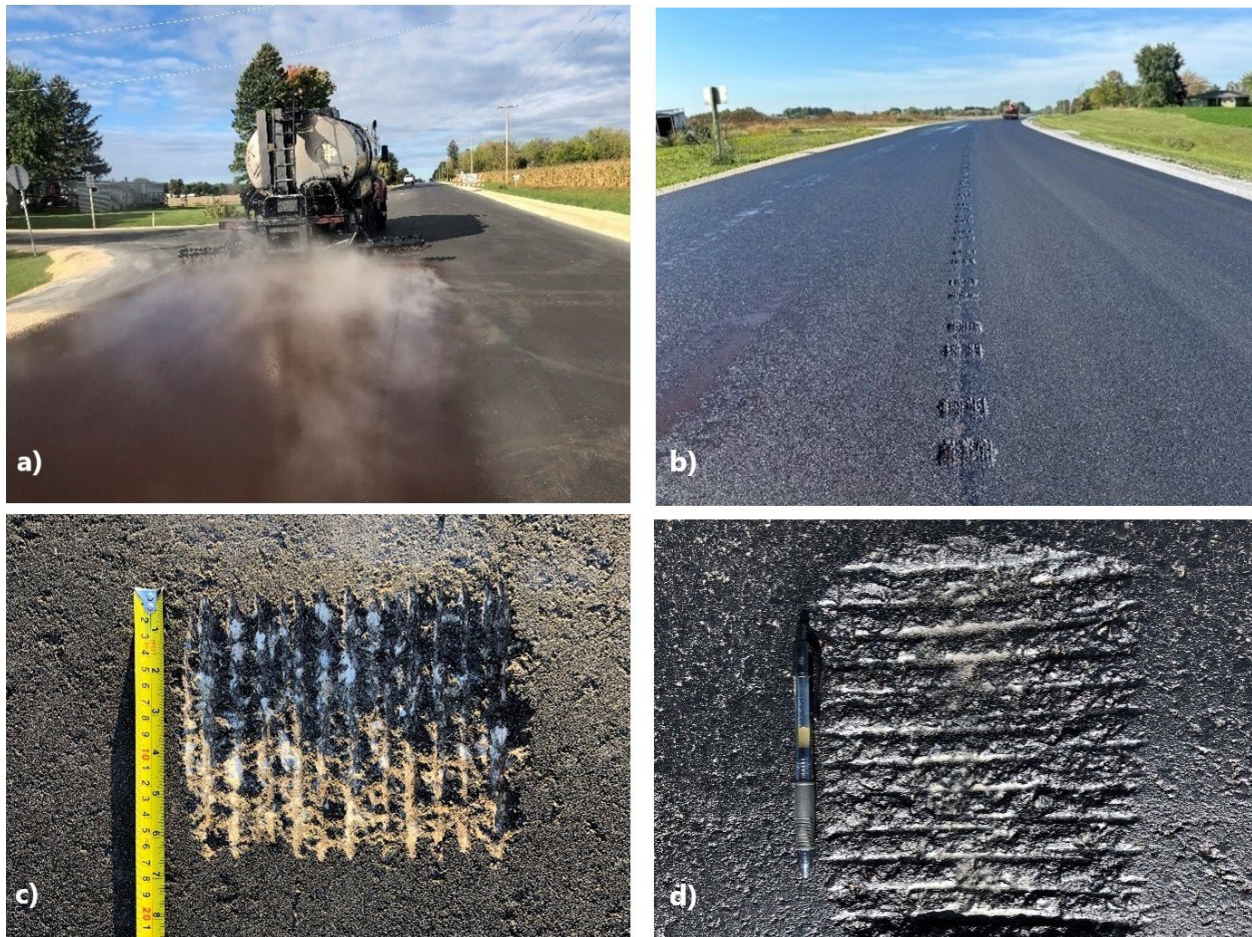
Figure 5.11: RPE Application Utilizing Full Lane Width Alternative (a). Photo (b) is After Final Pass Before RPE has Fully Dried. Photo (c) is CLRS Before RPE, Photo (d) is CLRS Following RPE, Note the Macro-Texture of the Underlying Surfacing, Characteristic of a Penetrating Emulsion Treatment.

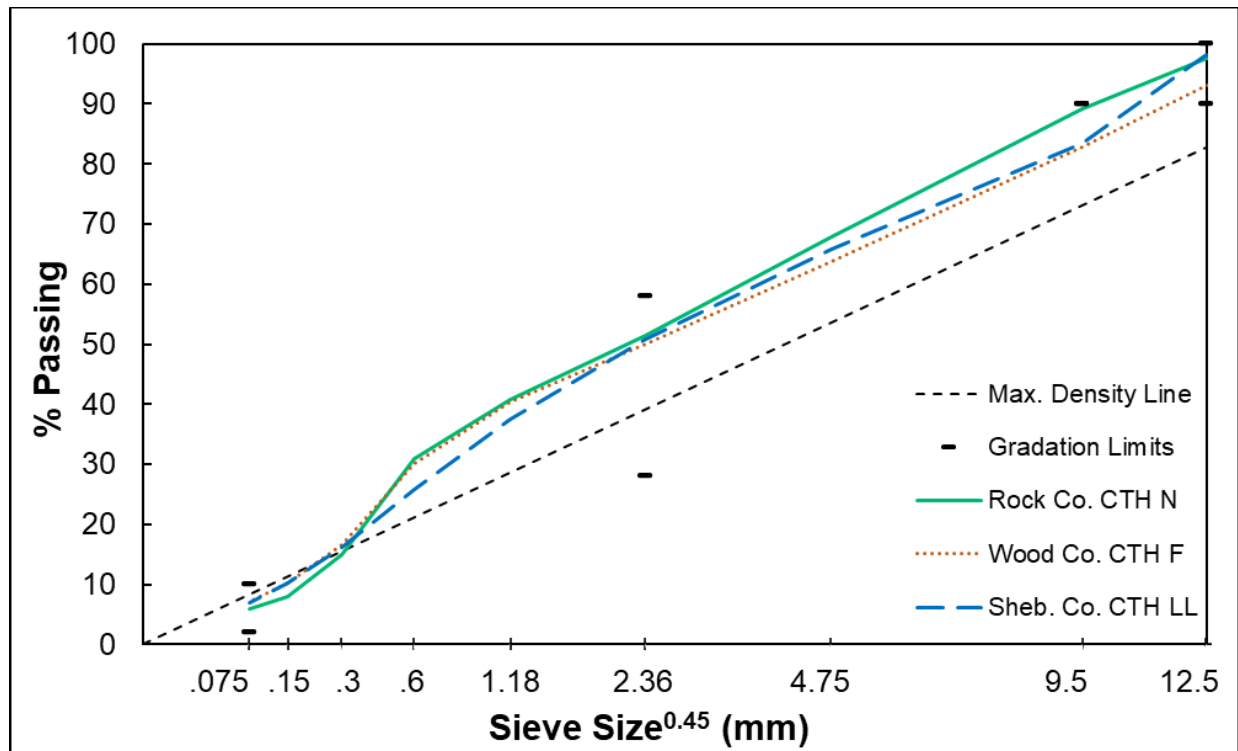
Figure 5.13: Average Mixture Gradations Shown on 0.45 Power Chart.

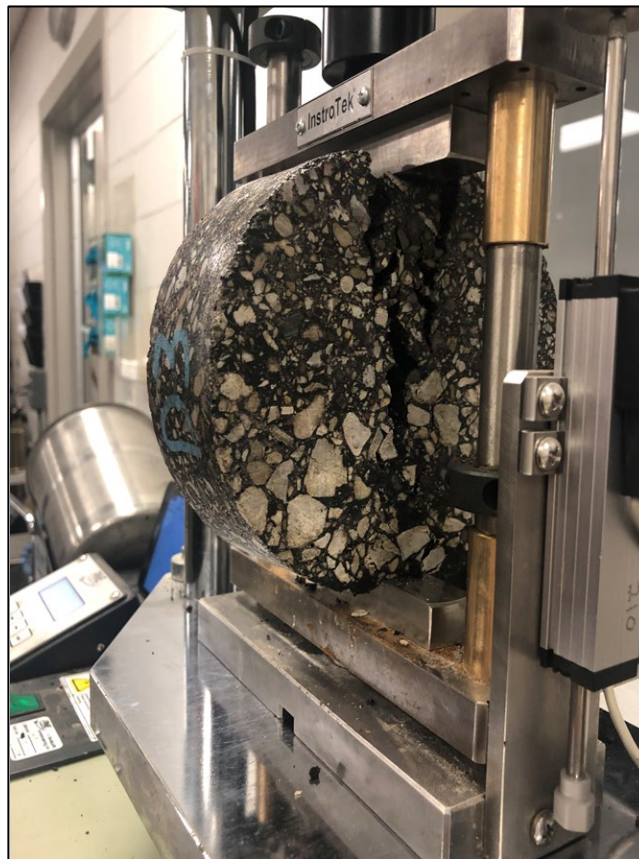
Figure 6.7: IDEAL-CT Setup for Testing of Field Cores.

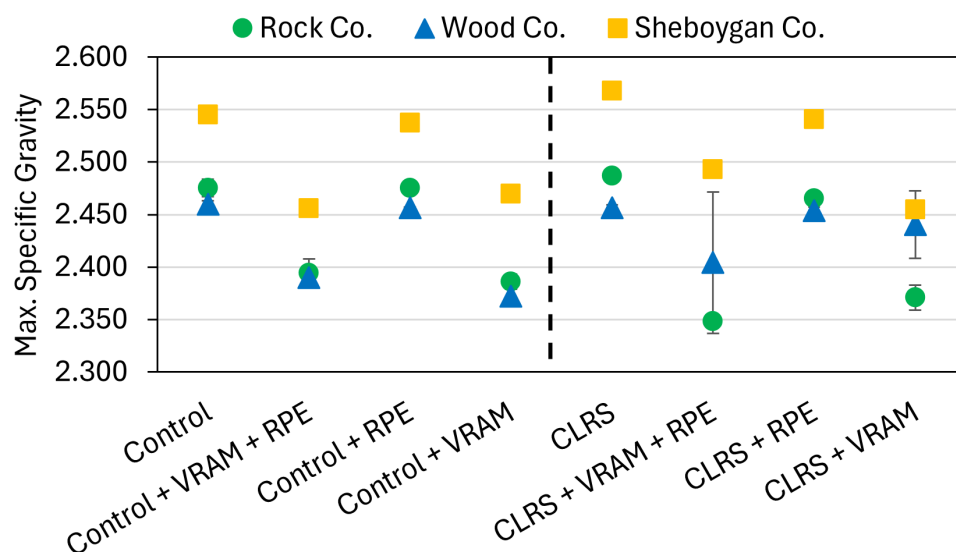
Figure 7.1: Maximum Theoretical Specific Gravity of Field Cores for Each Test Section and Project.

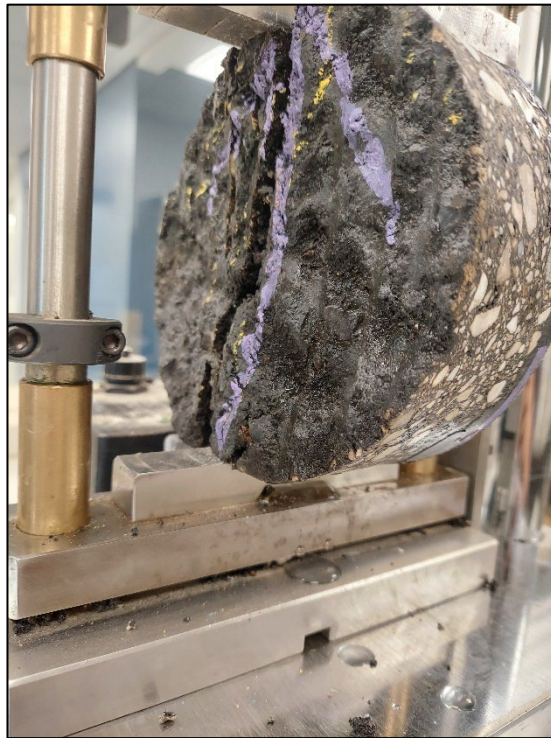
Figure 7.26: Ideal CT Testing Along the Longitudinal Joint.
