**Report No. UT-25.16**

# **IDENTIFYING SAFETY HOT SPOTS IN CLOSE PROXIMITY TO K-12 SCHOOLS**

Utah Department of Transportation  
Research & Innovation Division

**Final Report  
November 2025**

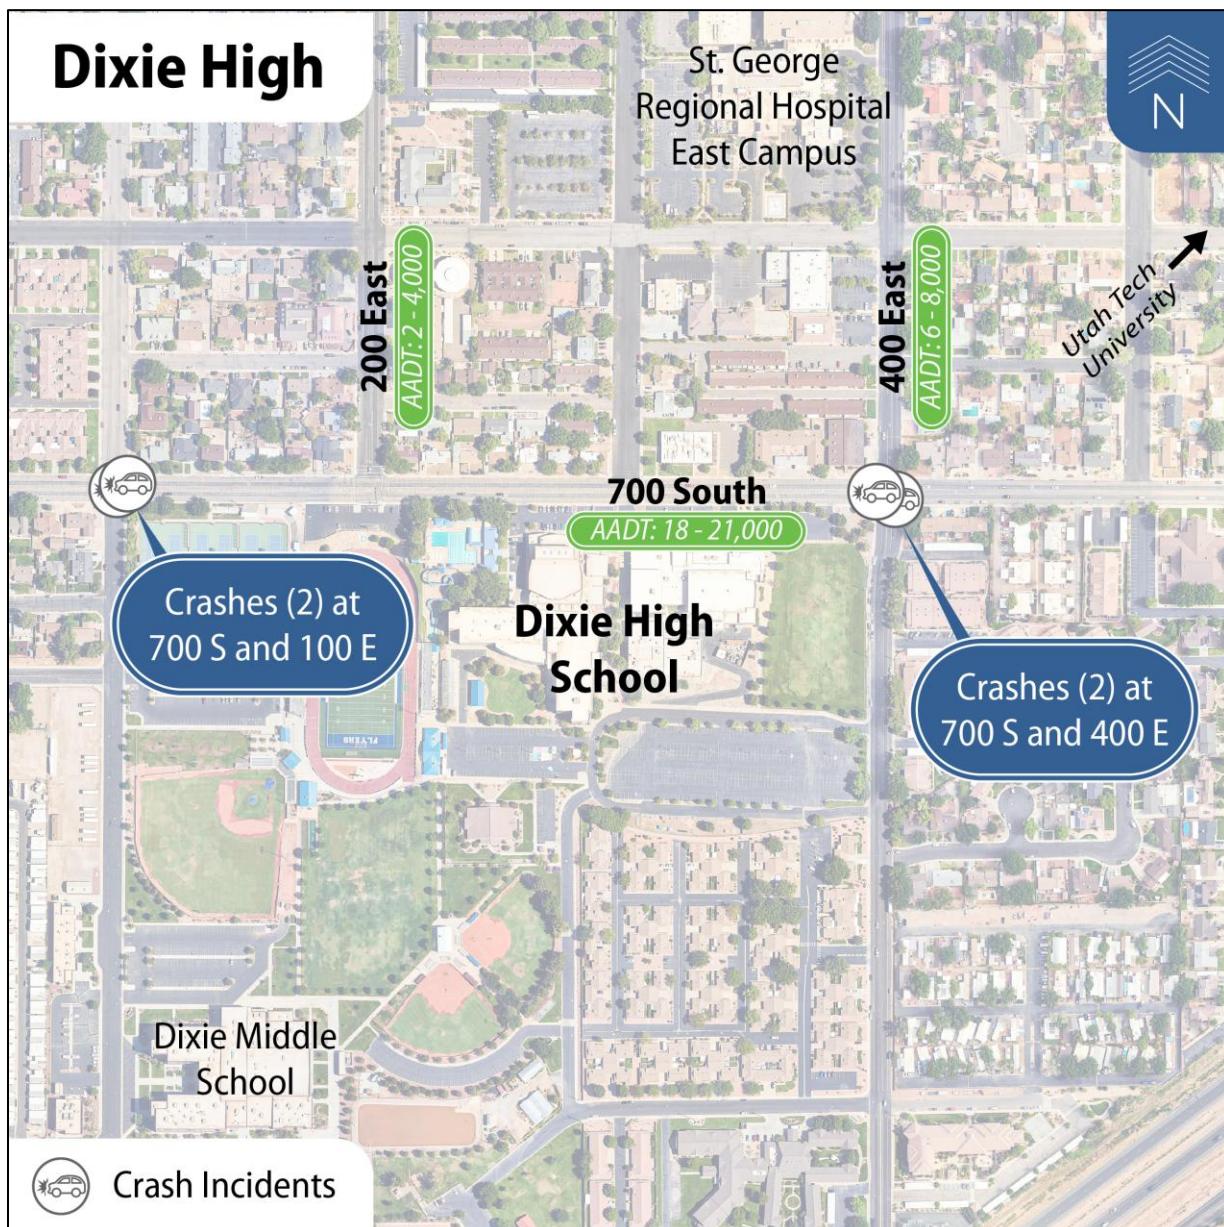
**Figure 4.18 Dixie High Overview**

Dixie High School is located on 700 South in St. George, Utah. As seen in Figure 4.18, it is near Dixie Middle School, the regional hospital, and Utah Tech University. 700 South has an AADT of between 18,000 and 21,000, creating opportunities for conflicts. As shown in Figure 4.19, three out of four school-related crashes involved bicycles/scooters/skateboards, and three crashes involved a right-turning vehicle.

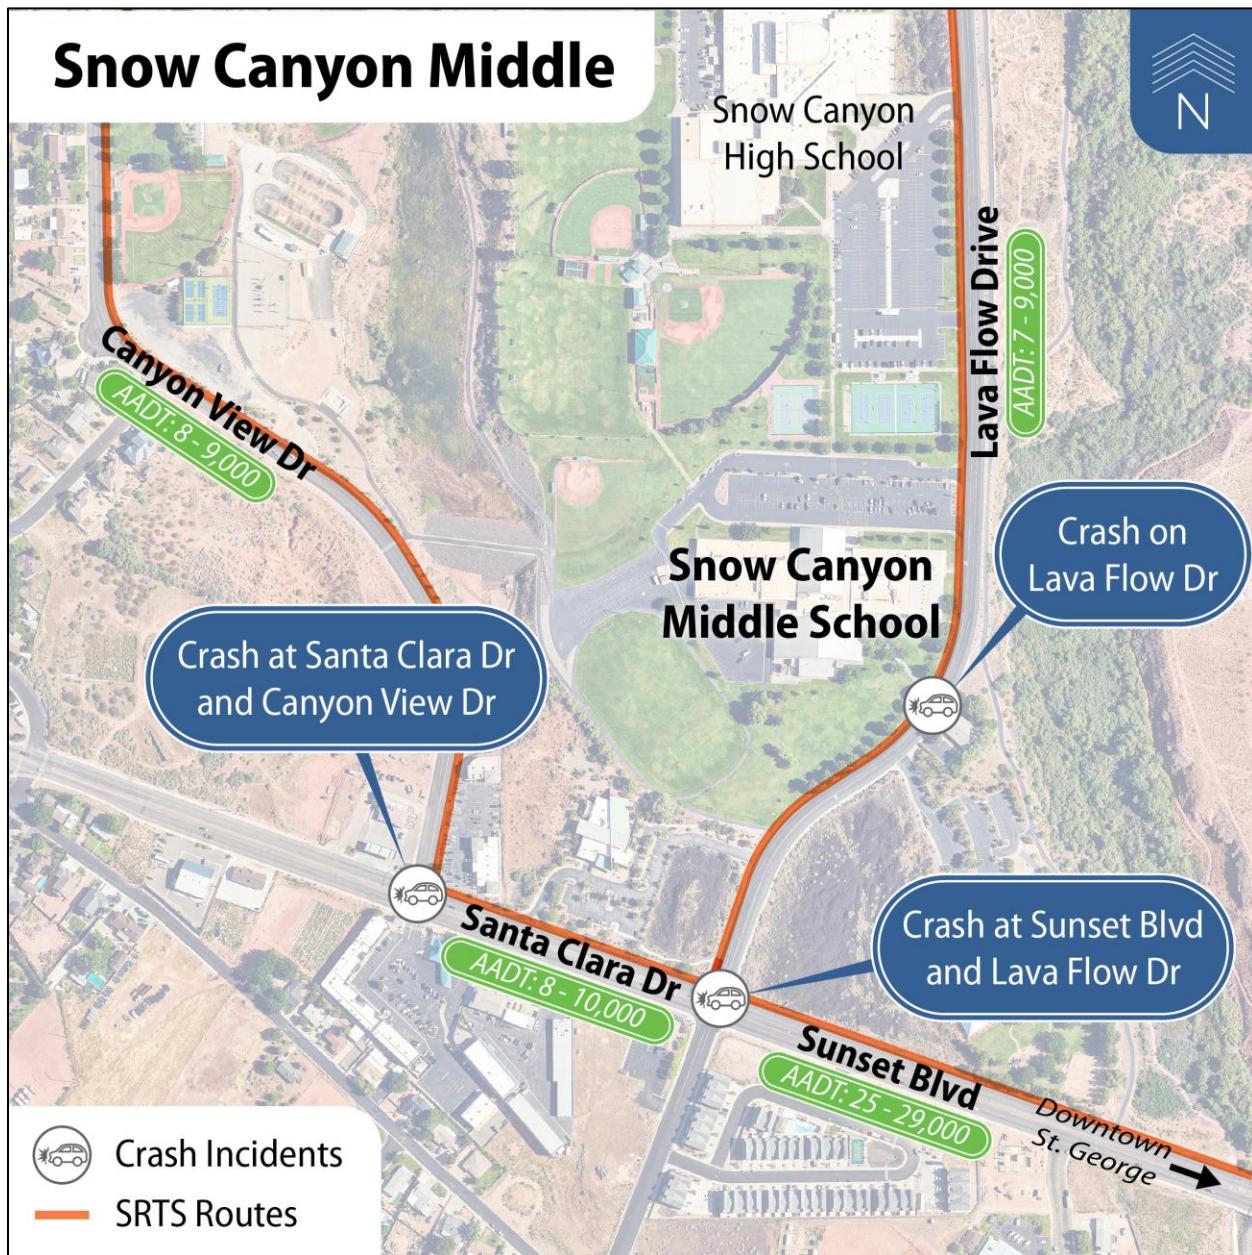
Figure 4.20 Snow Canyon Middle School Overview

bicycles/scooters/skateboards, and two crashes involved left-turning vehicles. Snow Canyon does have an SRTS plan in place; designated SRTS routes are shown in the figure.

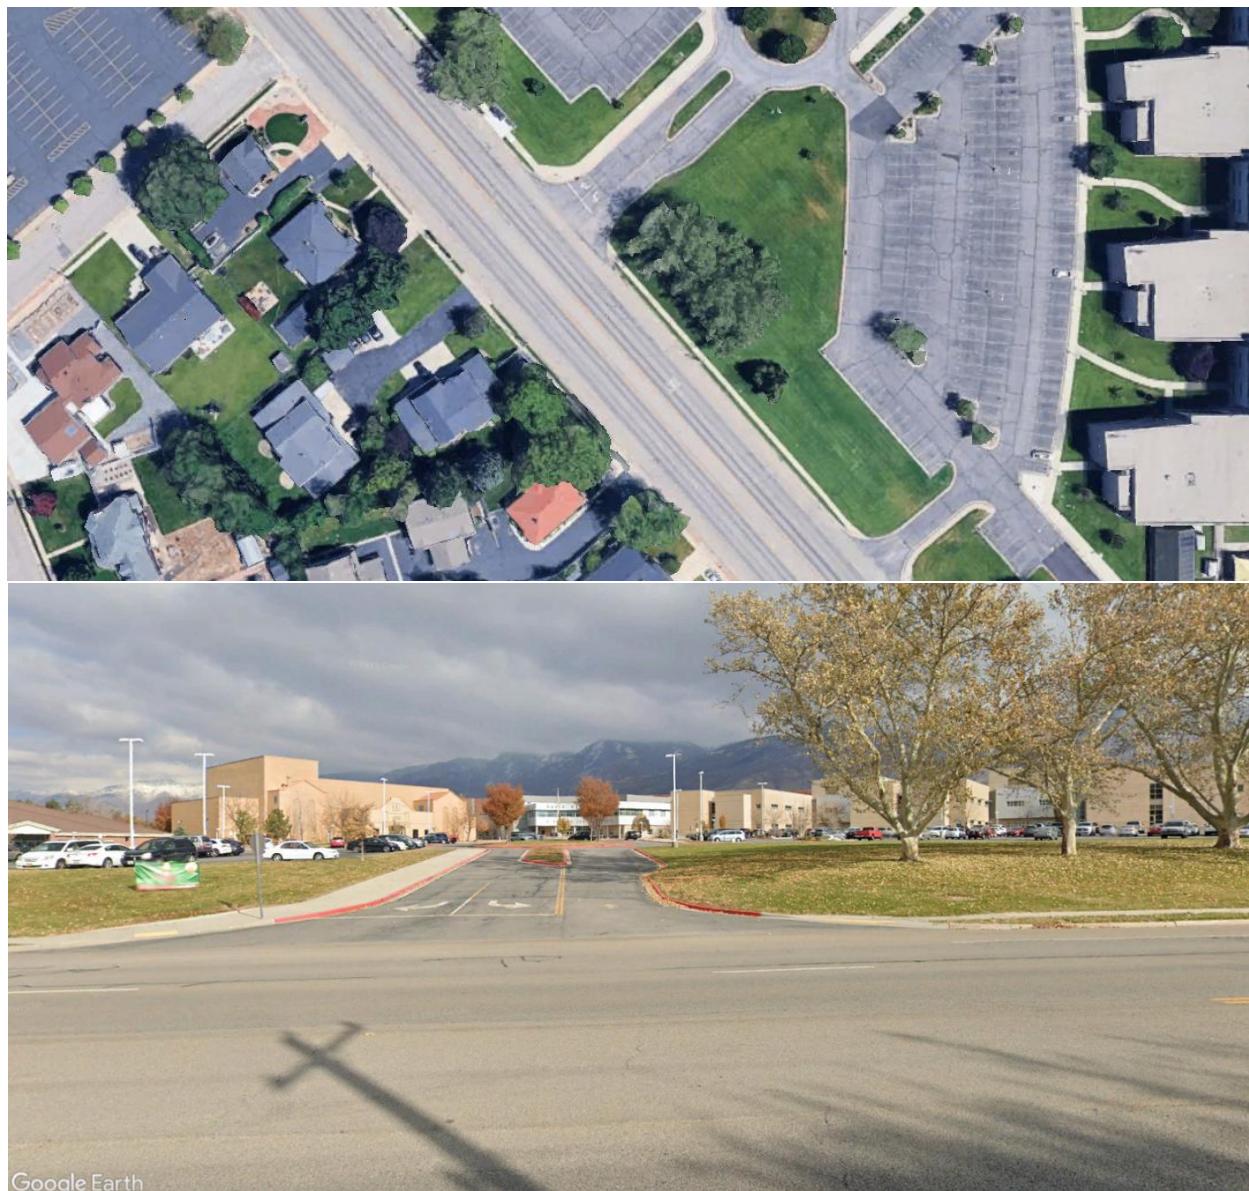
**Figure 5.2 Main Street (Facing East) at 325 South**

As shown in Figure 5.2 below, the main vehicle entrance to Davis High School (Main Street at 325 South) features a roundabout that directs drivers to guest parking (to the north), temporary limited parking (30 minutes or less, next to the school), and faculty parking (to the south). Outside of arrival and dismissal times, this access is used primarily by school visitors. High school students use this as an exit after school, leading to a large surge in traffic volumes that converge with increased pedestrian traffic on the sidewalk. Issues and recommended countermeasures for this site are listed in Table 5.2.

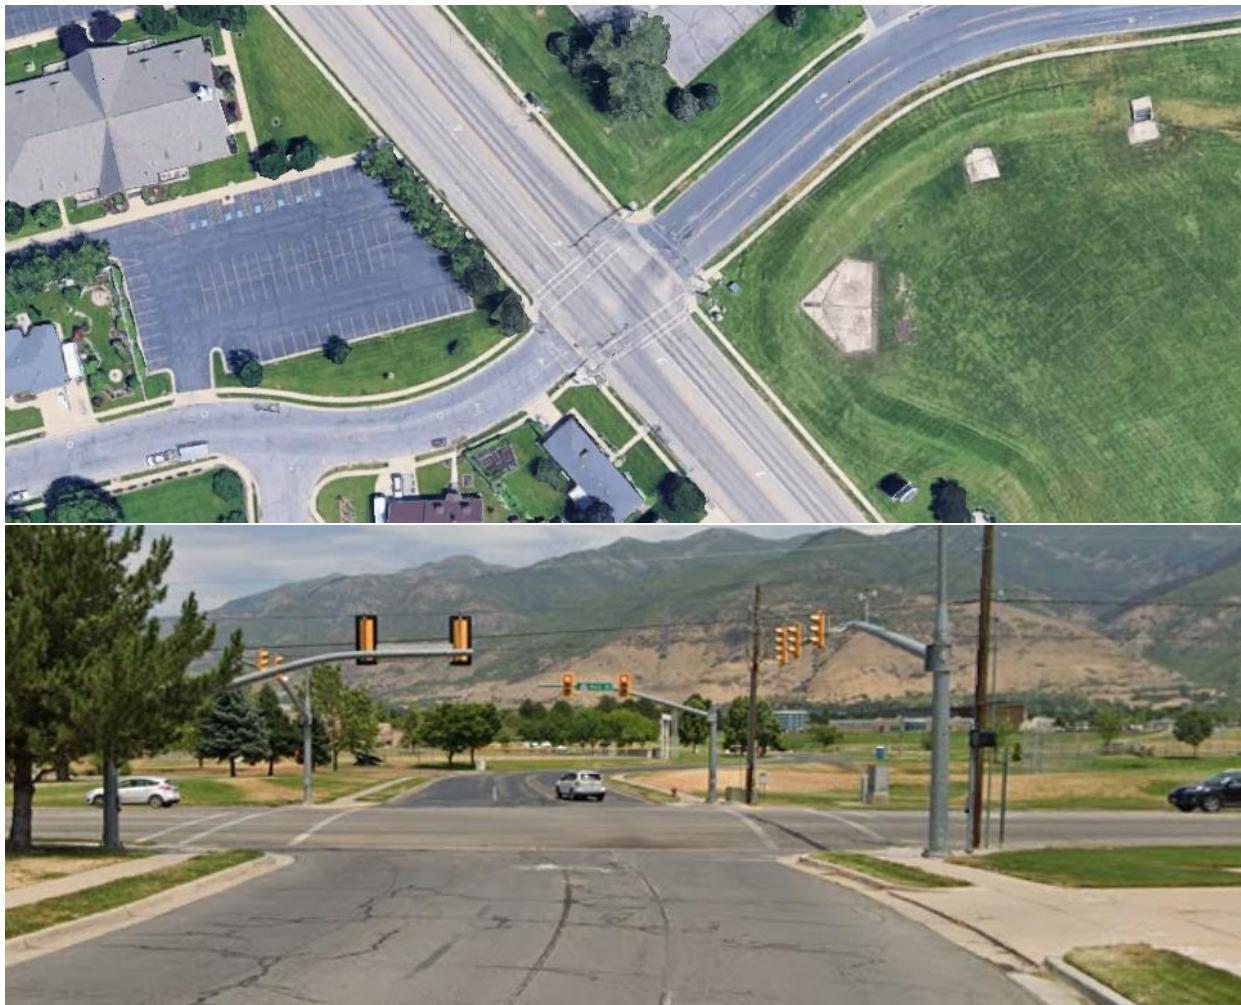
**Figure 5.4 Southbound Main Street (Facing East) at 550 South**

The Main Street roadway is 110 feet wide (curb to curb). Issues and recommended countermeasures for this site are listed in Table 5.4.

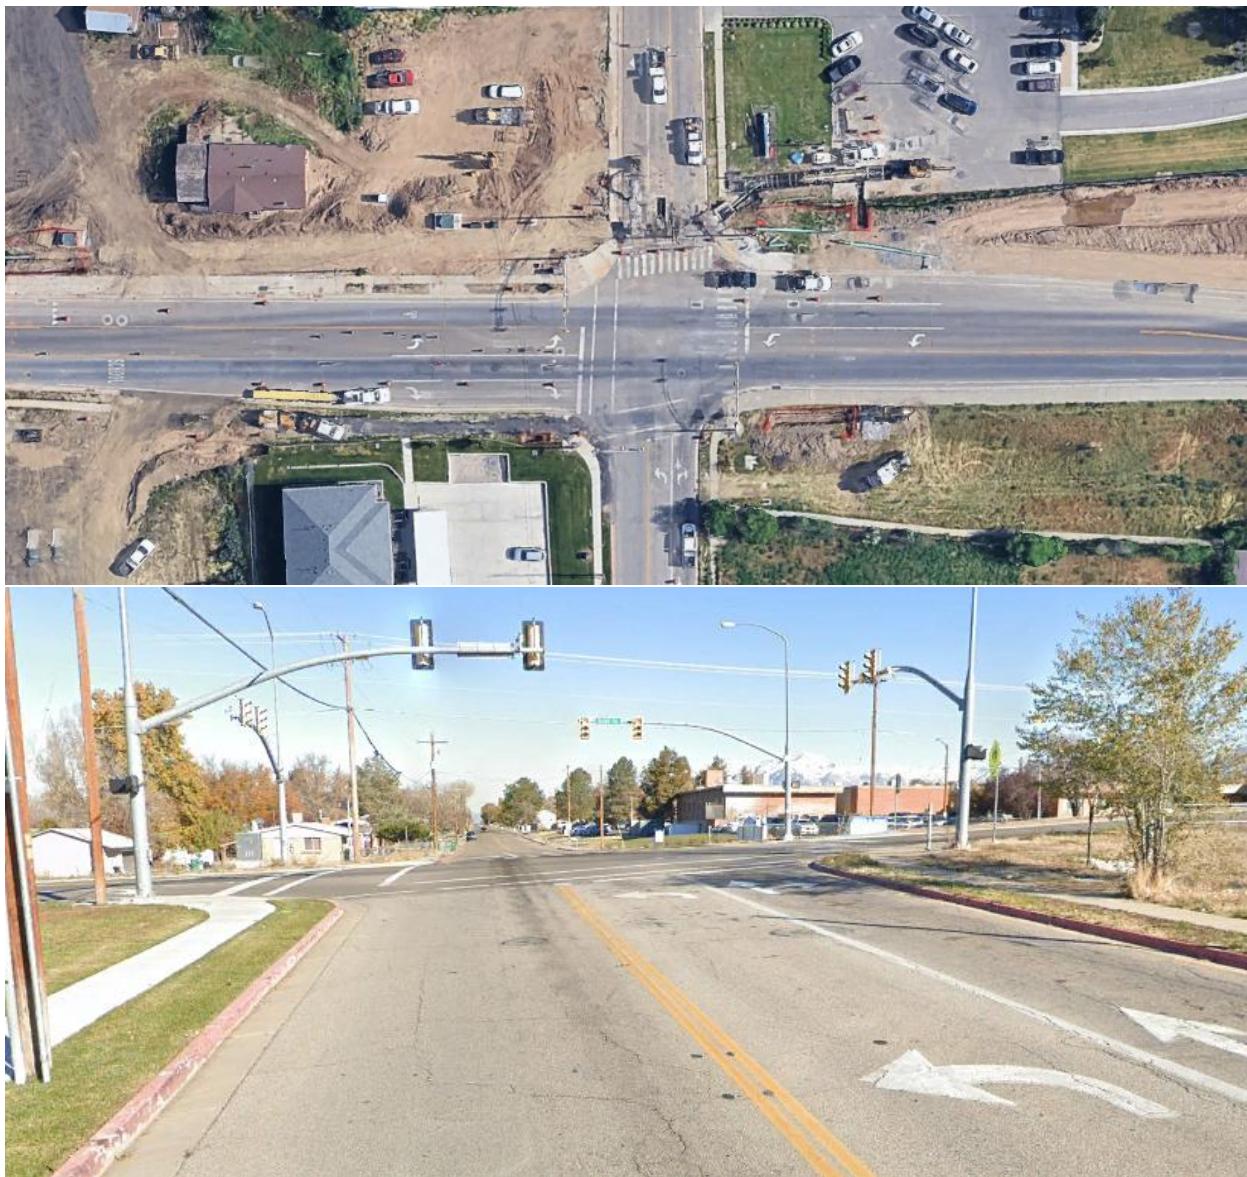
**Figure 5.5 2700 West at 5600 South (SR-97)**

The eastbound/westbound intersection approaches (on 5600 South) consist of a permissive left-turn lane, a through lane, and a right turn lane. The roadway width is 55 feet, and the crossing distance (ramp-to-ramp) is 75 feet (Error! Reference source not found.). 5600 South east of 2700 West includes a significant slope along a 1,000-foot segment between the intersection and a railroad bridge. Additionally, the Denver and Rio Grande (D&RG) Rail Trail crosses 5600 South approximately half-way between 2700 West and 2800 West. Issues and recommended countermeasures for this site are listed in Table 5.5.

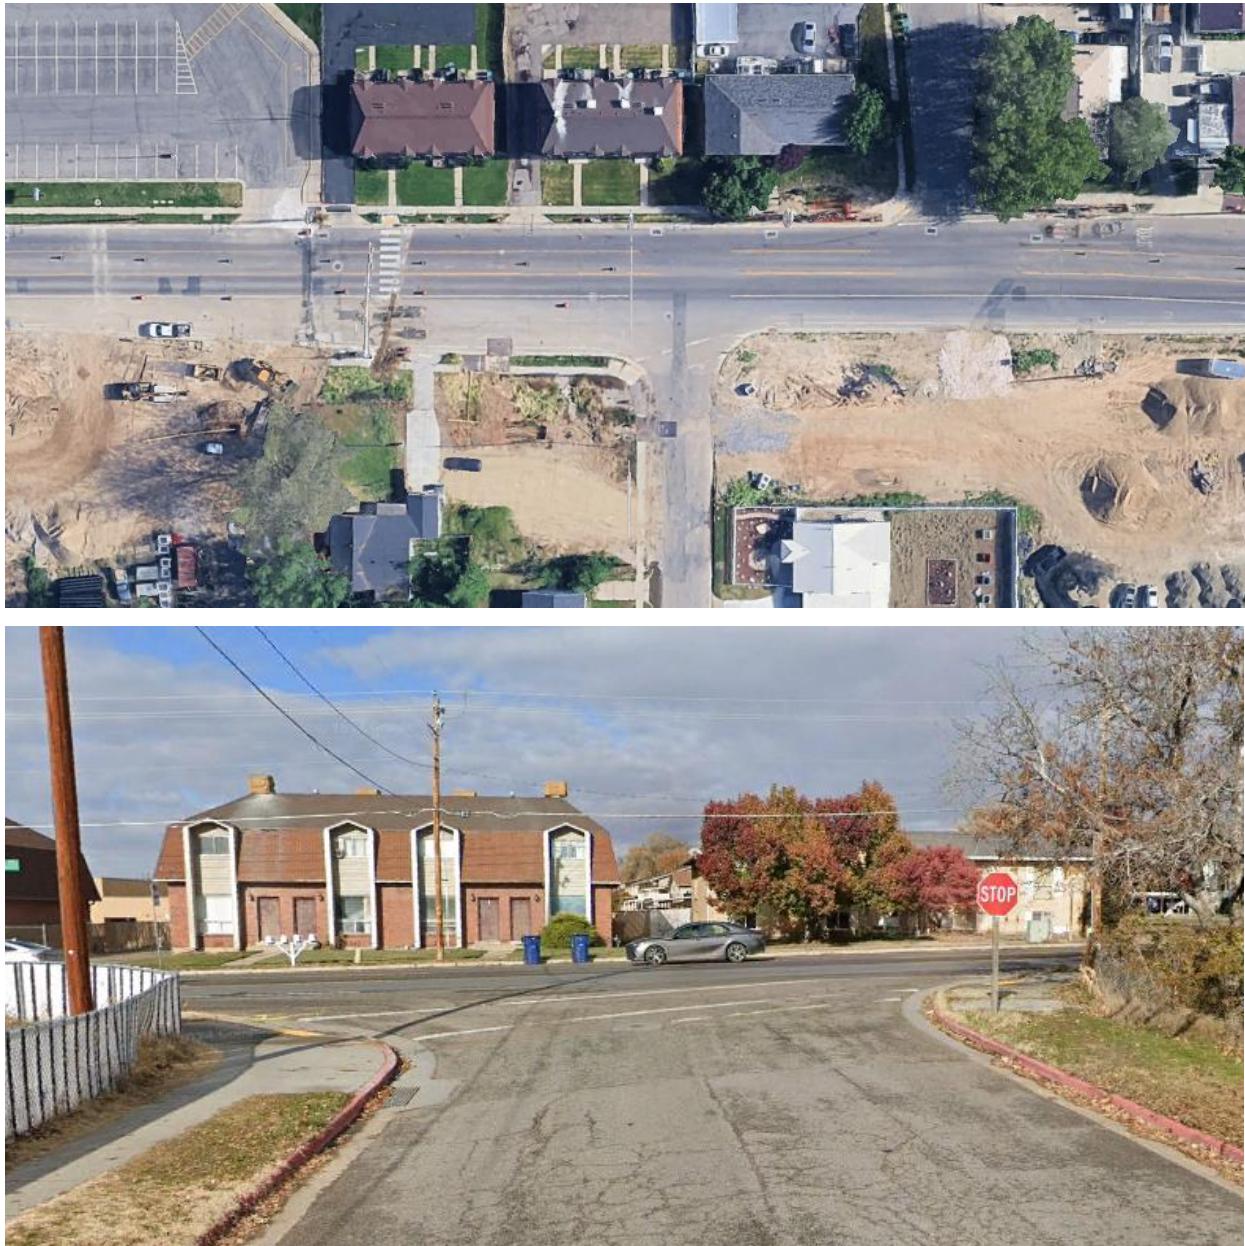
**Figure 5.6 5600 South (SR-97) at Southbound 2800 West**

standard crosswalk east/west, however there is currently no sidewalk on the east side of 2800 West. The crossing distance is 60 feet (ramp to ramp) while the roadway width is 30 feet (curb to curb). Eastbound 5600 South has a striped right-turn pocket approximately 65 feet long located between the HAWK crossing and southbound 2800 West. Issues and recommended countermeasures for this site are listed in Table 5.6.

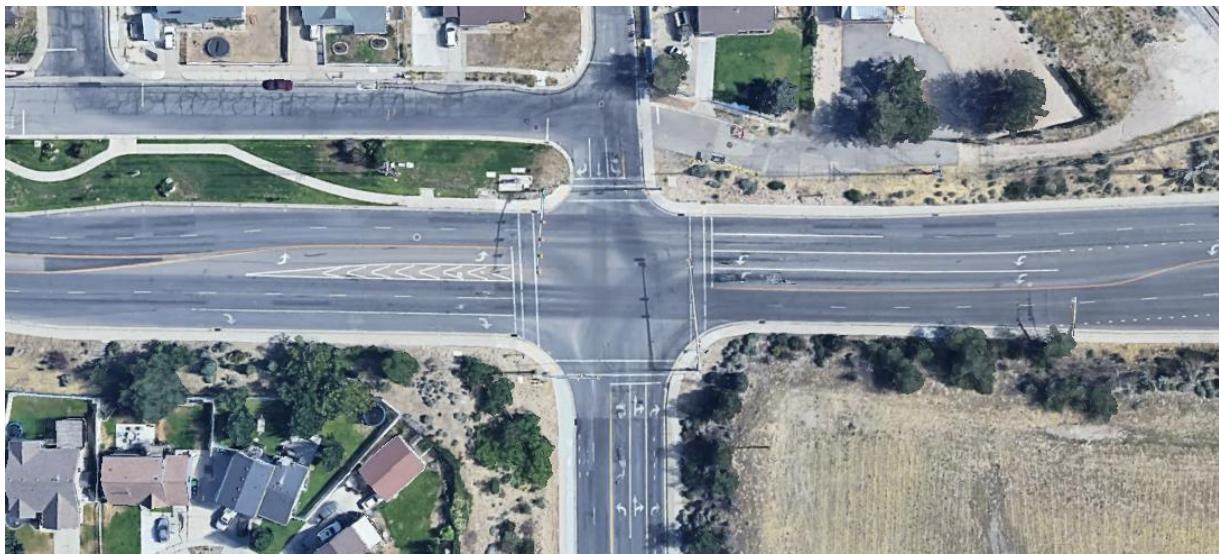
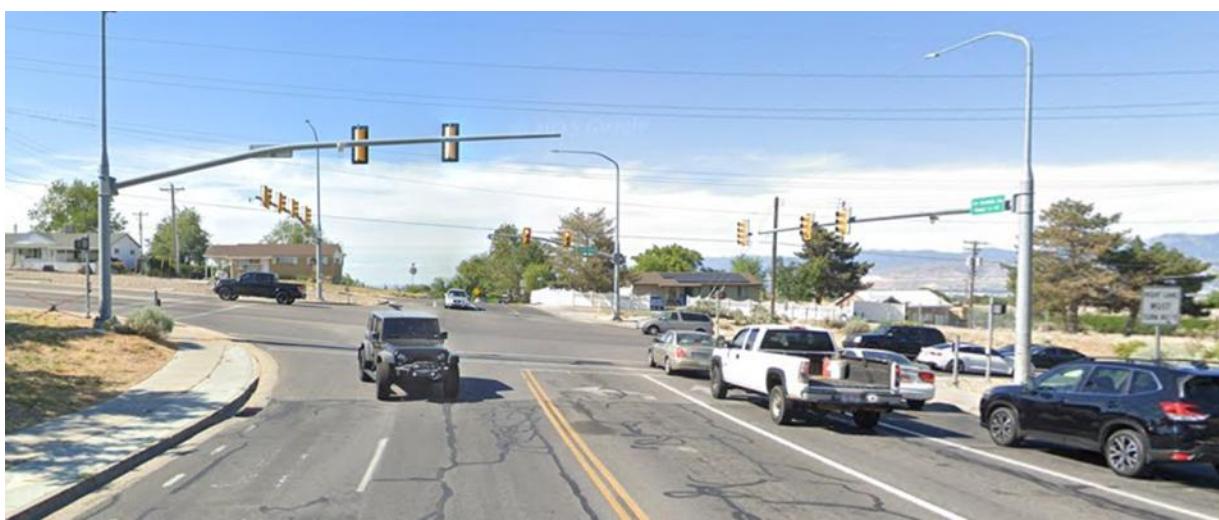
**Figure 5.7 Cougar Lane at 5400 South (SR-173)**

Both student-involved crashes at this location were the result of a left-turning vehicle coming southbound through the intersection. In one case, the driver of the left-turning vehicle struck a cyclist in the crosswalk as the rider was traveling northbound. In the second case, the driver of the left-turning vehicle hit an eastbound traveling vehicle, which caused the second vehicle to travel up onto the southeast sidewalk striking a pedestrian. Table 5.7 identifies the key issues for this location, with countermeasures to improve safety.

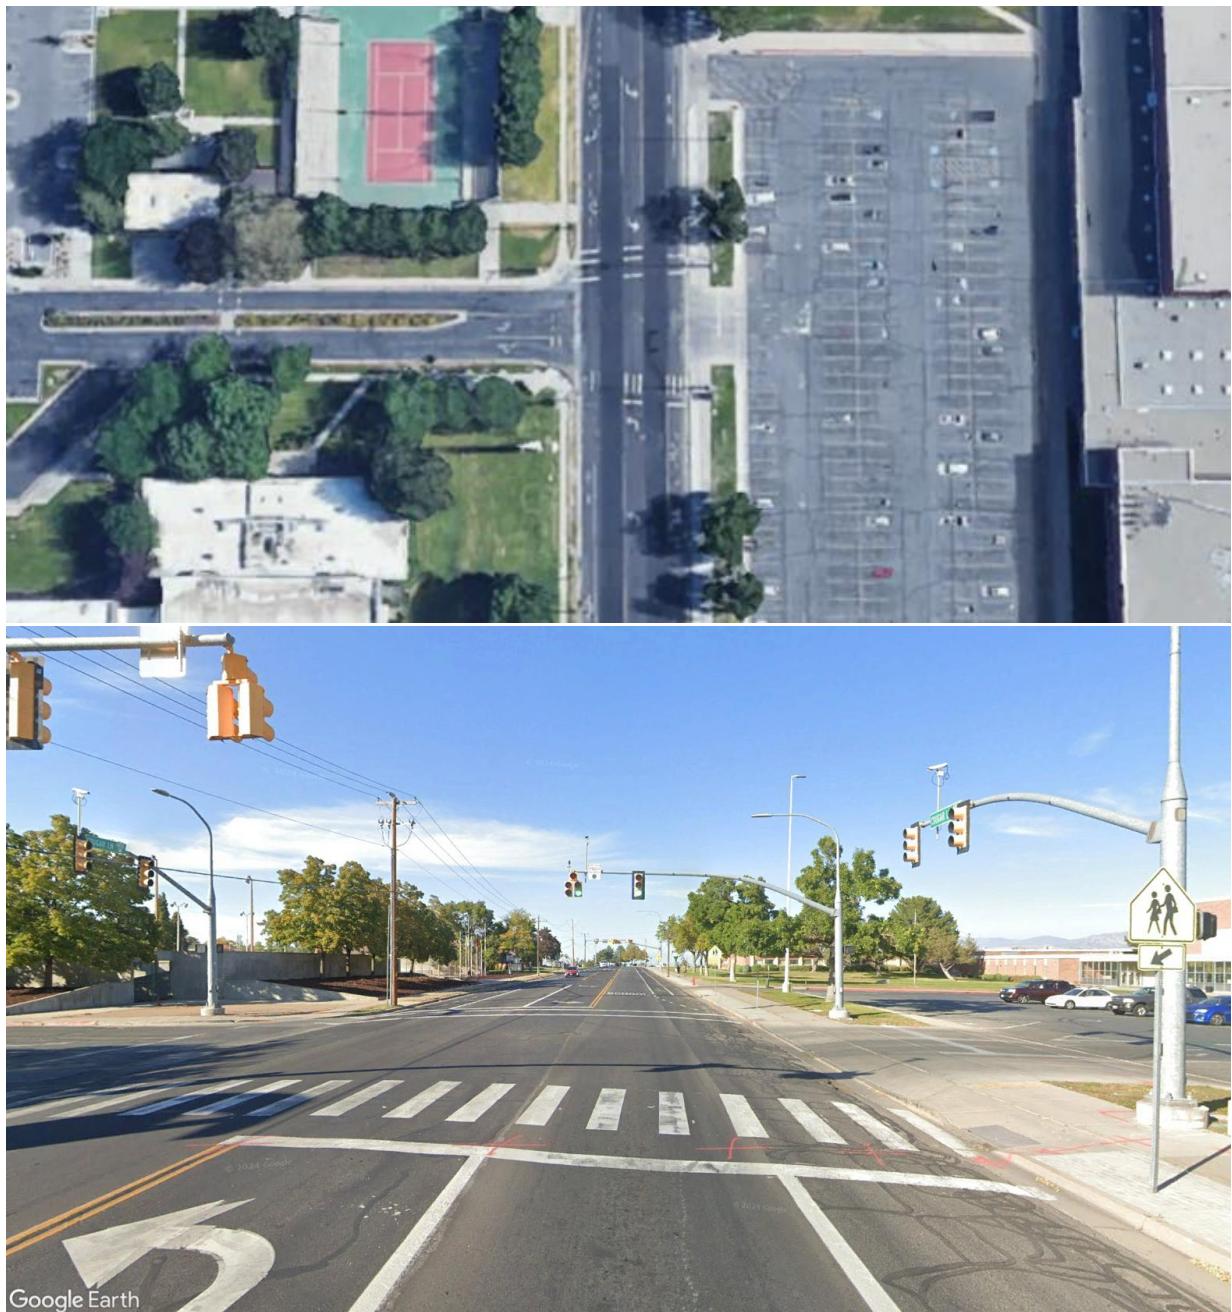
**Figure 5.8 Cougar Lane at KHS Entrance**

Both student-involved non-motorist crashes that occurred at this location involved a pedestrian being struck by a vehicle as the pedestrian was traveling west across the north leg of the intersection. Table 5.8 provides key issues and countermeasures for this site.

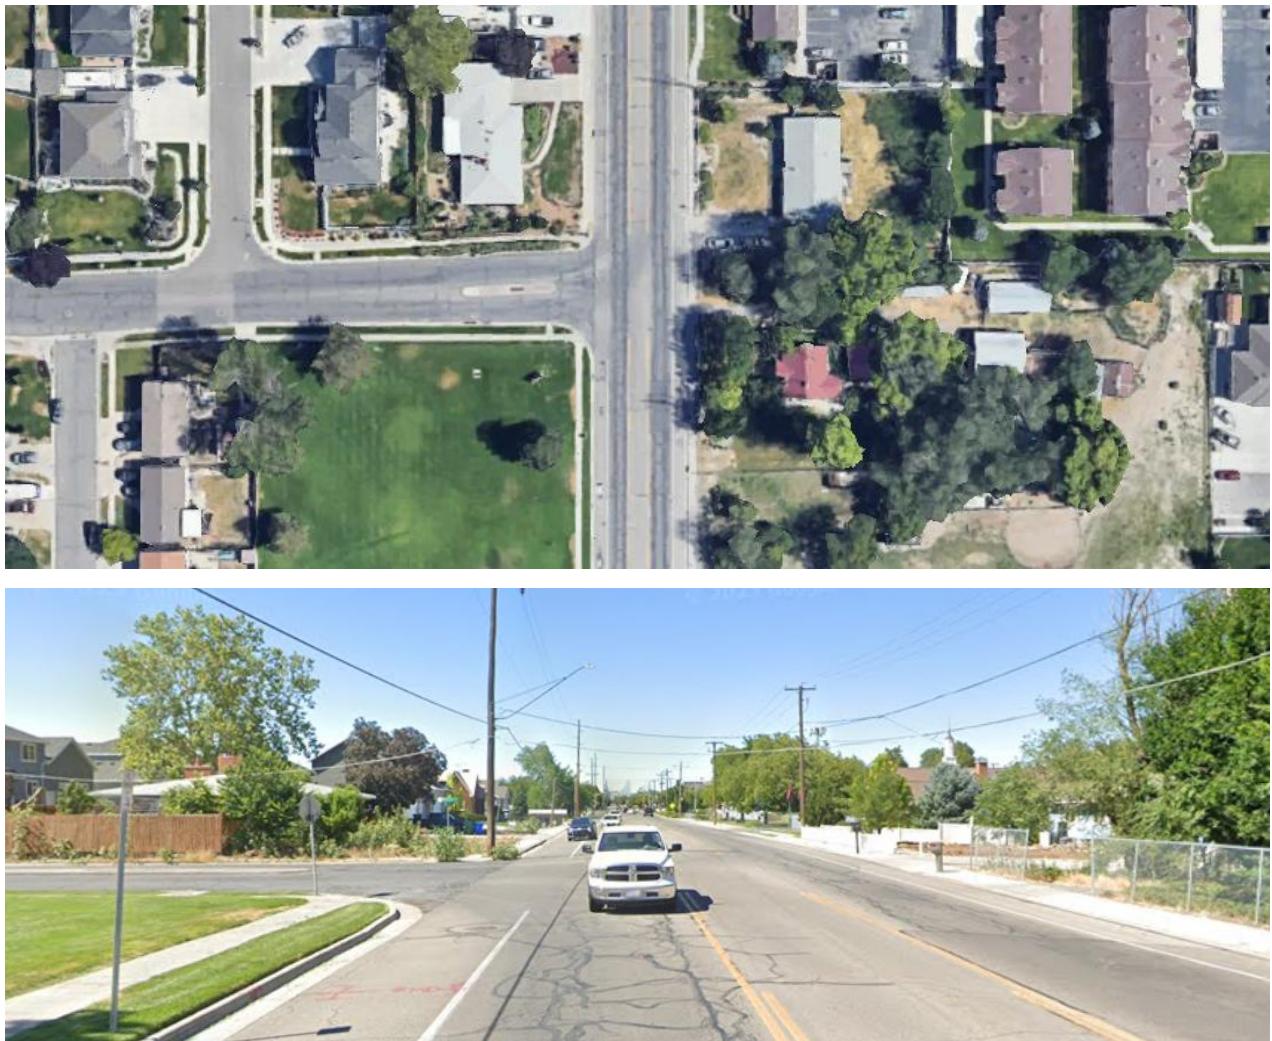
**Figure 5.9 2700 West and 7950 South**

pedestrians to wait at the intersection, and potentially decreasing pedestrian visibility. The crash involved at this intersection involved a vehicle on 7950 South approaching 2700 West eastbound and striking a pedestrian who was crossing 7950 South. Table 5.9 below lists the key issues and recommended countermeasures, along with potential costs.

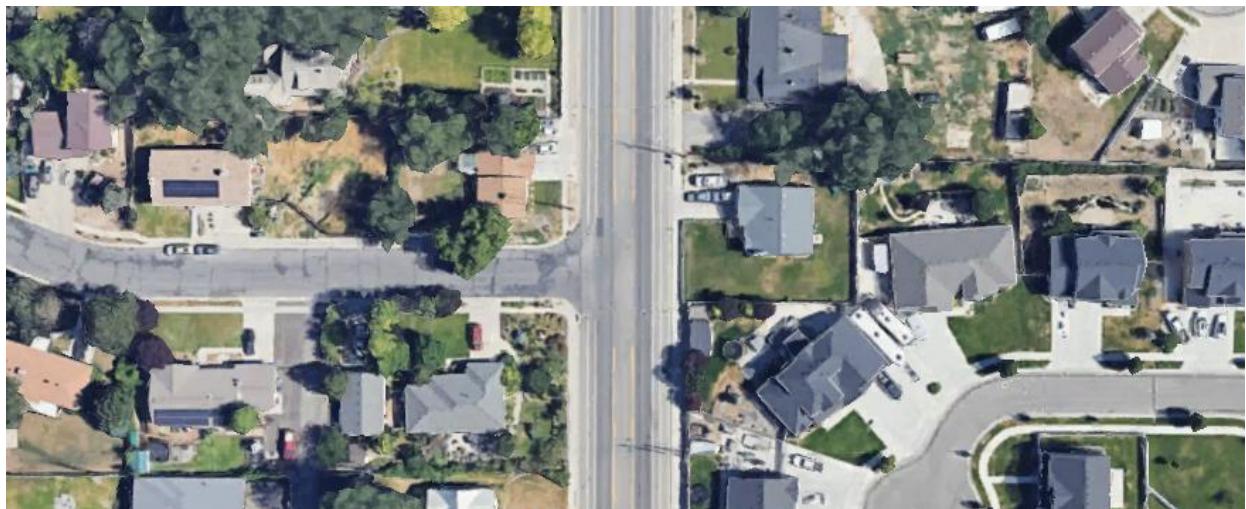
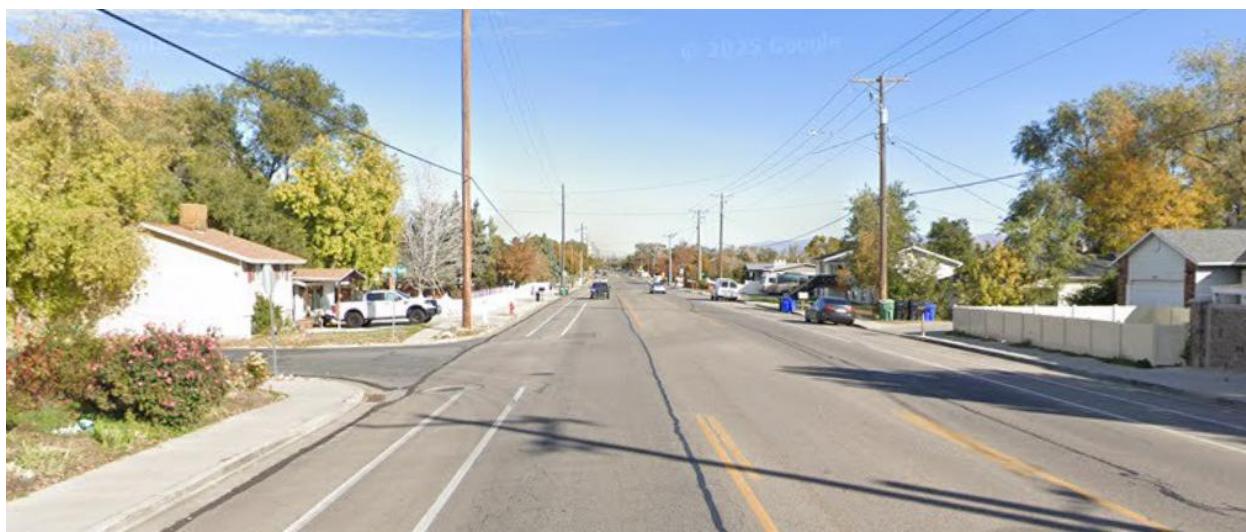
**Figure 5.11 2700 West and 8250 South**

As seen in Figure 5.11 below, the intersection of 2700 West and 8250 South is a T-intersection. Eastbound traffic approaching 2700 West is controlled by a stop sign. There is no pedestrian crosswalk across 8250 South, and no signs noting the presence of pedestrians or the nearby school area. The sidewalk ending at the north end of 8250 South does not feature an ADA ramp but simply ends at the curb. Both sidewalk corners are set back from the roadway, decreasing pedestrian visibility. Another feature of this area is that there are several trees and significant vegetation which potentially obscures pedestrians as they approach the intersection, making pedestrian visibility the key issue at this intersection. The crash recorded at this location consisted of an eastbound vehicle on 8250 South striking a bicyclist who was headed north toward the school area across 8250 South. Table 5.11 below displays countermeasures and associated costs for the issues at this location.

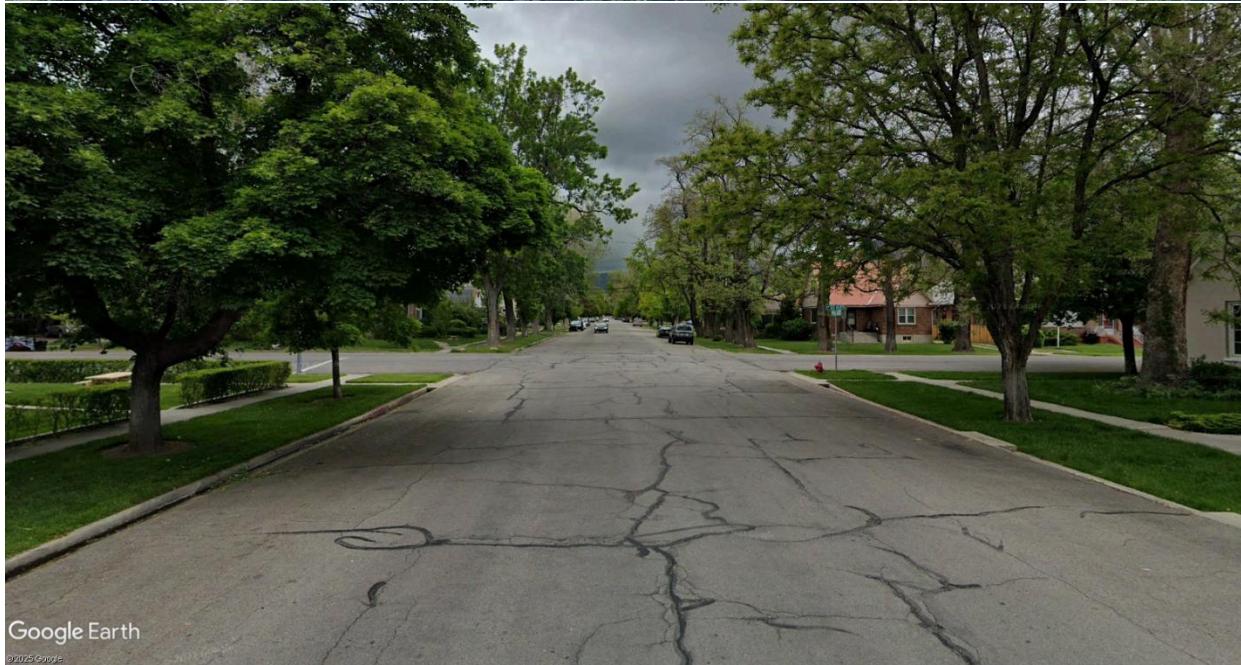
**Figure 5.12 400 East and 100 North**

400 East and 100 North are low-speed streets with posted speed limits of 25 MPH. However, as seen in Figure 5.12, the widths of these streets are not conducive to low speeds. The streets are approximately 45 feet wide, which equates to about 6 or 7 vehicle widths. Also, despite this being a residential neighborhood, 400 East and 100 North act as through routes for traffic, increasing opportunities for conflicts. There is also no signage warning of bicycles in the area. This lack of signage may have contributed to the bicycle-related crash at this intersection. Issues and recommended countermeasures for this site are listed in Table 5.12.

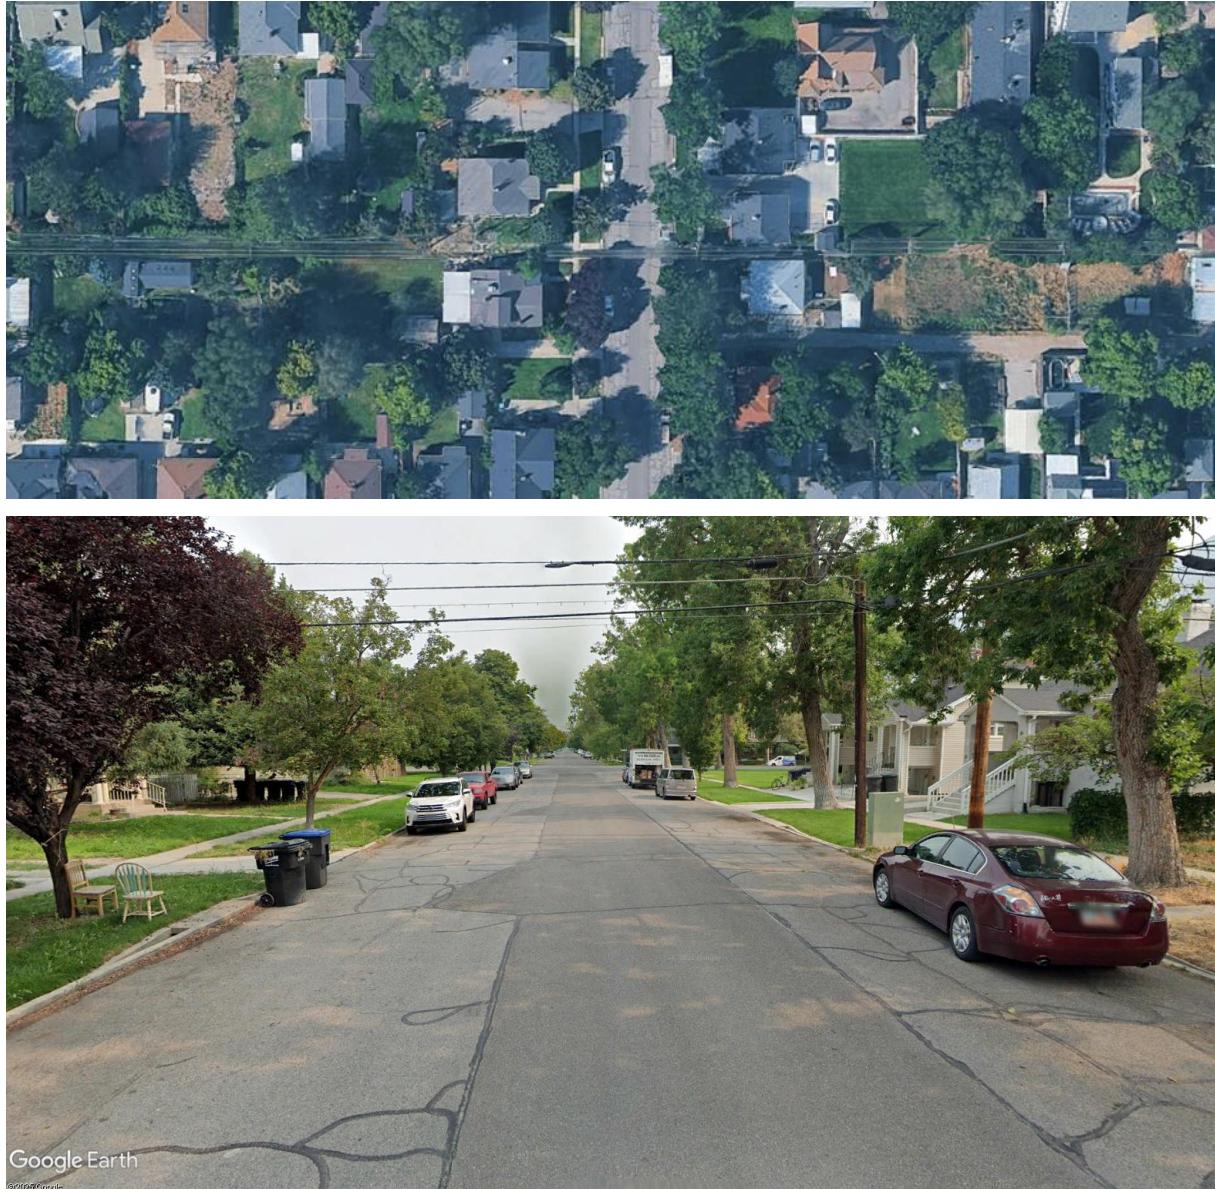
**Figure 5.13 500 East Between 100 South and Center Street (northbound)**

45 feet wide, which equates to about six or seven vehicle widths. Also, despite this being a residential neighborhood, 500 East acts as a through route for traffic, increasing opportunities for conflicts. Issues and recommended countermeasures for this site are listed in Table 5.13.

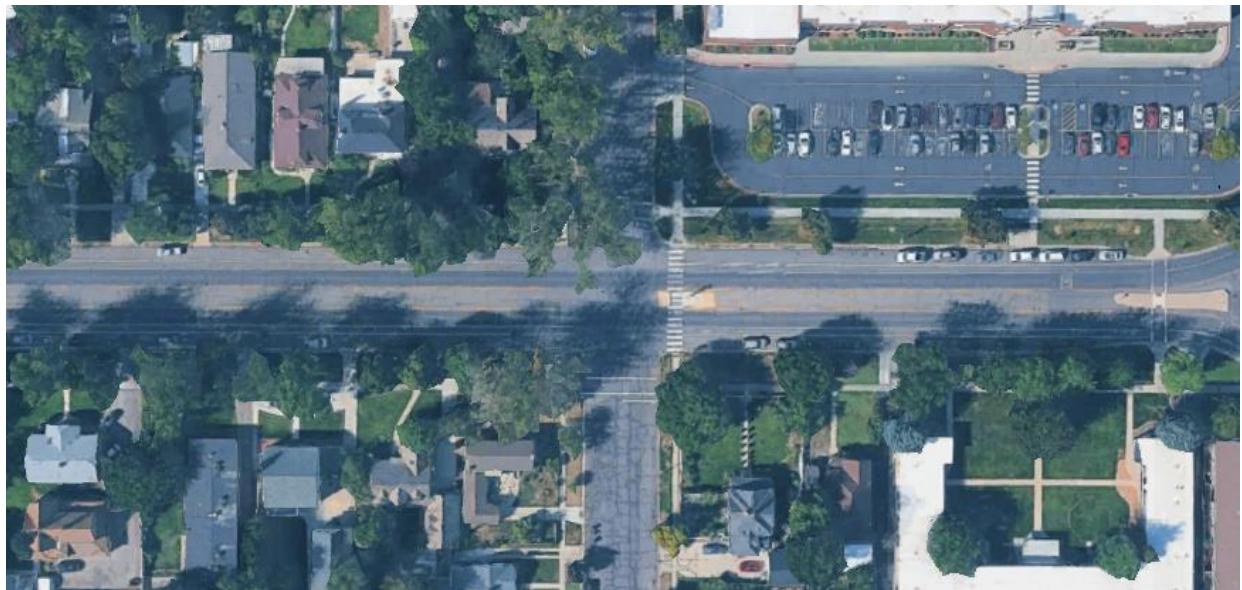
**Figure 5.14 Center Street and 600 East**

As seen in Figure 5.15, the intersection of Center Street and 600 East is on the southwest corner of Provo Peaks Elementary School and includes a school crosswalk on the east leg of the intersection. 600 East is a low-speed street with a posted speed limit of 25 MPH. However, the width of this street is not conducive to low speeds. The street is approximately 45 feet wide, which equates to about 6 or 7 vehicle widths. Also, despite this being a residential neighborhood, 600 East acts as a through route for traffic, increasing opportunities for conflicts. There is also no signage warning of bicycles or school-related traffic on the southbound approach which may have contributed to the bicycle-related crash at this intersection. Issues and recommended countermeasures for this site are listed in Table 5.14.

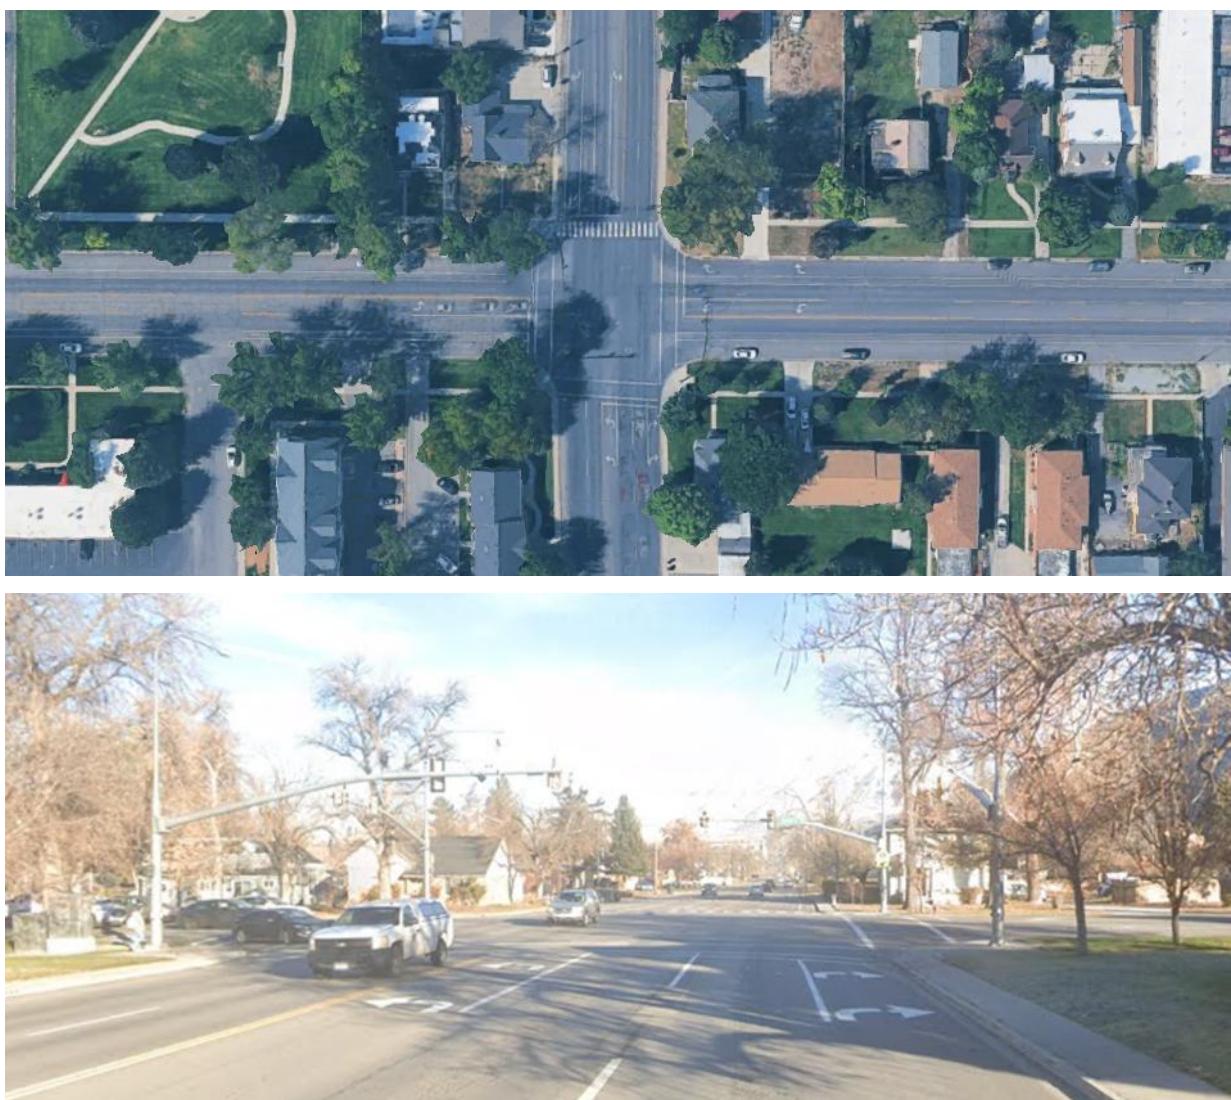
**Figure 5.15 Center Street and 900 East**

11,000 with a posted speed limit of 30 MPH and 900 East has a higher AADT of 10 – 20,000 with a posted speed limit of 35 MPH. This means there are more opportunities for dangerous conflicts on 900 East, where the student-related crashes occurred. The student-related crashes here involved turning vehicles. Each approach to the intersection uses permissive-protected left-turn phasing which could have contributed to these crashes. Also, it can be difficult for right-turning vehicles to see approaching pedestrians. Curb extensions can help make pedestrians more visible but may require lane reductions on some intersection approaches. Issues and recommended countermeasures for this site are listed in Table 5.15.

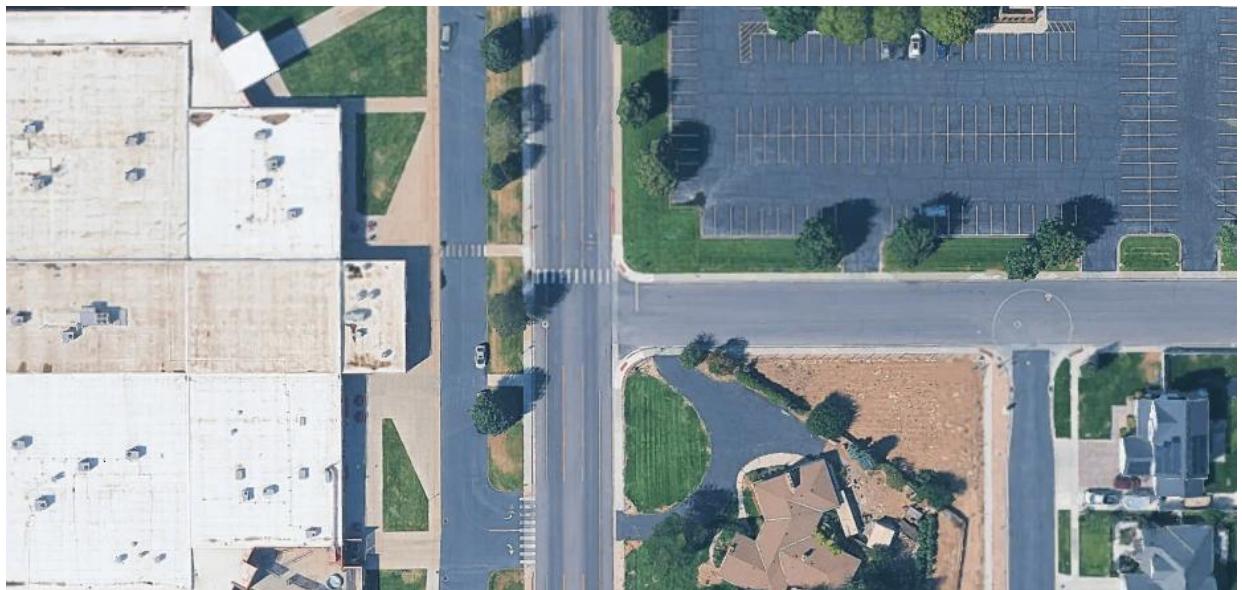
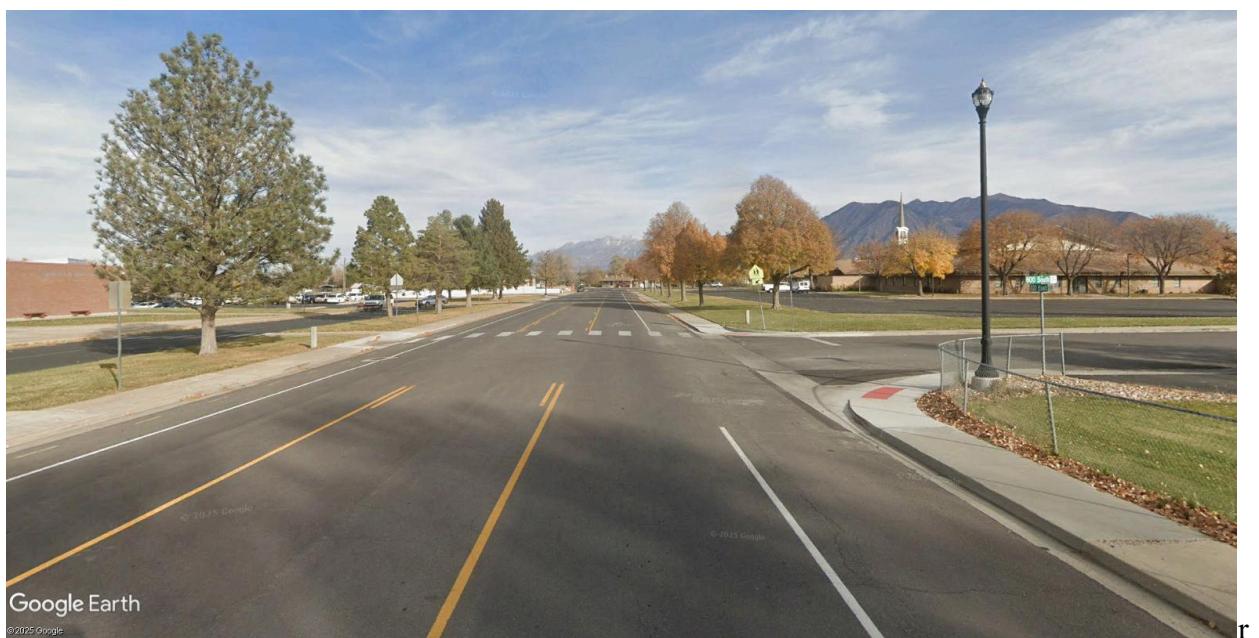
**Figure 5.17 820 East and 600 South**

As seen in Figure 5.18, the crossing on the north leg of the intersection of 820 East and 600 South is a school crosswalk which leads directly to Spanish Fork Jr. High. As such, a significant portion of students traveling on foot would be expected to cross at that location. Also, crash reports indicate that crashes occurred during dark conditions and there is only one streetlight on the opposite side of the intersection from the crosswalk. This streetlight also doesn't appear to have a directed beam which would be helpful for illuminating the crosswalk. 820 East and 600 South are low-volume residential streets, so they may also be viable for roadway narrowing. 820 East is 50 feet wide which can be narrowed to slow drivers down and make them more alert to pedestrians. Issues and recommended countermeasures for this site are listed in Table 5.17.
